# HISTORIC LANDMARK COMMISSION STAFF REPORT

Drayton Condominiums  
Major Alterations  
PLNHLC2011-00112  
1121 E. First Avenue  
April 6, 2011

# THE DRAYTON CONDOMINIUM PROJECT

WINDOW  
CONDITION  
SUMMARY

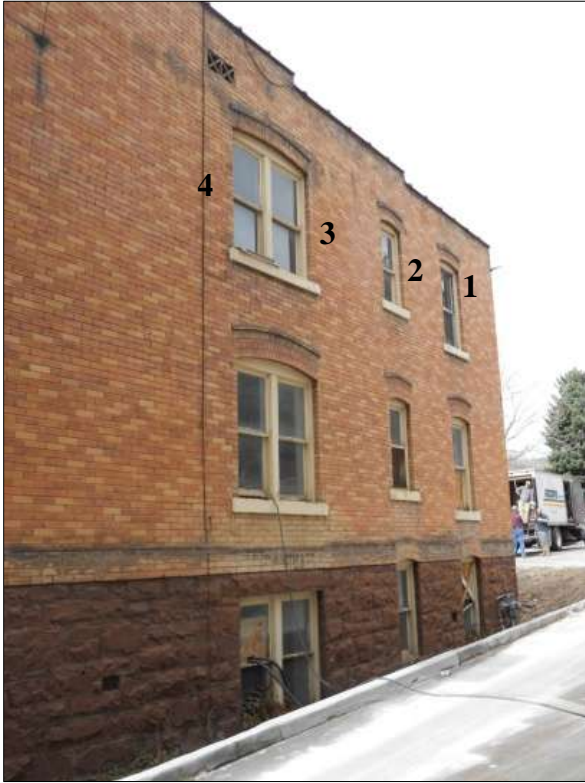
**East Façade**

<b>Number-Level</b>	<b>Condition</b>	<b>Proposed Treatment</b>	<b>Staff Recommendation</b>
01-Level 1	original/deteriorated	replace	replace
02-Level 1	original/sound	replace	repair
03-Level 1	original/sound	replace	repair
04-Level 1	original/sound	replace	repair
01-Level 2	original/sound	replace	repair
02-Level 2	original/sound	replace	repair
03-Level 2	original/sound	replace	repair
04-Level 2	original/sound	replace	repair
01-Level 3	Non-historic/sound	replace	replace
02-Level 3	original/sound	replace	repair
03-Level 3	original/sound	replace	repair
04-Level 3	original/sound	replace	repair

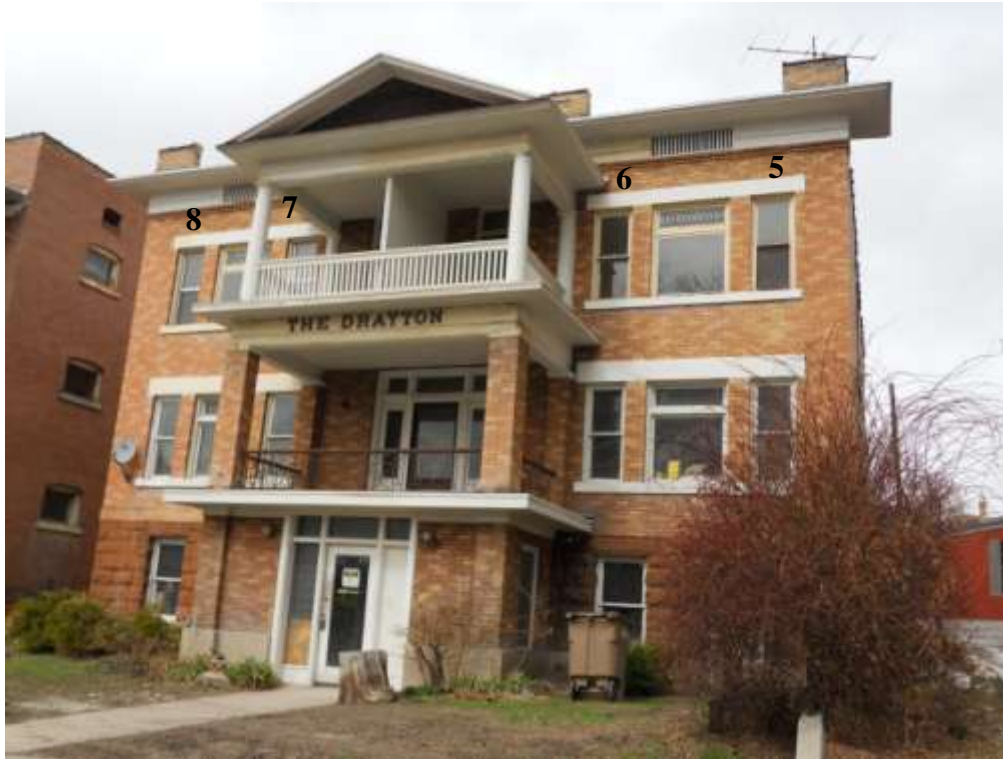
## Front and South Façade

Number-Level	Condition	Proposed Treatment	Staff Recommendation
05-Level 1	original/sound	repair	repair
06-Level 1	original/sound	repair	repair
07-Level 1	original/sound	repair	repair
08-Level 1	original/sound	repair	repair
05-Level 2	original/sound	repair	repair
06-Level 2	original/sound	repair	repair
07-Level 2	original/sound	repair	repair
08-Level 2	original/sound	repair	repair
05-Level 3	original/sound	repair	repair
06-Level 3	original/sound	repair	repair
07-Level 3	non-historic/sound	replace	replace
08-Level 3	non-historic/sound	replace	replace

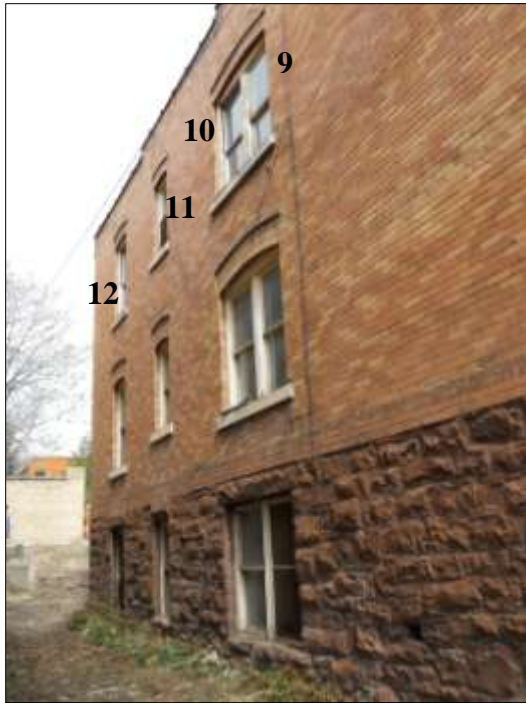
## West Façade

Number-Level	Condition	Proposed Treatment	Staff Recommendation
09-Level 1	original/sound	replace	repair
10-Level 1	original/sound	replace	repair
11-Level 1	original/sound	replace	repair
12-Level 1	original/sound	replace	repair
09-Level 2	original/sound	replace	repair
10-Level 2	original/sound	replace	repair
11-Level 2	original/sound	replace	repair
12-Level 2	original/sound	replace	repair
09-Level 3	original/sound	replace	repair
10-Level 3	original/sound	replace	repair
11-Level 3	original/sound	replace	repair
12-Level 3	original/sound	replace	repair

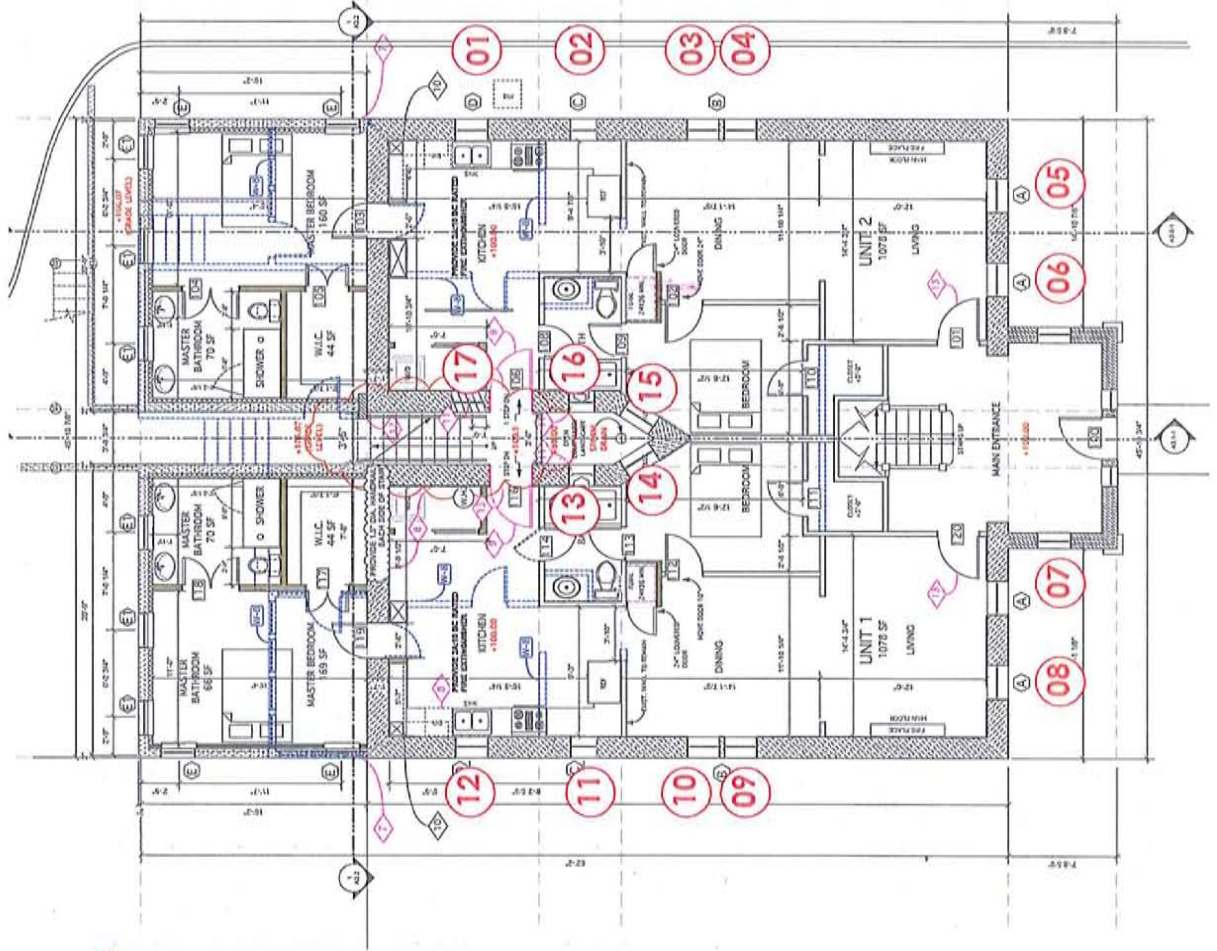
\* Window numbering begins at the northeast corner of the Drayton Building and continues clockwise around the building into the courtyard. The same for each level. Example:

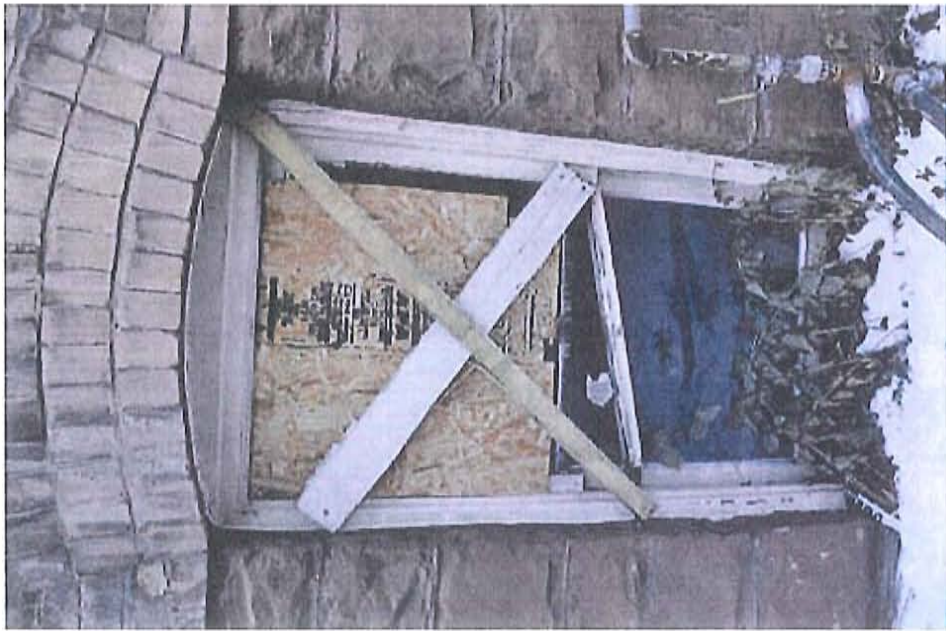
From the attached photographs and a site inspection, the original wood window 01-Level 1 on the east façade appears deteriorated. If the Commission were to consider a replacement window in this area, Planning Staff asserts that using a sash replacement would be the best approach. The metal windows are not original or consistent in design with the historic character of the building. In this instance, replacement would be an appropriate window treatment. Remaining original windows of this historic building could be rehabilitated, repaired, and upgraded with storm windows to make them energy-efficient while maintaining historic authenticity.

LEVEL 01	NUMBER/LEVEL/ELEVATION	CONSTRUCTION INTENT	CONDITION COMMENTS	IMAGE APPENDIX-NUMBER
	01 LEVEL 01-EAST	REPLACE UNIT W/ SIERRA PACIFIC CLAD DOUBLE HUNG	PAINTED SHUT, BROKEN MEETING RAIL	1
	02 LEVEL 01-EAST	REPLACE UNIT W/ SIERRA PACIFIC CLAD DOUBLE HUNG	PAINTED SHUT, NO COUNTER WEIGHT	2,3
	03 LEVEL 01-EAST	REPLACE UNIT W/ SIERRA PACIFIC CLAD DOUBLE HUNG	PAINTED SHUT, WOOD DETERIORATION	4
	04 LEVEL 01-EAST	REPLACE UNIT W/ SIERRA PACIFIC CLAD DOUBLE HUNG	NO COUNTER WEIGHT, BROKEN GLASS	5
	05 LEVEL 01-SOUTH	RETAIN AND REPAIR	COUNTER WEIGHT, PAINT & GLAZING PUTTY TO BE REPAIRED	6
	06 LEVEL 01-SOUTH	RETAIN AND REPAIR	COUNTER WEIGHT, PAINT & GLAZING PUTTY TO BE REPAIRED	7
	07 LEVEL 01-SOUTH	RETAIN AND REPAIR	COUNTER WEIGHT, PAINT & GLAZING PUTTY TO BE REPAIRED	10
	08 LEVEL 01-SOUTH	RETAIN AND REPAIR	COUNTER WEIGHT, PAINT & GLAZING PUTTY TO BE REPAIRED	11
	09 LEVEL 01-WEST	REPLACE UNIT W/ SIERRA PACIFIC CLAD DOUBLE HUNG	PAINTED SHUT, WOOD DETERIORATION	12
