Salt Lake City Historic Landmarks Commission
451 S. State St.
Salt Lake City, UT 84111

MEMORIAL HOUSE SUSTAINABILITY PLAN

90% DRAFT

SEPTEMBER 26, 2012

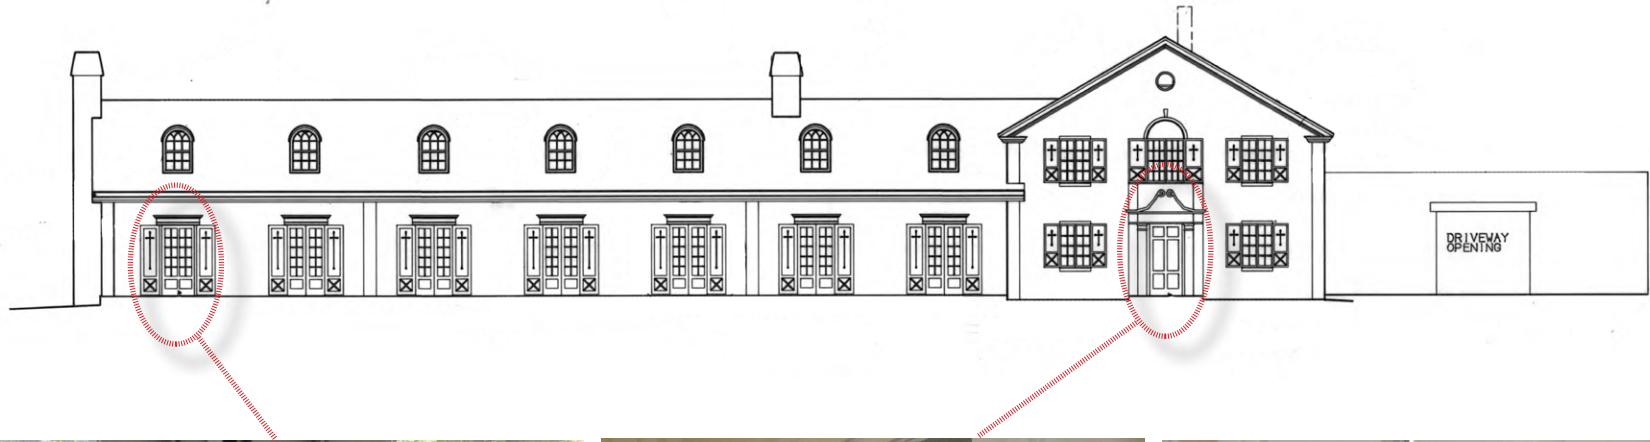
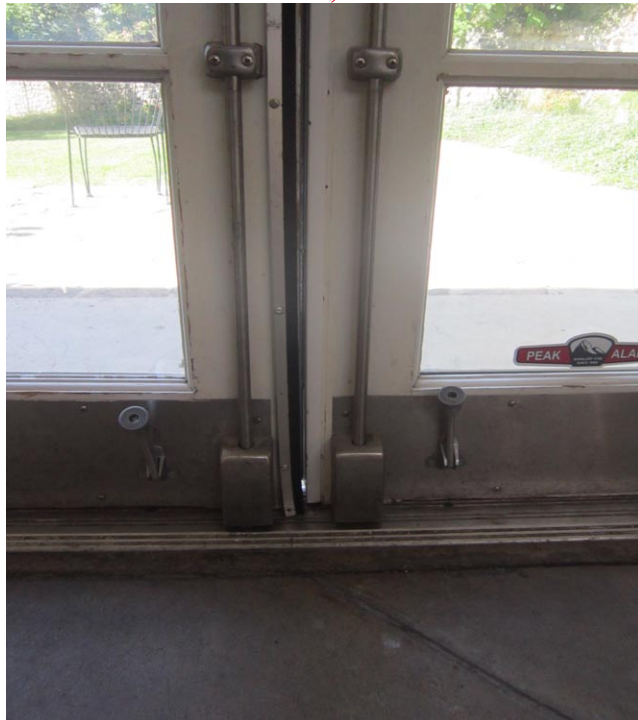
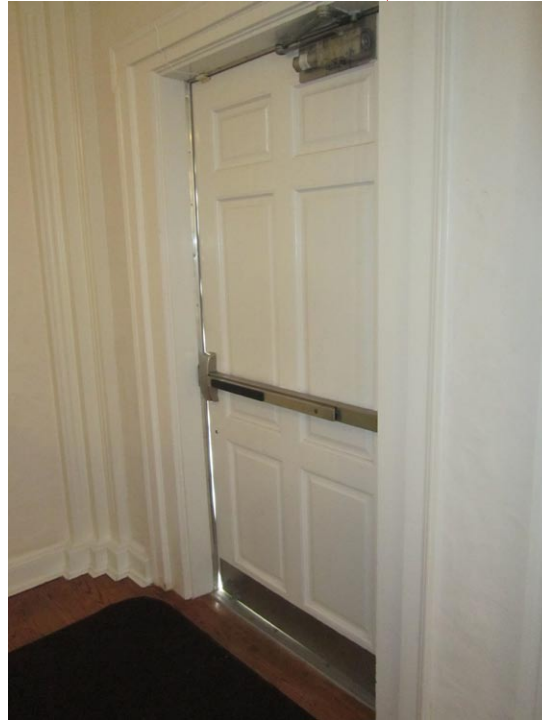
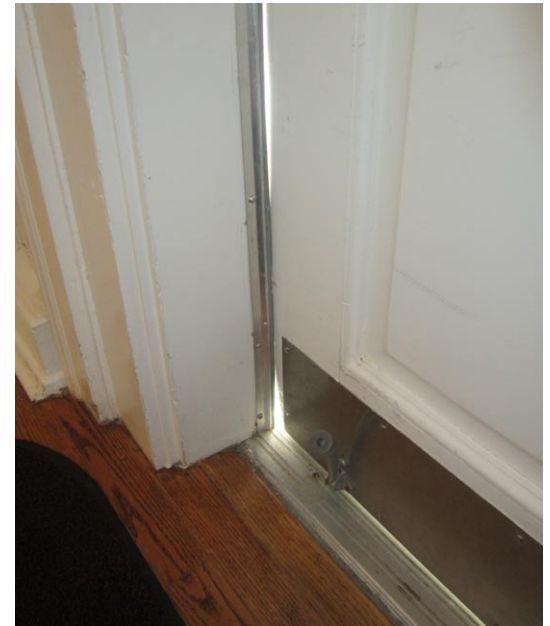
Graphic 1: Conditions of replacement doors

The doors of the main building are of two types, the original stile and rail wood doors, dating to the 1920s when the building was adapted from its use as a stable and converted to the meeting hall, and a replacement, ADA compliant door. (see Graphics 1 & 2)

While all the doors are far from air tight, the newer doors actually have the largest gaps around their edges.

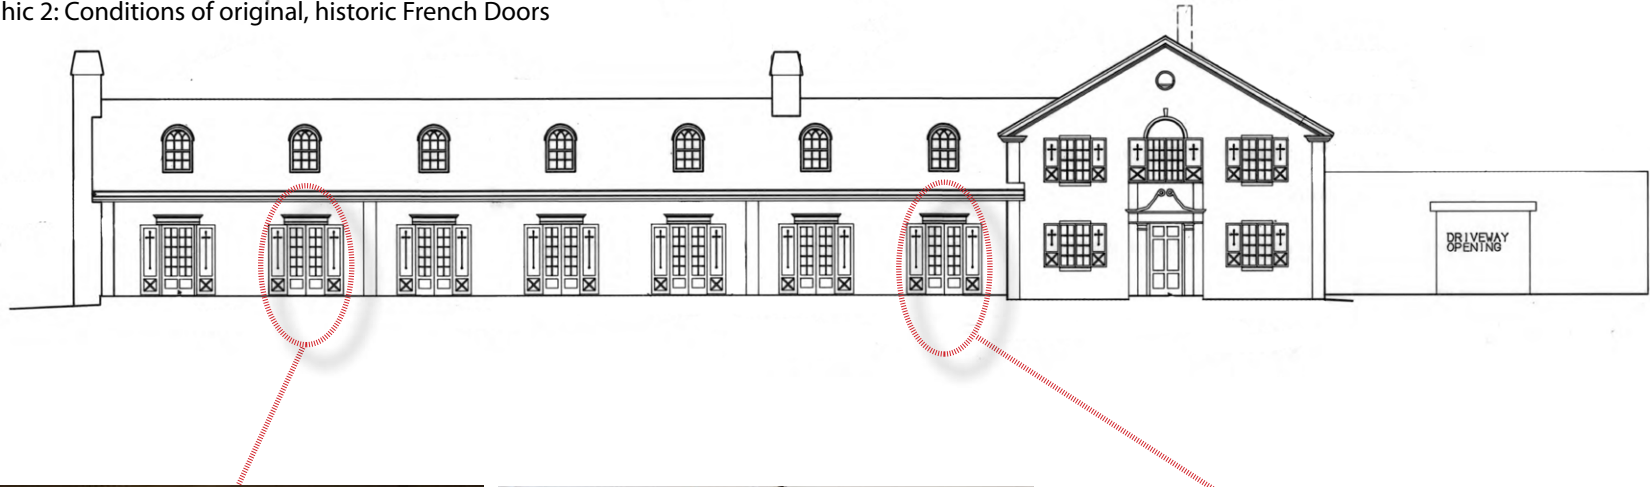
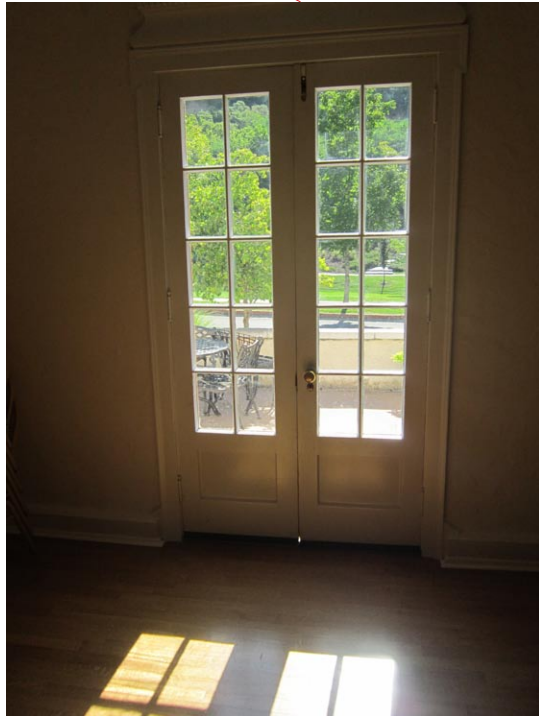
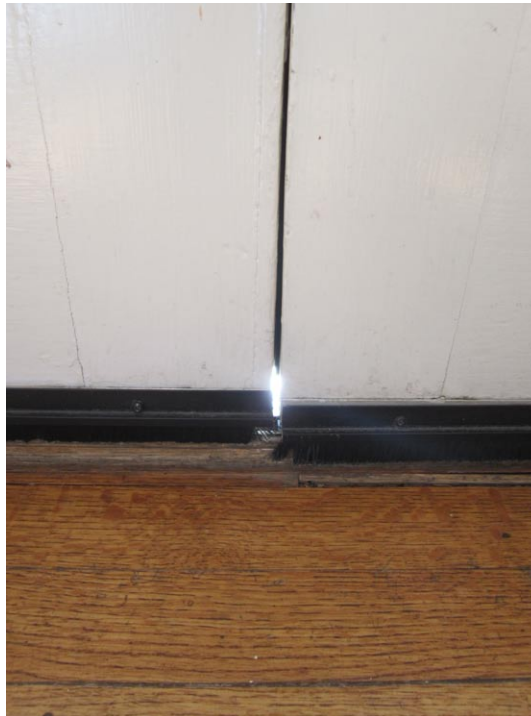
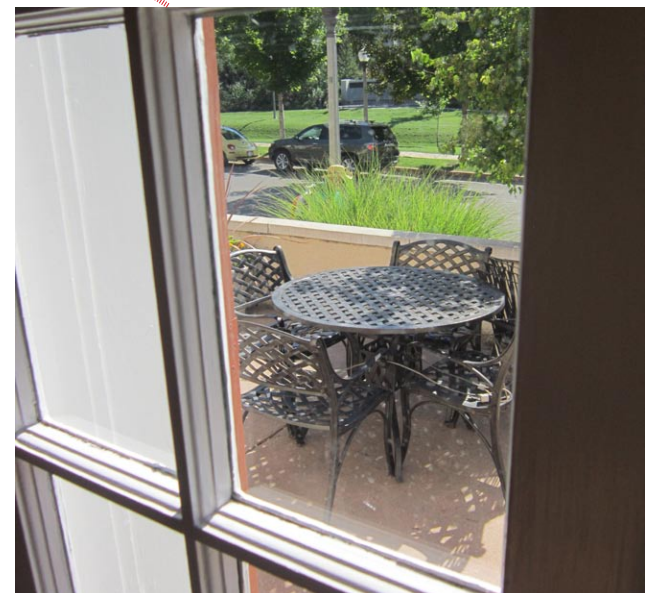
Graphic 2: Conditions of original, historic French Doors

For their age, some of the existing c. 1926 french doors appear to be in relatively good condition. While there are some gaps around the edge of the frame, there are few visible gaps between the double-leaf in each opening, with some notable exceptions. However, Memorial House staff describe the wood as 'rotting' and 'thin' with daylight visible through it for some units. A recent application of paint obscures this condition to some degree. Some of the doors show signs of deterioration at the base where water has damaged the wood over time. Additionally, the wood is failing in areas where the hardware is attached. Without exception, all of these doors (ca. 1926) have single glazed panes. There appears again to be an unsatisfactory U-factor value. (see Table 1 for R-value and U-factor estimates)

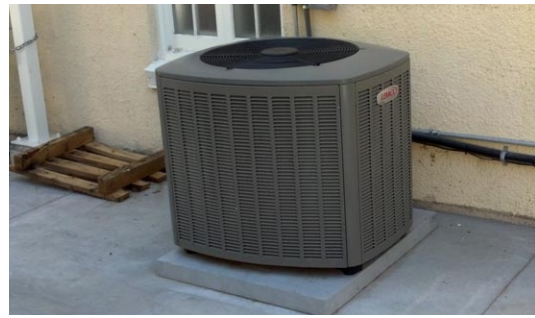
5-ton condensing unit for Main Hall

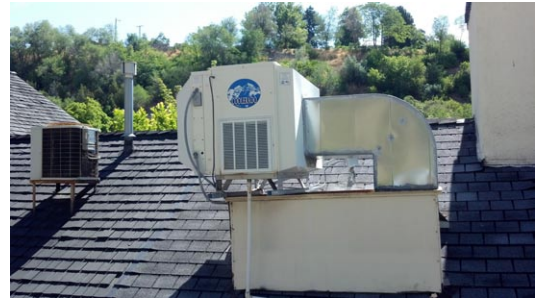
5-ton Coolerado unit for Main Hall and 2.5-ton condensing unit for second floor unit

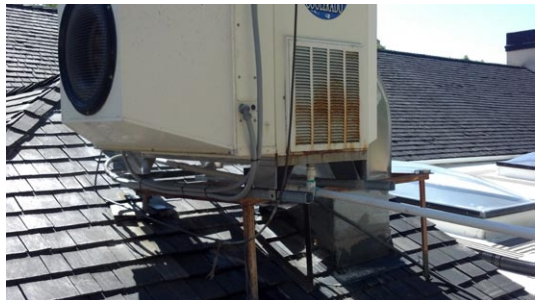
5-ton Coolerado unit for Garden Room

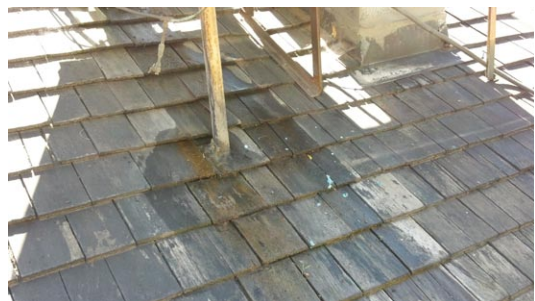
Leak from 5-ton Coolerado unit for Garden Room onto wood shingle roof

1. Correct leak on Garden Room Coolerado unit
2. Relocate thermostat for Main Hall to make it more responsive. The ideal location will place the thermostat in the main room it is controlling. Care should also be taken to avoid direct sunlight or drafts in the new location to avoid incorrect assessment of the ambient temperature of the space.
3. Replace handle on fireplace damper so that damper can be shut
4. Provide automatic ignition for the fireplace
5. Insulate ductwork in the basement, attic and Garden Room storage room
6. Modify controls to provide minimum ventilation air in heating occupied mode
7. Provide DX cooling for Garden Room furnace
8. Recommission cooling systems to restore efficiency.
9. Provide upgraded controls for Main Hall and Garden Room systems (see above)

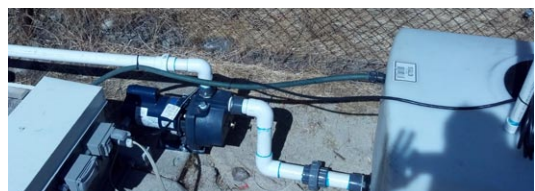
Pump and tank to pump waste water from Coolerado units to irrigation system

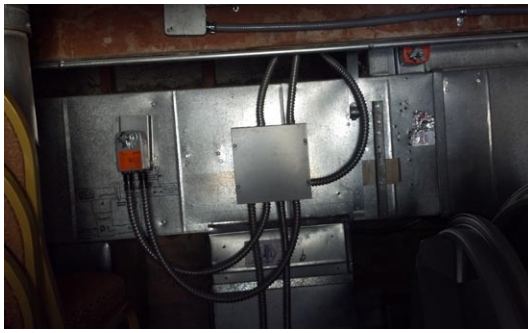
Dampers for Garden Room Coolerado unit and furnace

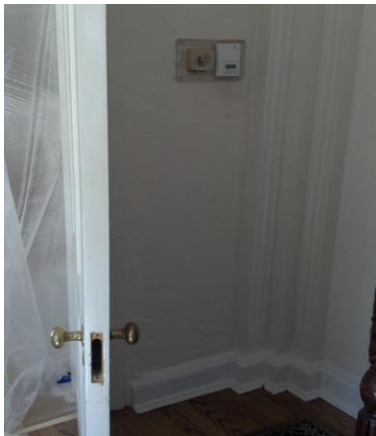
Thermostat for Main Hall behind the door in Corridor outside the Main Hall

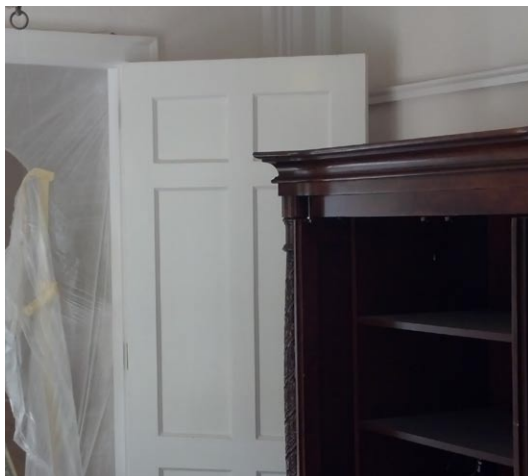
Thermostat for Main Hall in Corridor hidden behind the open door to the Main Hall

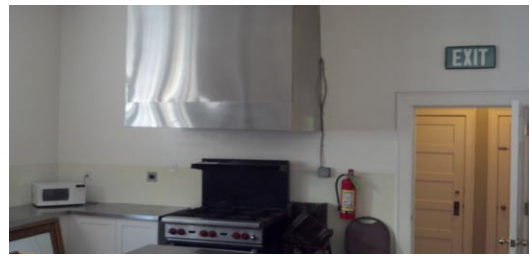
There is a Kitchen exhaust hood (that would not meet present standards) and no makeup air unit. The Kitchen is only used for food preparation for catered refreshments. The Kitchen should not be used as a commercial kitchen but should be adequate for its present use.

Kitchen hood

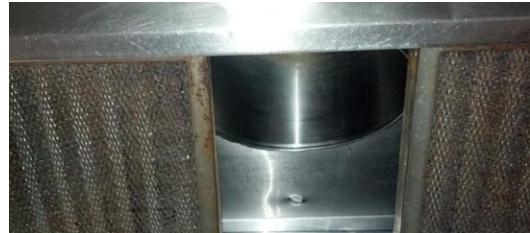
Kitchen hood showing open space between filters

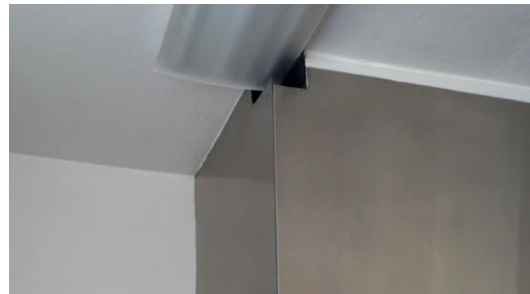
Kitchen hood showing hole for lighting fixture

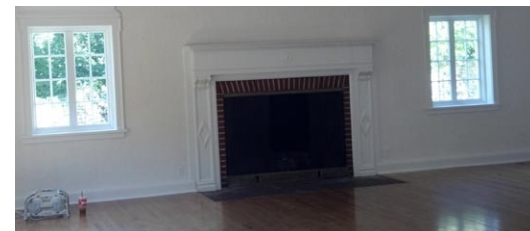
Fireplace without handle on damper

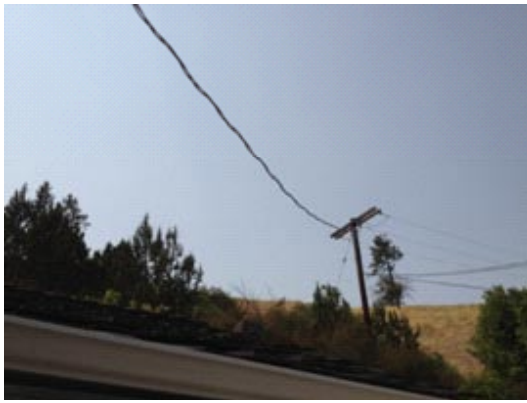
Power pole feeding building

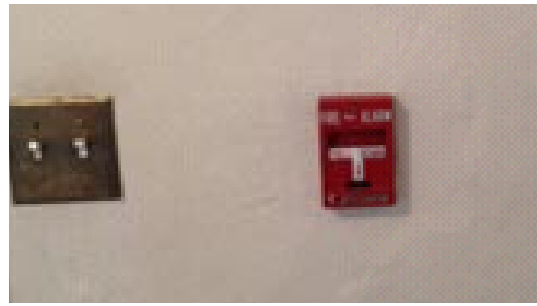
Fire Alarm pull station in acceptable condition.

1. Upgrade fire alarm system with new addressable panel.
2. Provide pull stations at the exit doors and near the stair on the second floor.
3. Provide smoke detection in the Main Hall.

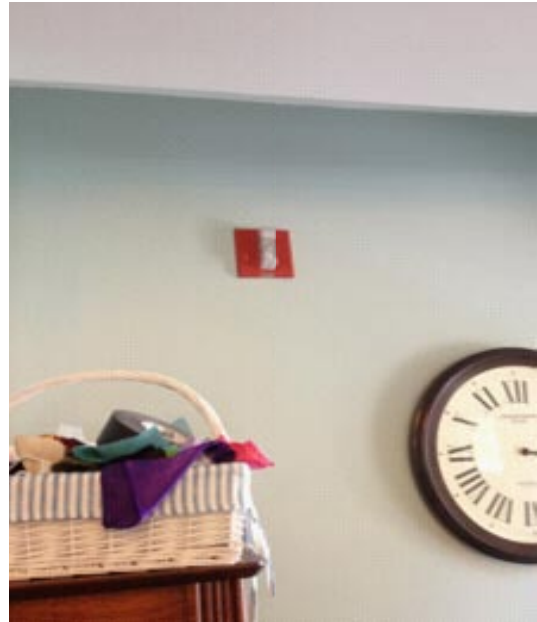
Fire alarm strobe in acceptable condition.
