Staff Report

To: Salt Lake City Historic Landmark Commission
From: Carl Leith, Senior Planner
801 535 7758 or carl.leith@slcgov.com
Date: June 2, 2016
Re: Determination of Contributing Status of a building at approximately 480 6th Avenue & 287 G Street

DETERMINATION OF CONTRIBUTING STATUS – SINGLE FAMILY DWELLING

Structural Evaluation and Recommendations

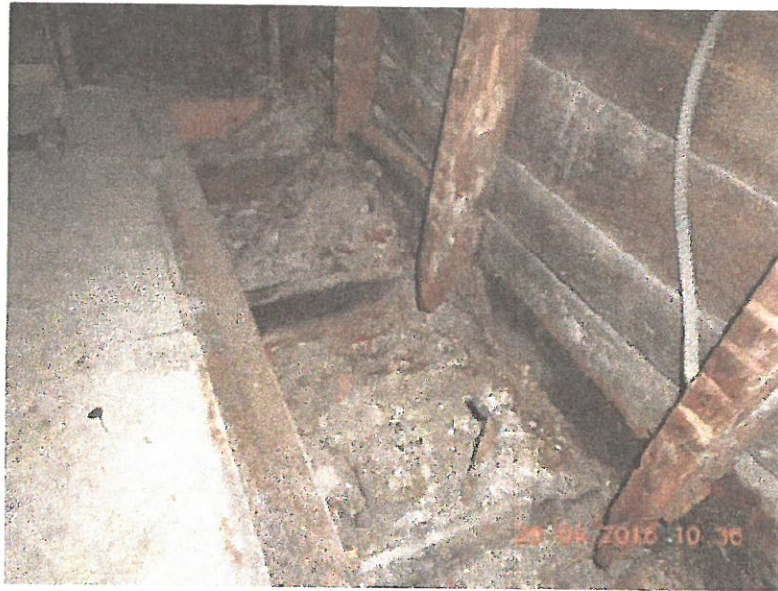
No.	Inadequacy	Recommended Repair	Photo No.	Schematic Sketch
S-1	Deteriorated bearing wall studs, lumber plank wall sheathing.	Remove rotten or damaged bearing wall studs. Replace with new studs. Remove rotten lumber wall planking, replace with new OSB sheathing or new lumber planking. New planking should be installed with at least (3) 8d nails per stud with (5) 8d nails at each plank end. Joints should offset at least one stud space and should be at least two planks between joints on the same support.	1,2,8,10	
S-2	Inadequate load path/connection at deteriorating foundation	Foundation should be replaced or repaired with adequate reinforcing to transfer both vertical and lateral forces. Provide new sill plate to attach floor framing.	5,7	
S-3	Inadequate load path at roof to wall connection.	Add blocking between rafters at top of wall, provide nailing or metal clip from roof sheathing to blocking and blocking to top of wall. Add additional stud at roof rafter bearing locations. Revise roof framing so rafters fully bear on wall and not on adjacent ceiling joist.	3,9	2

S-4	Deteriorated floor joists, non-treated wood embedded in concrete.	Remove rotten or deteriorated floor joists, new floor joists should bear on a pressure treated sill plate attached to the foundation.	1,4,5,10	3

Photo 1 –Deteriorated wall studs and floor joists

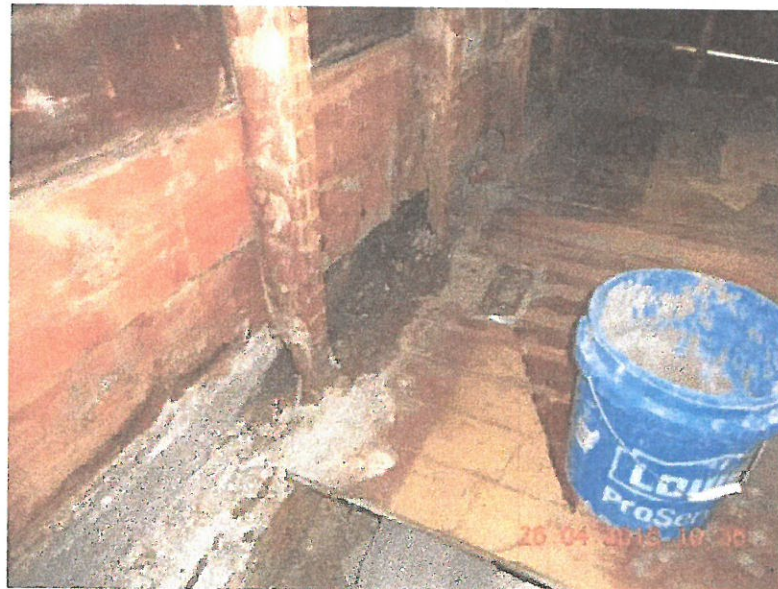
Photo 2 – Deteriorated wall studs and floor joists

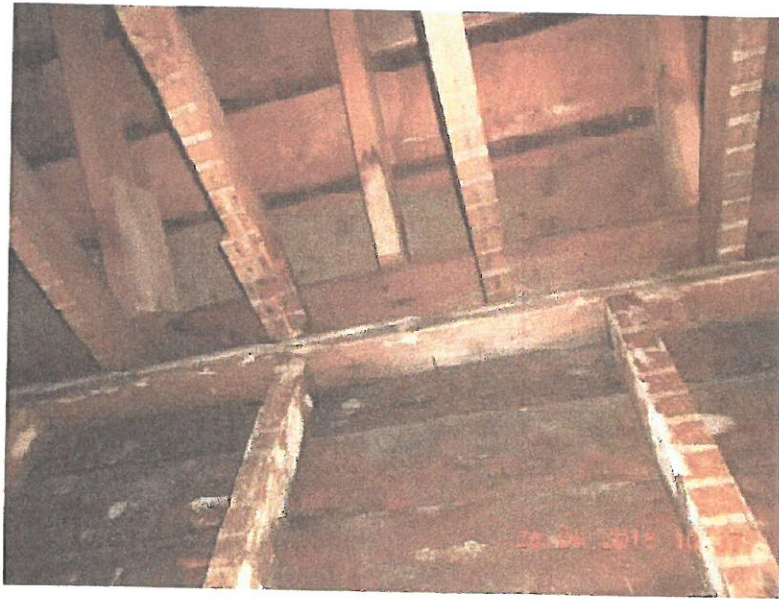
Photo 3 – Discontinuous load path at roof to wall connection

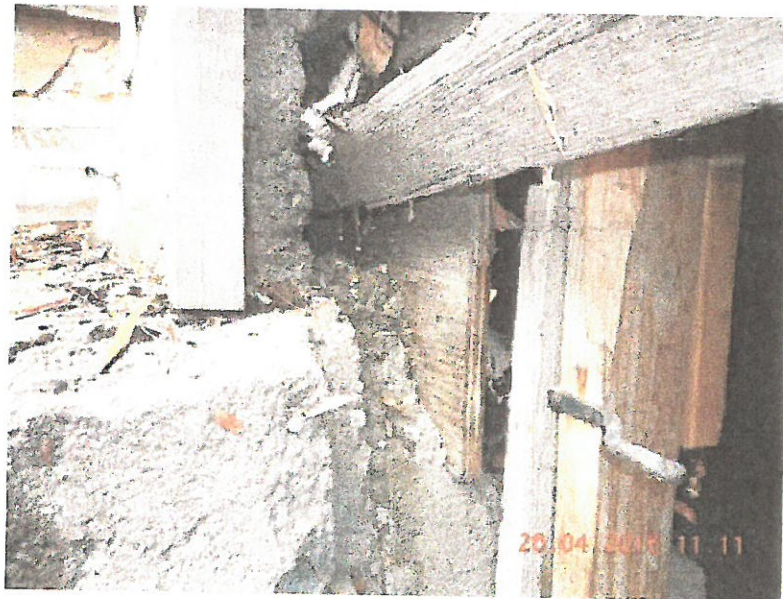
Photo 4 – Non-treated wood embedded in concrete

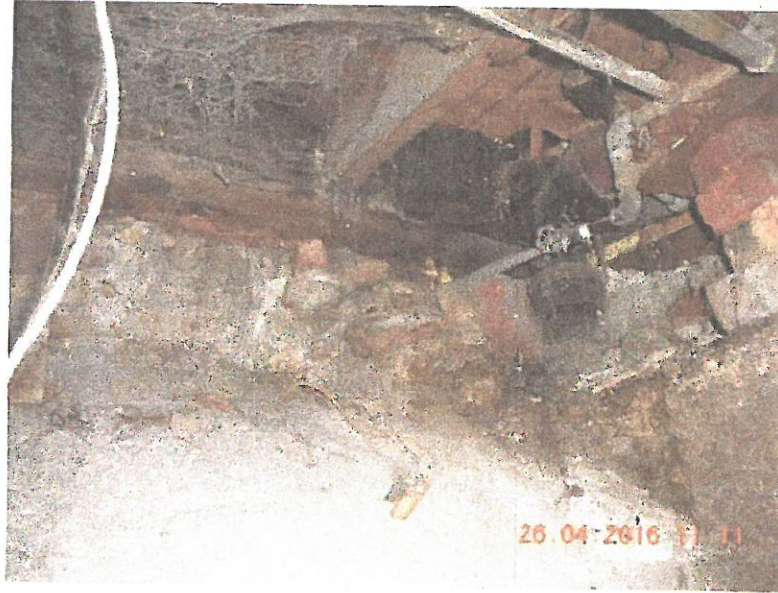
Photo 5 – Inadequate load transfer connection at deteriorating foundation

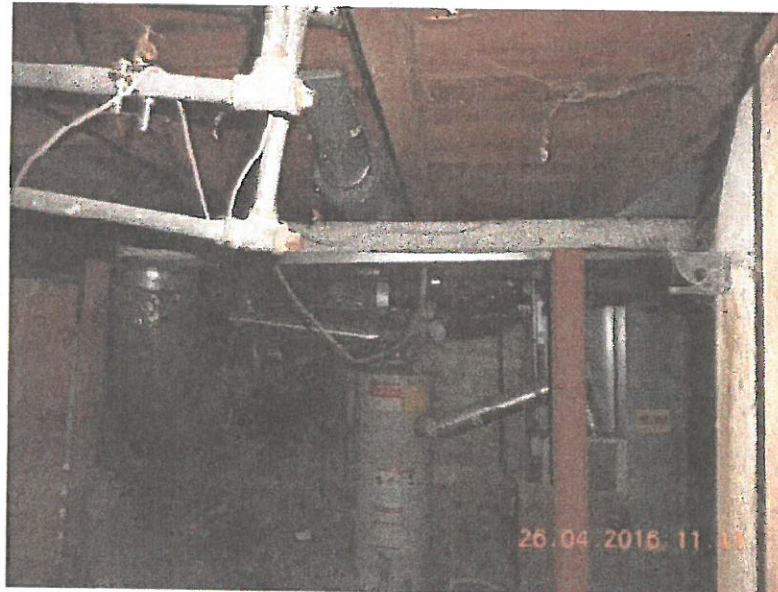
Photo 6 – Apparent added shoring for floor support

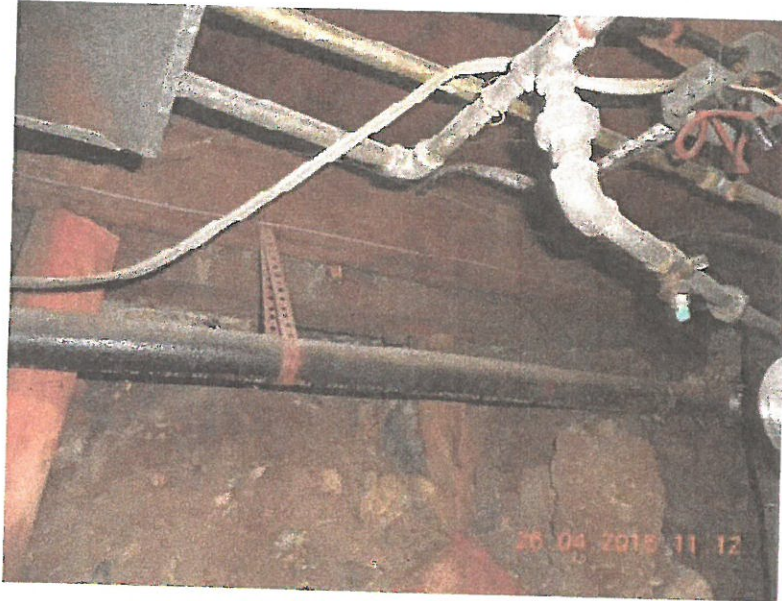
Photo 7 – Inadequate load transfer connection at deteriorating foundation

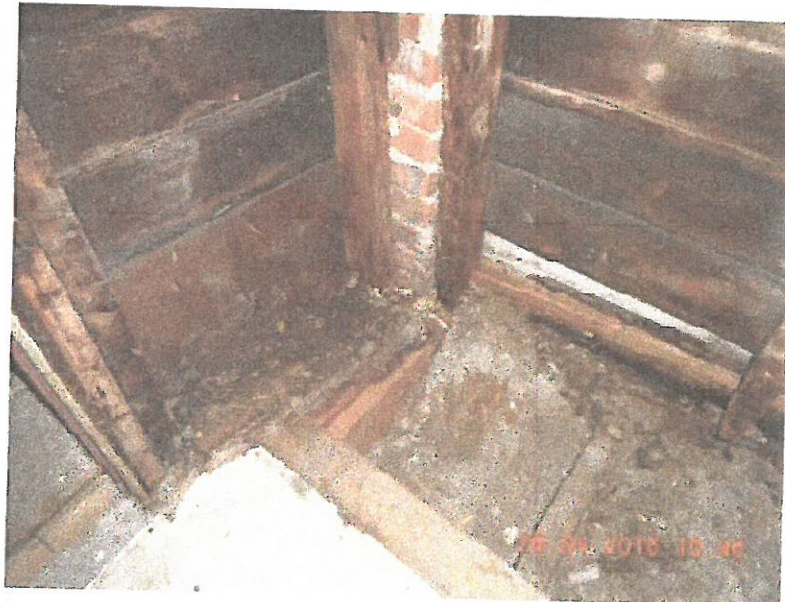
Photo 8 – Masonry infill in wall cavity

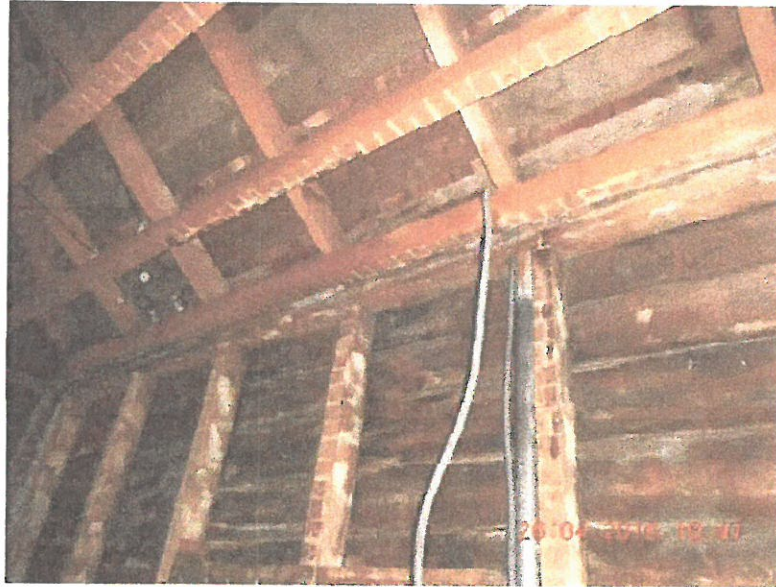
Photo 9 – Inadequate load path, rafters bearing on ceiling joist

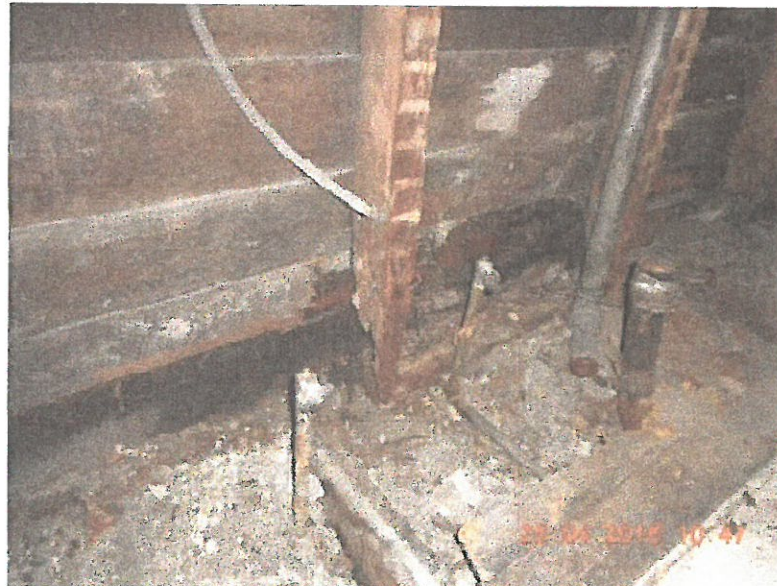
Photo 10 – Deteriorated foundation, sill plate, studs, and floor joists

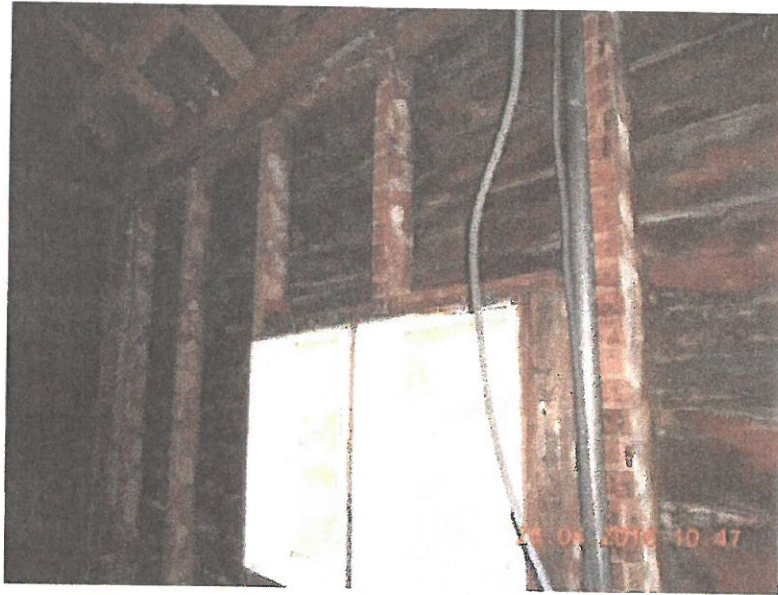
S-5	Inadequate support at wall openings.	Provide adequate header at wall openings. Support header with trim studs and full height king studs on each side of opening.	11	1
S-6	Severe settlement/partial collapse at west wall.	Replace deteriorated studs and floor joists. Repair or replace foundation to provide adequate bearing location for framing.	10,12	
S-7	Inadequate grading and north and west side.	Wood framed walls are not intended to retain soil. Lower finished grade elevation as needed to prevent soil from bearing against exterior walls. Revise exterior grading to provide adequate drainage away from the home.	13,14

Photo 61 – No headers, king studs at wall openings

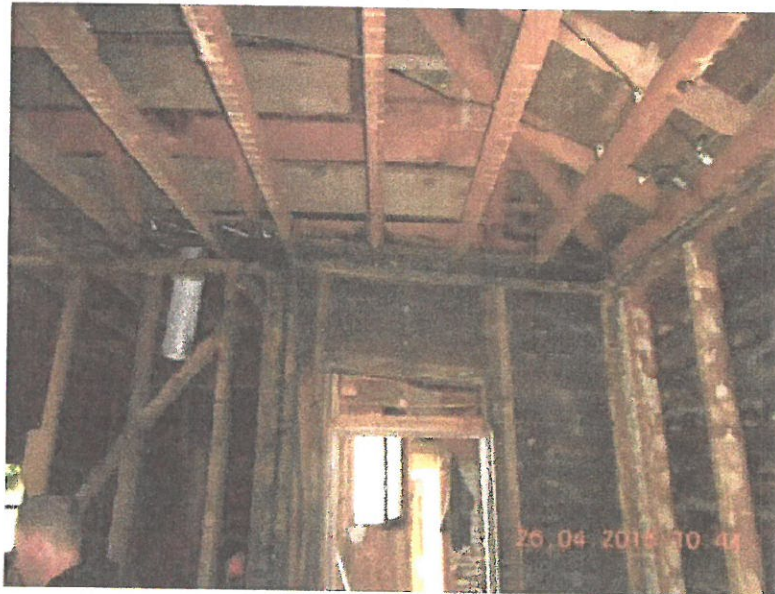
Photo 72 – Apparent settlement at west wall

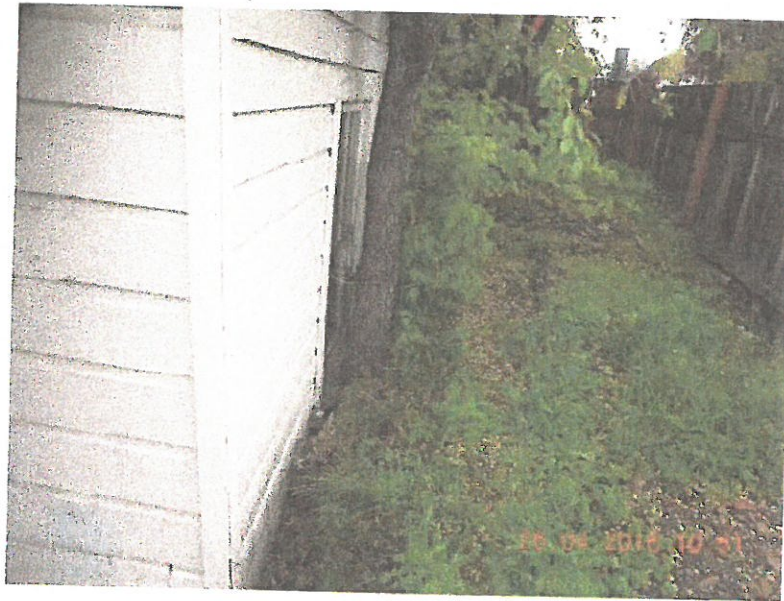
Photo 13 – Retained soils at the north exterior wall

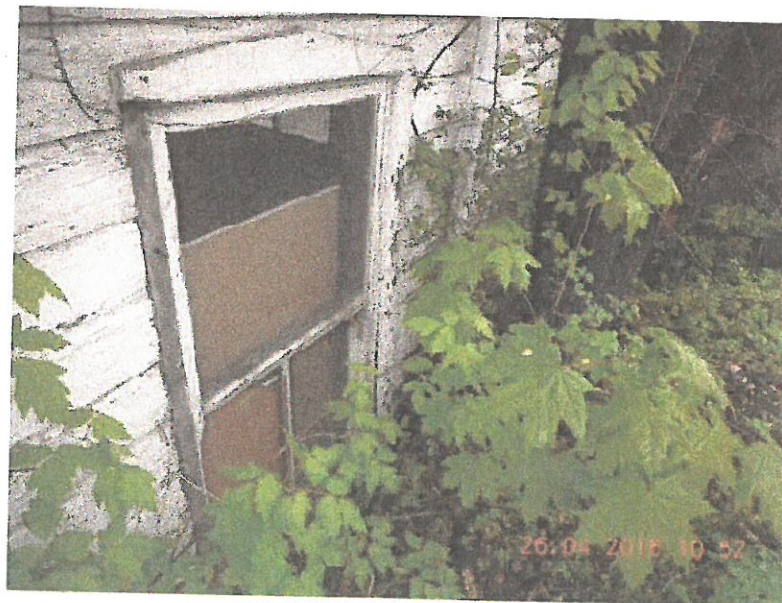
Photo 14 – Retained soils at the north exterior wall

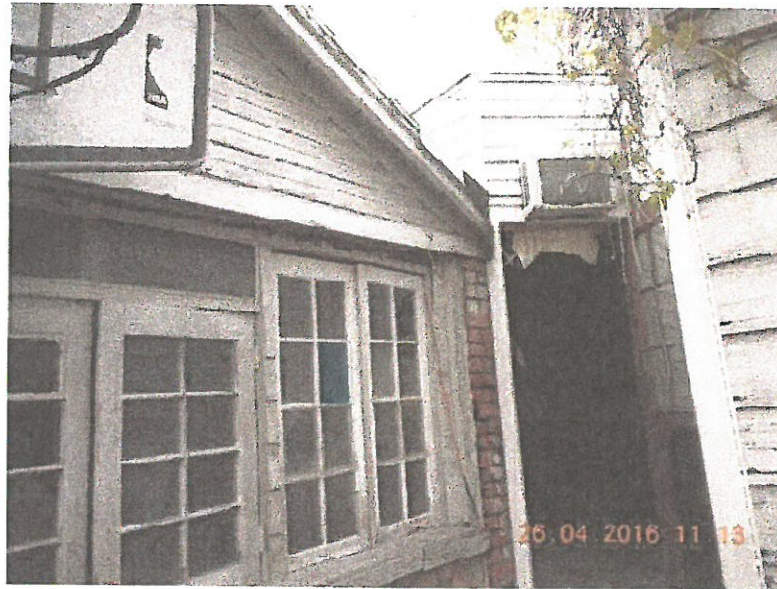
Photo 15 – Apparent addition between home and adjacent garage

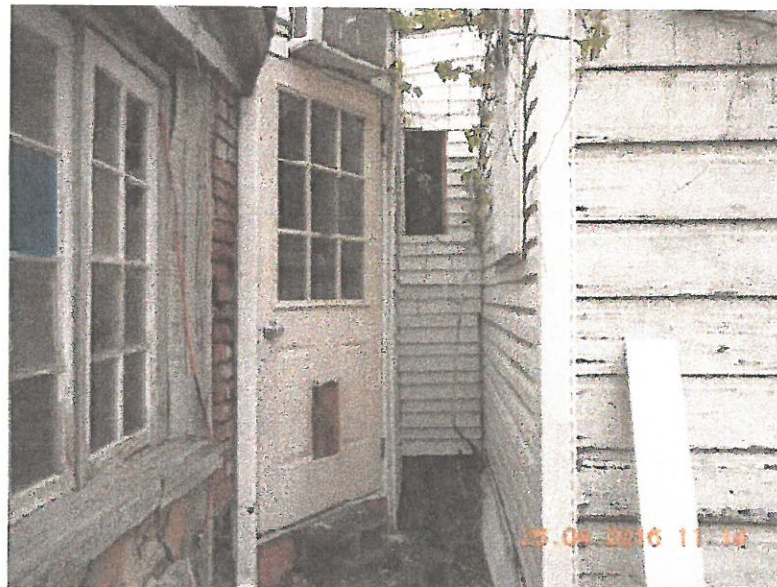
Photo 16 – Apparent addition between home and adjacent garage
