Work Session Memorandum

Re: PLNHLC2018-00454 Rehabilitation of Cottage and New Additions at approximately 287 G Street and 480 6th Avenue

REHABILITATION OF COTTAGE & NEW ADDITIONS

Page 3 May 12, 2016 Structural Evaluation and Recommendations 287 G Street

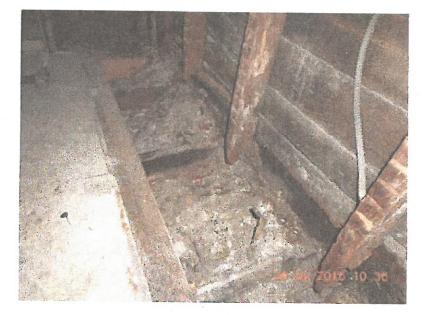
- Many bearing wall studs have rotted out at the connection to the floor which has caused severe settlement of the roof and main floor walls.
- Many floor joists have rotted out at the connection to the foundation walls which has contributed to the severe settlement of the main floor in the north east corner and west wall.
- The north wall and possibly a portion of the west wall appear to currently retain soil. This has likely point of failure.
- The original connection to the foundation of the bearing wall studs and floor joists was difficult to locate due to deterioration and will need to be re-established in order to provide an adequate load transfer path to the foundation.

Photo 1 -Deteriorated wall studs and floor joists

No. S-1	Inadequacy	Recommended Repair	Photo No.	Schematic Sketch
	Deteriorated bearing wall studs, lumber plank wall sheathing.	Remove rotten or damaged bearing wall studs. Replace with new studs. Remove rotten lumber wall planking, replace with new OSB sheathing or new lumber planking. New planking should be installed with at least (3) 8d nails per stud with (5) 8d nails at each plank end. Joints should offset at least one stud space and should be at least two planks between joints on the same support.	1,2,8,10	
S-2	Inadequate load path/connection at deteriorating foundation	Foundation should be replaced or repaired with adequate reinforcing to transfer both vertical and lateral forces. Provide new sill plate to attach floor framing.	5,7	
S-3	Inadequate load path at roof to wall connection.	Add blocking between rafters at top of wall, provide nailing or metal clip from roof sheathing to blocking and blocking to top of wall. Add additional stud at roof rafter bearing locations. Revise roof framing so rafters fully bear on wall and not on adjacent ceiling joist.	3,9	2

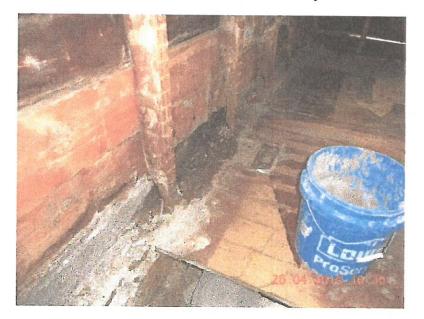
Photo 2 - Deteriorated wall studs and floor joists

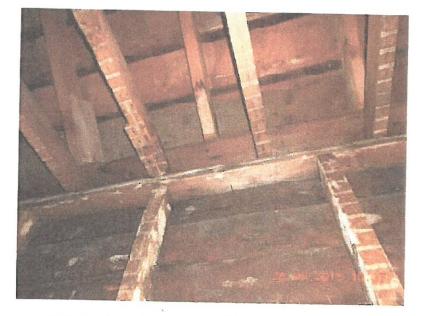
Photo 3 - Discontinuous load path at roof to wall connection

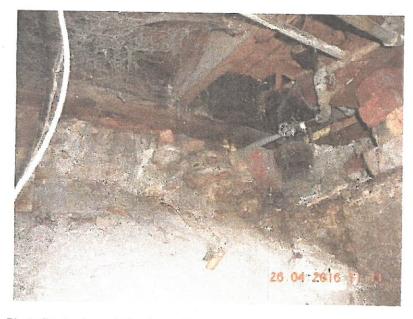
Photo 5 - Inadequate load transfer connection at deteriorating foundation

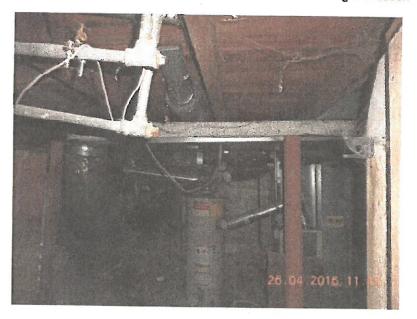
Photo 6 - Apparent added shoring for floor support

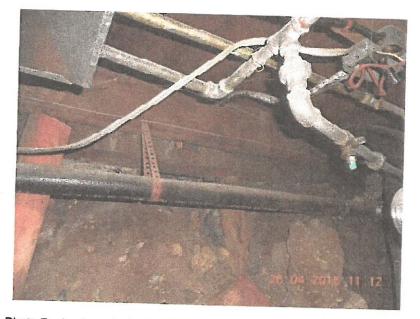
Photo 7 – Inadequate load transfer connection at deteriorating foundation

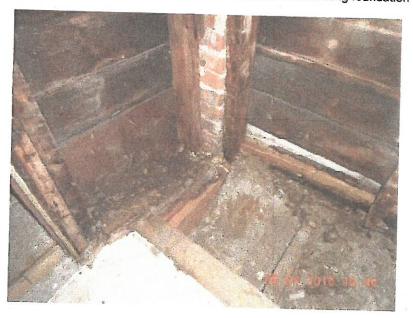
Photo 8 - Masonry infill in wall cavity

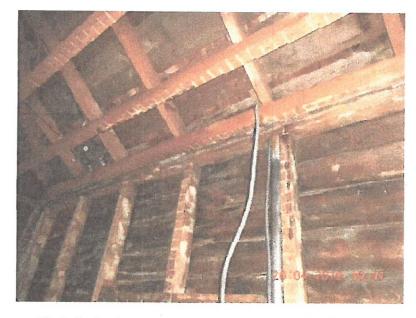
Photo 9 - Inadequate load path, rafters bearing on ceiling joist

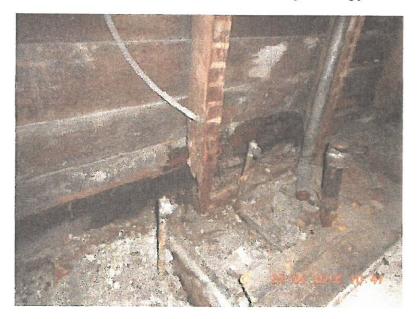
Photo 10 - Deteriorated foundation, sill plate, studs, and floor joists

S-4	Deteriorated floor joists, non- treated wood embedded in concrete.	Remove rotten or deteriorated floor joists, new floor joists should bear on a pressure treated sill plate attached to the foundation.	1,4,5,10	3

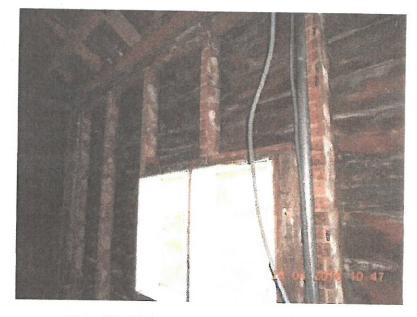
Photo 61 - No headers, king studs at wall openings

S-5	Inadequate support at wall openings.	Provide adequate header at wall openings. Support header with trim studs and full height king studs on each side of opening.	11	1
S-6	Severe settlement/partial collapse at west wall.	Replace deteriorated studs and floor joists. Repair or replace foundation to provide adequate bearing location for framing.	10,12	
S-7	Inadequate grading and north and west side.	Wood framed walls are not intended to retain soil. Lower finished grade elevation as needed to prevent soil from bearing against exterior walls. Revise exterior grading to provide adequate drainage away from the home.	13,14

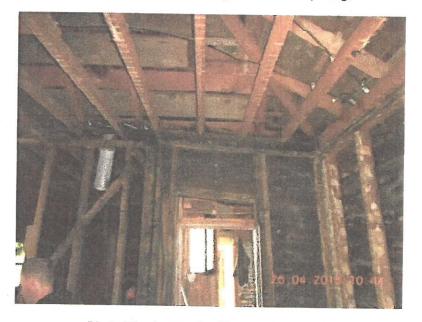
Photo 72 - Apparent settlement at west wall

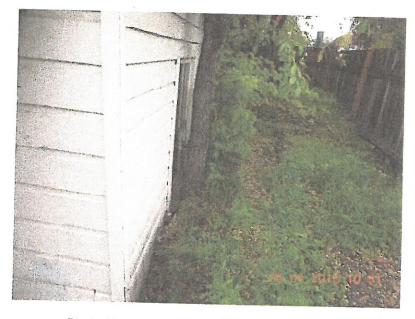
Photo 13 - Retained soils at the north exterior wall

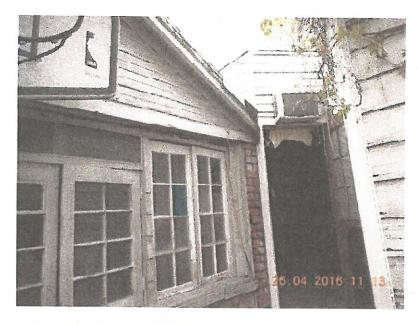
Photo 15 - Apparent addition between home and adjacent garage

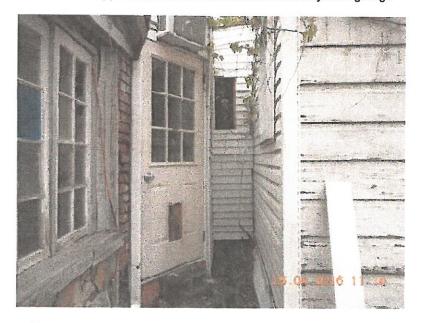
Photo 16 - Apparent addition between home and adjacent garage

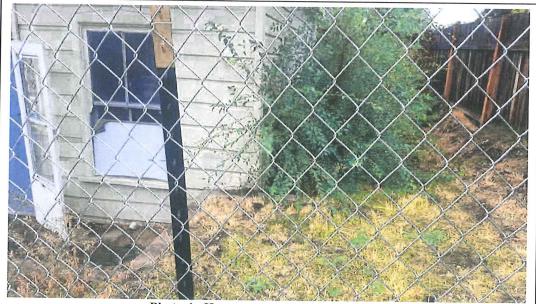
Photo 4: Home constructed below grade.

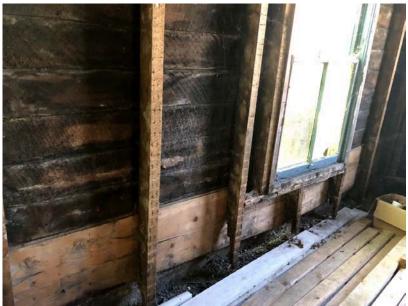
Image 1 - Existing North exterior wall being pushed by the current grading to be reinforced with new exterior retaining wall and foundation wall.

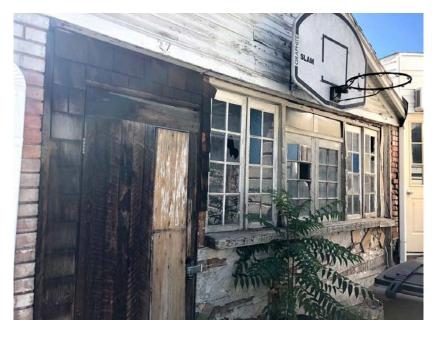
Image 2 - Existing Garage proposed to be removed.

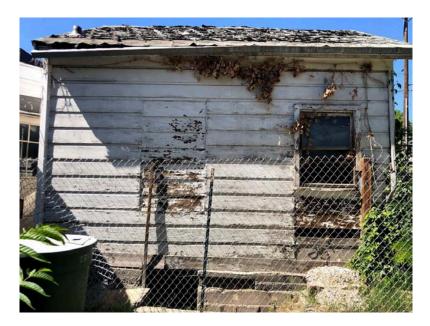
Image 3- Existing South exterior wall (to be restored)

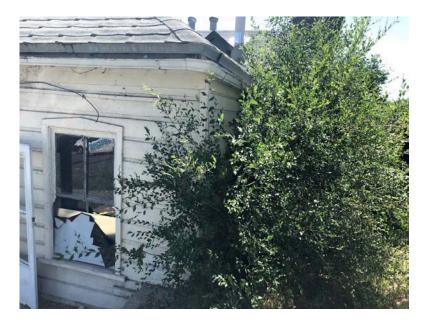
Image 5- Existing North exterior wall (to be restored)

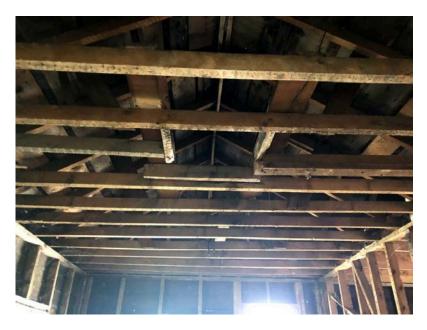
Image 6 - Existing roof (to be reinforced and restored)

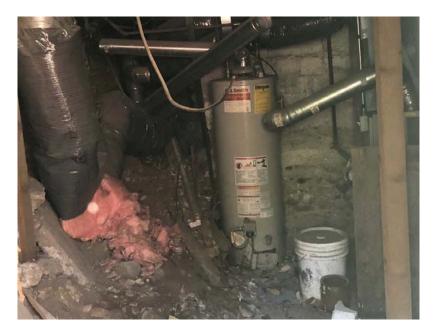
Image 7 - Existing basement/foundation (to be replaced.)
