Historic Structures Report

Devereux House

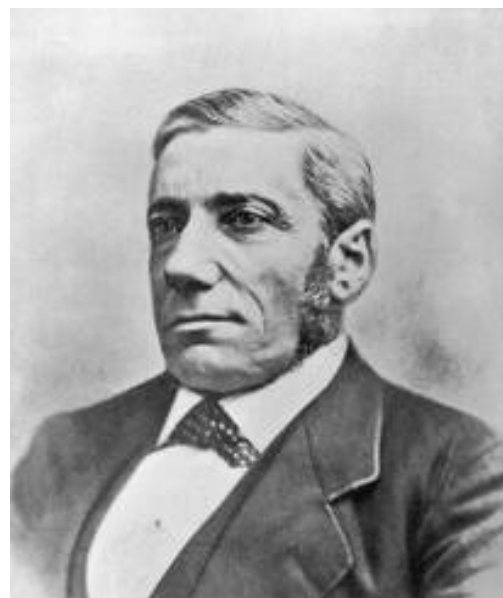
Figure II-1. William C. Staines.

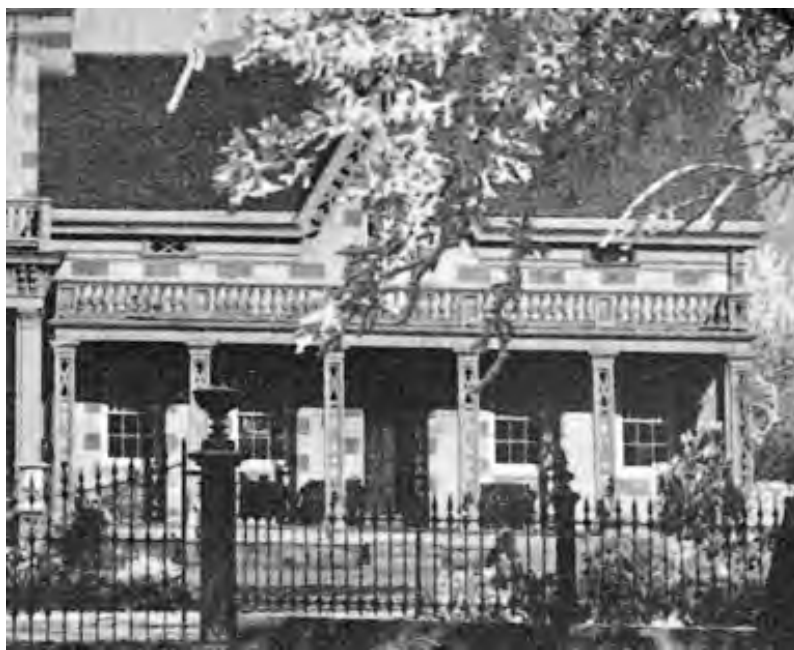
Figure II-2. A photograph of the Staines cottage between 1867 and 1874. Detail taken from MS 23304 b0000 f0001 d0014 0000 01.

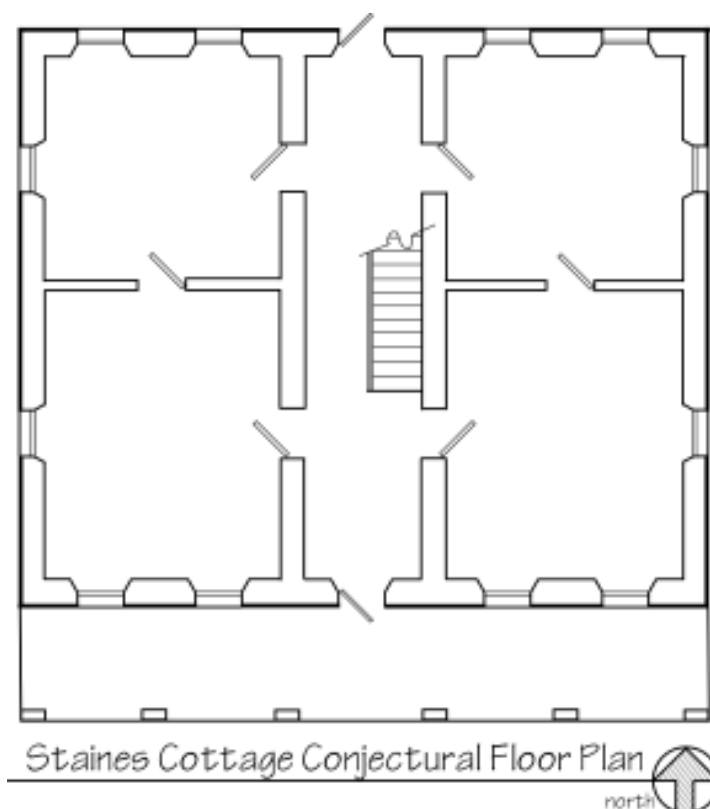
Figure II-3. A conjectural plan of the Staines cottage.

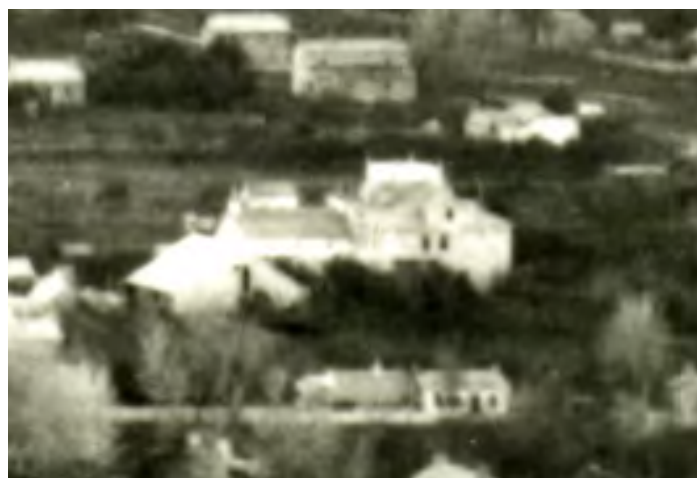
Figure II-4. A view of the north elevation of the Staines cottage and west wing of the Jennings residence before 1874. A detail taken from CHL PH 3821b1fd98t001.

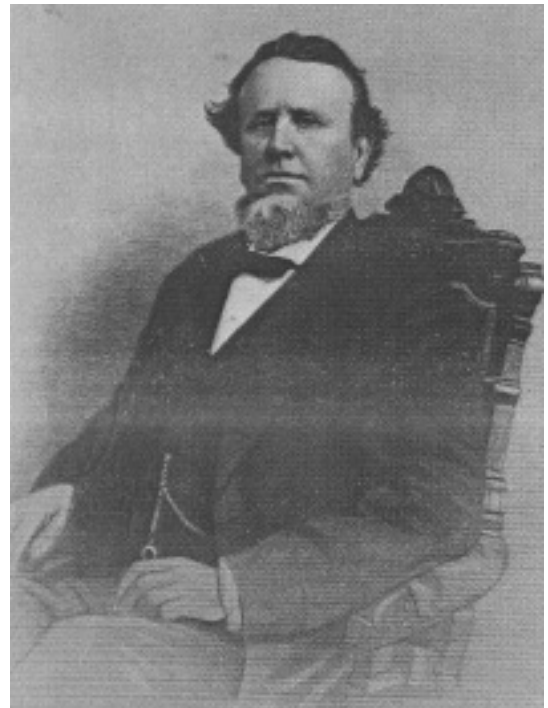
Figure II-5. William Jennings.

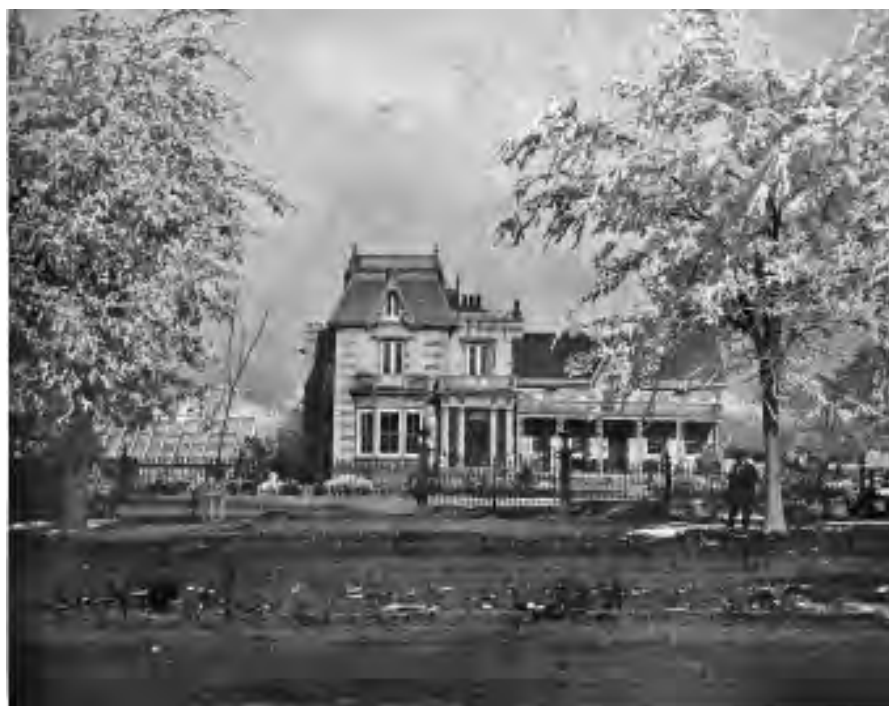
The laudatory description is short on details, with the exception of the identification of a green and gold color scheme in the Drawing Room, gilt frames for the pictures, and Danquart Weggland’s *Christ Blessing the Children* hanging on the wall.

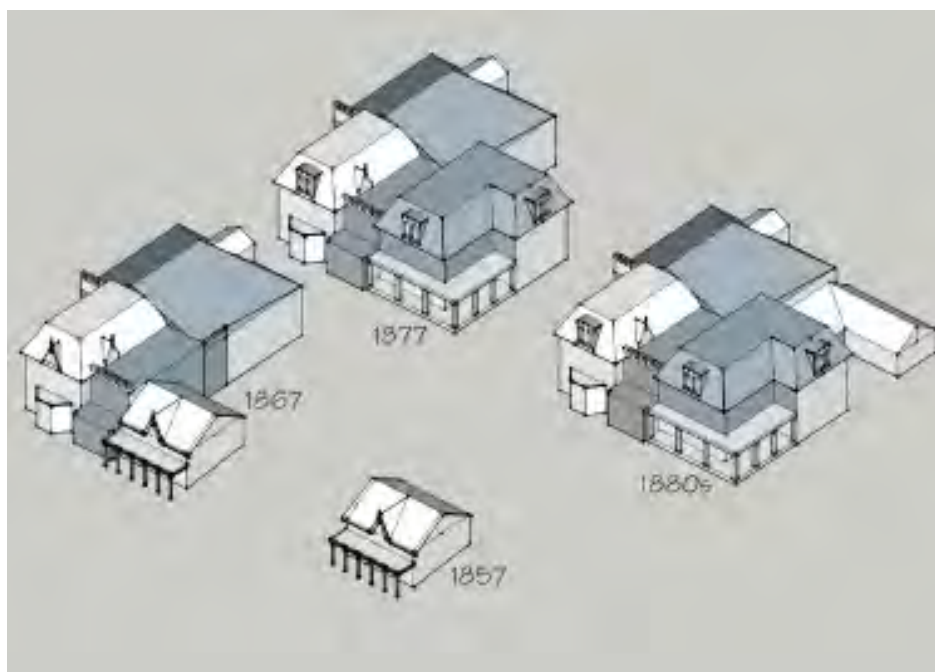
wife, Jane Walker, died at age 35, so that the future addition to the home was not based on needs of the families, but rather on the desire to display the wealth and prominence that had come to Jennings.

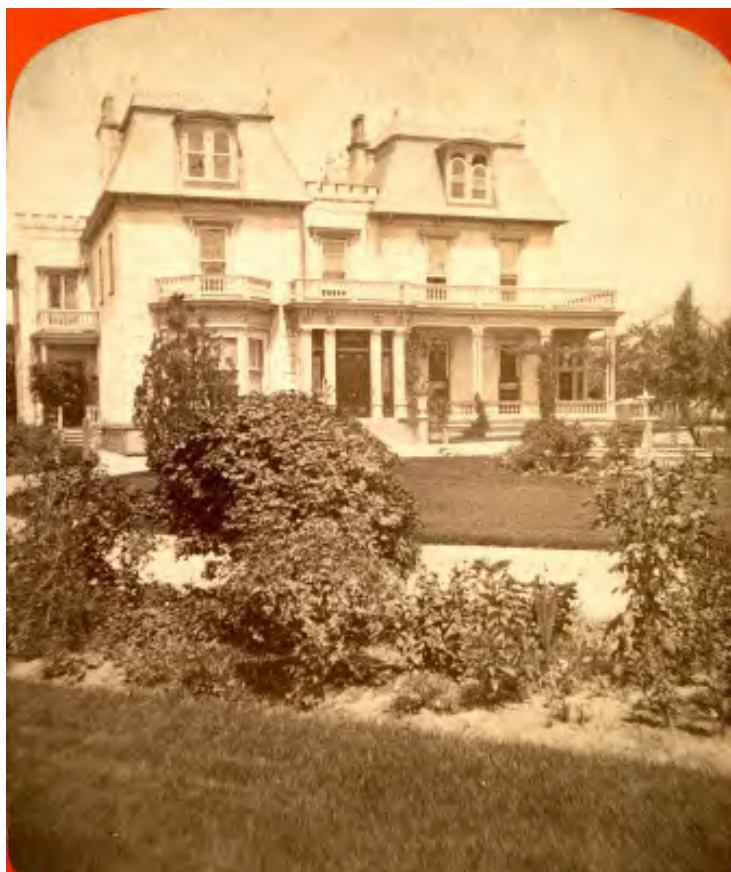
Figure II-8. The Devereux House with both the east and west additions about 1880, PH3135.

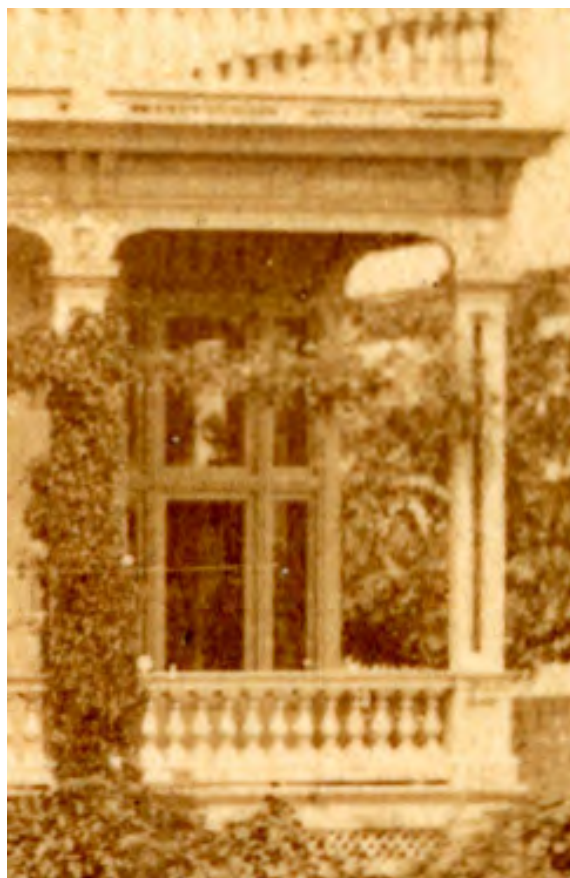
Figure II-9 (left). A detail from an 1880 photograph showing the Conservatory tucked underneath the porch roof.

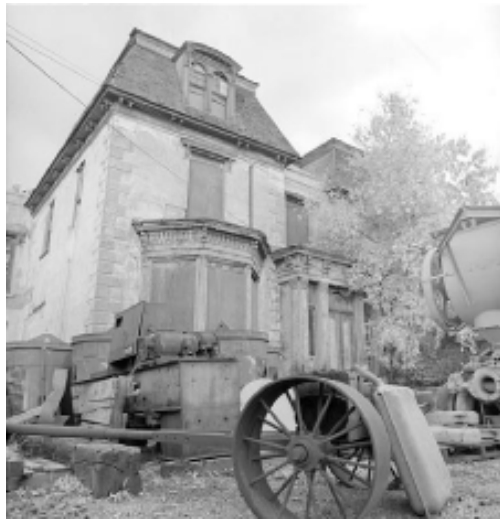
Figure II-13. A view of the Devereux House in 1971, *Deseret News* digital archive.

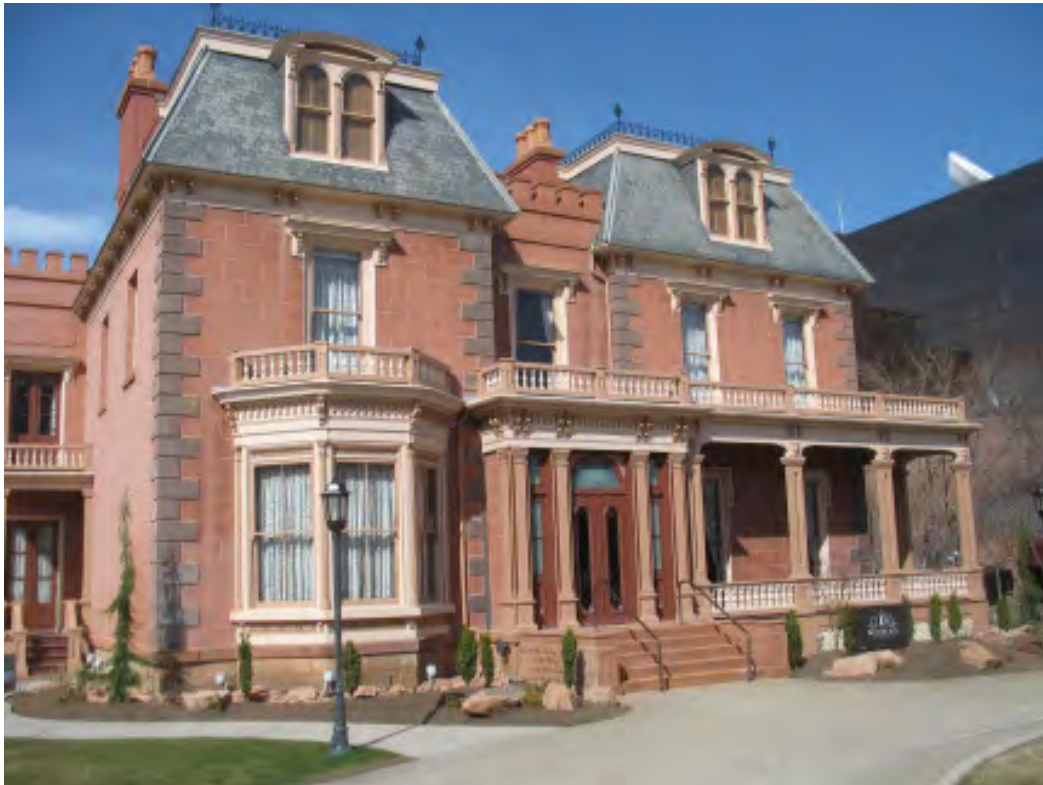
*Figure III-1.
The south
elevation of the
Devereux
House.*

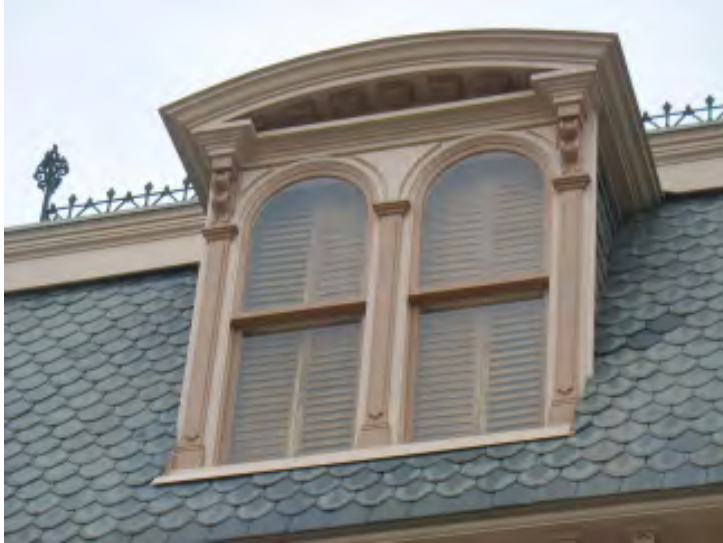
Figure III-5 (left). A mansard roof dormer.

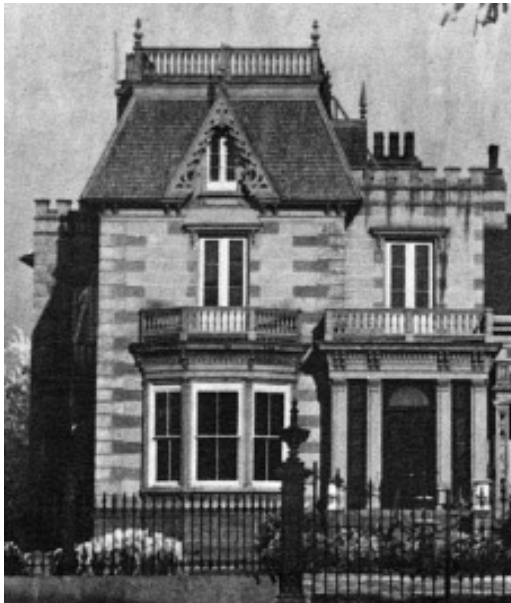
Figure III-7. A detail of a pre-1877 photograph showing the original gabled dormer which matched the one on the Staines cottage.

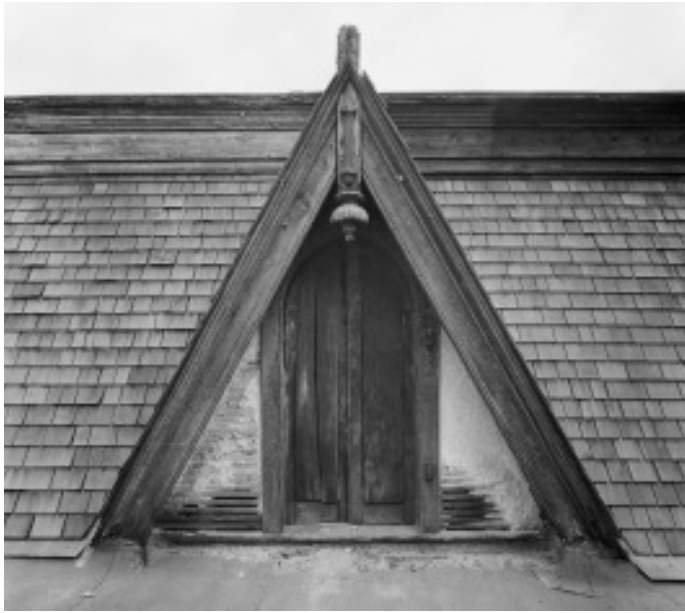
Figure III-8 (above). A view of one of the gabled dormers in the mansard roof in 1967, HABS #U-37, photo #14.

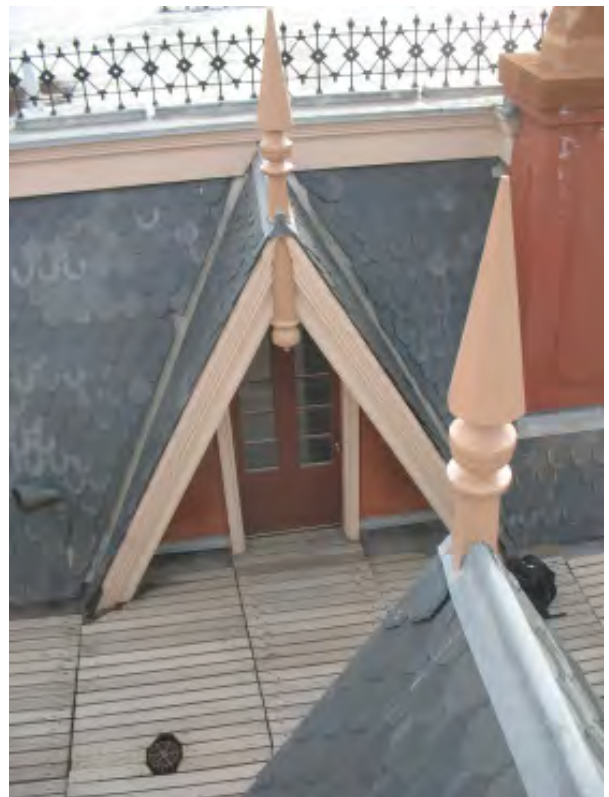
Figure III-9 (right). A view of the gables facing the low slope roof area between the east and west mansard roofs.

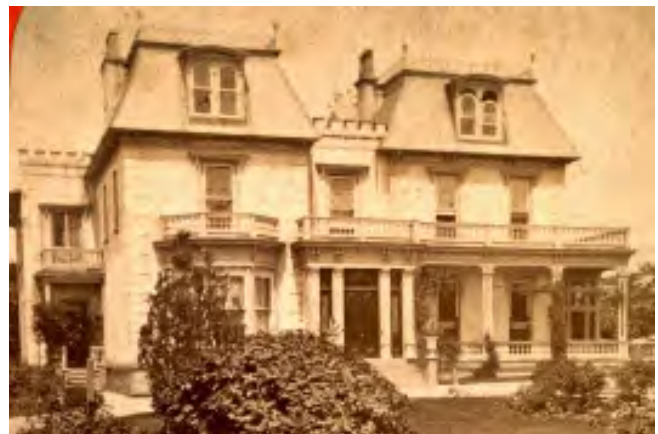
Figure III-10. A view of the Devereux House about 1880.

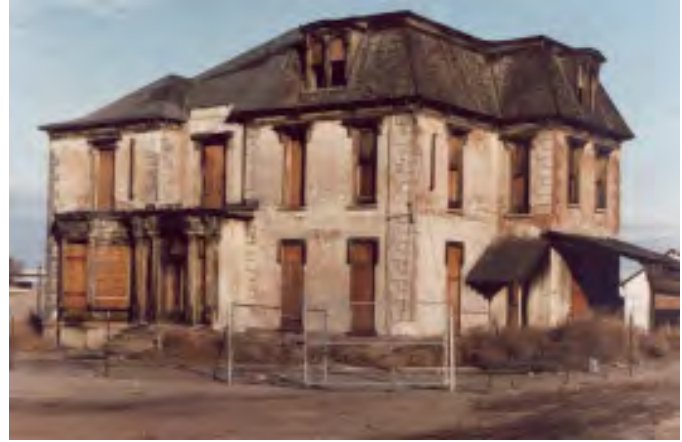
Figure III-11. A view of the Devereux House prior to restoration showing the missing porch, west mansard roof, and east projecting window bay.

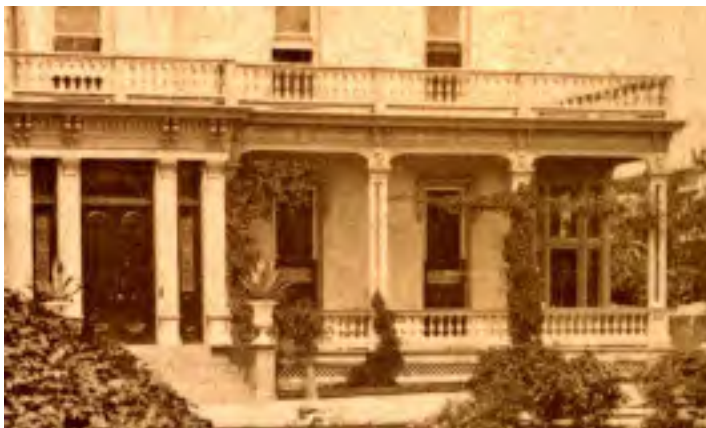
Figure III-12. The porch on the east wing about 1880.

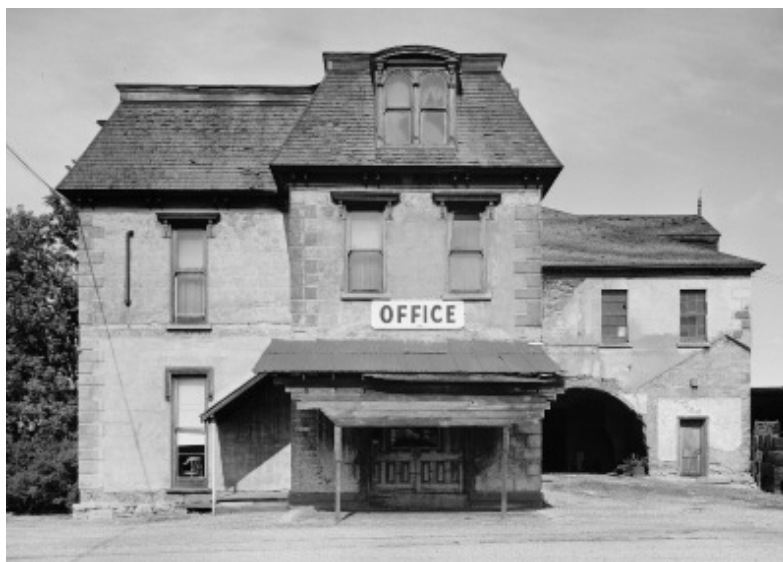
Figure III-15. A view of the east elevation in 1967, HABS #U-37, photo #11.

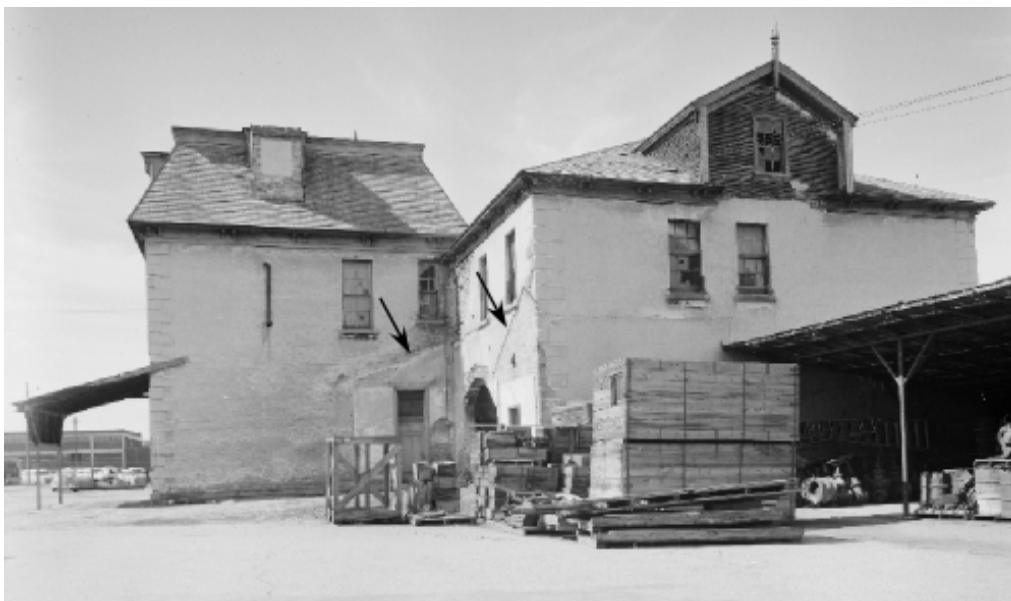
Figure III-18(left). The north elevation of the Devereux House in 1967, HABS #U-37, photo # 7. Note the outline of the missing roofs of the shed roof kitchen addition (left arrow) and the gable roofed laundry addition (right arrow).

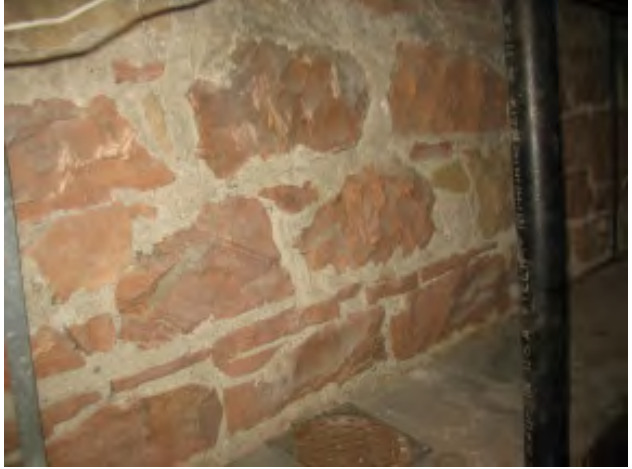
Figure III-26. A view of a typical sandstone foundation wall.

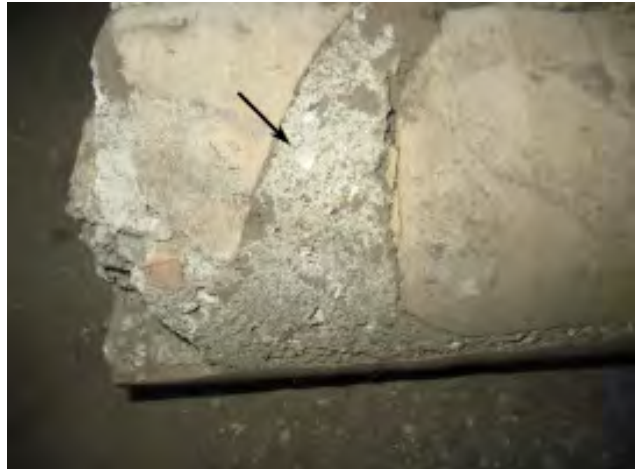
Figure III-27. A view of a 5 inch core of the foundation wall showing white lumps of lime in the mortar.

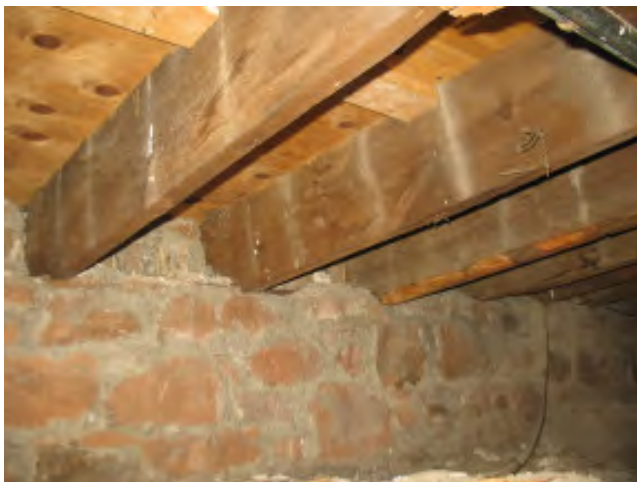
Figure III-28. A detail of the floor joists under the Drawing Room supported by a shelf in the foundation wall.

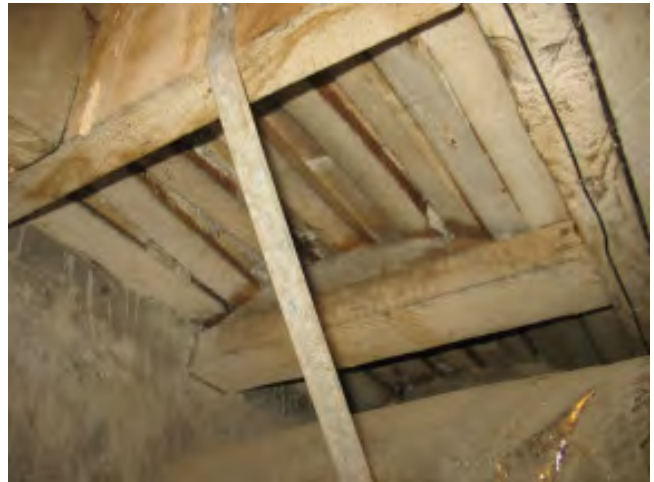
Figure III-29. Floor framing underneath the fireplace hearth in the Library.

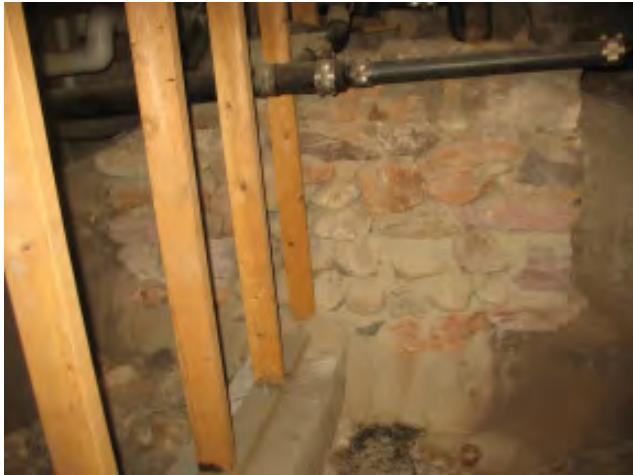
Figure III-30. The foundation of the original kitchen fireplace in the west wing, and a new support wall bearing on a concrete footer.

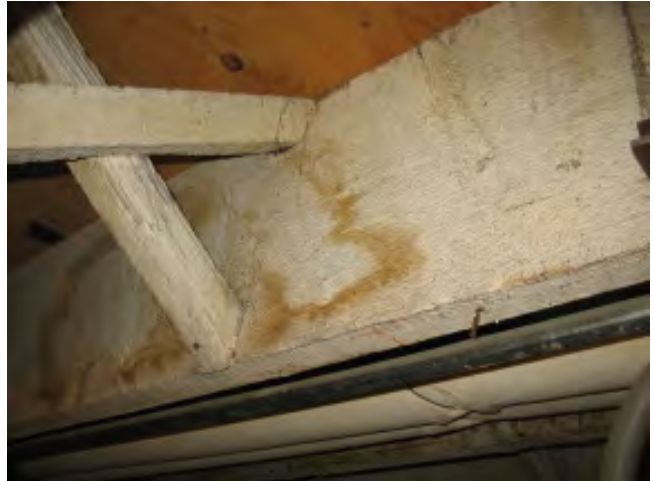
Figure III-31. Original joists and cross bracing in the east wing. Note the new plywood floor above.

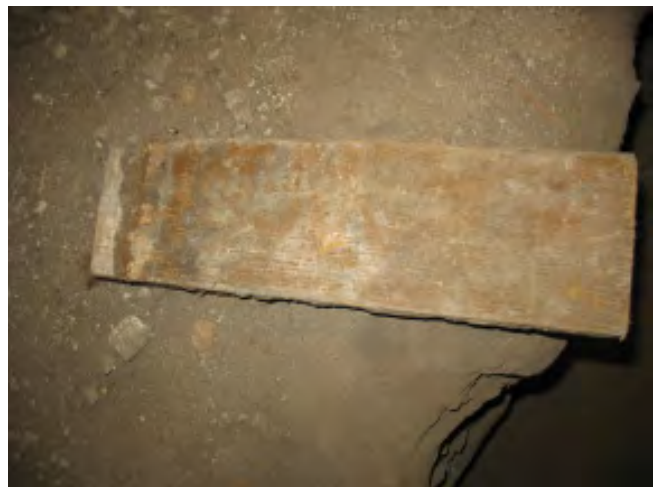
Figure III-32. A fragment of original flooring found in the crawl space.

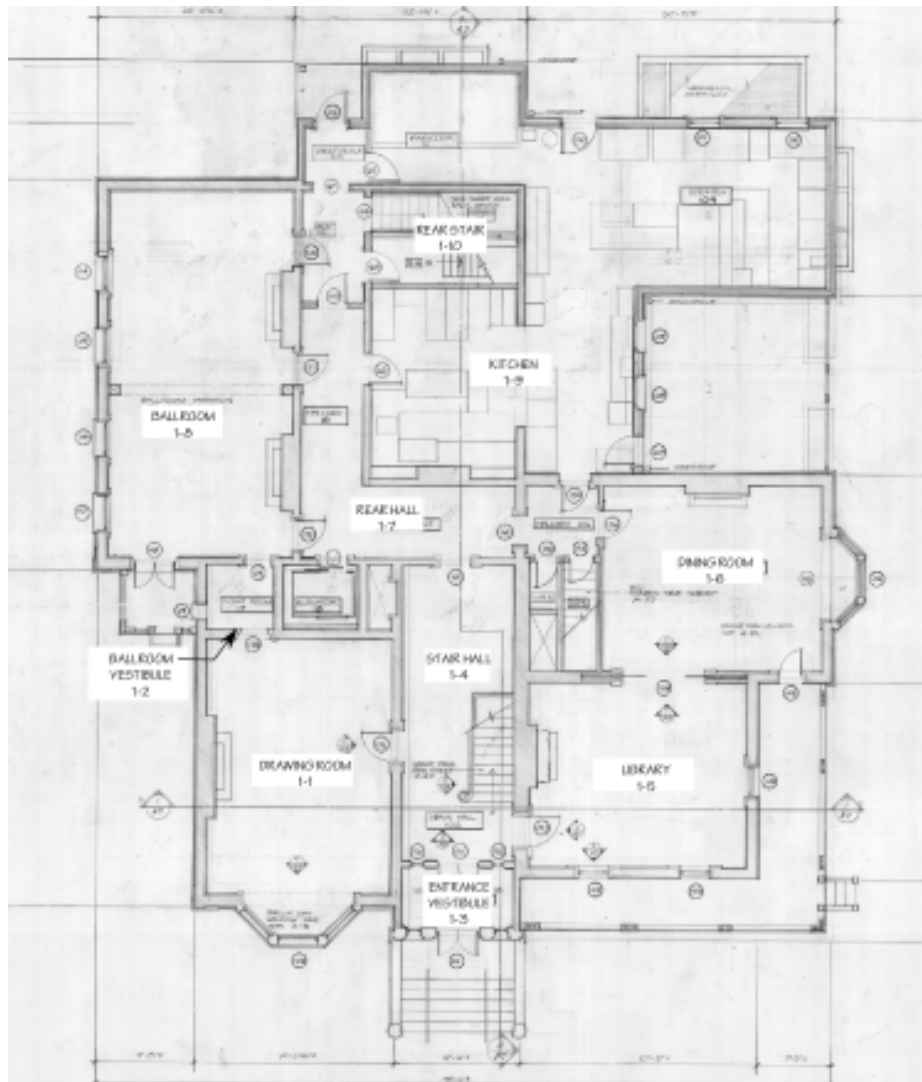
Figure III-33. The first floor plan of the Devereux House prepared for the 1980s restoration, Burtch Beall collection, University of Utah archives, with superimposed annotations.

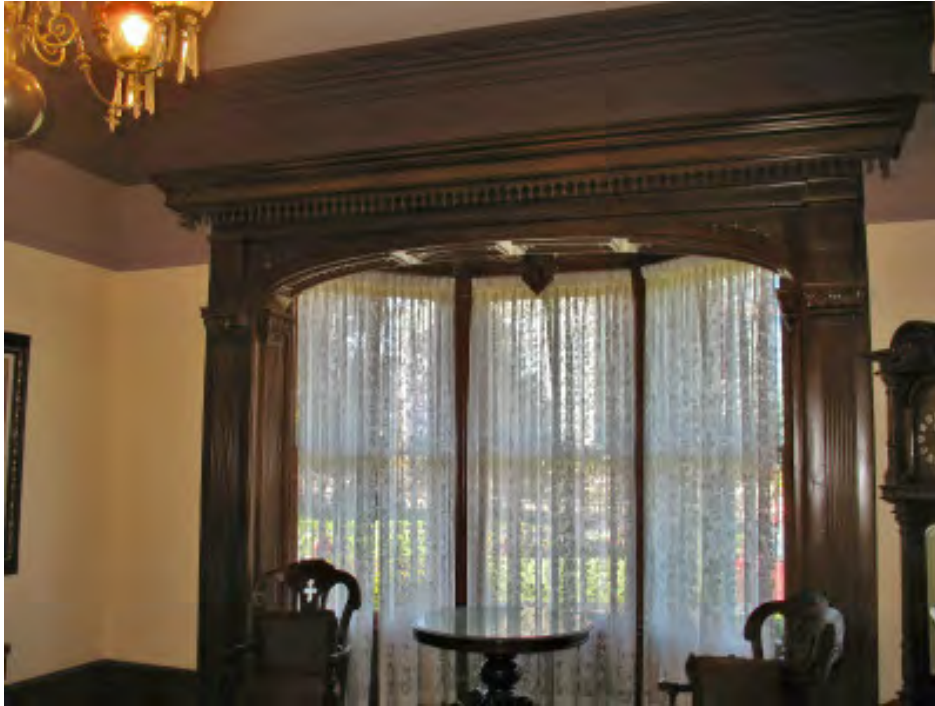
Figure III-34. A view of the projecting window bay on the south wall of the Drawing Room.

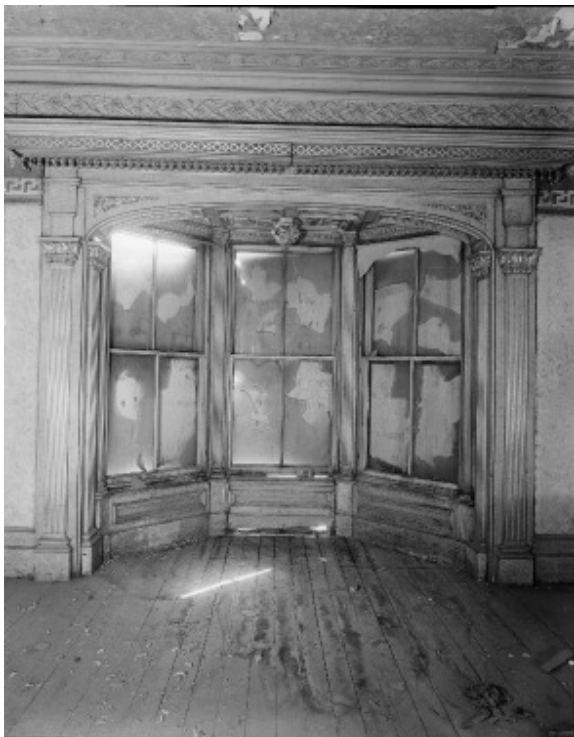
The fluted pilasters and bases framing the opening have worn surfaces and edges on the lower five feet, consistent with wear and tear one expects on a building of this age. Splices have been inserted to repair some of the wood surfaces to which the fluted pilasters are fastened, suggesting that much of the existing wood paneling was preserved and repaired as necessary (Figure III-36). Wood knots which have distorted the faux grained finish suggest that the arch is

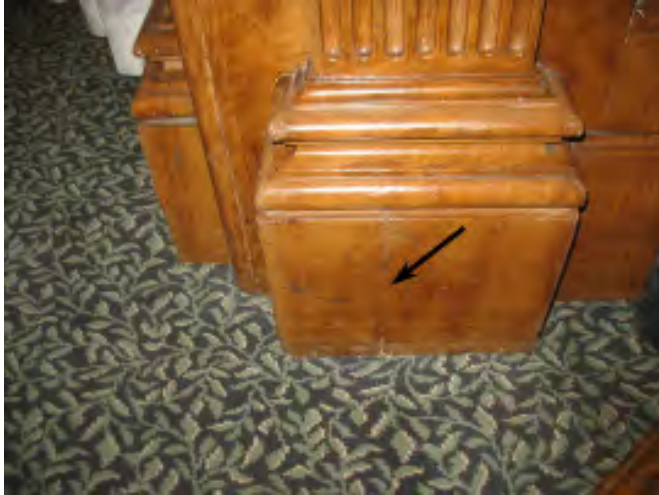
Figure III-36. A pilaster base showing a splice where a repair was inserted.

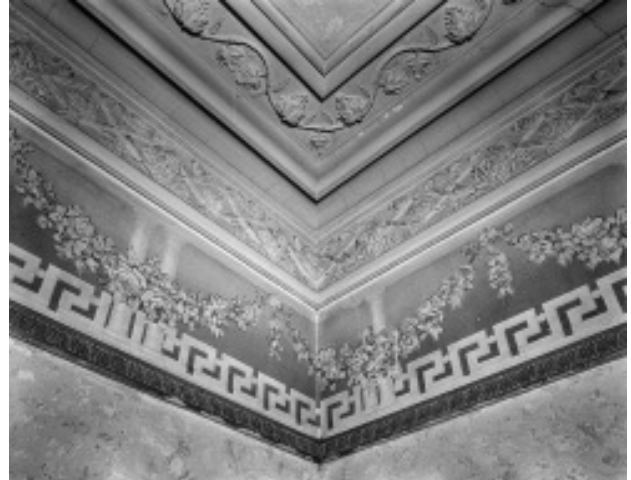
Figure III-37. A photograph taken prior to restoration showing the plaster grapevine motif on the ceiling and walls, and a wallpaper border below, HABS #U-37, photo # 17.

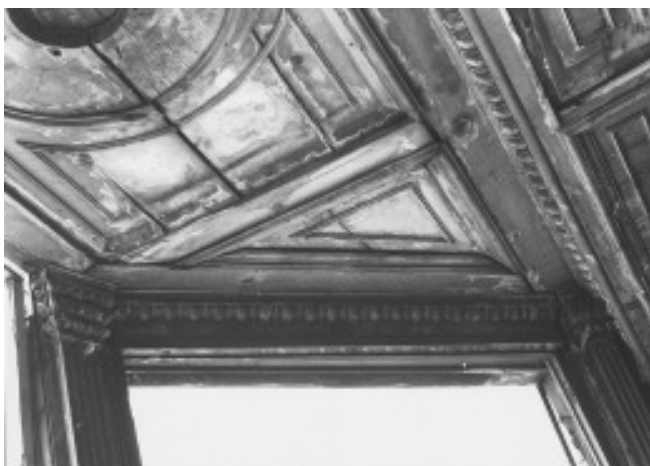
Figure III-38. A view of the projecting bay soffit before restoration, HABS #U-37, photo #19.

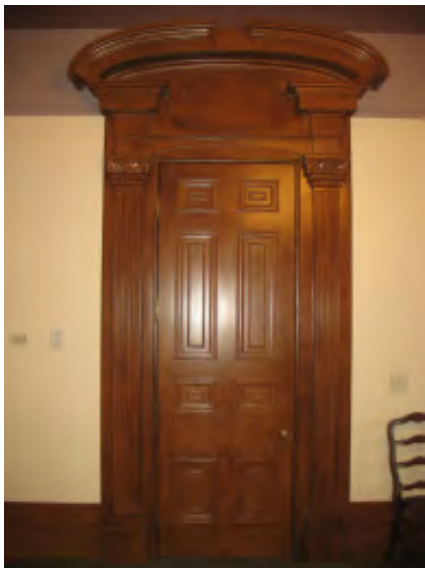
Figure III-41 (left). The door leading to the Stair Hall.

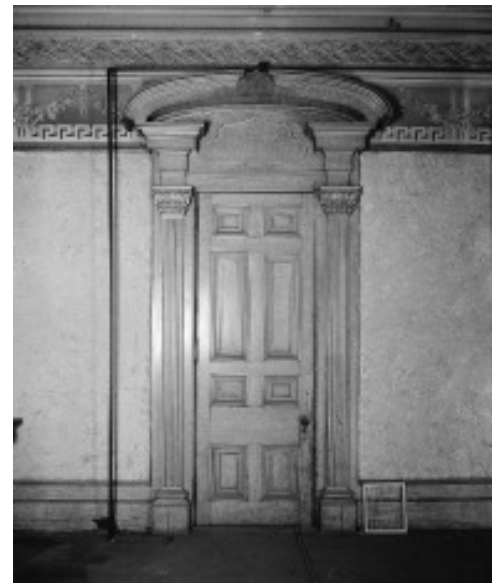
1-2 Ballroom Vestibule [9' x 6']

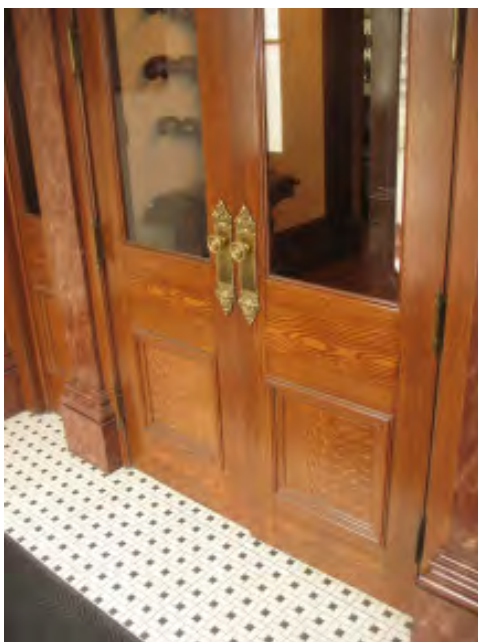
Figure III-43 (left). A view of the internal doors of the Entrance Vestibule.

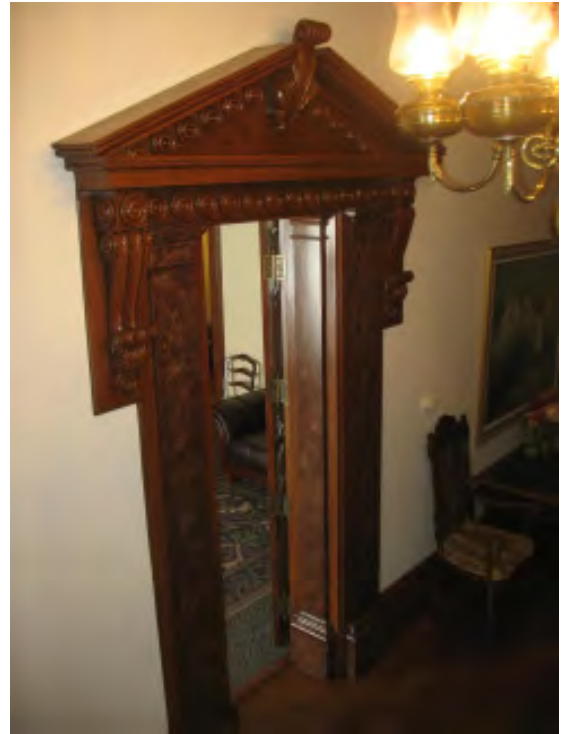
leading to the Library had sections which were relatively untouched by the fire and were used as a pattern from which the replacements were made [Burtch Beall Collection, Box 14, U of U Archives]. These doorways have triangular pediments supported by scrolled brackets. The pediments have a series of roundels placed under the horizontal and raking cornices.

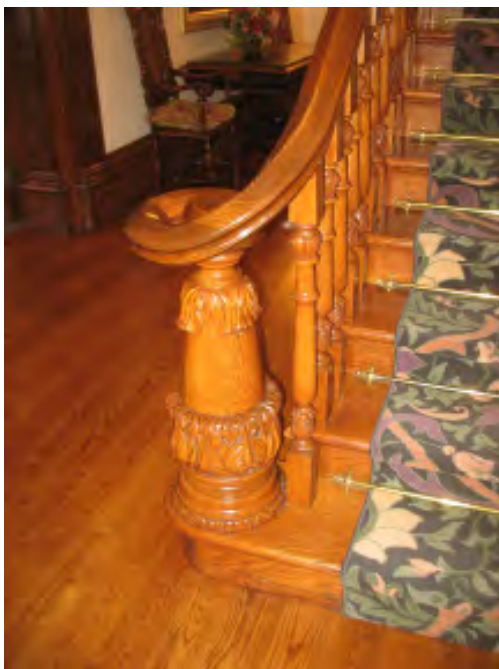
Figure III-49. A view of the replicated newel post.

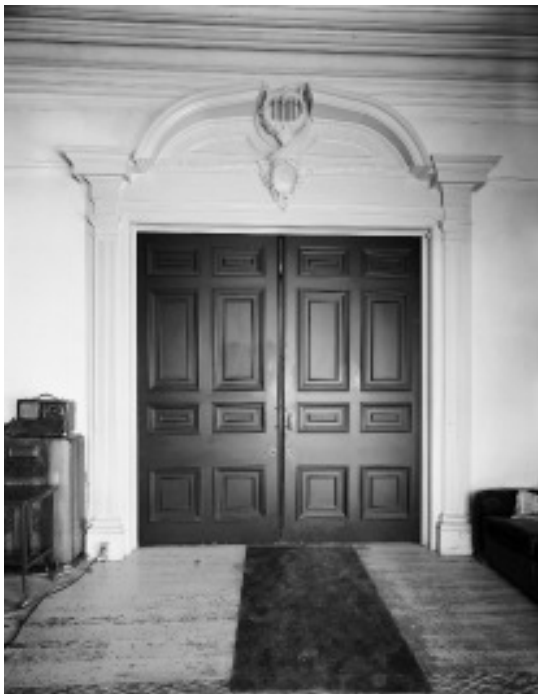
Figure III-50 (bottom) The double wide pocket doors in 1967, HABS #U-37, photo # 21.

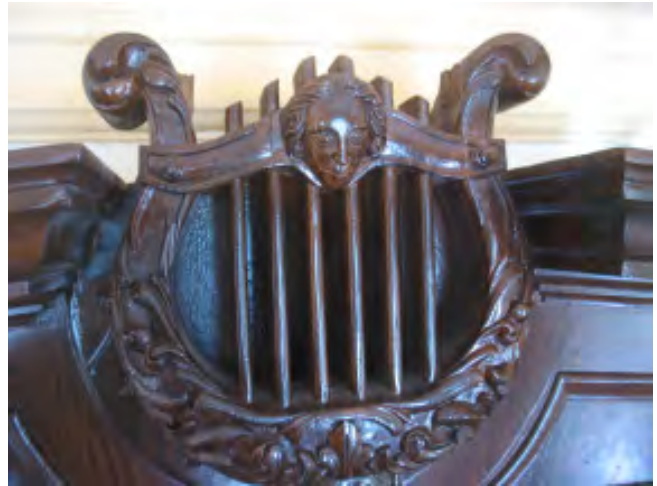
Figure III-52. A detail of the lyre in the double pocket door pediment.

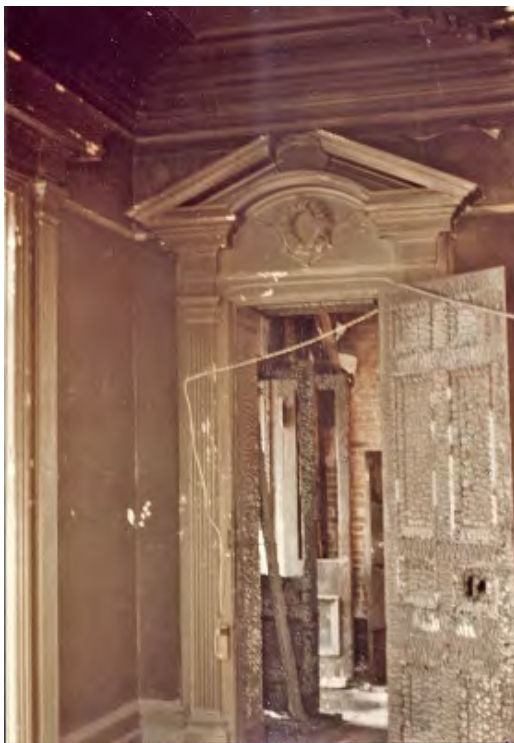
Figure III-53 (left) The door leading to the Stair Hall following the 1979 fire.

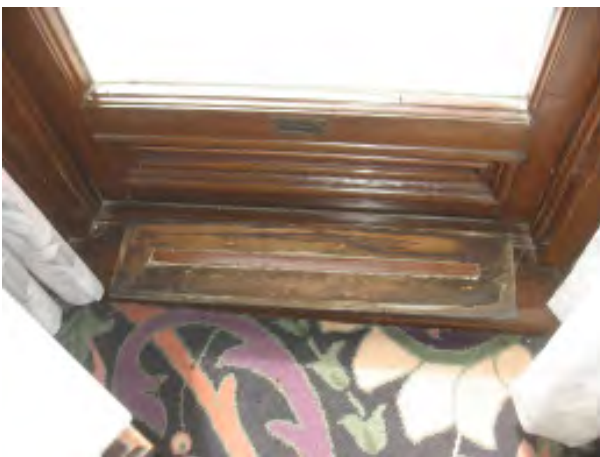
Figure III-57. An original window panel that had been stored in the basement placed adjacent to a window.

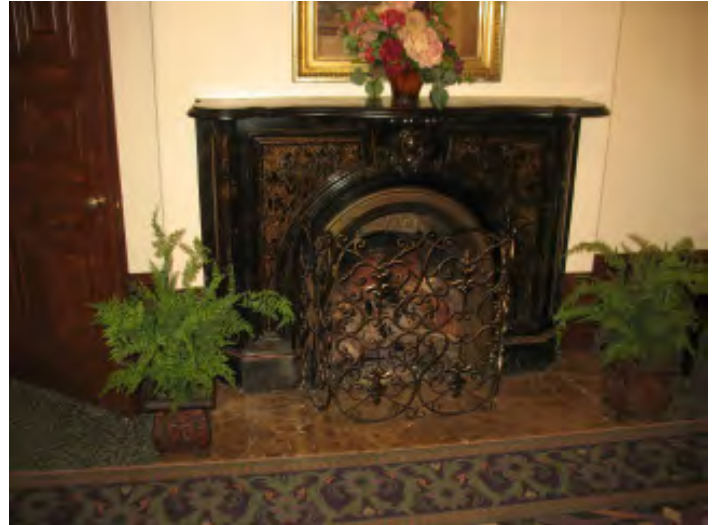
Figure III-59. The mantelpiece in the Library.

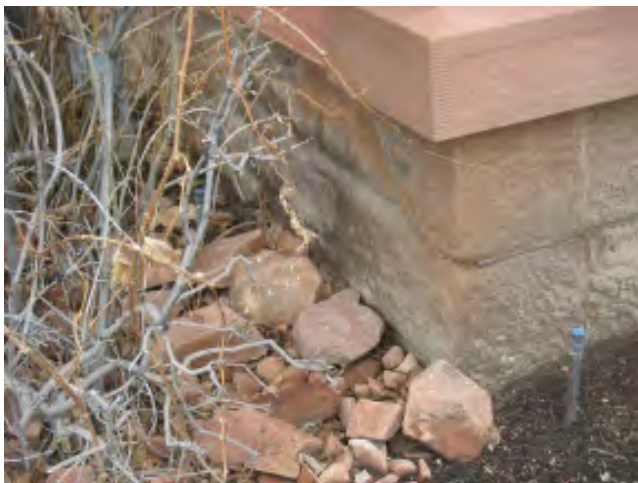
Figure IV-1. A detail of the southwest corner of the Devereux House foundation.

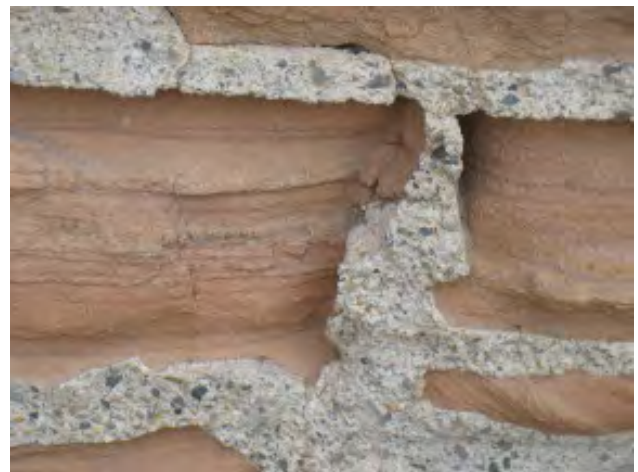
Figure IV-2. A detail of the west foundation wall showing the eroded sandstone around the hard mortar.

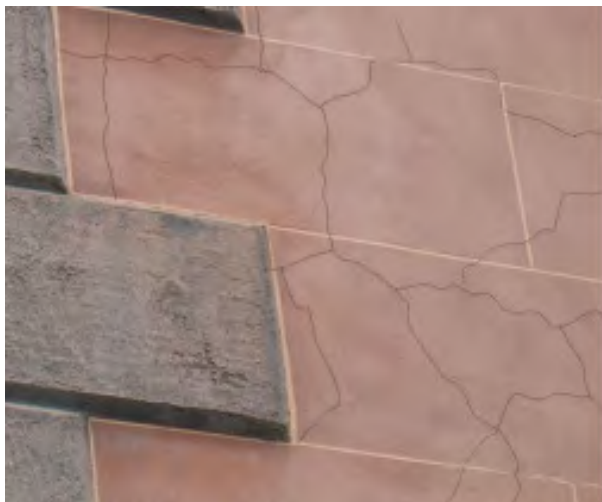
Figure IV-3. A detail of the stucco surface and quoins showing the cracking pattern on the stucco surface. Cracks have been outlined for clarity.

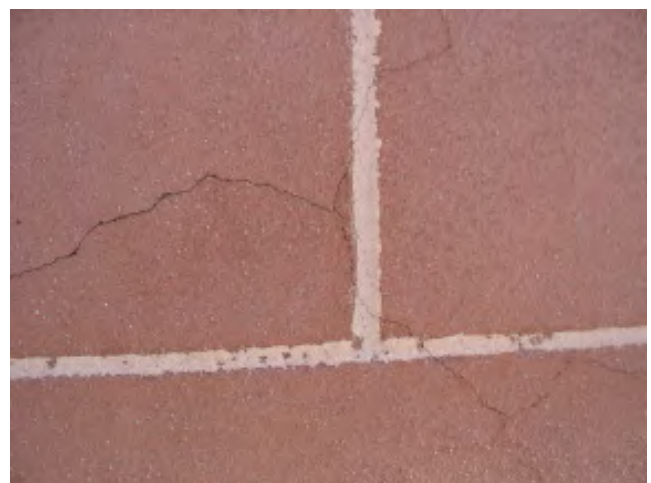
Figure IV-4. A close-up of the stucco surface showing the painted joint lines and cracks.

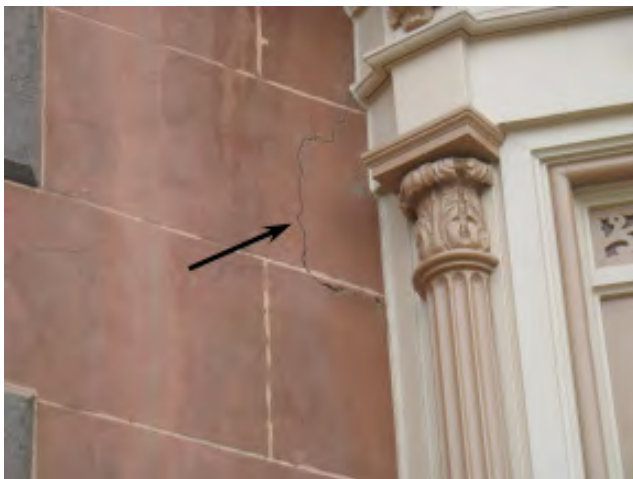
Figure IV-5. A detail of the crack at the location of the lintel bearing at the Drawing Room south bay window.

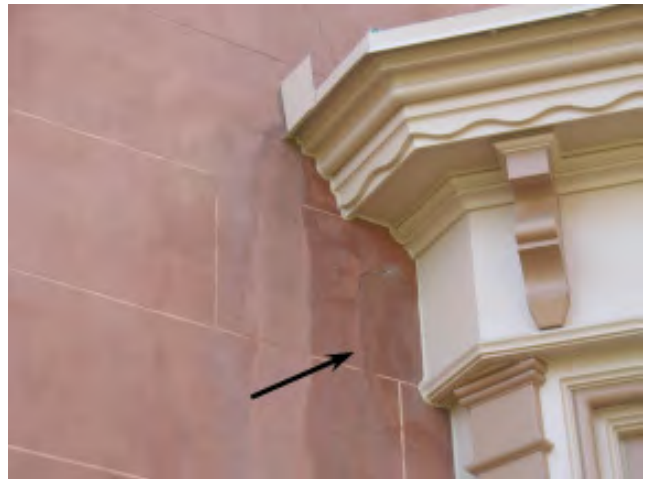
Figure IV-6. A detail of the cracks at the location of the lintel bearing at the Dining Room east bay window.

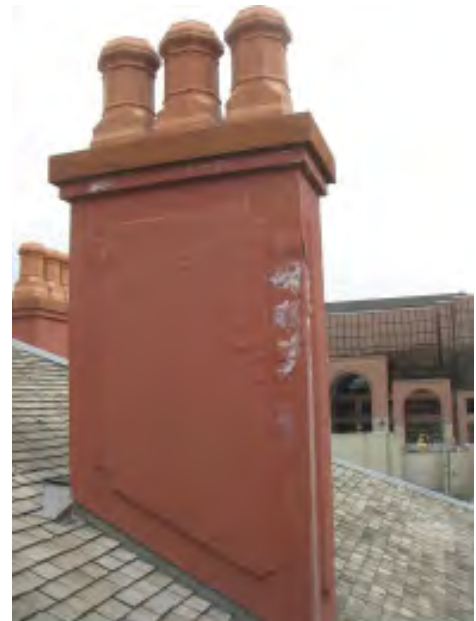
Figure IV-8 (top). A chimney with a bubbled elastomeric coating and efflorescence staining the surface.

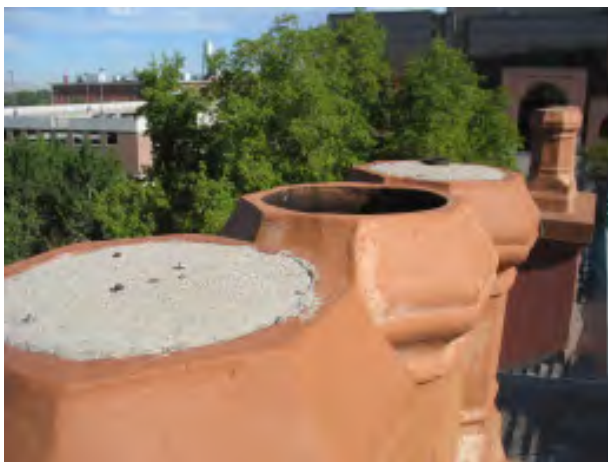
Figure IV-7 (left). A detail showing the grouted and functional terra cotta chimney flues.

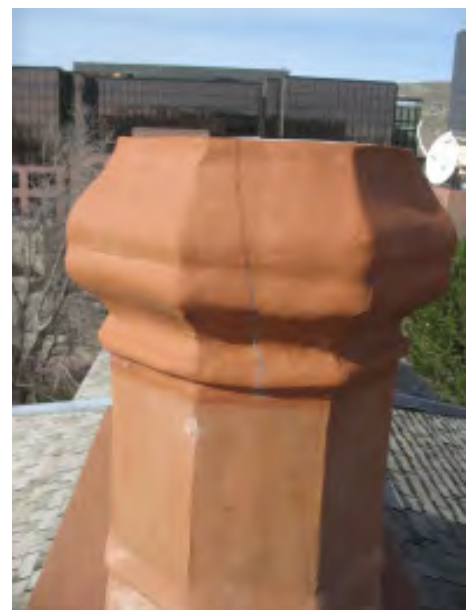
Figure IV-9 (right) A cracked terra cotta flue.

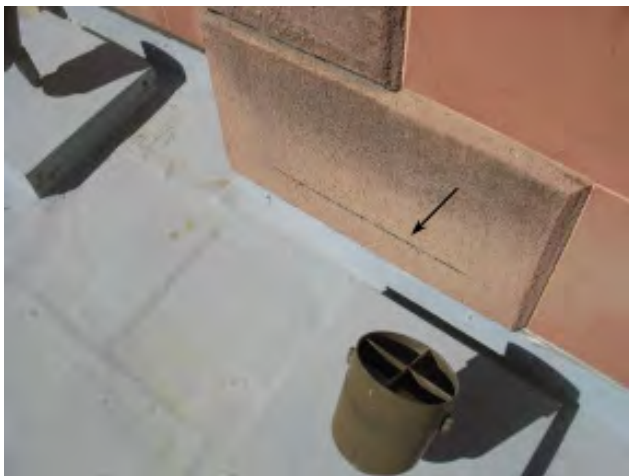
Figure IV-10. An EIFS quoin with a horizontal crack which allows water to enter the wall system.

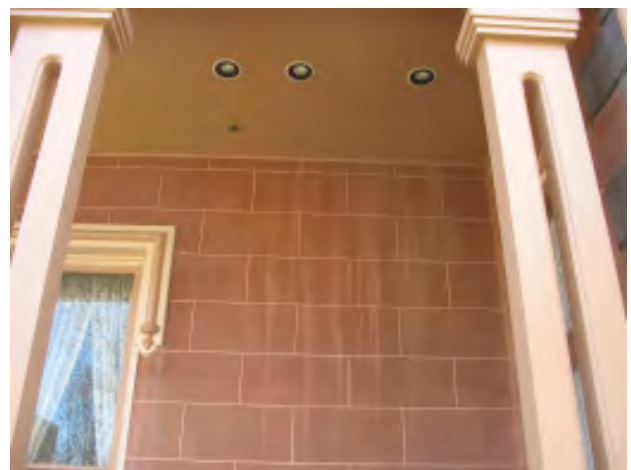
Figure IV-11. Water stains underneath the porch roof on the east elevation.

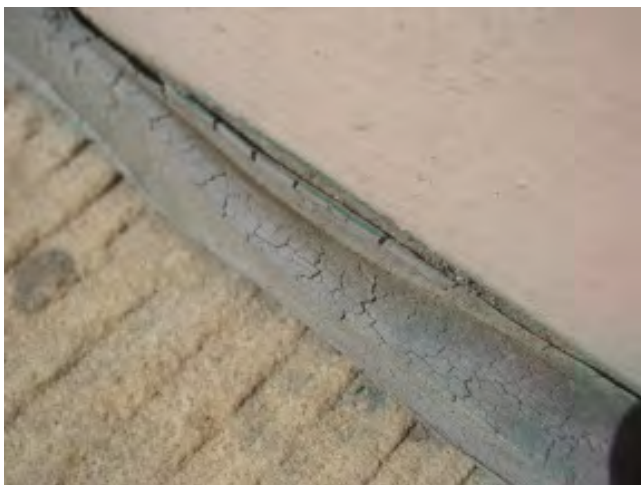
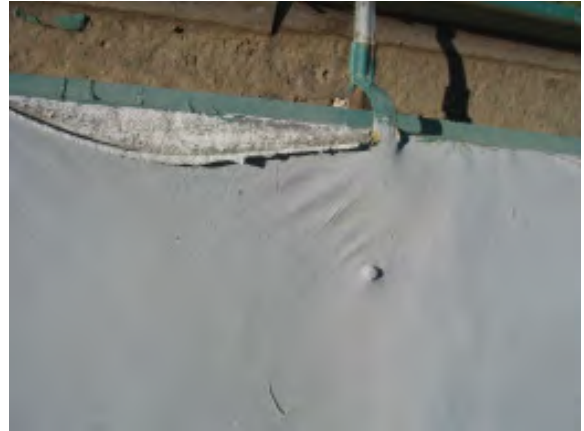
Figure IV-12. A detail of the edge of the porch roof showing the coating over the soldered metal peeling away.
