Historic Structures Report

Devereux House

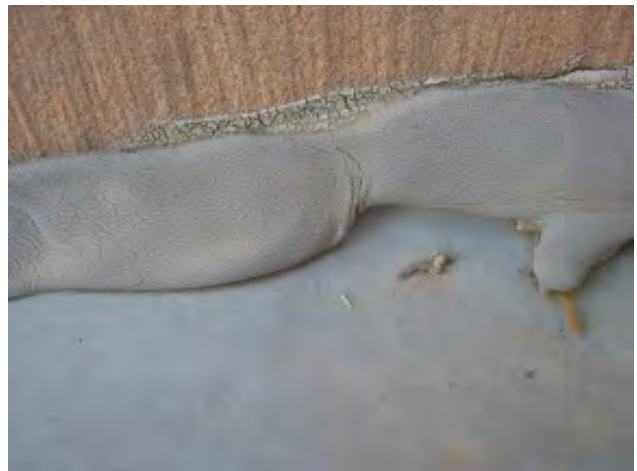
areas have sealant beads which have long failed, leaving an open path to the wall interior (Figures IV-14 & 16). The junction of the metal roofing, sandstone sill, and the reglet at the base of the stucco wall creates a difficult condition to waterproof, and open breaches were observed at this junction (Figure IV-17).

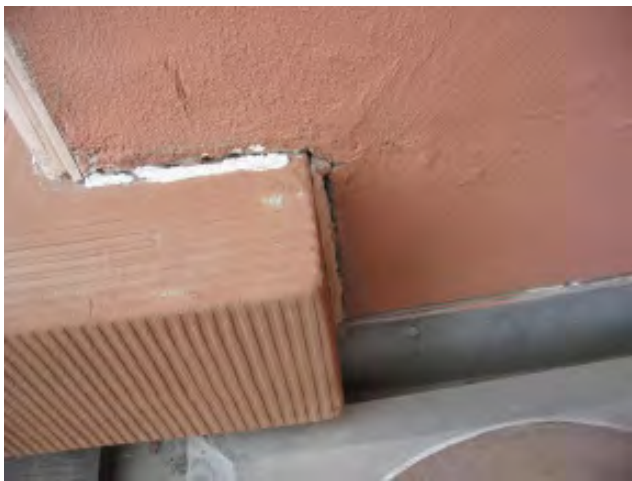
Figure IV-16. A detail of a window sill with an open breach where it meets the stucco wall.

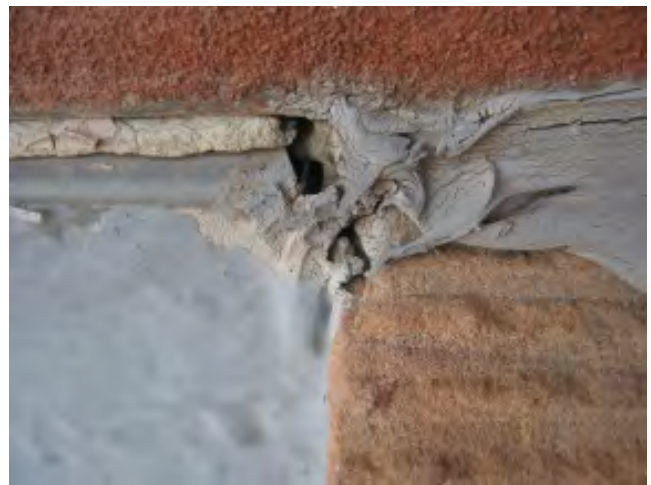
Figure IV-17. A detail at the junction of the turned up edge of the metal roofing and window sill.

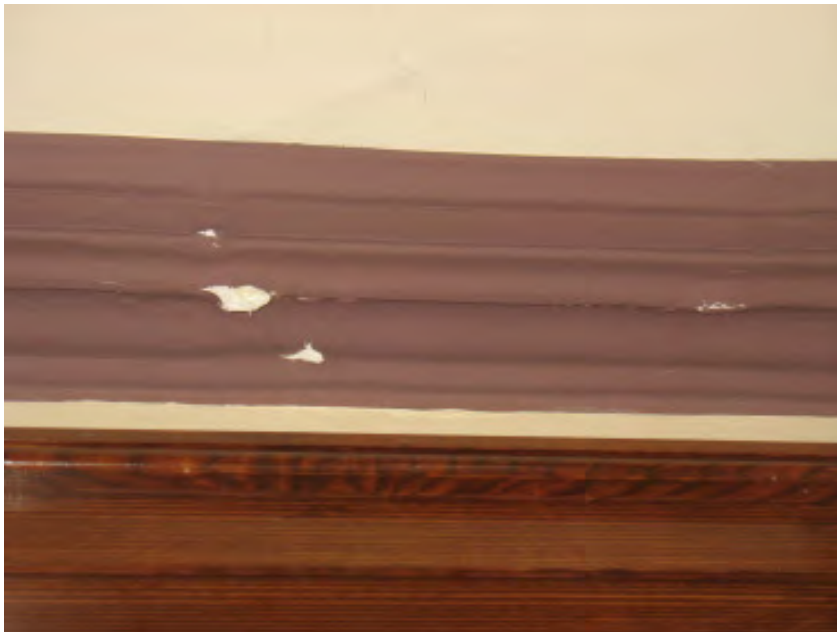
Figure IV-18. Water damage on a plaster crown molding in the Entrance Vestibule.

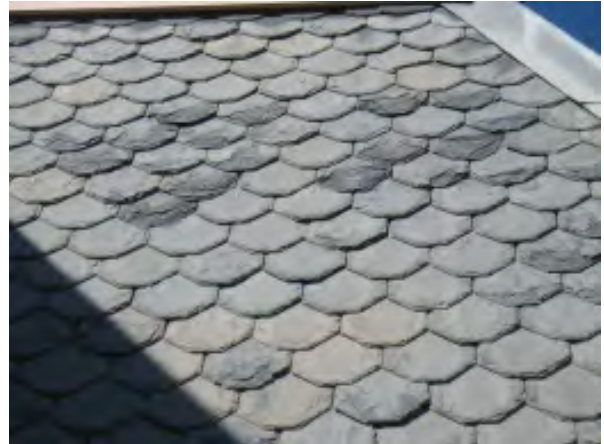
Figure IV-19. A detail of weathered slates on the south elevation.

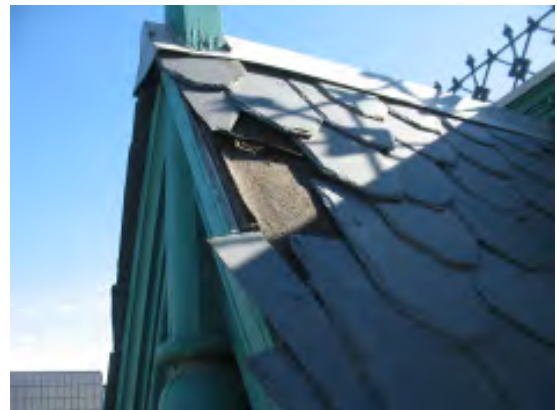
Figure IV-20. An area of missing slate showing the building paper and plywood underneath.

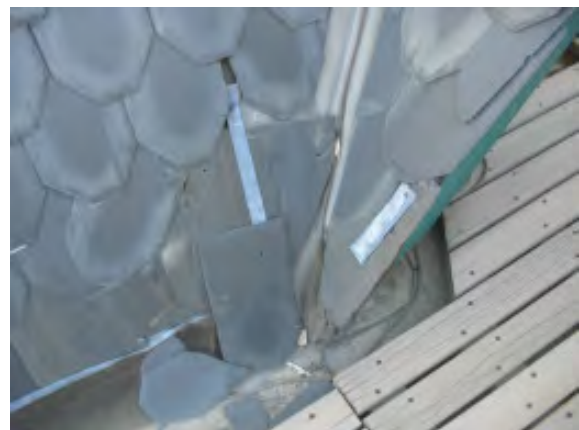
Figure IV-21. Slate repairs using a lead strip which has failed to hold the repair slate in position.

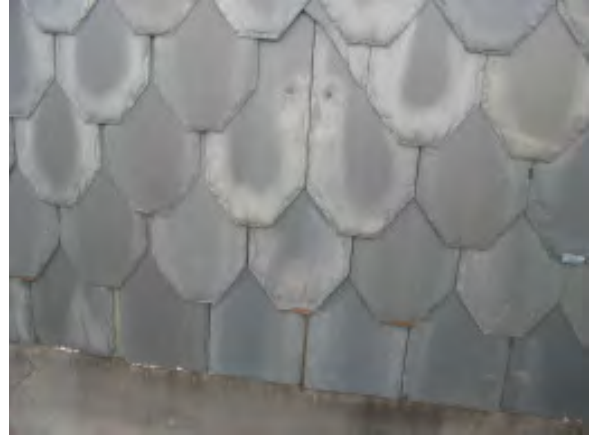
Figure IV-22. A detail of slates repaired with copper and lead tabs. Note the missing slate in the center of the photograph.

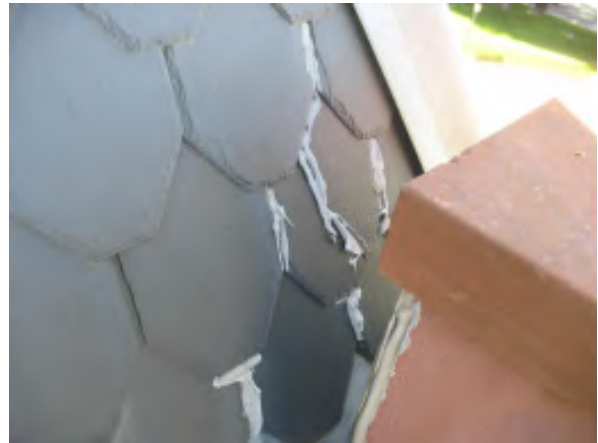
Figure IV-23. A section of roof slates on the east wing with sealant applied to the slate perimeters.

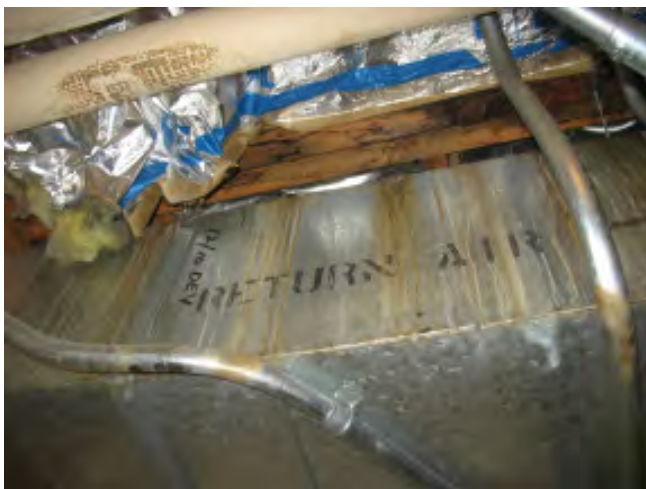
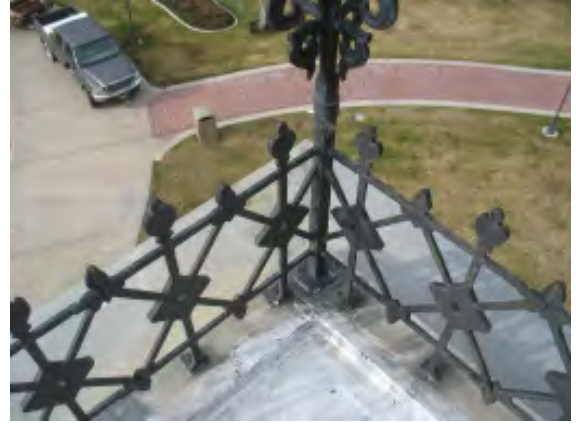
Figure IV-24. A detail of the southwest corner of the west wing roof, showing the uncoated metal roof outside the perimeter of the cresting, and a coating applied to the field inside the cresting.

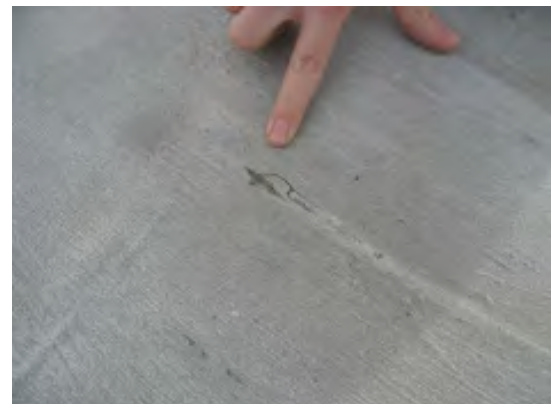
The metal cresting at the perimeter of the upper roof is fastened with screws that penetrate the roofing (Figure IV-28). The cresting has a foot with an open slot in which the screw is inserted. The foot rests on a small iron plate that is set on the roofing with a bed of sealant. In some cases the cresting has slipped off of the retaining screw fastener. The sealant has also pulled away from the plate, providing a potential path for water entry. The screw does not have a washer or sealant to prevent water entry at the screw hole. Crestings should be refastened to secure them to the roof. Given the observed condition of sealant at the perimeter of the plate, these plates should be removed, cleaned and repainted, and set in a new bed of sealant. Sealant or a washer should be installed below the cresting foot to prevent water entry through the screw hole.

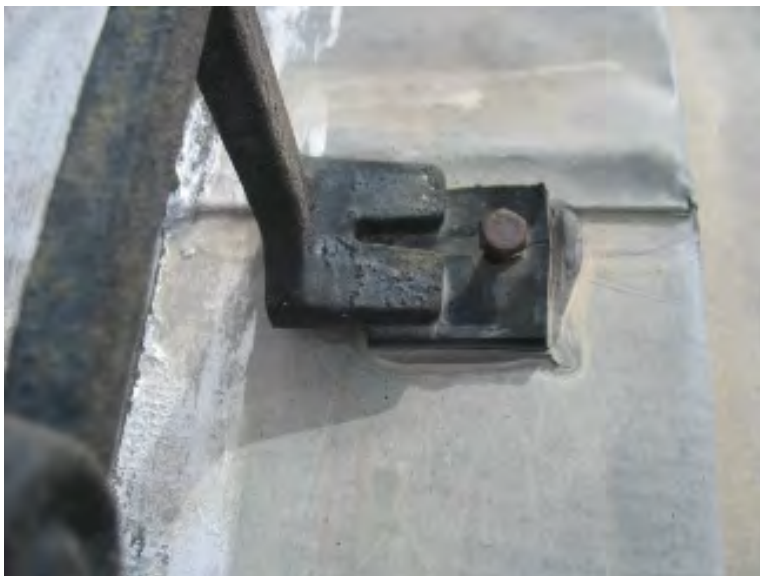
Figure IV-28. A detail of the supporting foot of the metal cresting which has slipped out of position.

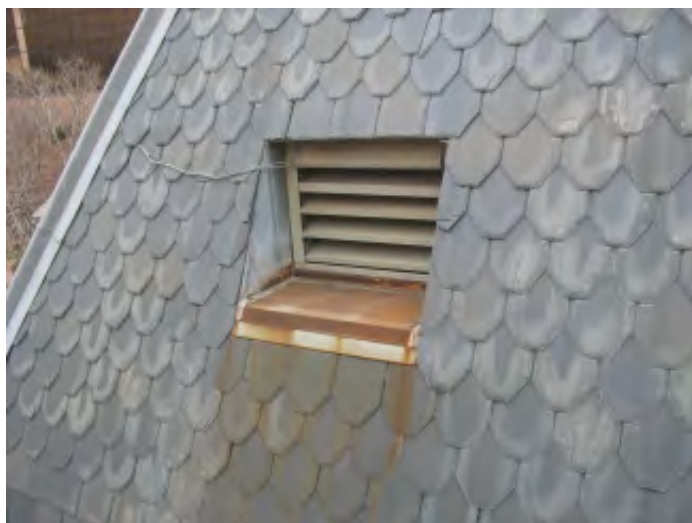
Figure IV-29. A mechanical room air duct penetrating the slate roof on the east wing.

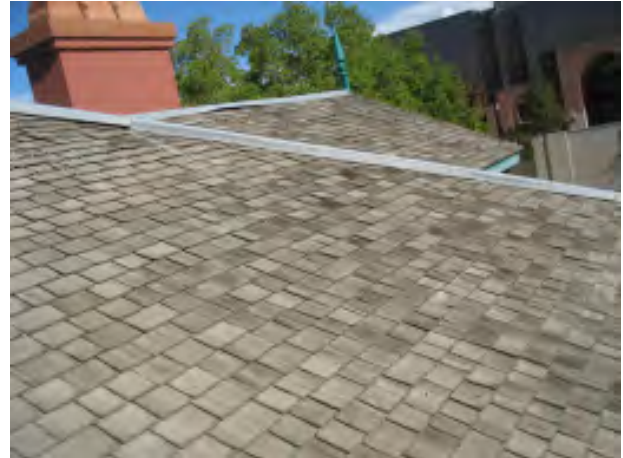
Figure IV-30. A view of the rear wing roof.

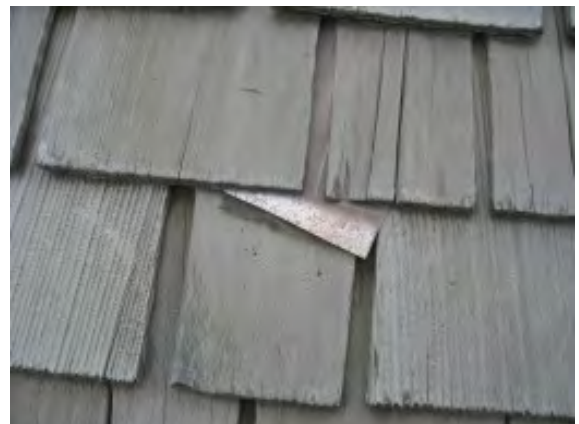
Figure IV-33 (right). A metal tab inserted where a shingle has split.

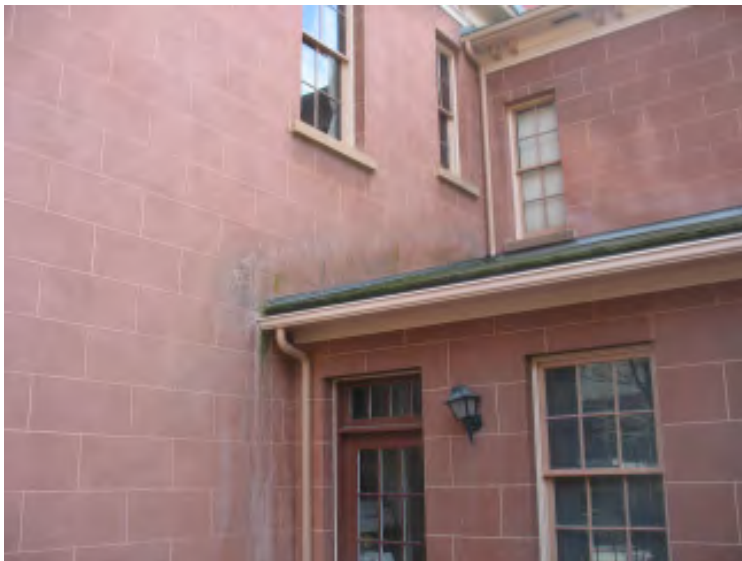
Figure IV-34. A view of the lower kitchen roof showing water staining on adjacent stucco walls.

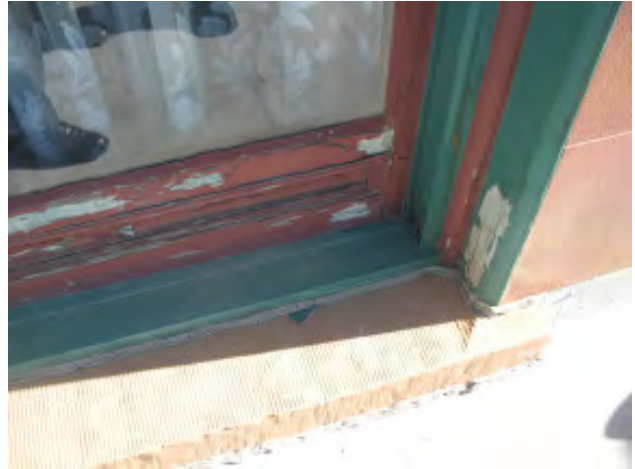
Figure IV-35. Peeling paint in 2010 on the south elevation prior to repainting.

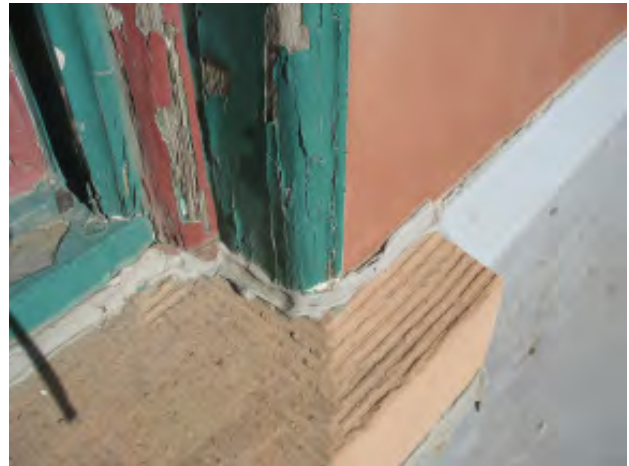
Figure IV-36. Peeling paint in 2010 on the south elevation.

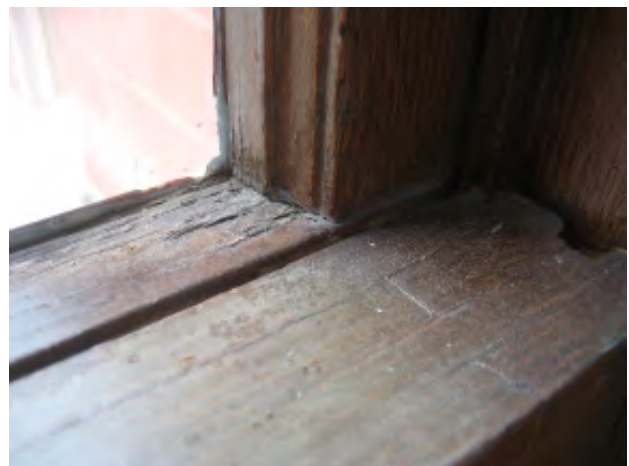
Figure IV-37 (below). A detail showing a deteriorated window sash where condensation pools at the bottom rail.

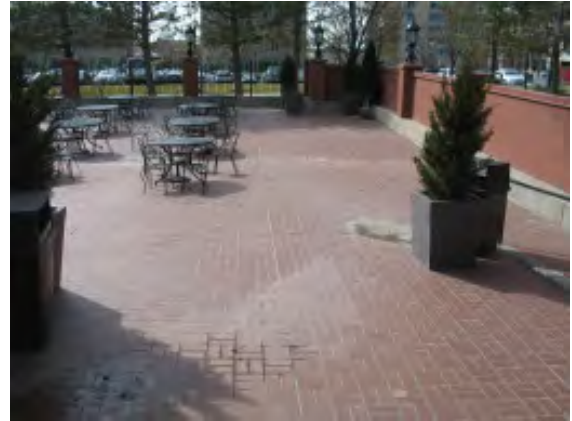
Figure IV-38. A view of the patio surface.

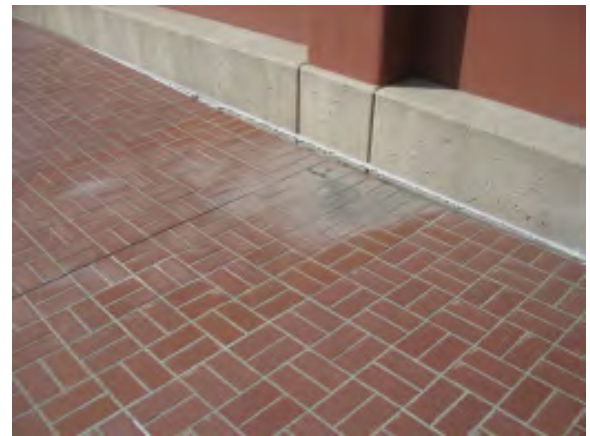
Figure IV-39. An area of subsidence in the patio slab. Note the level of the sealant installed at the original patio level, and the staining caused by ponding water

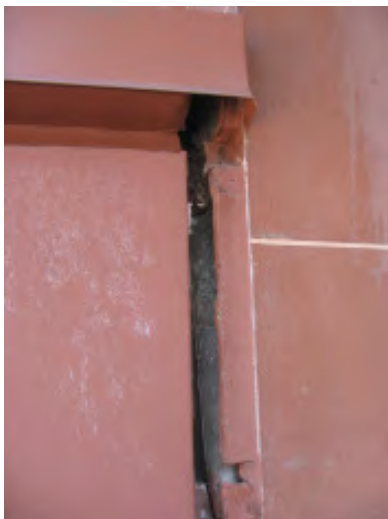
Figure IV-40 (left). A patio screen wall which has pulled away from the main building.

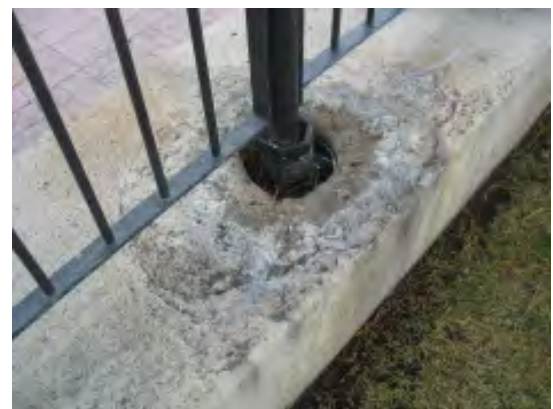
Figure IV-41 (right). A fence post sleeve which has corroded and spalled the surrounding concrete.

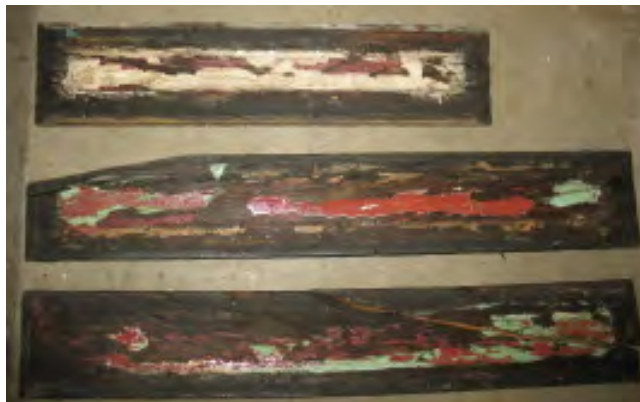
Figure V-3. The weathered side of saved window panel boards

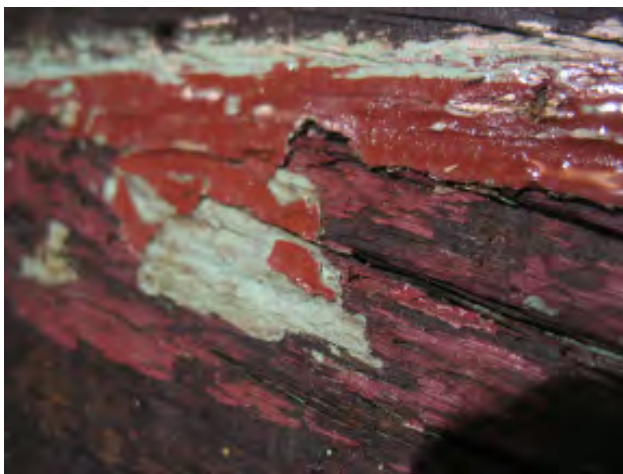
Figure V-7. The weathered surface of a painted board originally part of a panel on the bottom sash of a window.
