## APPENDIX C: STUDY REACH MAPS, SUMMARIES, AND RECOMMENDATIONS

## REACH UCC\_R09: PLEASANT VALLEY

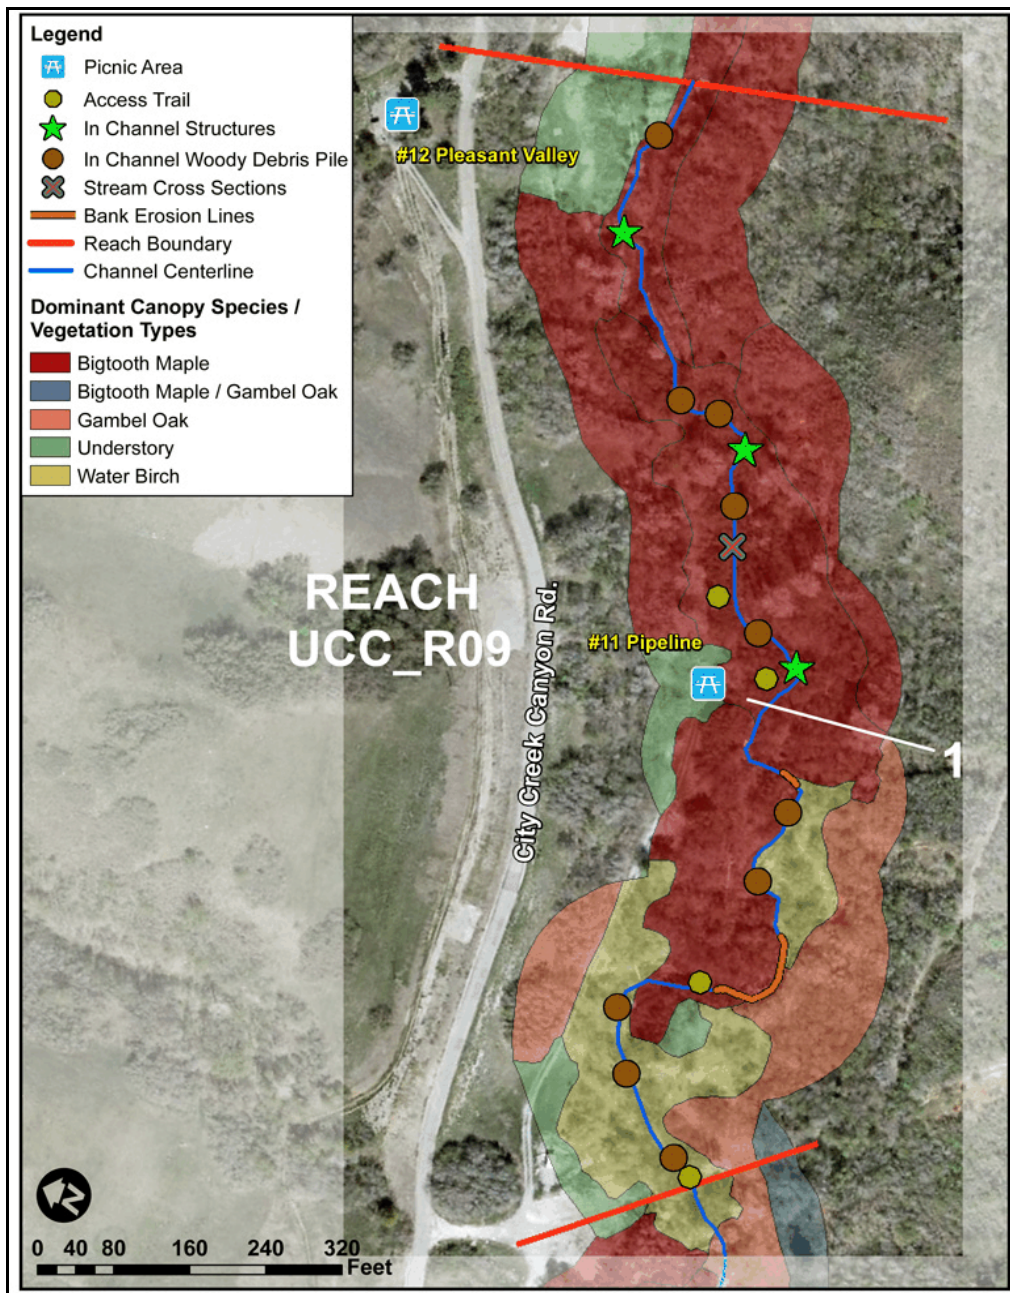
This reach is generally in very good condition. During the field assessment, nearly 20 trout were observed using habitat provided by undercut banks and in-channel woody debris piles. A diverse mix of native canopy, shrub, and understory species are present, and low floodplain surfaces/gravel bars are abundant. Localized weed control efforts are needed in the vicinity of developed picnic and restroom areas at the upstream and downstream ends of the reach.

- invasive species (burdock, houndstongue, Dyer's woad, toadflax, thistle, goatgrass, cheatgrass)

RECOMMENDATIONS	
IMPROVEMENT MEASURE	LOCATION
Invasive plant removal/control	within vegetation type(s)
Access control/trail reclamation	point 1 on map

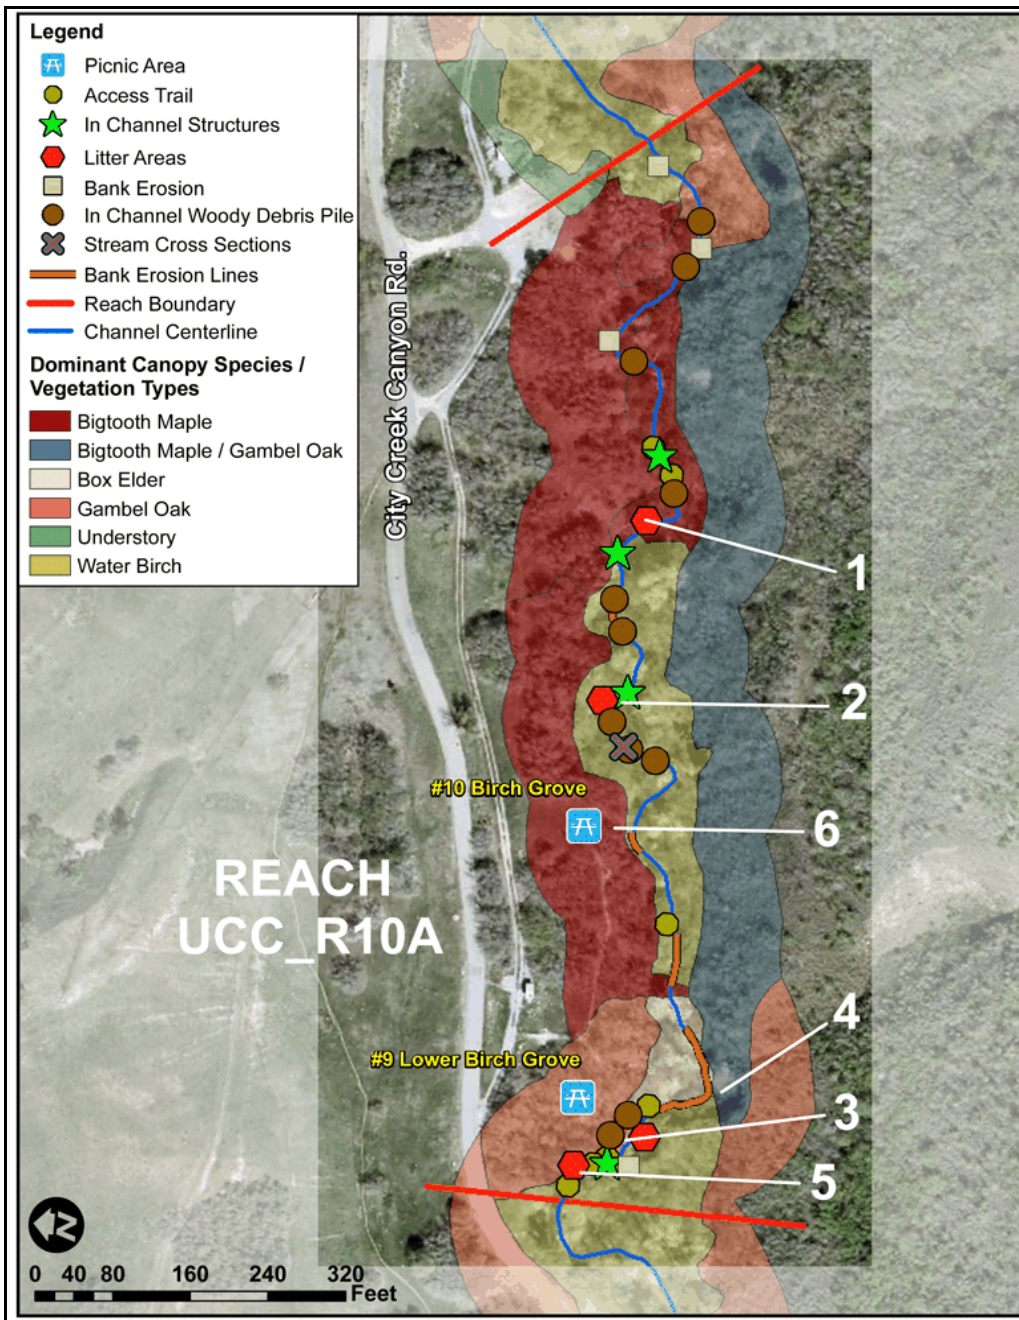
## REACH UCC\_R10A: PIPELINE

This reach includes two developed picnic sites. Beaver activity is evident in this reach, which contains many woody debris piles and a diverse mix of native canopy, shrub, and understory vegetation. Well-developed undercut banks provide excellent fish habitat, and more than 10 trout were observed during the field assessment of this reach. Several significant areas of erosion are evident where the stream has migrated into the steep hillside.

- trash (minor)
- invasive species (thistle, burdock, goatgrass, cheatgrass, toadflax, Dyer's woad)
- eroded access trails (minor)

RECOMMENDATIONS	
IMPROVEMENT MEASURE	LOCATION
Invasive plant removal/control	within vegetation type(s)
Monitor terrace erosion	point 4 on map
Stream cleanup	points 1, 2, and 3 on map
Mechanized trash removal	point 5 on map
Picnic site improvements/access stabilization	points 5 and 6 on map

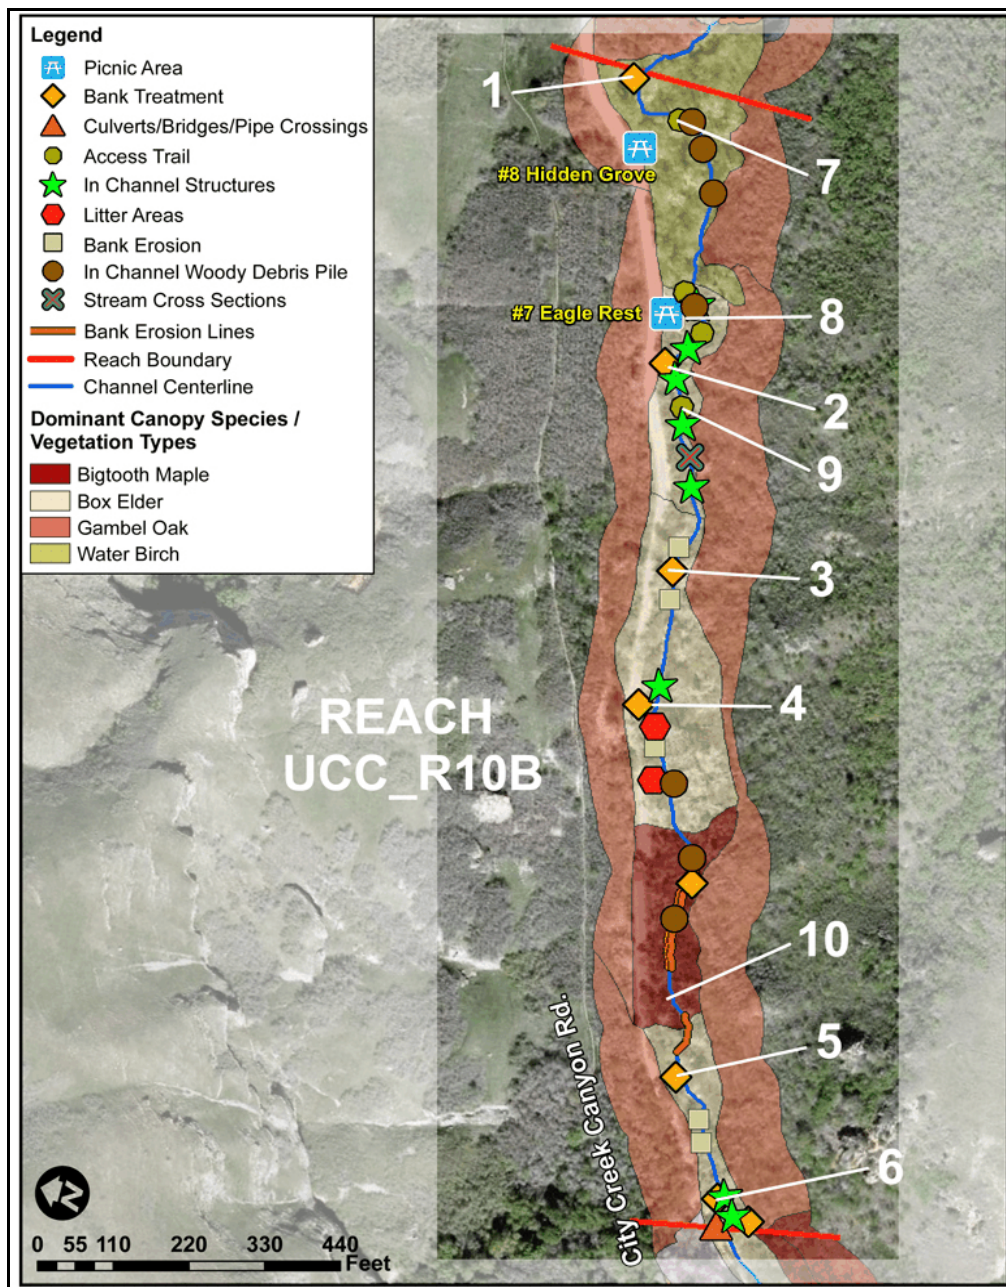
## REACH UCC\_R10B: EAGLES REST

Within this reach, the northern bank has been stabilized with gabion baskets in several locations. The channel passes through a conglomerate geologic formation in this reach, and bedrock is exposed in portions of the banks. Areas of steep, bare banks are common, but appear to be associated with natural processes typical of a steep canyon setting. The downstream boundary of the reach is at the red footbridge/water line crossing. Fish were observed in this reach.

- invasive species (burdock)
- gabions
- bank erosion

RECOMMENDATIONS	
IMPROVEMENT MEASURE	LOCATION
Invasive plant removal/control	within vegetation type(s)
Gabion basket retrofit	points 1, 2, 3, 4, 5 on map
Stabilize erosion/rills at ends of gabions	points 3 and 6 on map
Access trail stabilization	points 7, 9, and 10 on map
Picnic site improvements/access stabilization	point 8 on map

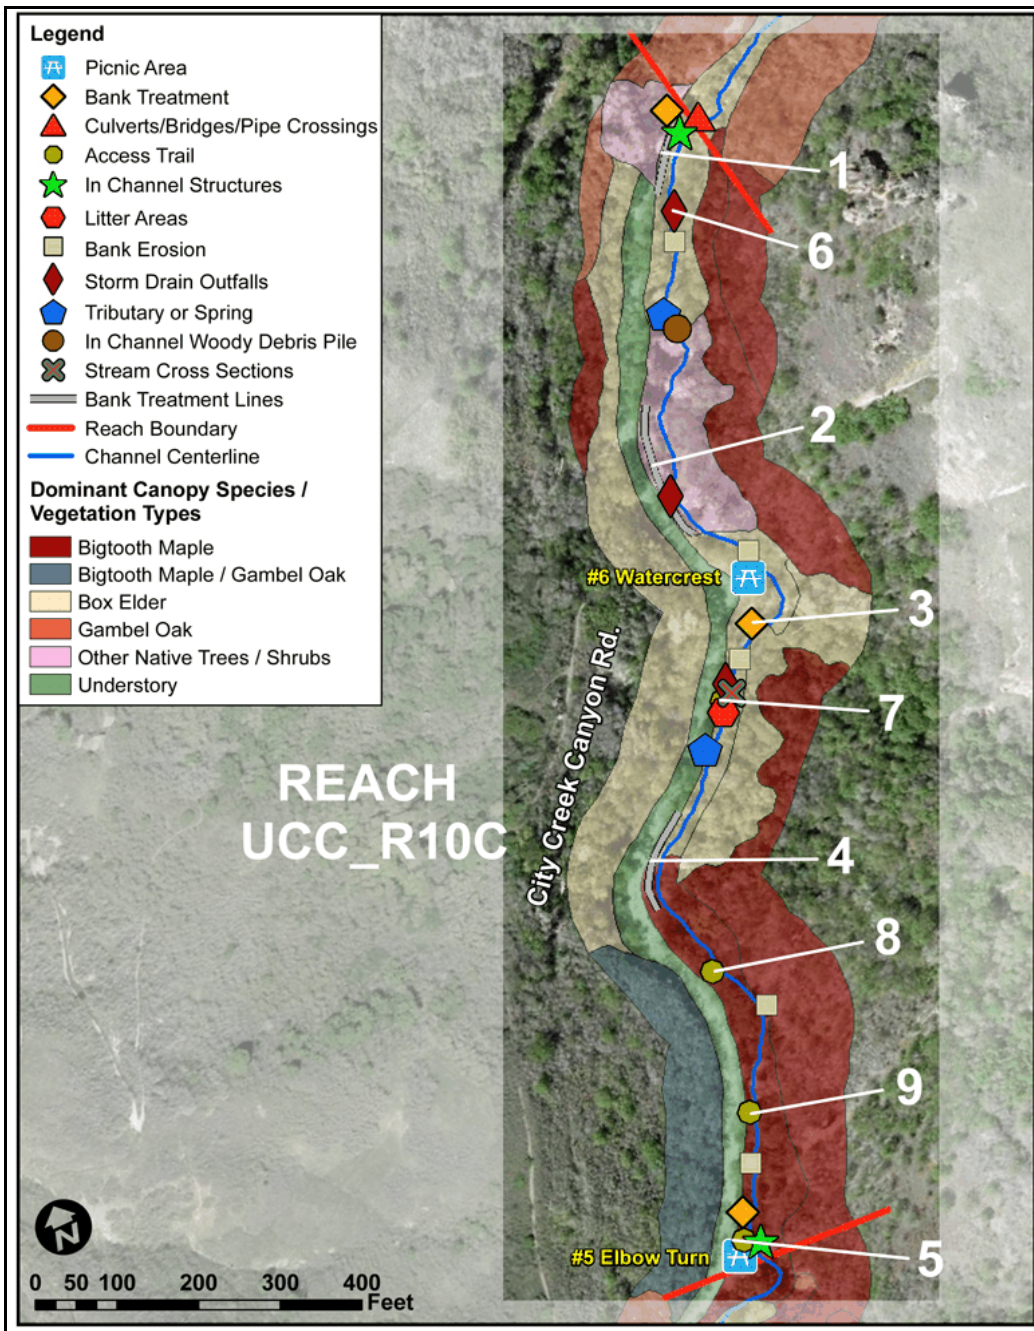
## REACH UCC\_R10C: WATERCREST

Starting at this reach, the alignment of City Creek shifts and begins to flow to the south. Several seeps/springs enter from the west bank. Fish were observed in this reach, which includes abundant undercut banks. Vegetative cover and floodplain width are limited by the proximity of the road and gabion basket protection on the west bank in several locations. Two picnic sites are present near the stream in this reach.

- invasive species (burdock, toadflax)
- eroded access trails
- gabions

RECOMMENDATIONS	
IMPROVEMENT MEASURE	LOCATION
Invasive plant removal/control	within vegetation type(s)
Gabion basket retrofit	points 1, 2, 3, 4, 5 on map
Picnic site improvements	points 3 and 5 on map
Outfall improvements	points 2 and 6 on map
Access trail stabilization/reclamation	points 5, 7, 8, 9 on map

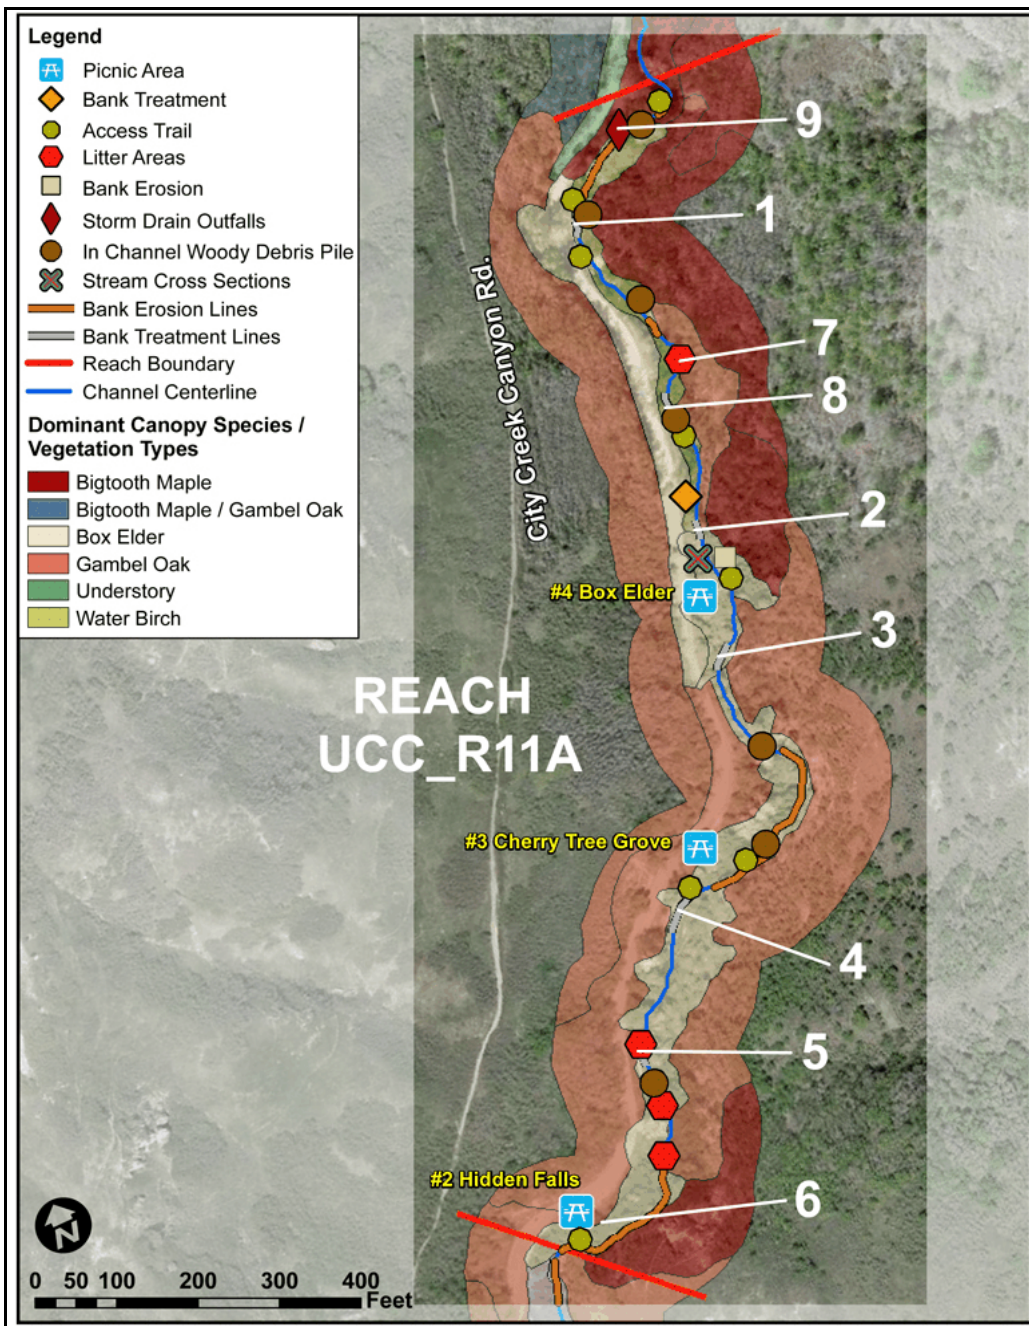
## REACH UCC\_R11A: ELBOW TURN

The upstream boundary of this reach is at the Elbow Turn picnic site; the reach also includes three other picnic sites. The stream channel flows very close to the road in some areas, and has meandered into some steep hillslope/rock outcrops on the east bank. Several relatively small areas of rip rap and gabion bank protection are present on the west bank. Fish were observed in this reach.

- invasive species (burdock, toadflax, Dyer's woad, thistle, houndstongue, cheatgrass)
- eroded trails/picnic site access
- gabions
- road proximity/repair practices
- hillslope erosion

RECOMMENDATIONS	
IMPROVEMENT MEASURE	LOCATION
Invasive plant removal/control	within vegetation types
Picnic site improvements	near points 3, 4 and 6 on map
Gabion basket retrofit	points 1, 2, 3, 4, 5 on map
Stabilize erosion/rills at ends of gabions	points 3 and 5 on map
Access trail stabilization/reclamation	points 1, 4, 6, 8 on map
Stream cleanup	point 7 on map
Mechanized trash removal	near point 5 on map
Protect stream from asphalt/road debris	point 8 on map
Outfall improvement	point 9 on map
Road maintenance/runoff management	reach-scale

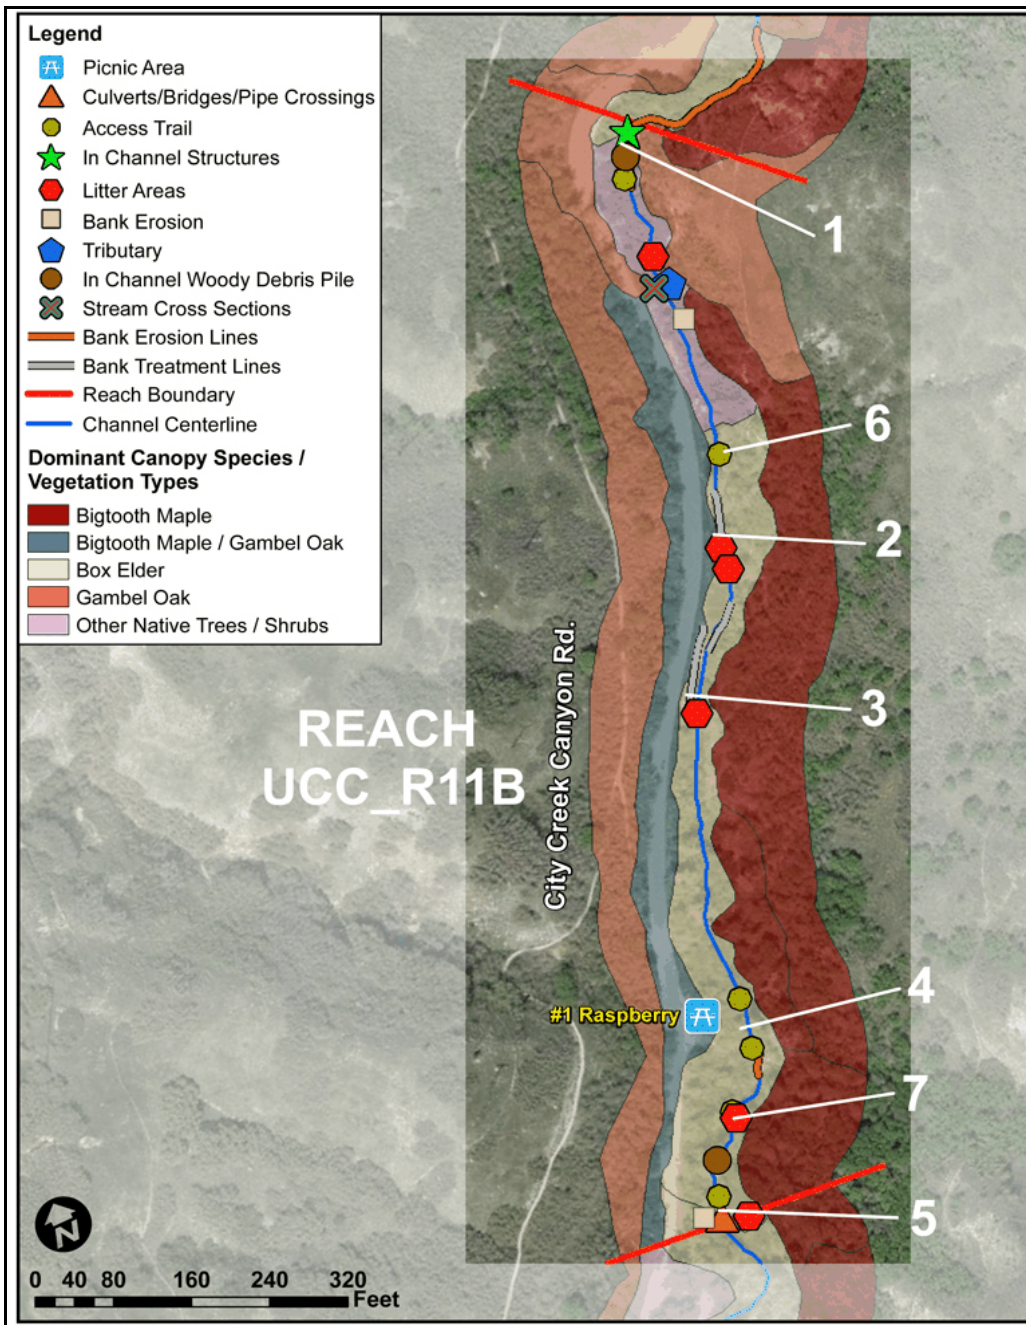
## REACH UCC\_R11B: HIDDEN FALLS

This reach begins at a natural bedrock outcrop/waterfall feature near the Hidden Falls picnic site. Near-stream vegetation (including dense stands of horsetail) is thick through much of this reach, but limited by the proximity of the road in other areas. Fish were observed, and a spring/seep was also noted. A broken wood plank footbridge crosses the channel at the downstream end of the reach. A small footpath parallels the stream along the east bank.

- invasive species (burdock, toadflax)
- eroded trails/picnic site access
- gabions
- trash (minor)
- road proximity/repair practices

RECOMMENDATIONS	
IMPROVEMENT MEASURE	LOCATION
Invasive plant removal/control	within vegetation type(s)
Stream cleanup	points 2 and 7 on map
Gabion basket retrofit	points 1, 2, 3 on map
Picnic site access controls	point 4 on map
Access trail stabilization/reclamation	point 6 on map and at picnic sites
Remove or repair footbridge	point 5 on map
Mechanized trash removal	point 2 on map
Protect stream from asphalt/road debris	reach-scale

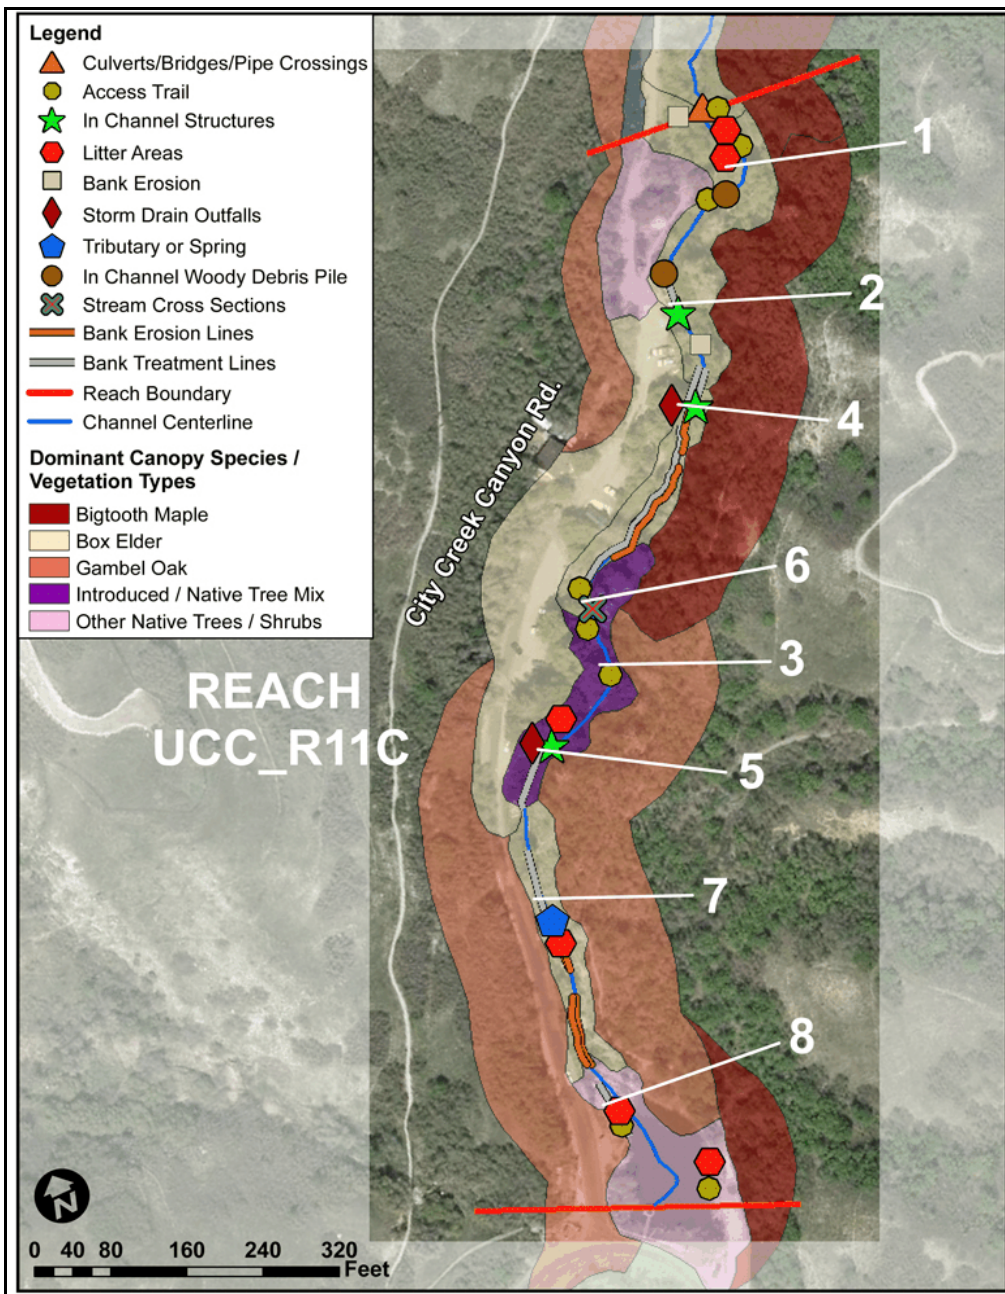
## REACH UCC\_R11C: GUARD SHACK GATE AREA

This reach includes the developed entrance gate area and the upper debris basin. Multiple concrete structures affect riparian conditions and appear to be in need of repair or replacement. Most of the right bank has been stabilized with gabion baskets, concrete walls, and boulder rip-rap, and lacks vegetation in areas. A flowing tributary channel enters from the east. This is the upstream-most reach where Siberian elm was noted as present, and the only reach where Russian olive was noted.

- invasive species (nine species)
- failing in-channel structures
- lack of vegetation along hardened bank areas
- road proximity/repair practices
- proximity of parking/maintenance areas
- eroded trails/picnic site access
- trash
- dredging/maintenance of debris basin

RECOMMENDATIONS	
IMPROVEMENT MEASURE	LOCATION
Invasive plant removal/control	within vegetation type(s)
Runoff management	maintenance/guard shack area
Storm drain improvement	points 4 and 5 on map
Replace/improve bank protection	point 5 on map and between points 2 and 4
Gabion basket retrofit	points 2 and 7 on map and between points 4 and 6
Replace/improve grade control structures	points 2, 4, 5 on map
Access control (fence)	between parking areas and stream
Access trail stabilization (steps)	points 1 and 3 on map
Revegetation-shrub layer	near points 2 and 8 on map
Stream cleanup	points 1 and 5 on map and around debris basin
Create vegetated buffer	reach-scale along west bank
Protect stream from asphalt/road debris	reach-scale
Install stabilized dredging access ramp	east side of debris basin

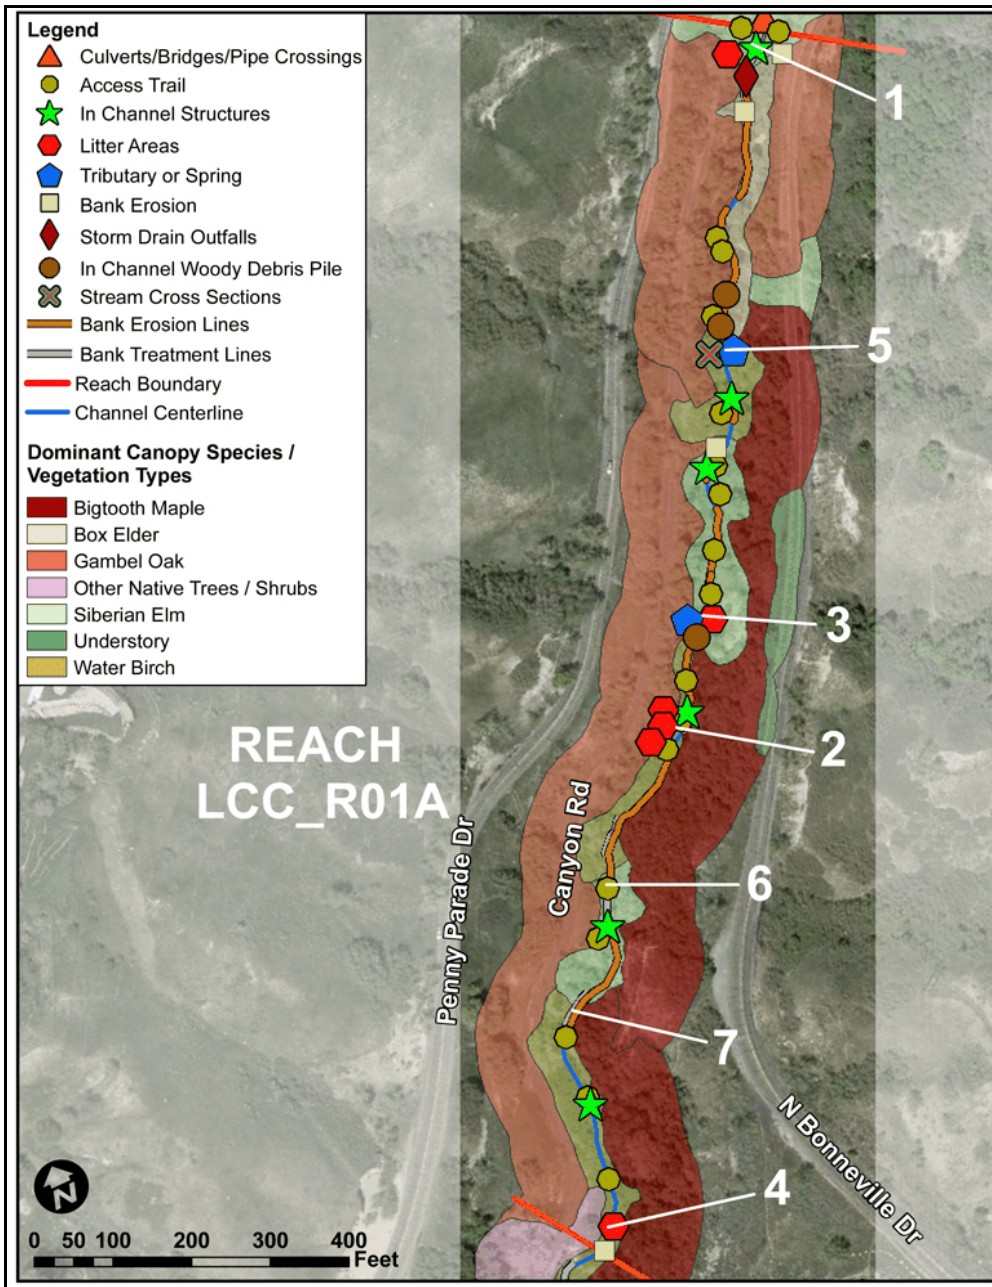
## REACH LCC\_R01A: BELOW BONNEVILLE BOULEVARD

In this reach the creek is tightly confined between a paved trail on the west side and Bonneville Boulevard and a conglomerate outcrop on the east side. Side slopes are steep and tall and lack understory cover in many areas; this appears to be primarily due to roadway fill and hillslope erosion rather than ongoing bed incision or toe failure. Access trails on the east side of the stream are steep and in poor condition. Invasive Siberian elm is the dominant tree species in portions of this reach.

- pipe outfall erosion
- hillslope erosion/ oversteepened slopes
- road/paved trail proximity
- eroded access trails
- soil compaction from foot traffic
- limited understory and shrub cover
- invasive species (eight species)
- gabions
- trash

RECOMMENDATIONS	
IMPROVEMENT MEASURE	LOCATION
Invasive plant removal/control	within vegetation type(s)
Revegetation (understory)	within vegetation type(s)
Revegetation (shrub)	within vegetation type(s)
Stream cleanup	points 1 and 2 on map
Mechanized trash removal	points 2, 3, and 4 on map
Storm drain improvement	near point 1 on map
Protect/restore tributary	point 5 on map
Biotechnical slope stabilization	reach-scale
Gabion basket retrofit	points 1, 6, 7 on map
Access control/trail stabilization	reach-scale
Narrow west side trail/lay back slopes	reach-scale

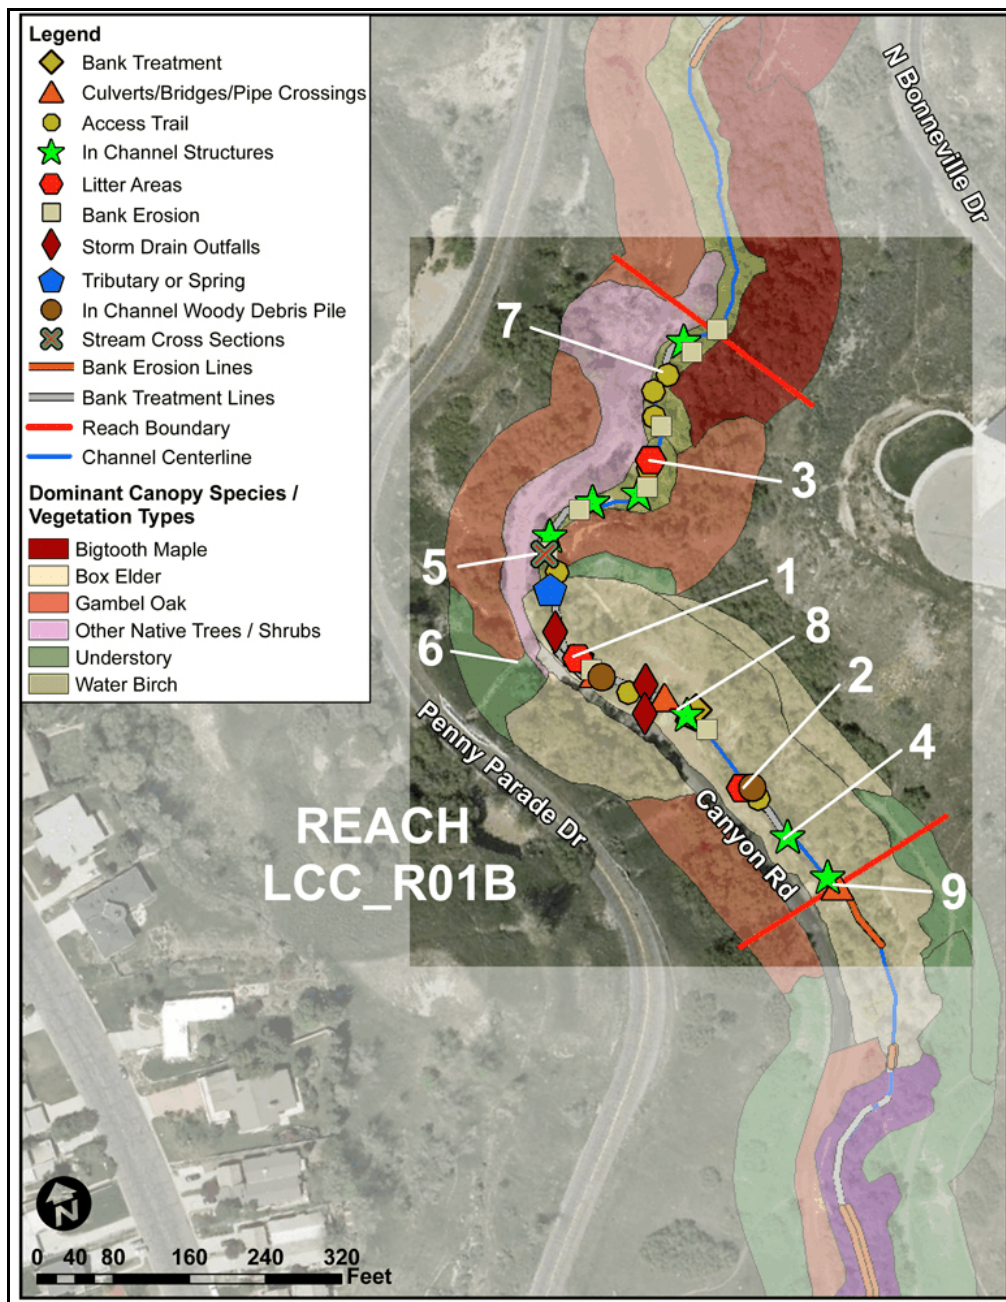
## REACH LCC\_R01B: UPPER FREEDOM TRAIL AREA

A brown footbridge crosses the creek in the middle of this reach, designating the start of the east-side Freedom Trail and off-leash dog area. The channel becomes less confined in this reach. Numerous utility crossings are present and the channel has been heavily controlled with concrete bed hardening structures and gabion and stone block walls. Slope erosion and road runoff have caused a large eroding gully above the westside trail midway through the reach. Understory vegetation cover is generally limited.

- bank hardening
- compaction from foot traffic (people and dogs)
- eroded access trails
- limited understory and shrub cover
- invasive species (seven species)
- trash
- road runoff/gully erosion

RECOMMENDATIONS	
IMPROVEMENT MEASURE	LOCATION
Invasive plant removal/control	within vegetation type(s)
Revegetation (shrub)	within vegetation type(s)
Revegetation (understory)	within vegetation type(s)
Stream cleanup	points 1 and 2 on map
Mechanized trash removal	points 3 and 4 on map
Runoff management	reach-scale
Stabilize large gully	point 6 on map
Gabion basket retrofit	near points 1, 4, 5, 7 on map
Access control/trail stabilization	reach-scale
Remove asphalt debris from bank	near point 5 on map
Add interpretive displays	reach-scale
Remove/improve streambed structures	near points 3, 7, 8, 9 on map

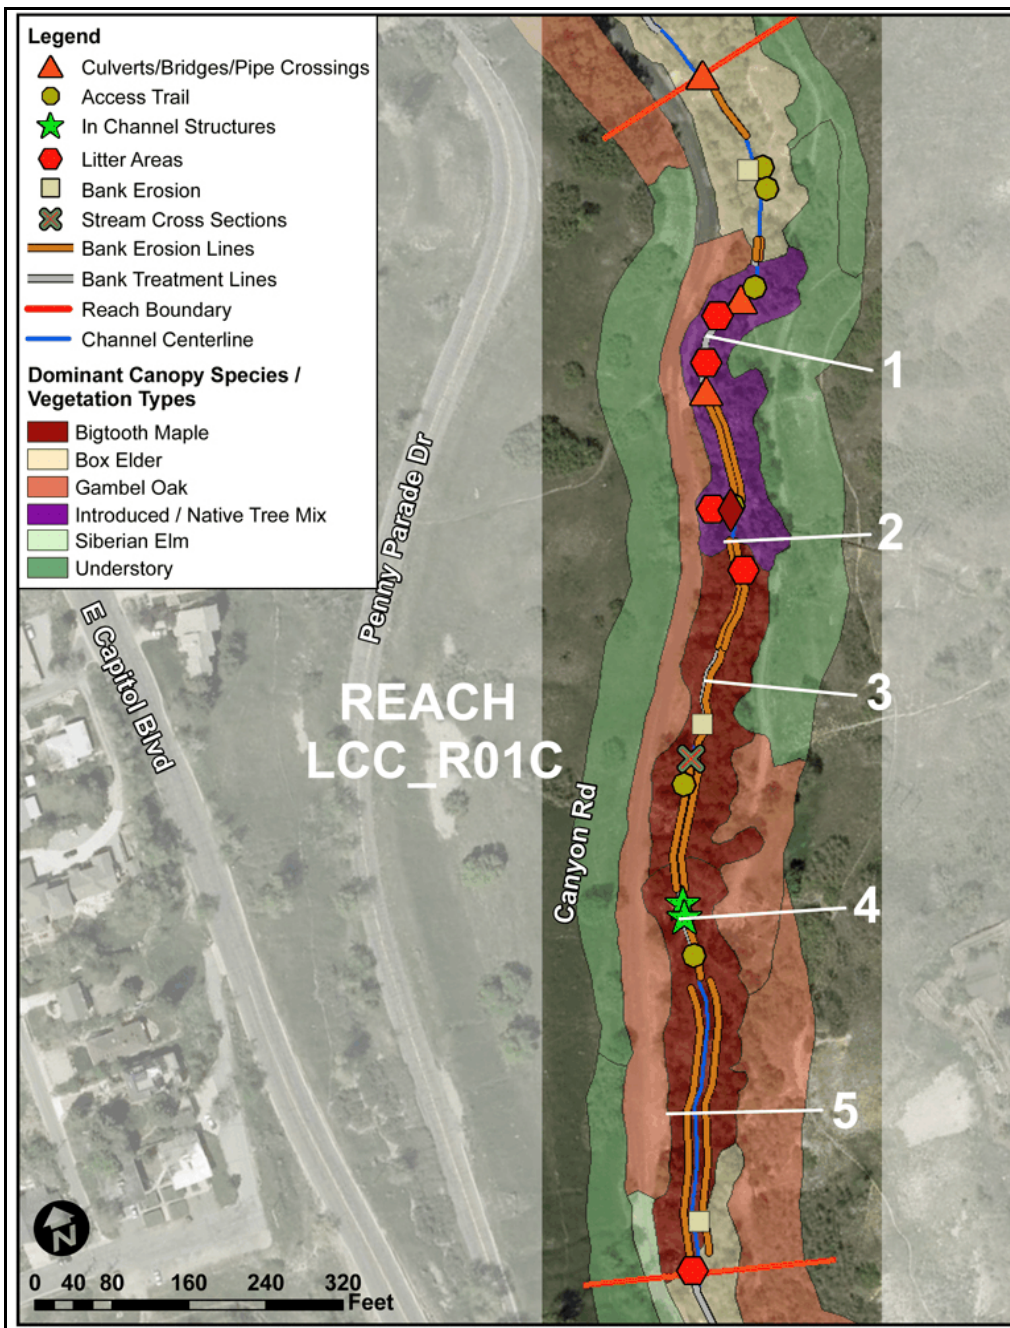
## REACH LCC\_R01C: LOWER FREEDOM TRAIL AREA

This reach starts at a concrete flume/stream gaging structure. Understory vegetation is lacking and most of the reach has weed classification of “high.” A concrete arch culvert that protects a utility crossing in the reach shows evidence of sedimentation. The east side of the stream is part of a designated off-leash dog area and receives heavy recreational use.

- Issues affecting riparian function:**
- gabion bank hardening
  - compaction from foot traffic (people and dogs)
  - eroded access trails
  - limited understory and shrub cover
  - invasive species (11 species)
  - storm drain outfall erosion
  - trash

RECOMMENDATIONS	
IMPROVEMENT MEASURE	LOCATION
Invasive plant removal/control	within vegetation type(s)
Revegetation (shrub and understory)	within vegetation type(s)
Stream cleanup	near points 1 and 2 on map
Storm drain improvement and asphalt debris removal	near point 2 on map
Gabion basket retrofit	near points 1, 3, and 4 on map
Access control/trail stabilization	reach-scale
Eliminate storage of branch trimmings/trash	point 5 on map
Add interpretive displays	reach-scale
Replace arch culvert with wider-span structure	point 1 on map

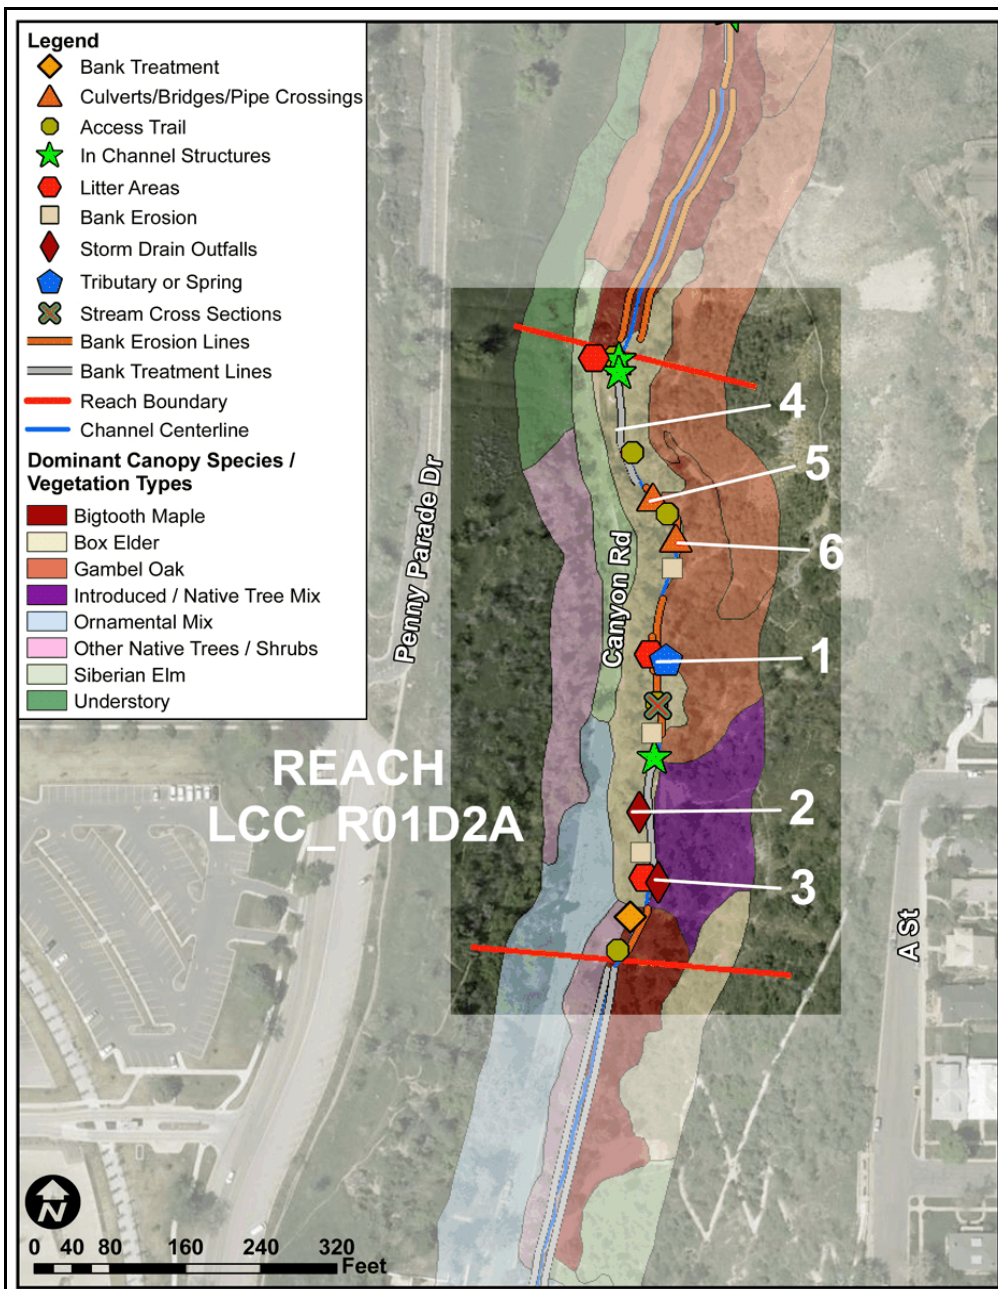
## REACH LCC\_R01D02A: UPPER MEMORY GROVE PARK

This reach starts at a grouted rock drop structure and extends to the start of the artificial rock-wall channel. A concrete footbridge midway through the reach marks the end of the off-leash dog area. Foot compaction affects bank stability and limits understory cover through much of the reach, and high densities of invasive plants are present. A large storm drain outlet on river left has been reported to frequently discharge white/“milky,” foamy water into the creek.

- gabion bank hardening
- compaction from foot traffic (people and dogs)
- eroded access trails
- limited understory cover
- invasive species (eleven species)
- storm drain outfall erosion and discharge
- trash (minor)

RECOMMENDATIONS	
IMPROVEMENT MEASURE	LOCATION
Invasive plant removal/control	within vegetation type(s)
Revegetation (understory)	within vegetation type(s)
Mechanized trash removal	point 1 on map
Storm drain improvement	point 2 on map
Identify and remedy source of "milky," foamy discharge	point 3 on map
Restore/protect tributary drainage	point 1 on map
Gabion basket retrofit	near points 2 and 4 on map
Access control/trail stabilization	reach-scale
Add interpretive displays	reach-scale
Replace arch culvert with wider-span structure	point 5 on map
Replace concrete footbridge with wider-span structure	point 6 on map

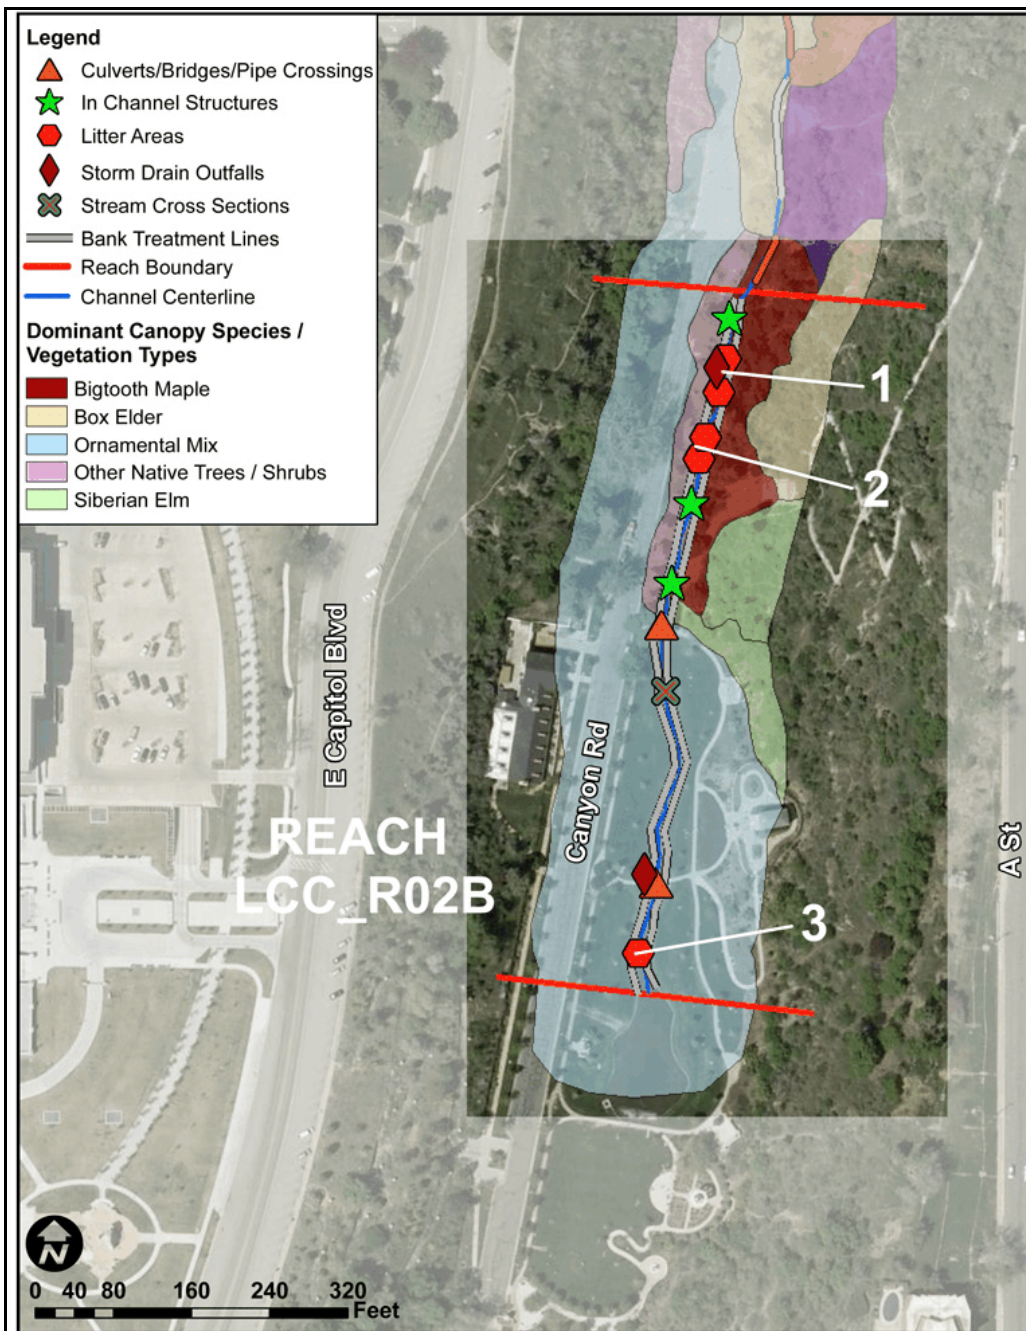
## REACH LCC\_R02B: LOWER MEMORY GROVE PARK

In this reach the stream is confined in a grouted rock channel and enters the N. Temple conduit at the bottom of the reach. Stream-side vegetation in the lower half of the reach is mowed grass, and the channel lacks shade. In portions of the upper half of the reach, riparian vegetation is dominated by introduced grasses and ornamental/invasive tree species. Three grouted drop structures control grade in the upper half of the reach.

- grouted channel
- introduced and invasive species (burdock, cheatgrass, Siberian elm, thistle)
- compaction from foot traffic
- eroded access trails
- lack of canopy and shrub cover
- limited native understory cover
- trash

RECOMMENDATIONS	
IMPROVEMENT MEASURE	LOCATION
Invasive plant removal/control	within vegetation type(s)
Revegetation (canopy)	within vegetation type(s)
Revegetation (shrub)	within vegetation type(s)
Restoration of native understory plants	within vegetation type(s)
Stream cleanup	near points 1, 2, and 3 on map
Establish "no-mow" buffer at edge of turf	downstream half of reach
Access control/trail stabilization	upstream half of reach
