APPENDIX C: STUDY REACH MAPS, SUMMARIES, AND RECOMMENDATIONS

This appendix provides summary information and maps for each of the fully-assessed study reaches. Maps include vegetation community types and locations of features such as litter areas, storm drain outfalls, culvert crossings, access trails, artificial bank treatments, and erosion areas. A brief description and selected photographs are also provided, along with tables summarizing stream channel data and vegetation characteristics. For each study reach, a table is also provided that lists appropriate types of improvement measures for the reach and describes where within the reach the measures should be applied. Measures identified for implementation at the reach-scale will typically require additional detailed site-level design work and engineering to determine specific locations and combinations of treatment techniques.

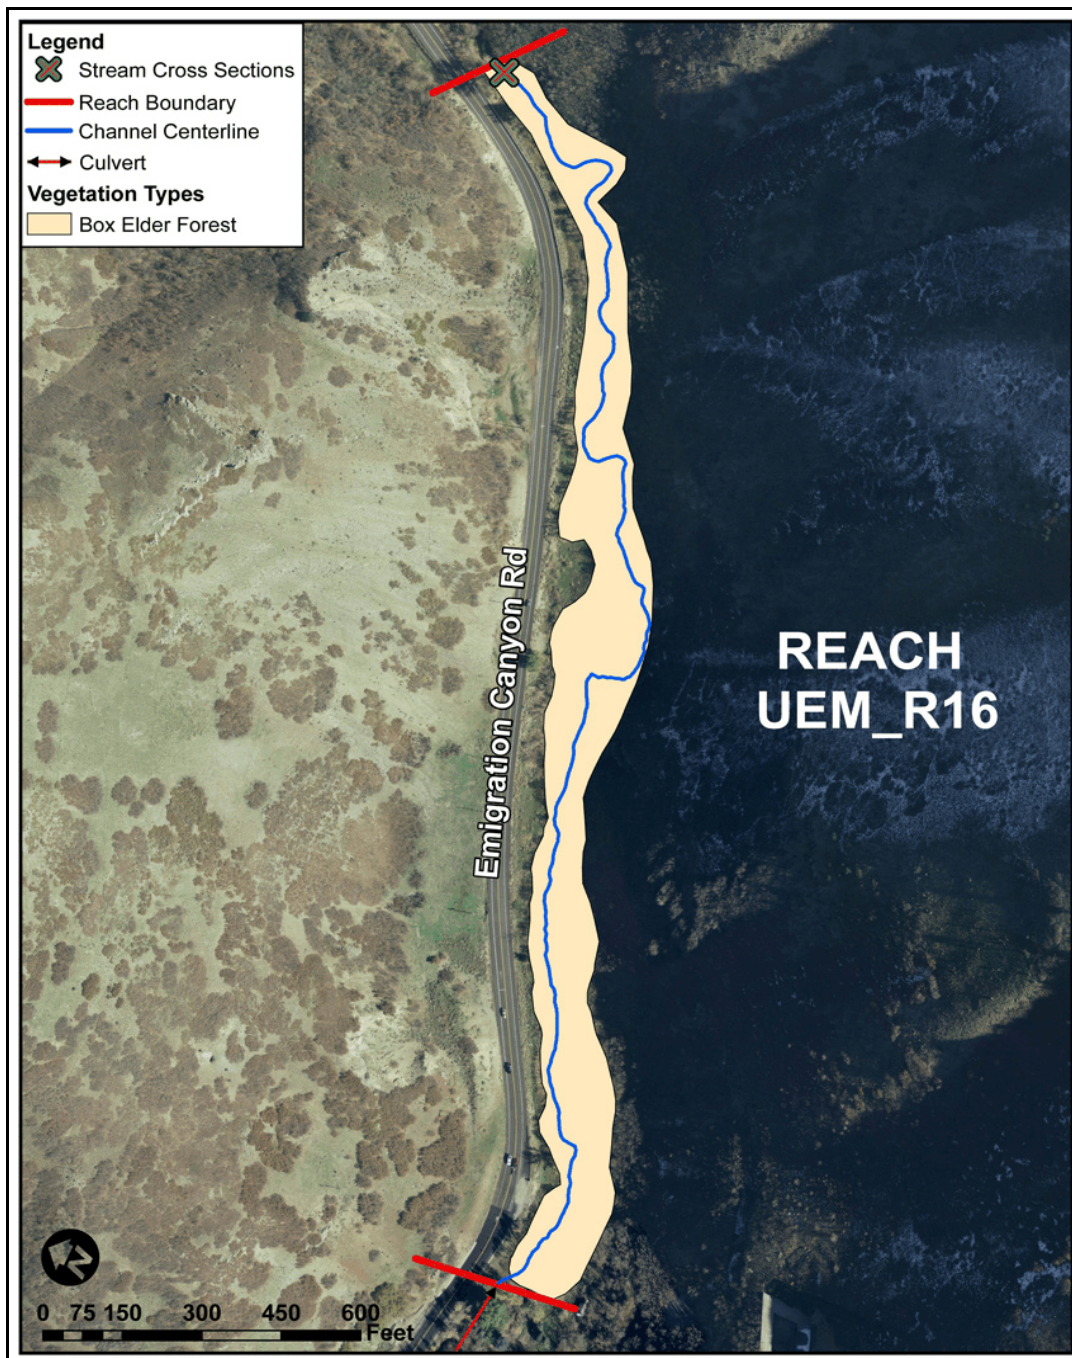
REACH UEM_R16: BELOW EMIGRATION TUNNEL SPRING

The reach, in Emigration Canyon, is in relatively natural condition. Lateral width is confined by the steep hillside to the south and the road to the north. Some low floodplain surfaces are present; however, root zone scour may indicate some degree of bed incision. The stream was dry at the time the reach was assessed. Vegetative structure is excellent in this reach, with native canopy, shrub, and understory layers present.

- bed incision (minor)
- low bank/root zone erosion
- seasonal lack of water flow
- invasive species (Siberian elm - minor amount)

RECOMMENDATIONS	
IMPROVEMENT MEASURE	LOCATION
Explore instream flow opportunities ^a	watershed-scale
Invasive plant removal ^a	within vegetation type(s)
Revegetation - shrub layer	within vegetation type(s)
Revegetation - understory layer	within vegetation type(s)
No-trespassing signage	reach-scale
Grade control	reach-scale
Bank stabilization	reach-scale

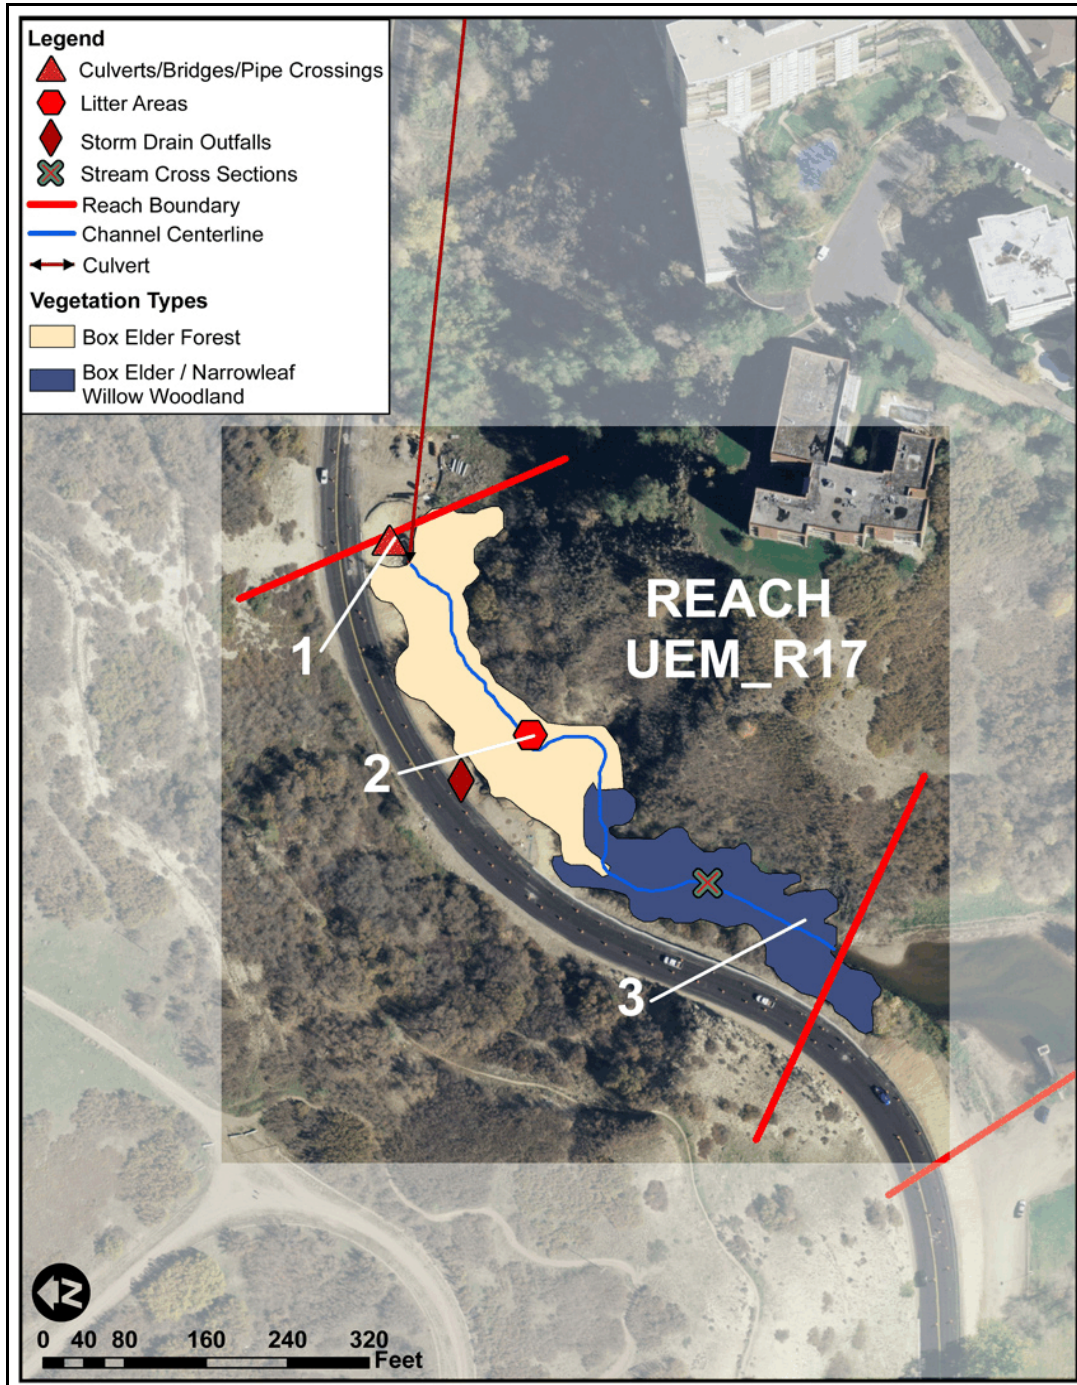
REACH UEM_R17: ABOVE DEBRIS BASIN

This reach begins at the outlet of a long culvert. The downstream end of the reach is affected by sediment deposition and the backwater from the debris basin. Human and dog access trails have affected some streambank areas just upstream of the basin. Emigration Canyon Road constrains the corridor on the north.

- Issues affecting riparian function:**
- eroded access trails
 - dog use
 - backwater effect/ sedimentation limits understory vegetation
 - trash (minor)
 - limited understory cover

RECOMMENDATIONS	
IMPROVEMENT MEASURE	LOCATION
Revegetation - understory layer ^a	within vegetation type(s)
Access control/ trail stabilization ^a	point 3 on map
Stream cleanup ^a	points 1 and 2 on map
Invasive plant removal	within vegetation type(s)
Revegetation - shrub layer	within vegetation type(s)
Grade control	reach-scale
Bank stabilization	reach-scale
Culvert replacement/outlet protection	point 1 on map

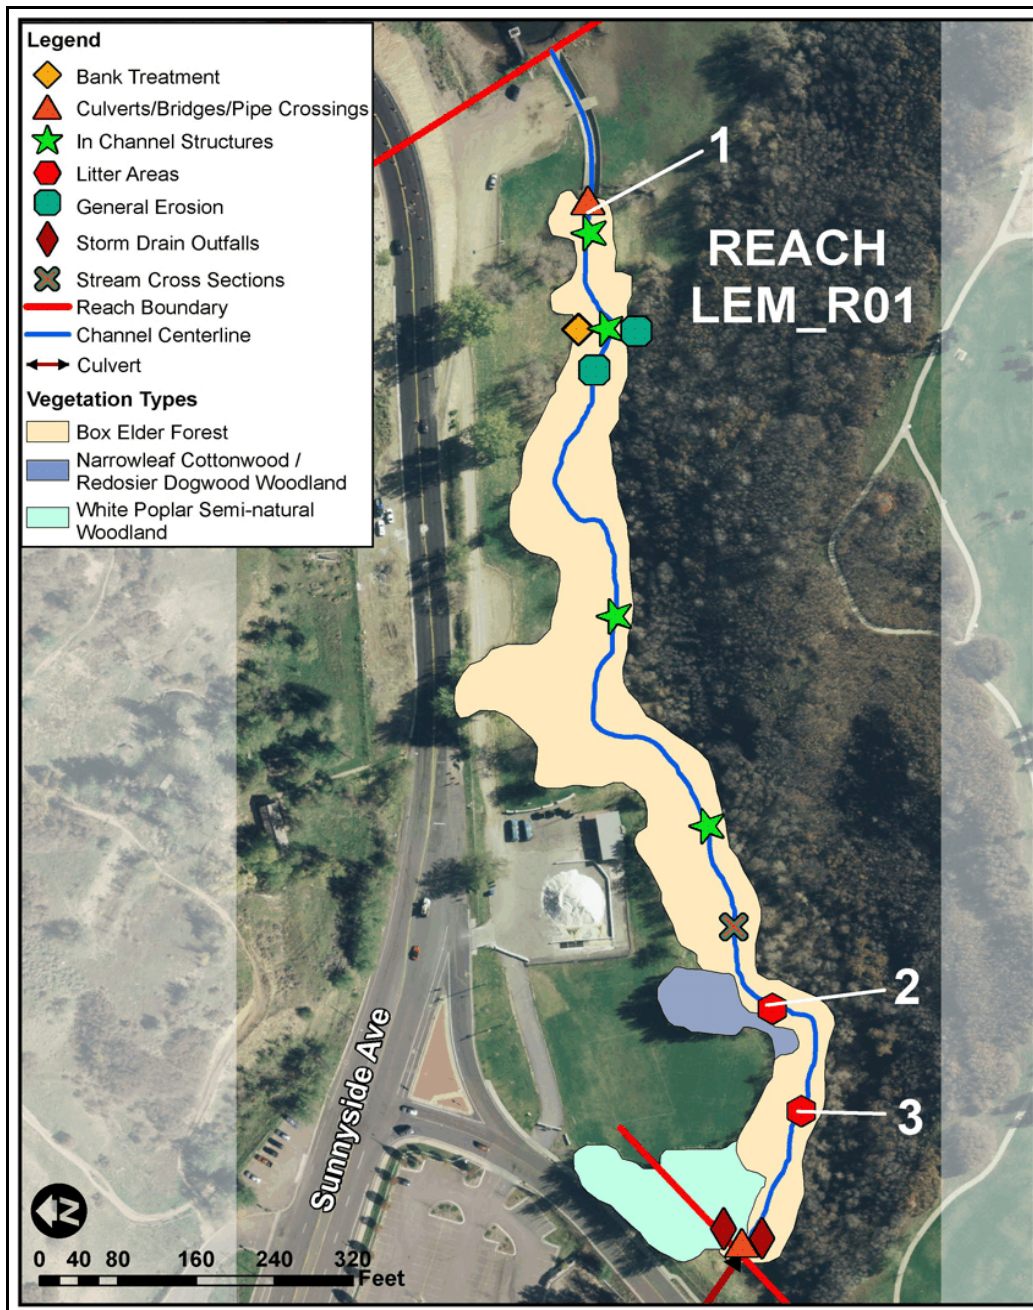
REACH LEM_R01: ROTARY GLEN PARK

This reach, located in Rotary Glen Park below the debris basin, is in generally good condition. The reach includes rip-rap grade control structures and a stream gaging weir. Some low bank erosion/root zone scour is evident. Vegetation cover in the understory, shrub, and canopy layers is generally good, but in one area the understory is comprised of nonnative invasive species.

- Issues affecting riparian function:**
- bed incision
 - low bank/root zone erosion
 - eroded access trails and dog use (minor)
 - understory dominated by nonnative species
 - invasive species (Siberian elm, broadleaved pepperweed, lesser burdock)
 - trash

RECOMMENDATIONS	
IMPROVEMENT MEASURE	LOCATION
Silt removal from debris basin pipe outlet	point 1 on map
Mechanized trash removal ^a	points 2 and 3 on map
Stream cleanup ^a	reach-scale
Invasive plant removal ^a	within vegetation type(s)
Restoration of native understory plants ^a	within vegetation type(s)
Bank stabilization	reach-scale
Grade control	reach-scale
Access Control ^a	reach-scale

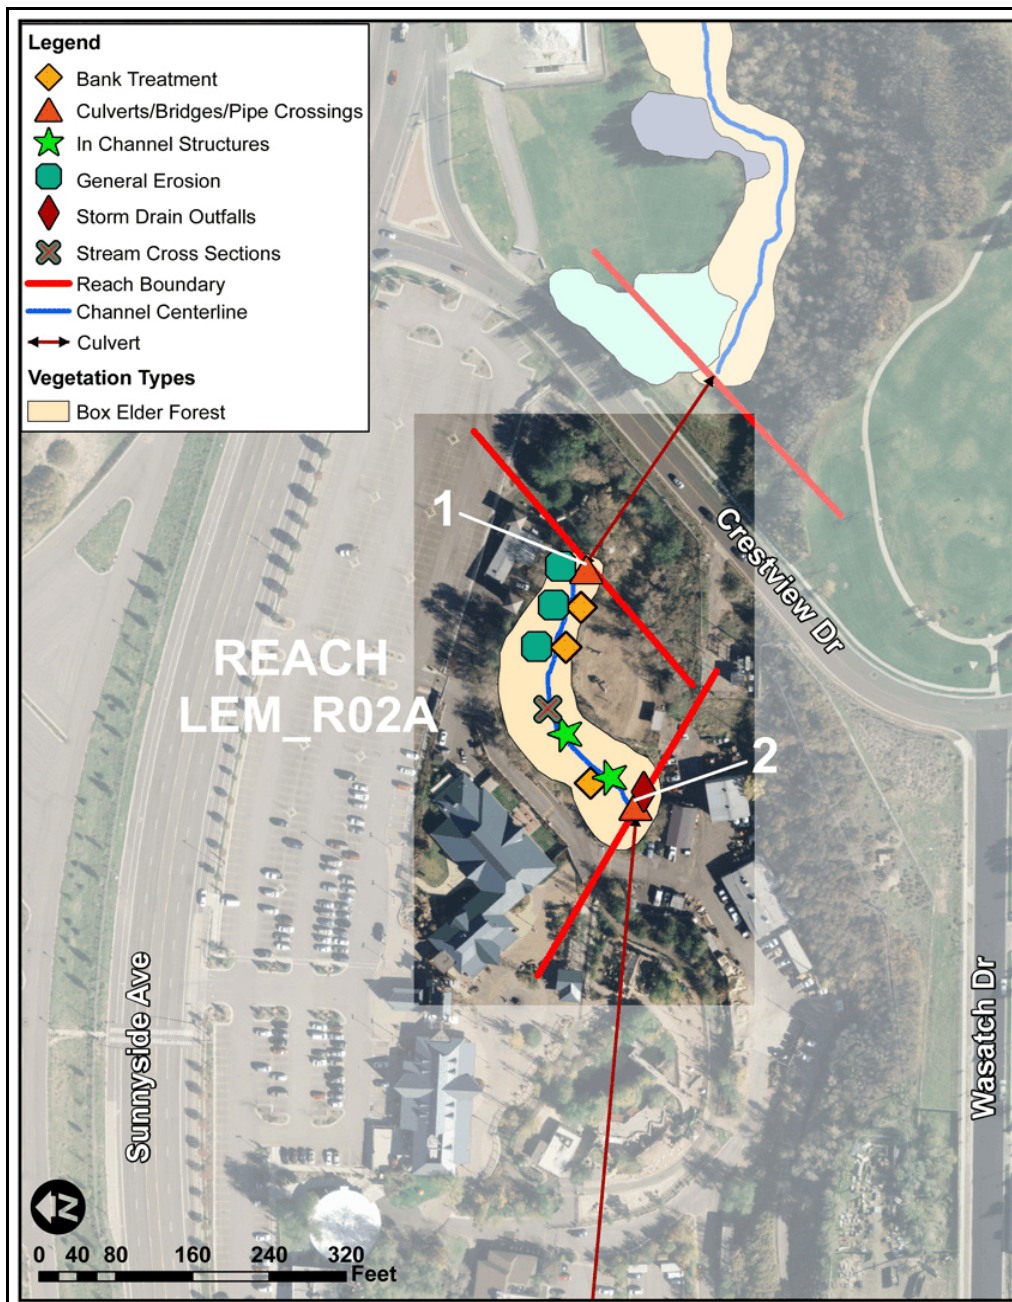
REACH LEM_R02A: UPPER HOGLE ZOO

This is a short stream reach that is part of a zoo display/train ride that depicts the Old West with sets and mannequins. The reach includes several grade control structures and some toe protection logs that were installed as part of an improvement project completed about 10 years ago. However, root zone scour and bank erosion are still evident, especially along the steep left bank that slopes up to animal pens. A stream gaging weir is present in this reach.

- scour/erosion at culvert outlet
- bed incision
- failing bank revetment
- low bank/root zone erosion
- lack of shrub cover
- understory dominated by nonnative species
- invasive species (periwinkle, lesser burdock)

RECOMMENDATIONS	
IMPROVEMENT MEASURE	LOCATION
Culvert replacement/outlet protection ^a	point 1 on map
Bank stabilization ^a	reach-scale
Grade control ^a	reach-scale
Revegetation - shrub layer	within vegetation type(s)
Invasive plant removal ^a	within vegetation type(s)
Restoration of native understory plants ^a	within vegetation type(s)
Storm drain improvement ^a	point 2 on map

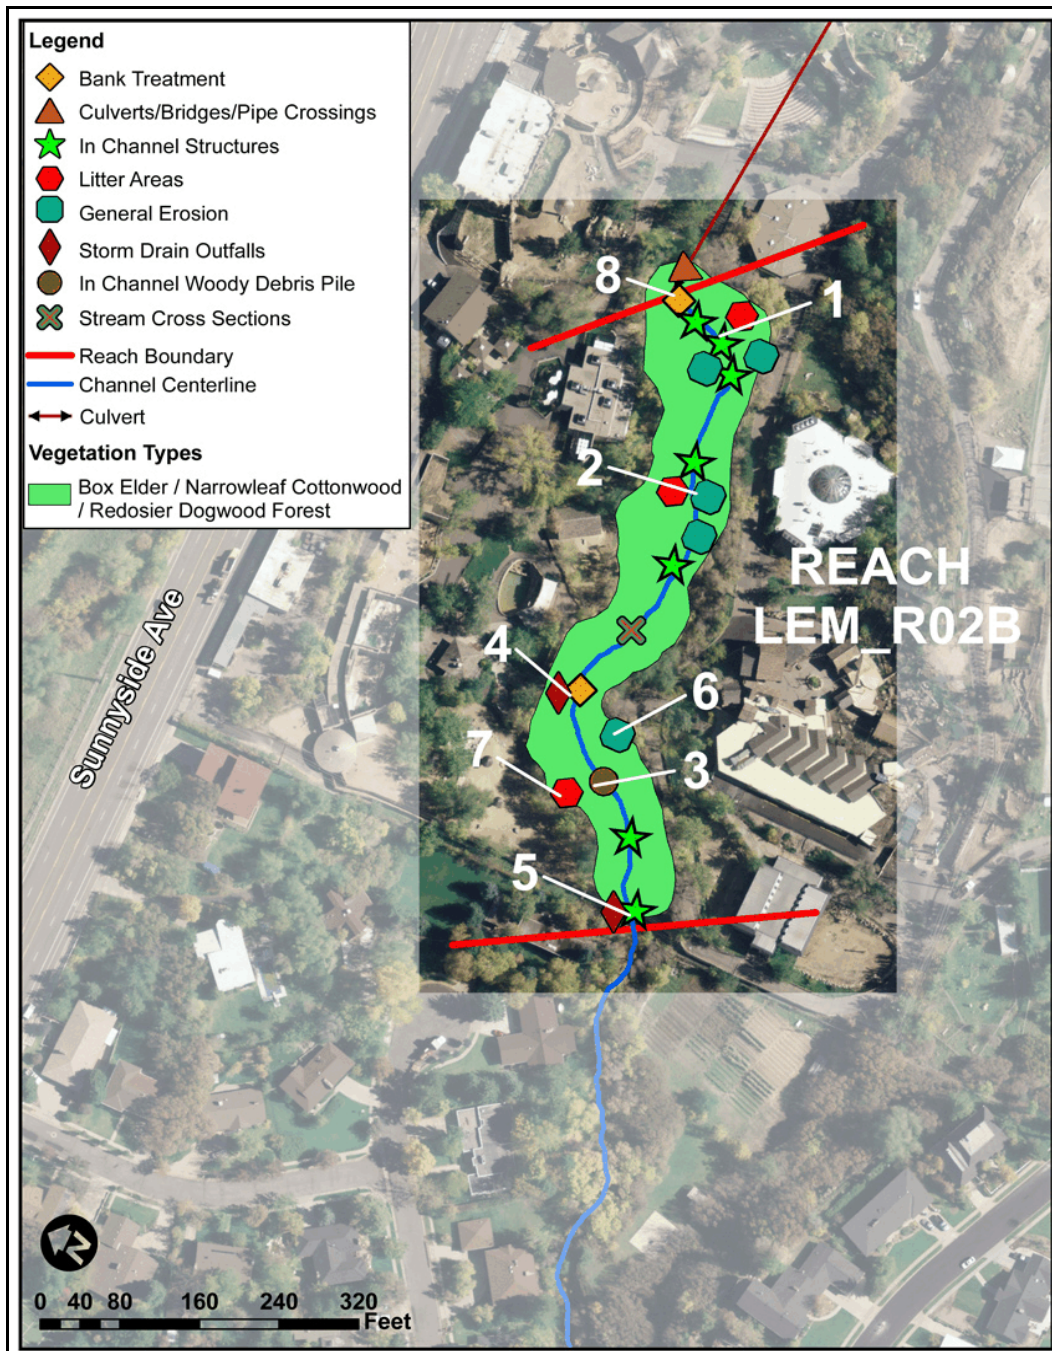
REACH LEM_R02B: LOWER HOGLE ZOO

This reach, located in the western part of Hogle Zoo, is deeply entrenched between tall, steep slopes that lack understory vegetation and show evidence of erosion in many areas. Several debris jams and cemented rip-rap grade control structures are present. The culvert outlet at the top of the reach and other in-channel structures are generally in poor condition. Animal waste on slopes may be a water quality concern.

- Issues affecting riparian function:**
- scour/erosion at culvert outlet
 - bed incision
 - failing in-channel infrastructure
 - failing bank revetment
 - low bank/root zone erosion
 - invasive species (Siberian elm, lesser burdock)
 - trash
 - lack of understory cover
 - storm drain outfall erosion
 - concentrated runoff/rilling

RECOMMENDATIONS	
IMPROVEMENT MEASURE	LOCATION
Mechanized trash removal ^a	points 1, 2, and 3 on map
Storm drain outlet protection ^a	points 4 and 5 on map
Runoff management ^a	points 6 and 7 on map
Culvert replacement/outlet protection ^a	point 8 on map
Stream cleanup (general) ^a	reach-scale
Revegetation - understory ^a	within vegetation type(s)
Biotechnical slope stabilization ^a	reach-scale
Comprehensive bank stabilization ^a	reach-scale
Grade control ^a	reach-scale
Invasive plant removal ^a	within vegetation type(s)

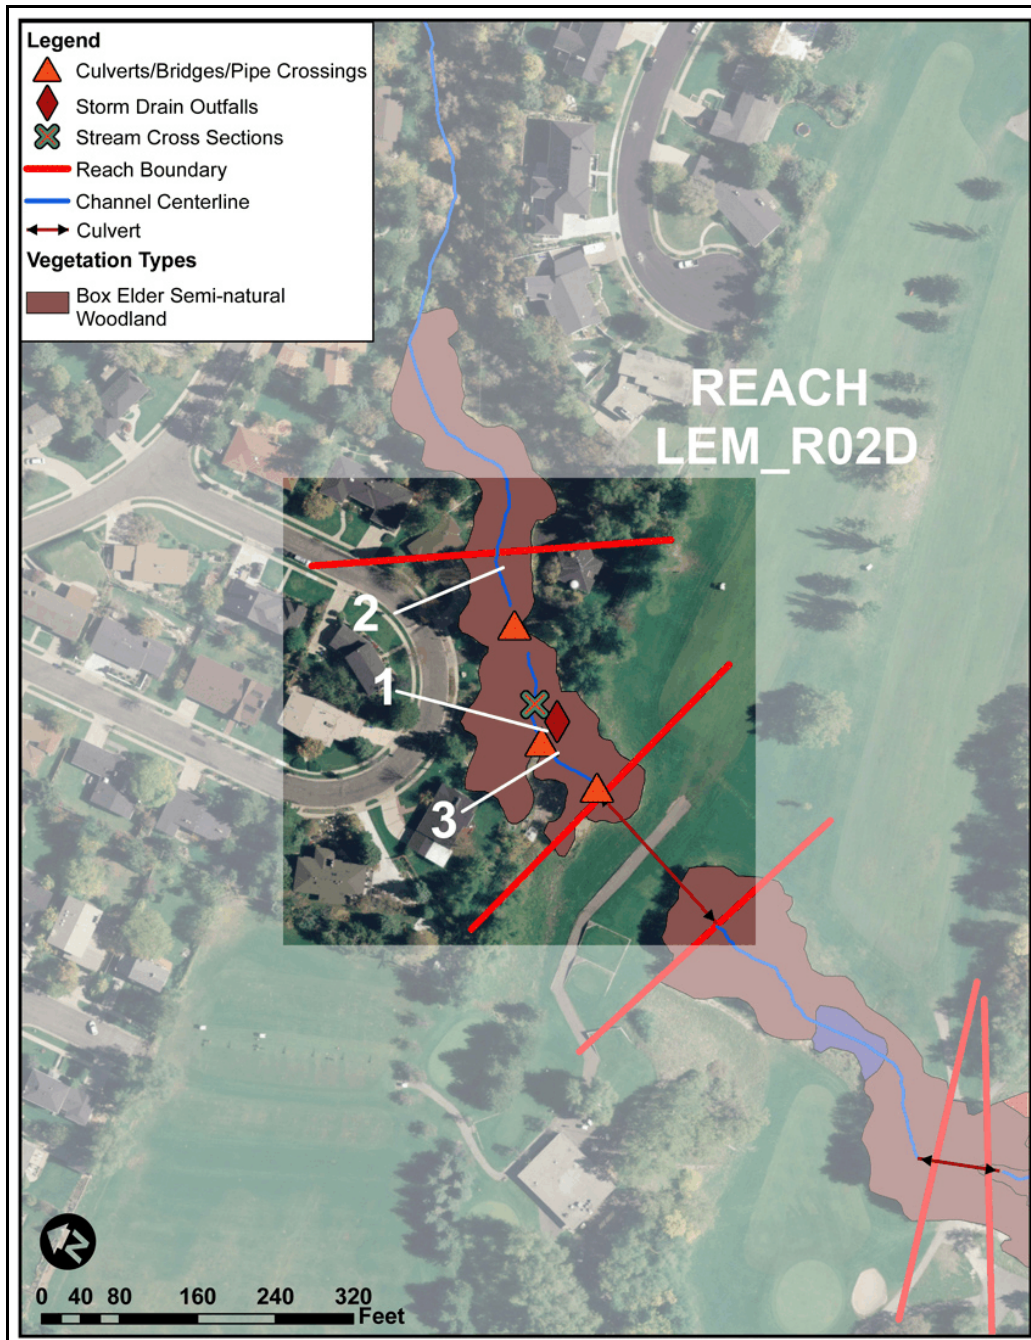
LEM_R02D: ABOVE BONNEVILLE GOLF COURSE

This is a short reach that has many pools and contains some low floodplain surfaces. A wide span open-bottom arch culvert is present at a pathway crossing in the middle of this reach and is in good condition. Backfill around an apparently new storm drain outlet is bare and unvegetated. Elevated exposed utility pipes cross the channel within this reach.

- poor revegetation/stabilization practices
- low bank/root zone erosion
- failing bank revetment
- invasive species (Siberian elm, lesser burdock)
- lack of understory cover
- lack of shrub cover

RECOMMENDATIONS	
IMPROVEMENT MEASURE	LOCATION
Storm drain outfall improvement ^a	point 1 on map
Revegetation of bare fill ^a	point 1 on map
Revegetation - understory/shrub ^a	within vegetation type(s)
Mechanized trash removal ^a	point 2 on map
No-trespassing signage	point 3 on map
Invasive plant removal/control ^a	within vegetation type(s)

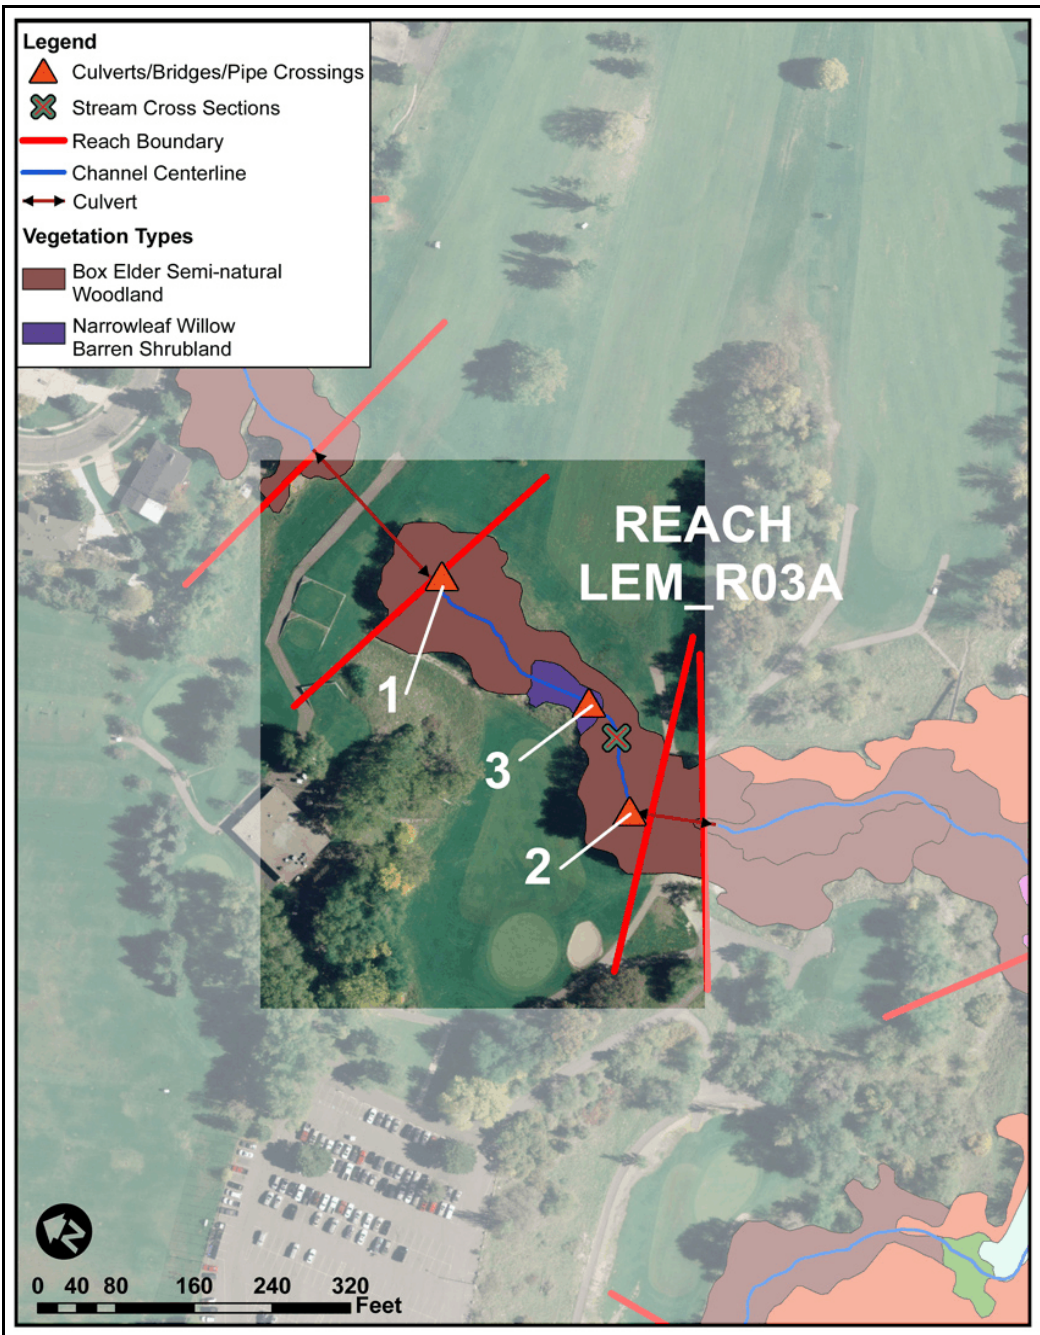
REACH LEM_R03A: BONNEVILLE GOLF COURSE - UPPER

This reach contains a high amount of large woody debris and subsequently the potential for debris jams is high. There are a number of pipes and irrigation-related items in the channel. The culvert outlet at the top of the reach is in poor condition, and the inlet at the bottom of the reach shows evidence of deposition/debris accumulation. Tree cover is lacking in the central portion of the reach.

- Issues affecting riparian function:**
- scour/erosion at culvert outlet
 - deposition/clogging at culvert inlet
 - terrace erosion
 - lack of understory cover
 - lack of shrub cover
 - lack of tree cover
 - invasive species (Siberian elm)
 - precarious in-channel irrigation pier

RECOMMENDATIONS	
IMPROVEMENT MEASURE	LOCATION
Culvert replacement/outlet protection ^a	point 1 on map
Culvert replacement ^a	point 2 on map
Redesign of irrigation pipe system/ removal of in-channel pier ^a	point 3 on map
Revegetation - understory/ shrub/ canopy ^a	within vegetation type(s)
Removal of invasive plants ^a	within vegetation type(s)
Grade control	reach-scale
Bank stabilization (general)	reach-scale

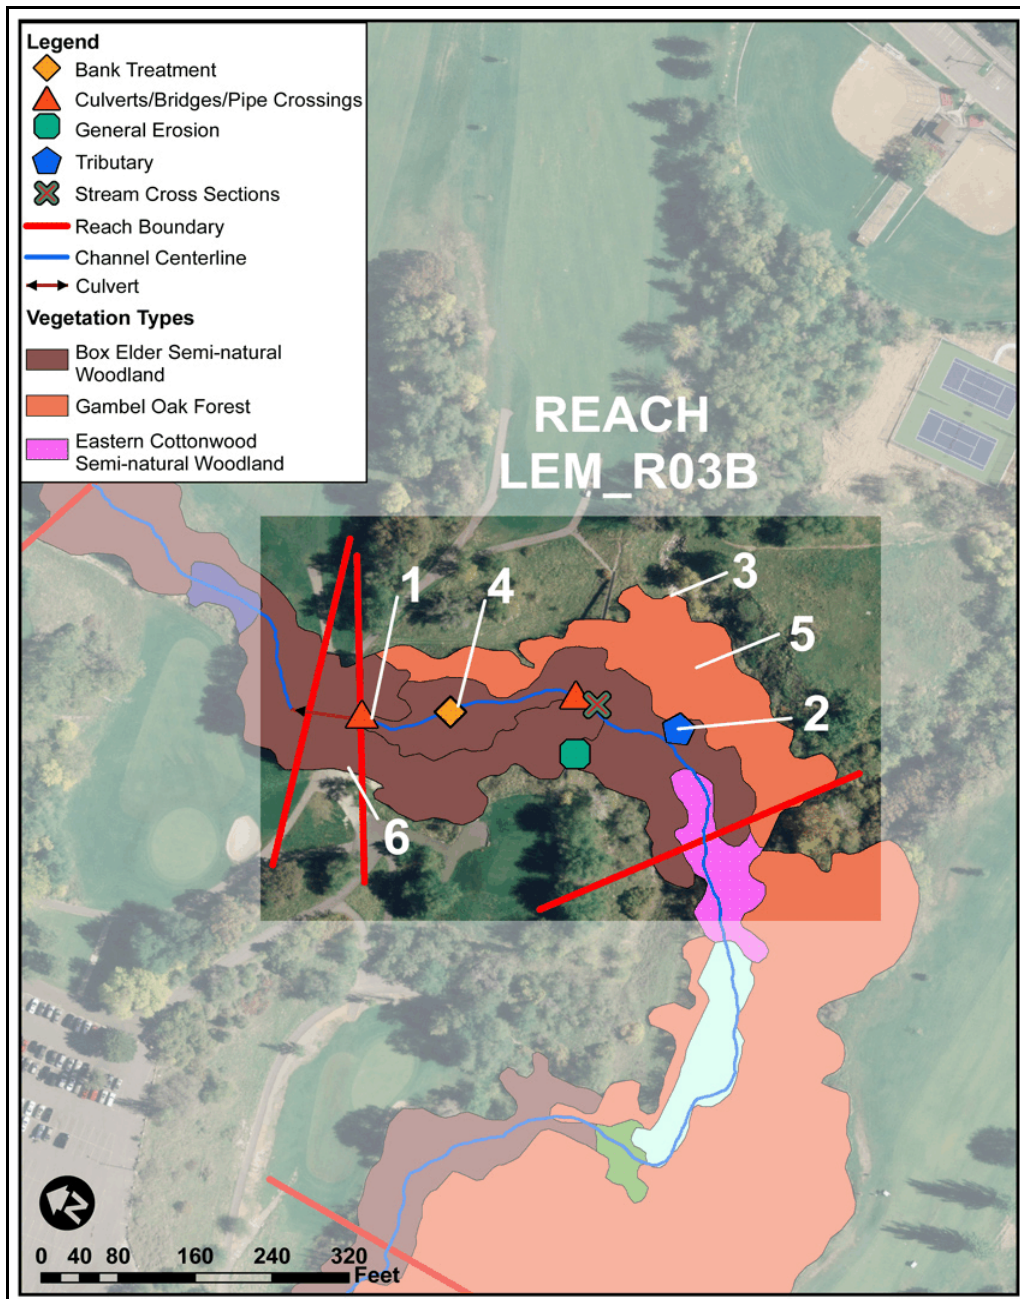
REACH LEM_R03B: BONNEVILLE GOLF COURSE - SUSPENSION BRIDGE

This reach is affected by an actively head-cutting storm outfall gully that enters from the east. Broken concrete pipe is present in the gully. The culvert outlet at the top of the reach is in poor condition, with scour and bank erosion evident. The streambed is noticeably silty, likely from the sediment generated in the eroding gully. A suspension bridge for golf carts crosses high above the channel in this reach. Channel width is relatively narrow.

- Issues affecting riparian function:**
- scour/erosion at culvert outlet
 - low bank/root zone erosion
 - excessive sediment from headcut/storm outfall gully
 - terrace erosion
 - storm drain outfall erosion
 - lack of understory cover
 - lack of shrub cover
 - invasive species (Siberian elm, Russian olive, cheatgrass)
 - trash

RECOMMENDATIONS	
IMPROVEMENT MEASURE	LOCATION
Culvert replacement/outlet protection ^a	point 1 on map
Stabilization/ grade control in storm outfall gully ^a	points 2 and 3 on map
Mechanized trash removal ^a	points 4 and 5 on map
Invasive plant removal ^a	within vegetation type(s)
Revegetation - understory/shrub ^a	within vegetation type(s)
Barrier installation to contain sand trap sand ^a	point 6 on map
Bank stabilization (general)	reach-scale

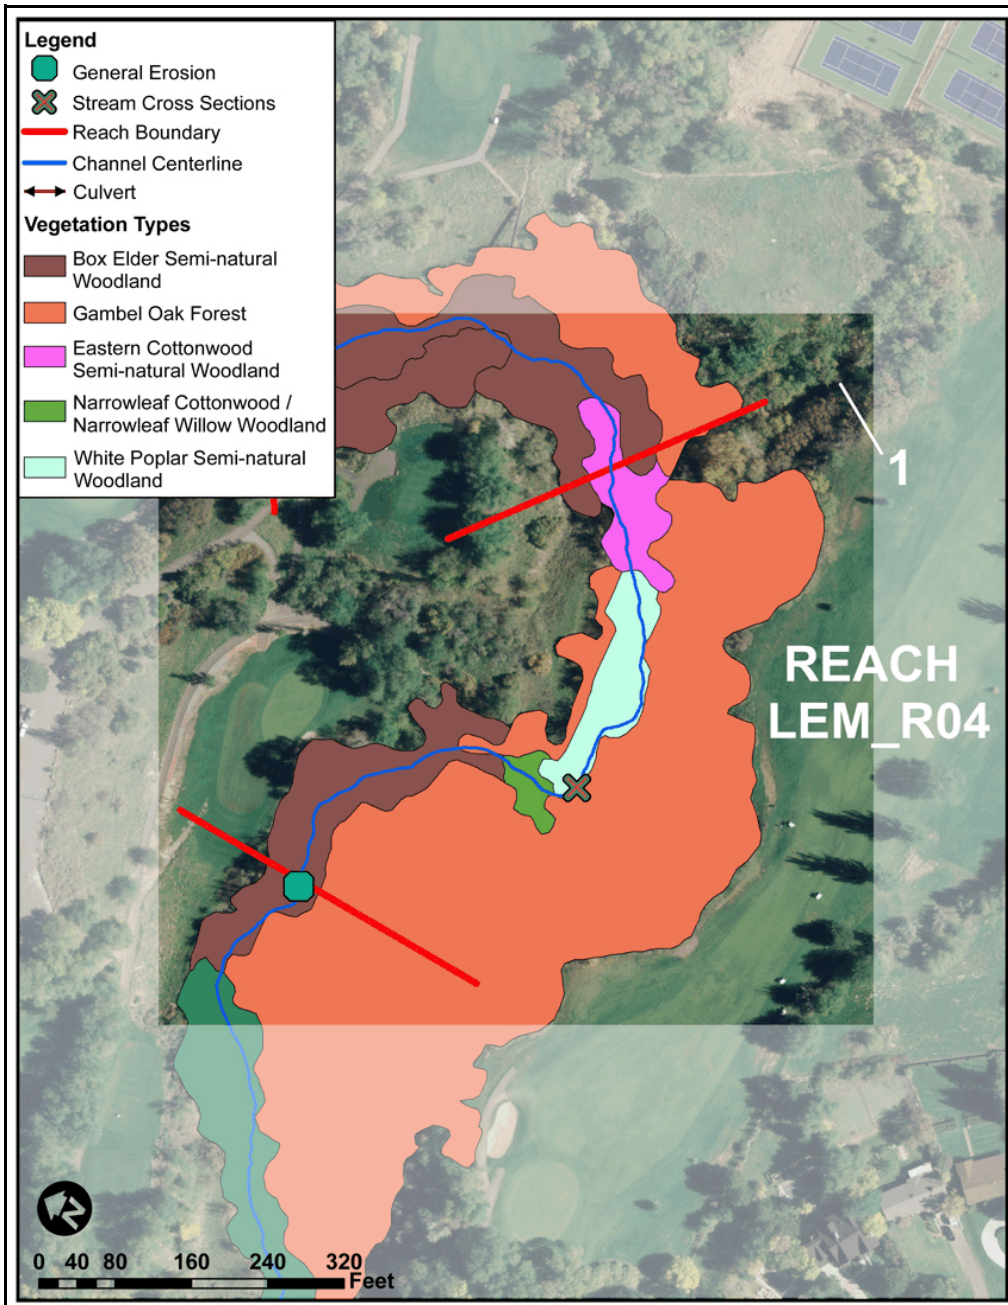
LEM_R04: BONNEVILLE GOLF COURSE - BELOW STORM OUTFALL GULLY

This reach is in a relatively natural condition, with no culverts and no noted in-channel structures. Tall, vertical, bare banks are present in several locations where the stream has eroded into high terraces associated with Lake Bonneville deposits. A second actively head-cutting storm outfall gully enters the stream at the top of this reach. Some active, low floodplain areas are present.

- sediment from headcut/storm outfall gully
- storm drain outfall erosion
- terrace erosion
- low bank/root zone erosion
- lack of understory cover
- lack of shrub cover
- invasive species (Siberian elm, Russian olive, myrtle spurge)

RECOMMENDATIONS	
IMPROVEMENT MEASURE	LOCATION
Stabilization/ grade control in storm outfall gully ^a	point 1 on map
Invasive plant removal ^a	within vegetation type(s)
Revegetation - understory/shrub ^a	within vegetation type(s)
Bank stabilization (general)	reach-scale

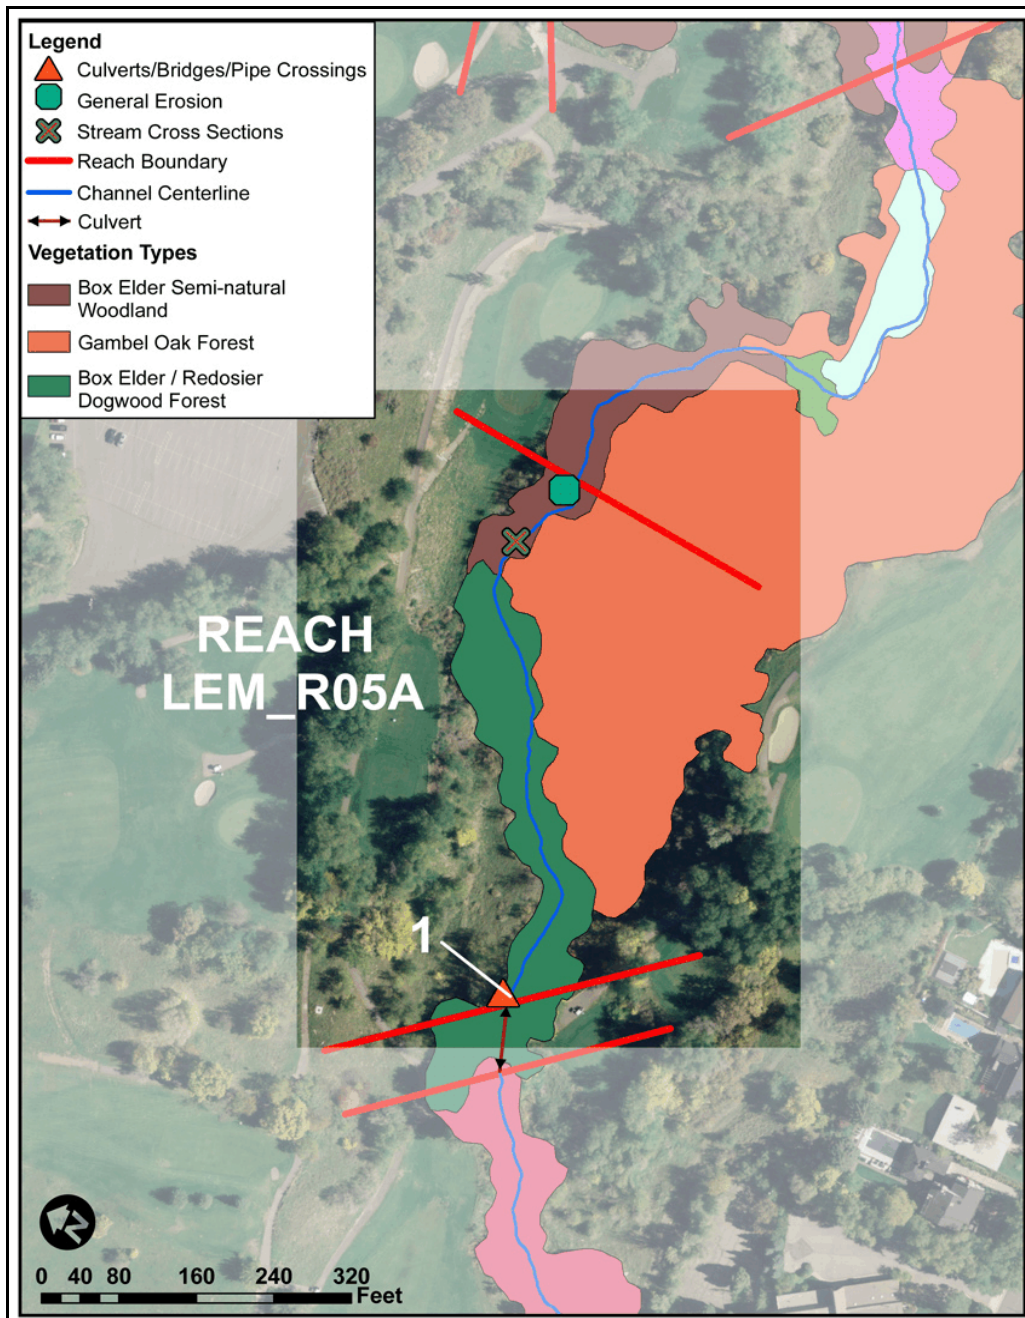
LEM_R05A: BONNEVILLE GOLF COURSE - OAK FOREST

This reach is similar in character to LEM_R04. The stream continues to be adjacent to a large area of intact Gambel oak forest. Erosion of tall Bonneville terrace deposits is evident, and vegetative understory cover is lacking. The culvert inlet at the bottom of the reach is being affected by a debris jam immediately above the inlet. Siberian elm and Russian olive are significant components of the tree community in this reach.

- Issues affecting riparian function:**
- terrace erosion
 - low bank/root zone erosion
 - debris jam at culvert inlet
 - lack of understory cover
 - invasive species (Siberian elm, Russian olive, myrtle spurge)

RECOMMENDATIONS	
IMPROVEMENT MEASURE	LOCATION
Culvert replacement ^a	point 1 on map
Invasive plant removal ^a	within vegetation type(s)
Revegetation - understory ^a	within vegetation type(s)
Revegetation - shrub	within vegetation type(s)
Bank stabilization (general)	reach-scale

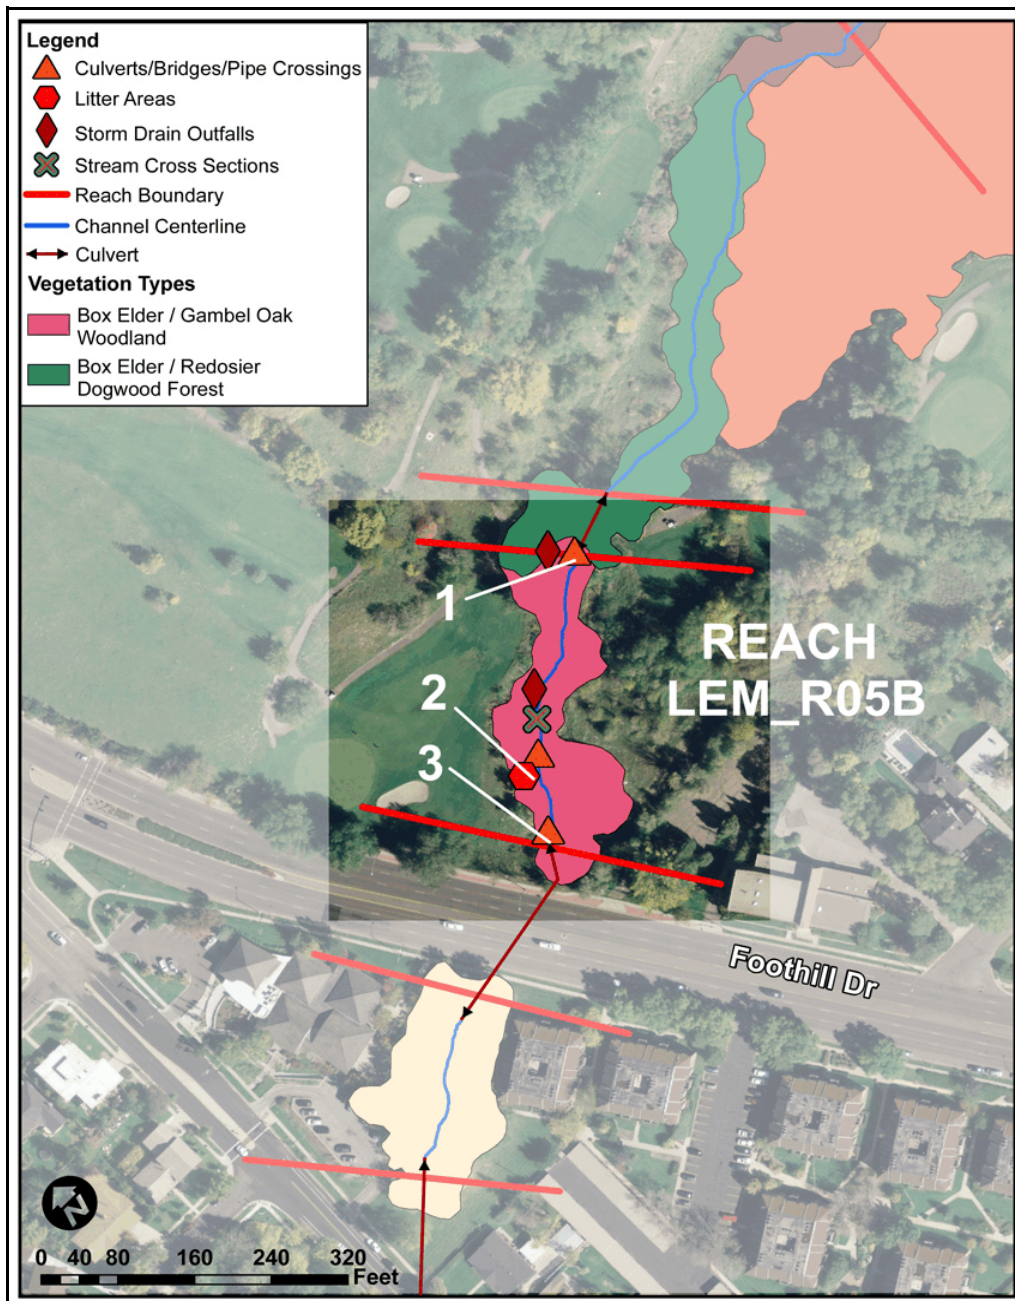
LEM_R05B: BONNEVILLE GOLF COURSE - ABOVE FOOTHILL DRIVE

In this reach, the stream is no longer confined by Bonneville terrace deposits, and terrace erosion is not evident. Woody debris continues to be abundant in the channel and on the banks. Trash, including an old couch, was observed in this reach. The culvert outlet at the top of the reach has a cracked headwall and the concrete apron is being scoured/undercut. An elevated exposed utility pipe crosses the channel in this reach.

- Issues affecting riparian function:**
- scour/erosion at culvert outlet
 - low bank/root zone erosion
 - invasive species (Siberian elm)
 - trash
 - storm drain outfall erosion (minor)
 - limited understory cover

RECOMMENDATIONS	
IMPROVEMENT MEASURE	LOCATION
Culvert replacement/outlet protection ^a	point 1 on map
Revegetation - understory ^a	within vegetation type(s)
Invasive plant removal ^a	within vegetation type(s)
Stream cleanup ^a	point 2 on map
Bank stabilization (general)	reach-scale
Storm drain outlet protection ^a	point 3 on map

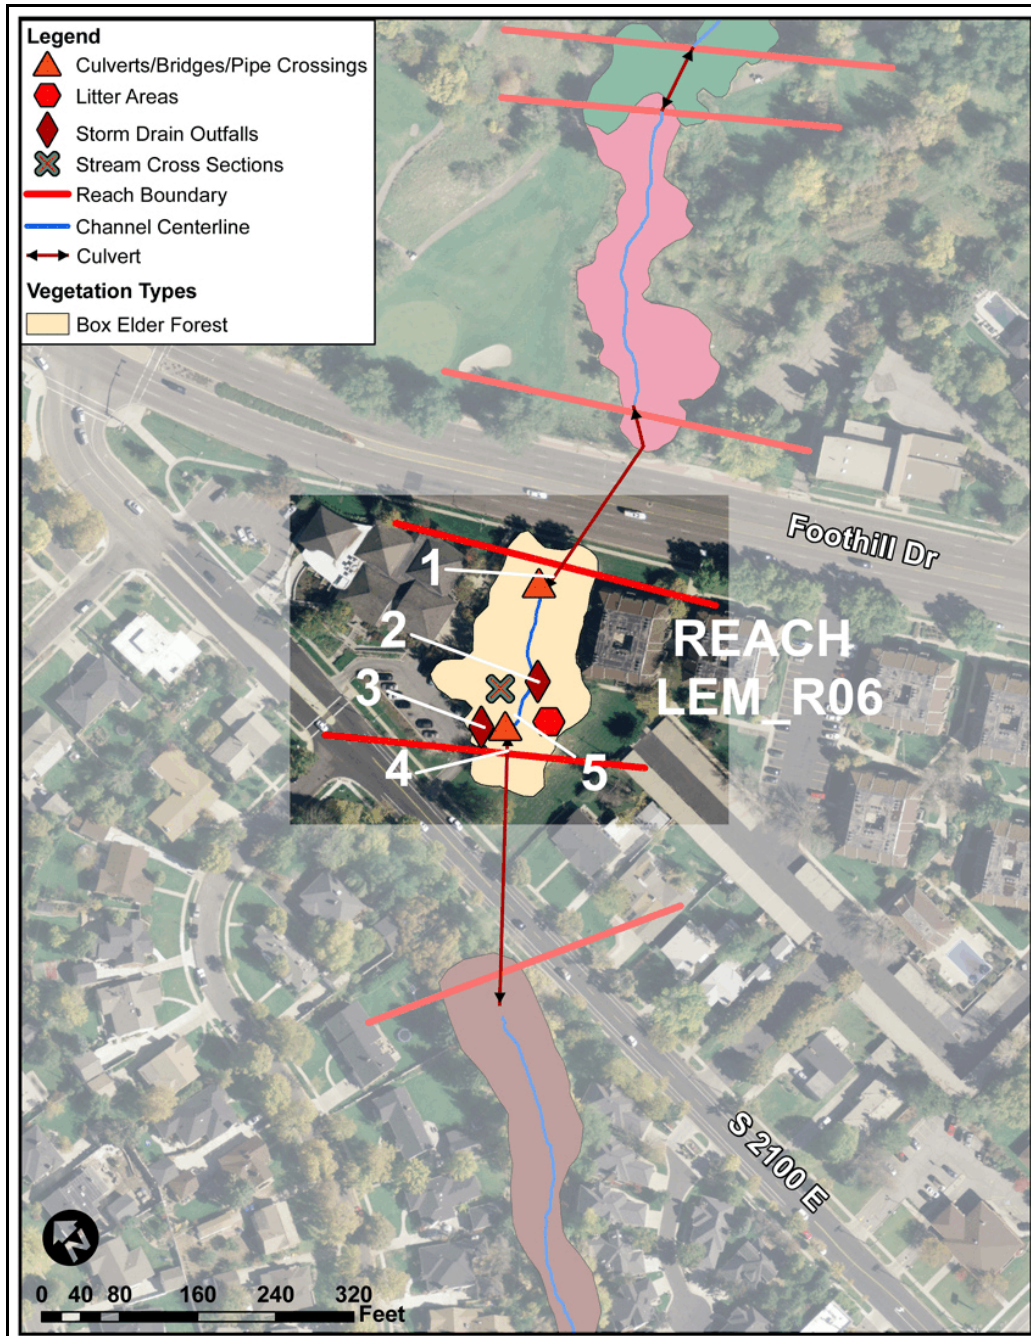
REACH LEM_R06: FOOTHILL DRIVE TO 2100 EAST

This is a short reach between culverts. The stream runs adjacent to the public library and foot traffic has created areas of bare ground and compacted soil. Understory vegetation is lacking, and erosion is present at two storm drain outfalls in the reach. The slopes above the culvert outlet at the top of the reach are steep and lack vegetation.

RECOMMENDATIONS	
IMPROVEMENT MEASURE	LOCATION
Storm drain outlet protection ^a	points 2 and 3 on map
Runoff management ^a	points 3 and 4 on map
Revegetation - understory ^a	within vegetation type(s)
Biotechnical slope stabilization ^a	point 1 on map
Bank stabilization (general) ^a	reach-scale
Revegetation - shrub ^a	within vegetation type(s)
Access control/ trail stabilization ^a	reach-scale
Stream cleanup ^a	point 5 on map

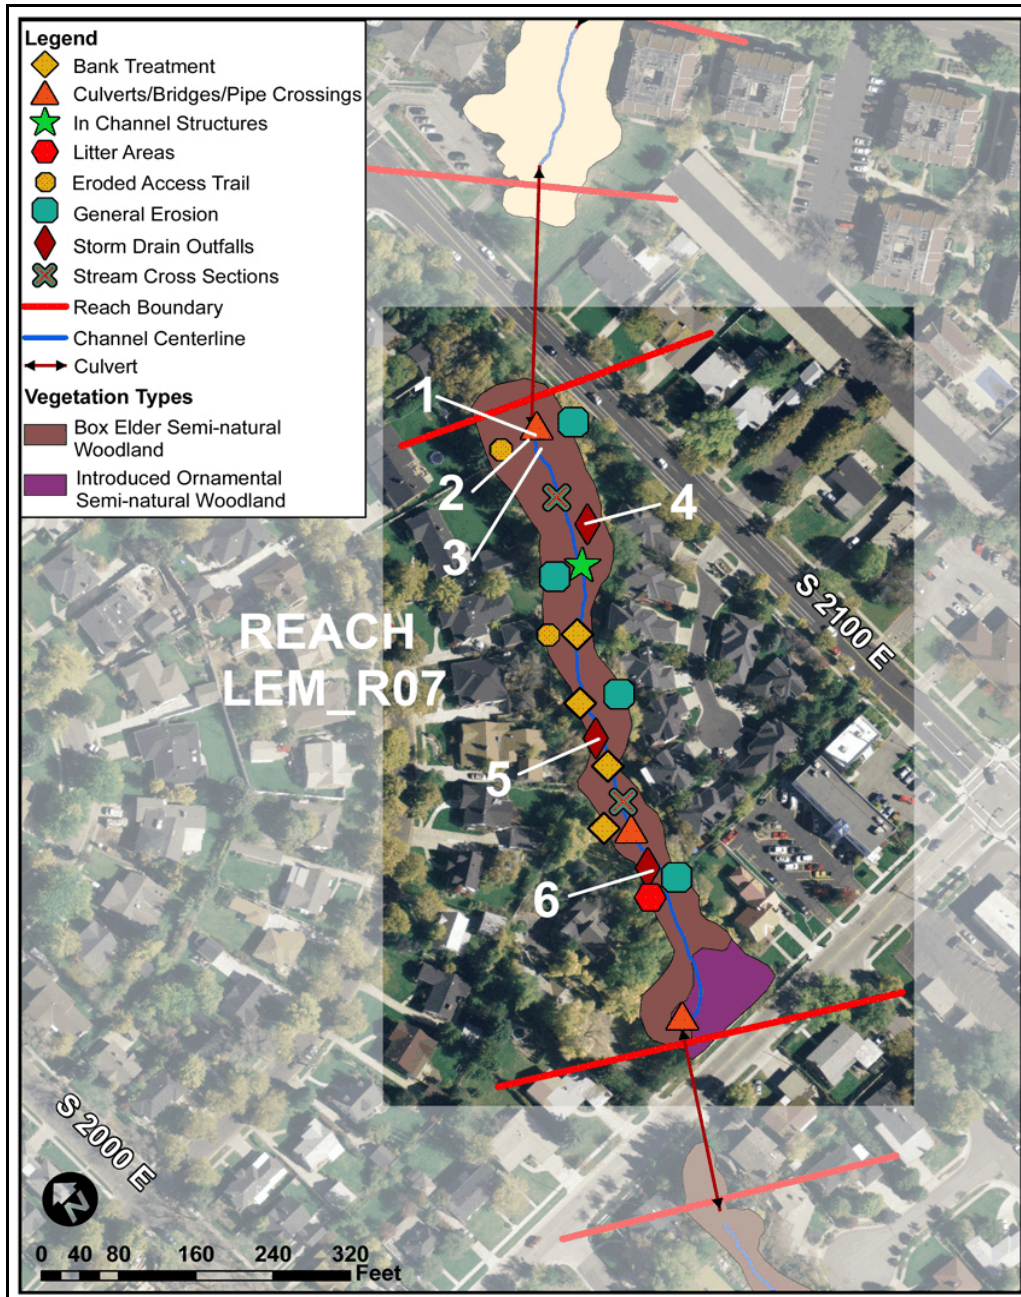
Channel and bank conditions in this reach are affected by landscaping and bank stabilization features (terracing, rock walls, etc.) constructed on individual nearby residential properties; many of the features are in disrepair due to continued erosion. English ivy and periwinkle vines dominate the understory vegetation. Severe bank erosion and scour are evident at the 2100 East culvert outlet; during storms the flow velocities exiting the culvert are extremely high.

- Issues affecting riparian function:**
- scour/erosion at culvert outlet (severe)
 - storm drain outfall erosion
 - bed incision
 - failing bank revetment
 - low bank/root zone erosion
 - eroded access trails
 - understory dominated by nonnative species
 - invasive species (periwinkle, English ivy)
 - terrace erosion

RECOMMENDATIONS	
IMPROVEMENT MEASURE	LOCATION
Culvert replacement/outlet protection ^a	point 1 on map
Comprehensive bank stabilization ^a	reach-scale
Comprehensive grade control ^a	reach-scale
Biotechnical slope stabilization ^a	point 2 on map
Access control/trail stabilization ^a	point 3 on map
Storm drain improvement ^a	points 4, 5, and 6 on map
Invasive plant removal ^a	within vegetation type(s)
Revegetation - canopy layer	within vegetation type(s)
Revegetation - shrub layer ^a	within vegetation type(s)
Restoration of native understory plants ^a	within vegetation type(s)
No trespassing signage ^a	near 1300 South
