APPENDIX C: STUDY REACH MAPS, SUMMARIES, AND RECOMMENDATIONS

This appendix provides summary information and maps for each of the fully-assessed study reaches. Maps include vegetation community types and locations of features such as litter areas, storm drain outfalls, culvert crossings, access trails, artificial bank treatments, and erosion areas. A brief description and selected photographs are also provided, along with tables summarizing stream channel data and vegetation characteristics. For each study reach, a table is also provided that lists appropriate types of improvement measures for the reach and describes where within the reach the measures should be applied. Measures identified for implementation at the reach-scale will typically require additional detailed site-level design work and engineering to determine specific locations and combinations of treatment techniques.

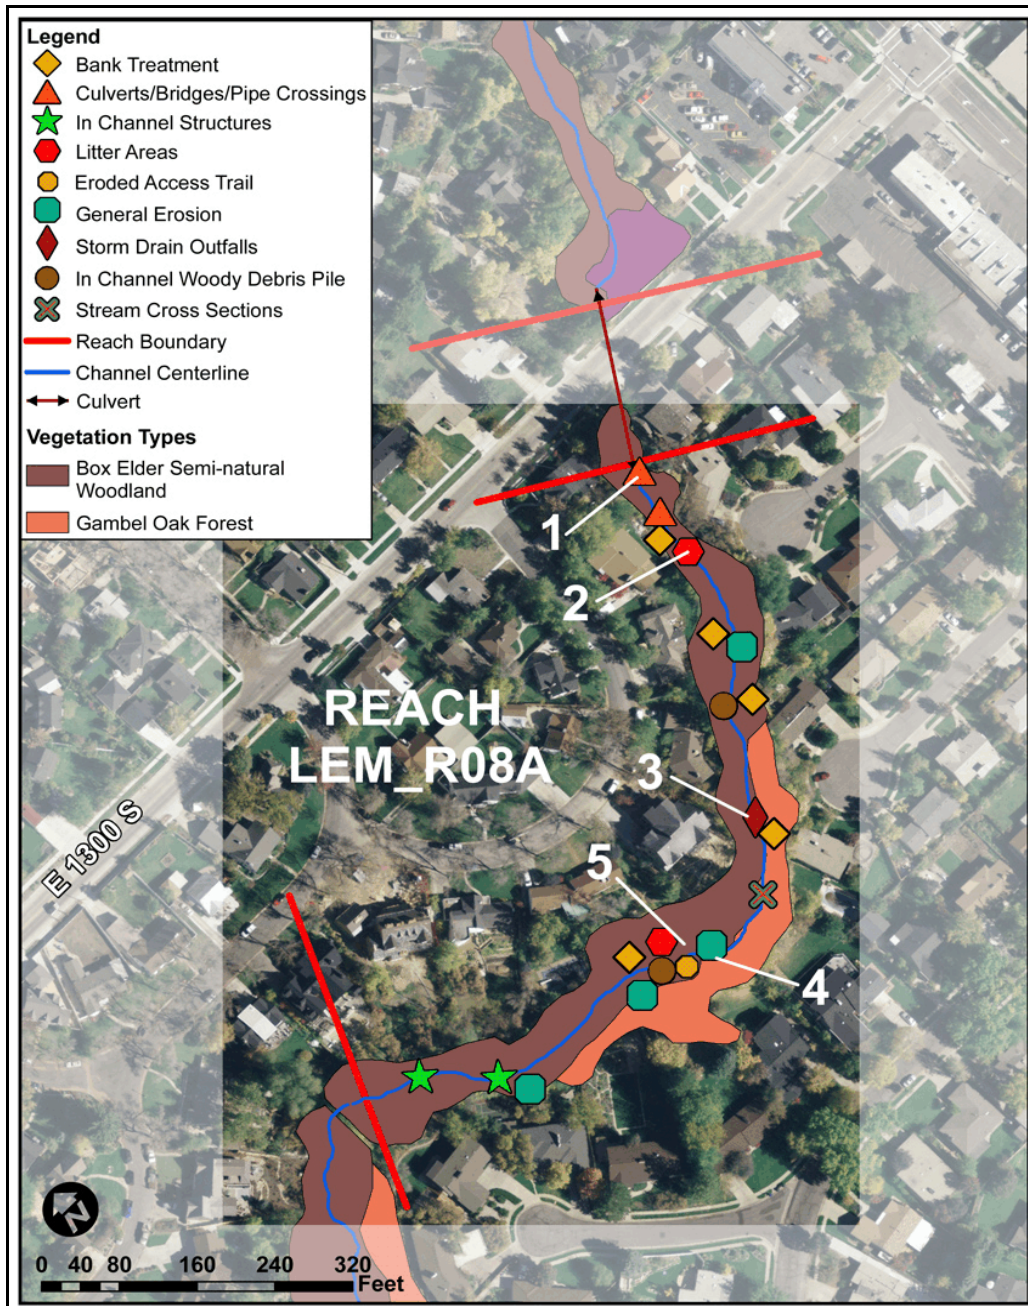
Emigration Creek continues through a residential area in this reach. Channel and floodplain conditions have been altered by development and structures (patios, rock walls, decks, etc.). Continued bank erosion poses a risk to fences, sheds, and other infrastructure. There have been various attempts at bank stabilization, but many of the revetment features are failing.

- Issues affecting riparian function:**
- storm drain outfall erosion
 - bed incision
 - terrace erosion
 - failing bank revetment
 - low bank/root zone erosion
 - eroded access trails
 - invasive species (Rampion bellflower, Tree of heaven, periwinkle, houndstongue)
 - scour/erosion at culvert outlet
 - understory dominated by nonnative species

RECOMMENDATIONS	
IMPROVEMENT MEASURE	LOCATION
Comprehensive bank stabilization ^a	reach-scale
Comprehensive grade control ^a	reach-scale
Invasive plant removal ^a	within vegetation type(s)
Restoration of native understory plants ^a	within vegetation type(s)
Storm drain improvement ^a	point 3 on map
Stream cleanup ^a	points 2 and 5 on map
Mechanized trash removal ^a	points 2 and 5 on map
Culvert replacement/outlet protection ^a	point 1 on map
Access trail stabilization ^a	point 4 on map
Revegetation - understory layer	within vegetation type(s)
No trespassing signage ^a	near 1300 South

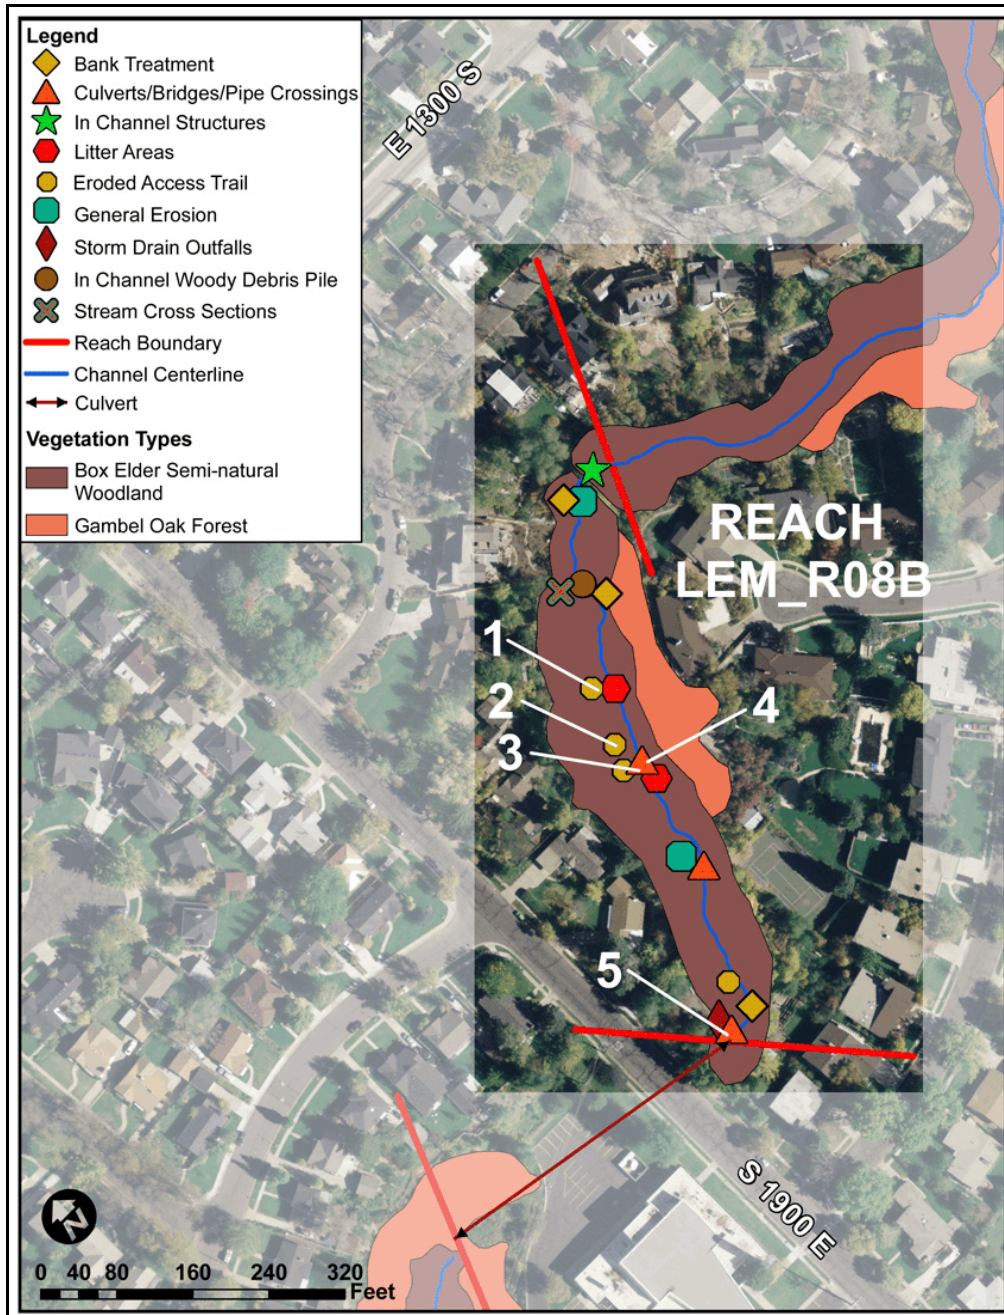
Much of this reach is influenced by a clay/root mass layer that confines low flow into a small and deeper channel. The culvert inlet at the bottom of the reach appears to clog occasionally, leading to some sediment deposition and flooding concerns. As with the reach upstream, residential development and bank stabilization attempts have altered channel and bank conditions. Terrace erosion and low bank/root scour are present. Nonnative plants dominate the understory vegetation.

- low bank/root zone erosion
- bed incision
- invasive species (Rampion bellflower, periwinkle, ivy, burdock)
- failing bank revetment
- terrace erosion
- eroded access trails
- storm outfall erosion
- deposition/clogging at culvert inlet
- limited shrub cover

RECOMMENDATIONS	
IMPROVEMENT MEASURE	LOCATION
Stream cleanup ^a	point 4 on map
Invasive plant removal ^a	within vegetation type(s)
Restoration of native understory plants ^a	within vegetation type(s)
Storm drain improvement ^a	point 5 on map
Comprehensive bank stabilization ^a	reach-scale
Comprehensive grade control ^a	reach-scale
Access stabilization ^a	points 1, 2, and 3 on map
Culvert replacement ^a	point 5 on map
No trespassing signage ^a	near 1900 East

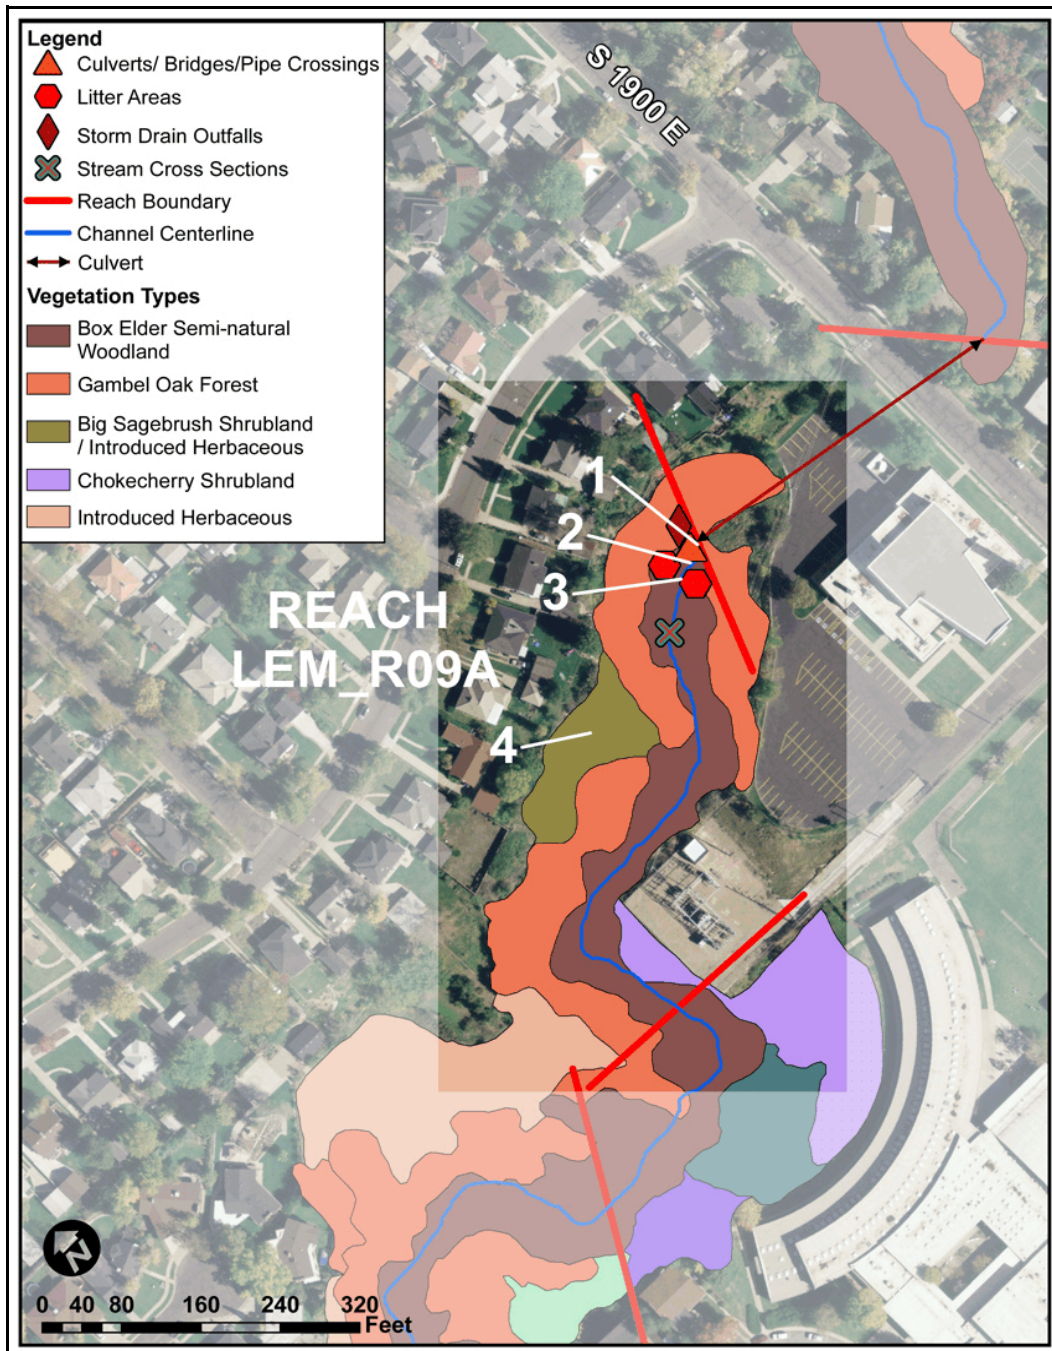
In this reach, development has encroached into portions of the south side floodplain. The channel contains a lot of silty material, and some streamside trees have a silt layer at the base of their trunks. A clay/ root mat layer affects channel and bank conditions through most of the reach, and appears to inhibit understory growth. Trout were observed in the reach, which historically included a meander bend to the east that has been culverted (Figure 3.6).

- Issues affecting riparian function:**
- terrace erosion
 - invasive species (myrtle spurge, Russian olive)
 - trash and yard waste
 - lack of understory cover

RECOMMENDATIONS	
IMPROVEMENT MEASURE	LOCATION
Revegetation - understory layer ^a	within vegetation type(s)
Invasive plant removal ^a	within vegetation type(s)
Storm drain improvement ^a	point 1 on map
Stream cleanup ^a	points 2 and 4 on map
Mechanized trash removal ^a	point 3 on map
Culvert replacement/outlet protection ^a	point 1 on map
Revegetation - shrub layer	within vegetation type(s)
Bank stabilization	reach-scale
Grade control	reach-scale

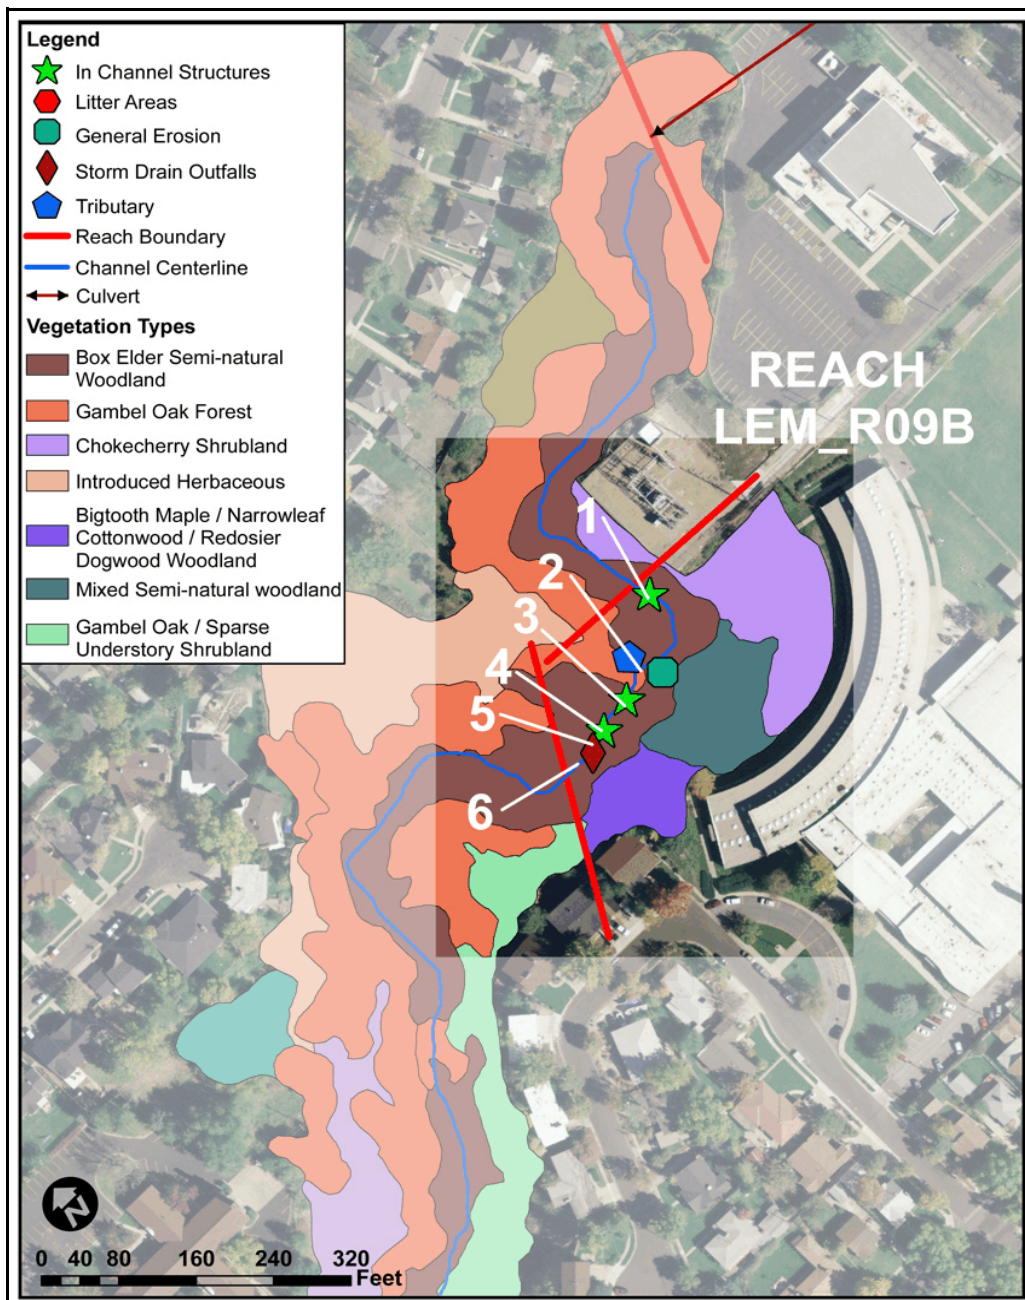
Several concrete in-channel drop structures trap debris and create pools in this reach. The purpose of these structures is unclear and they are in generally poor condition. The lawn area of the school extends all the way to the channel, stream banks have been compacted from heavy foot traffic, and understory and shrub cover are correspondingly poor. Historically the channel followed a longer meander closer to the current school building location (Figure 3.6).

- Issues affecting riparian function:**
- failing in-channel structures
 - eroded access trails
 - compaction from foot traffic
 - lack of understory cover
 - invasive species (Russian olive, myrtle spurge)
 - trash

RECOMMENDATIONS	
IMPROVEMENT MEASURE	LOCATION
Revegetation - understory layer ^a	within vegetation type(s)
Access control ^a	point 2 on map
Storm drain improvement ^a	point 5 on map
No-trespassing signage ^a	point 6 on map
Stream cleanup ^a	reach-scale
Removal/improvements to in-channel concrete structures ^a	points 1, 3, and 4 on map
Invasive plant removal ^a	within vegetation type(s)
Revegetation (shrub layer)/buffer creation ^a	within vegetation type(s)
Bank stabilization	reach-scale
Grade control	reach-scale

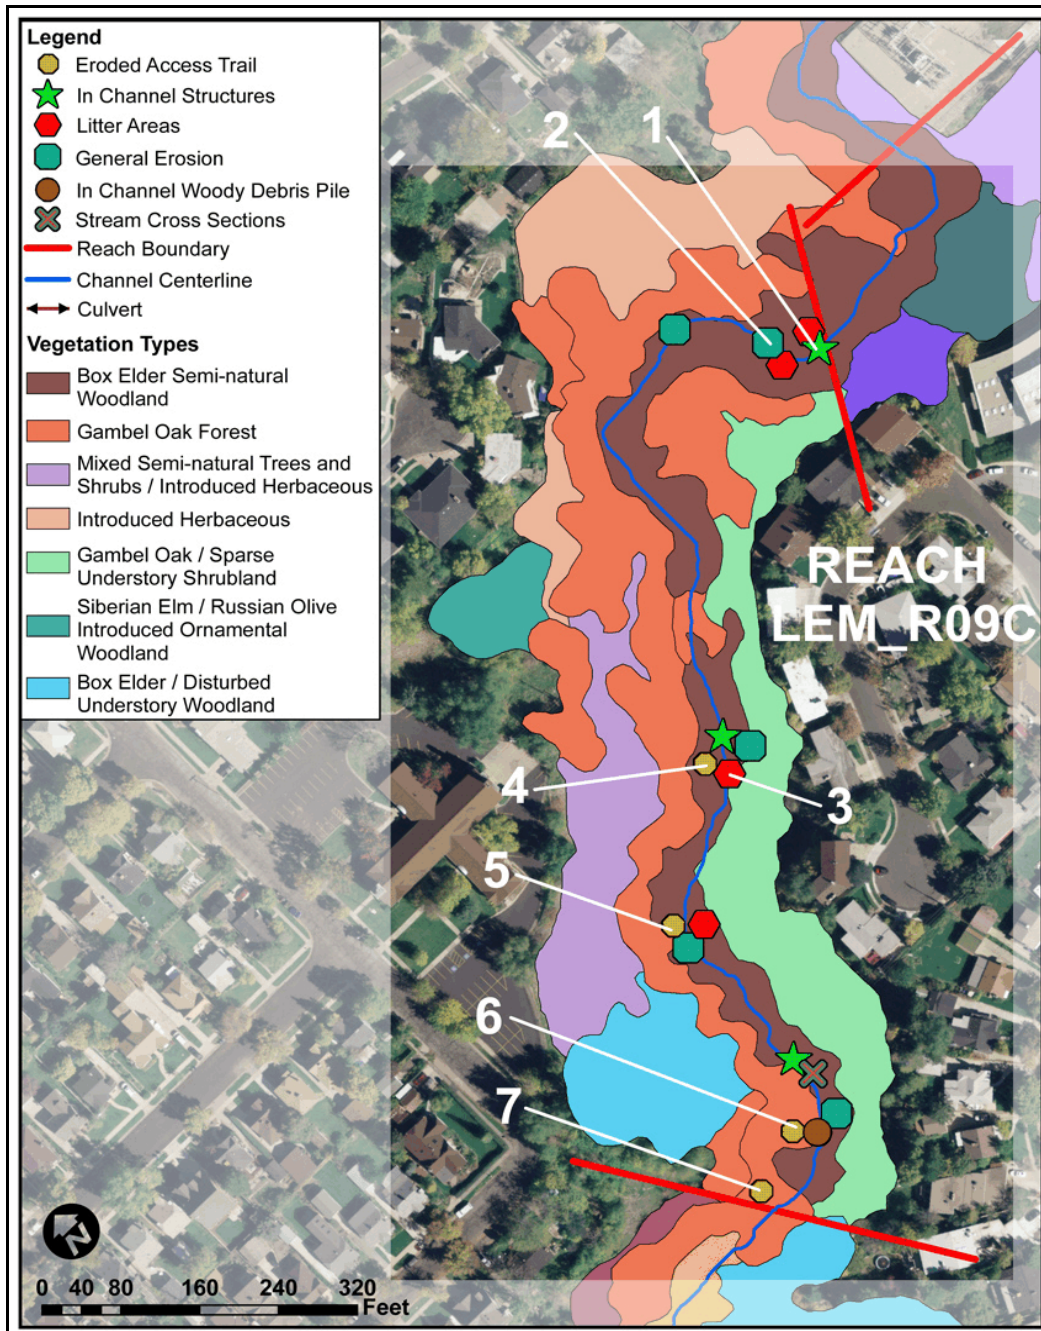
This reach has numerous tall vertical banks where the channel has meandered into terrace deposits; this bank erosion does not currently pose a risk to infrastructure. A clay/ root mat layer affects channel and bank conditions along much of the reach, resulting in poorly defined banks in some locations. Portions of this reach are impacted by trash and eroding trails associated with trespass/ recreational use. Weeds are also a significant problem.

- Issues affecting riparian function:**
- terrace erosion
 - eroded access trails
 - invasive species (Russian olive, Siberian elm, various noxious weeds)
 - limited understory cover
 - trash and yard waste

RECOMMENDATIONS	
IMPROVEMENT MEASURE	LOCATION
Stream cleanup ^a	points 1, 2, and 3 on map
Mechanized trash removal ^a	points 1 and 2 on map
Invasive plant removal ^a	within vegetation type(s)
Revegetation - understory layer ^a	within vegetation type(s)
No-trespassing signage ^a	reach-scale
Bank stabilization	reach-scale
Grade control	reach-scale
Access control/ trail stabilization ^a	points 4, 5, 6, and 7 on map
Replacement/improvements to in-channel rock/debris dams ^a	points 1 and 3 on map

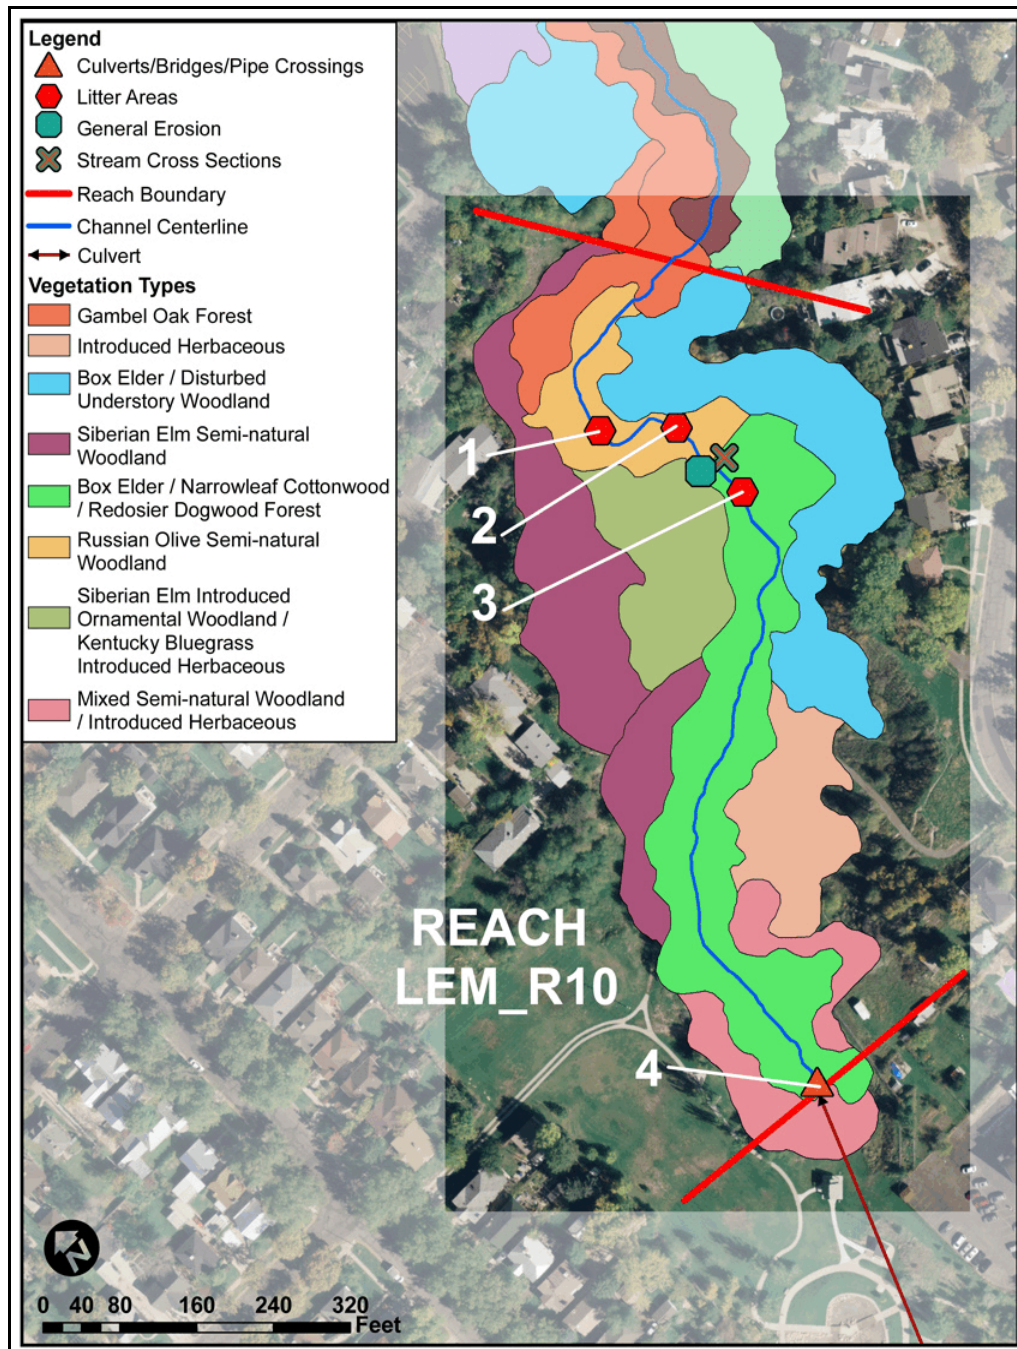
This reach is heavily used for recreation by people and dogs, which has affected bank stability and understory vegetation growth. Understory vegetation is further limited by sediment deposition that occurs when the downstream culvert inlet clogs. Failing bank revetment is present in some areas of the reach, as is root zone scour. Fill material has encroached into portions of the floodplain. Russian olive is a dominant species in the upper part of the reach.

- invasive species (Russian olive, Siberian elm, various noxious weeds)
- eroded access trails
- heavy dog use
- failing bank revetment
- low bank/root zone erosion
- terrace erosion
- backwater effect/ sedimentation limits understory vegetation
- lack of understory cover
- limited shrub cover

RECOMMENDATIONS	
IMPROVEMENT MEASURE	LOCATION
Stream cleanup ^a	points 1, 2, and 3 on map
Mechanized trash removal ^a	points 2 and 3 on map
Invasive plant removal ^a	within vegetation type(s)
Culvert replacement ^a	point 4 on map
Access control/ trail stabilization ^a	reach-scale
Revegetation - understory layer ^a	within vegetation type(s)
No-trespassing signage ^a	reach-scale
Revegetation - shrub layer ^a	within vegetation type(s)
Bank stabilization ^a	reach-scale
Grade control	reach-scale
Floodplain re-establishment ^a	reach-scale

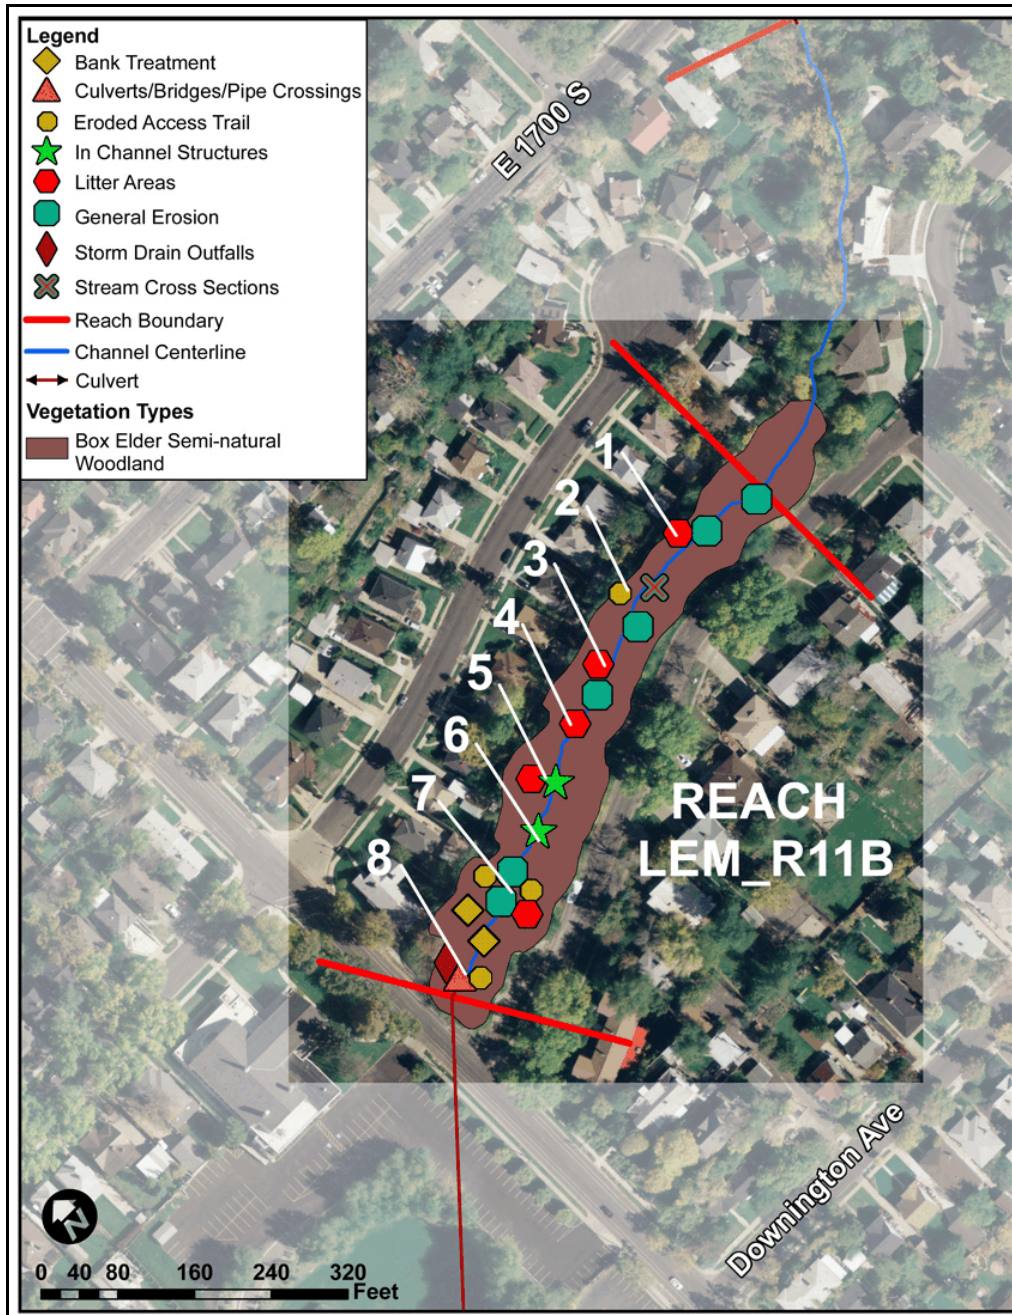
The channel in this reach appears incised and possibly straightened/channelized, with a narrow canal-like shape. The stream is tightly confined between residential homes on the north and Blaine Avenue to the south. The culvert inlet at the bottom of the reach clogs periodically. A metal grate-style trash rack spans the channel in the middle of the reach, and captured debris and sediment are regularly dredged from the channel in this location. Trash is prevalent in the reach.

- storm outfall erosion
- bed incision
- low bank/root zone erosion
- failing bank revetment
- low bank/root zone erosion
- terrace erosion
- eroded access trails
- lack of shrub cover
- invasive species (Siberian elm)
- trash

RECOMMENDATIONS	
IMPROVEMENT MEASURE	LOCATION
Stream cleanup ^a	points 1, 3, 4, and 5 on map
Mechanized trash removal ^a	points 4, 5, and 7 on map
Revegetation - shrub layer ^a	within vegetation type(s)
Storm drain improvement ^a	point 8 on map
Invasive plant removal ^a	within vegetation type(s)
Revegetation - understory layer ^a	within vegetation type(s)
Grade control ^a	reach-scale
Bank stabilization ^a	reach-scale
Access control/ trail stabilization ^a	points 2, 6, and 8 on map
Culvert replacement ^a	point 8 on map
No-trespassing signage	reach-scale

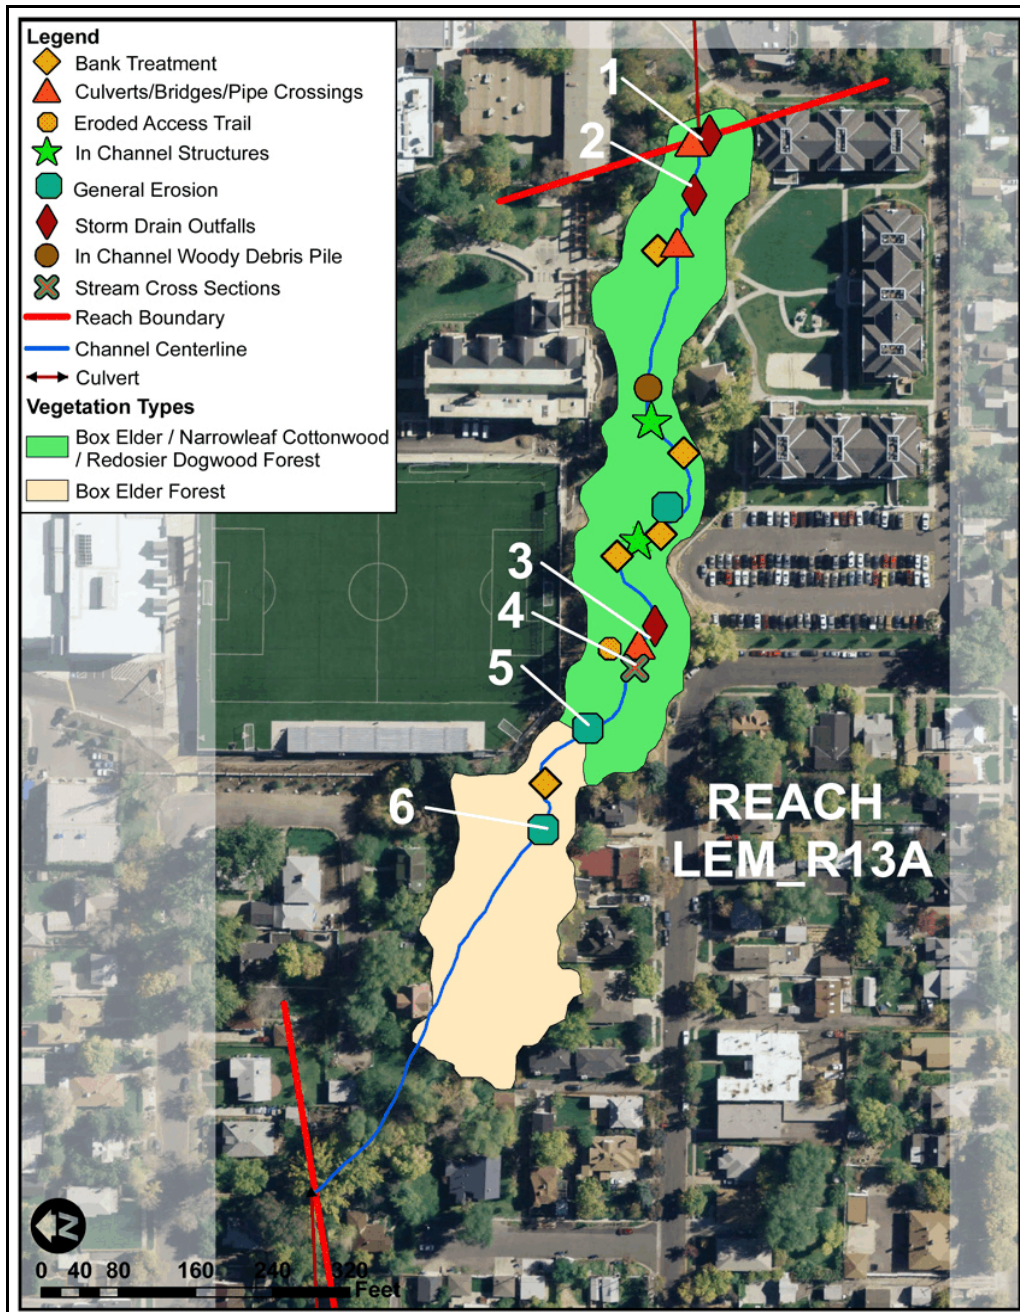
The upper part of this reach has many access areas and bare-dirt trails. Terrace erosion and root scour are evident. Boulder bank revetment was installed in various parts of the reach as part of a stabilization project completed in 2008. That project also involved installation of interpretive signs and some native shrub/ tree plantings, as well as construction of a concrete stage adjacent to the channel.

RECOMMENDATIONS	
IMPROVEMENT MEASURE	LOCATION
Storm drain improvement ^a	points 1, 2, and 3 on map
Culvert replacement/outlet protection ^a	point 1 on map
Invasive plant removal ^a	within vegetation type(s)
Revegetation - shrub layer ^a	within vegetation type(s)
No-trespassing signage ^a	point 6 on map
Bank stabilization ^a	reach-scale
Access control/ trail stabilization ^a	points 1 and 4 on map
Restoration of native understory plants ^a	within vegetation type(s)
Revegetation - understory layer ^a	within vegetation type(s)
Grade control	reach-scale
Removal of obsolete silt fence ^a	point 5 on map
