APPENDIX C: STUDY REACH MAPS, SUMMARIES, AND RECOMMENDATIONS

This appendix provides summary information and maps for each of the fully-assessed study reaches. These summaries are not intended to comprehensively provide all the information collected for each reach; rather, they are meant as a reference that provides a brief characterization and overview of existing conditions, issues, and recommendations for each assessed reach. The maps in this appendix include vegetation community types and locations of features such as litter areas, storm drain outfalls, culvert crossings, access trails, artificial bank treatments, and erosion areas. A brief description and selected photos are also provided, along with tables summarizing stream channel data and vegetation characteristics. For each reach, a table is also provided that lists appropriate types of improvement measures for the reach and describes where within the reach the measures should be applied. Measures identified for implementation at the reach-scale will typically require additional detailed site-level design work and engineering to determine specific locations and combinations of treatment techniques.

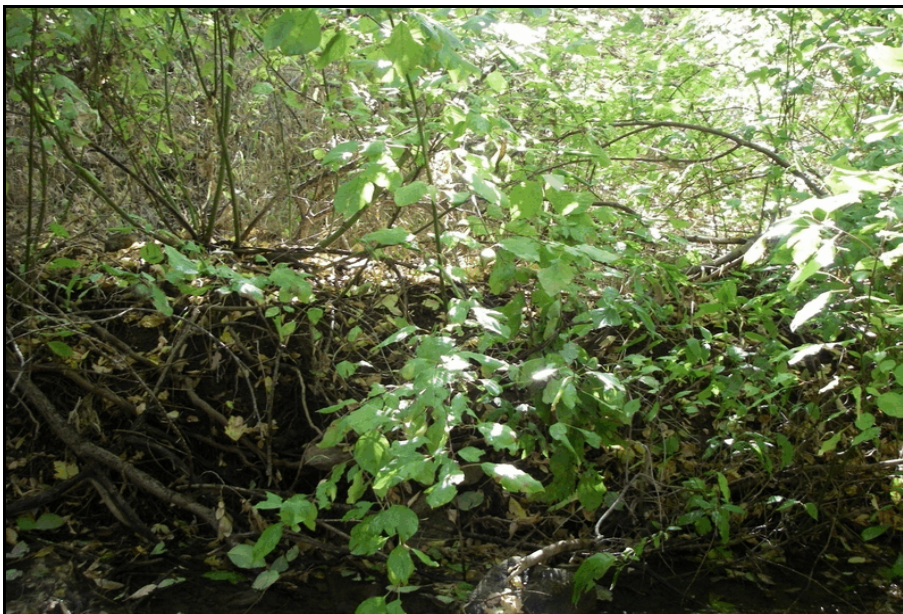
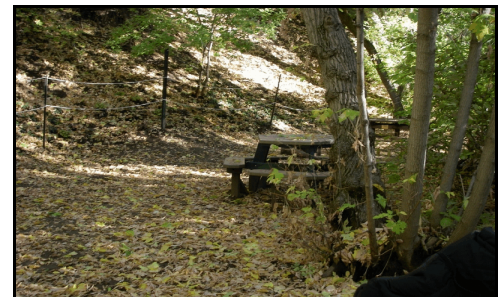
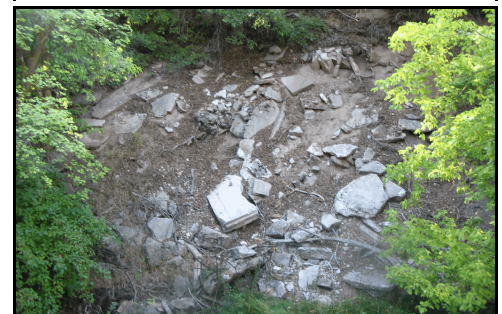
REACH URB_R09: UPPER RED BUTTE GARDEN

This reach flows through the downstream portion of Red Butte Canyon, and the channel is confined by steep hillslopes. The reach is in relatively natural condition, and although some trail and picnic facilities are present, recreational use does not appear to be negatively affecting riparian condition. Channel and bank slopes are steep, and the reach shows evidence of low bank/root scour, terrace/high bank erosion, hillslope slumping, and apparent bed incision. Vegetative structure and cover are generally excellent in this reach.

- low bank/root zone erosion
- terrace erosion
- eroded access trails (minor)
- invasive species (whiteweed, lesser burdock, Siberian elm)
- bed incision

RECOMMENDATIONS	
IMPROVEMENT MEASURE ^a	LOCATION
Invasive plant removal	within vegetation type(s)
Removal of concrete/asphalt on bank	point 1 on map
Biotechnical slope stabilization	point 1 on map
Revegetation of low bank at picnic area	point 2 on map

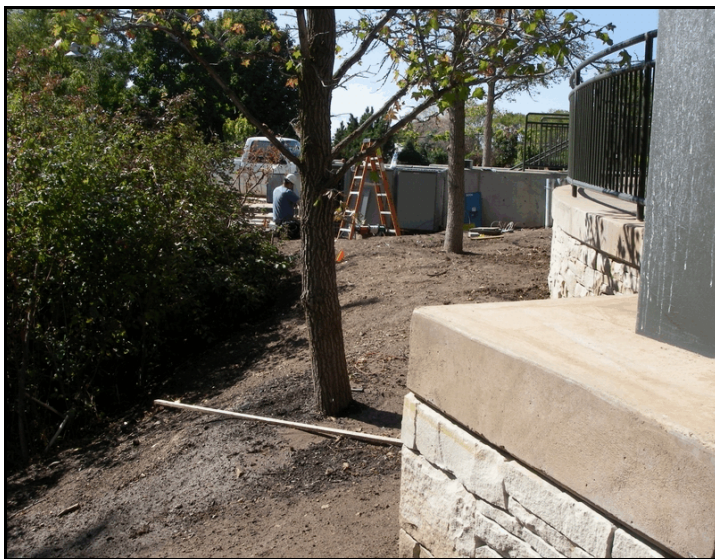
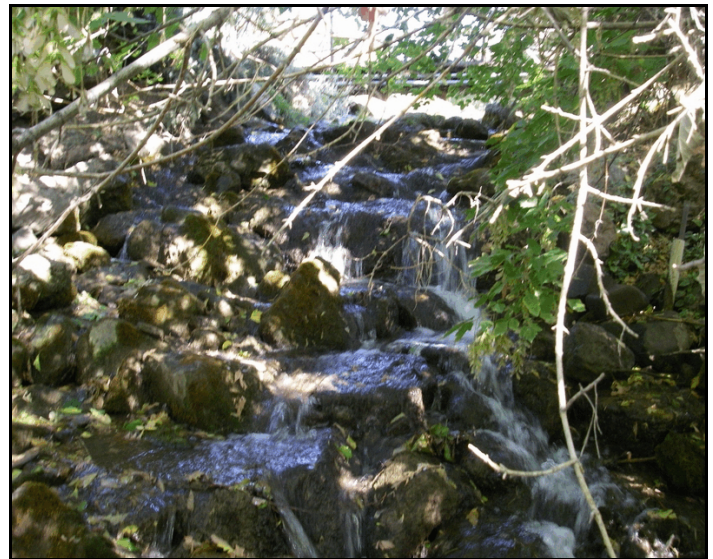
REACH LRB_R01: LOWER RED BUTTE GARDEN

This is a short reach downstream of the ponds in Red Butte Garden. At the time of field assessment, the riparian corridor was affected by construction activities associated with renovation of the Red Butte Garden concert venue. The banks through this reach are much lower and less confining than in Reach URB_R09, and several grade control structures are present. A narrow but thick buffer of riparian vegetation with excellent shrub density limits direct access to the stream. No invasive plant species were noted in this reach.

- affected by active construction at time of assessment

RECOMMENDATIONS	
IMPROVEMENT MEASURE ^a	LOCATION
Stream cleanup	point 1 on map
Monitor/protect riparian corridor	reach-scale

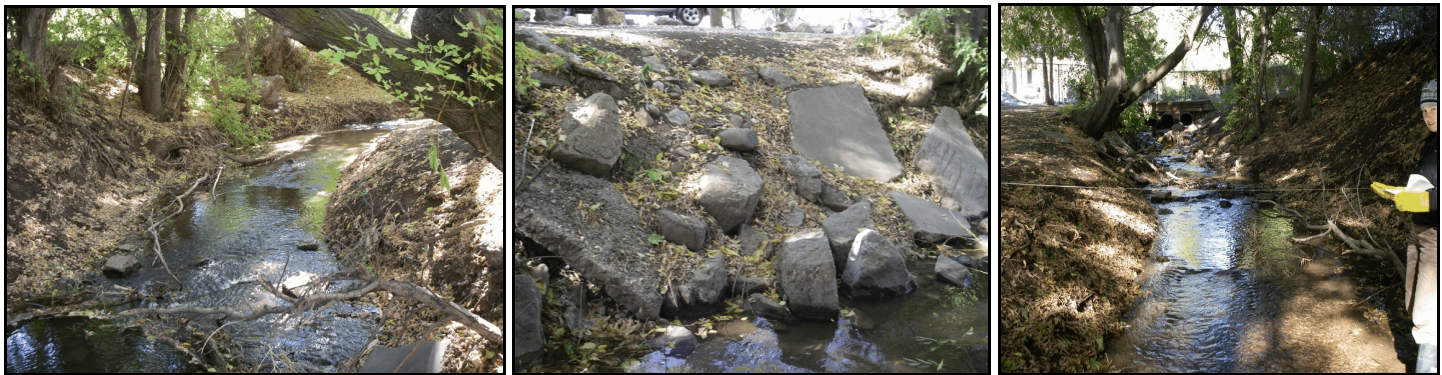
REACH LRB_R02: UNIVERSITY - BELOW RED BUTTE GARDEN

On the southeast side in this reach, the channel is confined by a tall bank that in some areas appears to have been affected by fill placement. The riparian area is impacted by heavy foot traffic that has compacted the soil and reduced understory vegetation cover. Rock and concrete pieces have been placed in several bank and in-channel areas; otherwise, bed material is dominantly sand and small gravel. Vegetation diversity is generally poor in this reach.

- Issues affecting riparian function:**
- heavy foot traffic/soil compaction
 - lack of shrub cover
 - lack of understory cover
 - low bank/root zone erosion
 - trash (minor)

RECOMMENDATIONS	
IMPROVEMENT MEASURE ^a	LOCATION
Access control	reach-scale
Revegetation - understory layer	within vegetation type(s)
Biotechnical slope stabilization	reach-scale
Revegetation - shrub layer	within vegetation type(s)
Bank stabilization	reach-scale
Mechanized trash removal (concrete pieces)	point 1 on map
Stream cleanup	point 2 on map
Invasive plant removal/control	within vegetation type(s)
Culvert replacement with bridge	point 3 on map

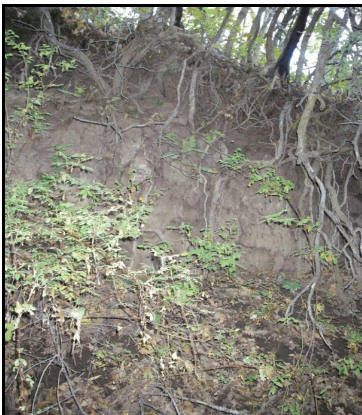
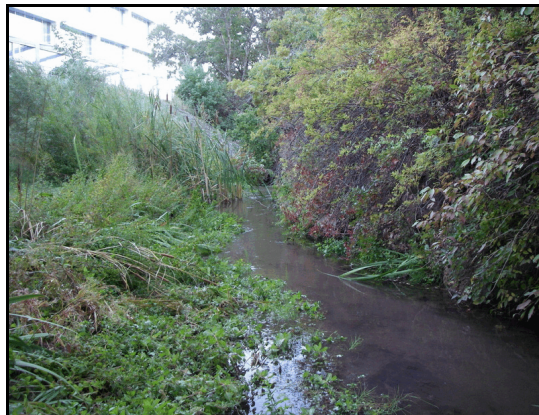
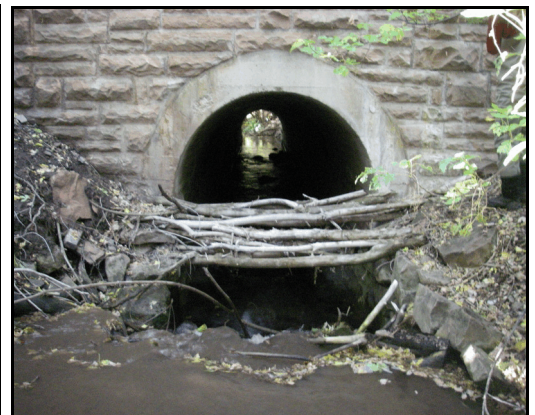
REACH LRB_R03: UNIVERSITY - ABOVE CHIPETA WAY

Although this reach is generally steep, rock grade control structures have created small sections with flat, slow-moving water and wetland vegetation. Tree cover is poor on the east bank at the upstream end of the reach where a building/access road extends to within 16 feet of the channel centerline. The channel is confined by tall, steep banks through much of the reach. Poorly designed gravel and concrete brick wall bank protection features are contributing to erosion on adjacent/opposite banks.

- Issues affecting riparian function:**
- invasive species (Russian olive, lesser burdock)
 - terrace erosion
 - low bank/root zone erosion
 - deposition/clogging at culvert inlet
 - failing bank revetment
 - limited tree cover

RECOMMENDATIONS	
IMPROVEMENT MEASURE ^a	LOCATION
Invasive plant removal	within vegetation type(s)
Removal/improvements to gravel bank protection	point 1 on map
Revegetation - canopy layer	point 1 on map
Removal/improvements to concrete brick wall	point 2 on map
Avoid placing yard waste on banks/leave "no-mow" buffer at edge of turf	reach-scale
Bank stabilization	reach-scale
Grade control	reach-scale
Culvert replacement/improvement	point 3 on map

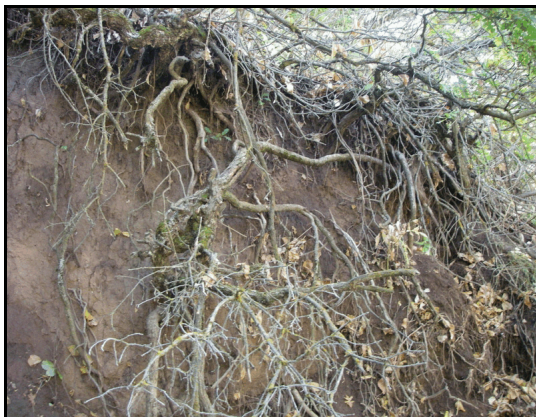
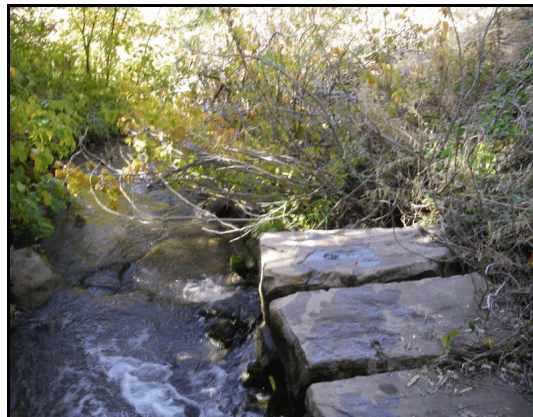
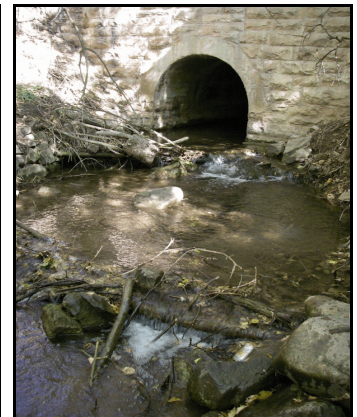
REACH LRB_R04A: UNIVERSITY - BELOW CHIPETA WAY

Banks are generally steep and tall in this reach, which flows between University parking lots and maintenance facilities. Significant amounts of trash were noted in the reach. Vegetative structure is relatively good; however, total forested width is limited in some areas. Poison ivy dominates the understory cover. Heavy root scour and significant bank erosion are prevalent within the reach.

- terrace erosion
- storm drain outfall erosion
- low bank/root zone erosion
- trash
- invasive species (Siberian elm)
- narrow forested corridor
- bed incision

RECOMMENDATIONS	
IMPROVEMENT MEASURE ^a	LOCATION
Stream cleanup	points 2, 3, 5, 6, and 7 on map
Mechanized trash removal	points 3 and 6 on map
Storm drain improvement	point 4 on map
Culvert replacement/improvement/removal	points 1 and 10 on map
Revegetation to increase total forested width	points 8 and 9 on map
Invasive plant removal	within vegetation type(s)
Bank stabilization	reach-scale
Grade control	reach-scale

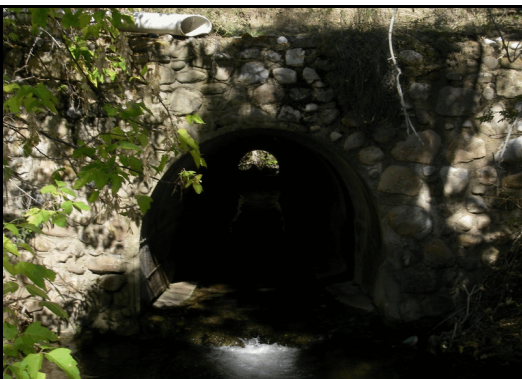
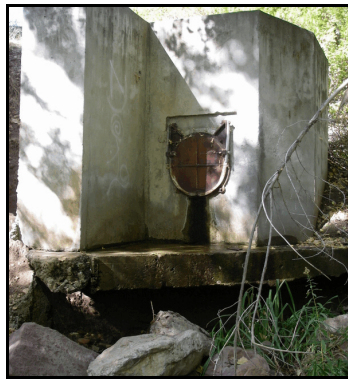
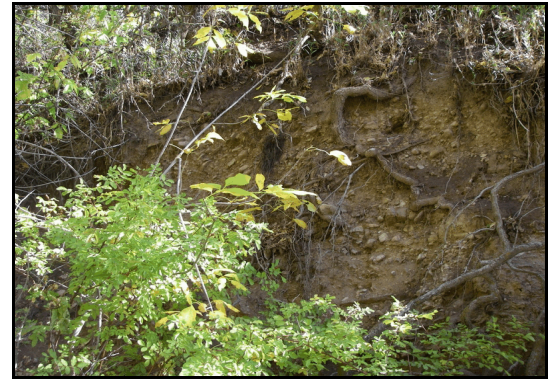
REACH LRB_R04B: UNIVERSITY - NEAR TENNIS COURTS

This reach is located between tennis courts on the west and a hotel building on the east. As with the upstream reaches, banks are generally tall and steep and terrace erosion is prevalent. Several storm drain outfalls are causing erosion within the reach. Understory cover and species diversity are somewhat limited, with poison ivy dominant.

- terrace erosion
- storm drain outfall erosion
- limited understory cover
- deposition/clogging at culvert inlet

RECOMMENDATIONS	
IMPROVEMENT MEASURE ^a	LOCATION
Storm drain improvement	points 2 and 3 on map
Culvert removal	points 1 and 4 on map
Revegetation - understory layer	within vegetation type(s)
Biotechnical slope stabilization	reach-scale
Bank stabilization	reach-scale
Grade control	reach-scale

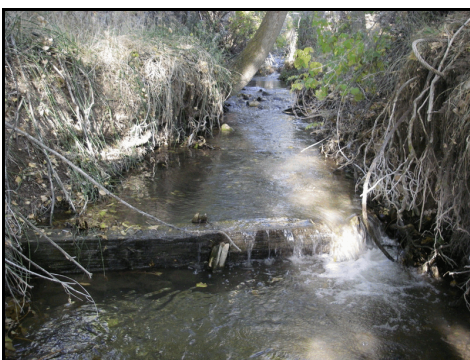
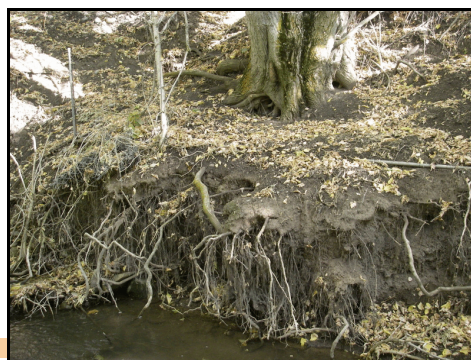
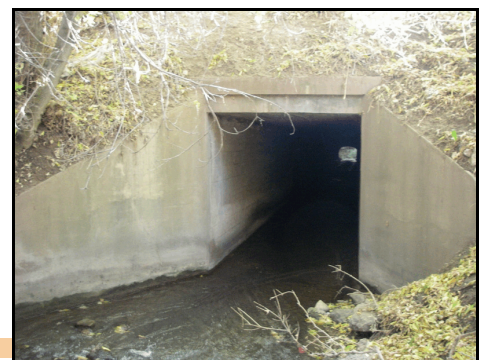
REACH LRB_R04C: UNIVERSITY - ABOVE FOOTHILL DRIVE

This reach flows between U.S. Army facilities on the west and University of Utah research park buildings on the east. Several litter areas including broken pieces of concrete, pipe, chain link fence, and silt fence are present. Bank erosion is evident primarily in the upper and lower portions of the reach. This reach contains several storm drain outfalls and a wooden grade control structure. Forested width and canopy cover are limited in some areas.

- trash
- storm drain outfall erosion
- terrace erosion
- invasive species (whiteweed, quackgrass)
- low bank/root zone erosion
- narrow forested corridor
- understory dominated by nonnative species
- bed incision
- limited shrub

RECOMMENDATIONS	
IMPROVEMENT MEASURE ^a	LOCATION
Restoration of native understory plants	within vegetation type(s)
Invasive plant removal	within vegetation type(s)
Mechanized trash removal	points 3 and 6 on map
Stream cleanup	points 2, 3, and 7 on map
Revegetation - canopy layer	within vegetation type(s)
Storm drain improvement	points 4 and 5 on map
Culvert removal	point 1 on map
Biotechnical slope stabilization	point 8 on map
Bank stabilization	reach-scale
Grade control	reach-scale

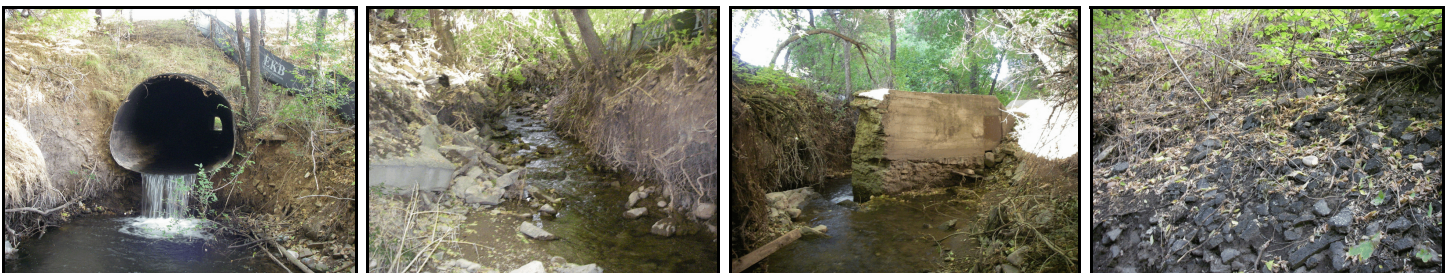
REACH LRB_R05A: VA MEDICAL CENTER - BELOW FOOTHILL DRIVE

This is a steep, short reach that is heavily impacted by development. Bank areas contain significant amounts of asphalt and concrete pieces that have failed to stabilize the banks and currently degrade aesthetics and limit vegetation establishment. The reach contains a concrete wall/weir/outfall structure that contributes to erosion and appears to be obsolete. Bed incision, root scour, and bank erosion are also ubiquitous through the reach. Shrub cover is lacking.

- Issues affecting riparian function:**
- scour/erosion at culvert outlet
 - storm drain outfall erosion
 - poor revegetation/stabilization practices
 - bed incision
 - failing in-channel infrastructure
 - failing bank revetment
 - low bank/root zone erosion
 - terrace erosion
 - trash
 - invasive species (Siberian elm)
 - lack of shrub cover

RECOMMENDATIONS	
IMPROVEMENT MEASURE ^a	LOCATION
Invasive plant removal	within vegetation type(s)
Revegetation - shrub layer	within vegetation type(s)
Culvert replacement/outlet protection	point 1 on map
Stream cleanup	point 5 on map; reach-scale
Mechanized trash removal	points 2 and 4 on map; reach-scale
Replace/improve obsolete concrete structure	point 3 on map
Bank stabilization	reach-scale
Grade control	reach-scale

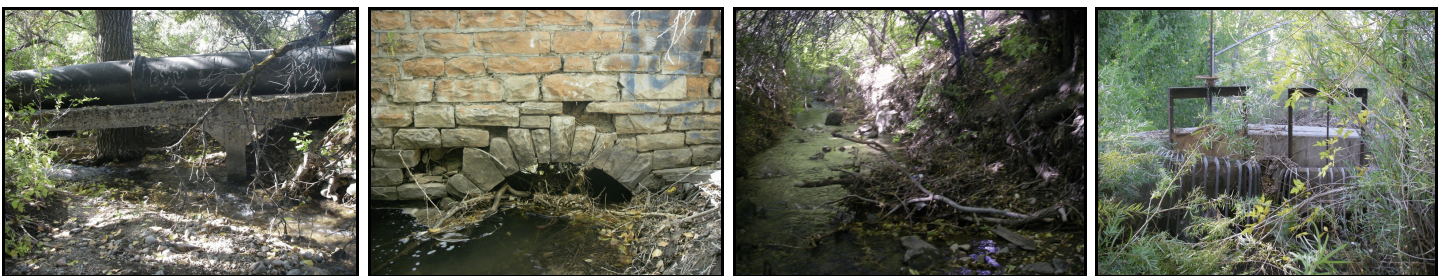
REACH LRB_R05B: VA MEDICAL CENTER - ABOVE SUNNYSIDE PARK

This reach flows between Veteran’s Administration and University of Utah facilities, ending at a diversion structure and bridge at the upstream end of Sunnyside Park. The reach contains seven storm drain outfalls, a utility pipe crossing, and a nearly clogged culvert at a trail crossing that does not appear to receive much use. Portions of the reach are in good condition.

- Issues affecting riparian function:**
- deposition/clogging at culvert
 - bed incision
 - terrace erosion
 - storm drain outfall erosion
 - limited shrub cover
 - limited understory cover
 - invasive species (Siberian elm, Russian olive)
 - low bank/root zone erosion

RECOMMENDATIONS	
IMPROVEMENT MEASURE ^a	LOCATION
Culvert replacement/outlet protection	point 1 on map
Culvert removal	point 6 on map
Storm drain improvement	points 3, 4, and 5 on map
Revegetation - shrub layer	within vegetation type(s)
Revegetation - understory layer	within vegetation type(s)
Invasive plant removal	within vegetation type(s)
Bank stabilization	reach-scale
Grade control	reach-scale
Biotechnical slope stabilization	point 2 on map

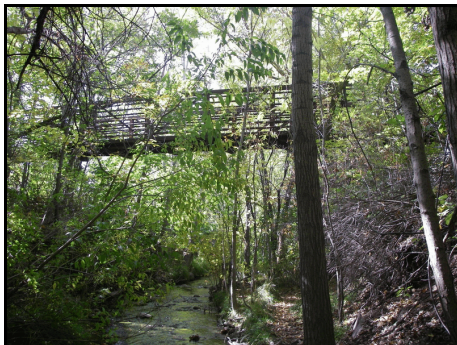
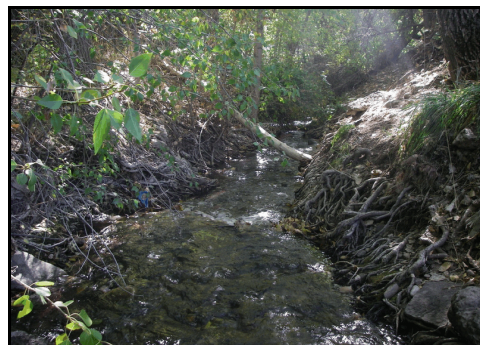
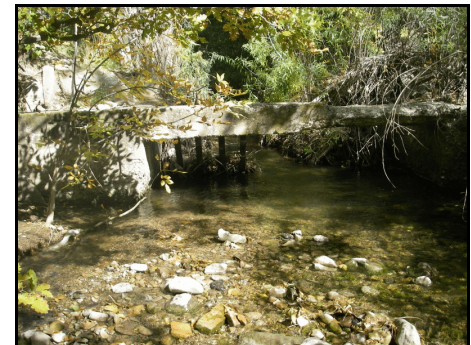
REACH LRB_R05C: SUNNYSIDE PARK

This reach contains a number of in-channel structures including a concrete diversion/weir structure and broken trash grate. The reach also contains several pedestrian access trails. Root zone scour and bank erosion are evident, particularly in the lower portions of the reach. Banks become less steep in the lower portion of the reach. Minimal understory vegetation cover is present.

- Issues affecting riparian function:**
- scour/erosion below concrete diversion weir
 - low bank/root zone erosion
 - eroded access trail
 - bed incision
 - invasive species (Russian olive, Siberian elm, houndstongue, whitetop)
 - lack of understory cover
 - failing in-channel infrastructure

RECOMMENDATIONS	
IMPROVEMENT MEASURE ^a	LOCATION
Scour protection at diversion weir	point 1 on map
Revegetation - understory layer	within vegetation type(s)
Access trail stabilization	point 2 on map
Invasive plant removal	within vegetation type(s)
Remove/repair trash grate	point 3 on map
Bank stabilization	reach-scale
Grade control	reach-scale
Establish "no-mow" buffer at edge of turf	reach-scale
Culvert replacement	point 4 on map

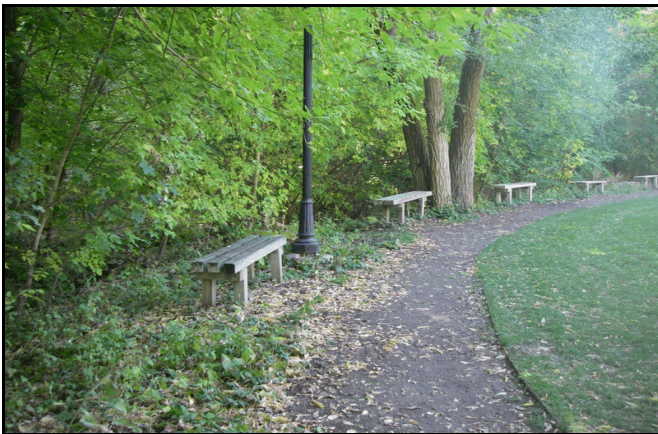
REACH LRB_R07: MILLER PARK/BONNEVILLE GLEN

This reach encompasses Miller Park and Bonneville Glen, a church-owned park area. Bank erosion and bed incision are issues within the reach. Various rock and concrete bank/ bed hardening structures are present in the reach, but in some areas the structures are failing or causing erosion on opposite/ adjacent banks. Established and user-created trails are prevalent throughout the reach, limiting shrub and understory cover and contributing to erosion. Invasive periwinkle and English ivy comprise much of the understory vegetation.

- Issues affecting riparian function:**
- bed incision
 - failing in-channel infrastructure
 - failing bank revetment
 - invasive species (English ivy, periwinkle, Scotch thistle, cheatgrass, Siberian elm, tree of heaven)
 - low bank/root zone erosion
 - scour/erosion at culvert outlet
 - eroded access trails
 - heavy foot traffic/soil compaction from dogs and people
 - understory dominated by nonnative species
 - lack of shrub cover

RECOMMENDATIONS	
IMPROVEMENT MEASURE ^a	LOCATION
Invasive plant removal	within vegetation type(s)
Restoration of native understory plants	within vegetation type(s)
Revegetation - shrub layer	within vegetation type(s)
Access control	reach-scale
Access trail stabilization	reach-scale
Bank stabilization	reach-scale
Grade control	reach-scale
Culvert replacement/outlet protection	points 1 and 4 on map
Mechanized trash removal	point 2 on map
Remove partial rock wall	point 3 on map

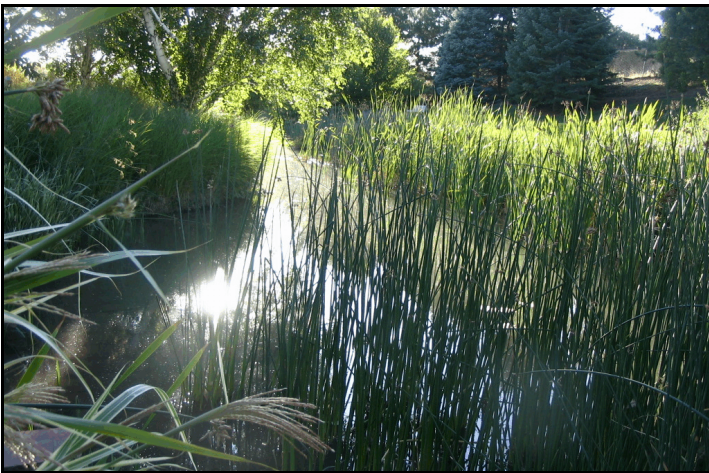
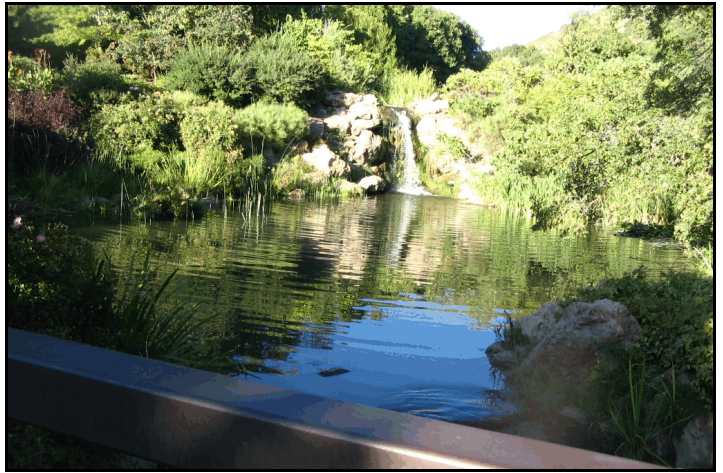
Reach URB R10: Middle Red Butte Garden

In this reach Red Butte Creek flows through a series of constructed, landscaped ponds within the formal portion of Red Butte Garden. The stream channel is in stable condition, and wetland plant species such as bullrush and common reed are present along the shoreline of some of the ponds. A moderate amount of houndstongue, a noxious weed, was noted in the corridor within the upstream portion of this reach.

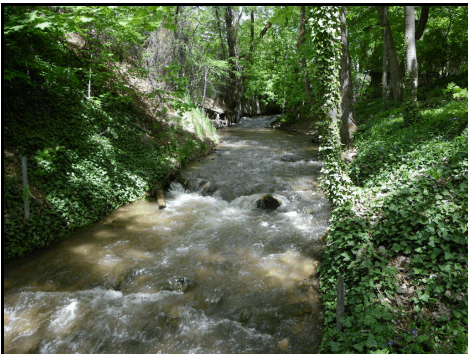
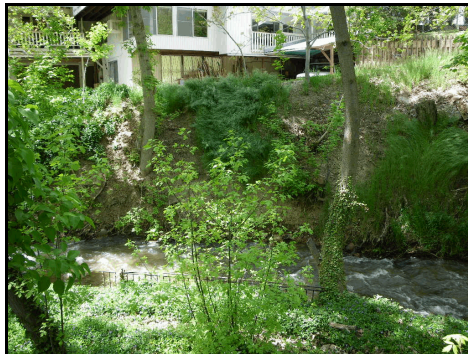
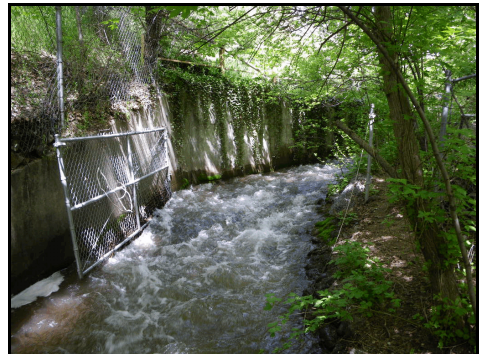
Reach LRB R06: Sunnyside Avenue to 900 South

This reach flows through a privately owned residential area. Conditions were qualitatively evaluated from a property near the upstream end of the reach and also from the culvert inlet at the downstream end of the reach. Banks are steep in this reach, and the channel has been artificially stabilized in a number of areas with a variety of structures including boards, concrete walls, rock weirs, and gabion baskets. Understory vegetation is dominated by invasive English ivy and periwinkle vine. Whitetop, a noxious weed, was also noted as present in the reach. Opportunities are somewhat limited in this reach due to infrastructure constraints, but improvements to habitat and filtration functions could be attained through restoration of native understory plants and biotechnical stabilization of steep upper slope areas. Installation of stabilized, pervious access steps could also improve stability and reduce potential erosion in areas where access trails currently consist of bare dirt.

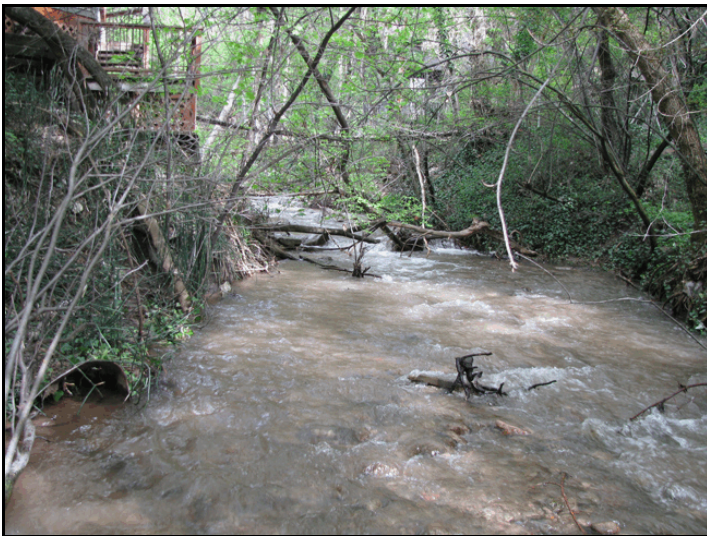
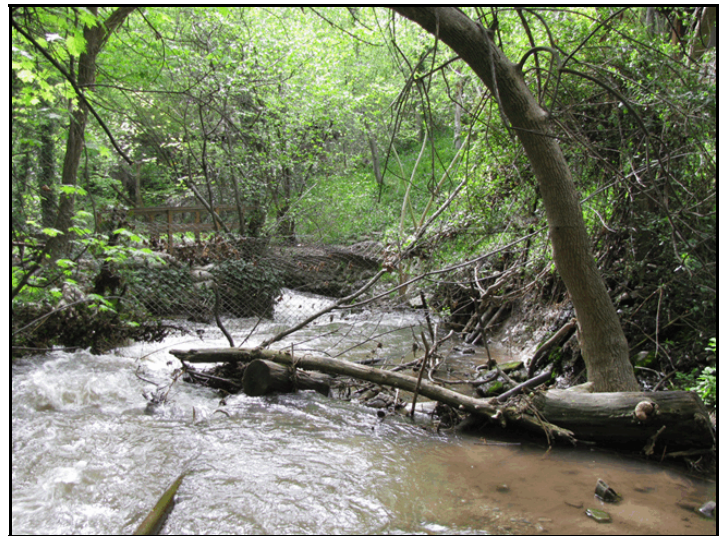
Reach LRB_R09: Above 1300 East

This reach was qualitatively evaluated from one property located near the middle of the reach. As in most of the study area, banks are steep and tall. The channel is well shaded by trees; understory vegetation is dominated by English ivy and periwinkle vine in some areas. Woody debris adds to in-channel habitat complexity. Streambanks have been hardened with grouted rock on some properties, and footbridges and fences occasionally cross the channel. Springs and seeps appear to be common in this reach and help to maintain baseflows while adding to habitat and vegetation diversity. Some of these springs have been developed with pipes and/or rock spring heads. In several areas within the reach, small cottages are present immediately adjacent to or directly above the stream channel. These historic structures were built to provide cool places to sleep during the summer. Recommended projects for this reach include restoration of native understory plants, biotechnical stabilization of upper slope areas, and replacement of dirt access trails with stable, pervious access steps.

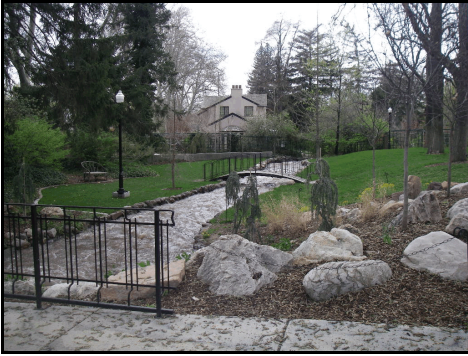
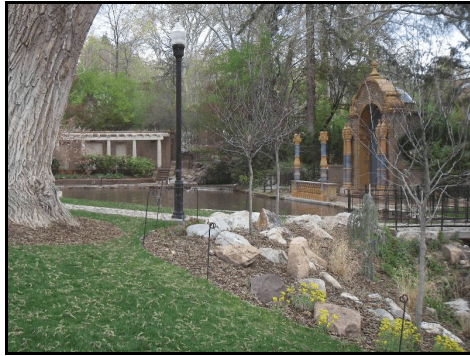
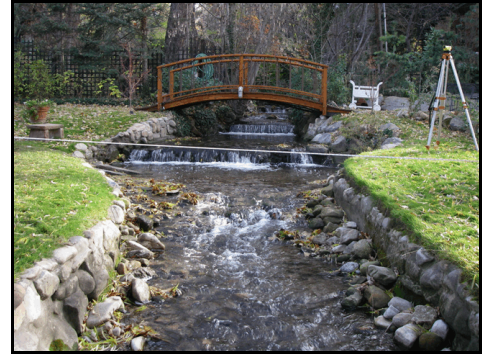
Reach LRB_R10: 1300 East to 1100 East

In this reach the Red Butte Creek channel drops below the lowest Bonneville bench level, bank height and steepness decrease, and the channel becomes less confined. This reach is completely within private property and was evaluated only in two locations where access was specifically permitted. In the areas assessed, the stream is channelized within artificially stabilized banks consisting of grouted rock walls, metal, or other hard structures. Fences commonly cross the stream at property lines, creating potential barriers to the transport of woody debris. As with reach LRB_R09, springs occur within the reach and footbridges have been constructed in several locations. Vegetation conditions vary among properties depending on landscaping, with natural vegetation in some areas and mowed grass in other areas. Within the historic Garden Park Ward property, the creek flows through a constructed pond. Opportunities within this reach are limited by the urbanized hydrology, infrastructure constraints, and

“formal” landscaped use of streamside areas. Restoration of native shrubs, understory plants, and trees along the streambanks would improve the riparian functions of shading, filtration, and habitat in this reach.

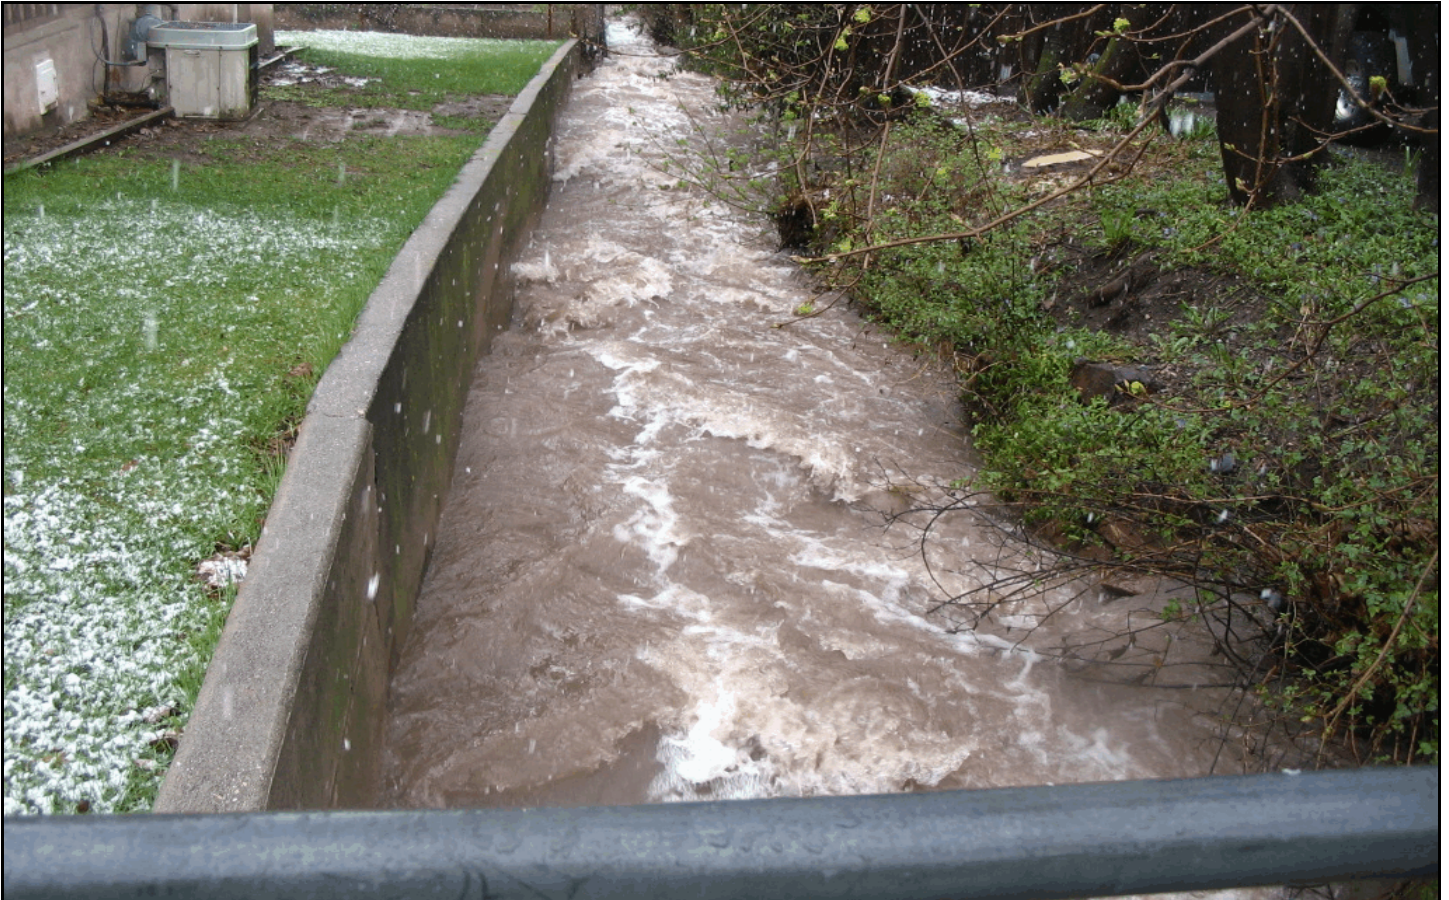
[Reach LRB_R11: Below 1100 East](#)

This is a short reach that is tightly confined by residential buildings. The channel has been stabilized with concrete walls and, during high flow periods, velocities are very high due to the lateral confinement of the channel. Opportunities are limited in this reach due to the urbanized hydrology and tight infrastructure constraints.
