Re: Miller Park Retaining Wall Investigation
1708 E 900 S, Salt Lake City, UT
ARW Job # 19075

19075_itr_20191003

Photo Appendix

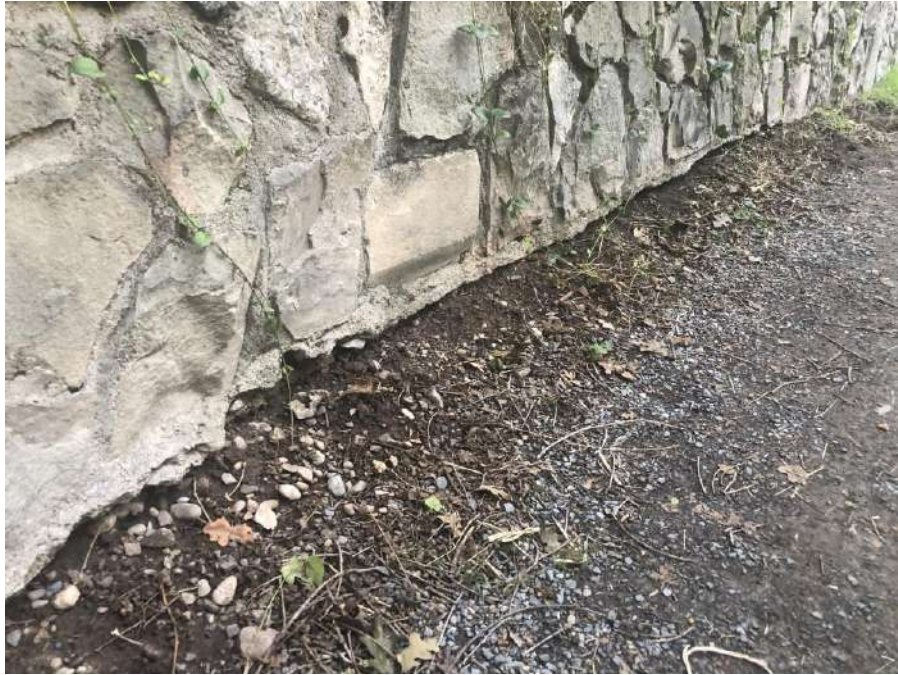
Photo #1 – Soil cover over toe of wall is not adequate

- 6- There are several walls that need to be repaired or replaced due to excessive erosion from sprinklers, drainage pipes and/or poor trail drainage or maintenance. There are also several locations where the toe of the existing rock walls are exposed. These areas need to be repaired with structural fill (and geofabric where needed). Sprinklers above and below trails should be removed where possible to eliminate saturated soil conditions and reduce soil erosion from runoff.

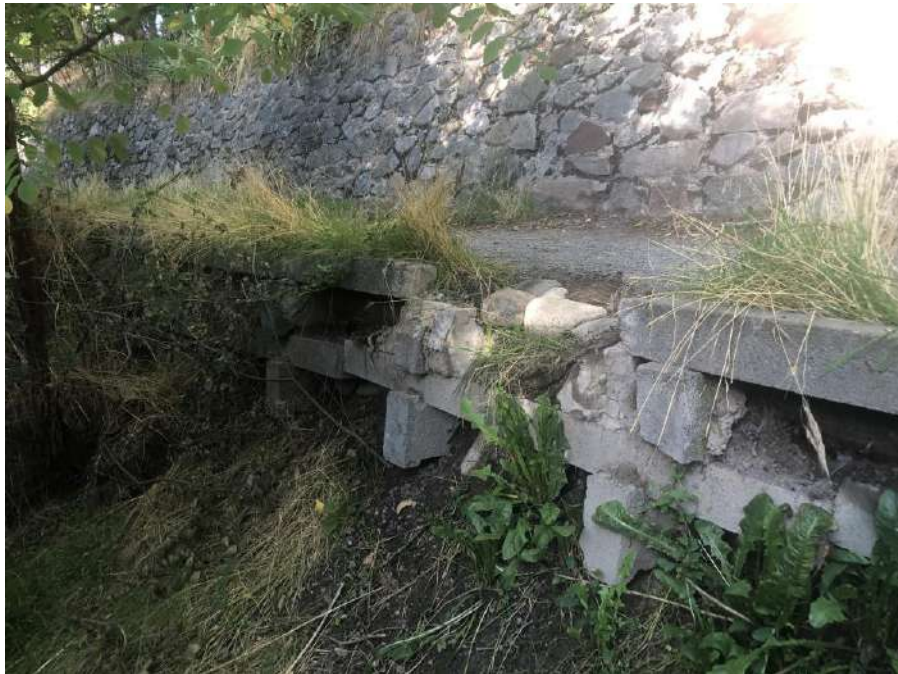
Photo #2 – erosion on the trail due to runoff and sprinklers has cause the crib walls to fail in several locations.

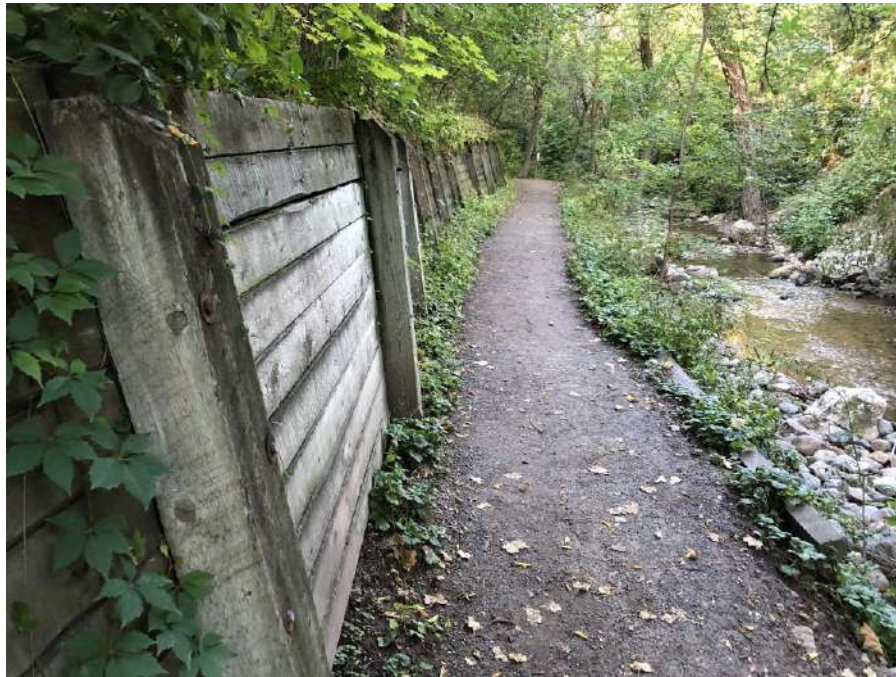
Photo #3 – Runoff from adjacent property owners' gutters is causing the wall to bulge and fail

- 3- Drainage pipes from property owners above the wall need to be addressed. There are several properties that are sending water from their gutters towards the existing retaining walls. This is causing excessive erosion above, behind and below the retaining wall structures. These drainage areas need to be remedied and the water needs to be piped around the wall as required. Addressing drainage issues will also help keep the soil less saturated above the walls.

- 7- Where walls are cracking or where rocks are missing, these areas should be re-pointed and the drainage above these walls should be addressed. The soil above these walls should remain as dry as possible throughout the year. It may also be prudent to add weep holes or drainage pipes behind walls that are bulging so that hydrostatic water pressures can be reduced.

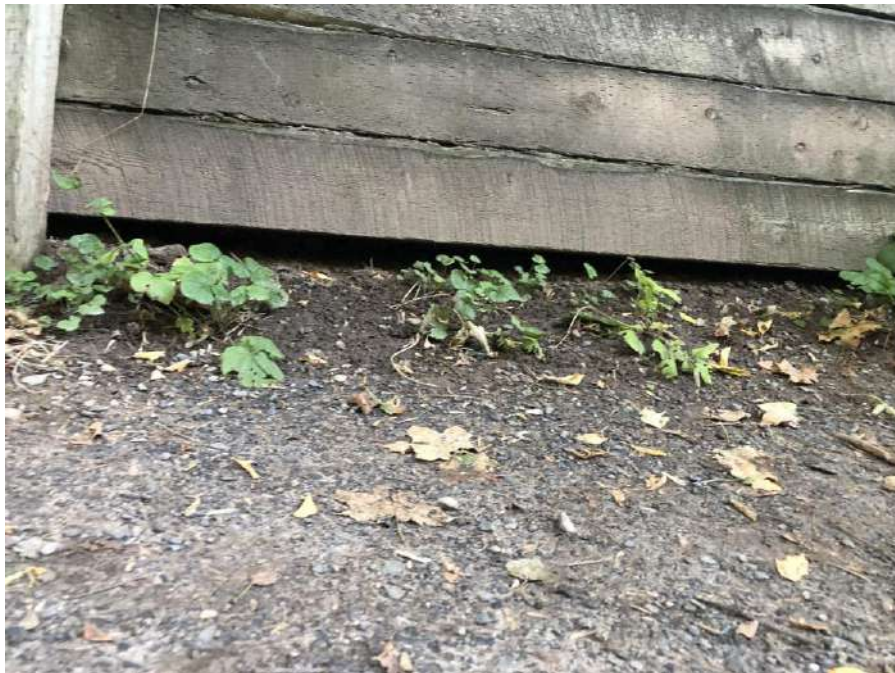
Photo #4 – Runoff from adjacent property owners is undermining existing walls.

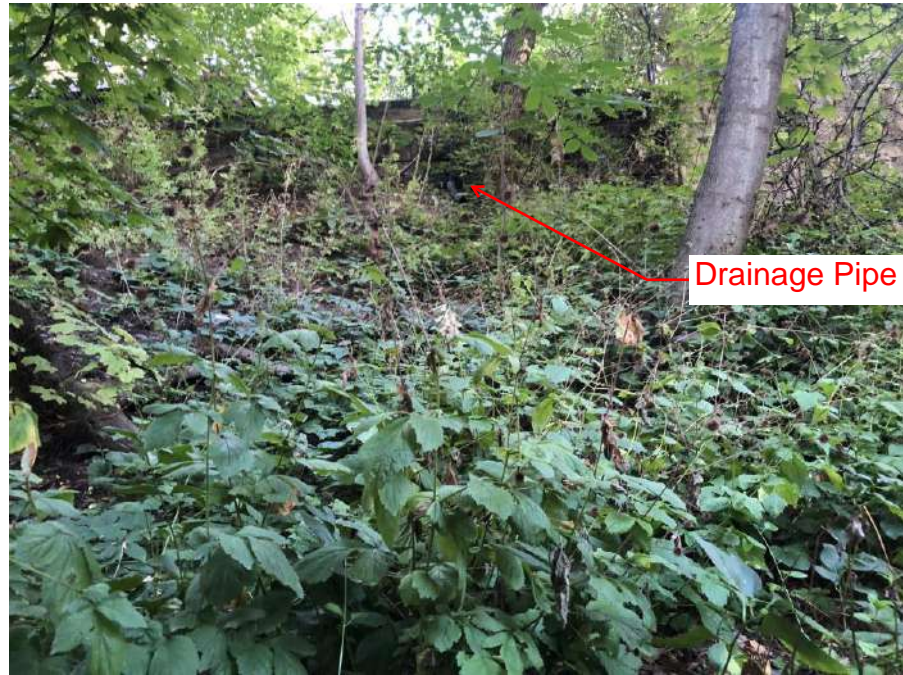
Photo #5 – Image of drainage pipe from neighboring property owners

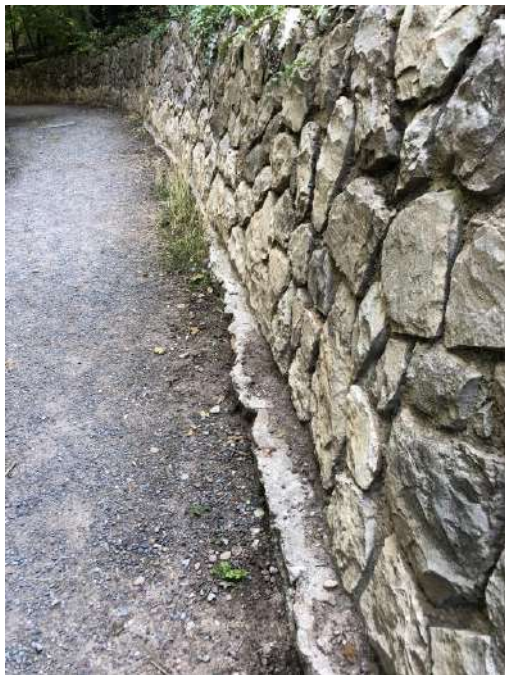
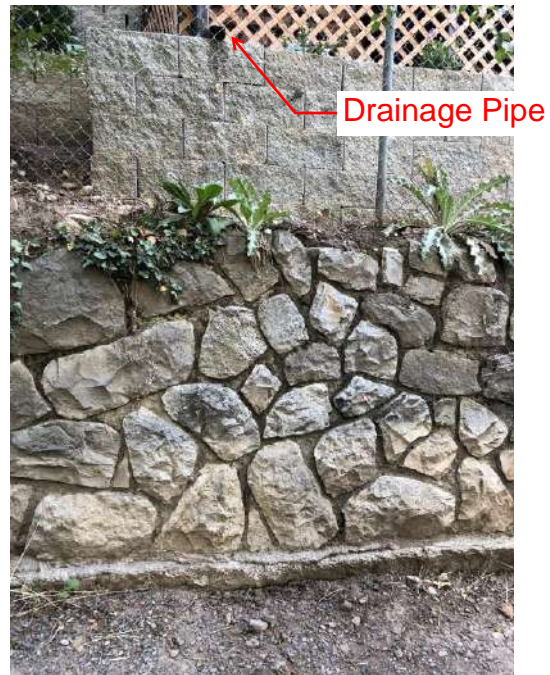
Photo #6 – Image of drainage pipe from neighboring property owners, example of adjacent structures encroaching on the existing rock walls, and example of toe of retaining wall being undermined.

- 5- There are several locations where the neighboring property owners have encroached on the existing rock walls with new retaining wall structures or new building structures. This is not advisable because it can increase loads on the retaining wall and cause it to fail. These structures should be removed, or deep foundations should be installed to independently support these structures. This will alleviate the additional lateral loads on the existing walls caused by these structures.

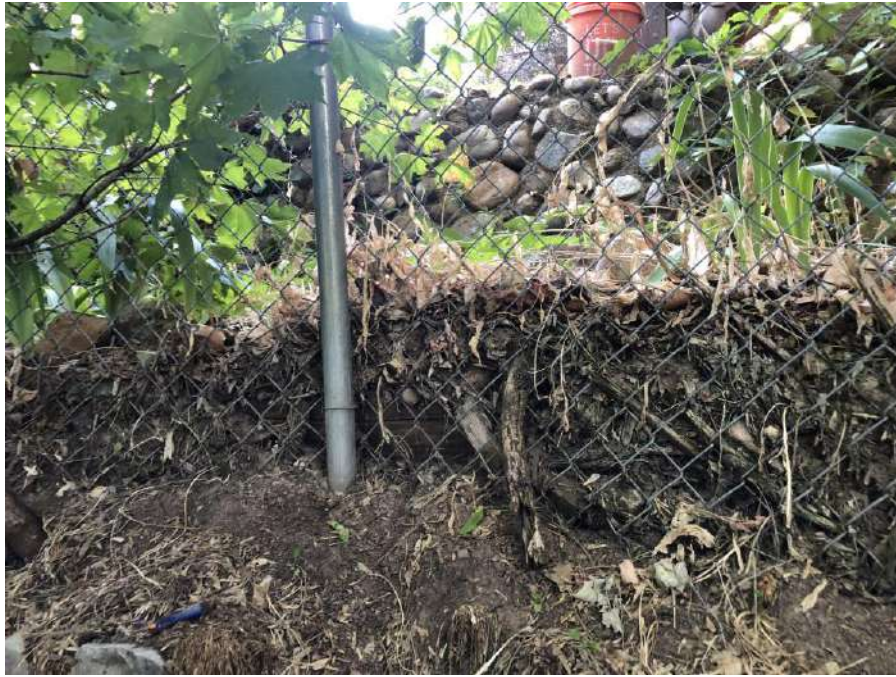
Photo #7 – Chainlink fences are collecting debris from runoff water and are retaining soil.

- 1- Chain link fences above the existing rock walls need to be removed and/or regularly maintained. These fences add additional lateral wind loads to the wall that were not accounted for in the original wall design. Property owners above the fences have not maintained the chain link fences in several areas and there is a build-up of debris against the fence that is increasing the retaining wall height and soil loads on the retaining wall structure below.

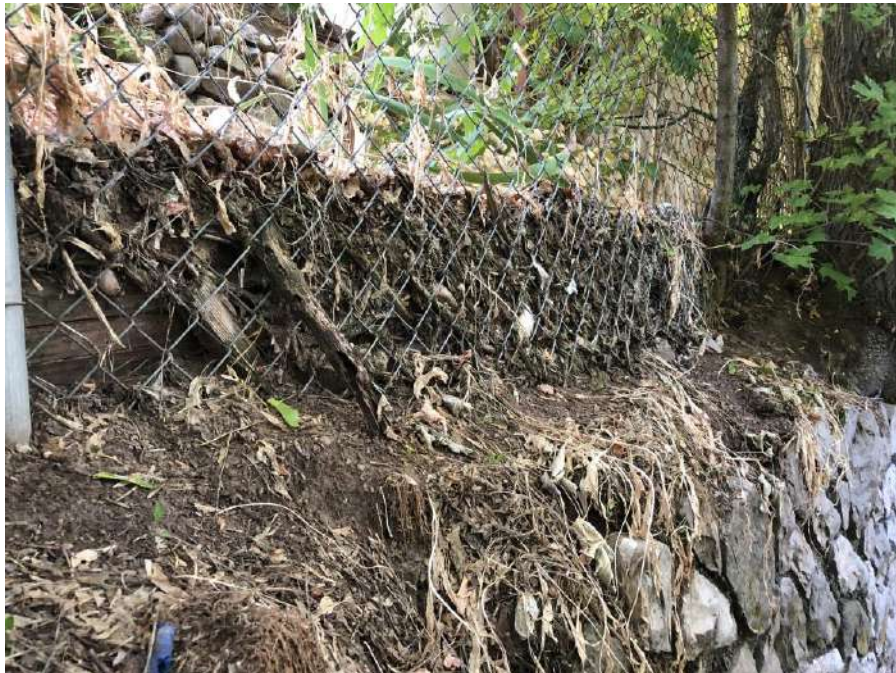
Photo #8 – Chainlink fences are collecting debris from runoff water and are retaining soil.

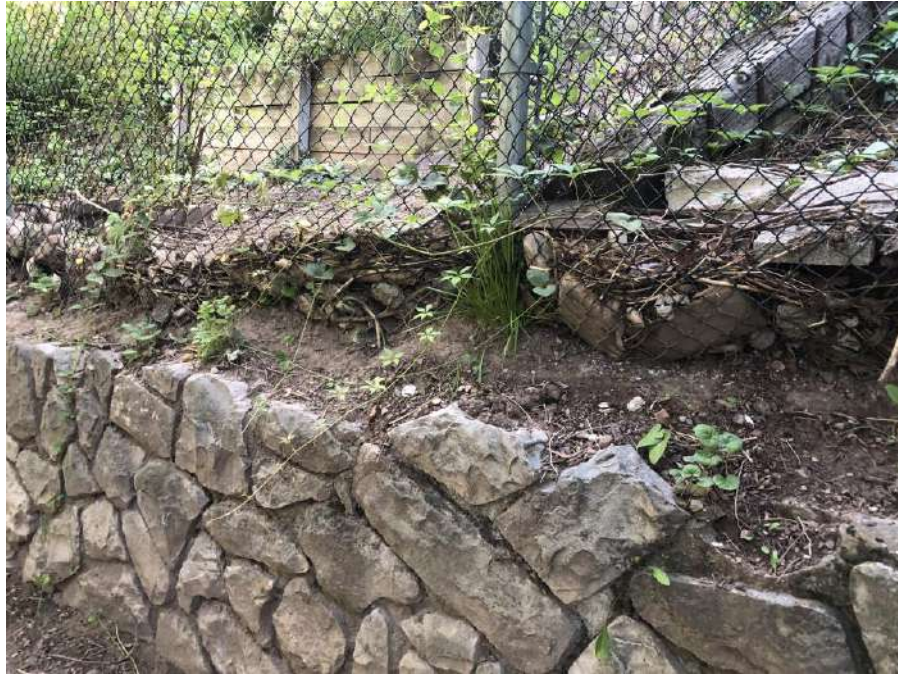
Photo #9 – Chainlink fences are collecting debris from runoff water and are retaining soil.

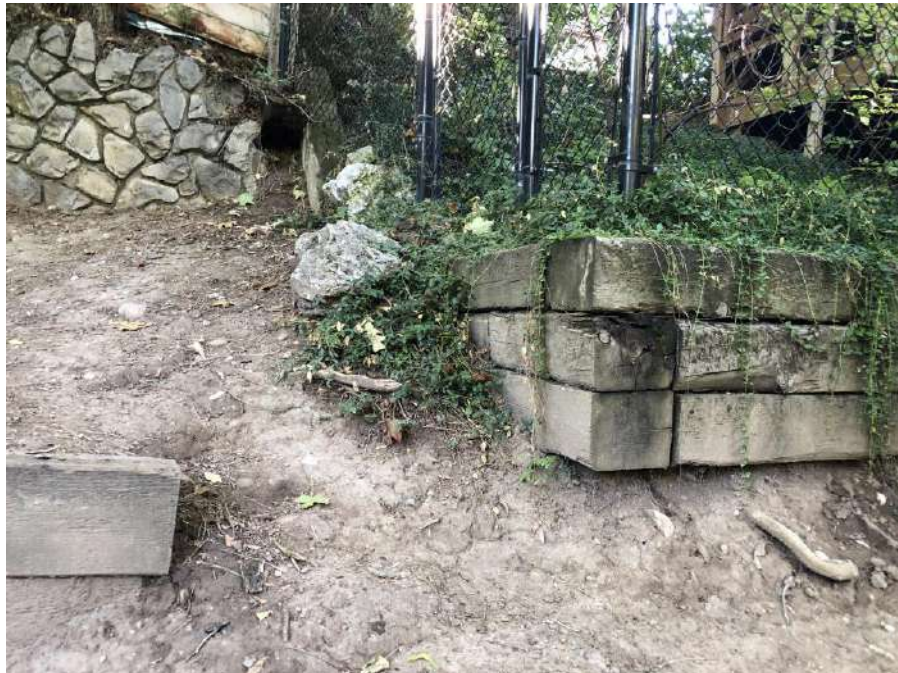
Photo #10 – Image of drainage from neighboring property owners and runoff from sprinklers causing the soil to erode and undermine the existing retaining wall structures.

- 2- Sprinkler systems above and below the wall (maintained by the city and homeowners) are causing excessive erosion behind the wall and in some cases the erosion is undermining the toe of the retaining walls. Retaining walls typically have a pipe drainage system and free draining material (gravel and/or water board) behind the wall so that water does not accumulate against the wall (creating a dam like structure with hydrostatic pressure on the wall). Weep holes are typically incorporated into new retaining wall designs to alleviate hydrostatic pressure behind walls. Eliminating water sources that create saturated soil conditions behind walls will help reduce soil/water loads on the wall and help extend its longevity. Saturated slopes are more prone to erosion and can cause unstable slopes above retaining walls.

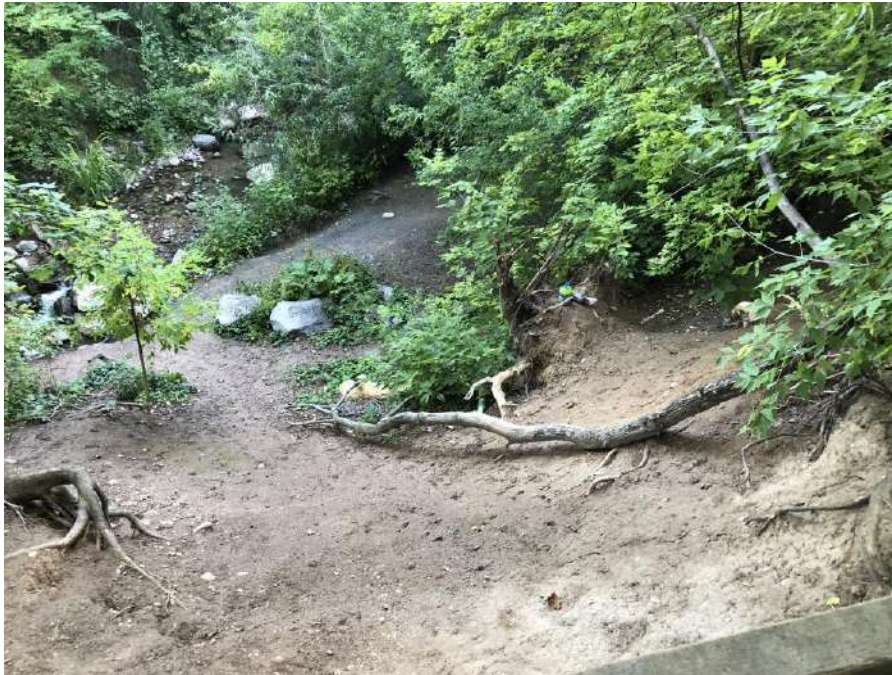
Photo #11 – Erosion that has occurred from sprinklers and runoff from neighboring properties

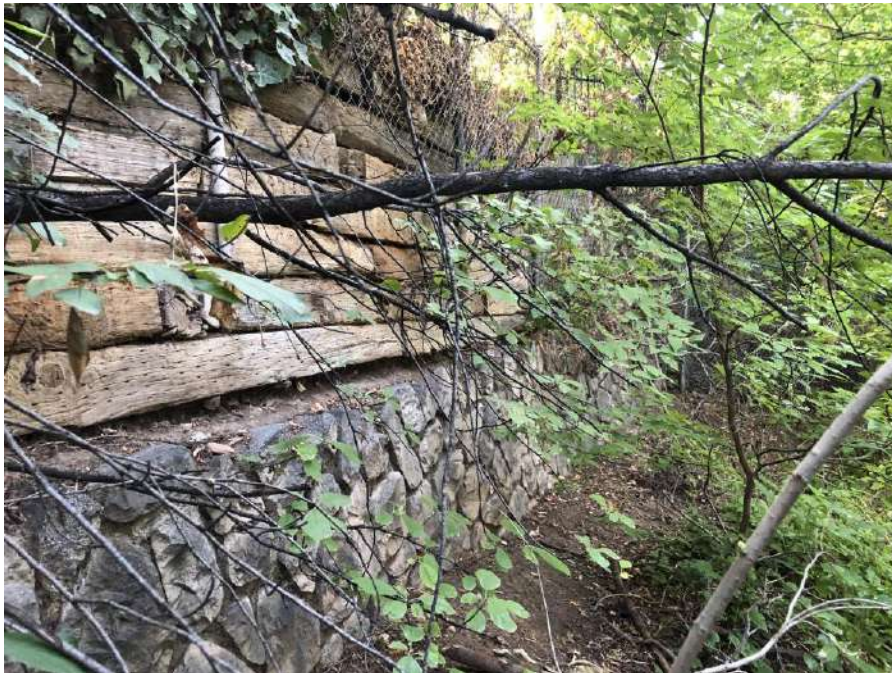
Photo #12 – Example of neighboring property owners building structures above existing rock walls.

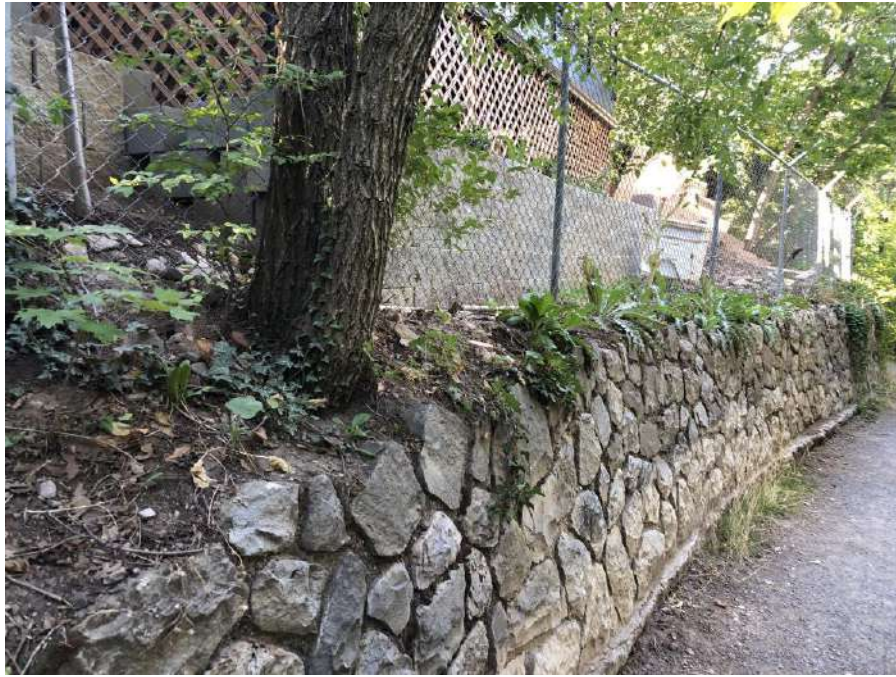
Photo #13 – Example of neighboring property owners building structures above existing rock walls. Trees that occur adjacent to the wall should be removed and the structural fill should be used to backfill over the toe of the existing rock wall.

- 4- Trees growing adjacent to the top of the walls need to be removed. The tall trees that occur behind walls can create additional lateral loads and damage to the walls during a wind event. It also appears that adjacent property owners have added excavated soil from their yards to the top of the existing walls. This additional soil load increases the horizontal loads on the wall which can exceed the initial design loads the wall was engineered to retain. This additional overburden from additional soil should be removed.

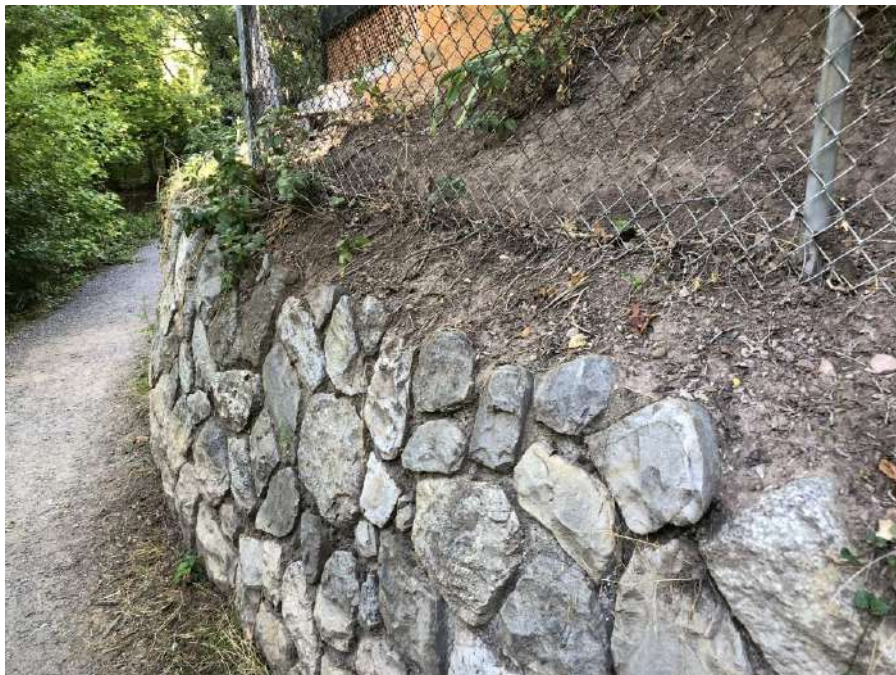
Photo #14 – additional soil has been added above the wall and should be removed

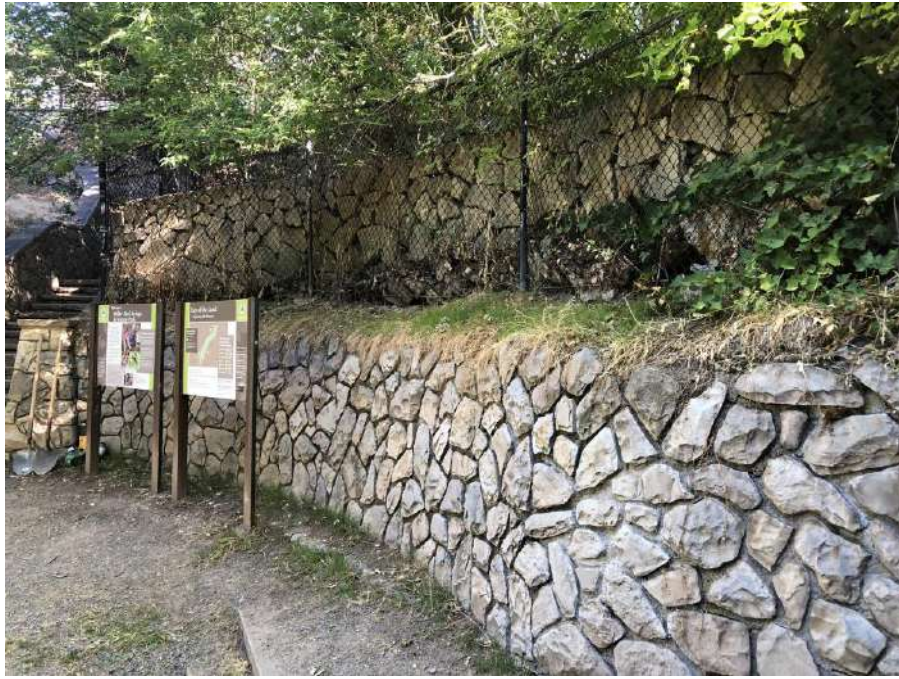
Photo #15 – There is a retaining wall built above the original rock wall that has large rocks caught in the fence. This wall is an example of neighbors building structures above the existing walls and creating additional loads on the existing structure.

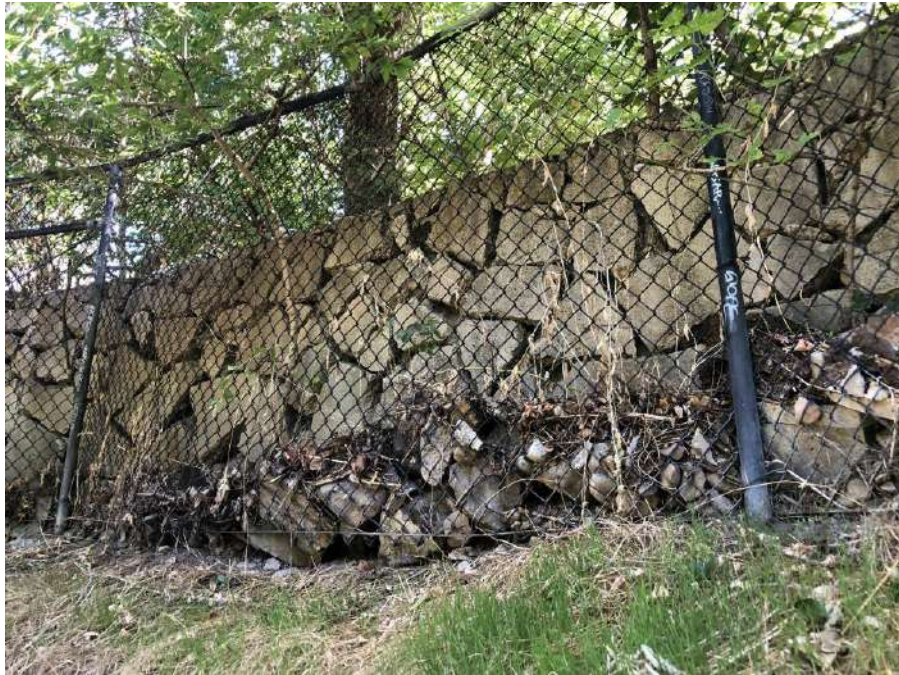
Photo #16 – There is a retaining wall built above the original rock wall that has large rocks caught in the fence. This wall is an example of neighbors building structures above the existing walls and creating additional loads on the existing structure.

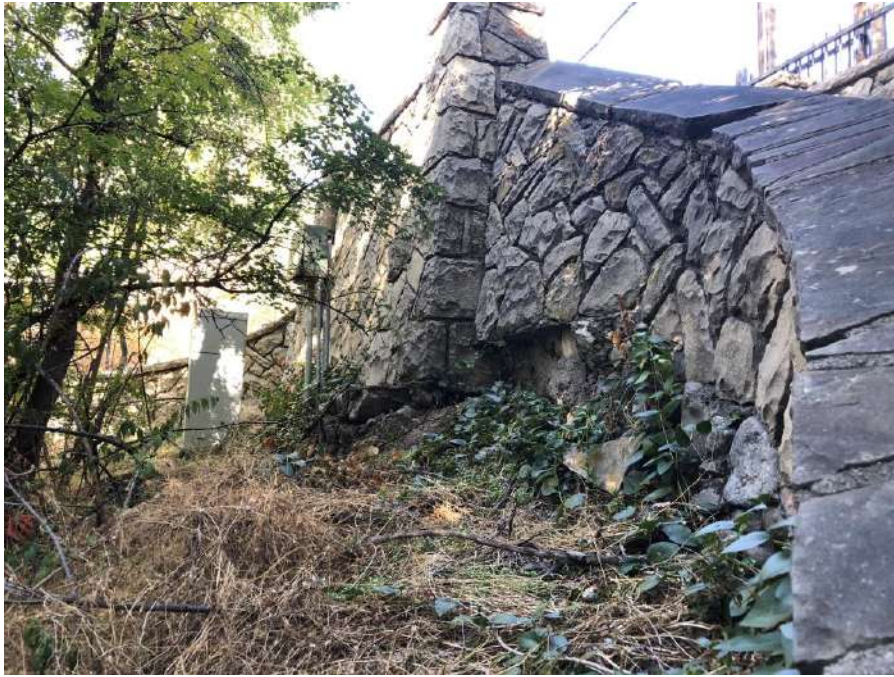
Photo #17 – The existing wall is being undermined and the toe needs to be covered with structural fill.
