October 10, 2019

Subject: Retaining Wall and Slope Stability Assessment
Miller Park Path
900 South and Red Butte Creek
Salt Lake City, Utah
Project No. 1190653

Applied Geotechnical Engineering Consultants, Inc. was requested to conduct a geotechnical engineering assessment of retaining walls and slope stability concerns at the Miller Park Path at 900 South and Red Butte Creek in Salt Lake City, Utah.

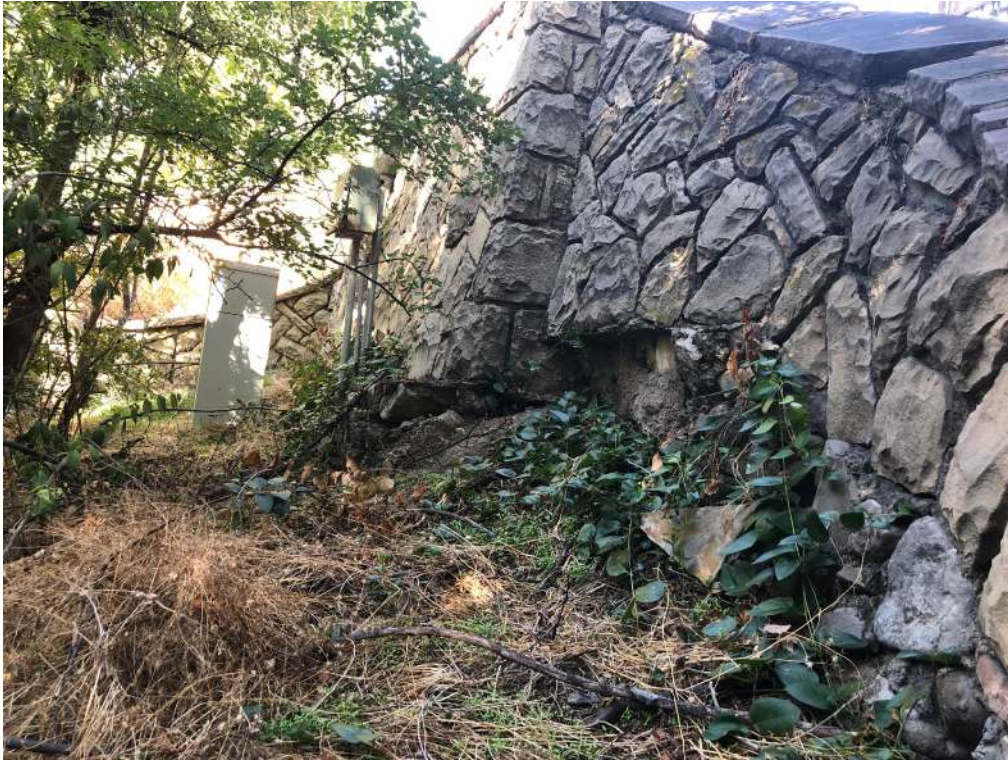
Near the entrance to the park, where the stairs extend down from 900 South, there is an area where the rock wall has been undercut (see Photograph 1). There is a lower tier of rock wall in this area that has significant cracking in the mortar between the rocks (see Photograph 2).

Photograph 1 - Undercut wall near the north park entrance at 900 South.

2. Crib walls in poor condition could be replaced with new crib walls, gabions, mechanically stabilized retaining systems or other systems.
3. Consideration may be given to replacing the soil cover at the base of undercut rock walls. This would likely be in conjunction with improving the retaining systems (such as crib walls) on the downhill side of the trail.

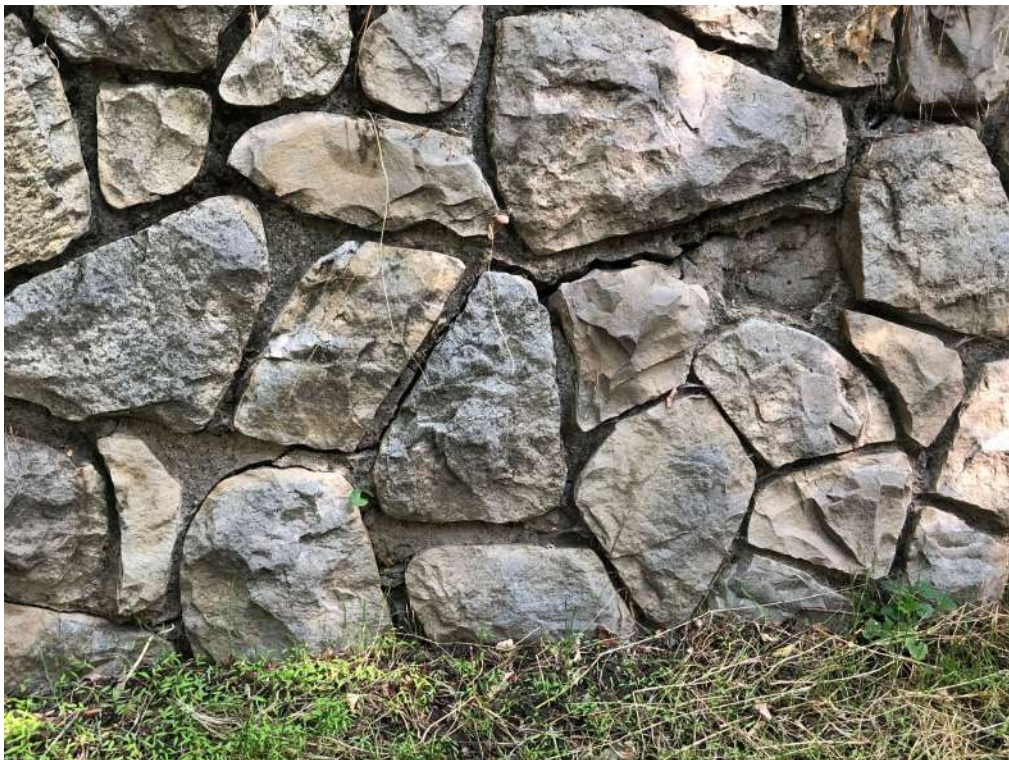
Photograph 2 - Cracks in lower-tier wall near north park entrance at 900 South.

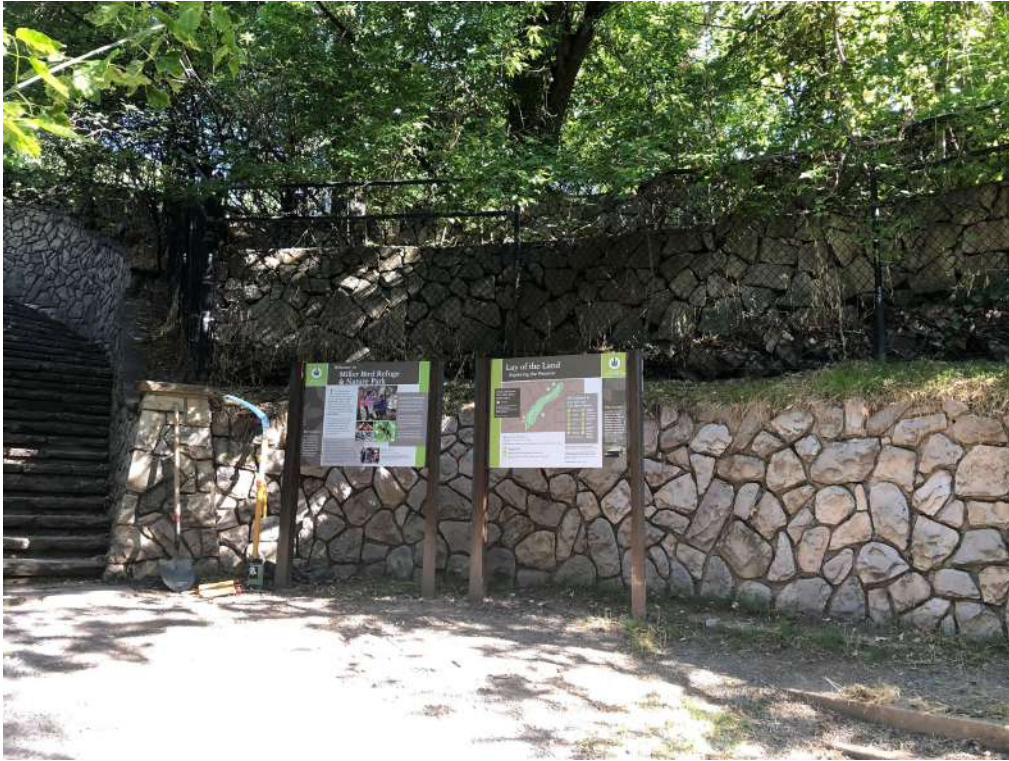
There is a retained slope constructed with broken pieces of concrete slab above the rock wall in this area that appears to have added significant load near the top of the rock wall (see Photographs 3 and 4).

Photograph 3 - Retained slope constructed above the top of the rock wall.

4. The stability of retaining walls may have been reduced where structures have been placed or grade has been raised near the top of the retaining walls. Consideration may be given to evaluating the effect of the structures and increased grade for these walls.

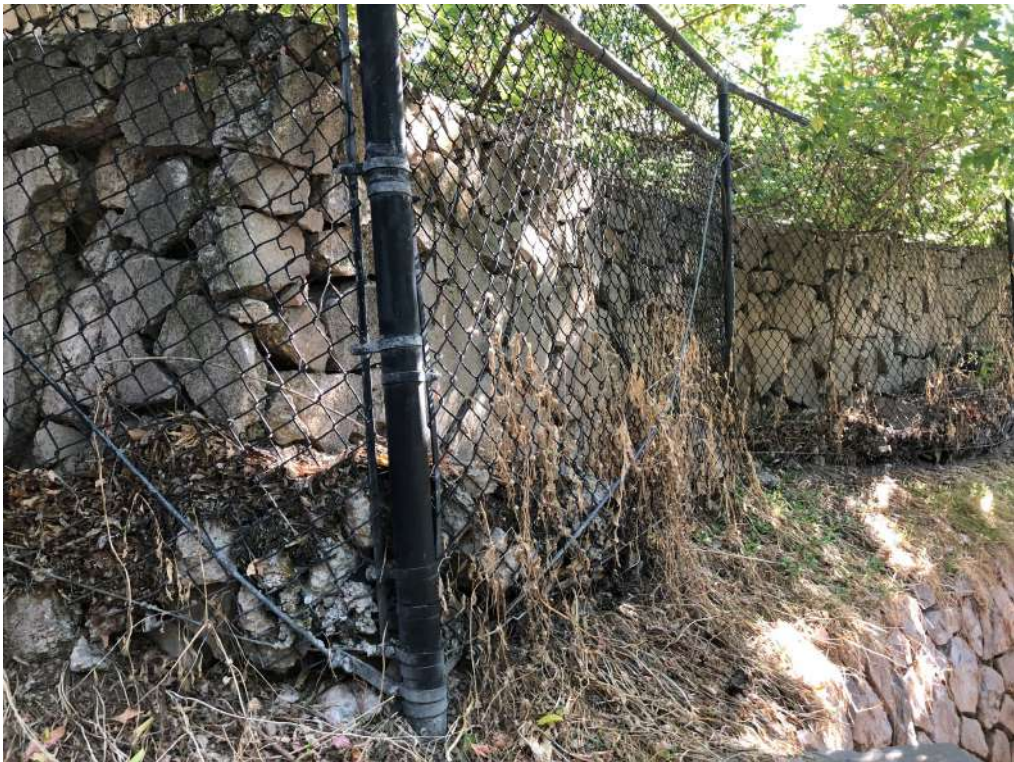
Photograph 4 - Retained slope constructed above the top of the rock wall.

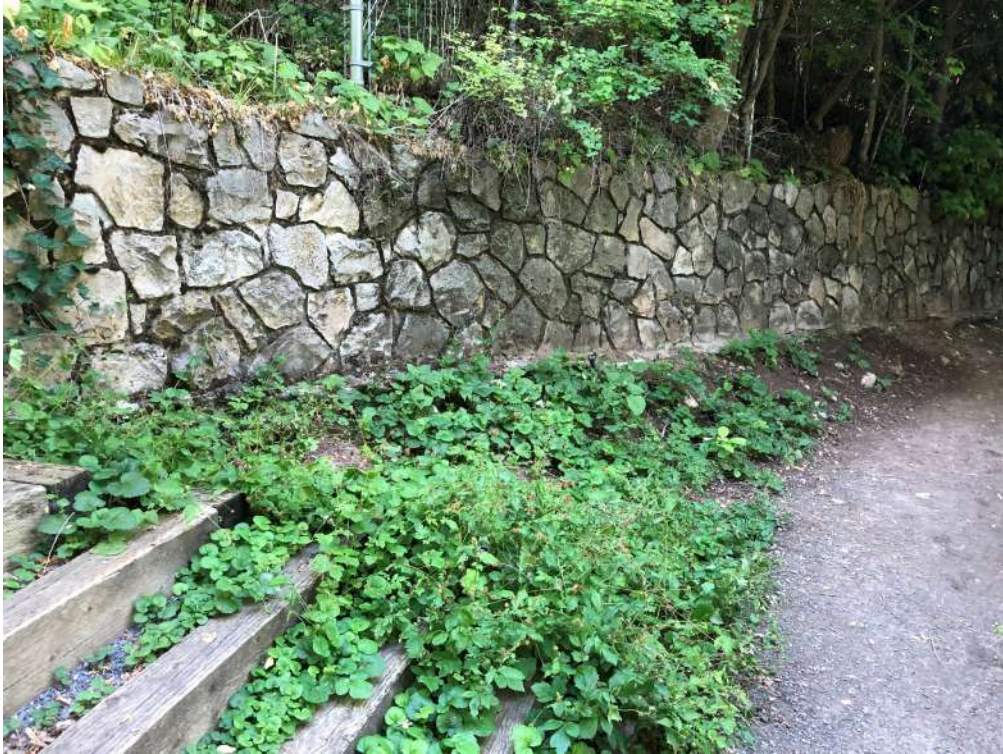
An amphitheater was constructed during recent improvements at the park utilizing timbers to retain the soil (see Photograph 5). The ground beyond the toe of the rock wall adjacent to the south side of the amphitheater has been lowered. This lowering of the ground reduces the stability of the rock wall.

Photograph 5 - Ground below the rock wall has been lowered.

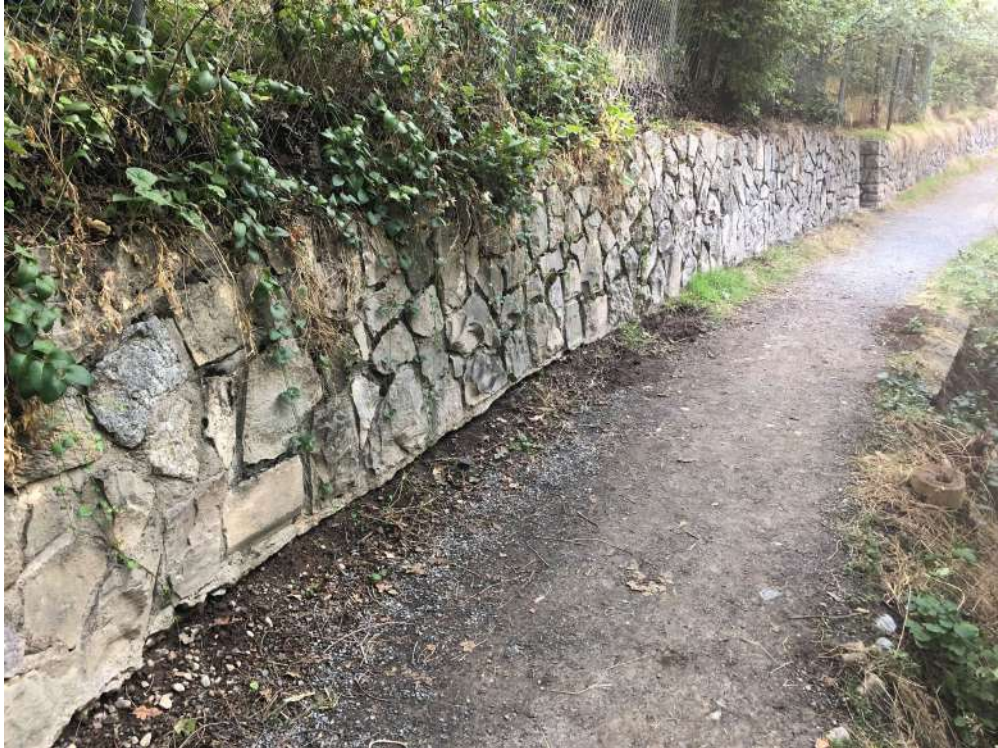
There are areas where it appears that soil has been removed at the base of the rock wall (see Photograph 6).

Photograph 6 - Ground at toe of wall appears lower than base rock.

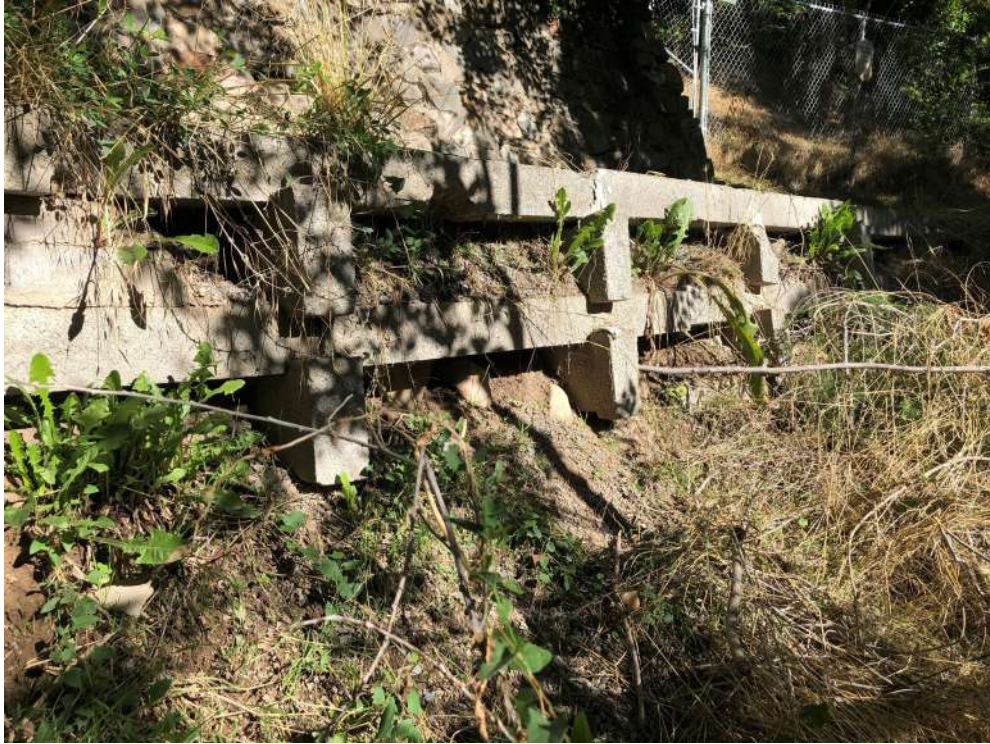
There are several areas of crib wall on the downhill side of the trail along the west side of the creek. The crib wall is in relatively poor condition where soil appears to have eroded from the crib wall and undercut the wall (see Photograph 7).

Photograph 7 - Crib wall on west side of creek has experienced erosion and undercutting.

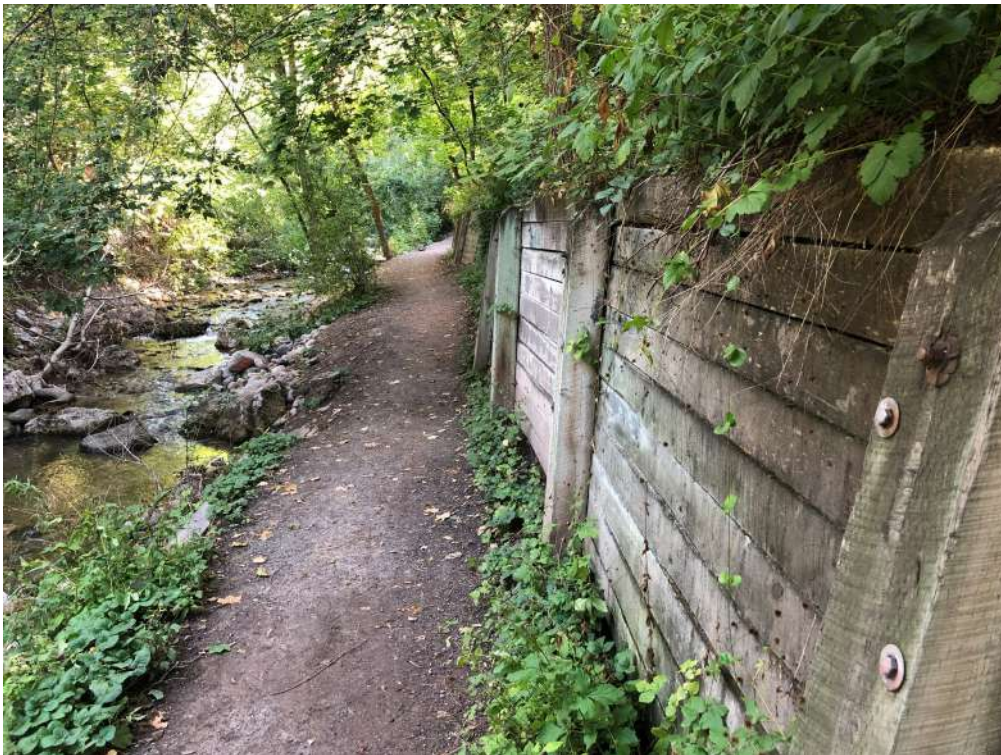
There is a timber retaining wall that appears to have soil anchors. A portion of this wall appears to be bulging or the top has rotated out away from the slope (see Photograph 8 and 10). Soil is exposed below the lowest timber lagging.

Photograph 8 - Timber wall section appears to have rotated away from slope.

6. Consideration should be given to further evaluation of the timber wall in the area where it appears to be rotating or bulging (see Photographs 8 and 10). Additional retaining systems on the toe side of this wall could be considered to buttress the wall and raise the grade of the trail below the wall. This is also an area where there are crib walls that should be considered for replacement on the creek-side of the trail.
7. The area at the north end of the park, adjacent the stairway from 900 South where the rock wall has been undercut (see Photograph 1) will be difficult to repair with the steep slope beyond the toe of the wall and the additional wall below. Soil nails or anchors with shotcrete may be a possible method of improving this area.

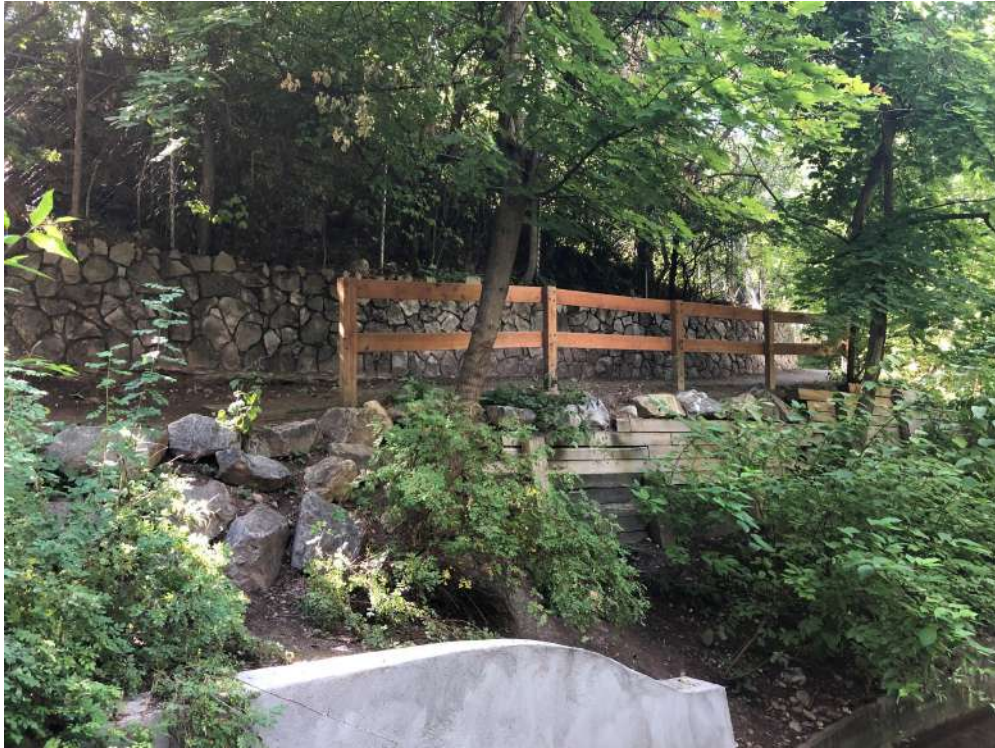
An area of the timber wall was modified near the north end of the trail on the east side. Additional height was added to the timber wall and it does not appear that additional soil anchors were provided (see Photograph 9).

Photograph 9 - Newer timbers added to the top of the older timber retaining wall.

5. We anticipate that when the timber wall was increased in height at the north end of the park, they may not have considered overall stability of the wall with the increased height (see Photograph 9). The stability of this wall should be reviewed and could be improved as needed. We anticipate that the area above this wall may be raised with additional fill to provide embedment of the rock wall above. Consideration could be given to reconstructing or improving the timber wall to facilitate the increased height.

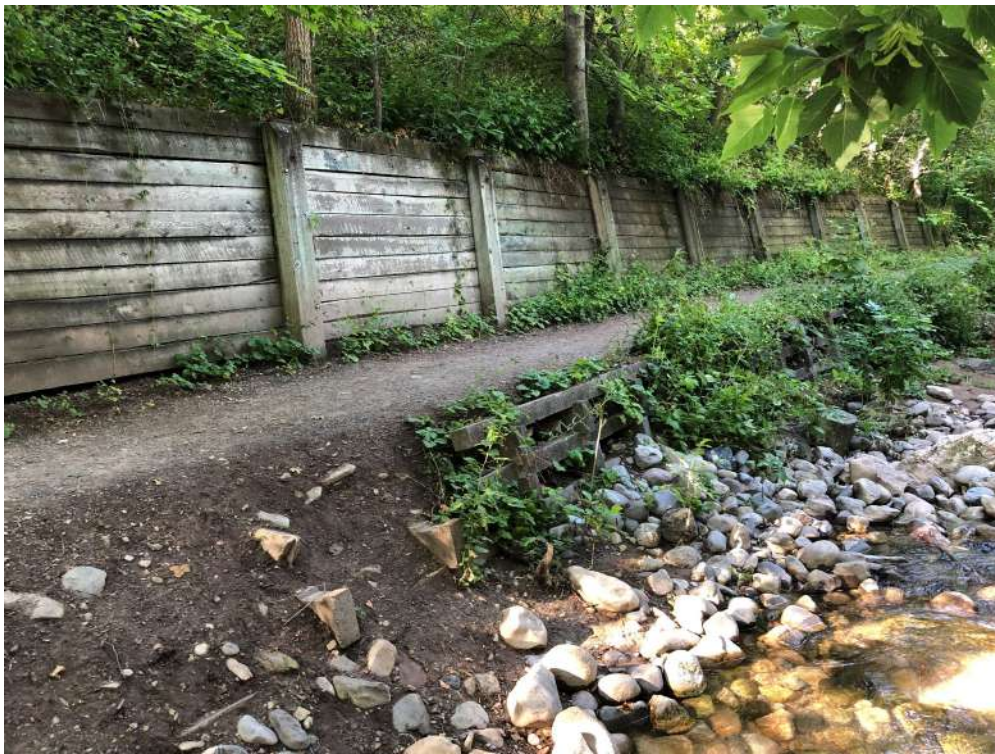
There are areas of crib wall on the downhill side of the trail along the east side of the creek. Like the crib walls on the west side, these walls appear to be in poor condition where soil has eroded from the crib wall units (see Photograph 10).

Photograph 10 - Crib wall on east side in poor condition. Timber wall above appears bulging or rotating.

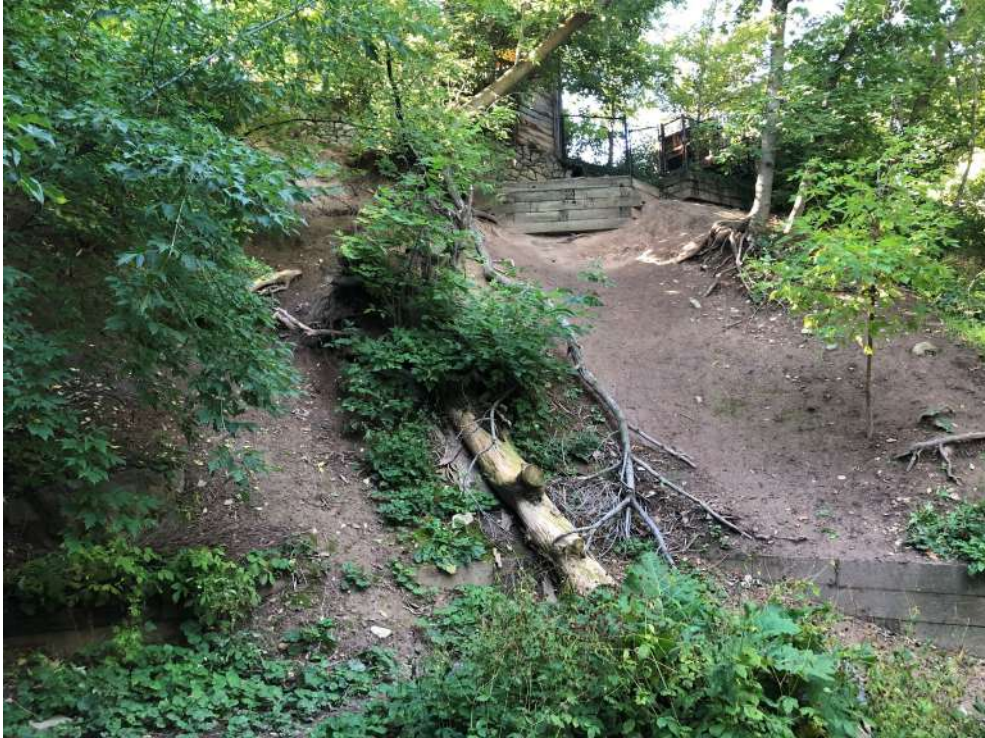
There are localized areas of significant erosion adjacent the rock wall on the east side of the creek (see Photograph 11). The rock wall in the area of this photograph can be seen near the top of the photograph, above the area of erosion. Photograph 12 is taken above this area and shows the rock wall with trees and structures near the top of the wall.

Photograph 11 - Area of erosion above the trail on the east side of the creek. The rock wall is seen near the top of the photo, above the area of erosion.

1. Erosion protection measures could be considered for areas that are experiencing erosion problems. Such measures could include regrading and/or providing additional retaining structures to flatten exposed slopes and control runoff, revegetation, eliminating access to slopes, providing erosion control mats or other measures.

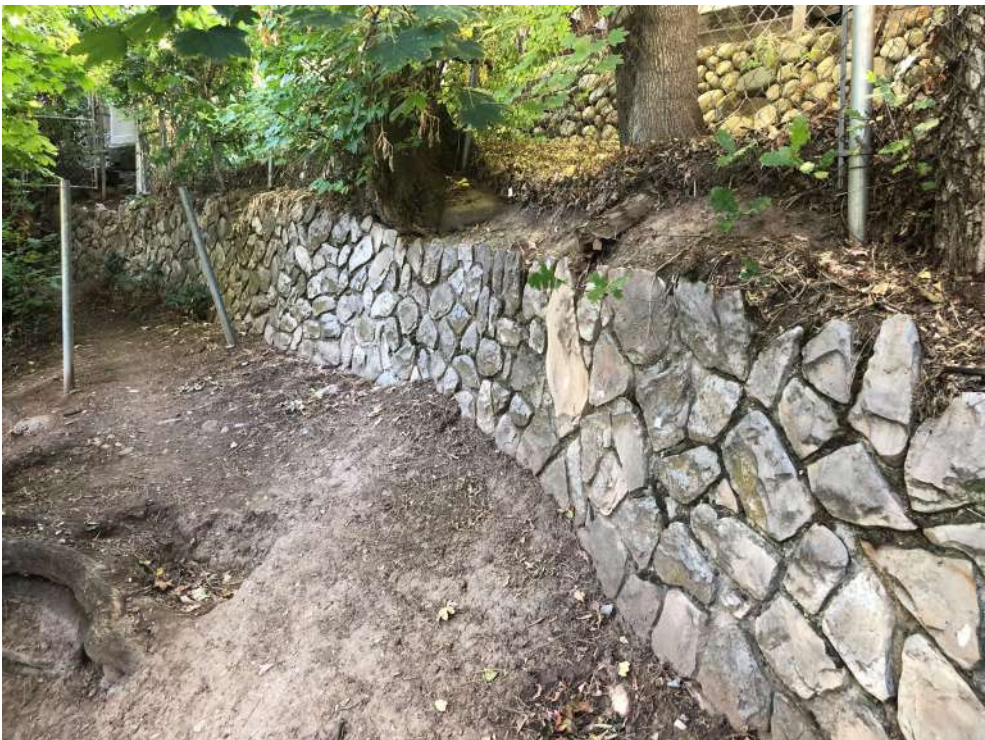
Photograph 12 - Rock wall above the area of erosion. Note trees and other loads near the top of the wall.

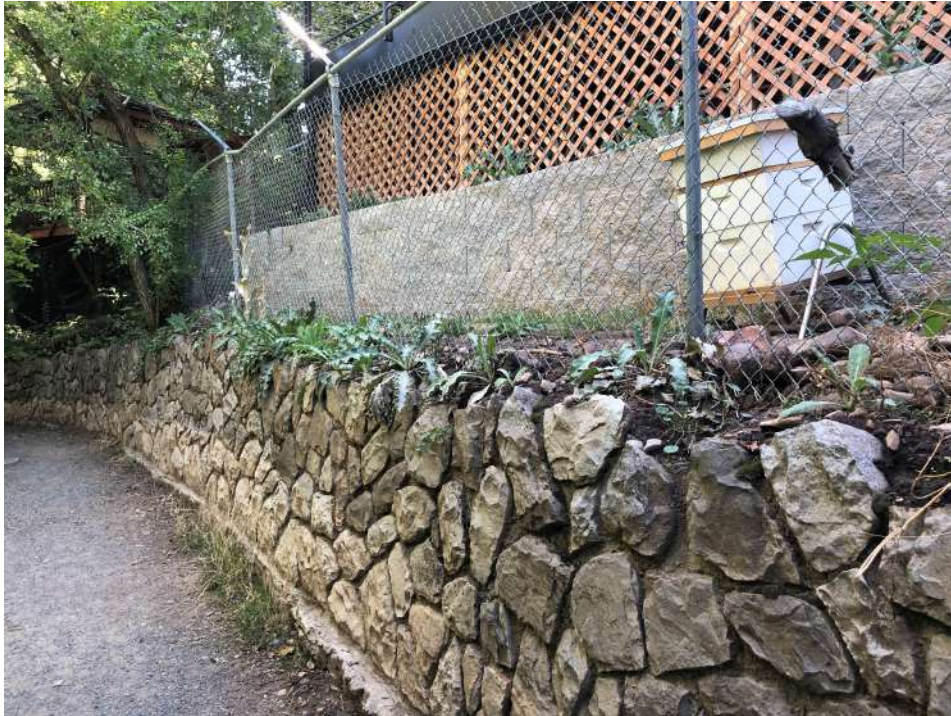
Structures have been placed near the top of the rock wall on the east side of the creek (see Photographs 13 to 15). Photograph 13 shows an area where the rock wall foundation has been exposed.

Photograph 13 - Area on the east side of creek where structures have been placed near the top of the wall. Also shown wall foundation exposed at the toe.

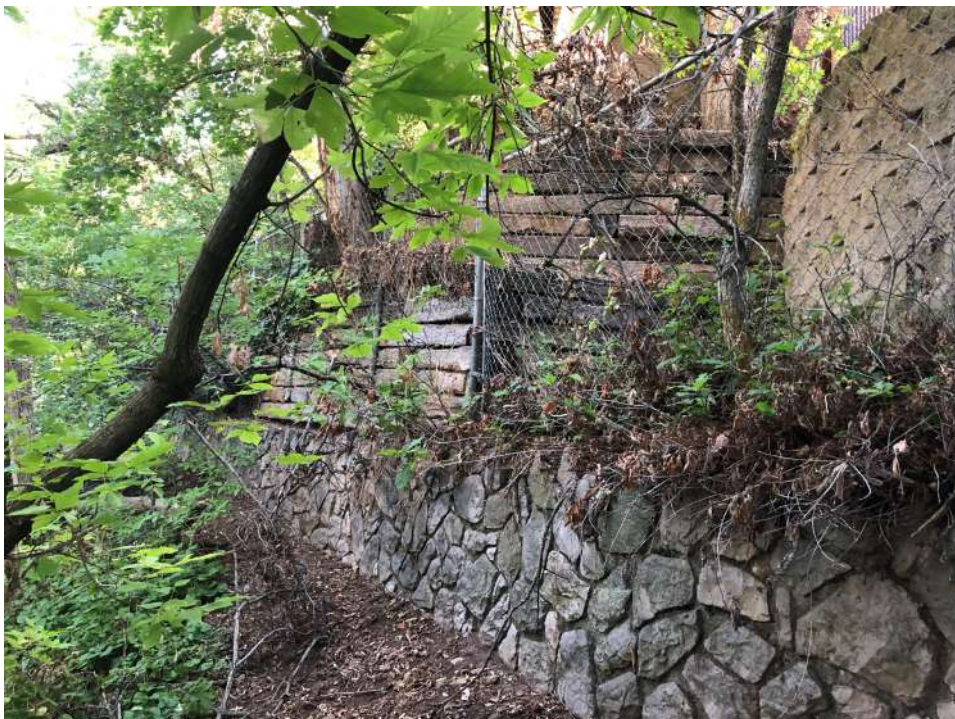
Photograph 14 - Structures encroaching near the top of the rock wall on the east side of the creek.

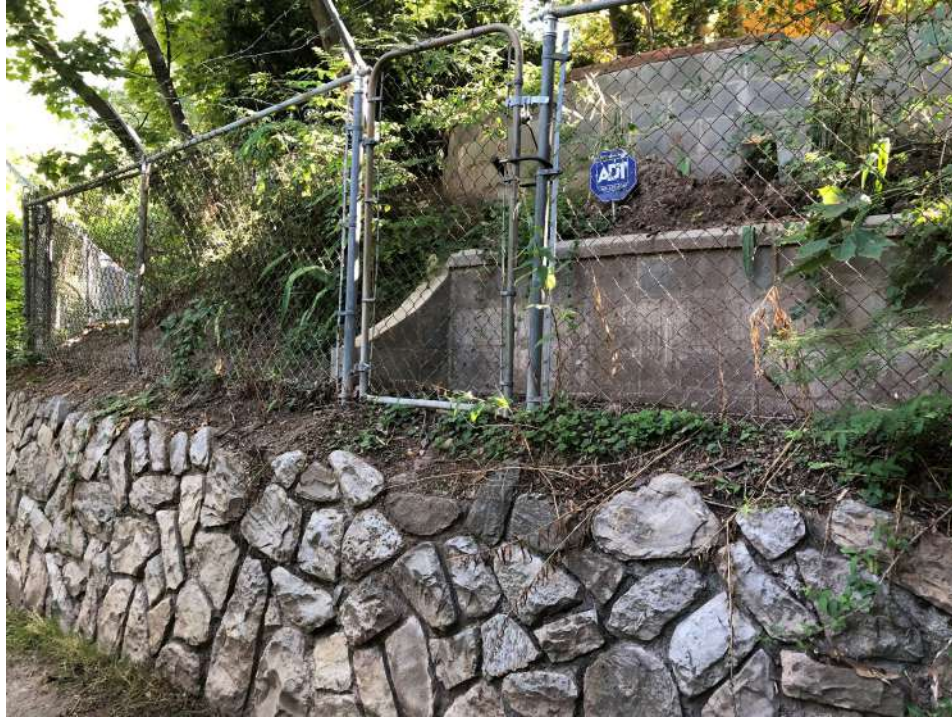
Photograph 15 - Structures encroaching near the tip of the rock wall on the east side of the creek.
