# HISTORIC LANDMARK COMMISSION

## STAFF REPORT

**Trudell/Thompson Window Replacement  
PLNHLC2010-00057  
249 South 1100 East  
May 5, 2010**

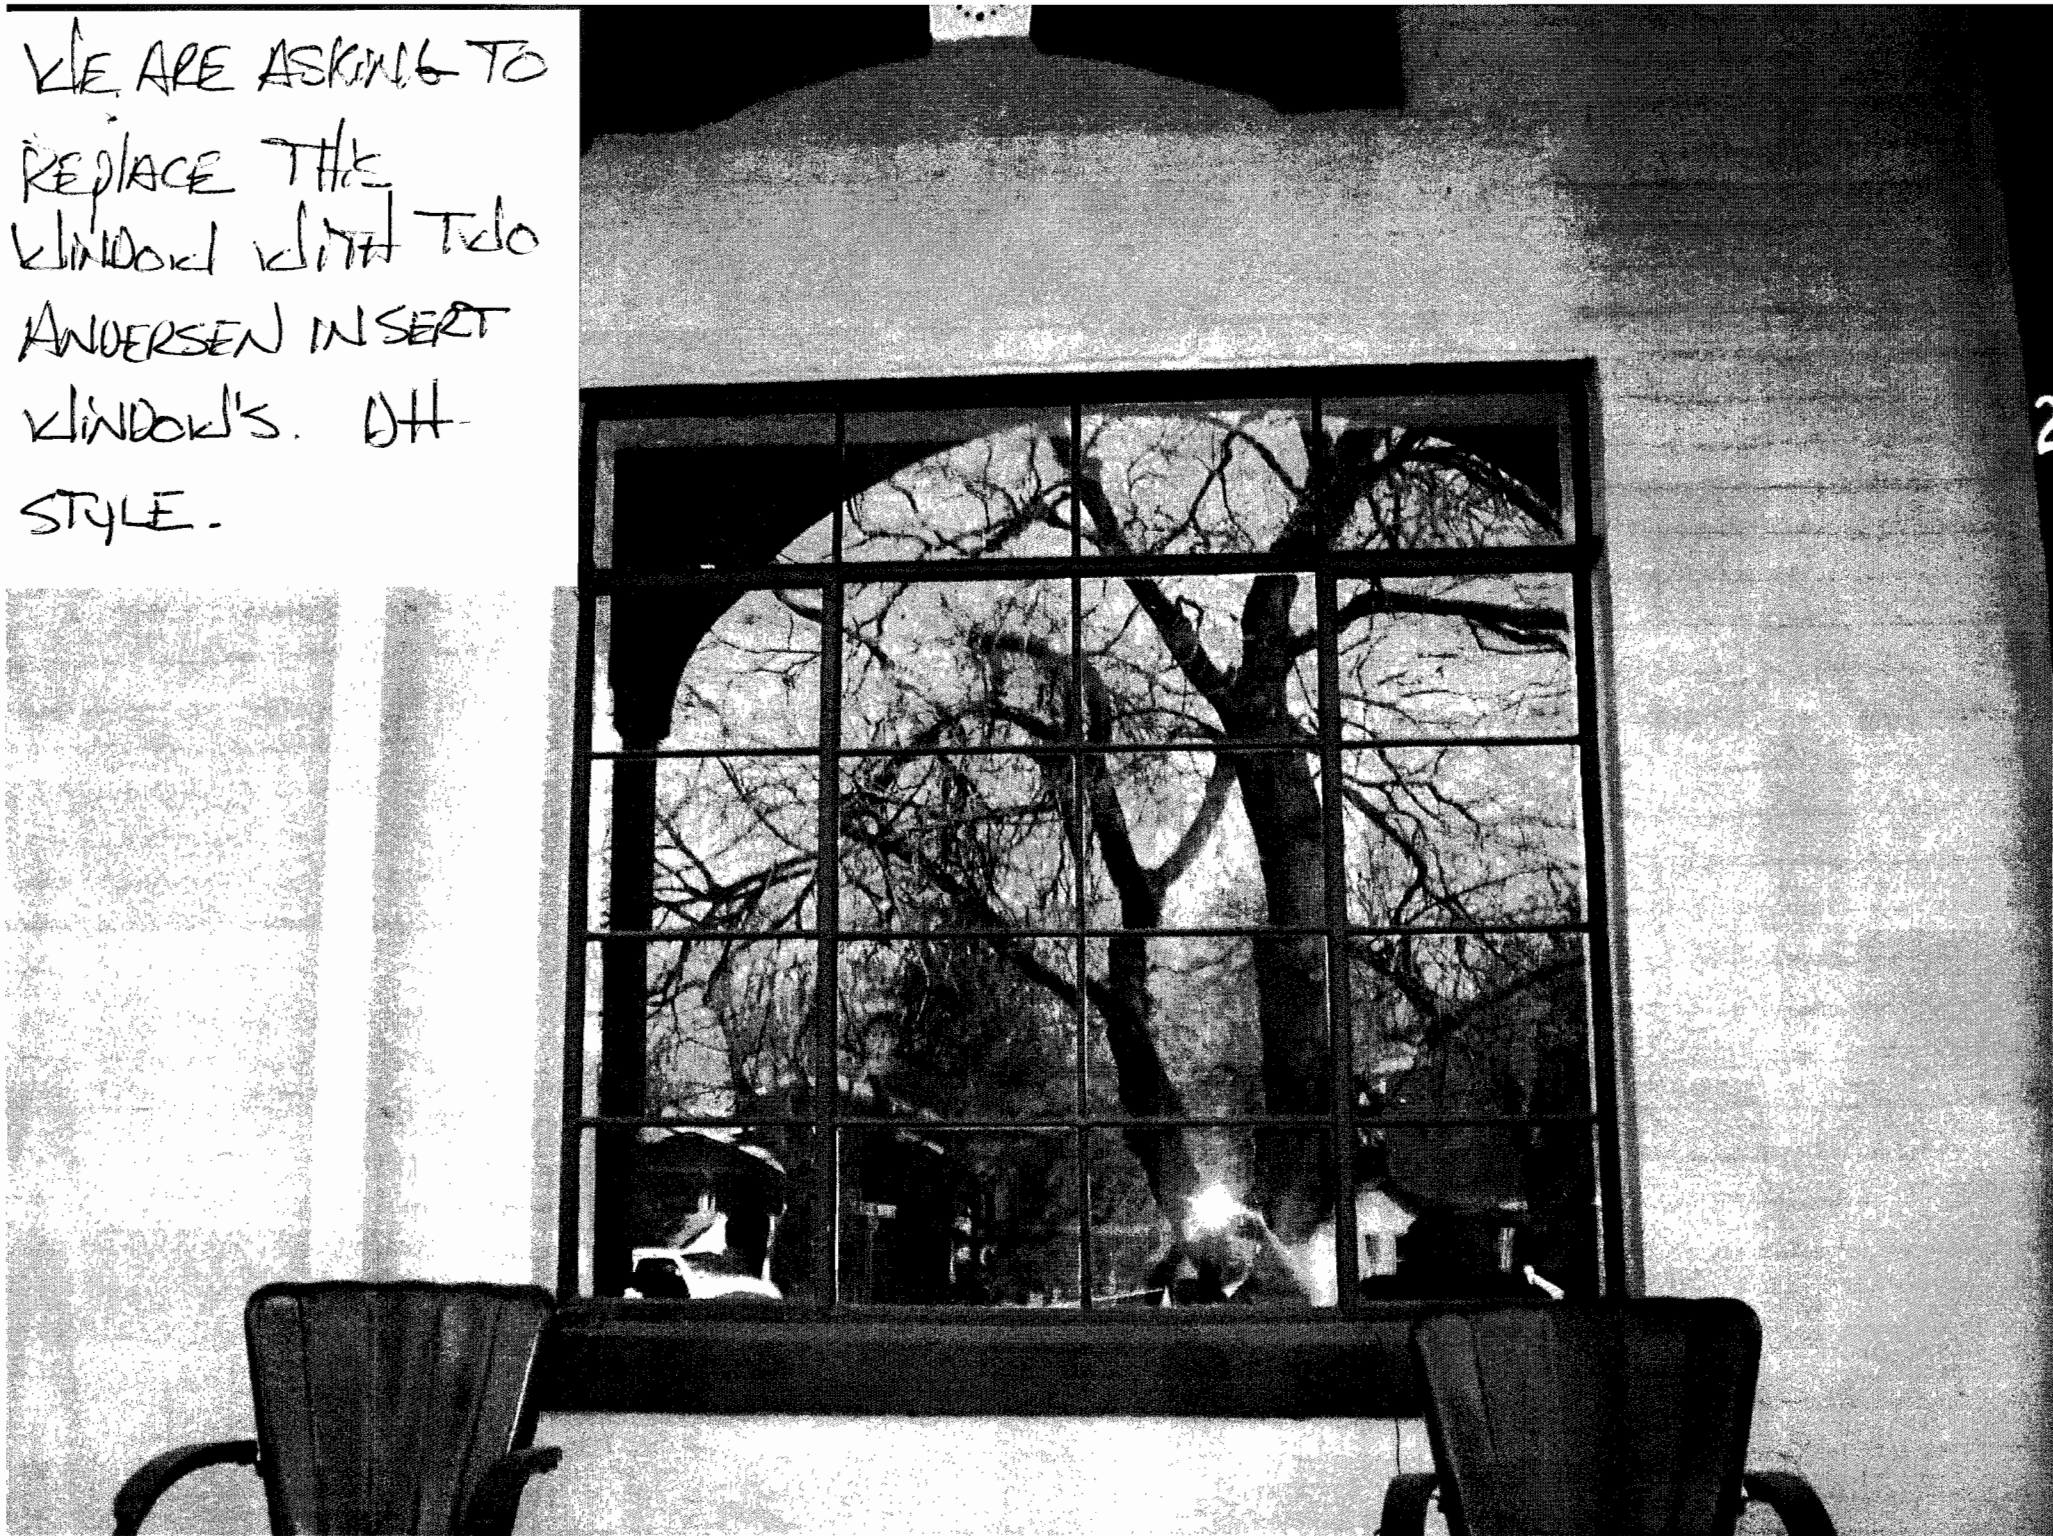
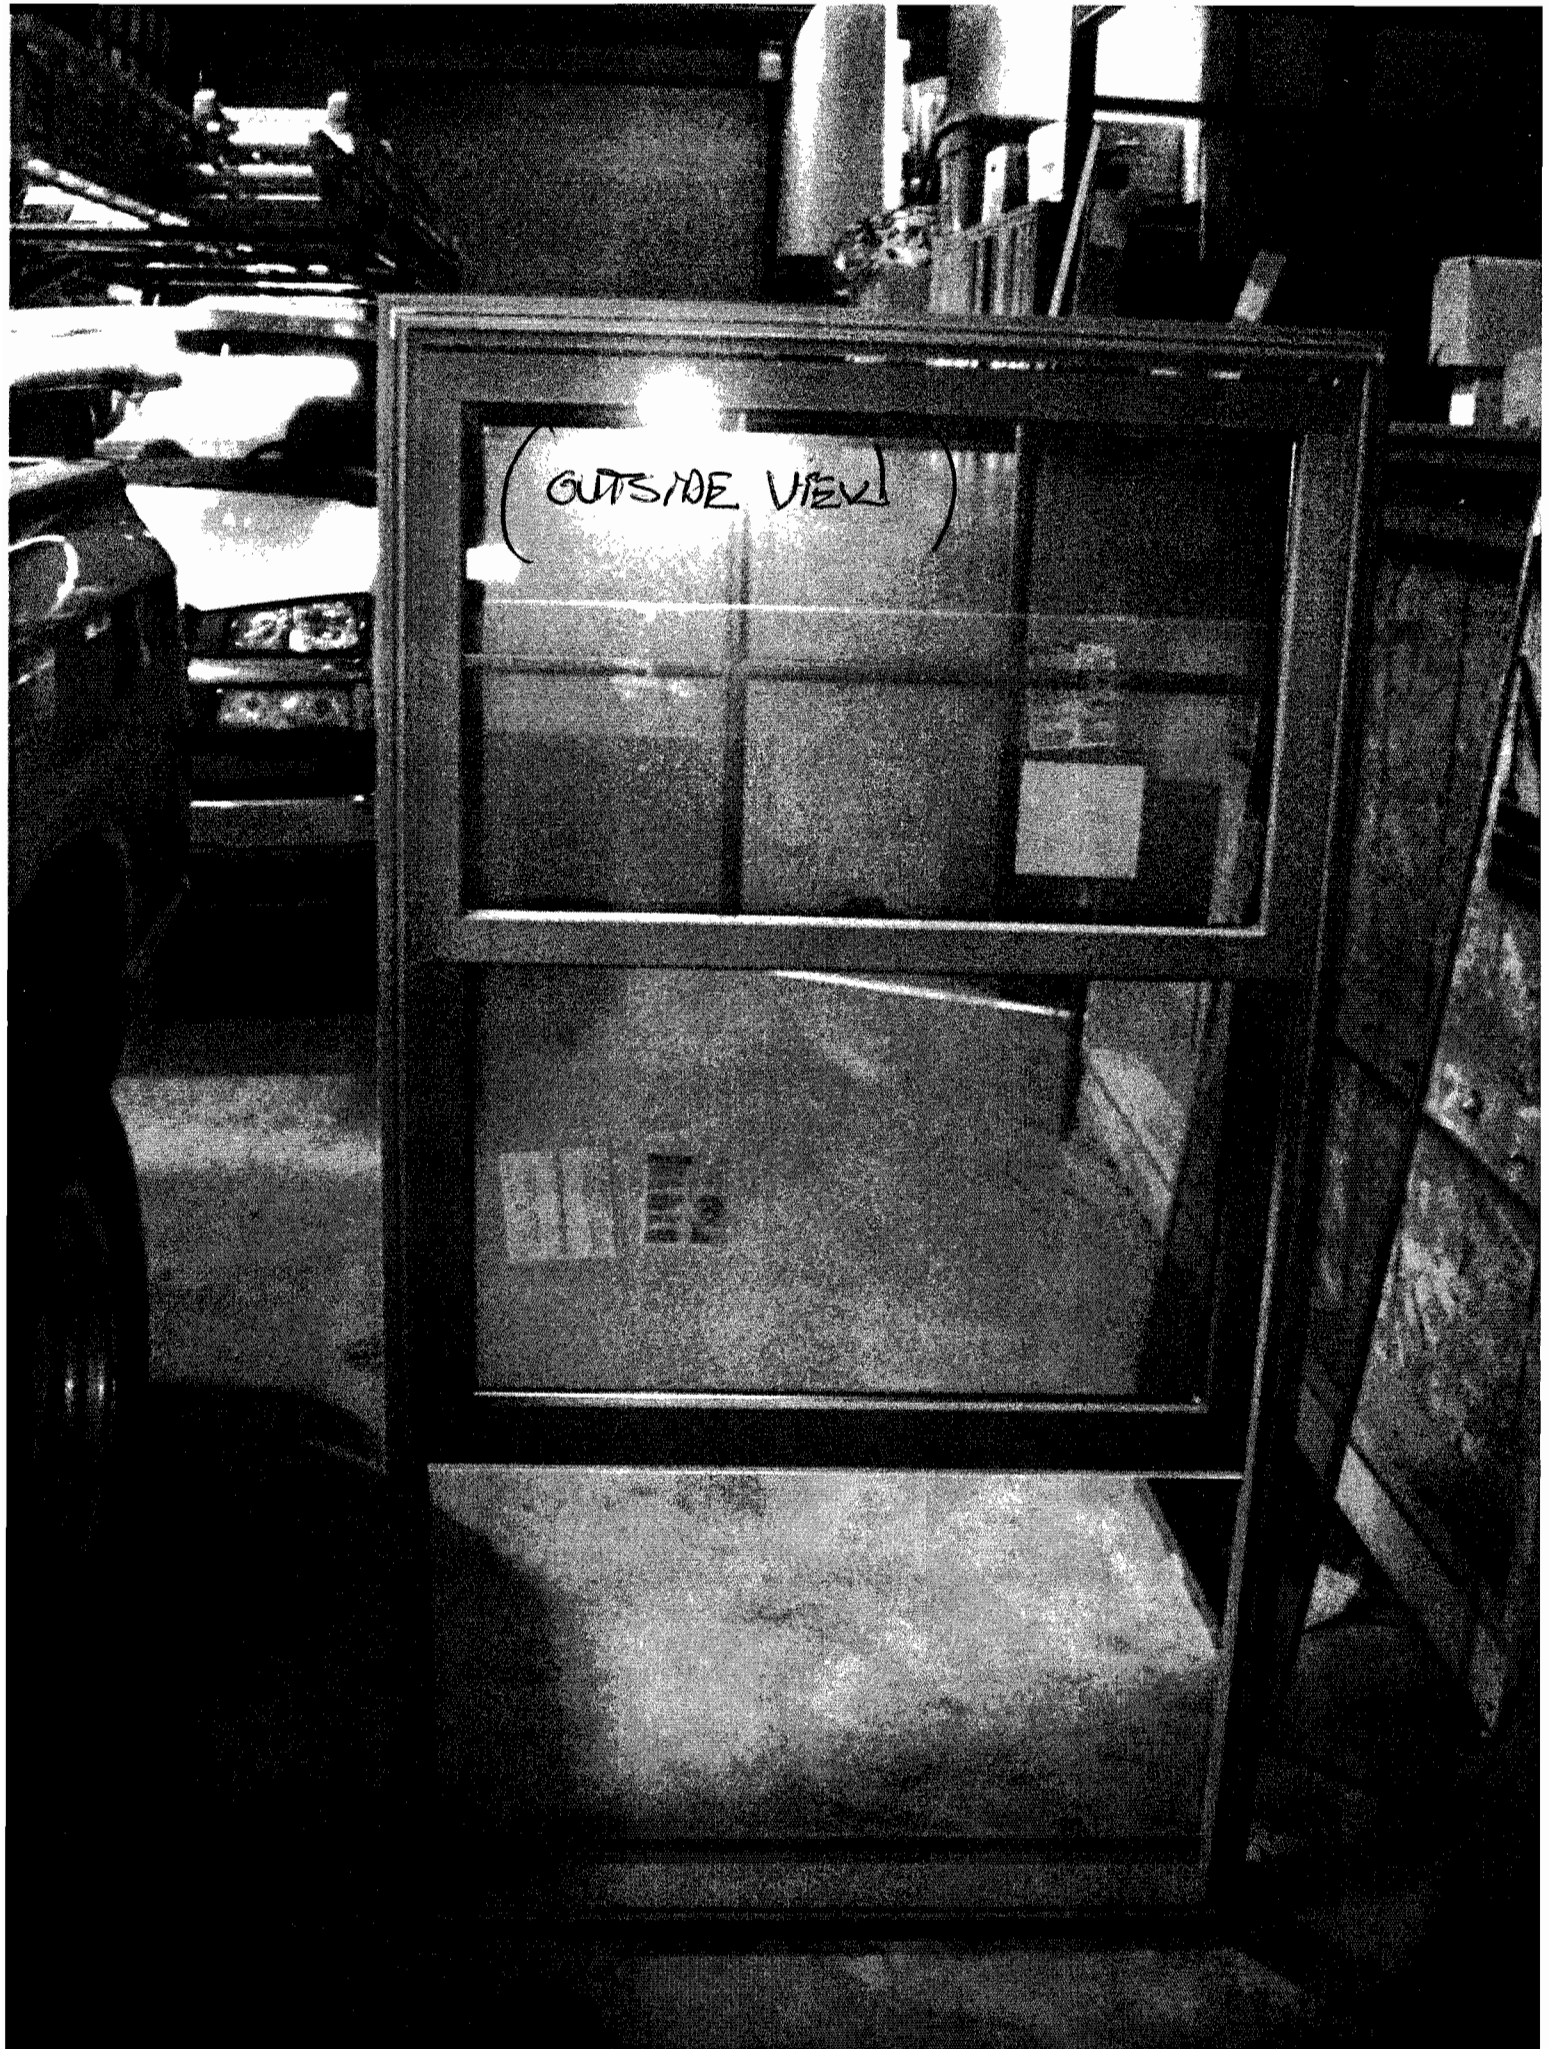
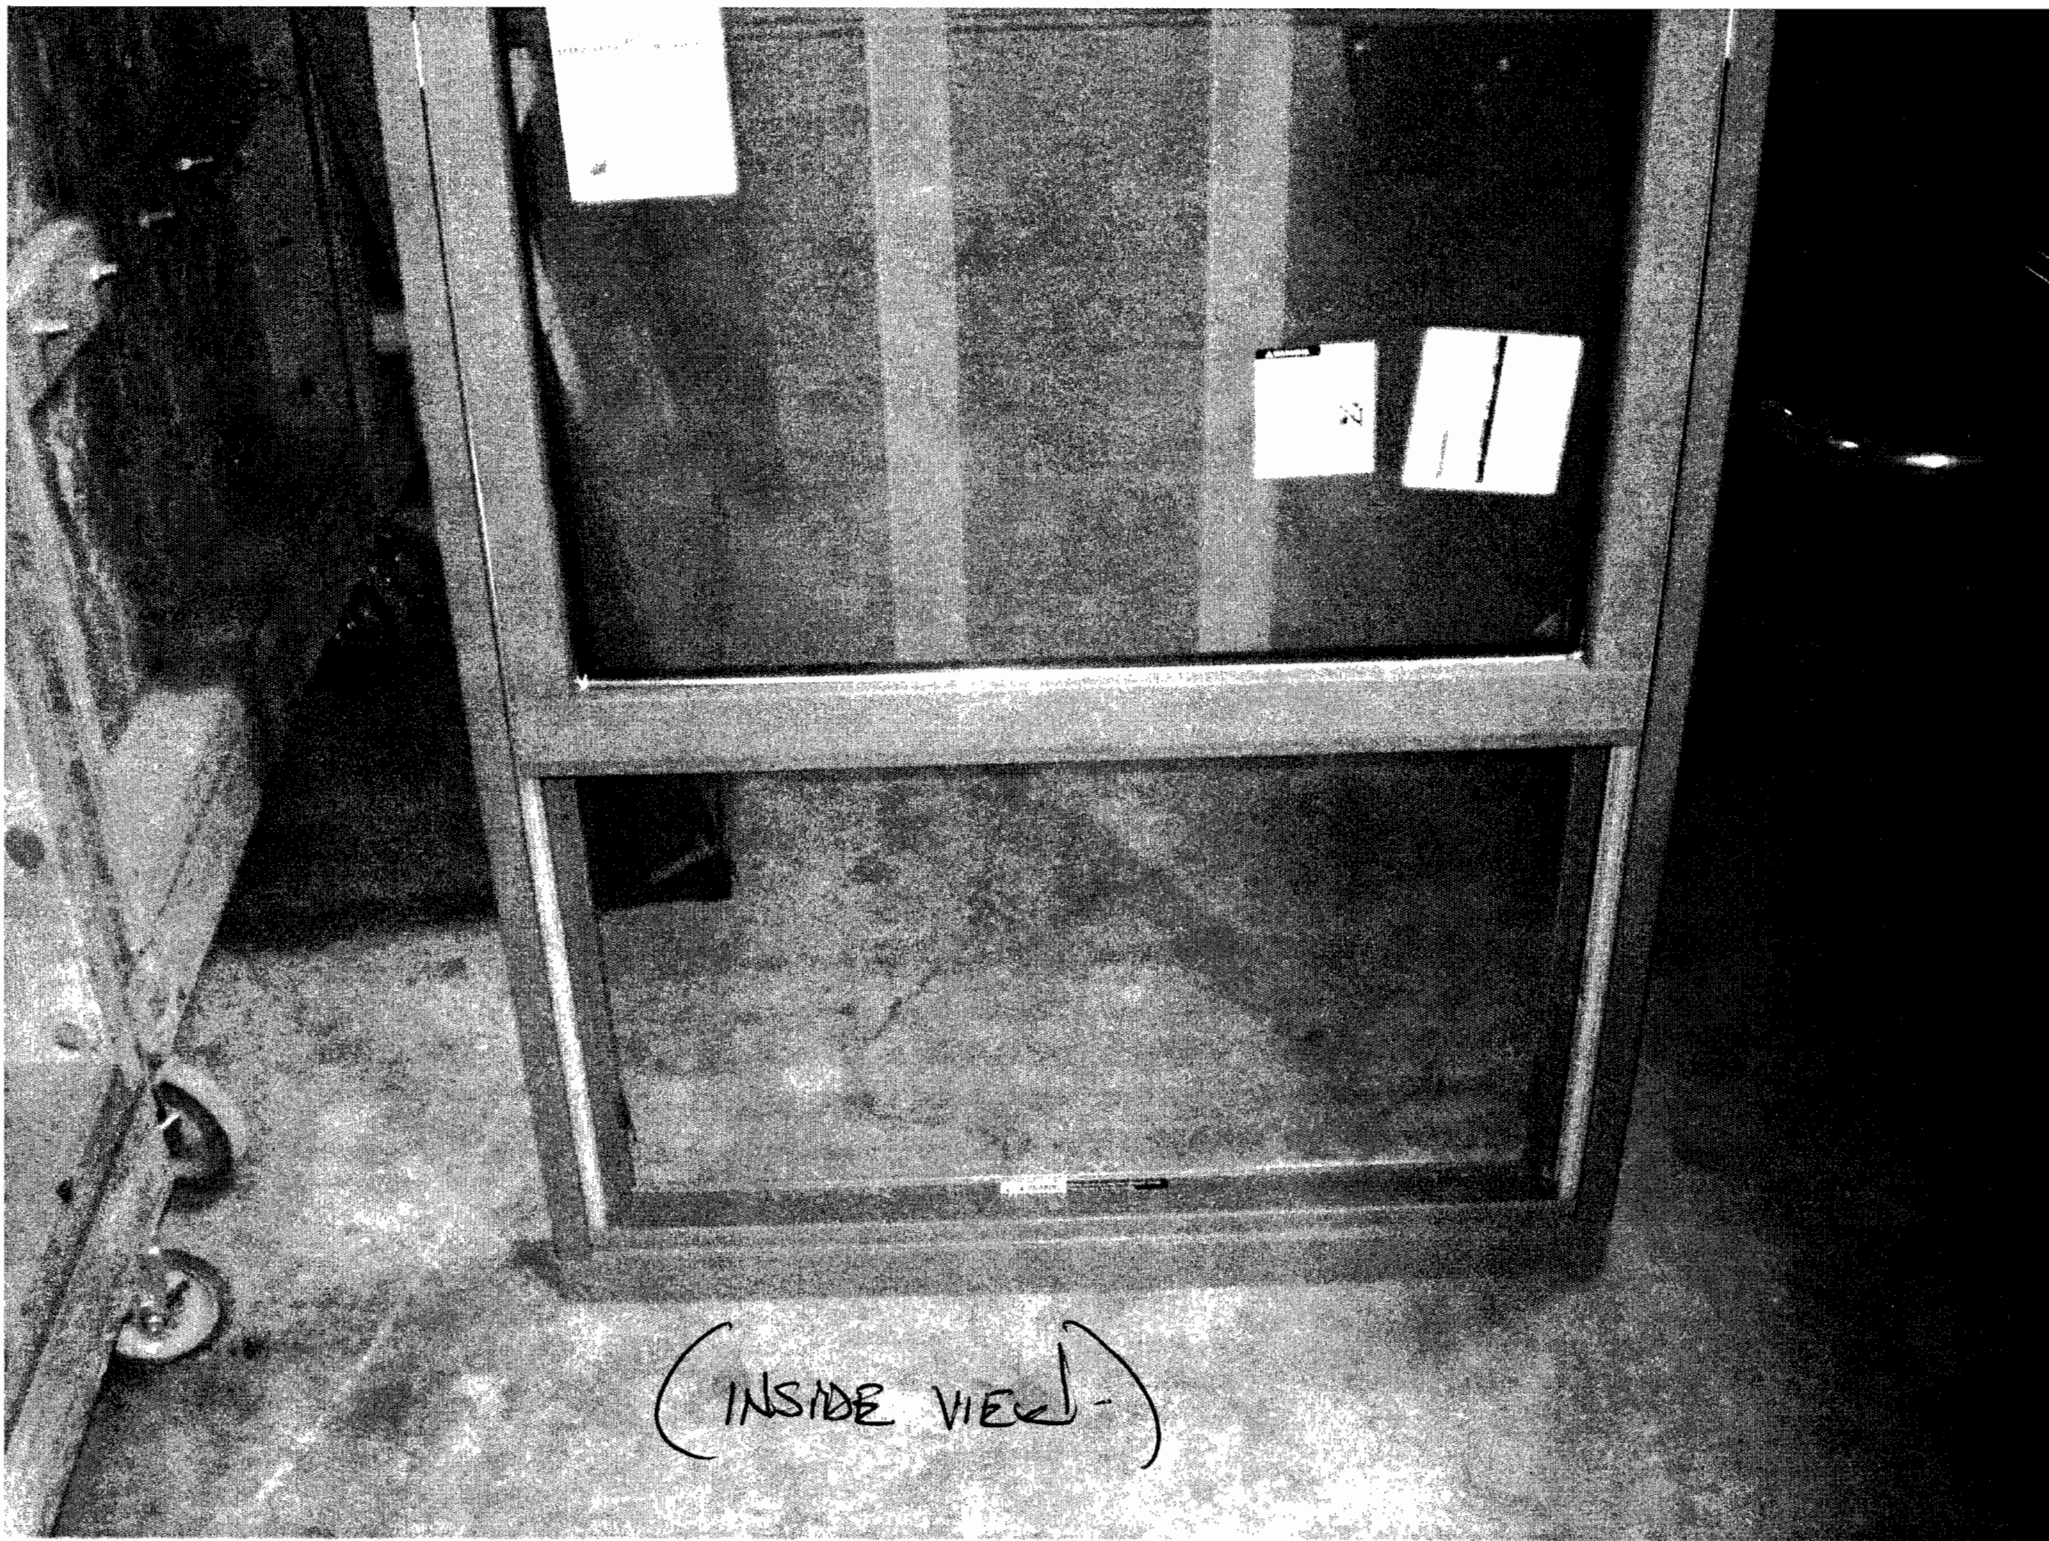
**Exhibit C –  
Photos – Front Facade**

Planning Staff's main concern with the proposed side-by-side double-hung windows is that there is no significant mullion feature separating the windows. Essentially, the proposed windows are separated by the width of the window frames. Typically, a more substantial mullion would separate side-by-side windows of this nature. Further, a window grid pattern is not evident on any of the historic photos that Planning Staff has been able to obtain. An internal grid (sandwiched between the double panes of glass) has been installed on the upper-level front façade windows. Planning Staff asserts that a grid pattern is not consistent with the historic characteristics of the windows that were in this home in 1936. Therefore, the grids should be removed from the newly replaced windows, and should not be included in any further replacement windows. To Planning Staff's knowledge, internal grid patterns are never appropriate for windows on the primary façade (and perhaps secondary or rear facades) for structures in the City's historic districts, nor have they ever been approved.

WE ARE ASKING TO  
REPLACE THE  
WINDOW WITH TWO  
ANDERSEN INSERT  
WINDOW'S. DH-  
STYLE.

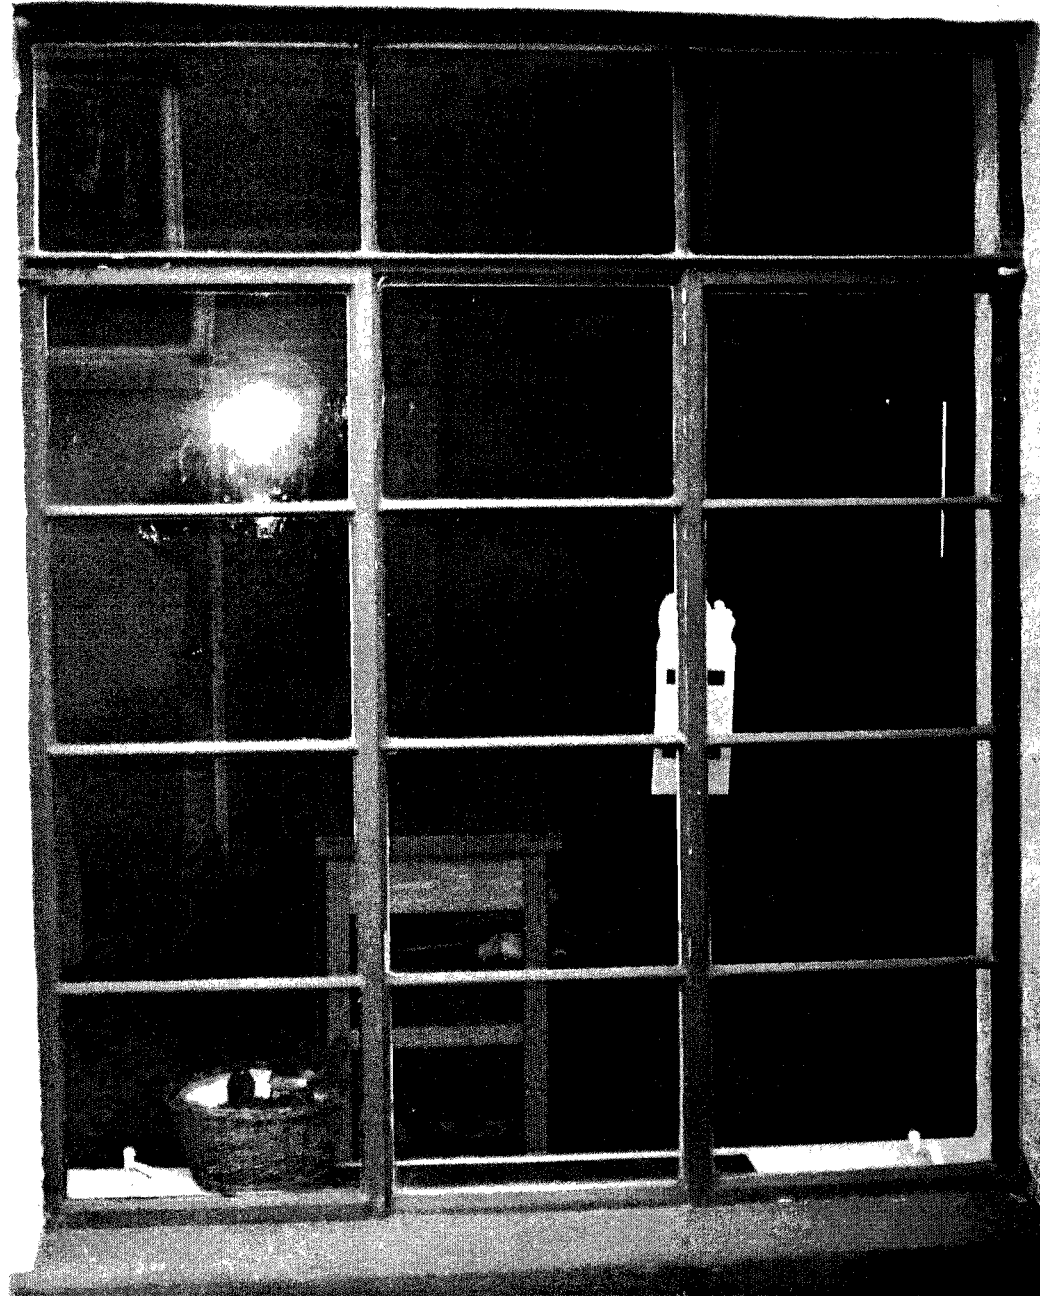
NORTH FAÇADE  
WINDOW

The proposed picture window on the north façade of the home does not honor the historic character of the property (Exhibit D). Instead of a picture windows in this location, Planning Staff has suggested either two side-by-side double-hung windows with a mullion, or a window with a transom. For reference, technical specifications for Anderson Picture Windows are attached (Exhibit H).

The proposed picture window on the north façade does not meet criteria 3.5, as it is highly unlikely that the original window in this location was a picture window. It is more likely that the window was of the single or double-hung variety, hence Planning Staff's suggestion that this type of window be used in this location.

WE ARE ASKING  
TO REPLACE THIS  
WINDOW WITH AN  
ANDERSEN PICTURE  
WINDOW.  
(INSERT)

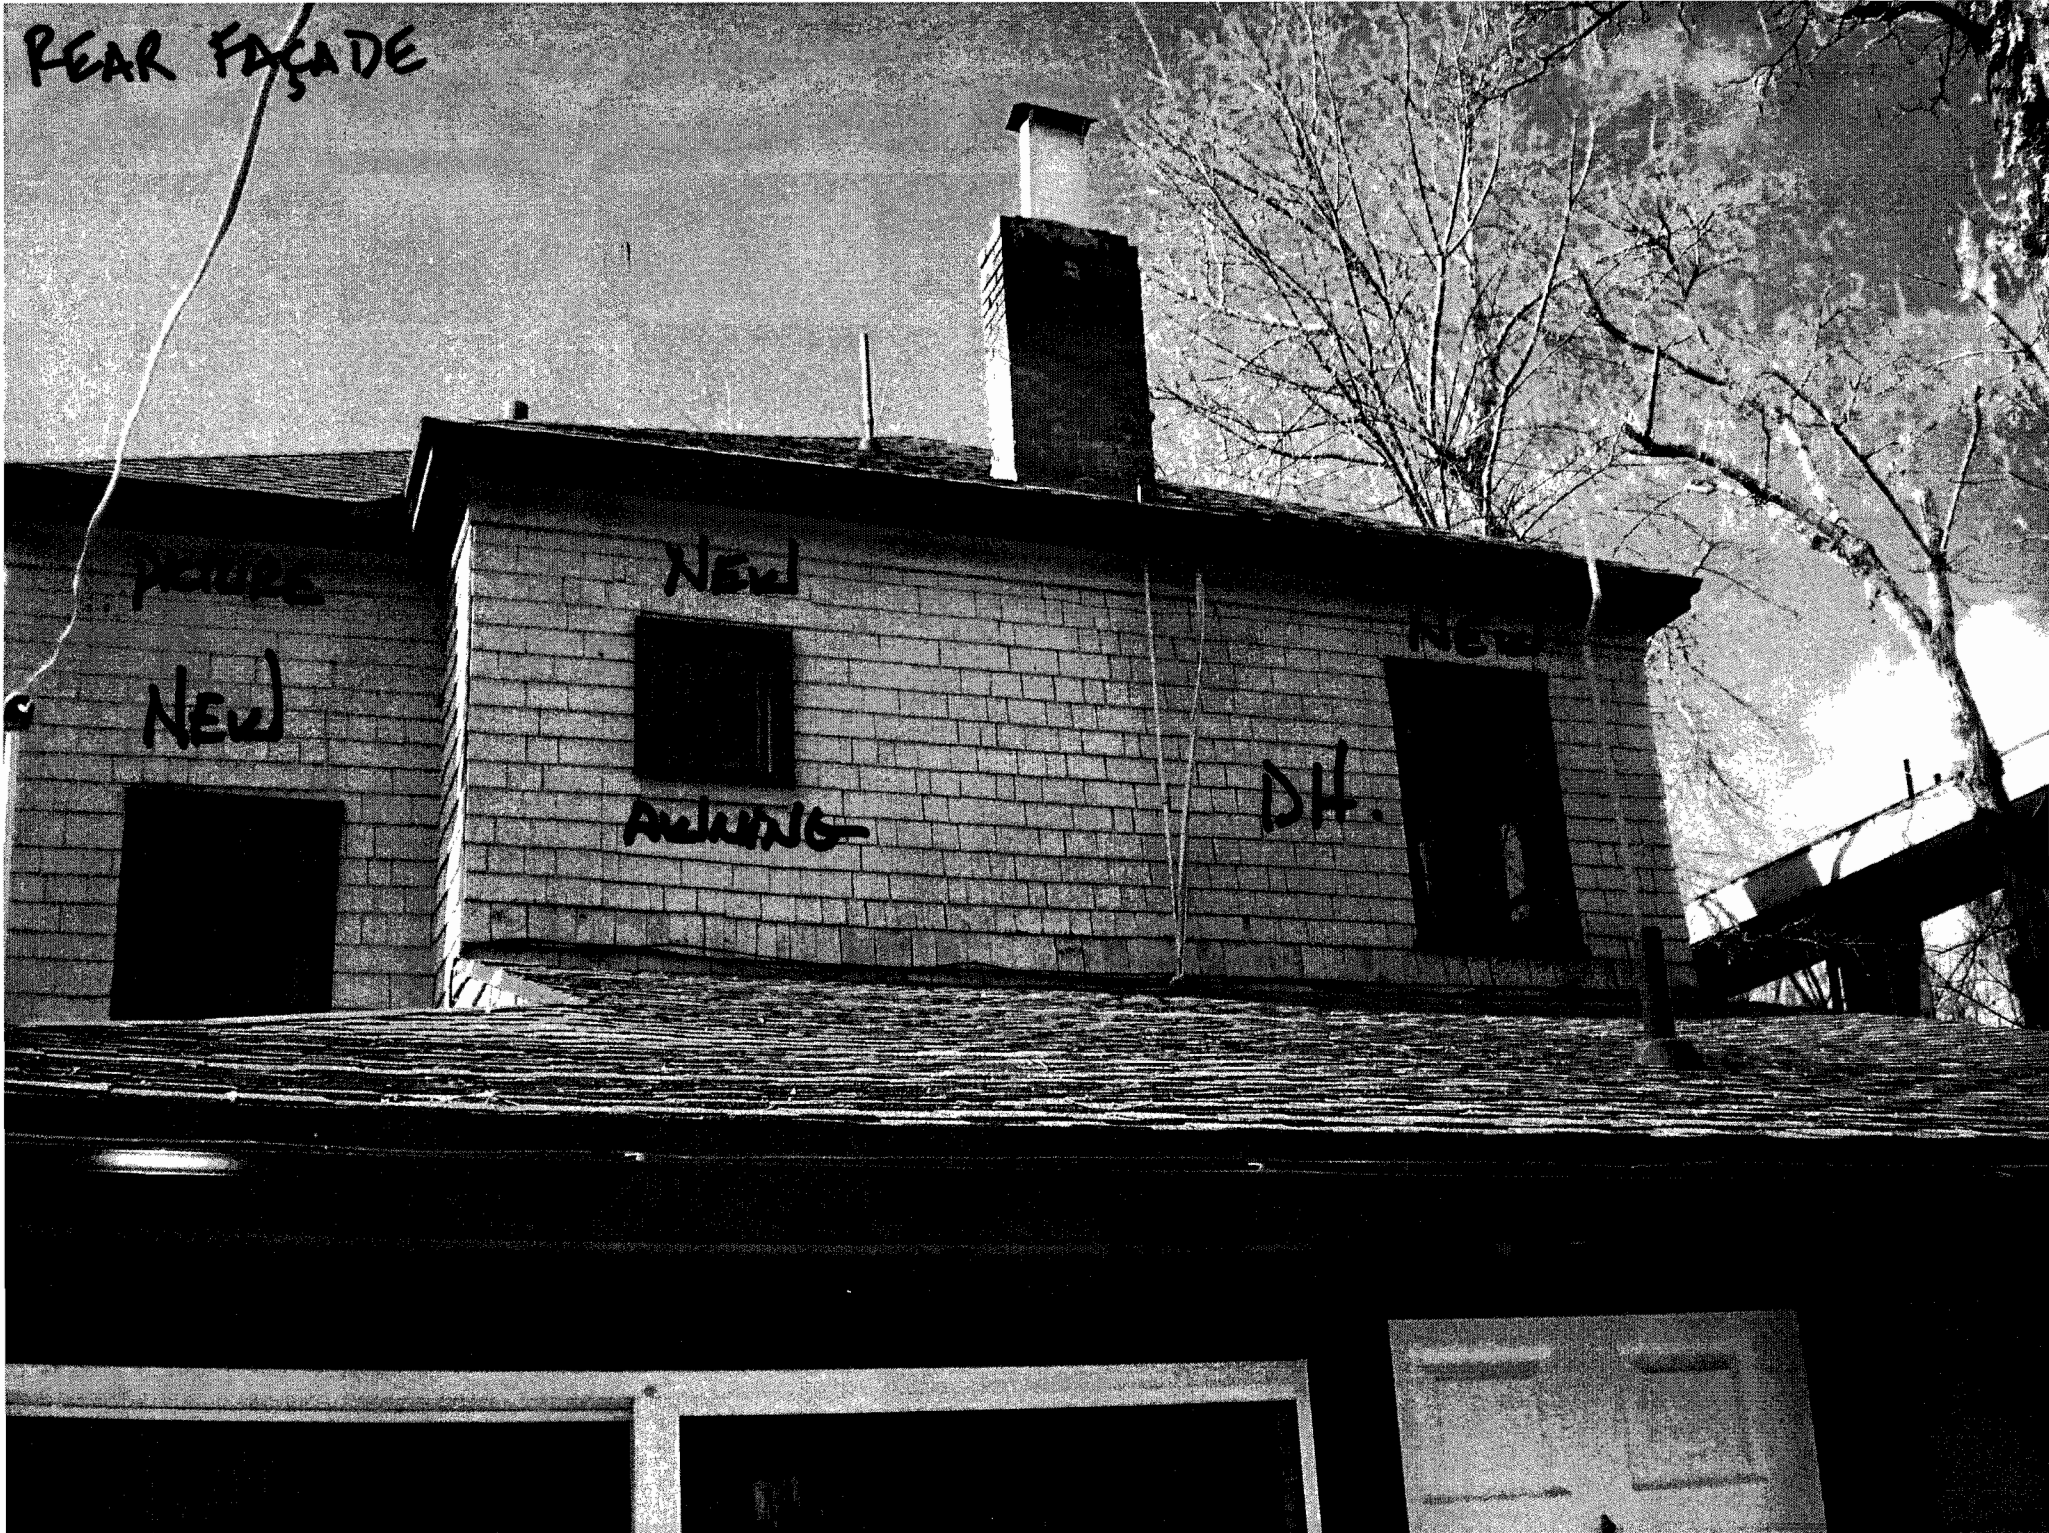
REAR FACADE

The windows that were recently replaced on the rear of the home, in general, retain and preserve the historic character of the property (Exhibit E). The new awning window and the new double-hung window are of the same configuration as the windows shown in the attached photograph from 1980. The new picture window is inconsistent with the more characteristic single or double-hung window pattern, however since it is on the rear of the building and not visible from the street, Planning Staff asserts that this particular window is acceptable.

The windows that were installed on the upper story of the rear façade, in general, do retain the historic character of the property and therefore should be allowed to remain.

The rear façade windows in general meet these criteria as well. As previously noted, a single or double-hung window would have been a better choice for the picture window that was installed, but the picture window appropriate in this particular case because of the location.

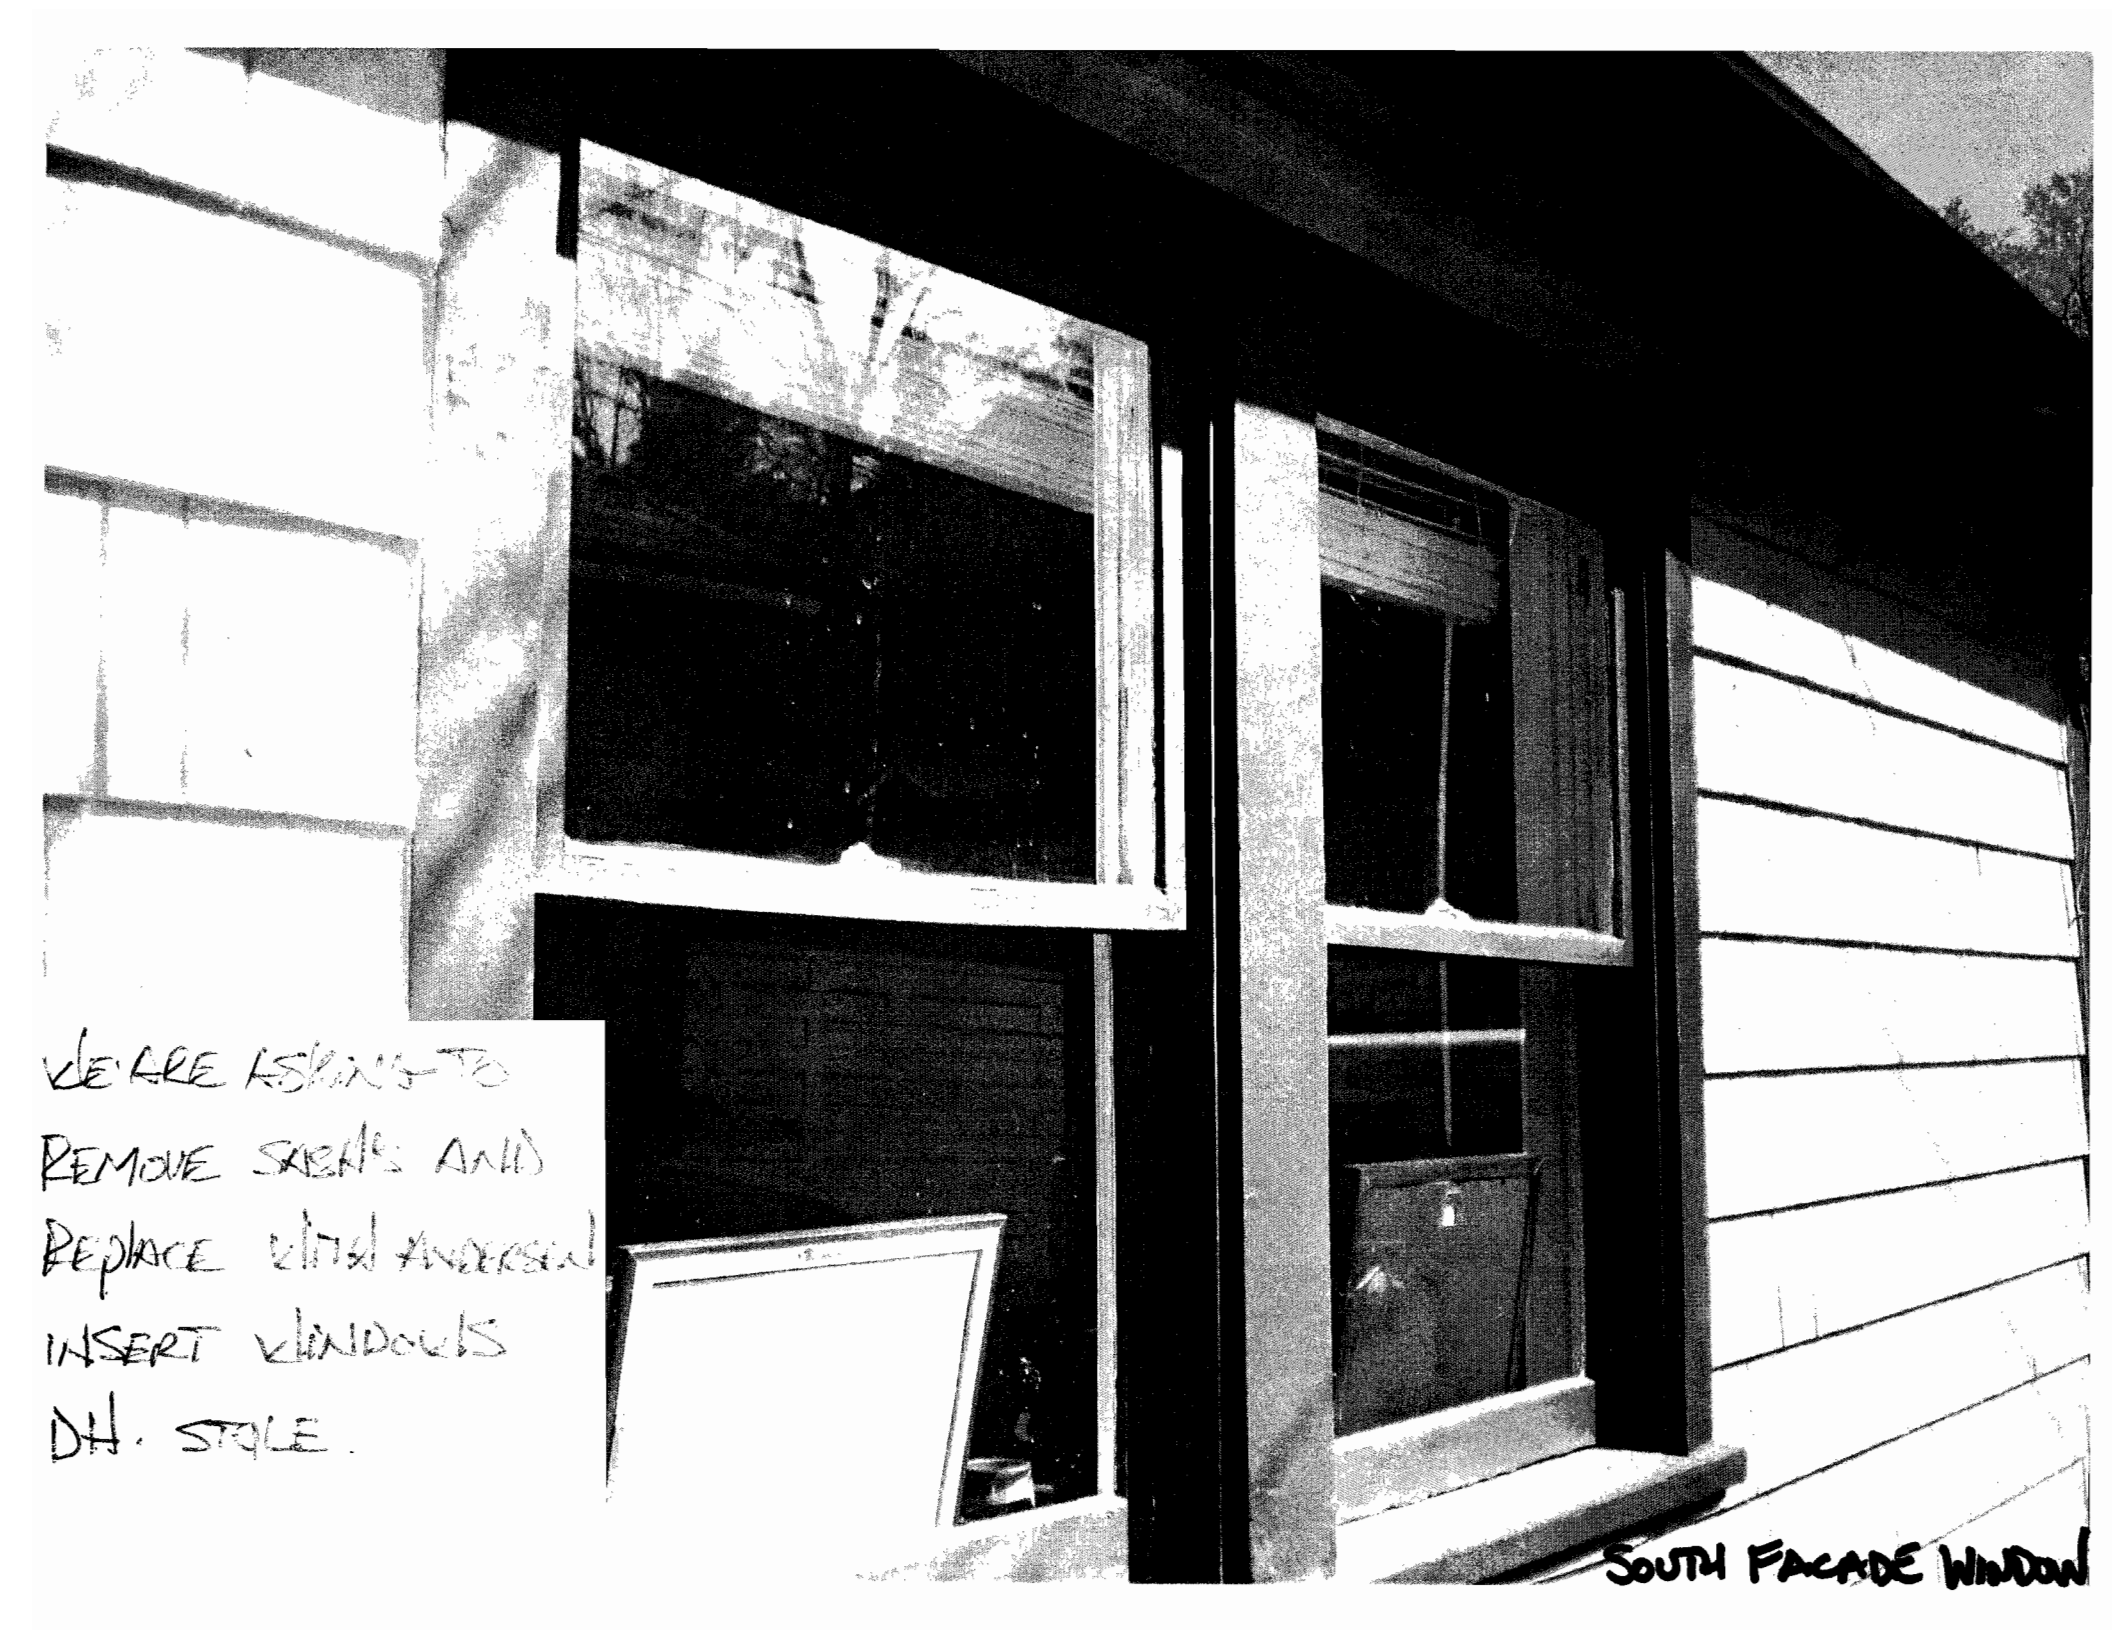
SOUTH FACADE WINDOW

**Discussion for Standards 4, 5, and 6 in relation to the south façade windows:** From the photographs submitted (Exhibit F) and a site inspection, the existing windows appear to be repairable and are character defining features of the building. The windows on this façade, proposed for replacement, are wood windows of the casement and single-hung varieties. While these windows may not be original, they are certainly older windows and contribute to the historic character of the home. These windows appear to have acquired historic significance in their own right and therefore should be retained and preserved. They display distinctive features and construction techniques, and are examples of craftsmanship that characterize a historic property. Planning Staff contends that these windows are not beyond repair and therefore should be preserved and maintained, rather than replaced.

WE ARE ASKING TO  
REMOVE SCREENS AND  
REPLACE WITH ANDERSEN  
INSERT WINDOWS  
DH. STOLE.

If the Historic Landmark Commission makes the determination that it is appropriate to replace these windows rather than repair them, Planning Staff suggests that a picture window is not an appropriate replacement style for the wood casement windows on the upper-level, and that the single-hung windows on the ground level be replaced with single or double-hung windows with a substantial mullion and no grid pattern.

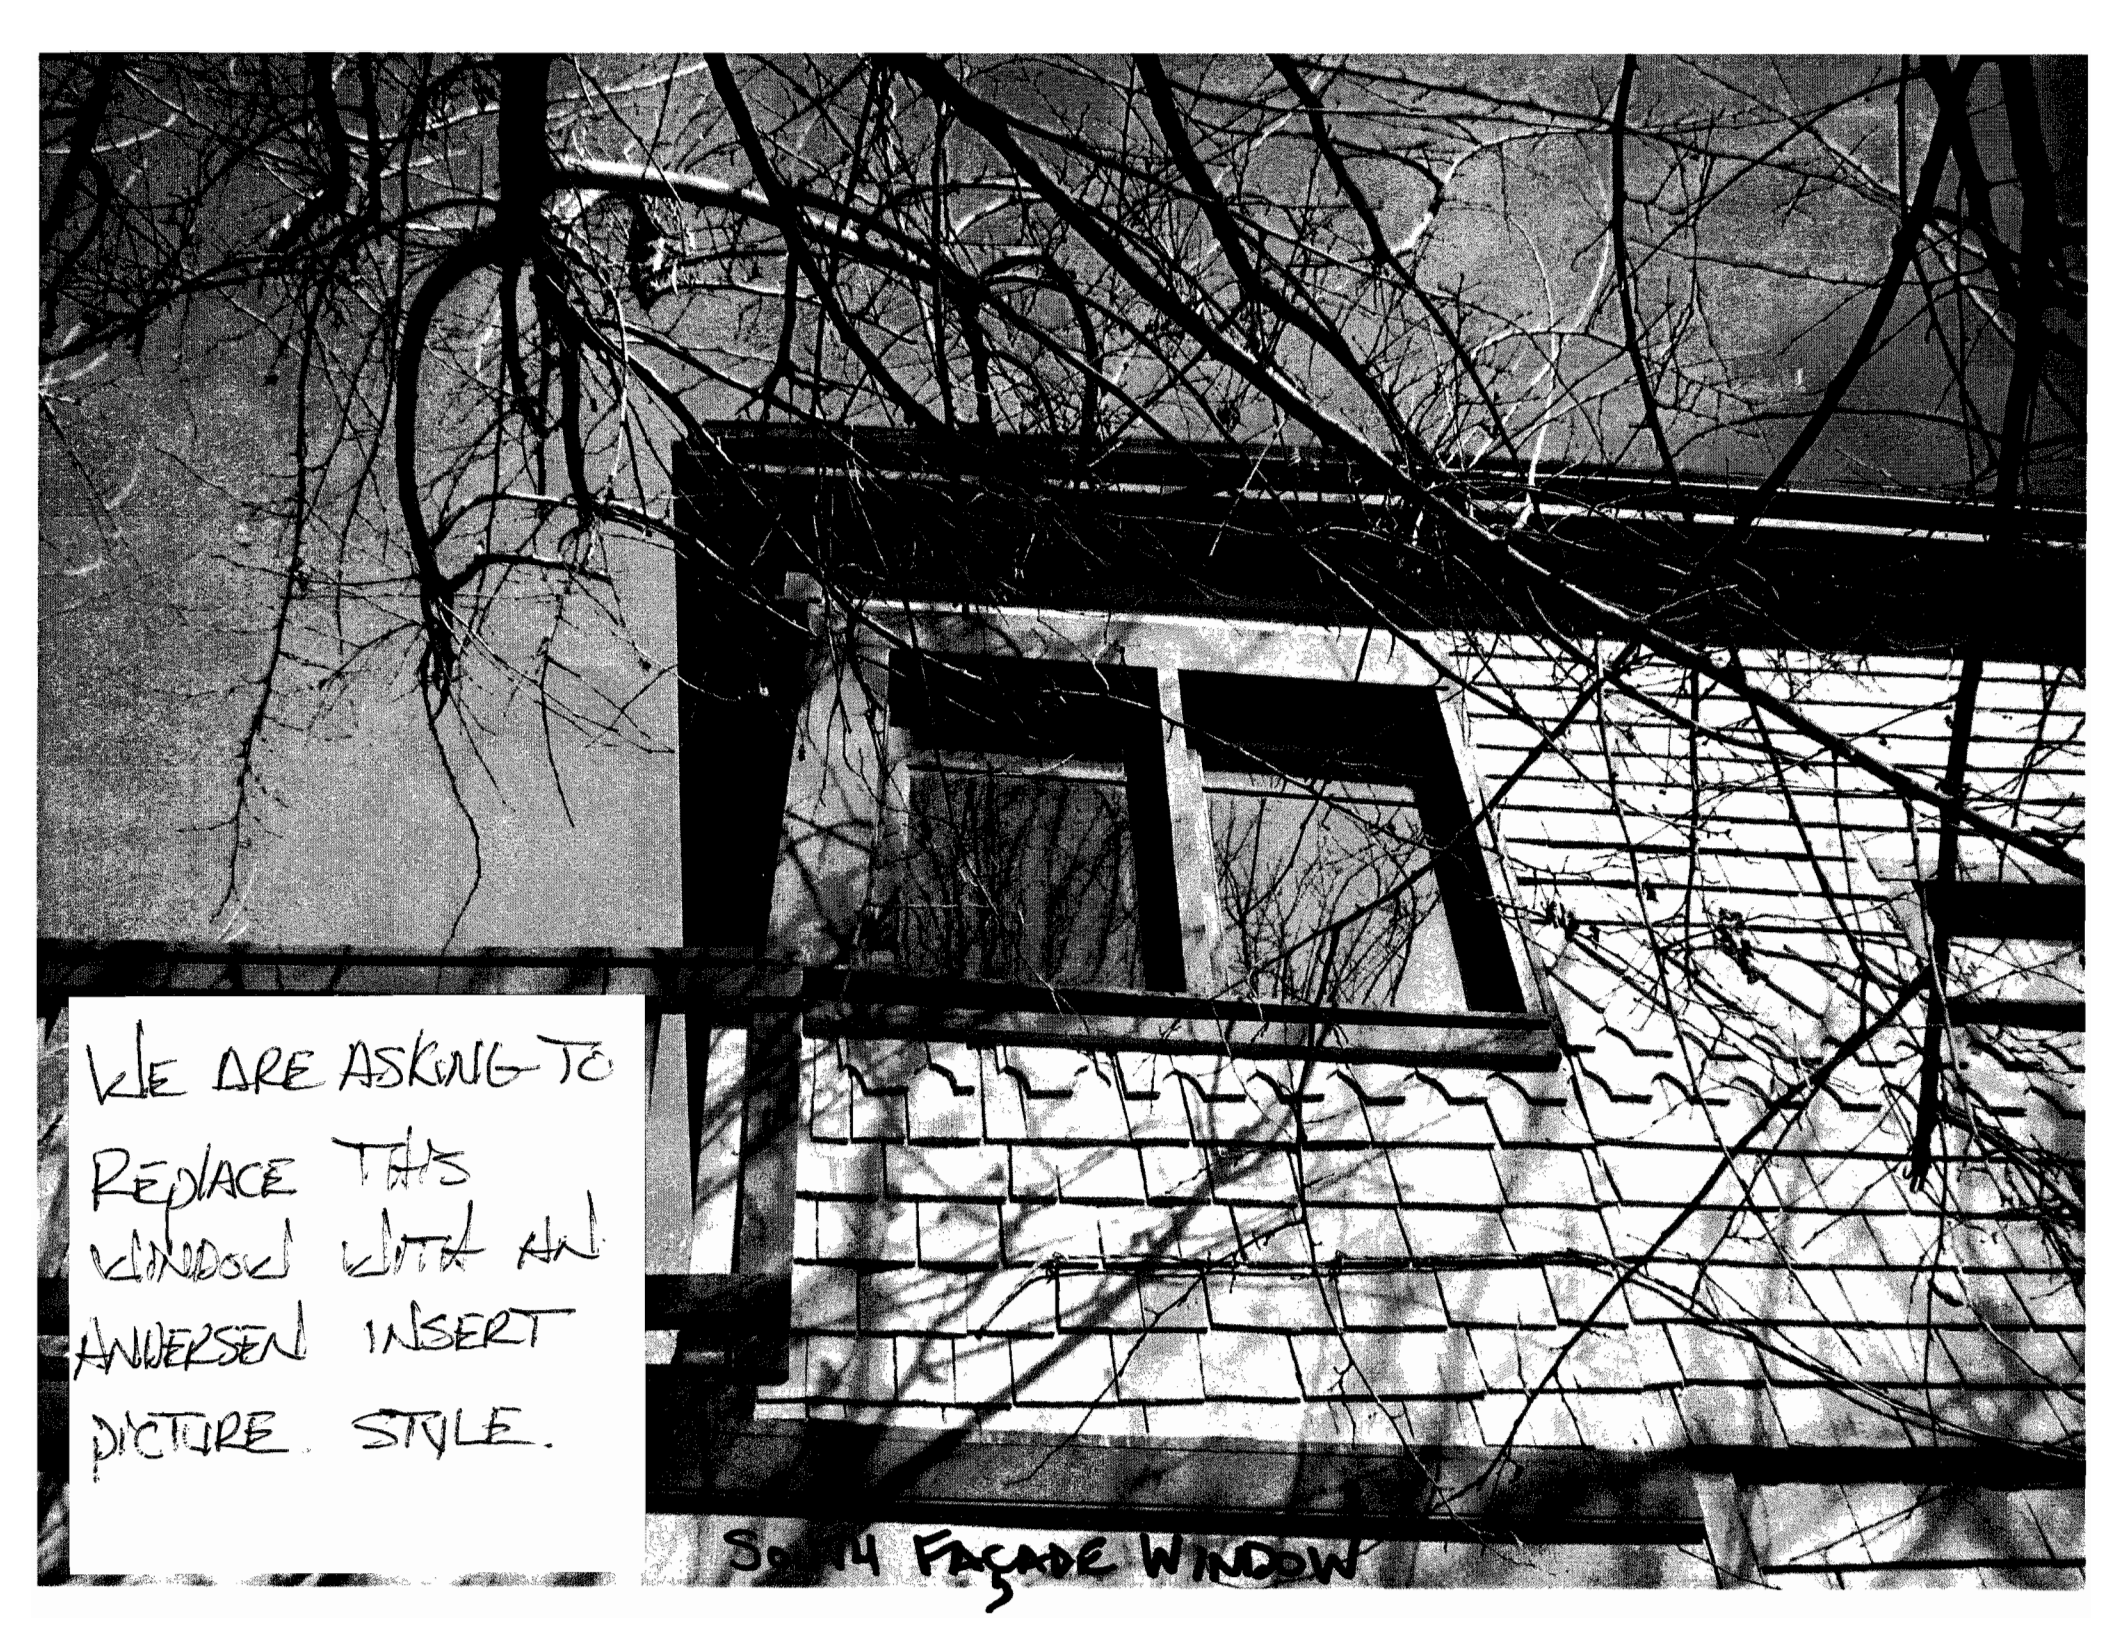
SOUTH FACADE WINDOW

WE ARE ASKING TO  
REPLACE THIS  
WINDOW WITH AN  
ANDERSEN INSERT  
PICTURE STYLE.
