# HISTORIC LANDMARK COMMISSION STAFF REPORT

## Lalouel Renovation PLNHLC2010-00546 Capitol Hill Historic District 163 West Clinton Avenue October 6, 2010

Planning Division  
Department of Community and  
Economic Development

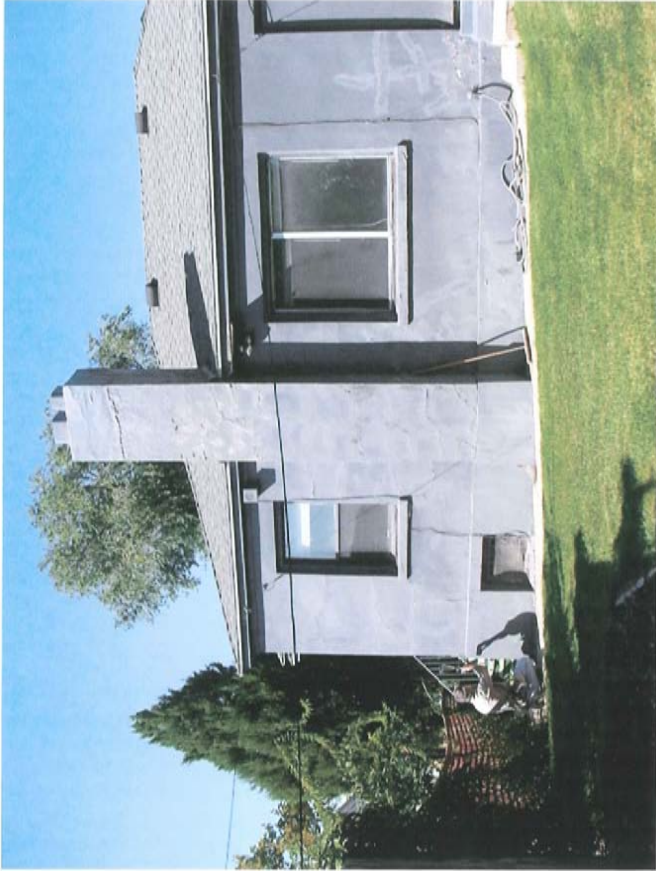
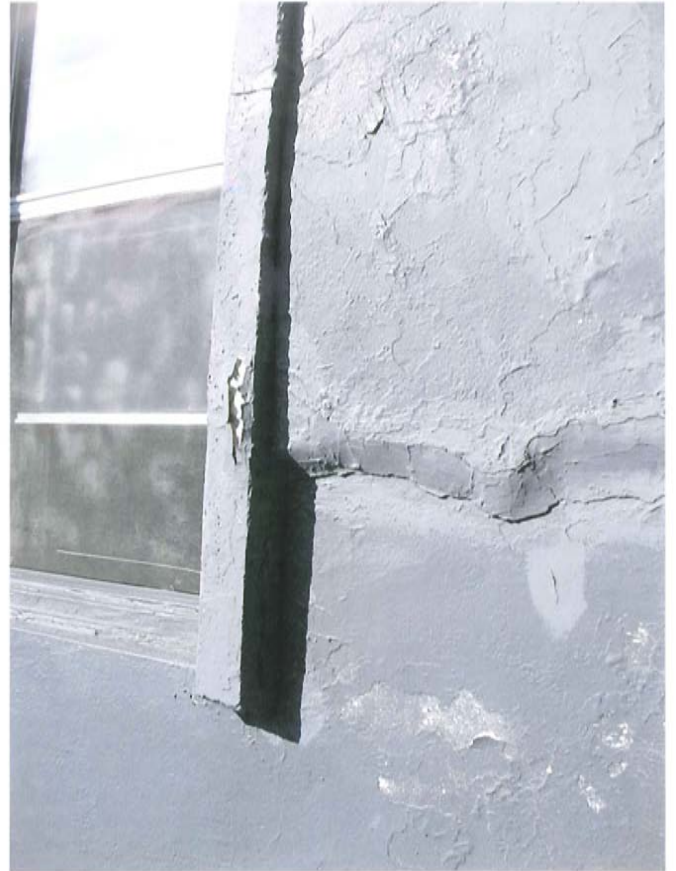
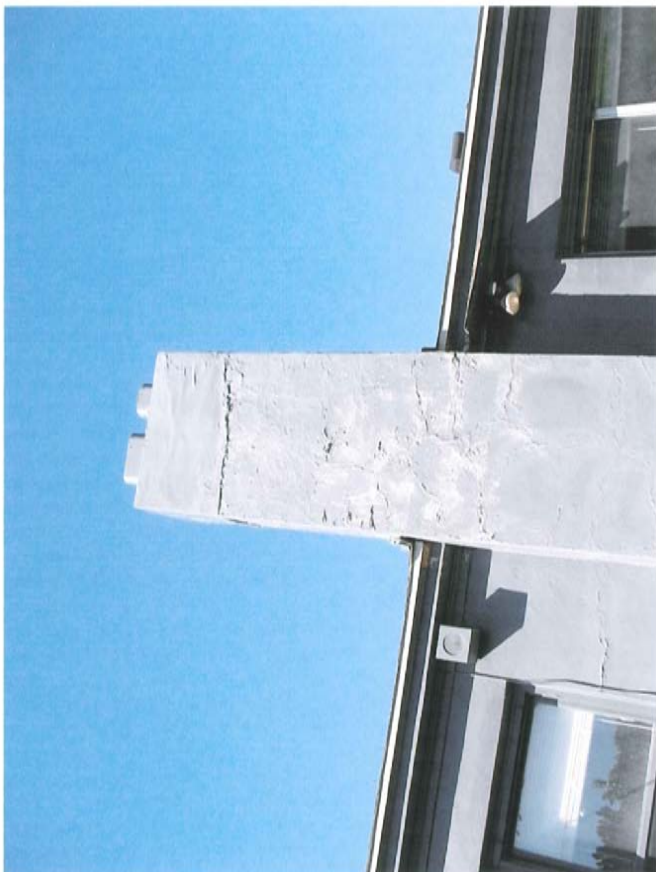
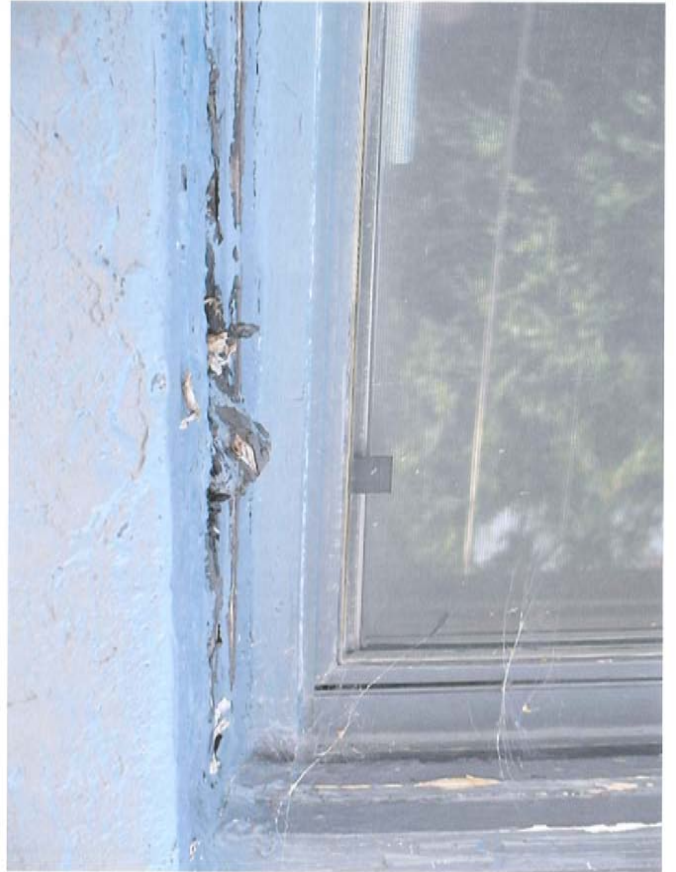
# Photos Before Foam Application

**Analysis:** The photos taken of this property prior to the application of the foam insulation show many signs that the existing stucco finish is deteriorating. Foam boards have already been adhered to the exterior wall, making it a challenge to remove the foam without additional extensive damage to the wall. The applicant chose to re-clad the building with EIFS instead of repairing the damaged stucco.

**Analysis:** The exterior wall on this house has suffered major deterioration. Damaged materials should be patched or consolidated. In this situation, however, some portions of the material may be beyond repair and larger surfaces of the wall should be replaced.

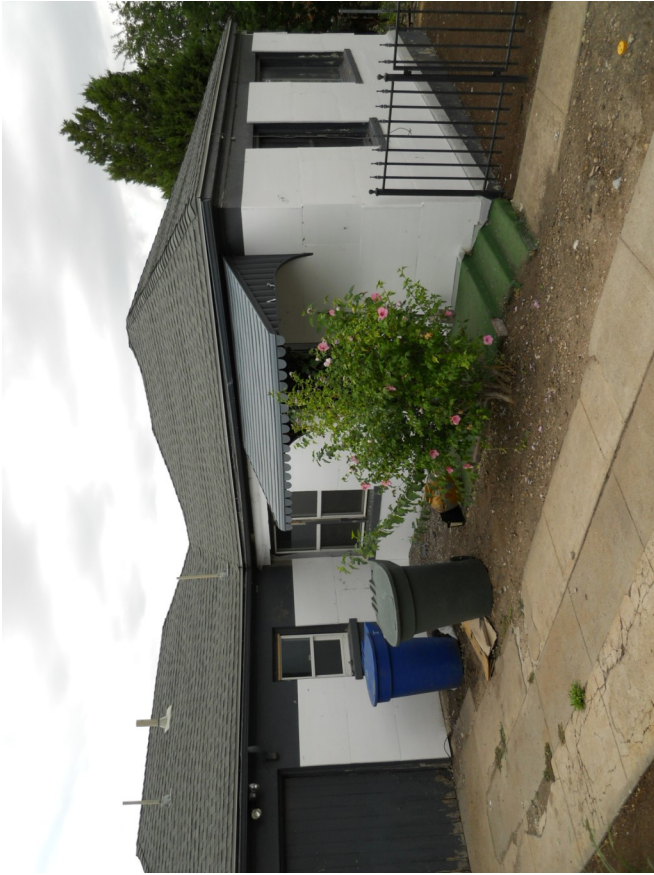
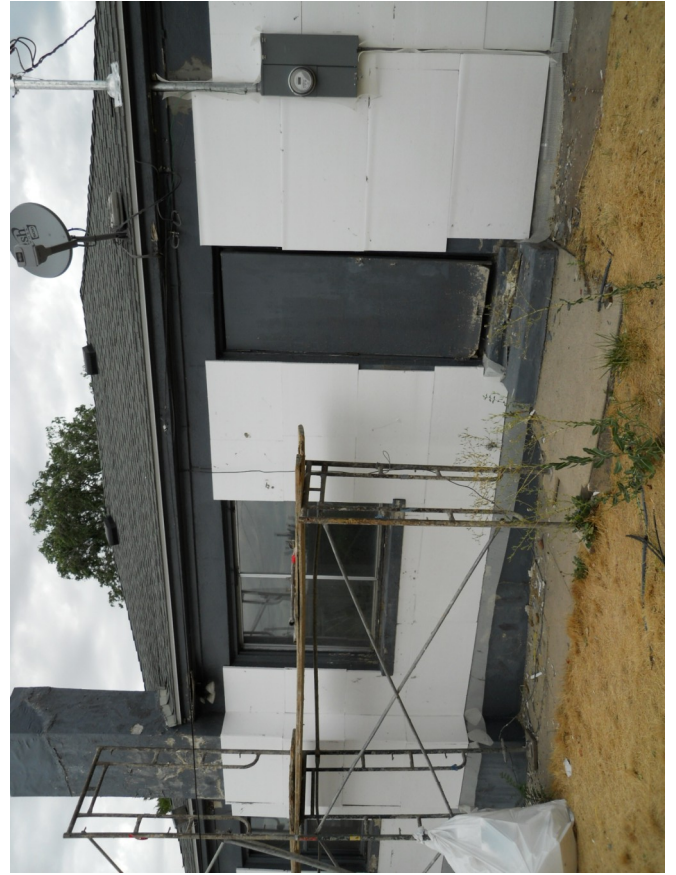
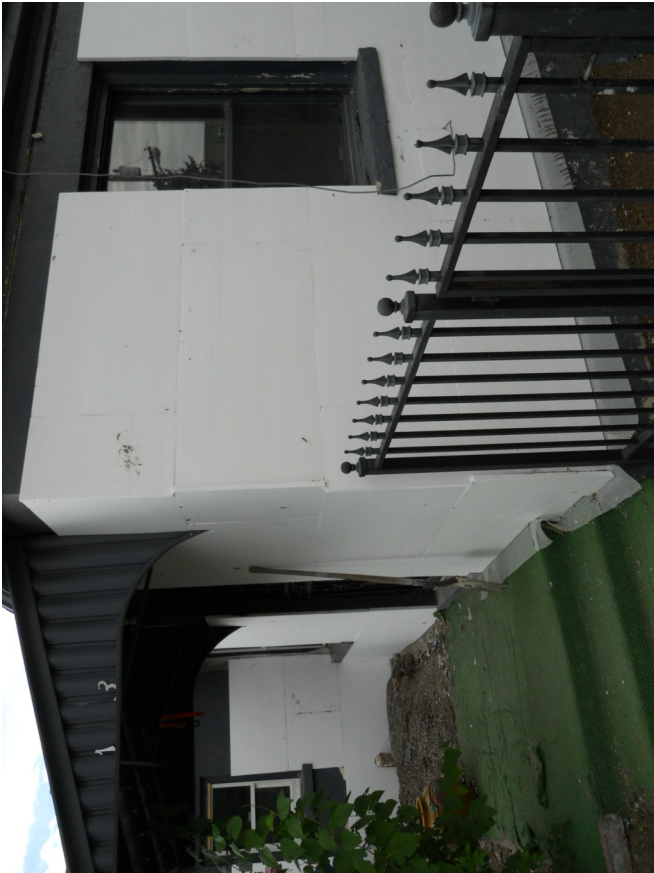
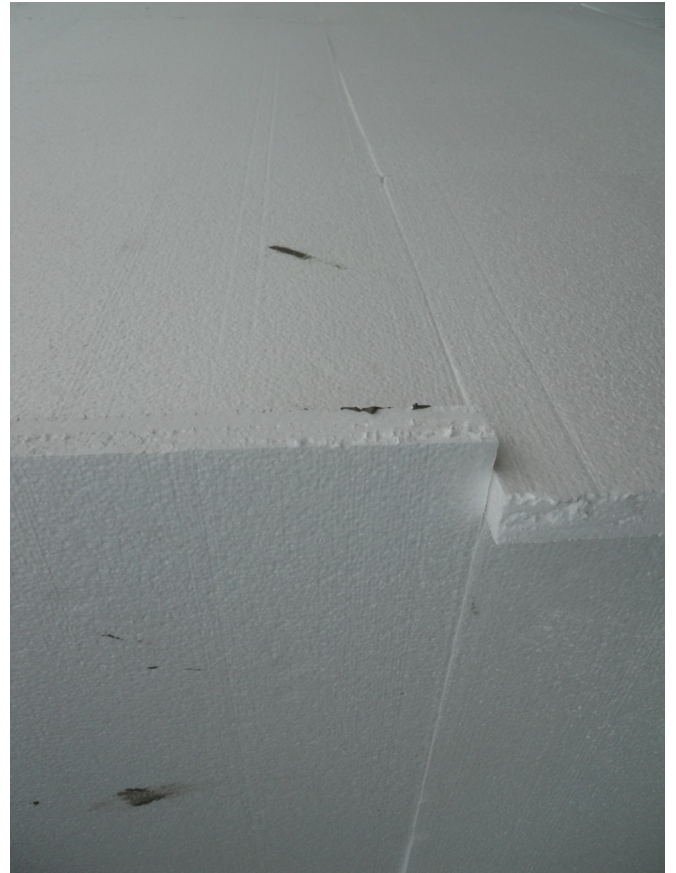
# Photos After Foam Application

**Analysis:** Addition of EIFS is a major alteration. Removal of the exterior insulation may cause significant damage to the historically significant stucco and the integrity of this site.

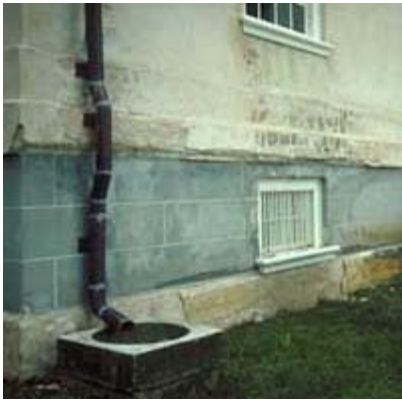
The damage to this stucco appears to be caused by moisture infiltration. Photo: NPS files.

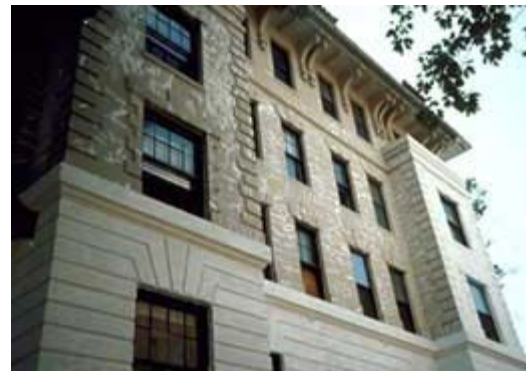
Caulking is not an appropriate method for repairing cracks in historic stucco. Photo: NPS files.
