HISTORIC LANDMARK COMMISSION STAFF REPORT

323 E. 2nd Avenue
Front Entryway & Rear Siding
Minor Alteration
PLNHLC2014-00725
Meeting Date: December 4, 2014

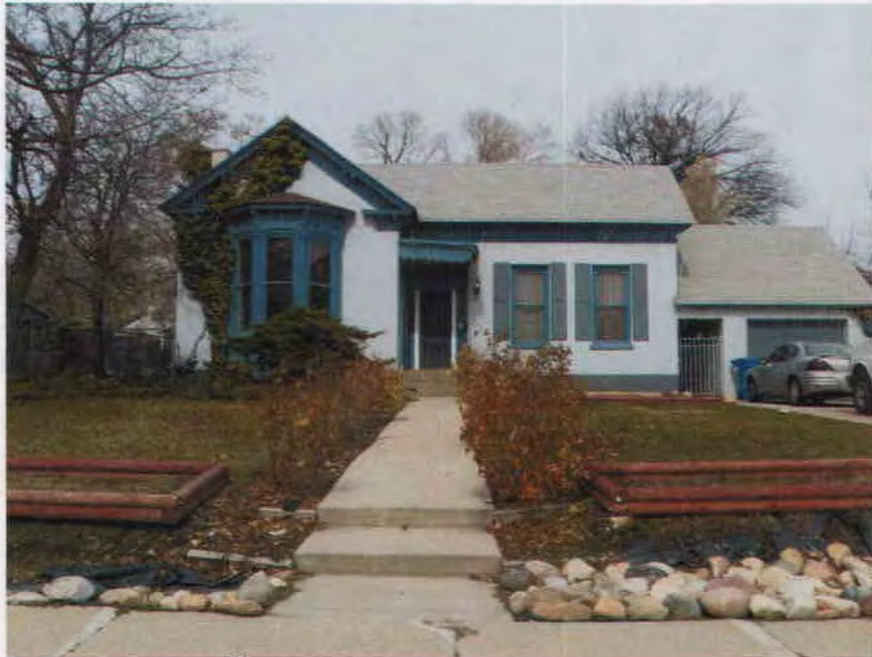
Front of 323 E. 2nd Avenue prior to modifications

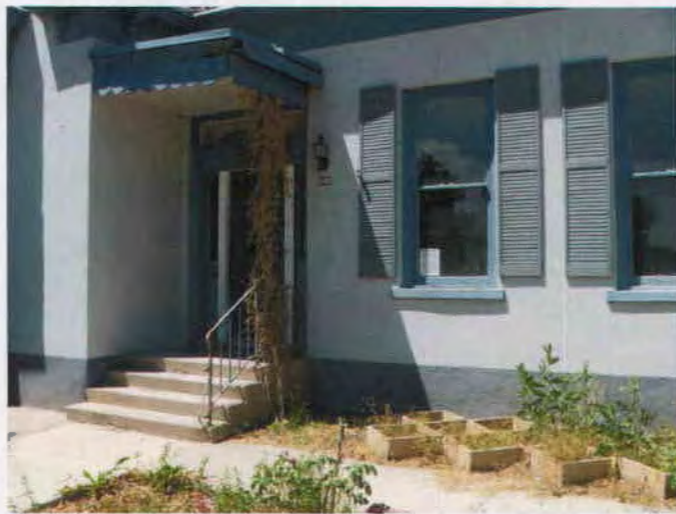
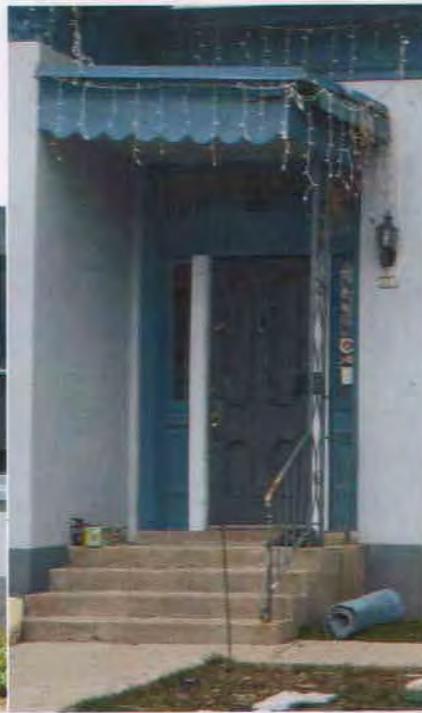
The front door and surrounding sidelights and transom have been completely replaced on the subject home. Arguably, the front door that was removed was probably not original, however the side lights and transom opening most likely were. The sidelights removed were paneled at the bottom almost half way up the door and topped with glass. It appears that the glass portion was rounded at the very top. The attached photos show the entry way that was replaced. The decorative wood crown and casing that was removed around the front door gave depth to both the door itself as well as the sidelights. Although not finished with glass, the transom was most likely original and is a feature that one would expect on a home of this age and style.

Front entryway

Had the applicant approached staff prior to the entire entryway being replaced, staff would have required that the sidelights be repaired, that the transom be repaired and returned to a glazed opening, and an appropriate paneled door chosen that would have been more historically accurate.

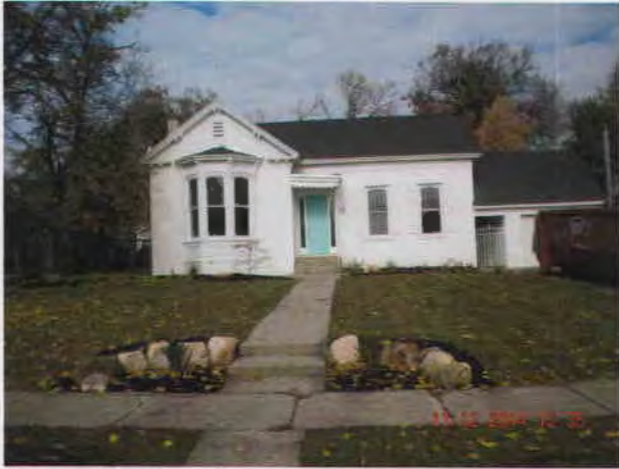
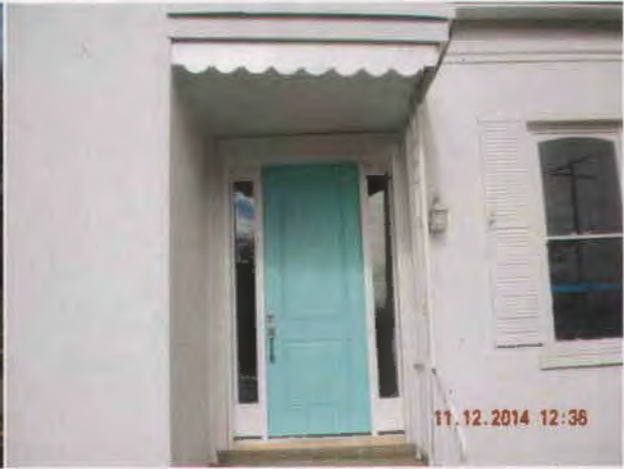
The new door entry loses the transom feature, as well as the original decorative sidelights. A new door was installed that proportionally is not historically appropriate for a structure of this time period. The new door is simply too tall and consists of only two panels. Typically, more panels would be present. The result is that the door and sidelights are elongated and appear to be very “flat”; the characteristic depth of the entryway has been lost.

Finding: The removal of the historic front entryway has significantly altered a primary character defining feature of the home and therefore does not meet this standard. The prior historic entryway features should have been repaired rather than replaced.

Front with altered entryway

1. The applicant shall replace the front door and side lights with materials that more closely resemble the items recently removed (see attached photographs).
2. The applicant shall remove all the T1-11 siding and make repairs to the horizontal wood siding underneath as warranted, or an historically appropriate horizontal lap siding shall be used.
3. The Historic Landmark Commission delegates oversight of required alterations to Planning Staff.

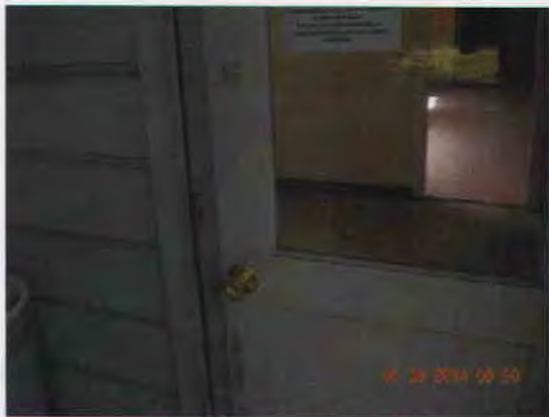
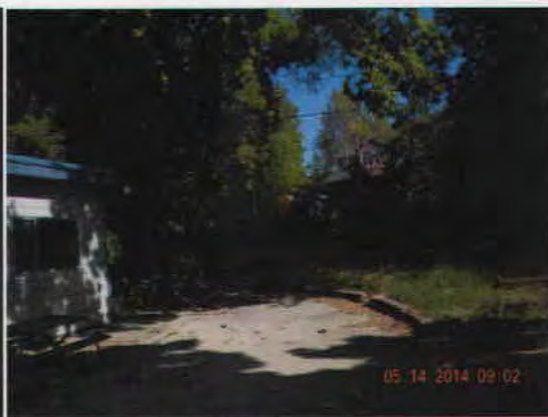
Analysis: In terms of the rear siding, according to City building permit records it appears that the rear addition on the subject home was constructed in the mid 1950's, and therefore has historic significance in its own right. The siding that was covered with the T1-11 siding was a wood horizontal lap siding as evidenced by the attached photos. A wood horizontal lap siding is historically appropriate and should have been retained and preserved. This historic siding, according to the applicant, was in disrepair in places and instead of being repaired as necessary it was covered over. Planning Staff asserts that the T1-11 siding should be removed and the wood horizontal lap siding should be repaired and restored, or an appropriate replacement siding used.

The applicant has indicated that the wood horizontal lap siding on the rear of the structure had many areas that needed repair, and was thus simply covered over with T1-11 siding. The applicant asserts that repair materials were/are not available. The covering over of the wood lap siding does not meet this standard of review and conflicts with the applicable design guidelines; repair should have occurred with similar material, or if beyond repair an appropriate cladding could have been identified such as wood lap or a composite lap siding. Further, the chapter concerning the Avenues in the Residential Design Guidelines specifically states that panelized product are inappropriate for primary structures.

Photos showing original wood horizontal siding in the rear of the home

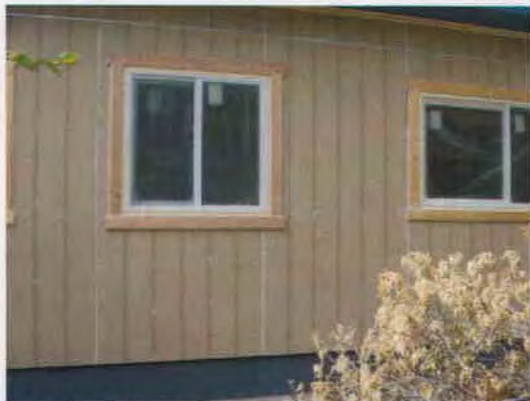
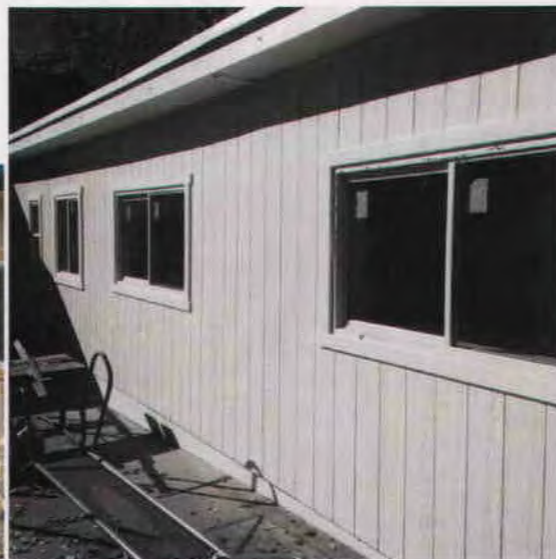
In terms of the T1-11 siding, an inappropriate material has been selected to cover over an historically appropriate wood cladding.

Analysis: The proposal does not include the use of vinyl or aluminum cladding applied to original or historic material, however T1-11 applied over original or historic material is a similarly inappropriate cladding treatment. T1-11 siding is an inappropriate application to a contributing structure in any of the City's historic districts.

T1-11 Siding on rear of the home
