Staff Report

To: Salt Lake City Historic Landmark Commission
From: Carl Leith
801 535 7758 or Carl.Leith@slcgov.com
Date: August 6, 2015
Re: City and County Building Seismic Upgrade, Stone Remediation & Window Refurbishment
PLNHLC2015-00557

SLCCB Seismic Upgrade & Stone Remediation

Salt Lake City and County Building
451 State St, Salt Lake City, UT 84111

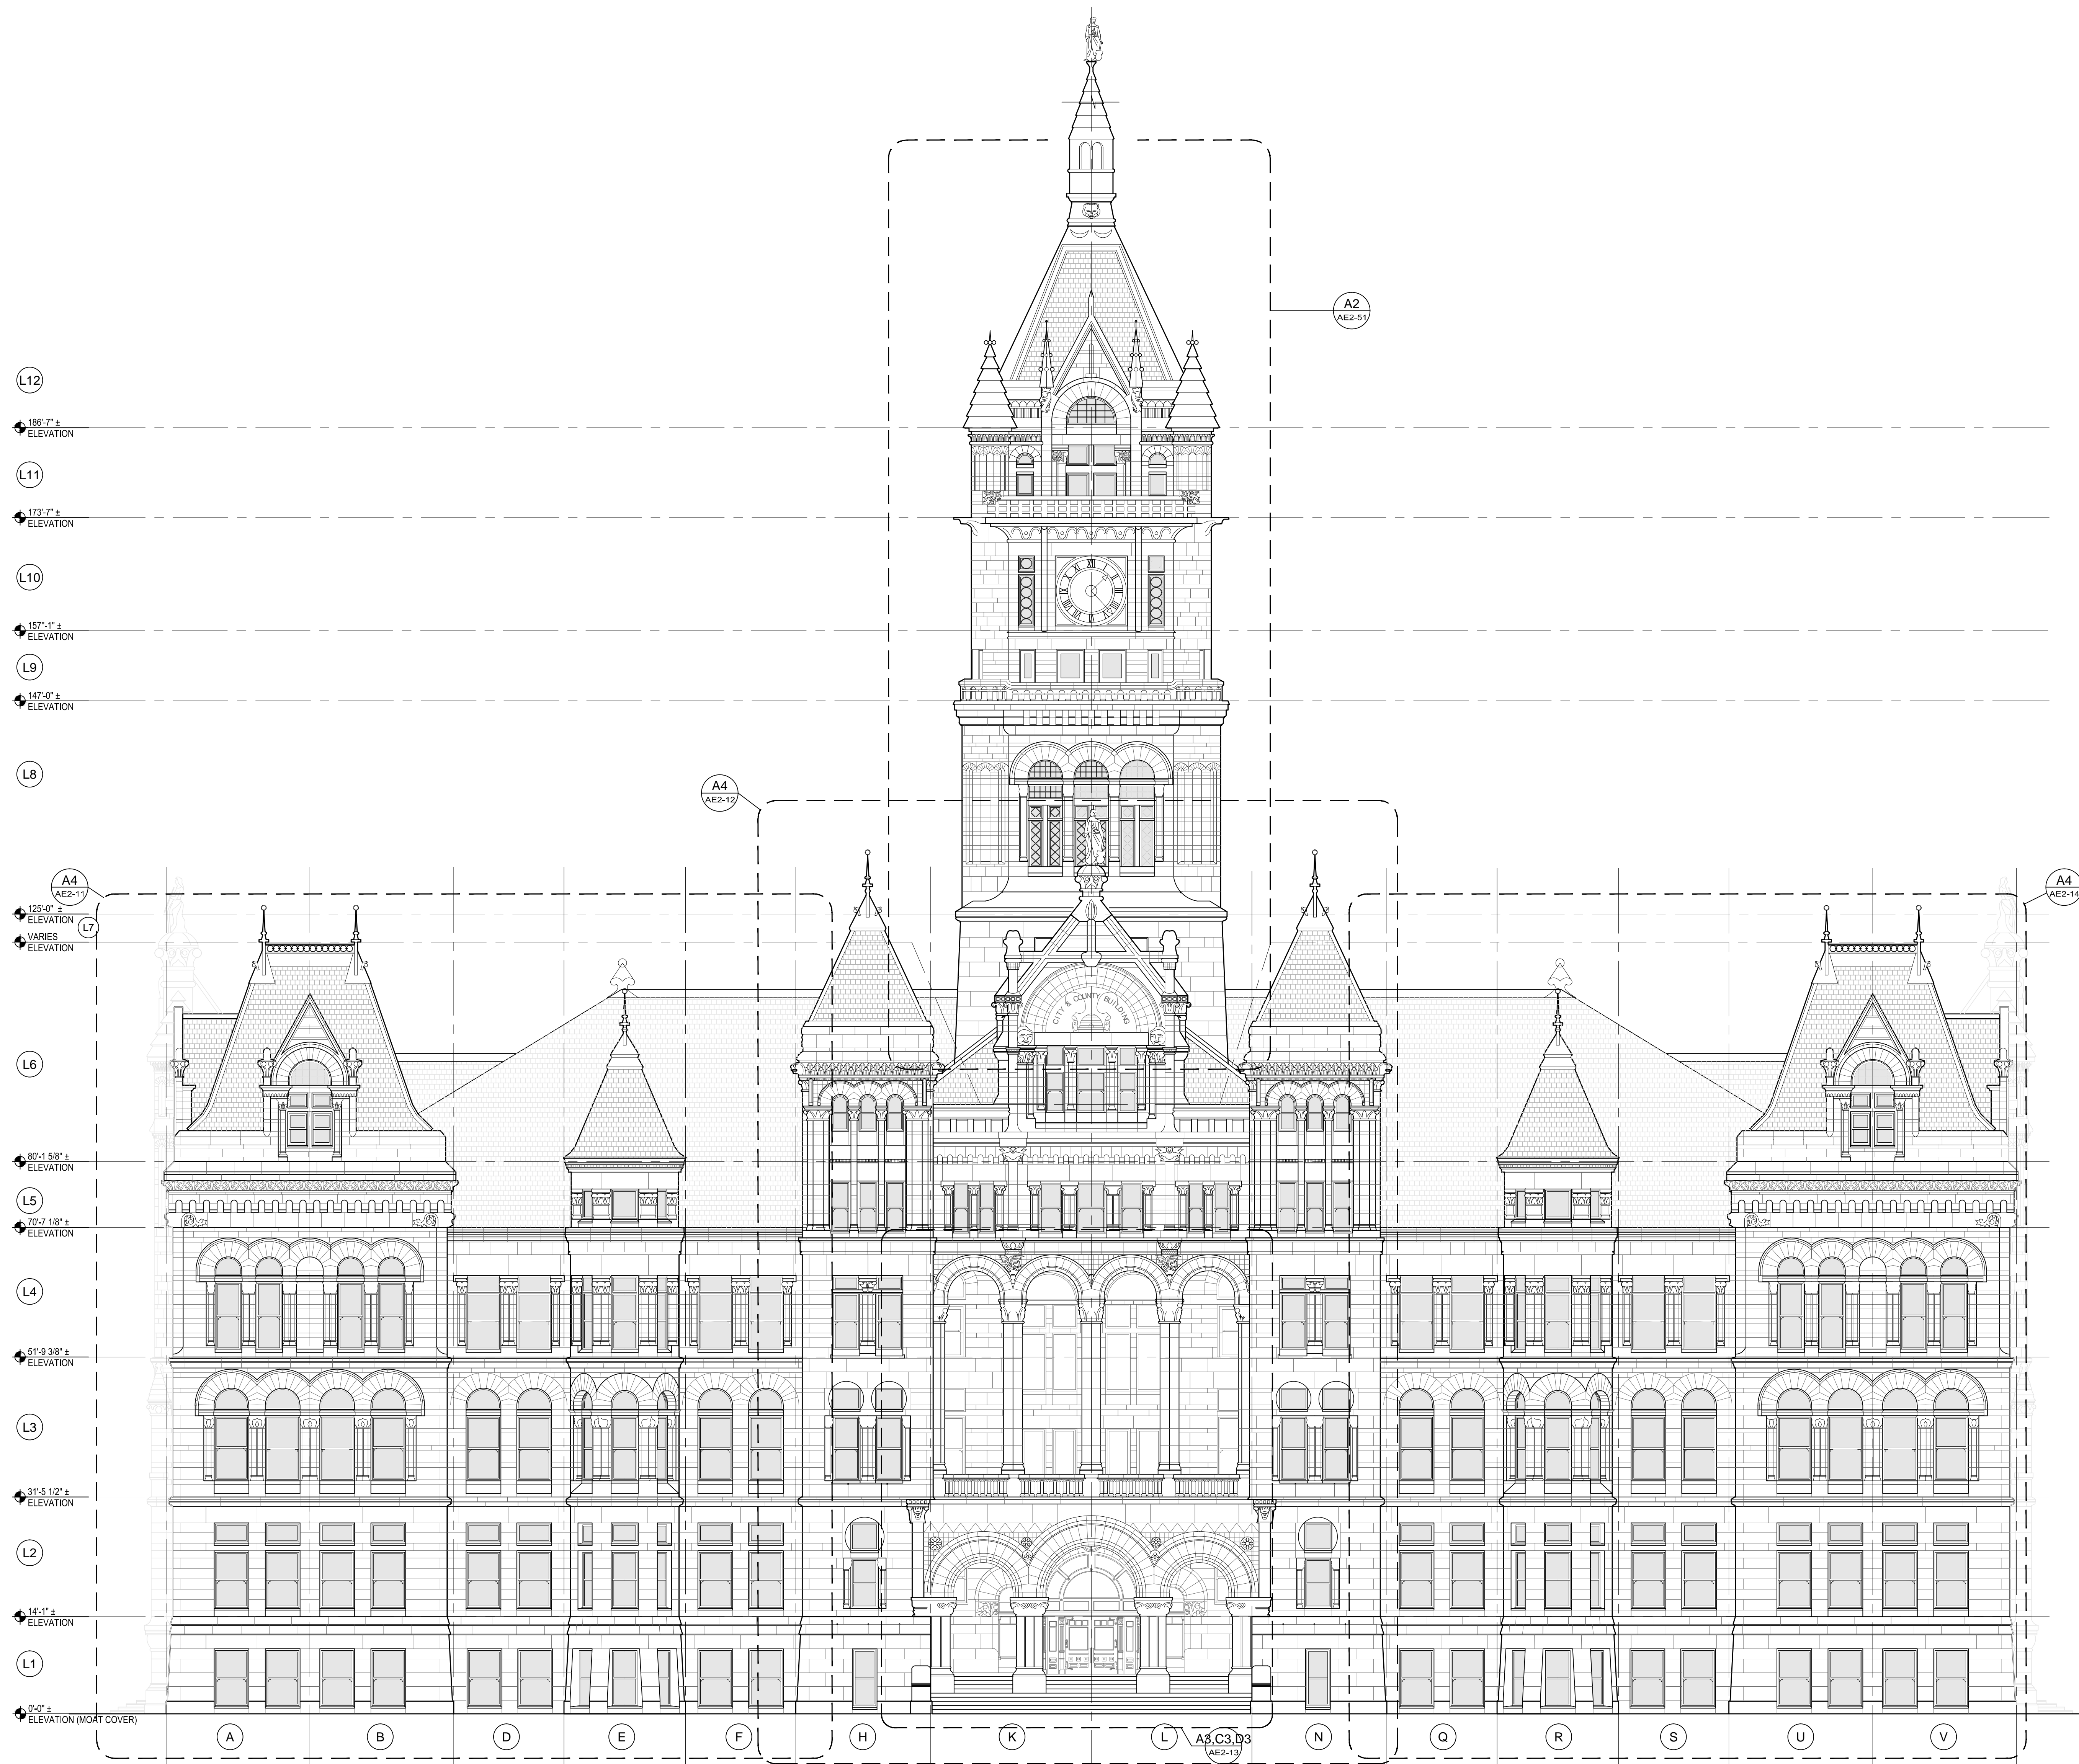
A1 WEST ELEVATION
A2.2 SCALE: 3/32"=1'-0"

- KEY NOTES**
- 04.011 REPAIR MORTAR 'WASH' AS NEEDED
 - 07.033 GUTTER
 - 09.002 DOUBLE LINE (GALV. PIPE BRACE) @ 45° TYP @ ALL CORNER CHIMNEYS
 - 09.003 PREP & PAINT STEEL COLLAR & BRACE AS SPEC'D
