HISTORIC LANDMARK COMMISSION STAFF REPORT

1120 E 400 S Major Alterations PLNHLC2014-00884 University Historic District 1120 E 400 South January 15, 2014

This is a request by Andrew Nielson for major alterations to the property located at approximately 1120 E. 400 South, in the University Historic District, and within the R-2 (Single and Two Family Residential) zoning district.

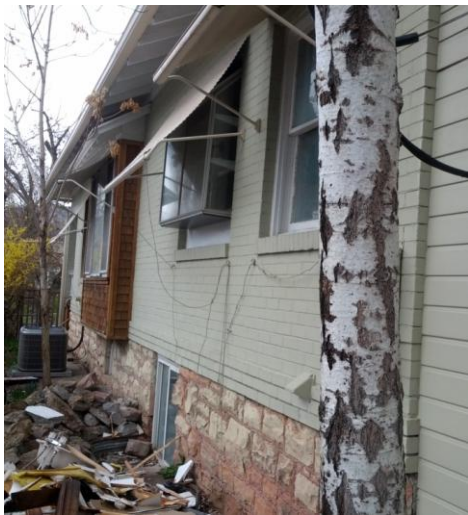
The applicant is asking for approval for a replacement of a metal garden box window along the west side of the home that was replaced with double hung beige wood windows. The new windows do not fit the original window opening. The area between the windows and the original window opening is trimmed with a smooth hardie board.

Former garden box kitchen window

The wood double hung window replacements do not meet this standard. The replacement window does not fill the original window opening. The kitchen window replacement could be approved with the condition that the new double hung windows fill the historic window opening.

- Kitchen Replacement Window
 - New double hung windows should match all the other windows on the home in material, dimension and design
 - New window should fit the entire original window opening and be designed similarly to original windows on the building

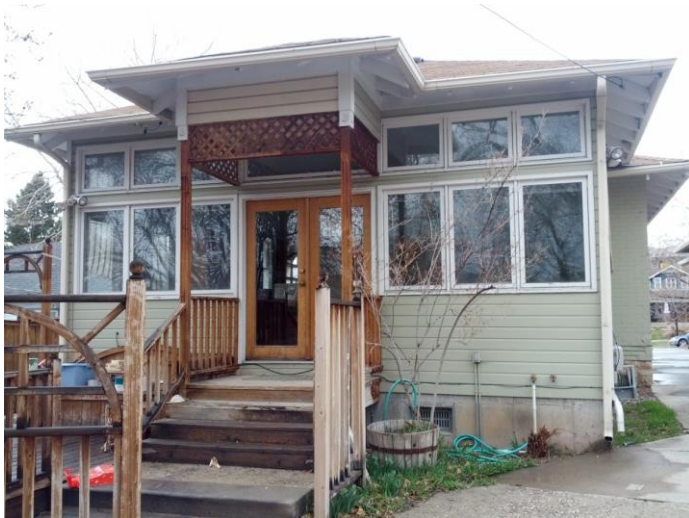
The applicant is asking for approval for changes to the rear addition design that was constructed differently than what was approved in the original Certificate of Appropriateness. The new addition design maintains 8 of the 12 existing windows. Four of the windows were removed and replaced with a new steel door. Also, the French doors originally in the back were removed and replaced with another steel door. The rear of the property contains two steel doors placed directly next to each other. The applicant states that the architect made a mistake in the original drawings and the walls were shifted to the east 6", which moved the wall of the master bedroom (the door to the awning is the door to the master bedroom) to the east and the double doors had to be changed to a single door. The applicant provided a redlined drawing of the shift, but this information should be confirmed with the inspector that this change was necessary. Also, according to the measurements provided by the applicant/contractor, the original proposed door that was to be located at the west corner of the rear addition would have been above grade by 32" which would have changed the original design. However, it is unclear as to why a design was chosen to place two doors next to each other. The existing awning above the former double doors remains.

Former rear addition

Although the rear addition is not readily visible from the street and it is not a historic part of the property, the rear addition should be compatible in scale, proportion, design, and should not detract from the character of the home. The rear addition alterations detract from the home being built in what appears to be a disorderly manner. The French doors that existed previously under the awning were removed and replaced with a single steel door leading to the master bedroom. The additional steel door placed directly west of the other steel door creates a visual discord since the two doors are not lined up with the existing remnant roof projection. The proposed redwood material for the deck is appropriate since wood is a typical deck material and consistent with materials allowed in historic settings. However, the overall rear addition contains many asymmetrical elements, which is not characteristic of historic bungalows. The two steel doors placed directly next to each other are not characteristic of single family bungalows in the area. Also, the windows on the south side of the rear addition are not symmetrical. There are two windows along the west portion of the south elevation and six windows on the east portion of the south elevation and this adds to the visual confusion and asymmetry of the rear addition. Furthermore, the deck stairway does not symmetrically lead up to the doors or the awning along the back.

This standard is not met in regards to the rear addition and deck. The double doors give the impression that the home is a duplex, which creates a false sense of history and architecture for the property. This standard could be met with the condition that one of the doors be removed so the design does not suggest the look of a duplex.

A rear addition alteration and new rear deck could be approved with the condition that a comprehensive approach is used to implement a redesign of the rear addition. This should include either reinstalling French Doors or putting more space between the two door entries, and addressing the asymmetry in regards to the placement of the doors, existing awning, and windows. A rear deck could be approved with the condition that the design of the railings and balustrades meet the guidelines relating to proportion, scale, and style of the railing design, and the stair placement complements the rear addition design.

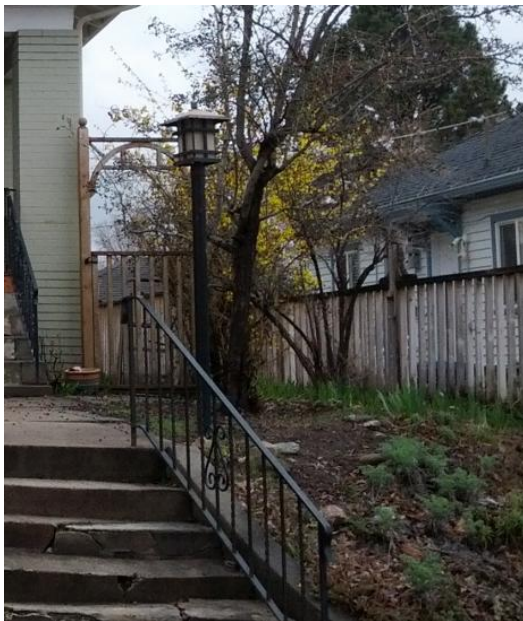
The applicant is seeking approval of the removal of the wood fence that was removed along the west side of the property. The applicant would like to replace it with a 6' cedar wood fence with 8' posts. The proposed fence will be located along the property line and extend between the front elevation of the house and the rear existing fence shared with the neighbor to the west. The applicant proposes a design that is similar to the picture below.

Former fence along west edge of property

The removal and replacement of the fence meets this standard. The fence that was in place was not historic and the design, materials, and dimensions of the new fence are compatible with the character of the home and the neighborhood.

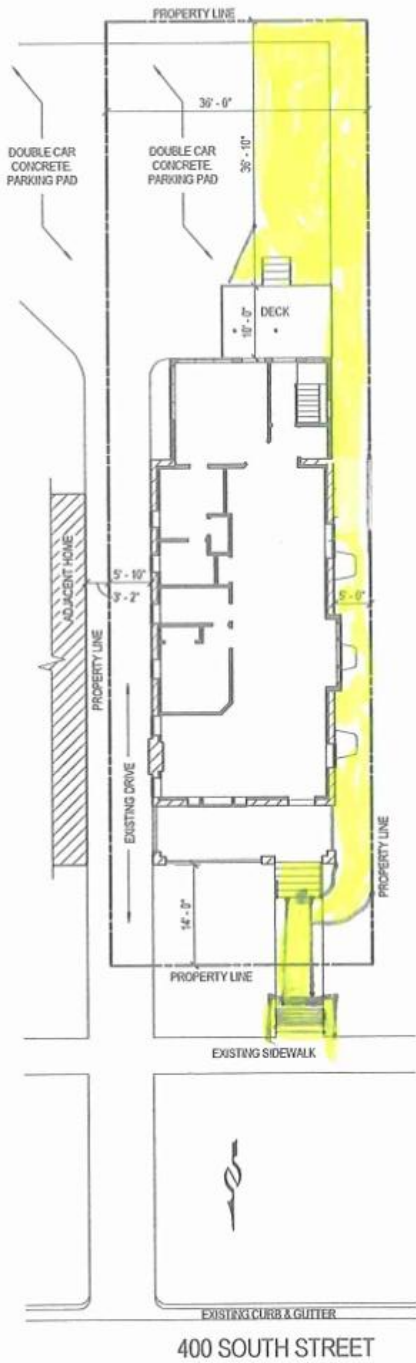
The applicant is seeking approval for concrete work that was completed on the stairs in the front yard, the porch stairs, the walkway connecting the two sets of stairs, and the walkway along the western edge of the home leading towards the back of the home. The shape of the stairway in the front yard was changed from a curved design to a straight design. The set of porch stairs was repaired with a new layer of cement and the concrete work was continued from the front walkway to the west side of the property to the back of the property.

Highlighted areas show where concrete work was completed

The additional concrete work on the property – repairs to porch steps and repairs and additional cement work connecting the front to the back of the property does not change the historic character of the property and is appropriate.

The concrete work partially meets this standard. The concrete work completed on the porch stairs, the walkway from the front stairs to the porch stairs, and the walkway along the west portion of the home meet the standard as they do not impact the historic character of the property. The front yard stairway does not meet this standard. The alteration of the fanned front stairway to a design with straight lines is not appropriate as the fanned stairway is a historic feature of the majority of properties along the block. The front stairs could be approved with the condition that the historic fanned stairs are reinstated.

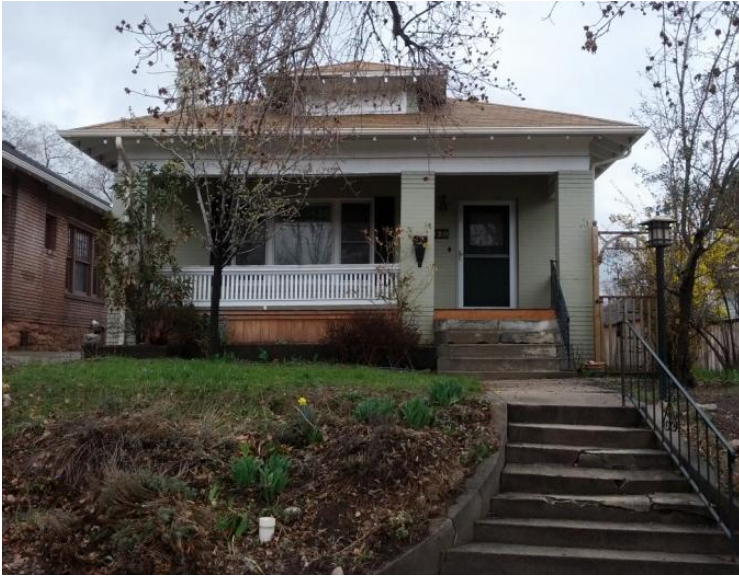
The applicant is seeking approval for the removal of the front metal railings along the west side of the stairs and proposes to replace them with similar metal railings. The proposed new metal railings mimic the design of the previously unoriginal and inappropriate metal railings. Although a stop work order is currently in place on the property, new metal railings have been installed without approval.

Former front porch and front yard handrails

The front metal railing that was in place, but which has since been removed was not a historic element of the porch. Between application and the publication of this staff report, new metal handrails have been installed along the east side of the stairs on the property. Since the handrails are a new detail, they should be replaced to be compatible with the design of the original porch. The wood railing around the porch appears to be historic, and wood material would be suggested for at least the stair hand rail adjacent to the porch to best maintain the character of the home. More flexibility can be granted to the front yard handrail. The replacement railing installed is a more contemporary thin white painted metal. This material and design is not compatible with the historic character of the home. Using wood and taking inspiration from the existing wood porch balustrades and railing would make the proposed porch handrails more compatible.

The metal licorice style railing is not compatible with the original porch in terms of material and design. This metal or wrought iron was commonly used to replace porch railings in the 1950s and 1960s. Although the metal railing that was installed seeks to replace a later inappropriate choice of railing, there is no historical basis for the replacement. There can be more flexibility with the front yard handrail since there is not a lot of historical basis to determine a wood handrail was used at the front of the property.

This standard is not met. There is no historical basis for the new metal replacement railing. The front porch handrail could be approved with the condition that the new porch handrail is compatible with the material, proportion, and scale of the historic porch. The front yard handrail could be approved as a simple metal design that extends appropriately to the sidewalk rather than extending two-thirds down the front yard steps.

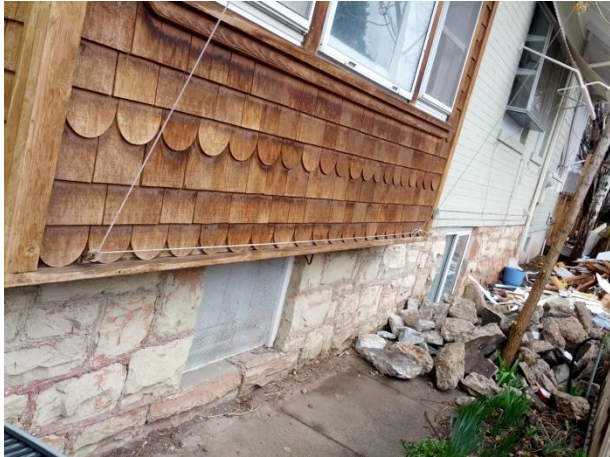
Unpainted original sandstone foundation

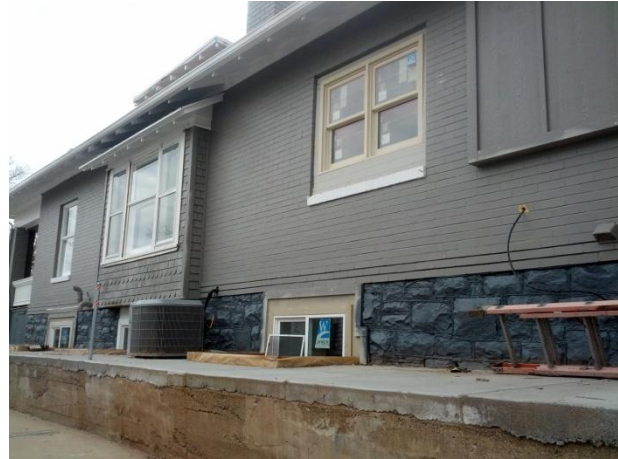
Original sandstone foundation was painted dark gray

The original unpainted sandstone foundation of the home was painted a dark gray color. This does not retain and preserve the historic character of the property and the original sandstone foundation is a defining feature of the property. Additionally, painting sandstone is inappropriate as it prevents the stone to naturally breathe and can trap moisture in the stone which may cause future moisture problems with regard to the foundation. However, the removal of paint from sandstone may cause more damage. If the paint were to be removed reinstating the original sandstone finish, this work would need to be done in a sensitive manner to minimize any additional damage to the stonework.

The painting of the sandstone foundation does not meet this standard. The original sandstone foundation is a distinct feature of the historic property and the painting of the sandstone prevents the stone from breathing properly, which may cause foundation moisture problems and result in damage to this important character defining feature. This standard could be met with the condition that the sandstone paint is removed in the gentlest manner to preserve and retain the important historic material

Staff recommends that the paint on the sandstone be removed to best preserve the character and physical integrity of the home. If the paint is to be removed, it should be done in the gentlest means possible and to begin with trial patches to determine the most effective treatment.

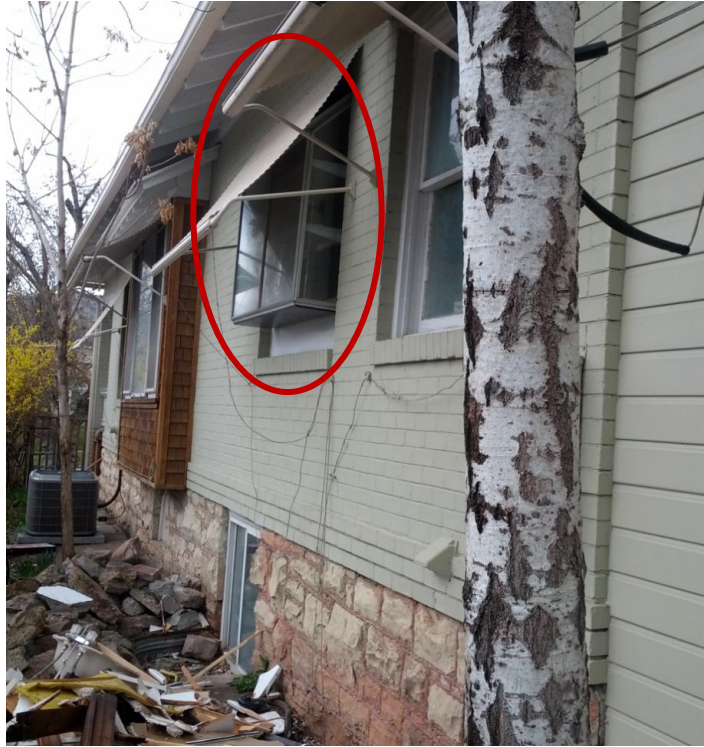
Former garden box window

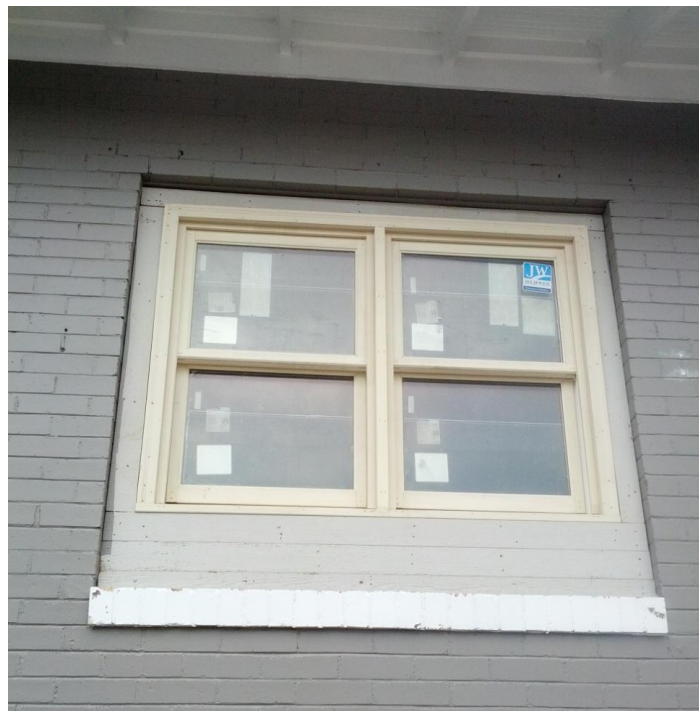
New wood double hung kitchen replacement windows

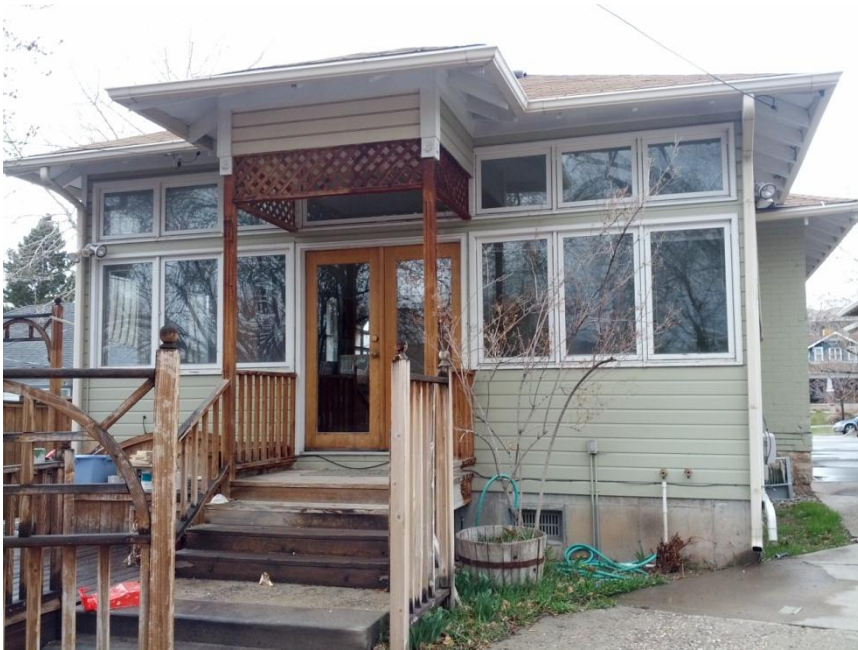
Former rear addition/porch

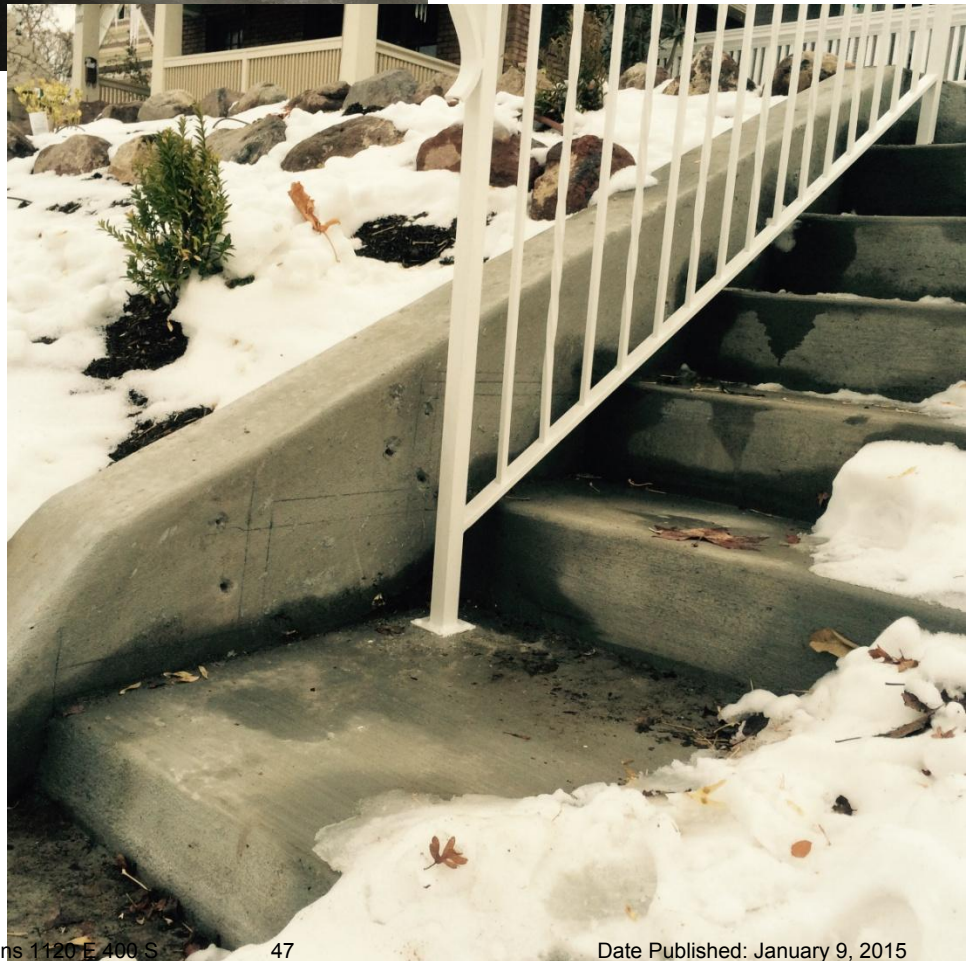
New painted front metal handrails – front yard handrail does not extend the whole length of stairs

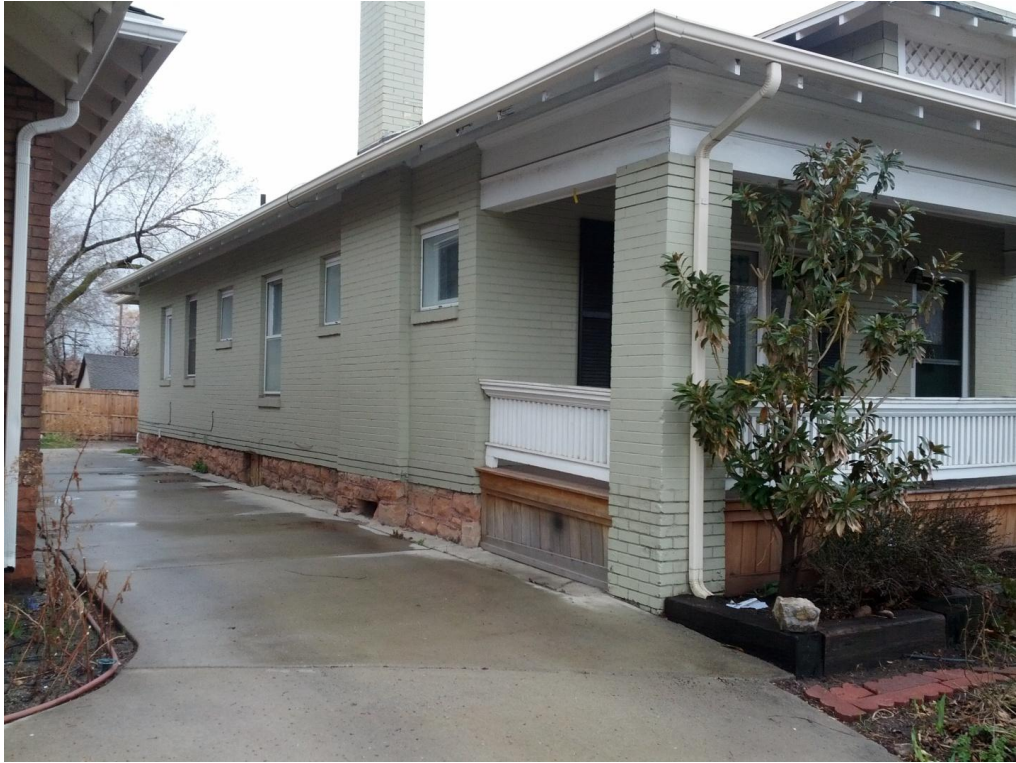
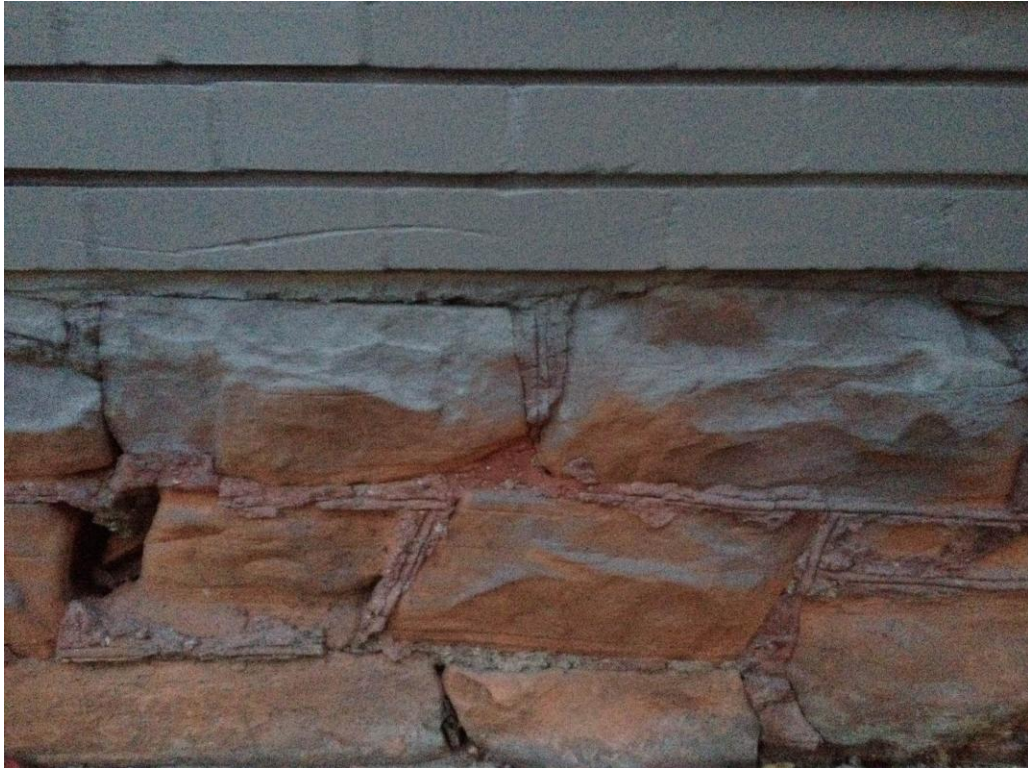
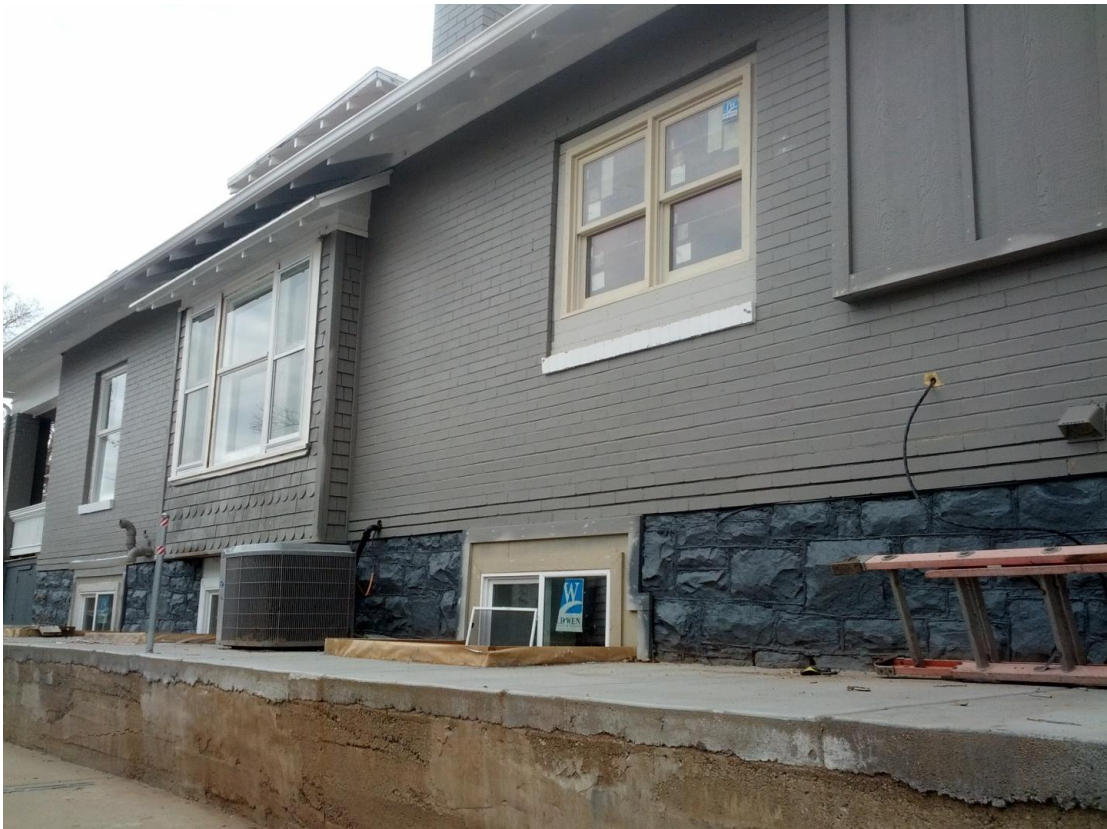
Original sandstone foundation painted dark gray

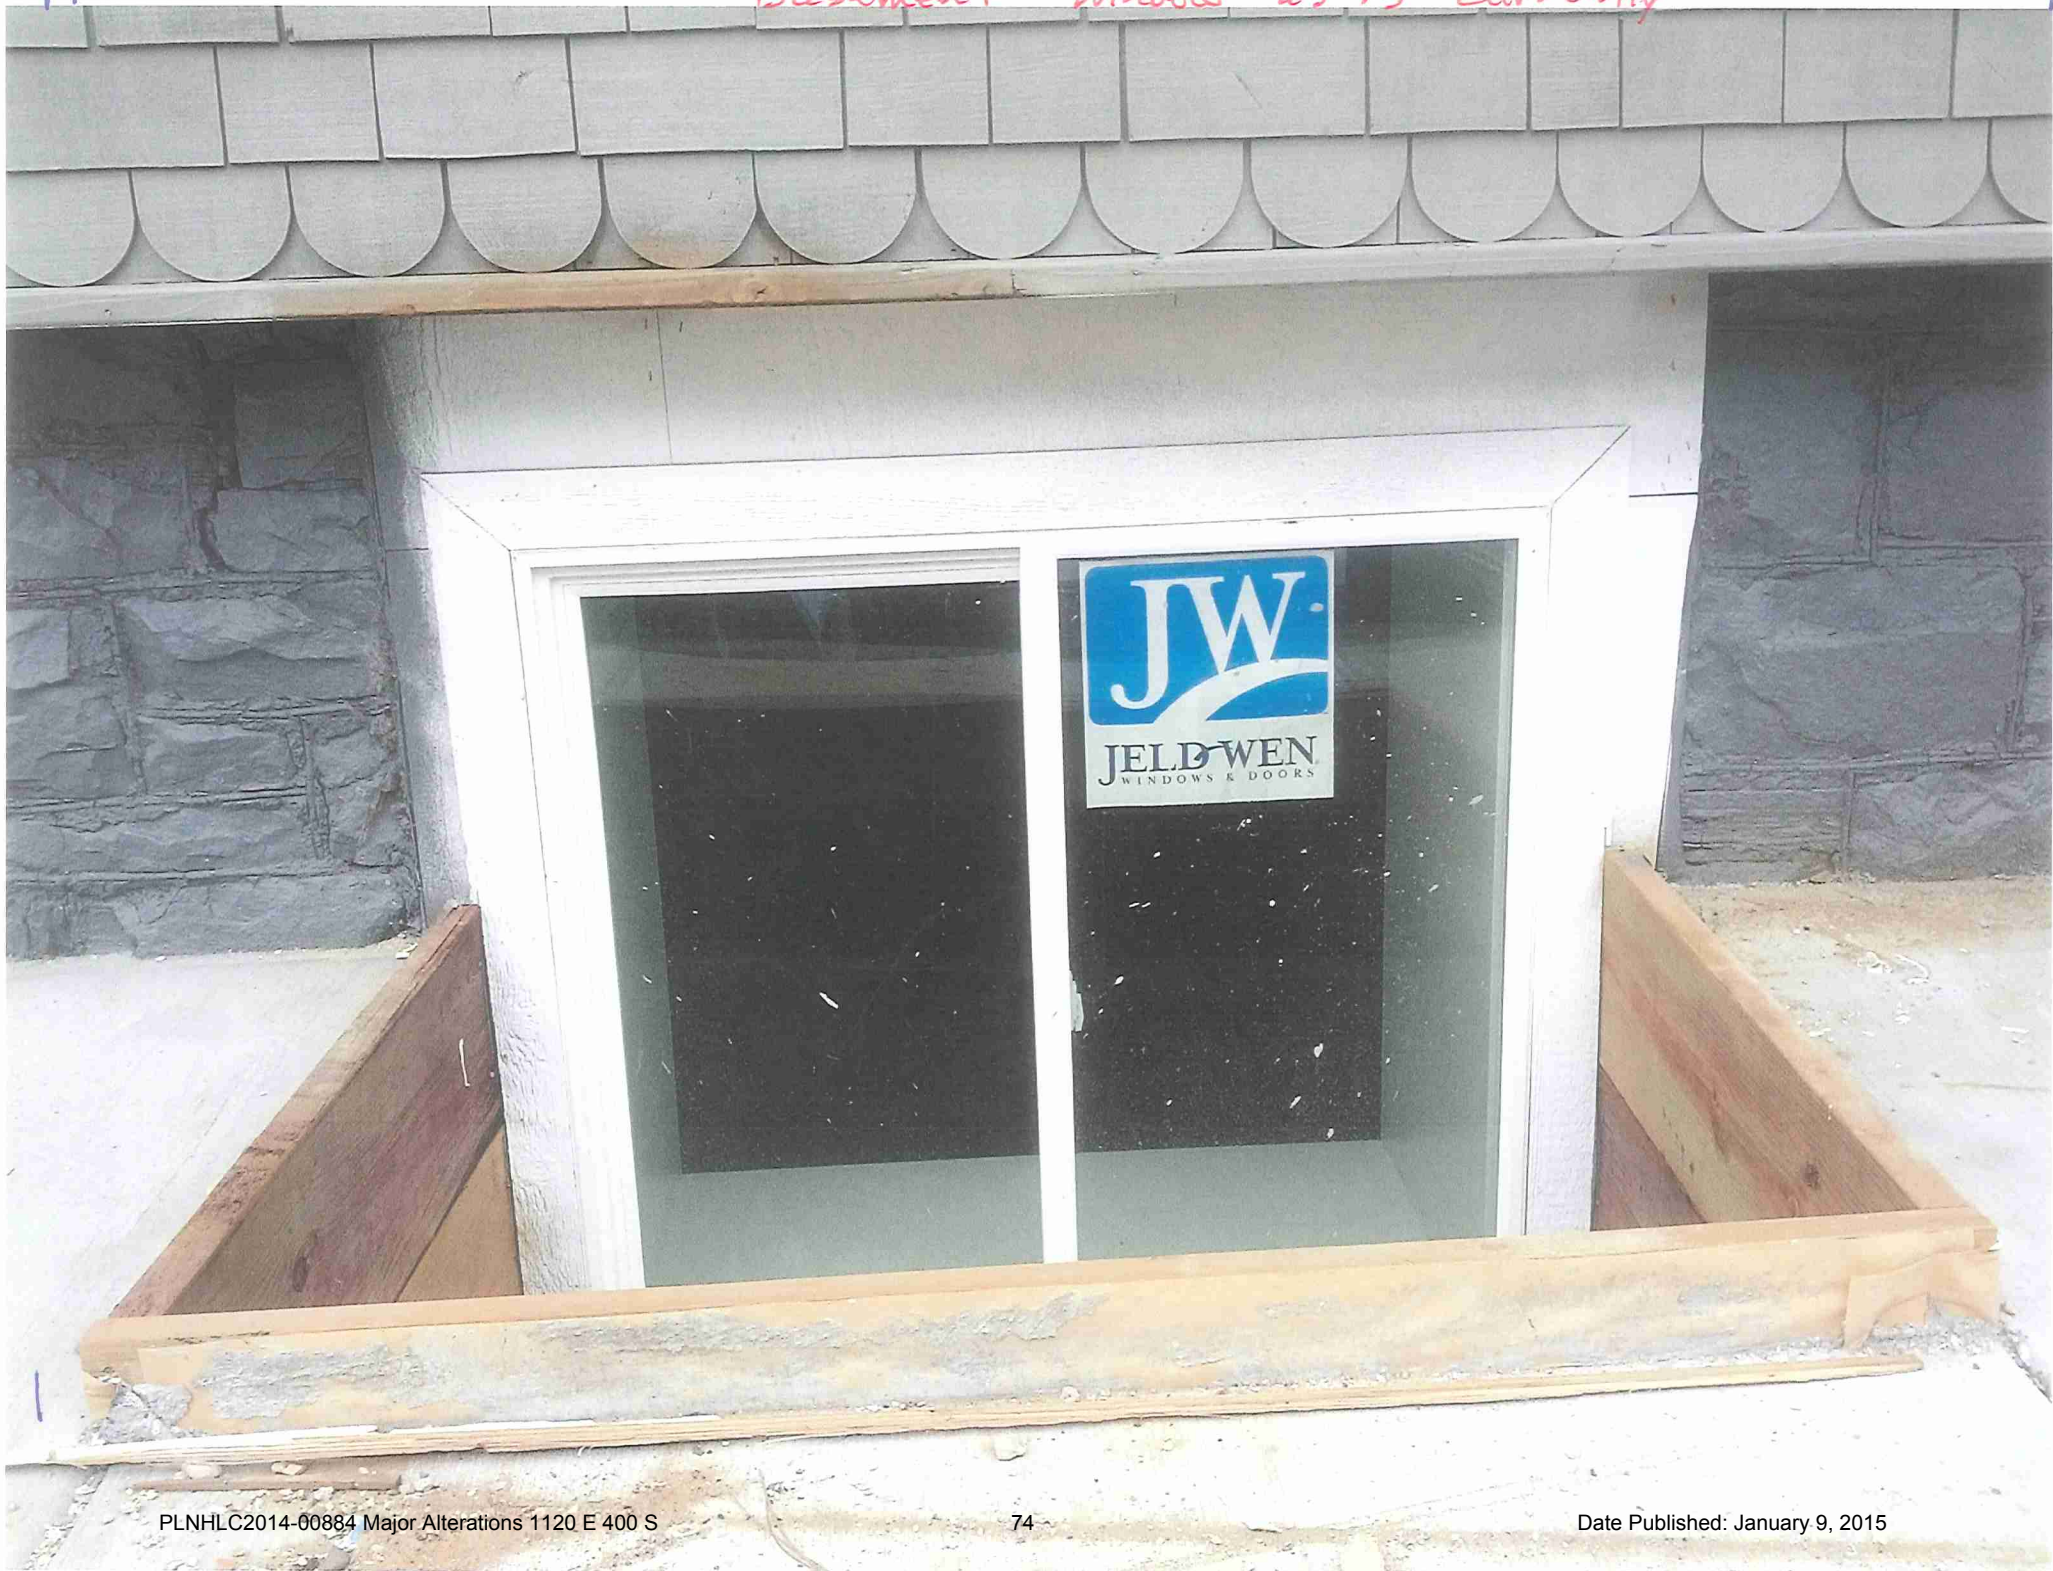
P1

The placement of 3 new basement vinyl sliding windows measuring 4'0" x 4'0" changes the character of the property and adversely affects the integrity of the foundation by altering and enlarging openings in the basement foundation which is not necessary to meet egress requirements. Although the new proposal contains 3 basement windows instead of 4, the proposal of 4'0" x 4'0" sliding windows changes the character of the home since the windows on the home are more vertical in nature. The initial COA included the approval for vinyl casement windows measuring 2'6" x 4'0" (which meets egress) to minimize the impact on the original sandstone foundation and maintain the vertical nature of the openings along the west façade of the building as all the historic windows are double hung. The former existing windows measured 2'6" x 2'0" and 3'6" x 3'0". The impact of cutting the original sandstone foundation should have been minimized, which suggested that the width of the openings of the new windows not exceed 2'6". The larger windows do not carry on the vertical character of the home and the larger cuts made in the sandstone adversely affect the original foundation of the home. We would allow new egress windows but they should be installed to preserve the original openings as best as possible and to minimize the damage to the sandstone foundation, in the most sensitive fashion.

The cuts made in the sandstone caused some of the sandstone to crumble around the new openings. A miratex material and scrap wood was used to fill in this space between the foundation and the window openings. This gap filling work completed around the basement windows was not completed in a consistent manner with all three windows and it appears to have been completed in a haphazard manner. Although the applicant proposes to improve what was installed by using hardie board to fill in the gaps between the sandstone and the window openings, it does not resolve the loss of the original sandstone foundation. Any sandstone lost as a result of the new windows should be reinstated to retain the physical integrity of the home.

Basement window as is currently

- The basement windows:
 - Replace with casement windows,
 - Resulting gaps from the crumbling sandstone between the windows and the original sandstone be repaired and filled in with high quality matching sandstone that is compatible

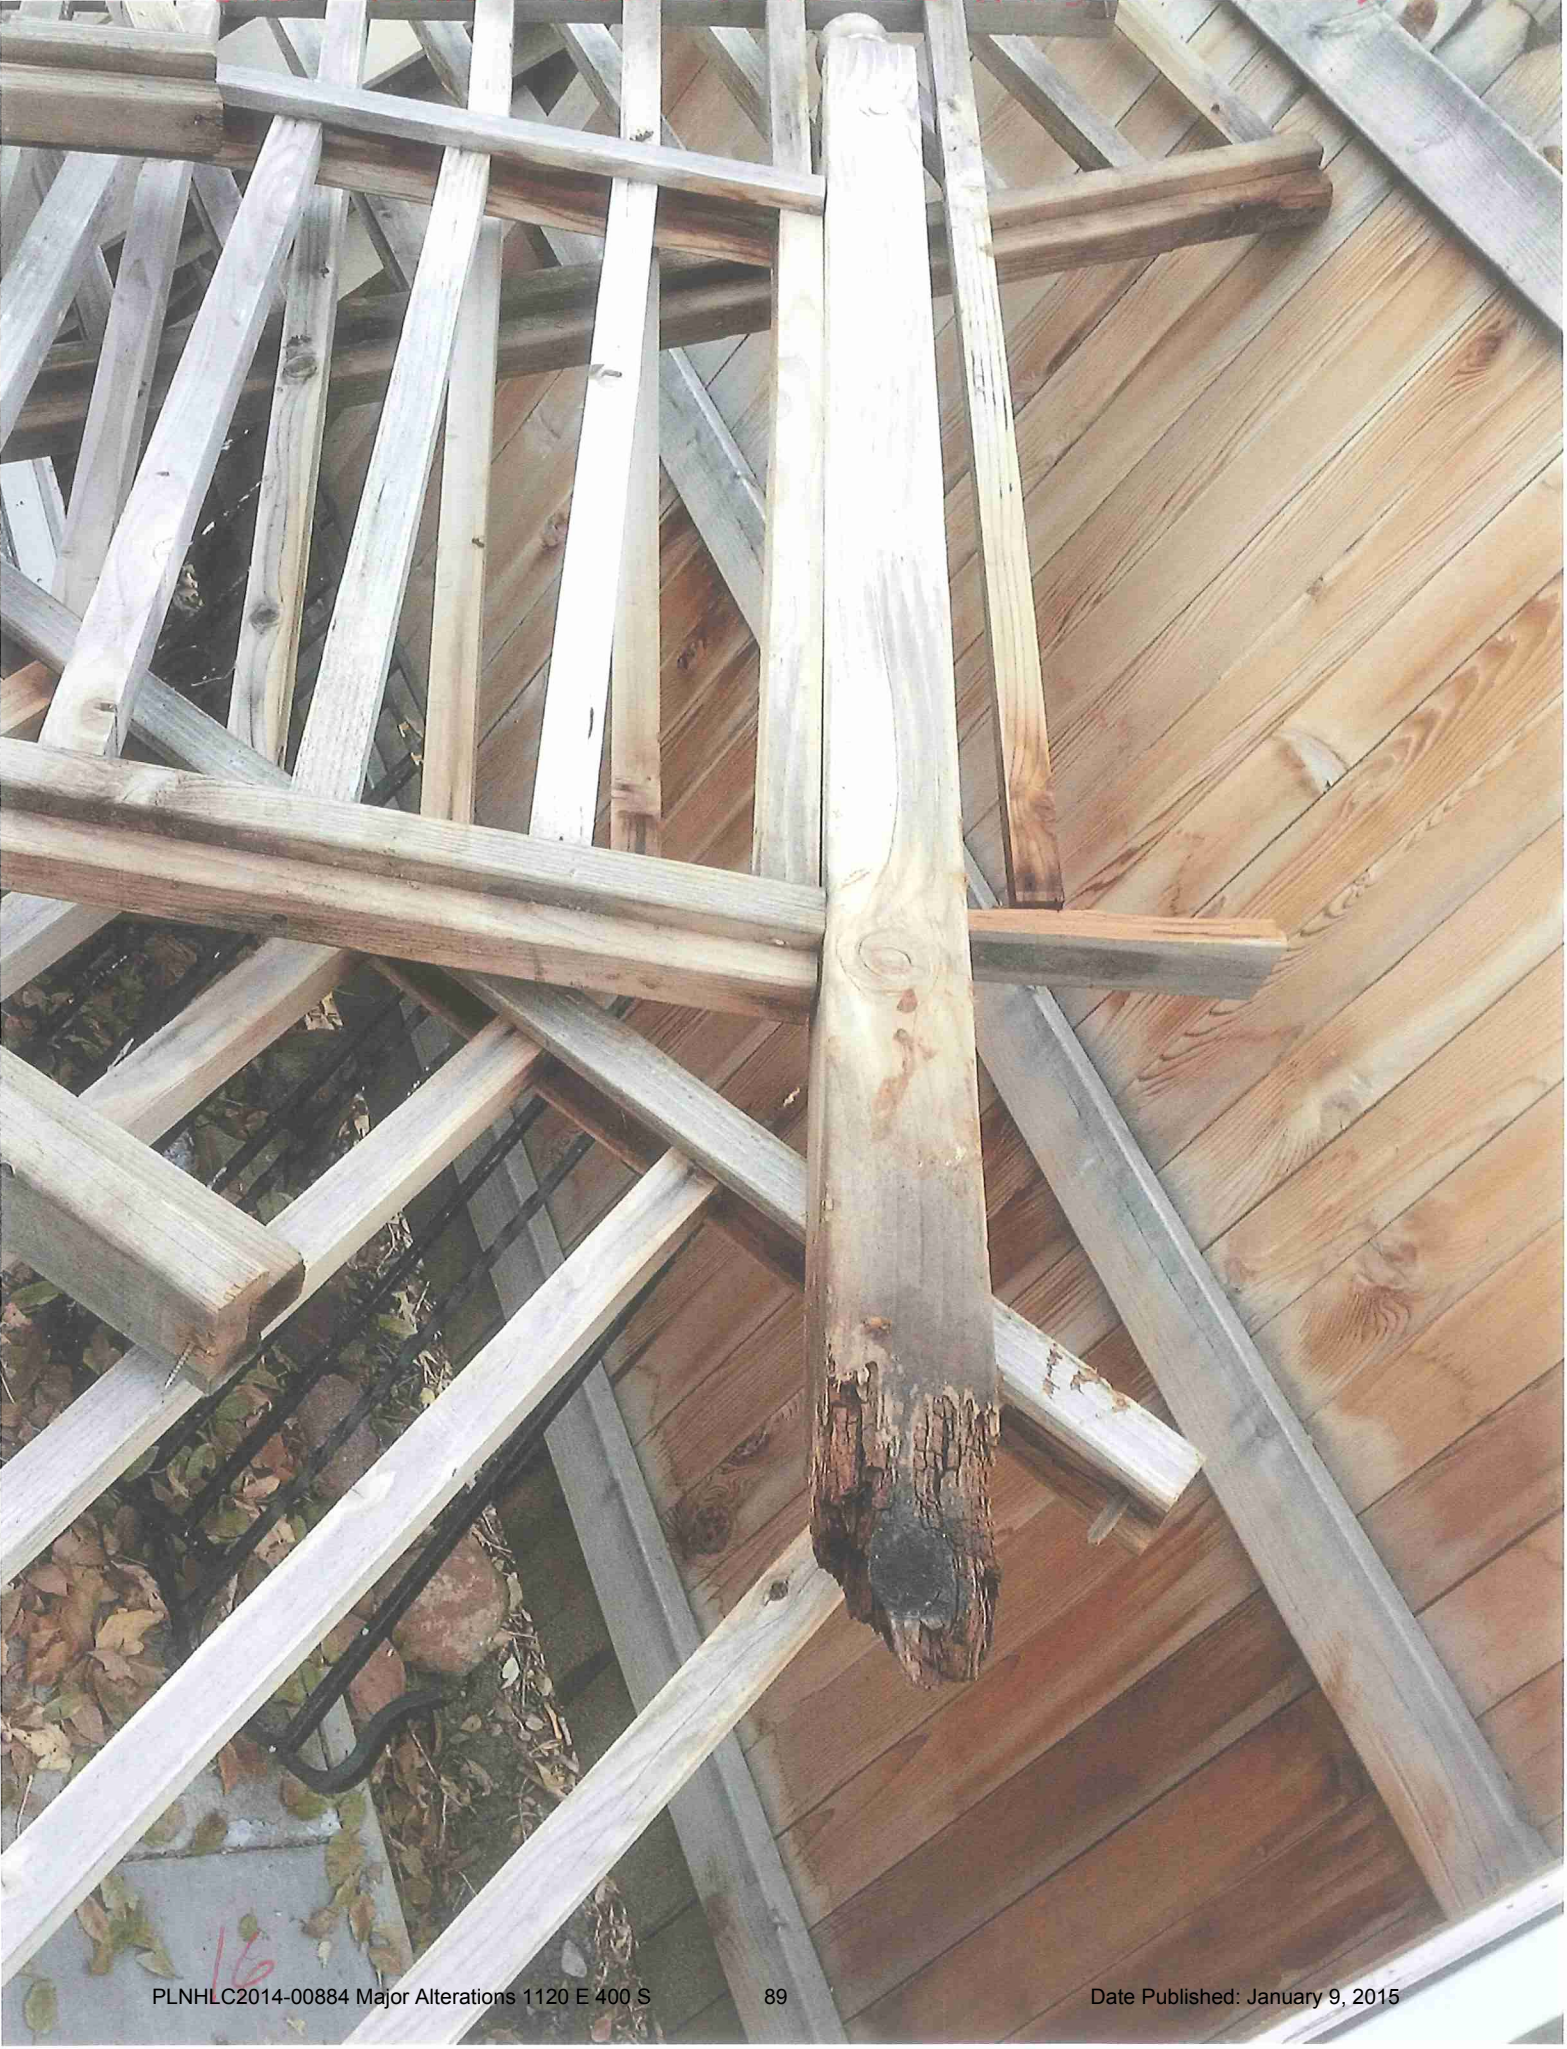
16

Old rotten deck materials (Fir)

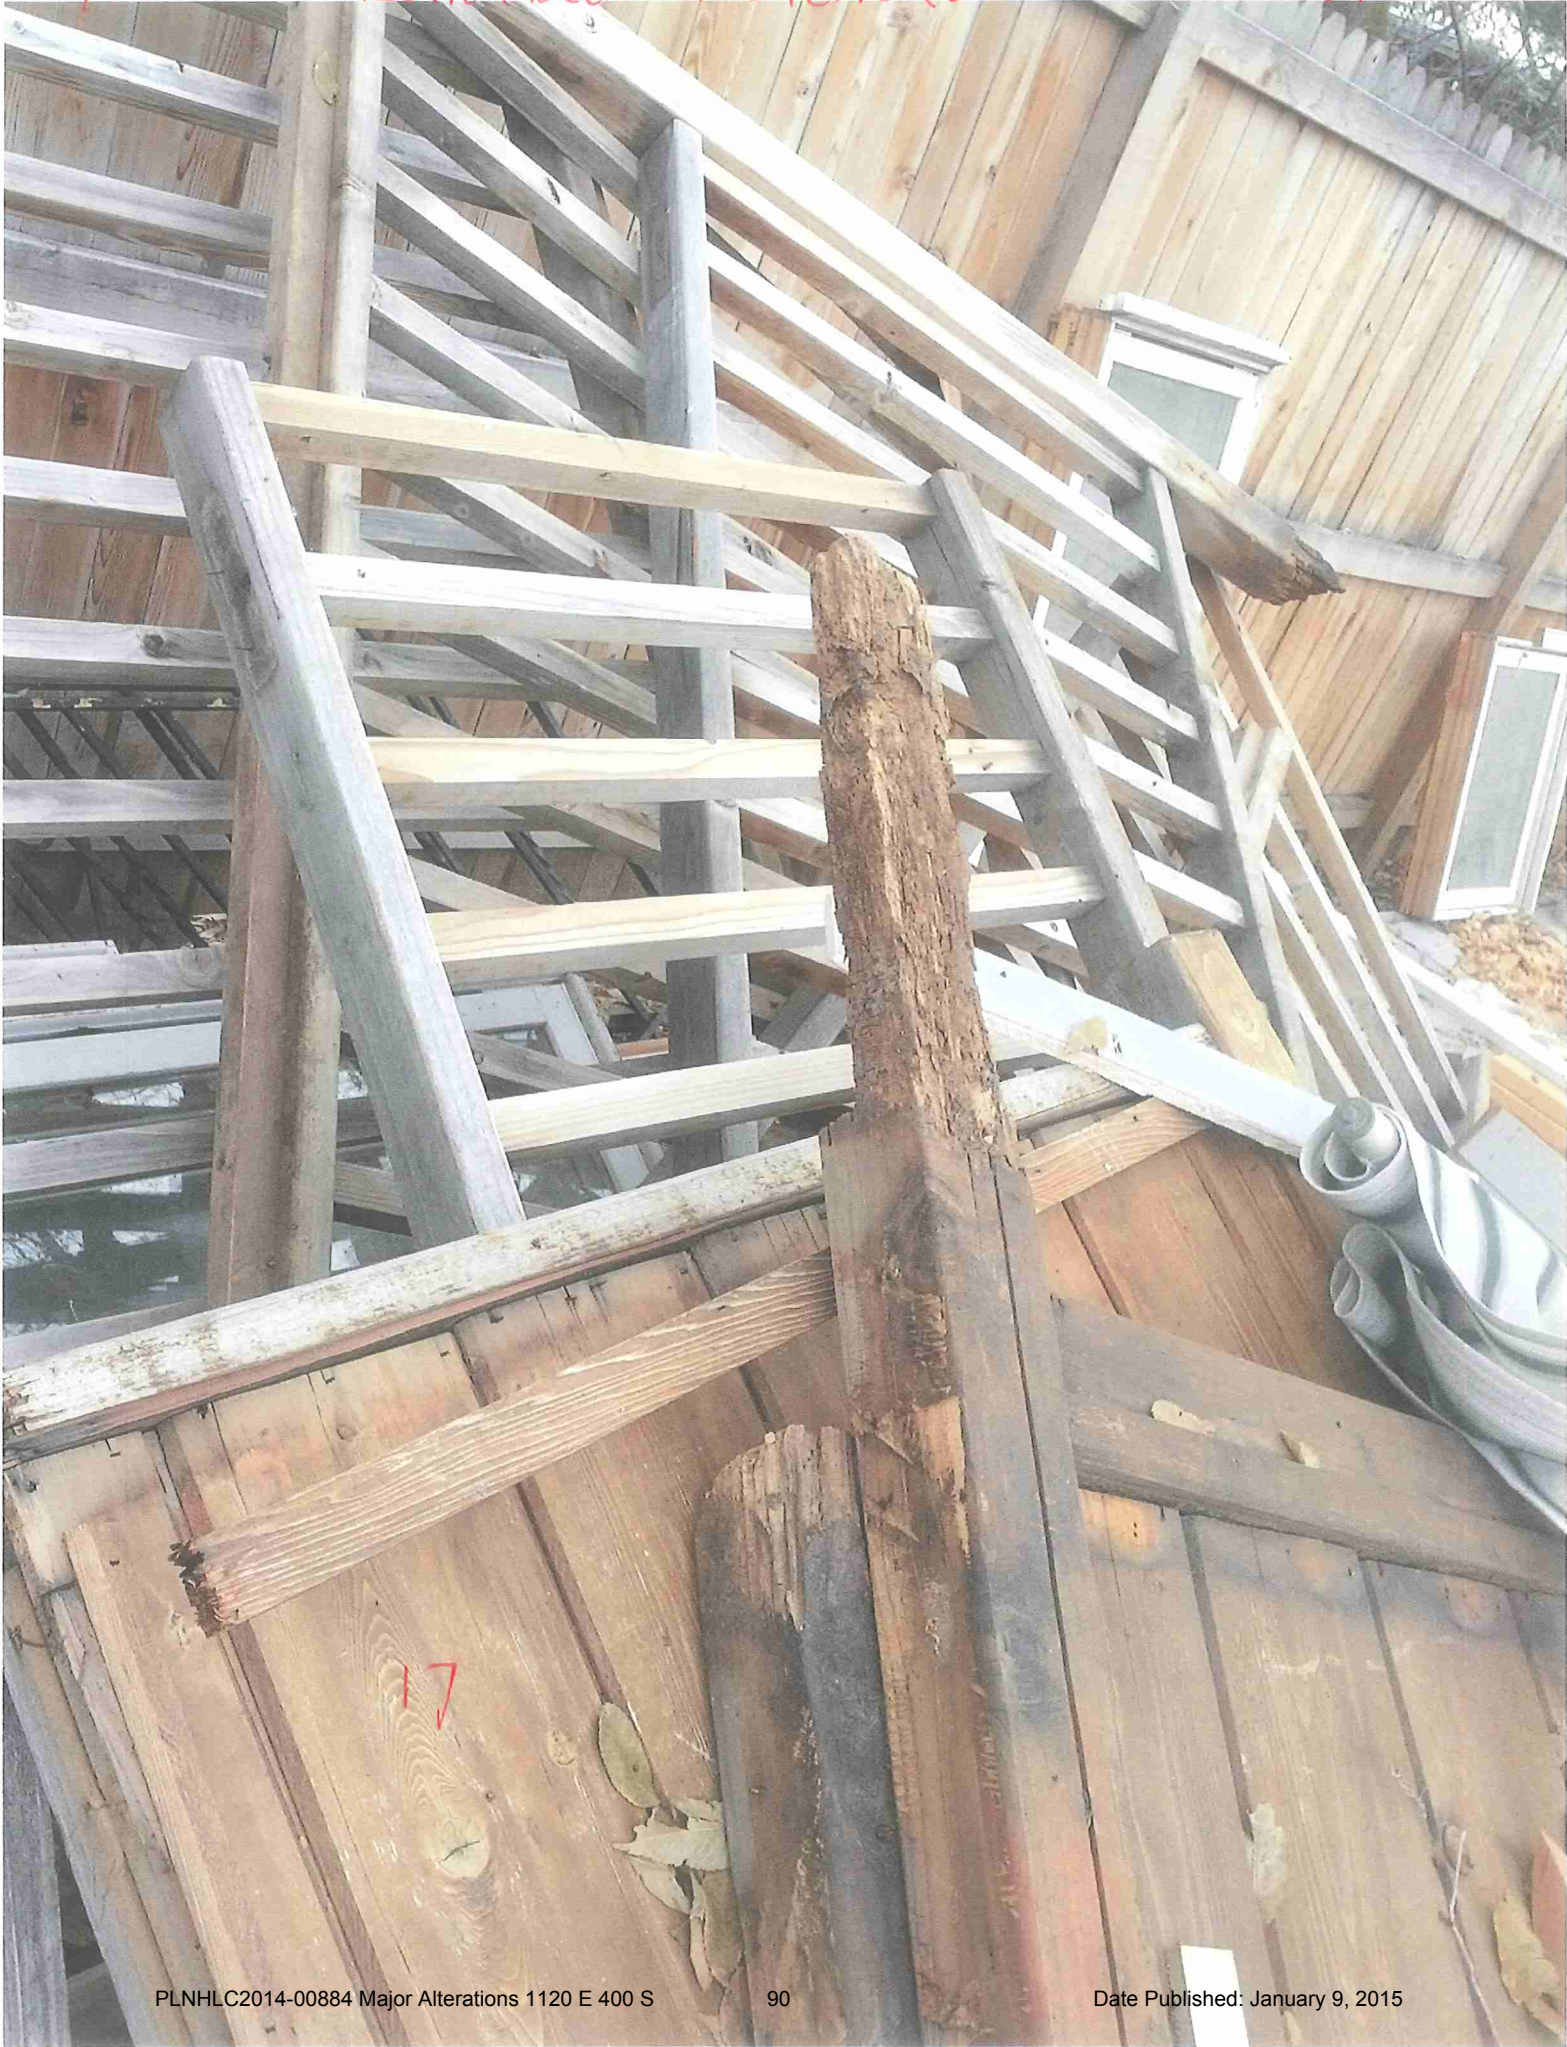
17

Rotten Deck materials
