HISTORIC LANDMARK COMMISSION STAFF REPORT

1120 E 400 S Major Alterations PLNHLC2014-00884 University Historic District 1120 E 400 South January 15, 2014

This is a request by Andrew Nielson for major alterations to the property located at approximately 1120 E. 400 South, in the University Historic District, and within the R-2 (Single and Two Family Residential) zoning district.

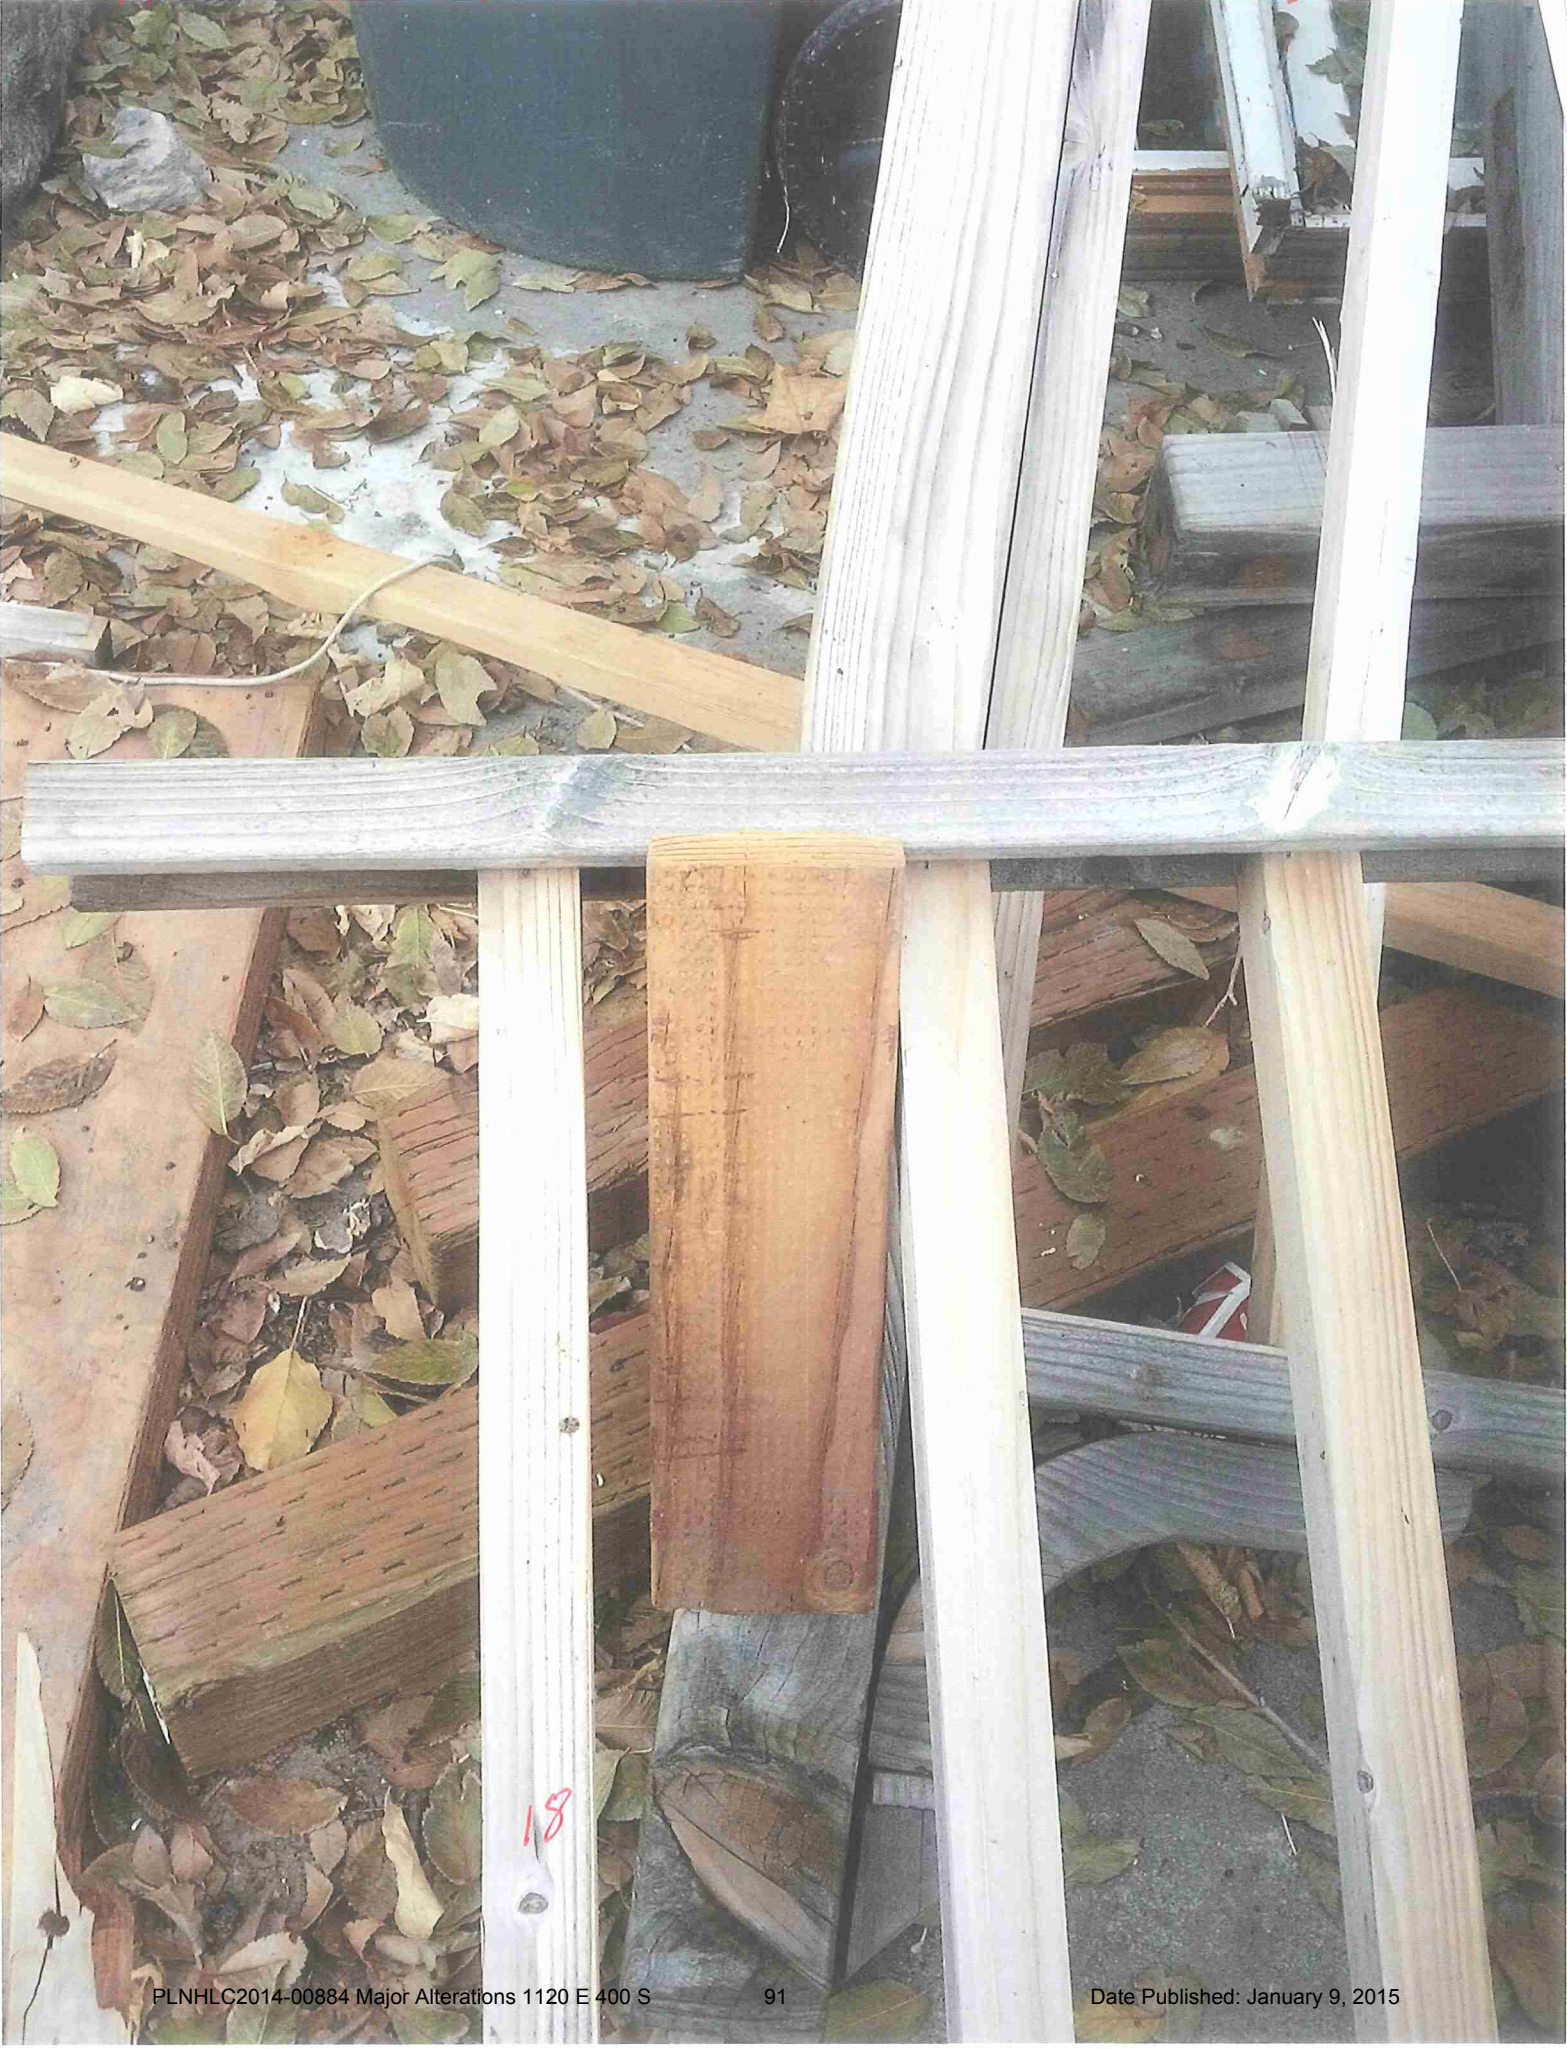
18

Old Deck Railing (Not too code)

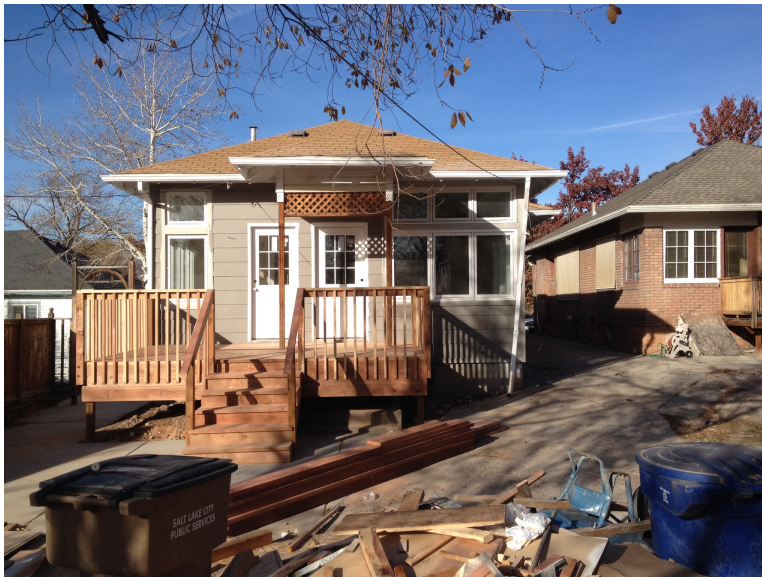
As it is our viewshed, our primary concerns are features on the rear (south side) of the home. The originally approved plans called for retention of the existing double doors onto an existing small porch and addition of another door on the southwest corner of the home at ground level. The roofline, which remains unchanged, has an overhang above the original double doors. As built, the wooden double doors were removed and replaced with 2 white metal doors. Placement of the doors is not symmetrical, and the overhang now extends awkwardly over the eastern door but not completely over the western door. The new porch appears to have been forced onto the house without any concern for either form or function. Wooden posts support the overhang, and these are now in the middle of the porch. The western post is in front of the western door when the home is viewed from the south. The stairs of the porch mostly align with the western door, but if one were to ascend the stairs, sidestepping around the post could be required to approach the door.

The lap siding on the southern and eastern faces of the home is of different widths. From our home, both faces are concurrently visible and clearly different. The approved plans stated that the siding would match.
