Work Session Memorandum

Re: PLNHLC2018-00454 Rehabilitation of Cottage and New Additions at approximately

287 G Street and 480 6th Avenue

REHABILITATION OF COTTAGE & NEW ADDITIONS

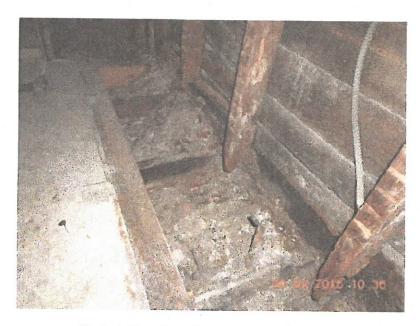
Many bearing wall studs have rotted out at the connection to the floor which has caused severe settlement of the roof and main floor walls.

Photo 1 -Deteriorated wall studs and floor joists

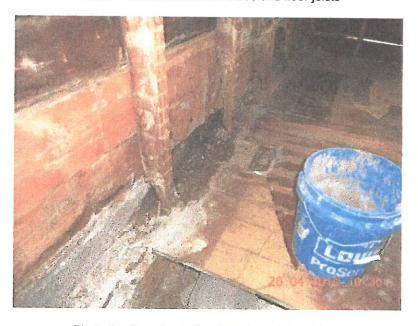
Photo 2 - Deteriorated wall studs and floor joists

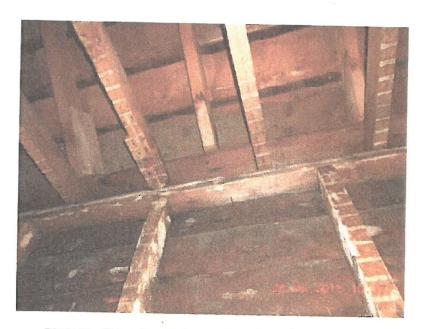
Photo 3 - Discontinuous load path at roof to wall connection

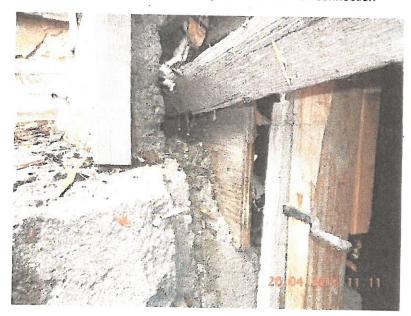
S-4	Deteriorated floor joists, non- treated wood embedded in concrete.	Remove rotten or deteriorated floor joists, new floor joists should bear on a pressure treated sill plate attached to the foundation.	1,4,5,10	3

Photo 4 - Non-treated wood embedded in concrete

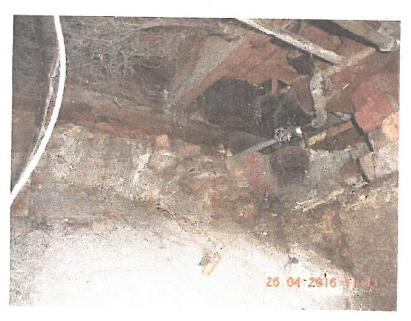
Photo 5 - Inadequate load transfer connection at deteriorating foundation

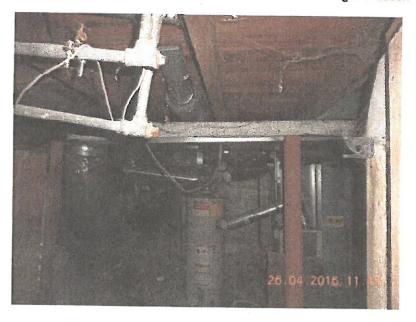
Photo 6 – Apparent added shoring for floor support

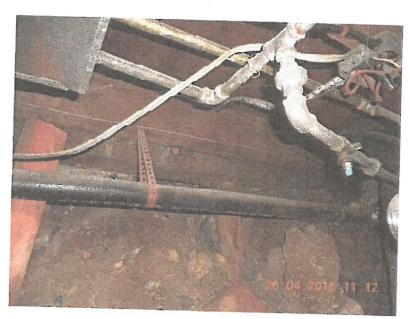
Photo 7 - Inadequate load transfer connection at deteriorating foundation

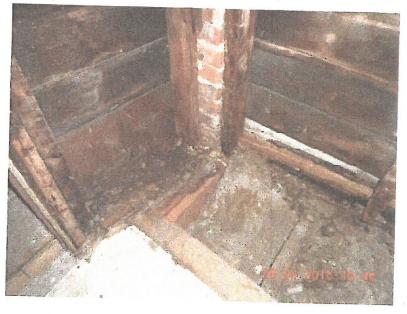
Photo 8 - Masonry infill in wall cavity

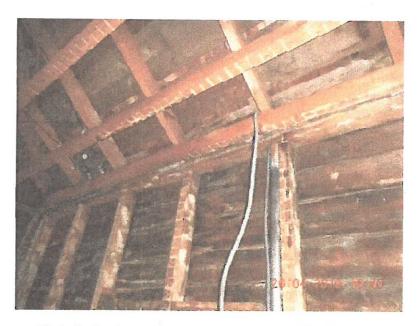
Photo 9 - Inadequate load path, rafters bearing on ceiling joist

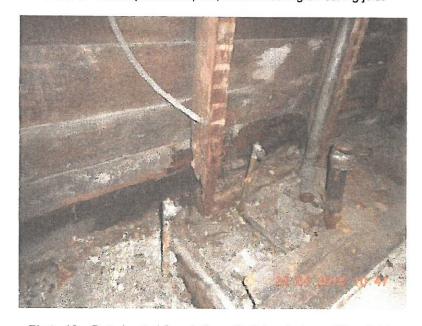
Photo 10 - Deteriorated foundation, sill plate, studs, and floor joists

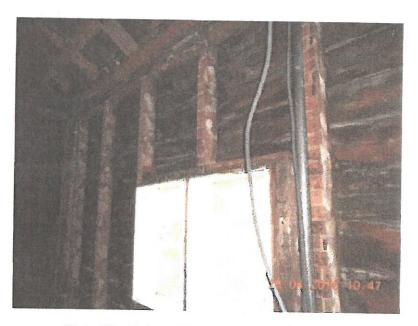
Photo 61 - No headers, king studs at wall openings

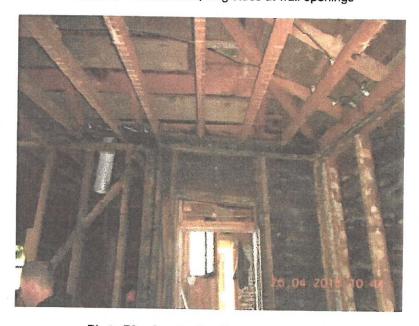
Photo 72 - Apparent settlement at west wall

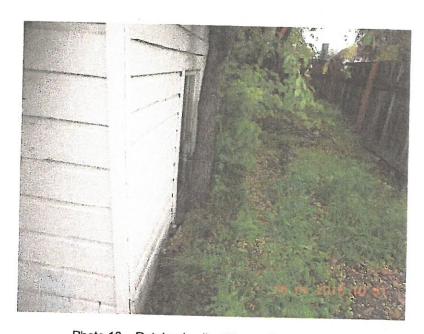
The north wall and possibly a portion of the west wall appear to currently retain soil. This has likely caused the bearing wall studs and exterior sheathing to become saturated and eventually rot out to the

Photo 13 - Retained soils at the north exterior wall

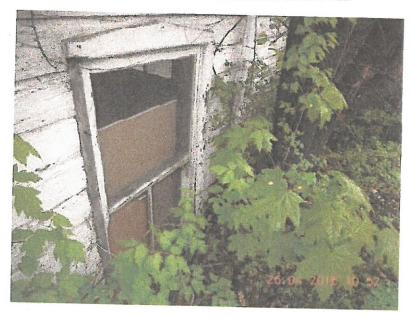
Photo 14 - Retained soils at the north exterior wall

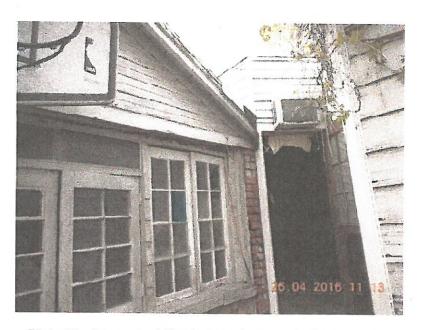
Photo 15 - Apparent addition between home and adjacent garage

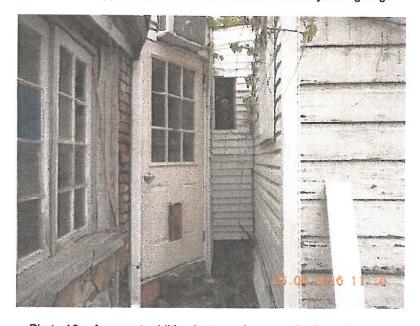
Photo 16 - Apparent addition between home and adjacent garage

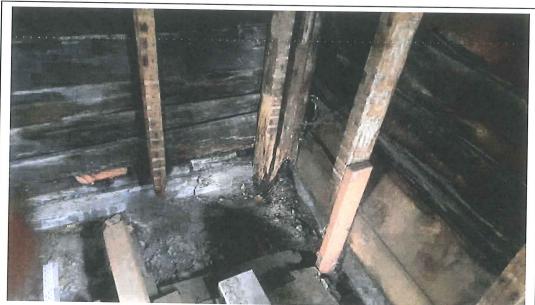
Photo 1: Deteriorated walls studs

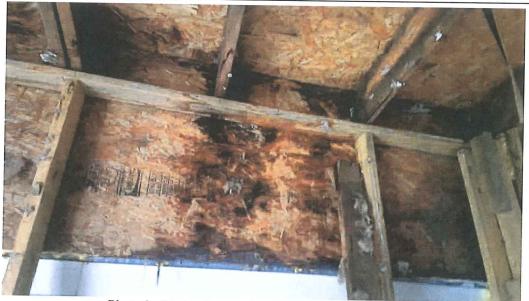
Photo 2: Water damage from improper roof drainage

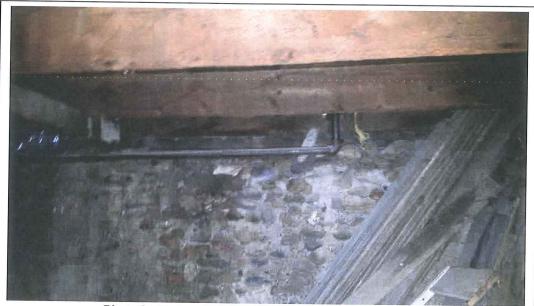
Photo 3: Under sized floor beam and cobble foundations.

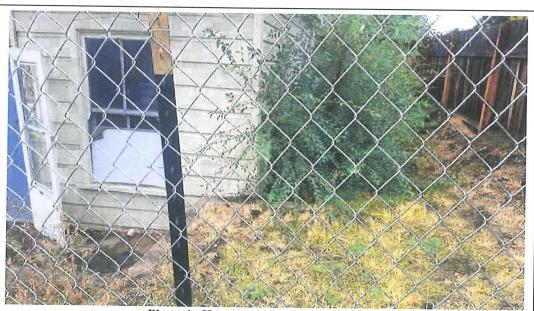
Photo 4: Home constructed below grade.

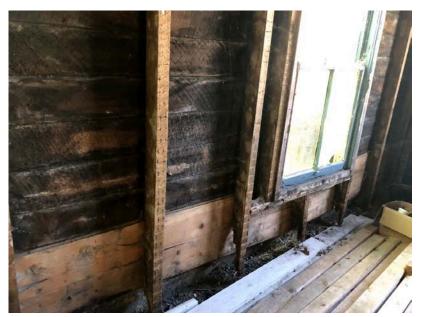
Image 1 - Existing North exterior wall being pushed by the current grading to be reinforced with new exterior retaining wall and foundation wall.

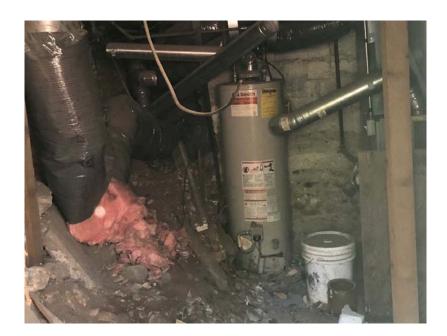
Image 7 - Existing basement/foundation (to be replaced.)
