Staff Report

PLANNING DIVISION
DEPARTMENT of COMMUNITY and NEIGHBORHOODS

To: Salt Lake City Historic Landmark Commission
From: Kelsey Lindquist, Senior Planner, (801) 535-7930
Date: August 27, 2020
Re: PLNHLC2020-00016

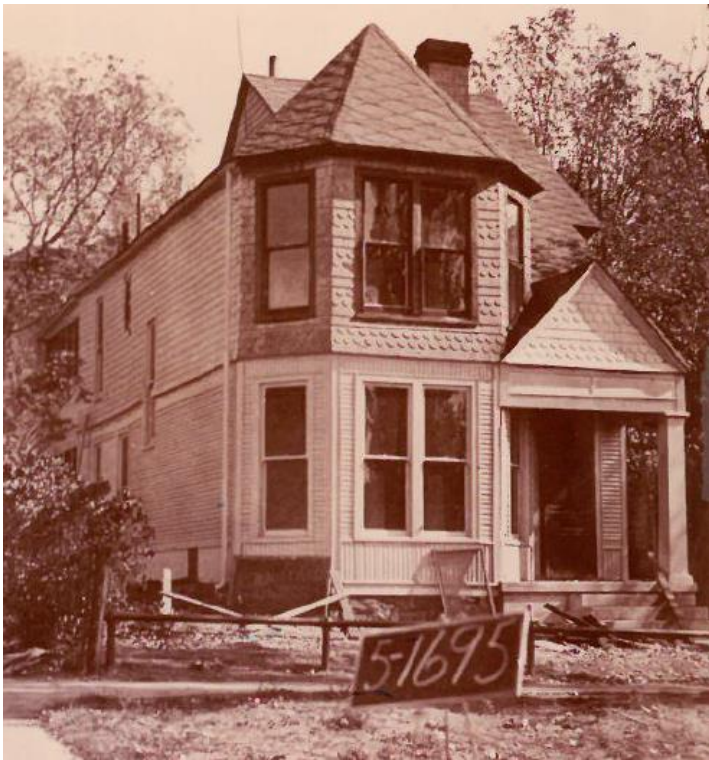
Archived Photo of 88 R

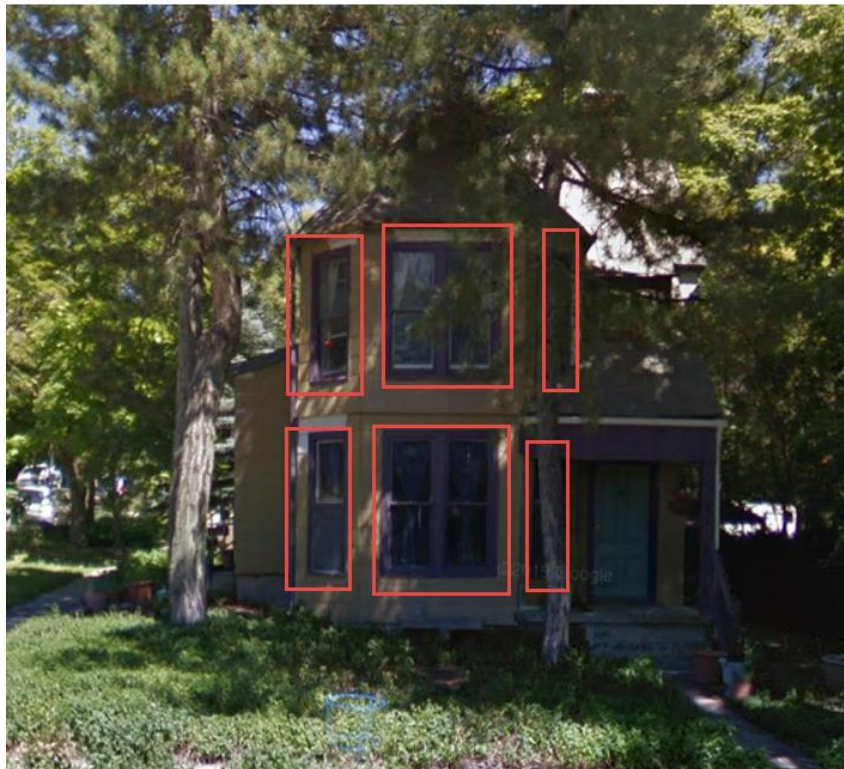
The modification to the windows that placed this property under enforcement, include the replacement of eight original windows on the primary elevation located in the two-story segmental bay. The replaced windows were wood and double-hung in style. The property owner removed these windows and installed vinyl picture windows on the front portion of the bay and single-hung windows on the first and second story sides of the bay.

Photo of Windows Prior to Replacement

The applicant's supplemental information, regarding the replacement of the windows, suggests that the windows were in disrepair. The applicant claims that the windows were drafty, broken and in need of replacement. Unfortunately, staff was not contacted to conduct a site visit to evaluate the state of the original windows. Staff regularly conducts site visits with concerned property owners to discuss the condition of original windows and various options for restoration, repair or storm window installation. It is difficult to know the condition of the original windows, prior to the removal and replacement.

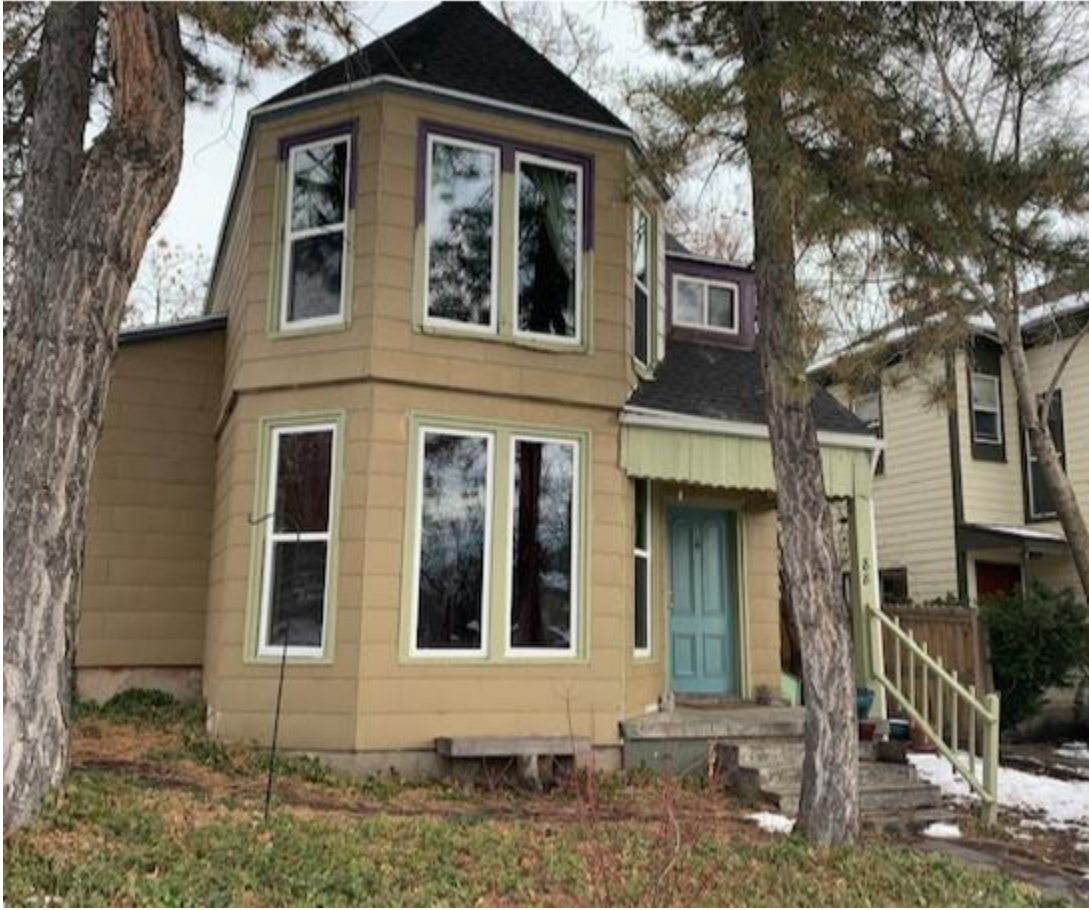
Image of the Replaced Windows

In the case of original windows that are beyond repair, compatible and appropriate replacements are required. In the case of the subject property, the applicant replaced original double-hung windows with fixed picture windows on the front elevation. The side windows were replaced with single-hung vinyl windows. Additionally, the reveal of the original windows was lost with the removal and replacement. The vinyl windows were installed to be flush with the wall plane of the structure. The window trim has remained.

The subject windows were character defining features of the subject property. If a window is not a character defining feature, or readily visible from the public way, staff may administratively approve a request for repair or replacement. However, based on information contained within this report, the request to completely remove and replace a character defining feature is not in keeping with applicable standards.

If denied, the recently installed windows would need to be replaced with windows in the appropriate style and material.

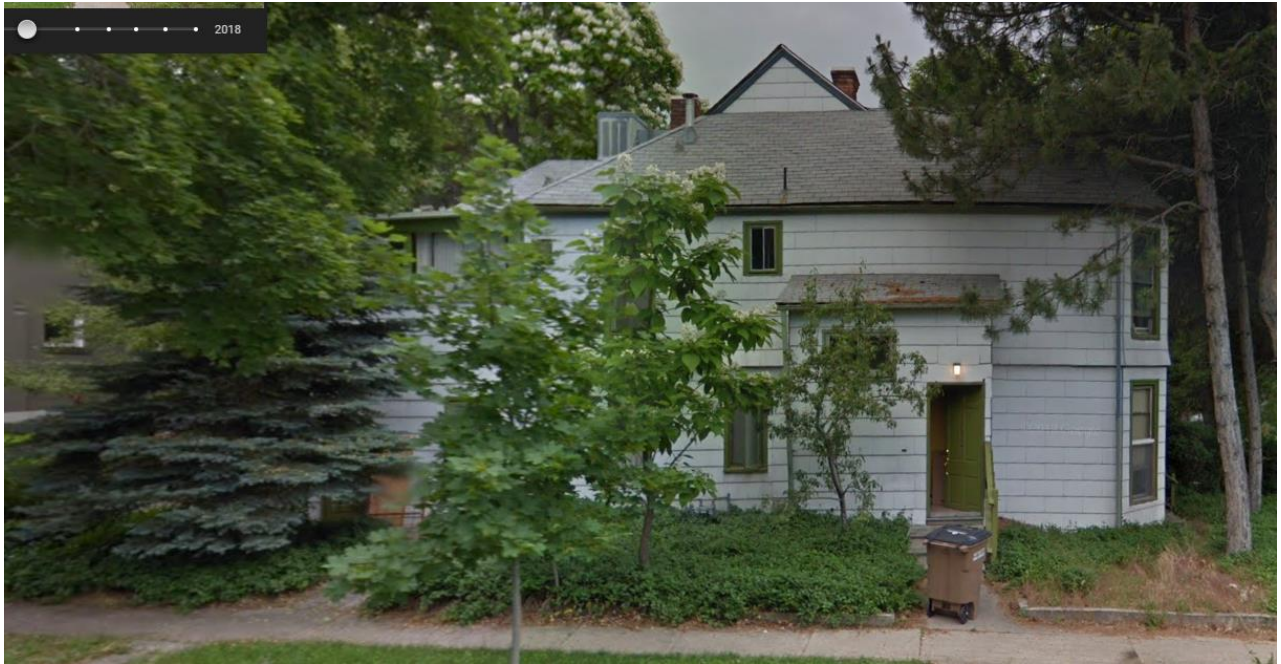
The applicant provided information that relates to the windows on the north and south elevations. The windows do not appear to have been recently installed; however, they are not original. The street view from 2011 illustrates two wooden casement windows on the north elevation. This elevation has been significantly modified with the construction of the side addition. Staff does not believe that these previously replaced windows detrimentally impact the character defining features of this structure. This elevation, while it is visible from the public way, has been significantly altered and is still considered a secondary elevation.

Image of North Elevation from 2011

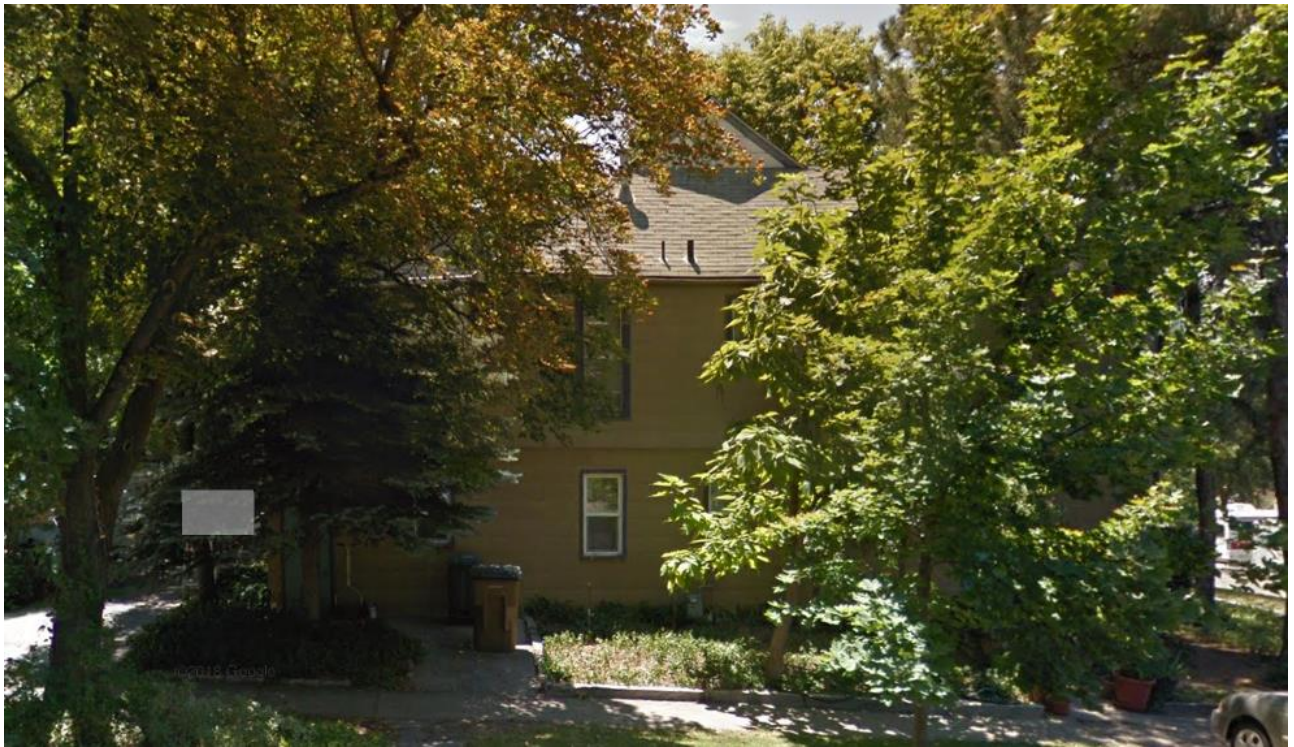
Current Image of North Elevation
