Staff Report

To: Salt Lake City Planning Commission
From: Katia Pace, (801) 535-6354, katia.pace@slcgov.com
Date: February 3, 2022
Re: PLNHLC2021-01144 – Major Alterations @ 229 N Almond Street

Major Alteration

PROPERTY ADDRESS: 229 N Almond Street

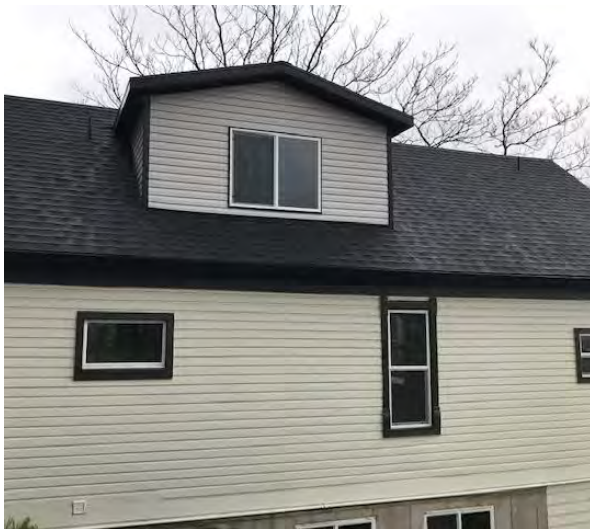
Findings: All windows visible from the street should be replaced back from vinyl to wood windows. Original openings should be kept. Since replacement is necessary, the new material should match the material being replaced in composition, design, texture and other visual qualities. The proposed wood windows will match the material being replaced. Window trim on the East elevation will match the original window trim.

North façade showing windows to be replaced

1. Replace three vinyl windows in the East elevation, front façade, with wood double hung windows.
2. Replace three vinyl windows on the main level of the North elevation with wood windows.
3. Replace three vinyl windows on the main level of the South elevation with wood windows.
4. Approve the five windows in the West elevation as is.
5. Replace window trim on primary façades to match the original trim.

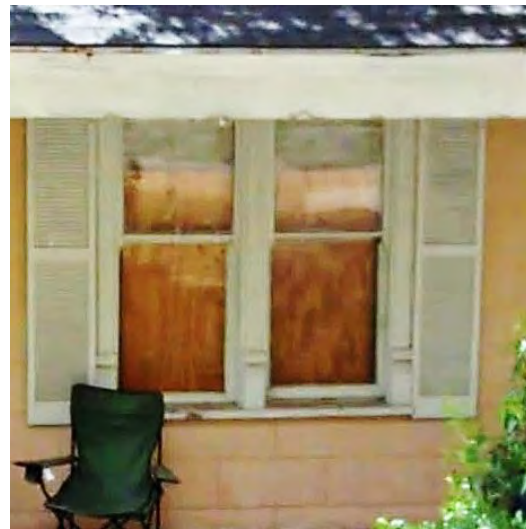
Front façade, showing original trim

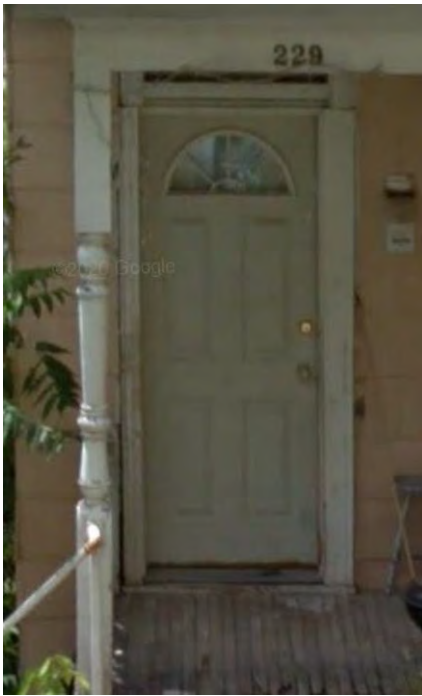
The front and basement doors were replaced. The front door was not original to the house, the original transom above the front door was kept. The frame for the front door was partially replaced.

Door before renovation.

1. Approve the front door that was replaced.
2. Replace the frame of the front door to match the original frame.
3. Approve basement door as is.

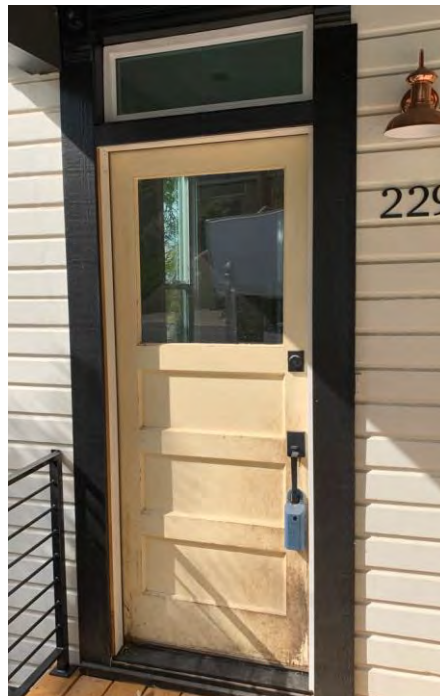
Door after renovation (proposed door).

Findings: Elements such as the front door should be recognized as products of their own time. The front door that the applicant has replaced corresponds to the architectural style and period of significance of the historic home.

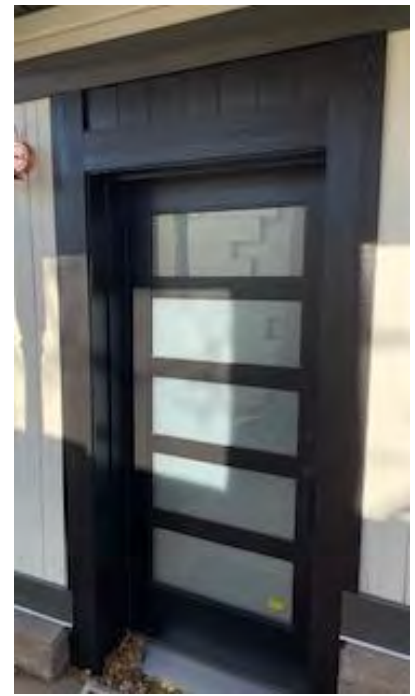
The door to the basement entrance was replaced with a door that is out of period.

Basement door after renovation.

The door to the basement entrance is not visible from the street and staff is not recommending a new door at this location.

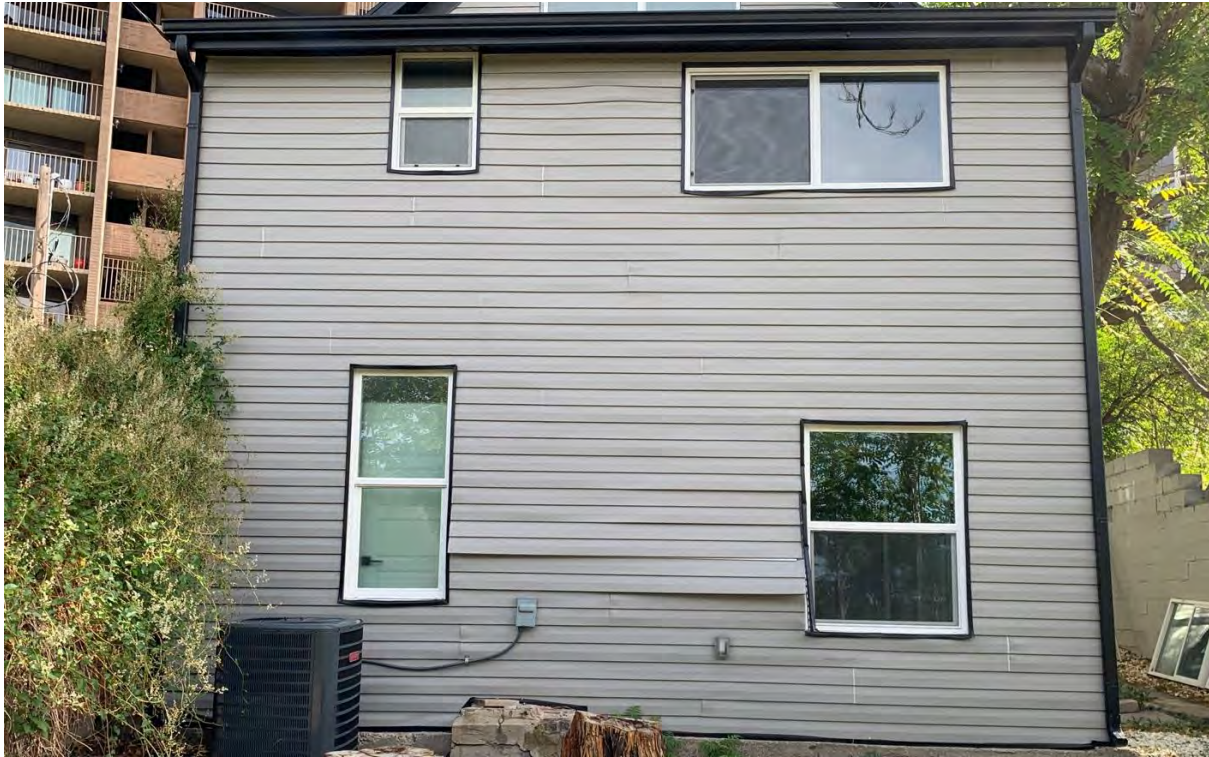
The siding on the rear addition was replaced with cement fiber lap on the north and south elevations and with vinyl siding on the west elevation.

Findings: Vinyl is not a material that is allowed in historic properties, staff finds that the standards for renovation would be met by removing the vinyl siding and replacing it with cement fiber.

West Elevation – showing vinyl siding proposed to be replaced with fiber cement.

1. Approve the removal of the asbestos shingles and exposure of the original siding.
2. Replace the vinyl siding on the West elevation with cement fiber.

4. Replacement of vinyl siding on the rear of the house with cement fiber lap siding, same as the siding on the sides of the addition.

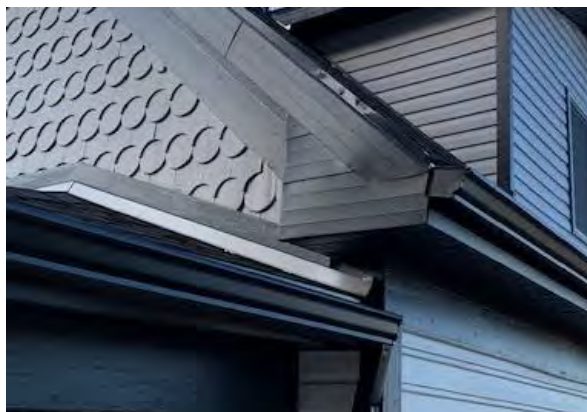
The hipped roof front porch is supported by lathe-turned posts. The posts are original to the house. The wood soffit and fascia on the porch and around the house were replaced with aluminum. The wood barge boards on the gable were also replaced with aluminum.

Barge board after renovation.

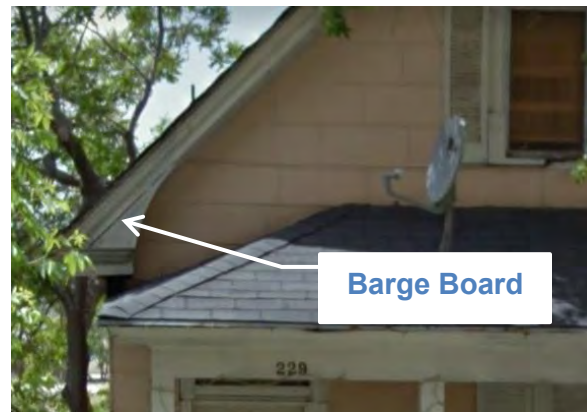
Barge board before renovation.

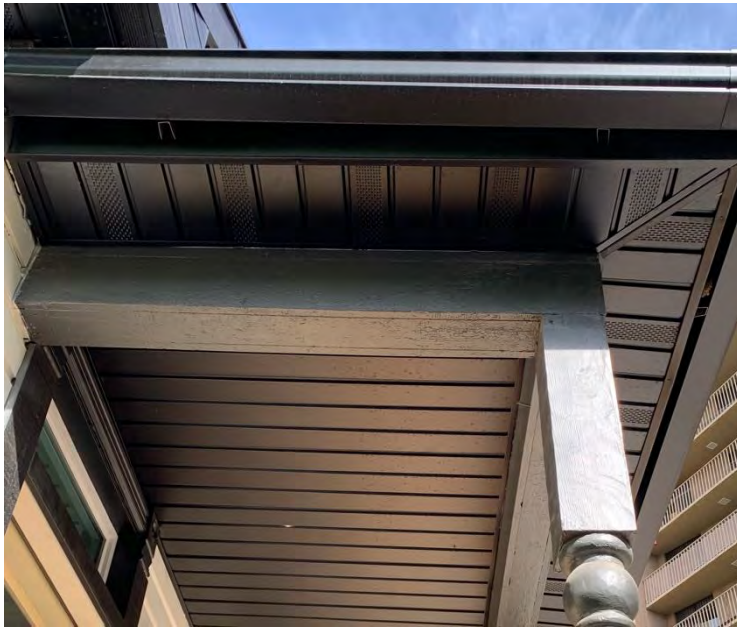
East Elevation - Soffit and fascia to be restored.

Where replacement of the soffit and fascia is necessary, the use of materials that are like the original in both style and physical qualities is appropriate.

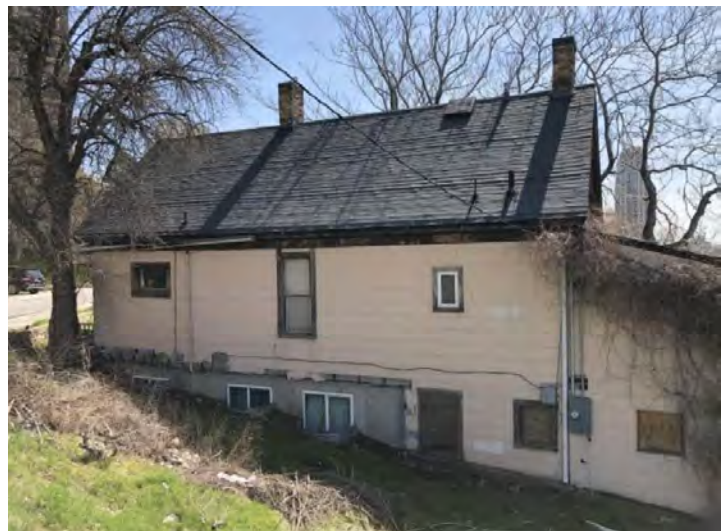
Findings: Chimneys are considered significant features of historic properties. Removal of chimneys is not typically recommended for approval by staff. In this case, staff is not recommending that the chimneys are reinstalled because they would be replica chimneys since the actual chimneys are gone.

North Elevation – two chimneys removed.

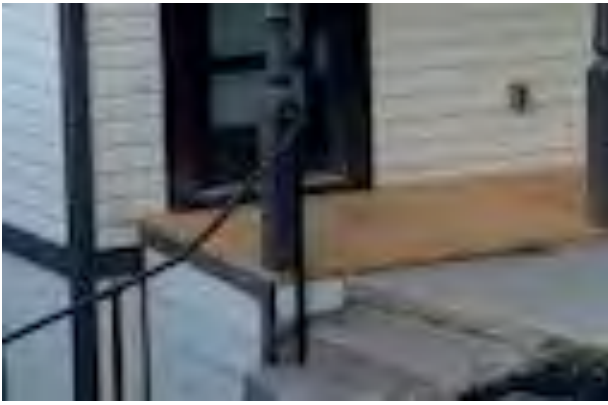
Deck on the front porch was wood and was deteriorating, the new renovation replaced the deck with wood.

East Elevation – Deck after renovation.

Proposal: Approve replacement of the wood deck in the front porch.

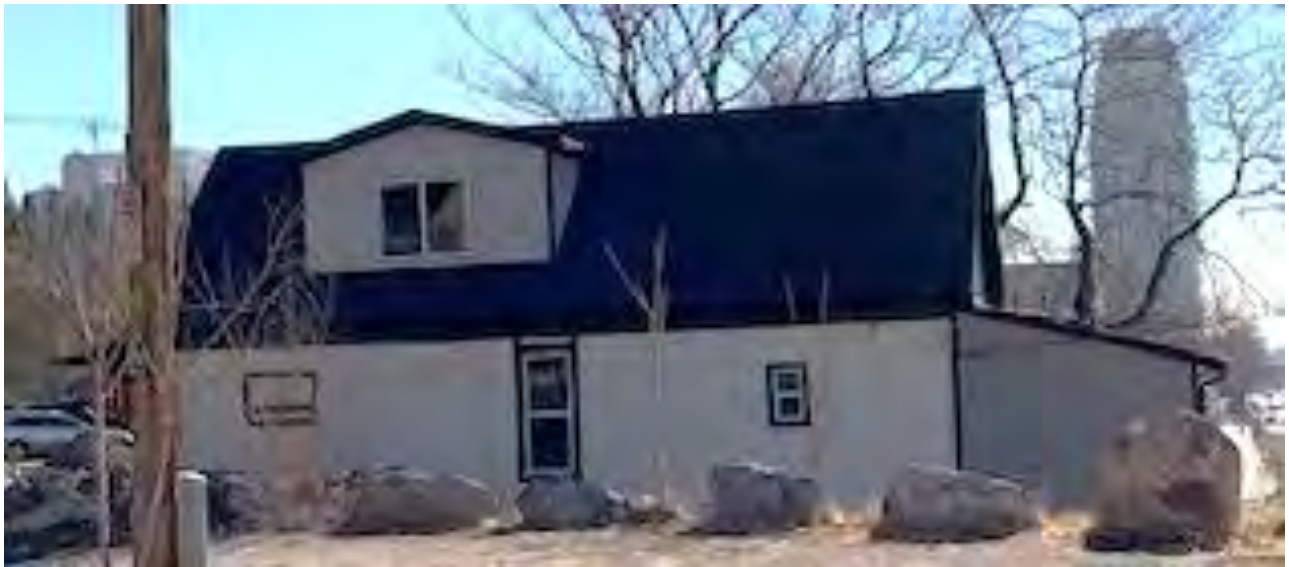
North Elevation – Showing dormer to be removed.

Findings: Dormers need to be designed to be compatible with the size, scale, material and character of the property, neighborhood, or environment.

Proposal: The applicant proposes to remove the dormer on the North elevation and restore the roof to its original form.

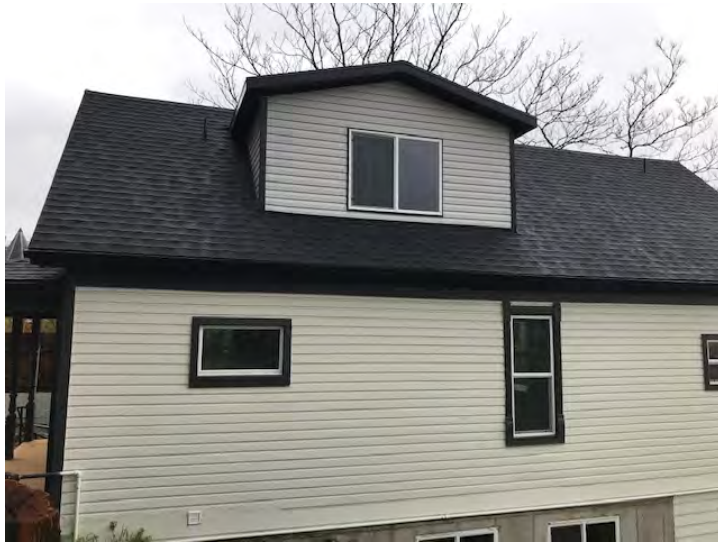
North façade showing windows to be replaced.

Findings: Deteriorated architectural features shall be repaired rather than replaced wherever feasible. In the event replacement is necessary, the new material should match the material being replaced in composition, design, texture and other visual qualities. The proposed wood windows will match the material being replaced.

1. Replace three vinyl windows in the East elevation, front façade, with wood double hung windows.
2. Replace three vinyl windows on the main level of the North elevation with wood windows.
3. Replace one vinyl window on the dormer with two wood windows (North elevation).
4. Replace windows in the South and West elevations with vinyl windows.

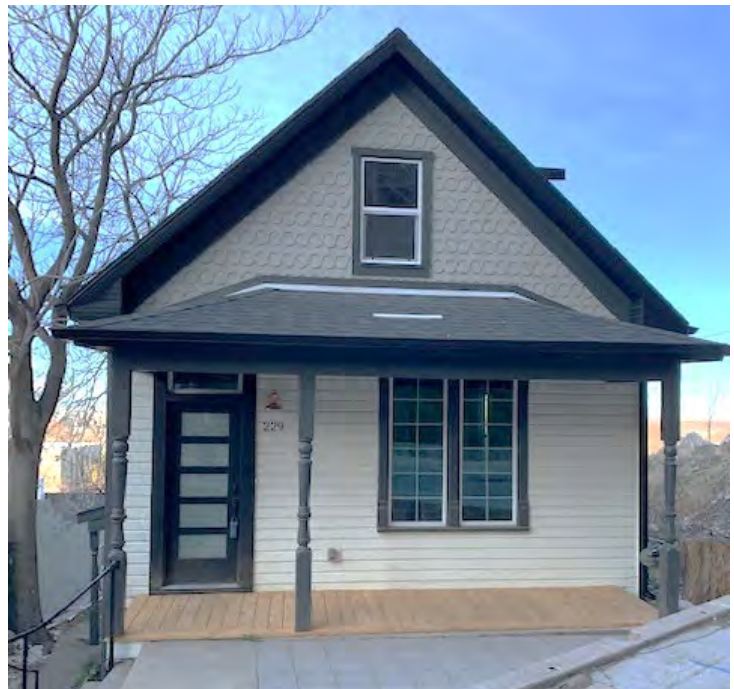
Front façade showing windows and door to be replaced.

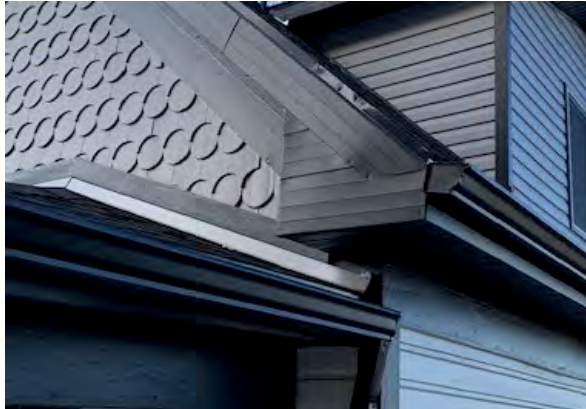
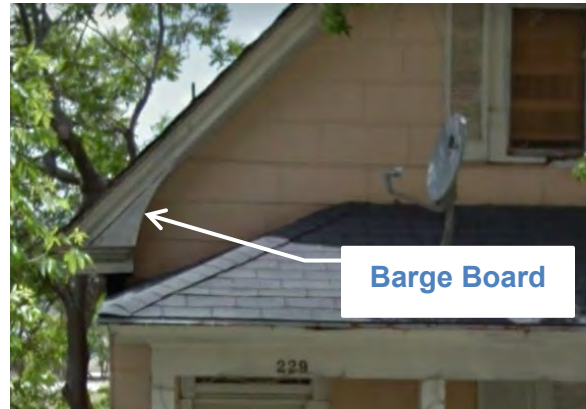
Findings: The barge board is a distinctive feature and an example of craftsmanship that characterizes this historic home and needs to be reinstated. The function of the barge board in this house is still needed.

Front façade gable showing aluminum fascia and before the barge board was removed.

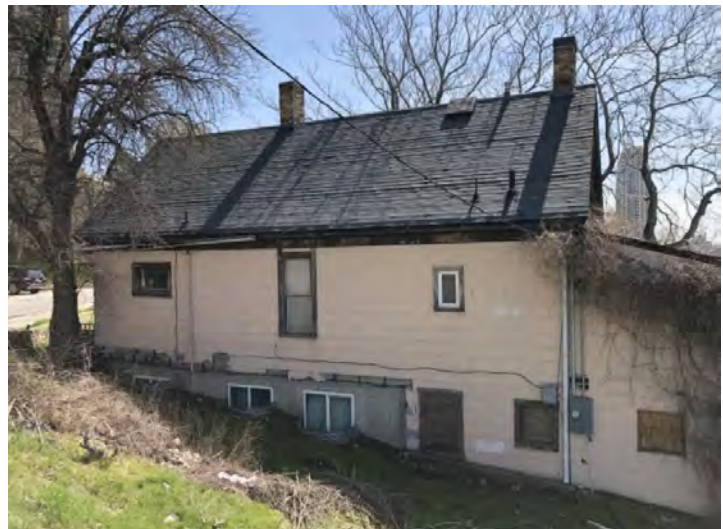
Findings: Chimneys are considered significant features of historic properties. Removal of chimneys is not typically recommended for approval by staff. In this case, staff is not recommending that the chimneys are reinstalled because the new dormer was built where the front chimney was located, and the rear chimney would be a replica since the actual chimney is gone. Standards for renovation of a contributing structure do not recommend reconstruction of nonexistent features.

Before photo showing two chimneys. North façade.

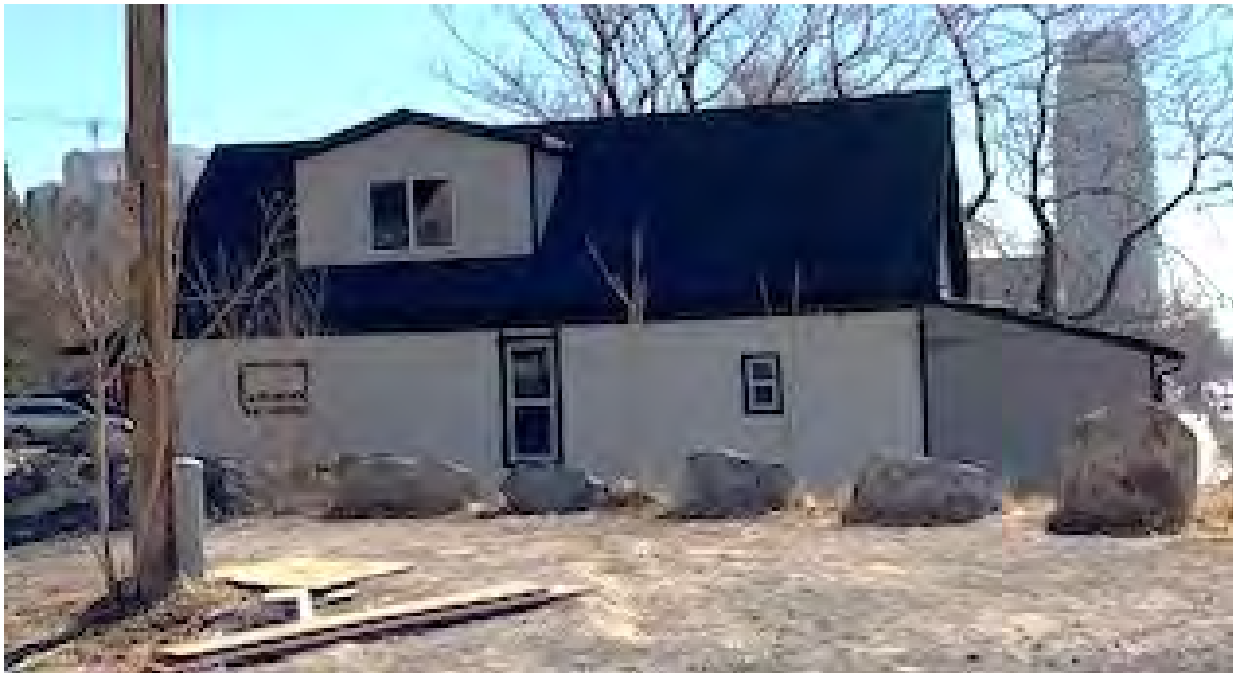
The dormer was built with a pitched roof that does not match the pitch of the house, the pitch on the dormer is a lot flatter in comparison with the pitch of the house. The dormer is very wide and has a horizontal orientation. The roof ridge of the dormer is of the same height as the roof ridge of the house. The siding of the dormer is vinyl and the window on the dormer is a sliding vinyl window.

Showing the new dormer on the North elevation.

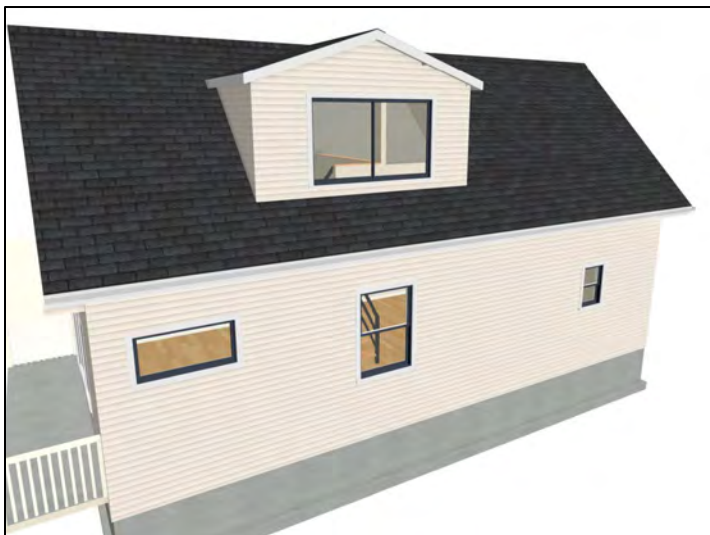
Existing dormer with gable roof and sliding windows

1. Change the roof shape from a pitch roof to a hip roof, to echo the hip roof at the front of the house. That would be in keeping with some of the roofline and would reduce some of the height of the dormer.
2. Change the siding of the dormer from vinyl to wood lap siding.
3. Change the one vinyl/slider window of the dormer with two double hung wood windows side by side.

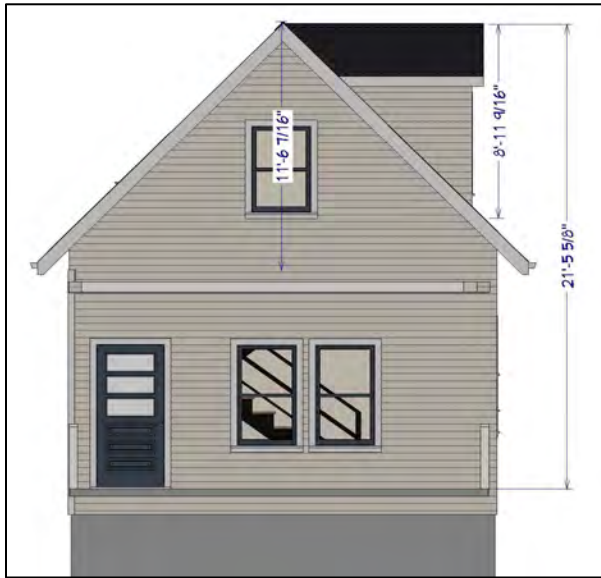
The proposed hip roof is a positive change because it relates to the roof on the porch of the house and it lowers the height. The proposed changes to the siding and window are also positive. However, staff finds that this dormer, even with the proposed changes, would not be subordinate to the roof and the scale of the home.

Pitch roof, approximately 9 feet tall to the ridge of the dormer roof
