# Staff Report

## MINOR ALTERATION – WINDOW REPLACEMENT

**PROPERTY ADDRESS:** 129 West 400 North  
**PARCEL ID:** 08-36-283-009-0000  
**HISTORIC DISTRICT:** Capitol Hill Local Historic District  
**ZONING DISTRICT:** SR-1A and H Historic Preservation Overlay District

PLNHLC2021-01311  
129 W 400 N Window Replacement  
Historic Landmark Commission  
April 7, 2022

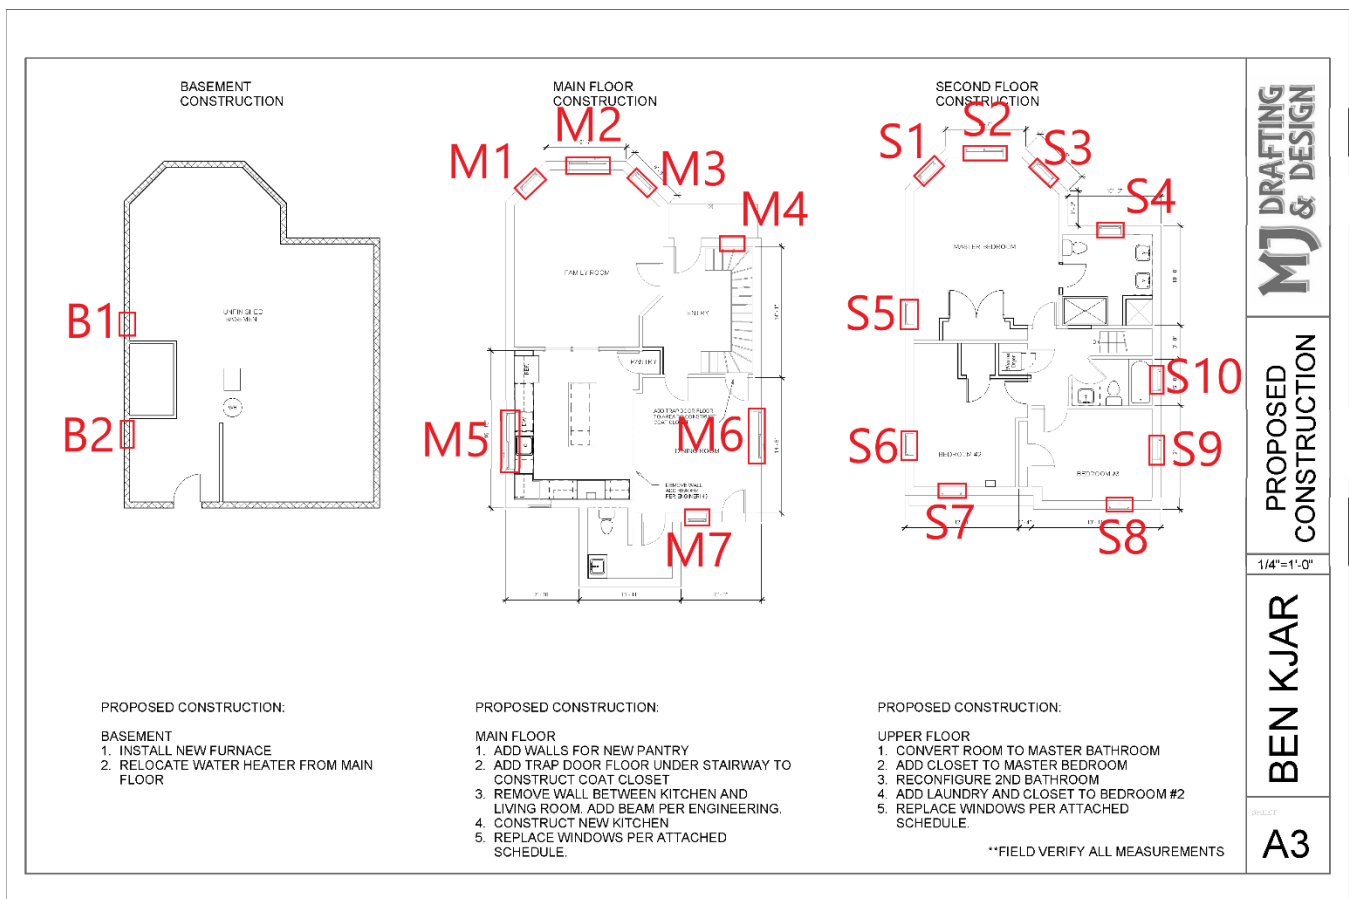
Figure 1: Floor plan submitted by Applicant with Staff annotations of replaced windows.

The Applicant has replaced multiple windows in the historic home as shown in the image above; the windows which were replaced are outlined in red. A number of these windows (B1, B2, M6, M7, S5, S6, S7, S8, S9, and S10) are not readily visible from the public right of way and could be eligible for an administrative approval, however, Staff has found the windows on the front façade do not meet the standards of approval and has forwarded the entire request to the Historic Landmarks Commission.

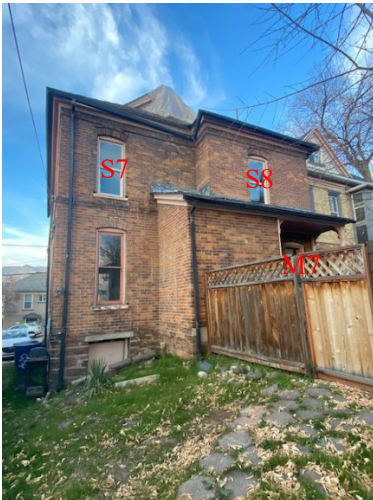
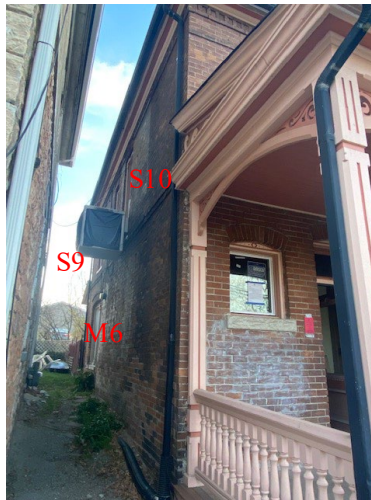
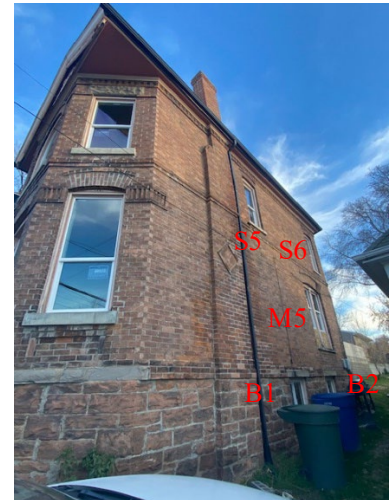
Windows B1, B2, M6, M7, S5, S6, S7, S8, S9, and S10 are located on secondary façades and are not readily visible from the public right of way. Windows B1, B2, S5, and S6 are located on the western (side) façade. The surrounding homes are built closely enough to the subject structure that the windows on the secondary façades are not easily seen. Windows M5 is also located on a secondary façade, however, these windows are shorter than the originals and the opening in the façade has been enclosed with a wooden board. Changes to the opening sizes within the brick itself is highly discouraged by the standards so these windows are not appropriate. The Residential Design Guidelines prohibit the increasing or decreasing the sizes of the openings in the façades and these windows should be replaced with a window that is the same size as the originals and the pre-existing opening. Windows S10, S9, and M6 are located on the eastern (side) façade and are even more difficult to see from the public right of way, these windows are appropriate for their locations in the building. Additionally, windows M7, S7, and S8 are located on the rear of the building and are not visible at all from the public street. Therefore, these windows are appropriate.

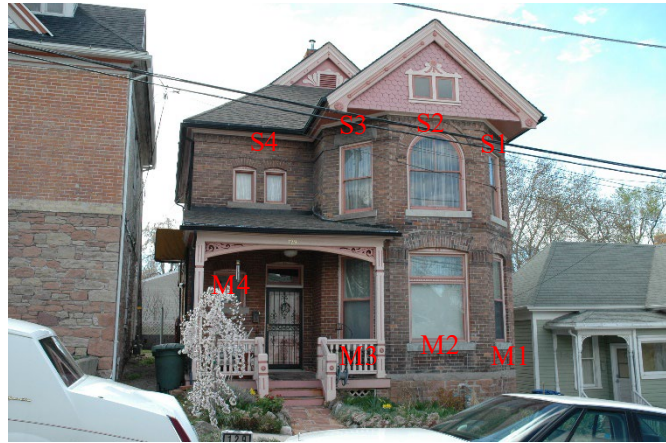
Figure 5: 2006 RLS Survey photograph of subject property showing original windows and woodwork details.

Windows M1, M2, M3, M4, S1, S2, S3, and S4 are highly visible from the 400 North public street and the original windows were character-defining features of the structure. As shown in the 2006 photograph of the site (right) windows M1, M3, S1, and S3 are wooden double-hung windows with equally-sized glazing. Windows M2 and S2 are both fixed picture windows with decorative muntins. The brick arches slightly above the rectangular M2 window while the S2 window features arched glazing and a brick arch above the opening as well. Similarly, windows M4 and S4 are also fixed rectangular picture windows, with M4 featuring decorative wooden carving around the frame.

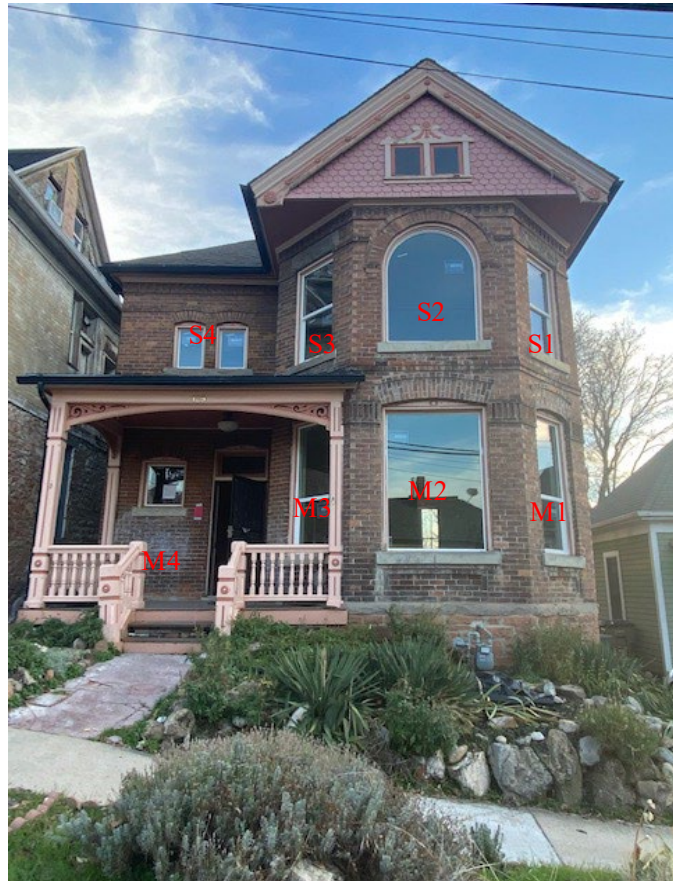
Figure 6: Photograph of front exterior provided by Applicant.

As shown in the photo to the lower right, the Applicant has replaced windows M2 and S2 with fixed picture windows, but without the muntins and woodwork. The muntins and woodwork on these windows contributed significantly to the historic character of the structure and have been lost with the replacement of the original windows.

Windows M1, M3, S1, and S3 have been replaced with vinyl single-hung windows. Windows M4 and S4 have also been replaced with fixed picture windows. The size of the window opening in the brick front façade has not been altered as part of these replacements; the Applicant has not painted the exterior or altered the lintels above and below the windows. The proportions of glazing for windows S1 and S3 appear to be the same as the originals but windows M1 and M3 do not utilize the same proportions of glazing as the historic windows. The windows have been set into the brick façade at approximately the same depth as the original windows. There is also a difference in texture and detailing of materials between the original wooden framed windows and the vinyl framed replacement windows.

If approved in part as recommended by staff a certificate of appropriateness will be issued for window replacements on the secondary facades not readily visible from the public way. If denied in part as recommended by staff, the Applicant would not be able to replace the windows on the front elevation which are visible from the right of way. The applicant would be required to submit a new minor alteration application with more appropriate replacement windows for review.
