## APPENDIX C: STUDY REACH MAPS, SUMMARIES, AND RECOMMENDATIONS

## UPC\_R16A: UPPER SUICIDE ROCK

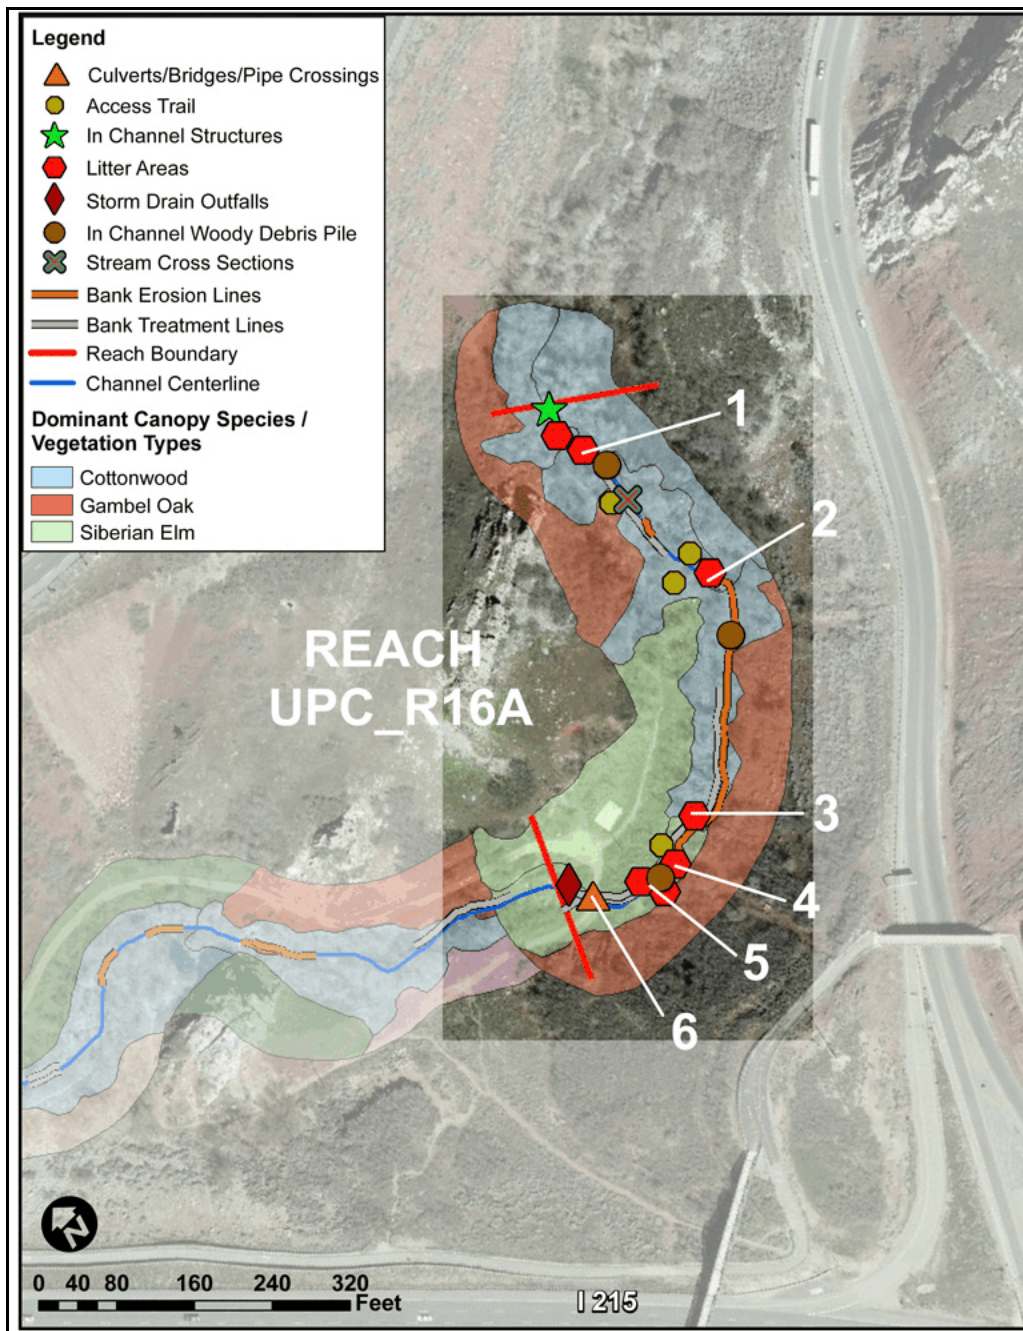
This reach extends from the upstream boundary of the study area to the concrete flume structure above Suicide Rock. The channel has been affected by highway fill, diking, and historic diversions. Cottonwood and willow density and age-class diversity are excellent in portions of the reach. The 70-foot-long flume structure constricts the channel and floodplain to a width of about 7 feet. Trout were noted in this reach during field assessments.

- invasive plants (Siberian elm, tree of heaven, burdock, spurge, cheatgrass, whitetop)
- poor revegetation/stabilization practices
- poorly designed bank revetment
- eroded access trails
- limited understory cover
- trash

RECOMMENDATIONS	
IMPROVEMENT MEASURE	LOCATION
Invasive plant removal/control	within vegetation type(s)
Revegetation (understory)	within vegetation type(s)
Stream cleanup	points 2 and 5 on map
Mechanized trash removal	points 1, 2, 3, 4, 5 on map
Slope stabilization	along highway fill slope
Remove/replace concrete flume	point 6 on map
Access control/trail stabilization	reach-scale

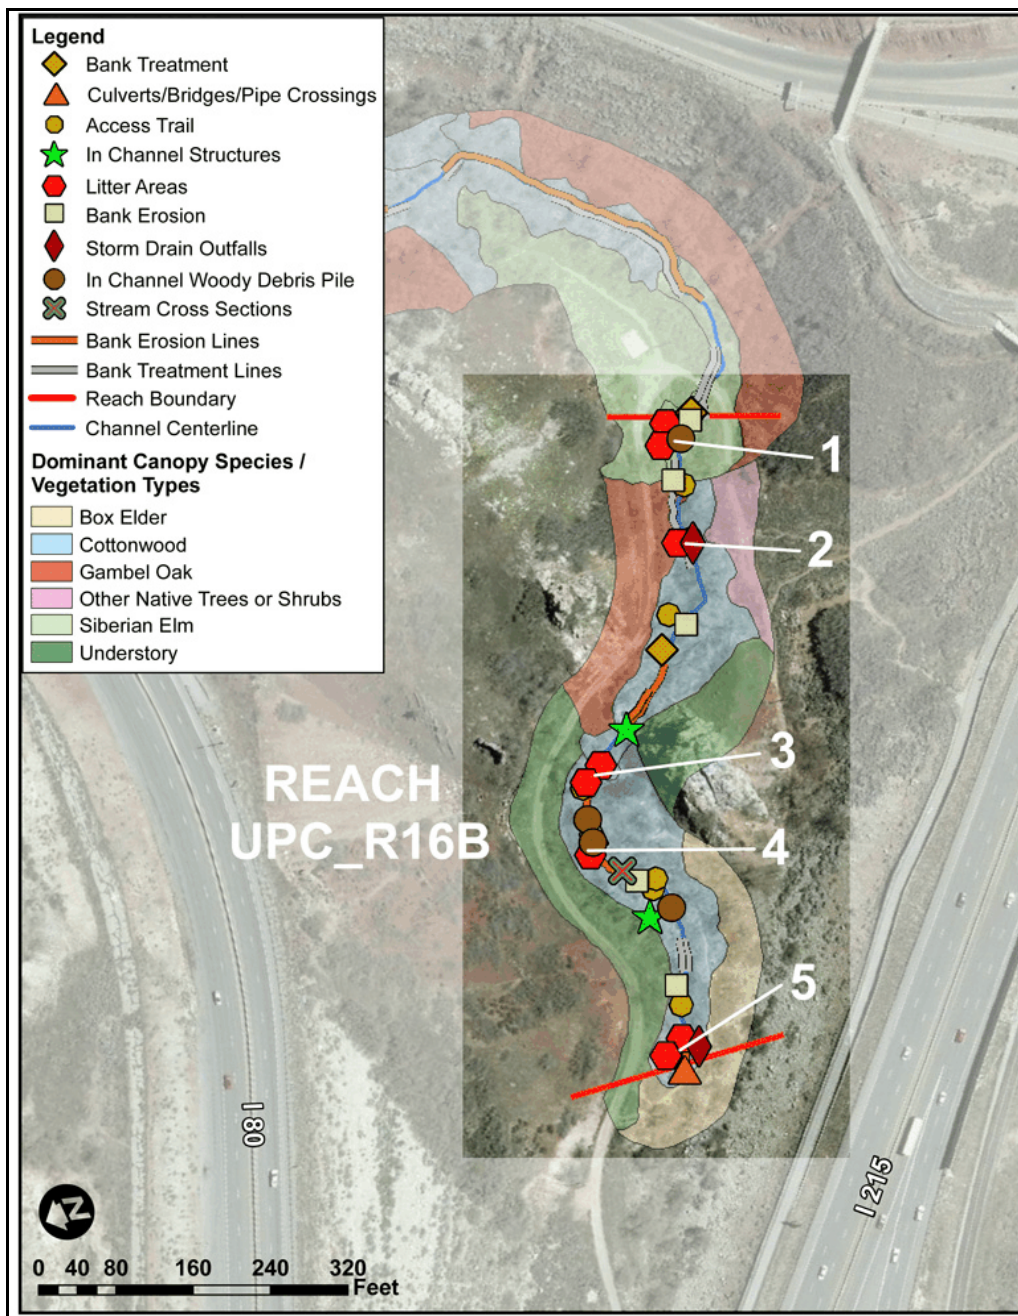
## UPC\_R16B: LOWER SUICIDE ROCK

This reach includes various infrastructure remnants from the historic Parleys Canyon Reservoir and aqueduct that occupied this site from about 1880 to 1950. Graffiti artists paint the rock outcrop and concrete structures in the reach, and people access the I-215 culvert to “shoot the tube” here. Cottonwood and willow density and age-class diversity are excellent in portions of the reach.

- invasive plants (Siberian elm, Russian olive, whitetop, cheatgrass, burdock, spurge, houndstongue)
- eroded access trails
- soil compaction from foot traffic
- obsolete/degraded pipes and concrete
- trash and graffiti

RECOMMENDATIONS	
IMPROVEMENT MEASURE	LOCATION
Invasive plant removal/control	within vegetation type(s)
Stream cleanup	points 1, 3, 5 on map
Mechanized trash removal	points 1, 2, 4, 5 on map
Storm drain improvement	points 2 and 5 on map
Biotechnical slope stabilization	point 5 on map
Access control/trail stabilization	reach-scale
Runoff management	north side access road

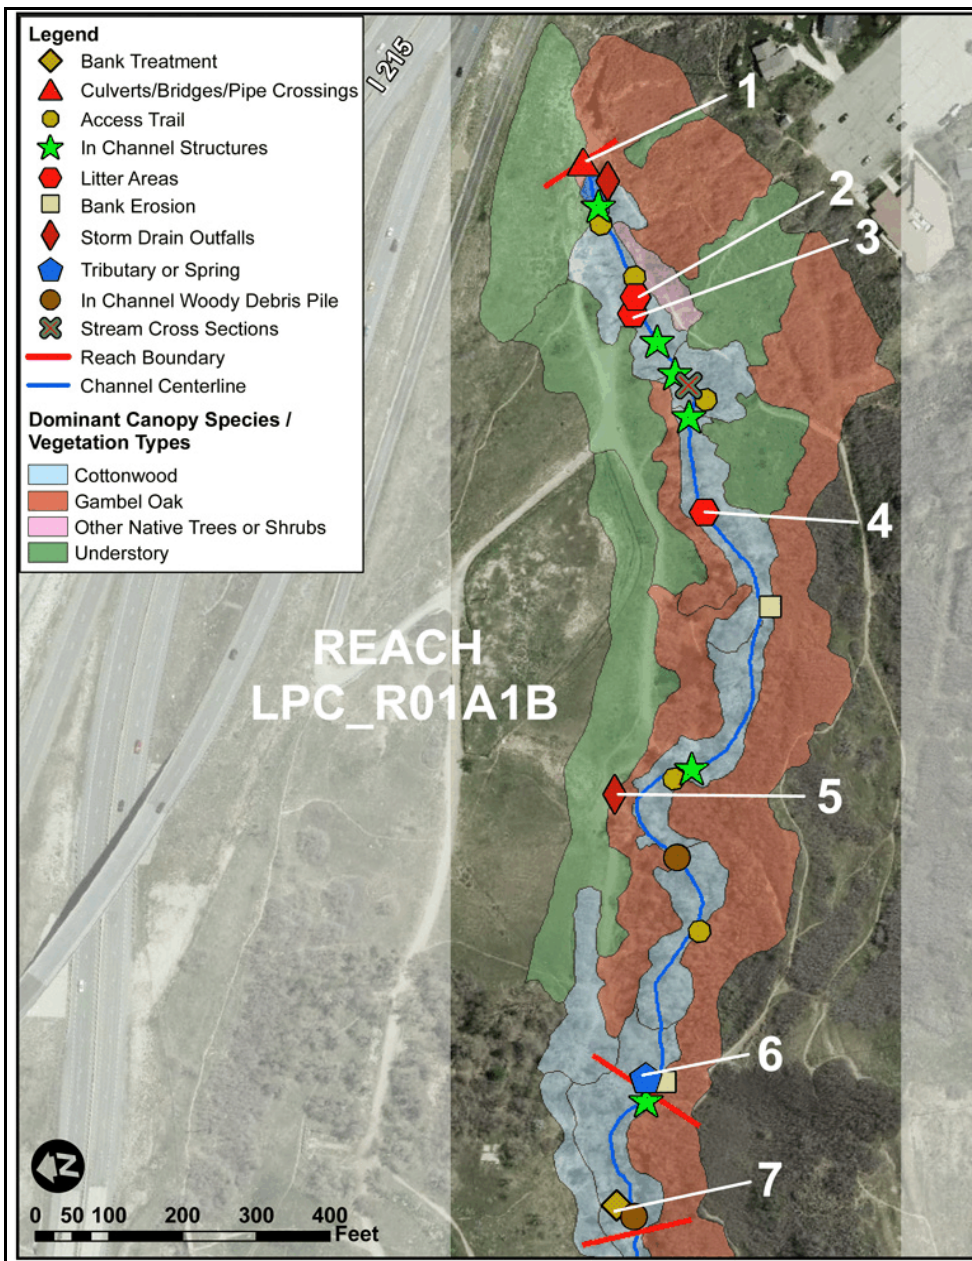
## LPC\_R01A1B: UPPER PARLEYS PARK

This reach extends from the I-215 culvert outlet to a large ponded area (LPC\_R01B) created by a major woody debris jam. This ponded area and the pool at the upstream culvert outlet receive heavy dog use. Cottonwoods are the dominant streamside tree species. Fill slopes above the I-215 culvert outlet lack vegetation and runoff has been poorly managed. Eroded access points are frequent in this reach, and near-stream understory cover is less than 6% through the majority of the reach. A tributary spring channel enters from the north near the downstream end of the reach.

- invasive plants (nine species)
- lack of understory cover
- eroded access trails/trail proximity
- soil compaction from dog/human foot traffic
- poor runoff management
- poor revegetation/stabilization practices
- fill encroachment
- storm drain outfall erosion
- graffiti and trash

RECOMMENDATIONS	
IMPROVEMENT MEASURE	LOCATION
Invasive plant removal/control	within vegetation type(s)
Revegetation (understory)	within vegetation type(s)
Biotechnical slope stabilization	points 1 and 7 on map
Access control/trail stabilization	reach-scale
Storm drain improvement	point 5 on map
Stream/graffiti cleanup	point 1 on map
Mechanized trash removal	points 2, 3, 4 on map
Runoff management	point 1 on map and reach-scale
Fill removal	point 5 on map
Restoration/protection of spring	point 6 on map

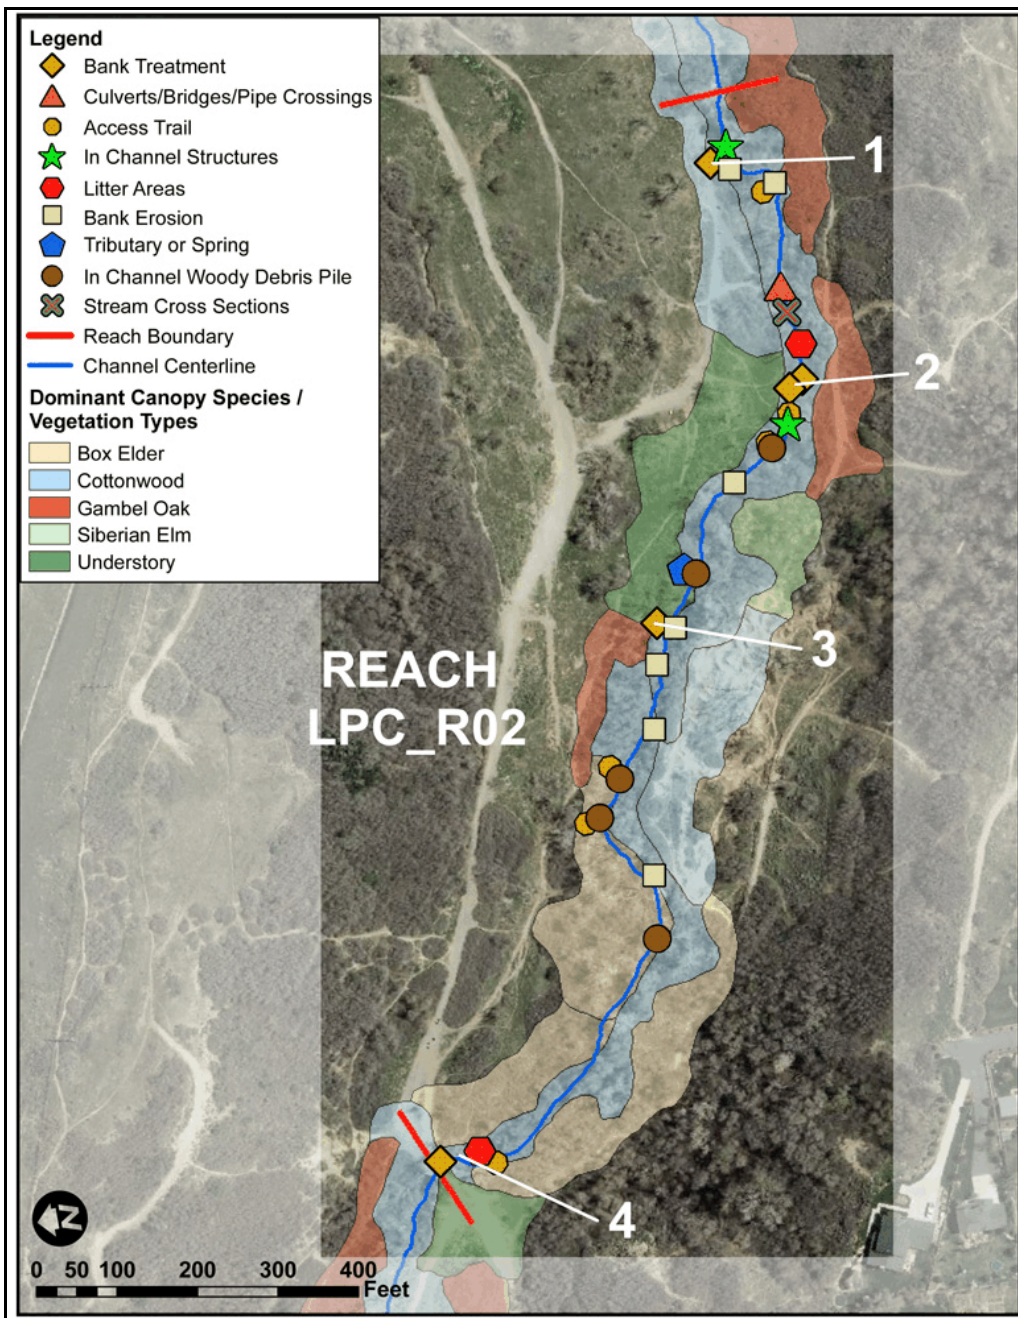
## LPC\_R02: MIDDLE PARLEYS PARK

This reach encompasses the central portion of the park and includes the BMX bike jump area and a wooden footbridge. Existing rip rap bank treatments lack vegetation. The channel is influenced by several small user-built rock weirs; pools in the reach contain fine sediments that cloud the water when disturbed. Several small springs are present on the south side of the channel.

- invasive plants (nine species)
- limited understory cover
- eroded access trails/trail proximity
- soil compaction from dog/human foot traffic
- poor revegetation practices
- fill encroachment into floodplain
- disturbance from flood control equipment
- trash (pipes, concrete chunks)

RECOMMENDATIONS	
IMPROVEMENT MEASURE	LOCATION
Invasive plant removal/control	within vegetation type(s)
Revegetation (understory)	within vegetation type(s)
Rip rap retrofit	points 1, 2, 3, 4 on map
Access control/trail stabilization	reach-scale
Mechanized trash removal	near points 2 and 4 on map
Fill removal/slope flattening	central portion of reach
Bank stabilization	reach-scale
Restoration/protection of springs	reach-scale

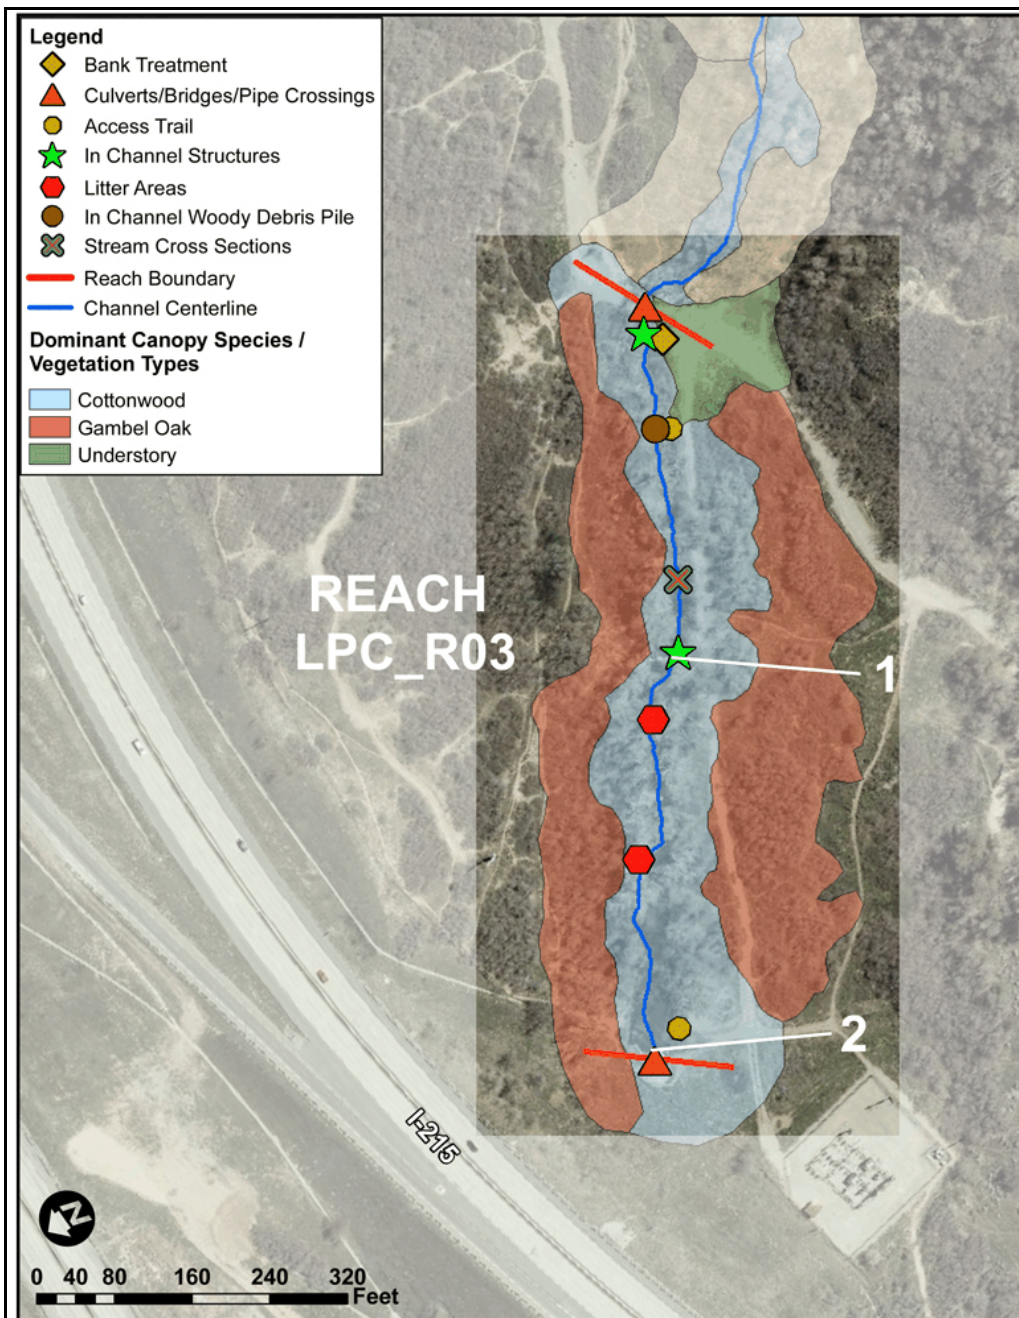
## LPC\_R03: LOWER PARLEYS PARK

In this reach, a gravel road on the south side of the channel provides access to metal debris grate structures and to the power sub-station. The stream appears to have been historically straightened and dredged in this reach, restricting floodplain width and connectivity. Pools are present at the box culvert at the top of the reach and at the grated inlet to the I-80 culvert at the bottom of the reach.

- invasive plants (six species)
- limited understory/shrub cover
- eroded access trails/trail proximity
- soil compaction from dog/human foot traffic
- poor revegetation practices
- flood control dredging/access

RECOMMENDATIONS	
IMPROVEMENT MEASURE	LOCATION
Invasive plant removal/control	within vegetation type(s)
Revegetation (understory)	within vegetation type(s)
Revegetation (shrub)	within vegetation type(s)
Access control/trail stabilization	reach-scale
Floodplain re-establishment	south side of channel
Retrofit/remove metal grate structure	point 1 on map
Safety/aesthetic improvements at pipe inlet	point 2 on map

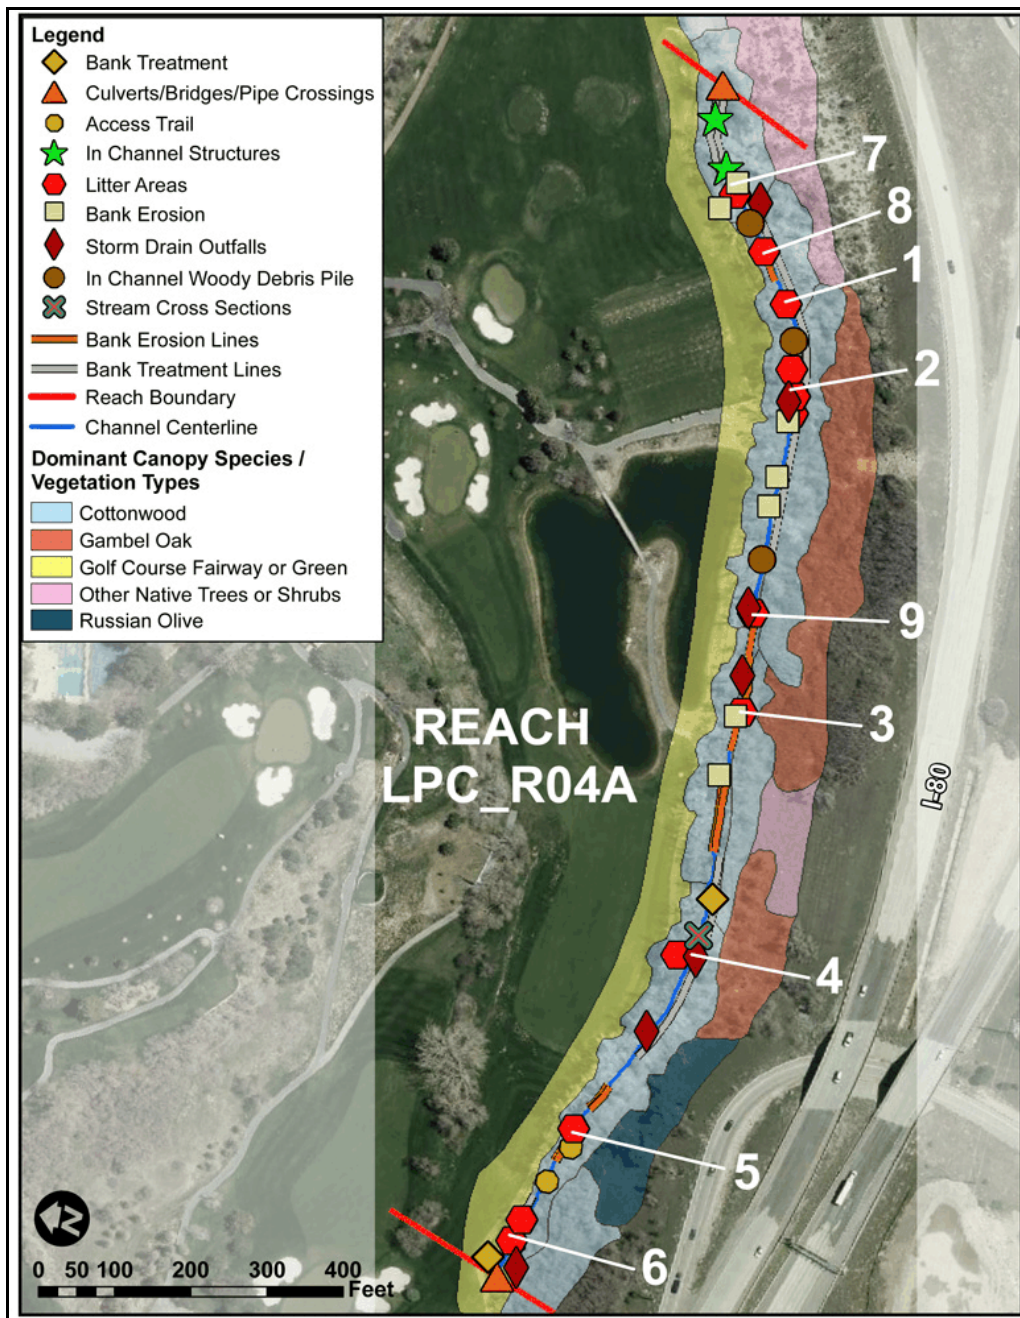
## LPC\_R04A: COUNTRY CLUB - ABOVE 2300 EAST

This reach includes the eastern portion of the Country Club golf course starting at the I-80 culvert outlet. The channel is straight and constricted between the highway fill slope and the developed golf course. A concrete weir diversion structure is present near the top of the reach. Much of the south bank is protected with gabion baskets that appear to be old and in fair condition.

- invasive plants (eight species)
- storm drain outfall erosion
- gabions
- fill encroachment
- scour below concrete weir
- trash
- mowing practices

RECOMMENDATIONS	
IMPROVEMENT MEASURE	LOCATION
Invasive plant removal/control	within vegetation type(5)
Revegetation (canopy/shrub)	within vegetation type(5)
Restoration of native understory plants	within vegetation type(5)
Stream cleanup	points 1, 2, 3, 4, 5, 6 on map
Mechanized trash removal	points 2, 7, 8, 9 on map
Replace concrete diversion weir	point 7 on map
Storm drain improvement	points 2 and 6 on map
Gabion basket and rip rap retrofit	points 7 to 9; near points 4 and 6
Biotechnical slope stabilization	near point 8; point 9 to 3
Establish "no-mow" buffer	reach-scale
Avoid placing grass clippings on banks	reach-scale

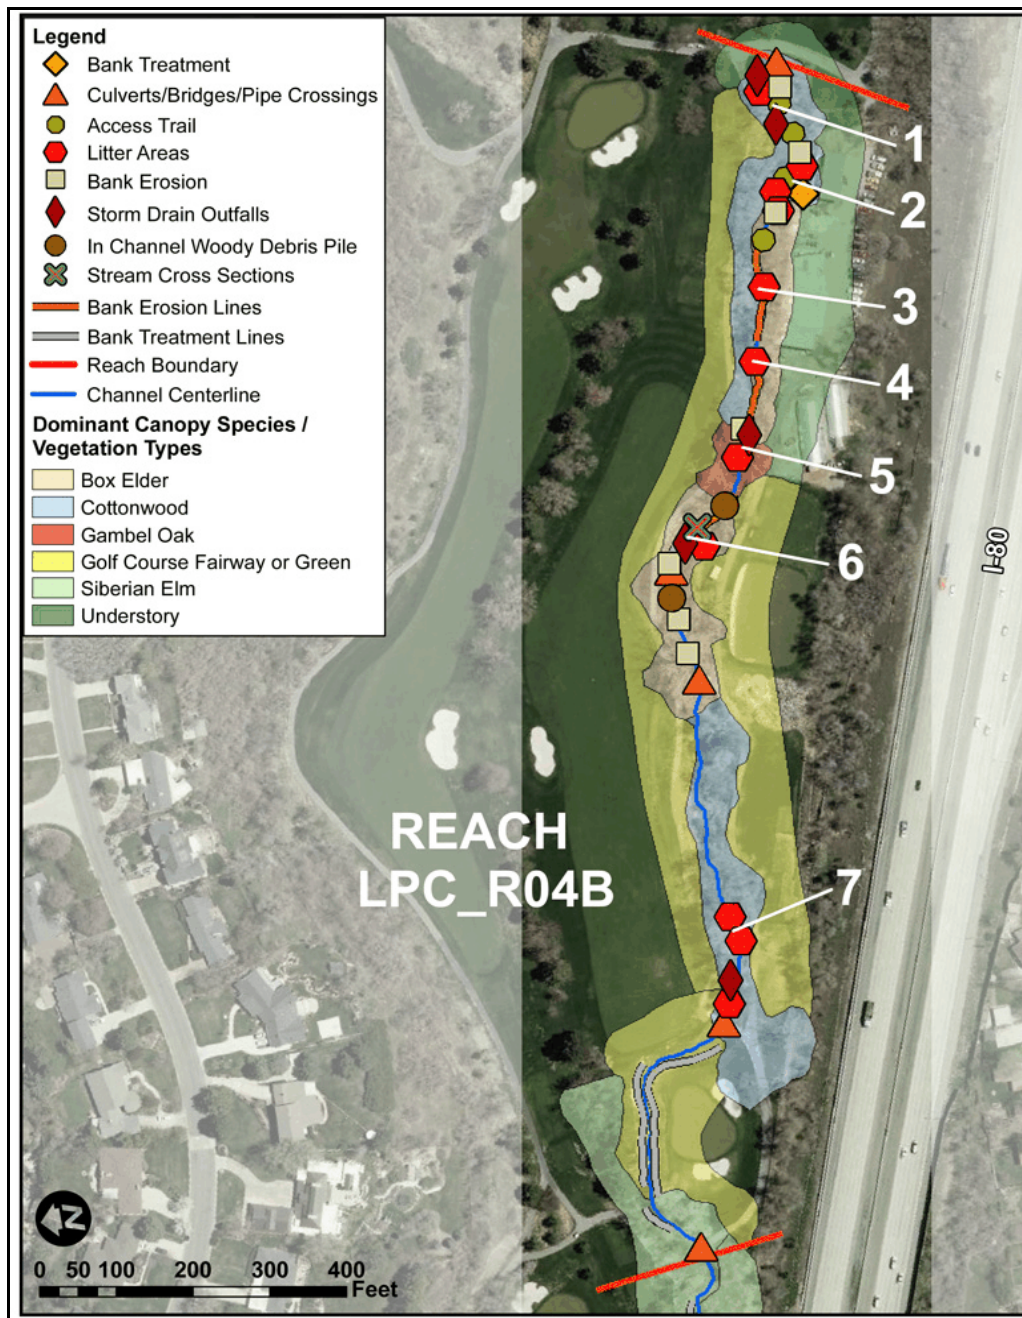
## LPC\_R04B: COUNTRY CLUB - BELOW 2300 EAST

This reach is located near the golf course maintenance facility. Three bridges cross the channel in the reach, and paved golf cart paths parallel the channel on both sides. At the western end of the reach, the stream was recently daylighted and now flows in a grassy, unshaded, boulder-lined channel. Significant amounts of concrete rubble and other trash items are present near the maintenance buildings.

- invasive plants (five species)
- limited shrub cover
- infrastructure proximity
- lack of canopy cover
- eroded access trails
- fill encroachment
- poor stabilization practices
- mowing practices
- trash

RECOMMENDATIONS	
IMPROVEMENT MEASURE	LOCATION
Invasive plant removal/control	within vegetation type(s)
Revegetation (canopy)	adjacent to daylighted channel
Revegetation (shrub)	within vegetation type(s)
Restoration of native understory plants	adjacent to daylighted channel
Bank/slope stabilization	eastern portion of reach
Stream cleanup	points 2, 6, 7 on map
Mechanized trash removal	points 1, 2, 3, 4, 5, 7 on map
Storm drain improvement	points 1 and 5 on map
Access trail reclamation/stabilization	reach-scale
Implement storm water BMPs	maintenance area
Establish "no mow" buffer	western portion of reach
Replace crossings with full-span structures	two crossings south of point 6 on map

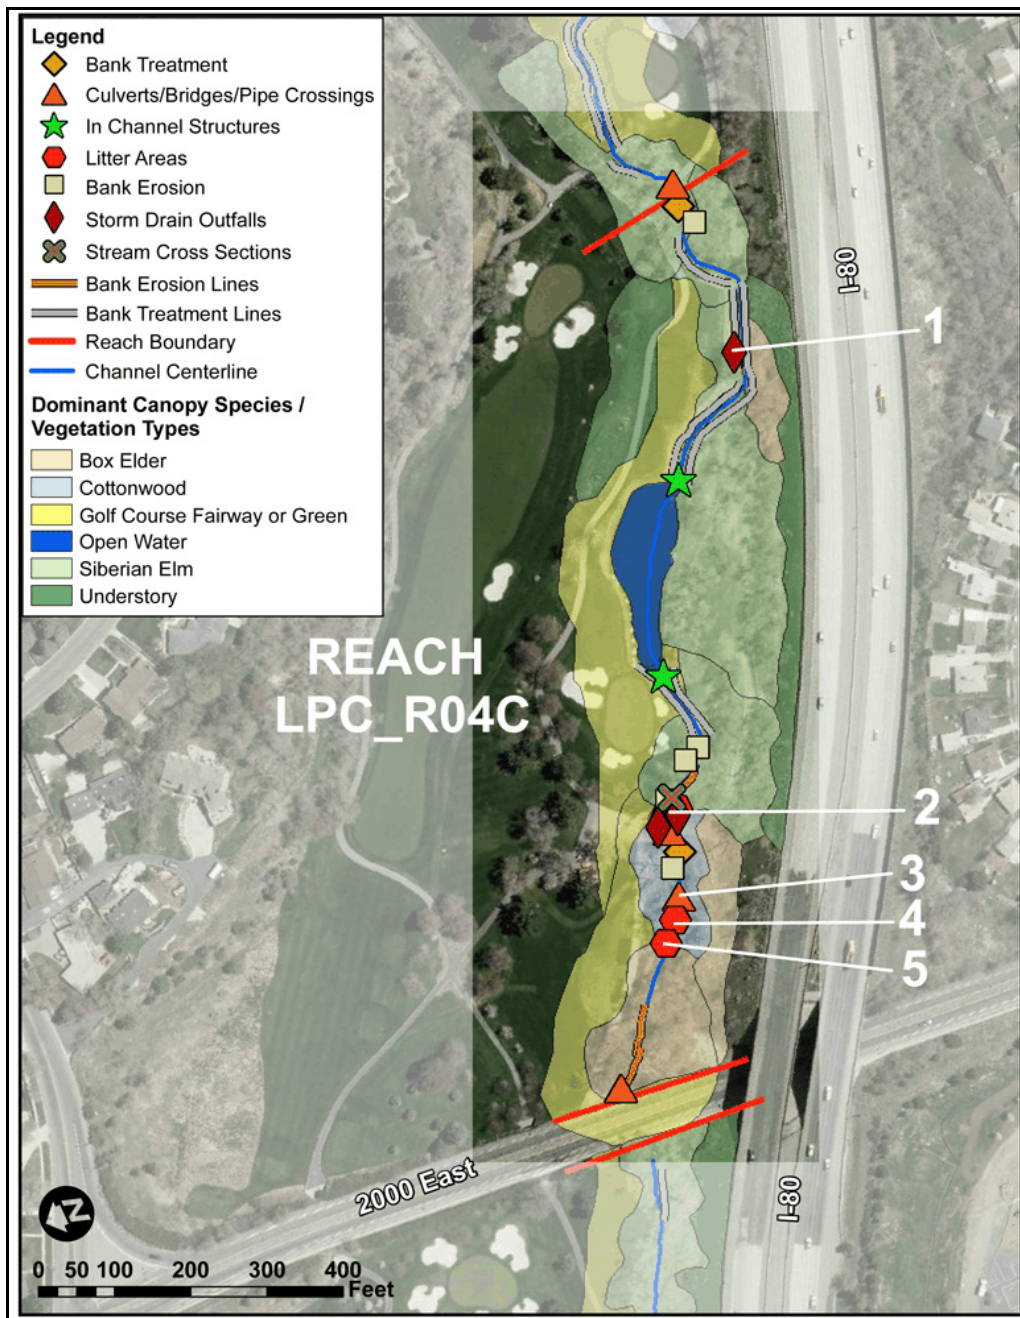
## LPC\_R04C : COUNTRY CLUB - ABOVE 2000 EAST

The channel flows through a large pond in this reach. Above the pond, banks have been stabilized with concrete slabs and rip rap. In the western portion of the reach, banks show evidence of considerable root zone scour and toe erosion. This is the only reach in the study area where invasive saltcedar was noted as present; immediate control is recommended. Siberian elm dominates much of the canopy cover in the reach.

- invasive plants (11 species, including saltcedar)
- unprotected storm drain outfalls
- low bank/root zone erosion
- bank scalloping from lack of woody plants
- limited shrub/canopy cover
- canopy dominated by invasive species
- fill encroachment

RECOMMENDATIONS	
IMPROVEMENT MEASURE	LOCATION
Invasive plant removal/control	within vegetation type(s)
Revegetation (canopy)	within vegetation type(s)
Revegetation (shrub)	within vegetation type(s)
Mechanized trash removal	points 2, 4, and 5 on map
Storm drain improvement	points 1 and 2 on map
Bank stabilization	eastern and western portions of reach
Grade control	eastern and western portions of reach
Remove obsolete bridge	point 3 on map
Rip rap retrofit	near point 2 on map

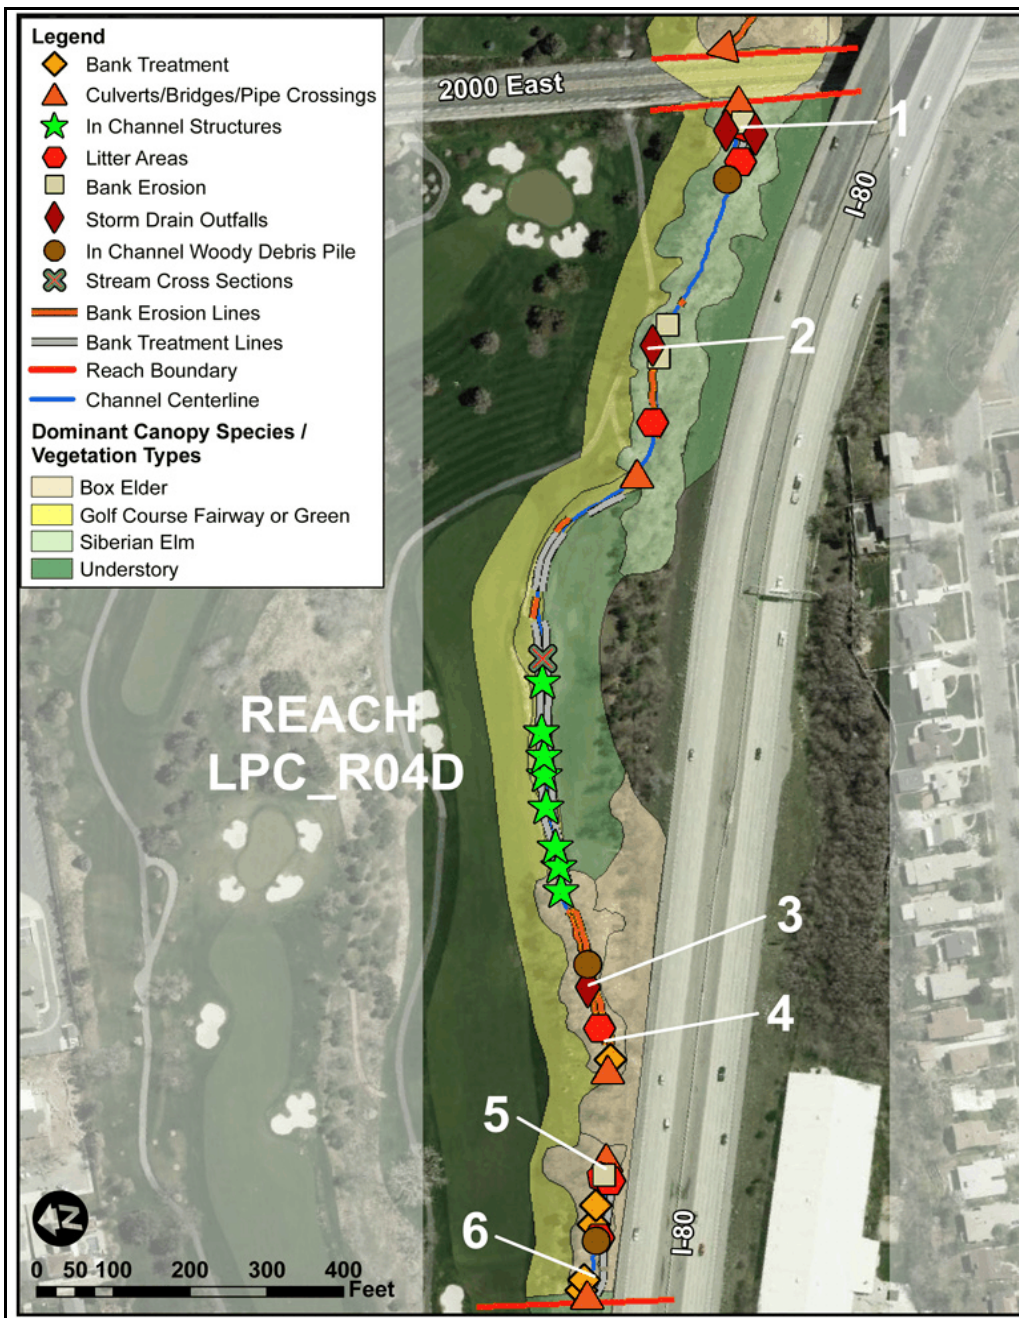
## LPC\_R04D: COUNTRY CLUB - BELOW 2000 EAST

In the central portion of this reach, the stream was recently daylighted and now flows in a constructed boulder-lined channel vegetated with bluegrass. Just below the reach, a portion of stream adjacent to the freeway was recently piped. The fill slopes above this new pipe are the only place in the study area where yellow star-thistle was noted; immediate control is recommended.

- invasive plants (nine species including yellow star-thistle)
- deposition/clogging at culvert inlet
- unprotected storm drain outfalls
- lack of shrub/canopy cover
- limited native understory cover
- unvegetated gabions
- trash

RECOMMENDATIONS	
IMPROVEMENT MEASURE	LOCATION
Invasive plant removal/control	within vegetation type(s)
Revegetation (canopy/shrub)	along recently daylighted channel
Restoration of native understory plants	along recently daylighted channel
Culvert outlet protection	point 1 on map
Stream cleanup	points 1 and 5 on map
Mechanized trash removal	point 4
Storm drain improvement	points 1, 2, 3 on map
Gabion basket retrofit	points 5 and 6 on map
Slope flattening/bank stabilization	near point 3 on map
Establish "no mow" buffer	along recently daylighted channel

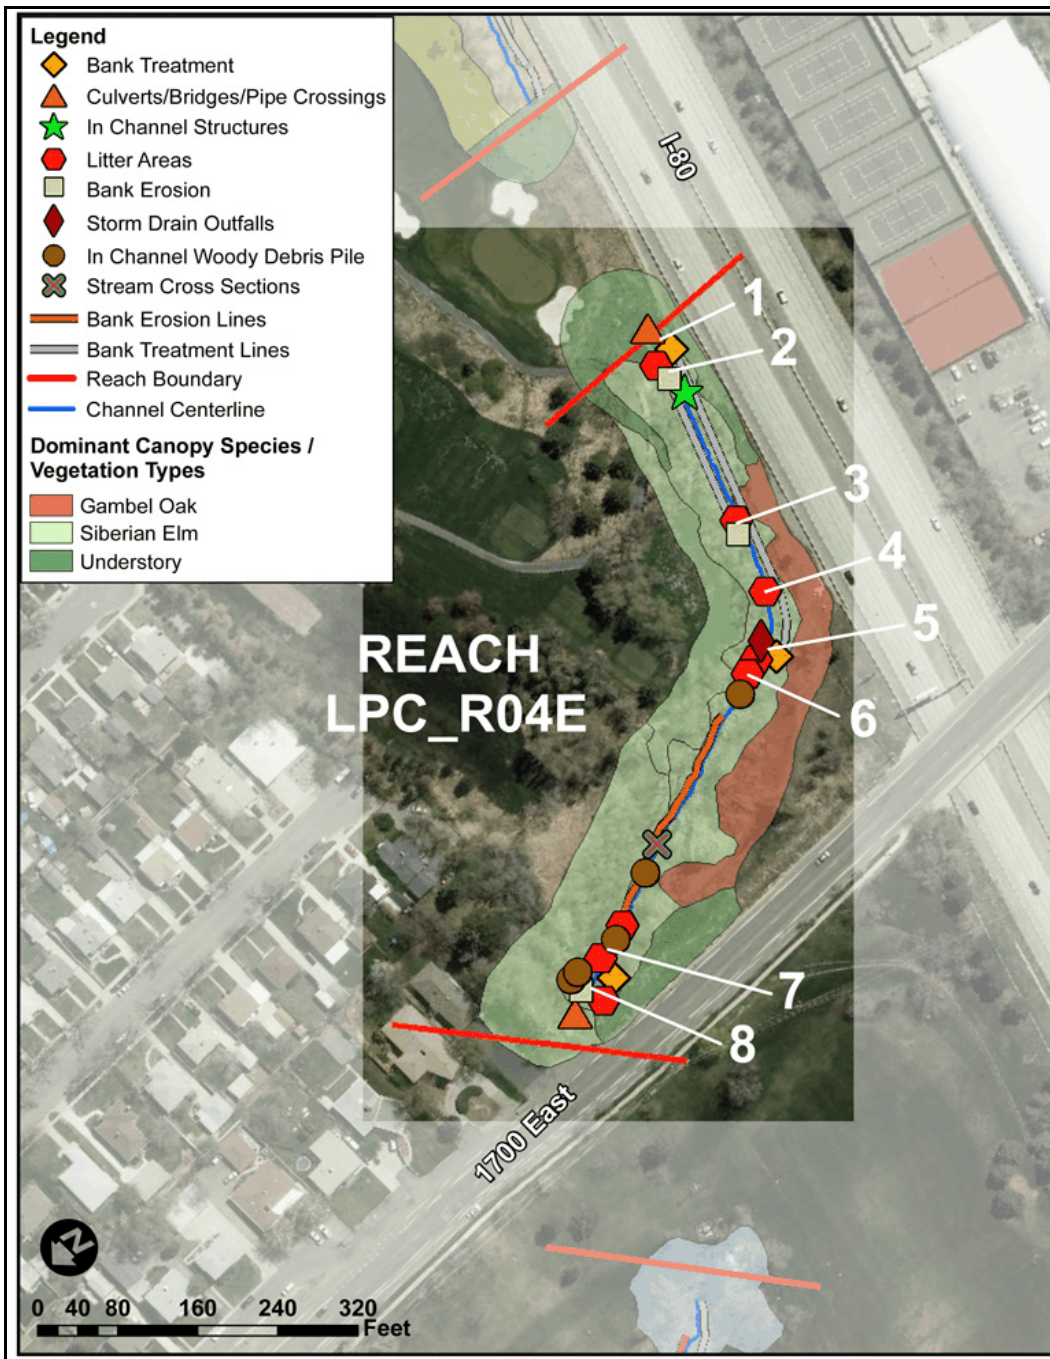
## LPC\_R04E: COUNTRY CLUB - ABOVE 1700 EAST

This is a confined, isolated reach surrounded by fill slopes and roads. Vegetation is dominated by invasive species. Portions of the banks have been hardened with grouted rock and grouted gabions that are generally in poor condition and are being undercut.

- invasive plants (eight species)
- unprotected storm drain outfalls
- limited native understory cover
- fill encroachment
- poor stabilization practices
- trash, graffiti

RECOMMENDATIONS	
IMPROVEMENT MEASURE	LOCATION
Invasive plant removal/control	within vegetation type(s)
Restoration of native understory plants	within vegetation type(s)
Stream cleanup	near points 3, 5, 7 on map
Mechanized trash removal	points 2, 4, 6, 8 on map
Storm drain improvement	points 5 and 8 on map
Biotechnical slope stabilization	north of point 2 on map
Gabion basket retrofit	point 1 on map
Bank stabilization	reach-scale
Grade control	reach-scale
Retrofit concrete wingwall protection	near point 8 on map

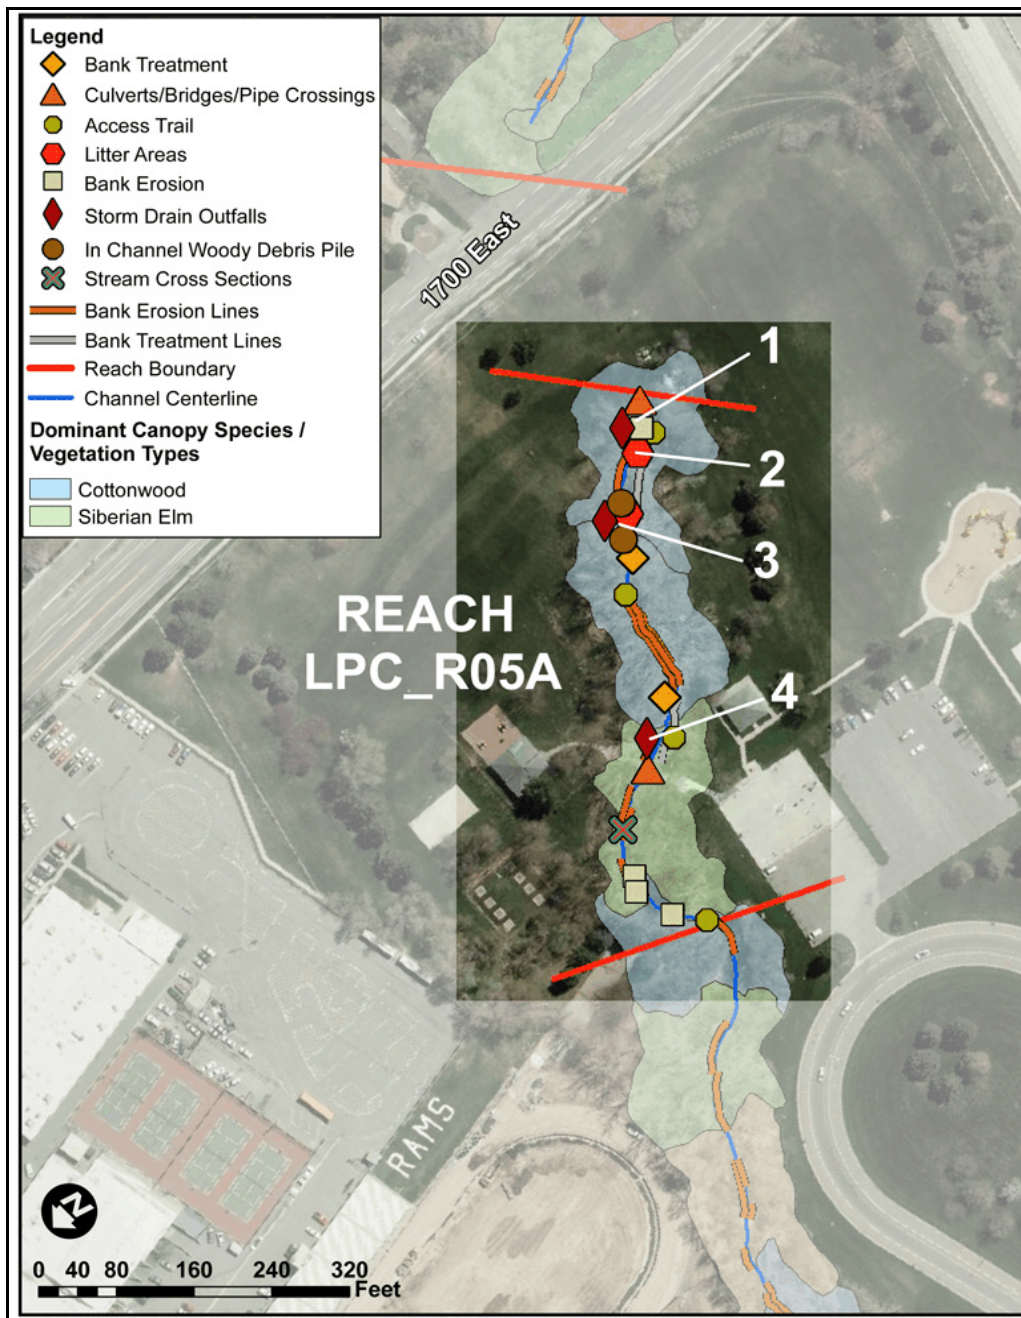
This is the easternmost reach of Parleys Creek within Sugar House Park. Canopy cover from native trees is good, although Siberian elm is also very common. Bank stability is affected by root zone scour and compaction from foot traffic, and the channel is relatively wide and shallow. A blue footbridge crosses the channel midway through the reach.

- invasive plants (four species)
- foot compaction/bank erosion
- eroded access trails
- storm drain outfalls
- limited native understory cover
- low bank/root zone erosion
- trash, graffiti

RECOMMENDATIONS	
IMPROVEMENT MEASURE	LOCATION
Invasive plant removal/control <sup>a</sup>	within vegetation type(s)
Restoration of native understory plants <sup>a</sup>	within vegetation type(s)
Stream cleanup <sup>a</sup>	points 2 and 3 on map
Retrofit concrete headwall protection	point 1 on map
Storm drain improvement <sup>a</sup>	points 1, 3, 4 on map
Bank stabilization (toe protection/shrub planting) <sup>a</sup>	reach-scale
Grade control	reach-scale
Access control/trail stabilization <sup>a</sup>	reach-scale
Establish "no mow" buffer <sup>a</sup>	reach-scale

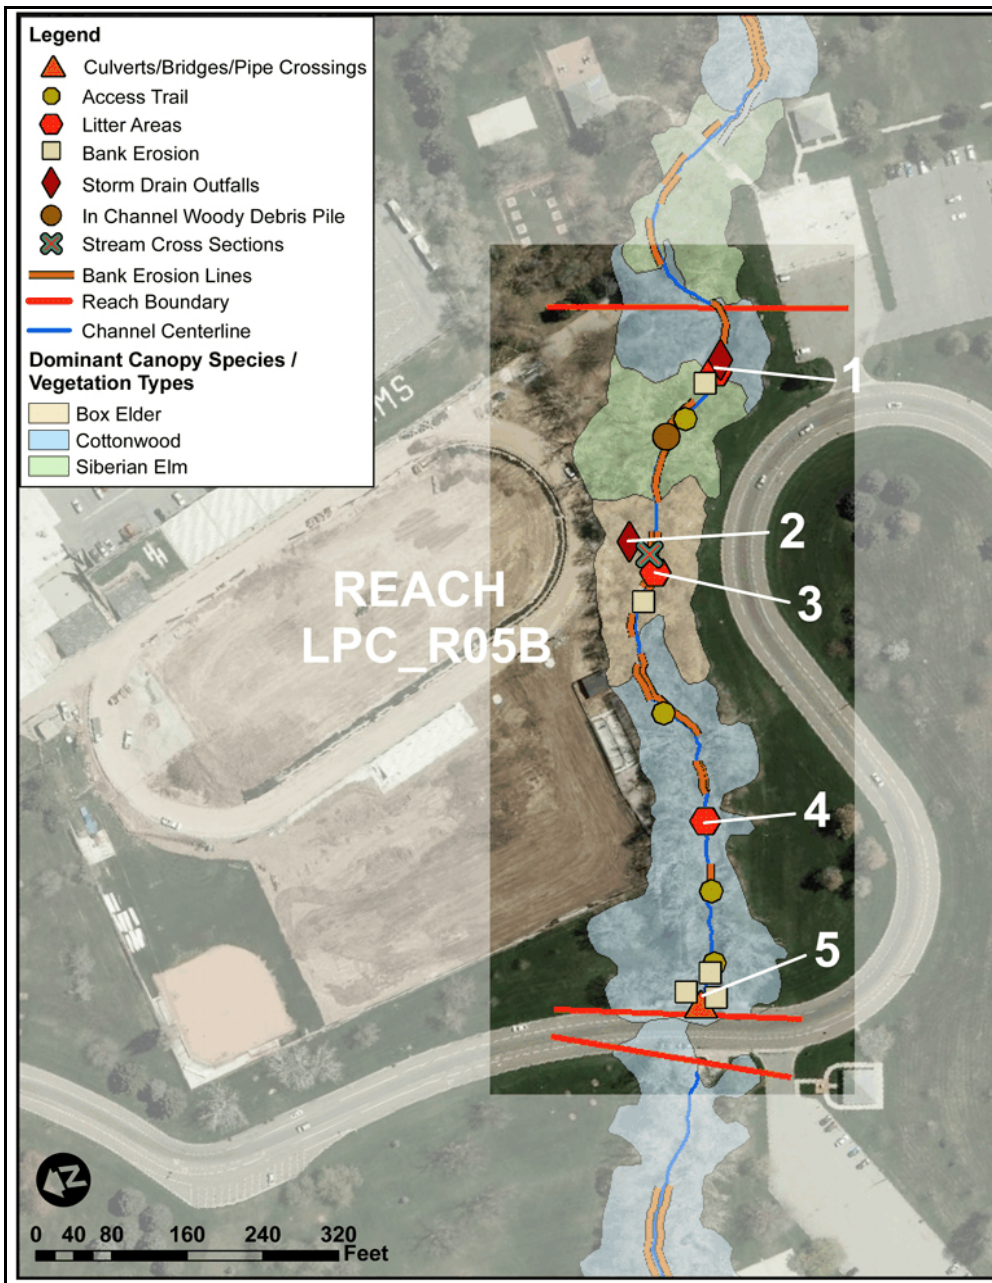
## LPC\_R05B: SUGAR HOUSE PARK - NEAR HIGHLAND HIGH TRACK

The channel becomes narrower in this reach relative to LPC\_R05A, but otherwise is quite similar in character. Several well-developed gravel bars are present. Fill material for the track facility constrains floodplain width on the north bank in the downstream part of the reach. Native shrub cover is very good in this reach, but banks show evidence of root zone scour and scalloping.

- invasive plants (six species)
- foot compaction/bank erosion
- eroded access trails
- storm drain outfalls
- fill encroachment
- limited native understory cover
- low bank/root zone erosion
- trash, graffiti

RECOMMENDATIONS	
IMPROVEMENT MEASURE	LOCATION
Invasive plant removal/control <sup>a</sup>	within vegetation type(s)
Restoration of native understory plants <sup>a</sup>	within vegetation type(s)
Stream cleanup <sup>a</sup>	points 1, 3, 4 on map
Storm drain improvement <sup>a</sup>	points 1 and 2 on map
Bank stabilization (toe protection) <sup>a</sup>	reach-scale
Grade control <sup>a</sup>	reach-scale
Access control/trail stabilization <sup>a</sup>	reach-scale
Establish "no mow" buffer <sup>a</sup>	reach-scale
Culvert replacement/headwall retrofit <sup>a</sup>	point 5 on map

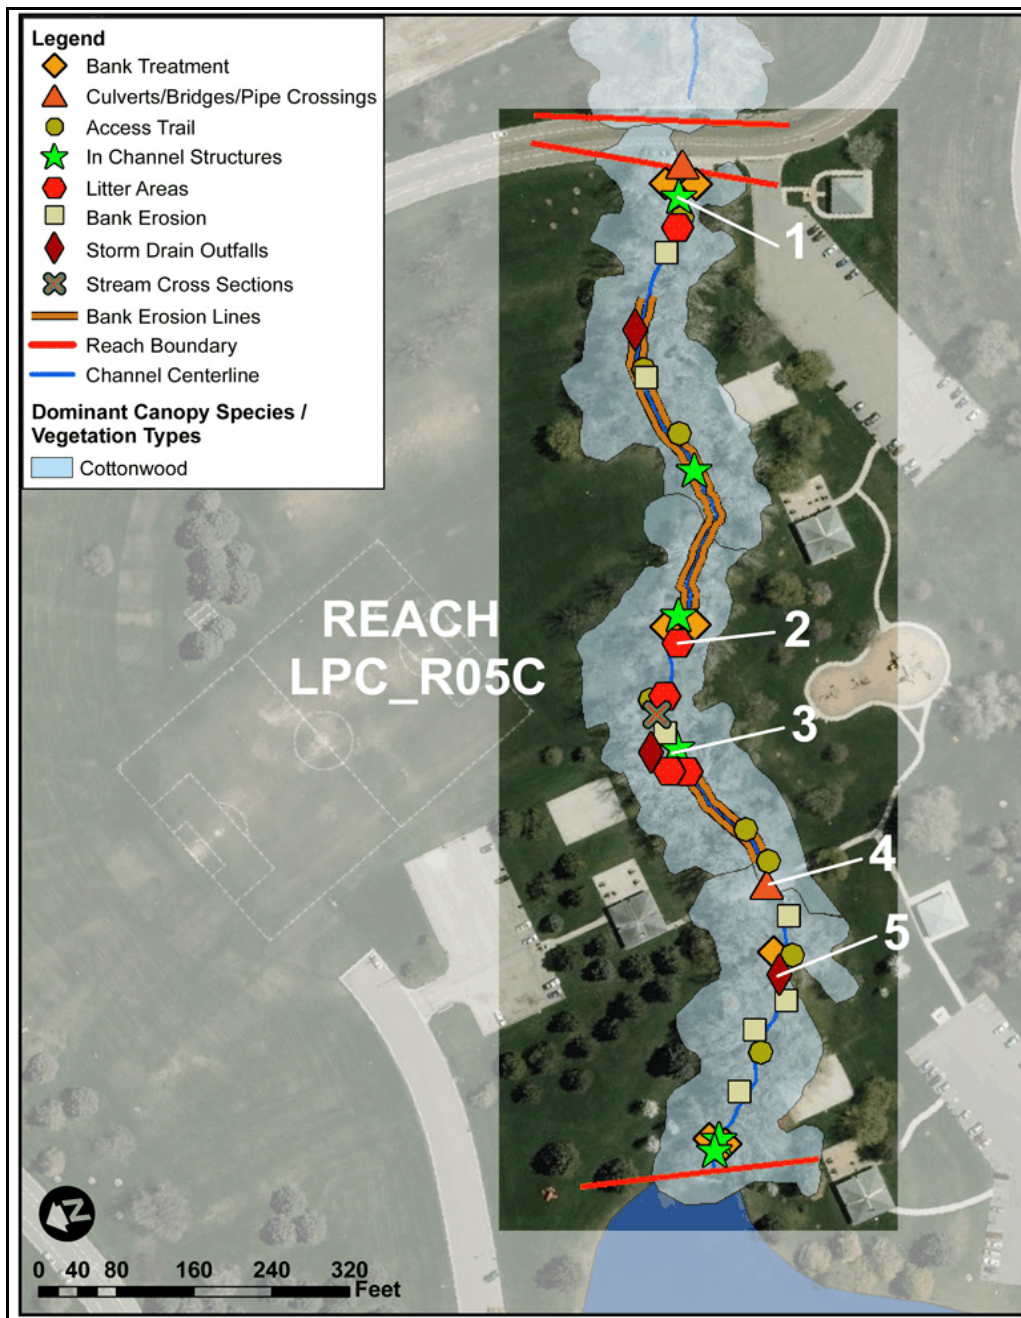
## LPC\_R05C: MIDDLE SUGAR HOUSE PARK

In this portion of the park, the character of riparian corridor becomes less natural than upstream. Developed picnic facilities are present, and mowed turf lines the banks. Canopy cover is good and is dominated by native cottonwood trees. Aesthetics are affected by various streambed and bank hardening structures made of concrete, grouted rock, and rip rap.

- invasive plants (Siberian elm, burdock)
- foot compaction/bank erosion
- eroded access trails
- storm drain outfalls
- lack of native understory cover
- limited shrub cover
- low bank/root zone erosion
- trash, graffiti

RECOMMENDATIONS	
IMPROVEMENT MEASURE	LOCATION
Invasive plant removal/control <sup>a</sup>	within vegetation type(s)
Restoration of native understory plants <sup>a</sup>	within vegetation type(s)
Culvert replacement/outlet protection <sup>a</sup>	point 1 on map
Stream cleanup <sup>a</sup>	near points 1 and 3 on map
Mechanized trash removal	points 2 and 3 on map
Replace crossing with full-span structure	point 4 on map
Storm drain improvement	point 5 on map
Access control/trail stabilization <sup>a</sup>	reach-scale
Bank stabilization (toe protection/shrub planting) <sup>a</sup>	reach-scale
Grade control/retrofit existing bed structures <sup>a</sup>	reach-scale
Establish "no mow" buffer <sup>a</sup>	reach-scale
