## APPENDIX C: STUDY REACH MAPS, SUMMARIES, AND RECOMMENDATIONS

## UPC\_R16A: UPPER SUICIDE ROCK

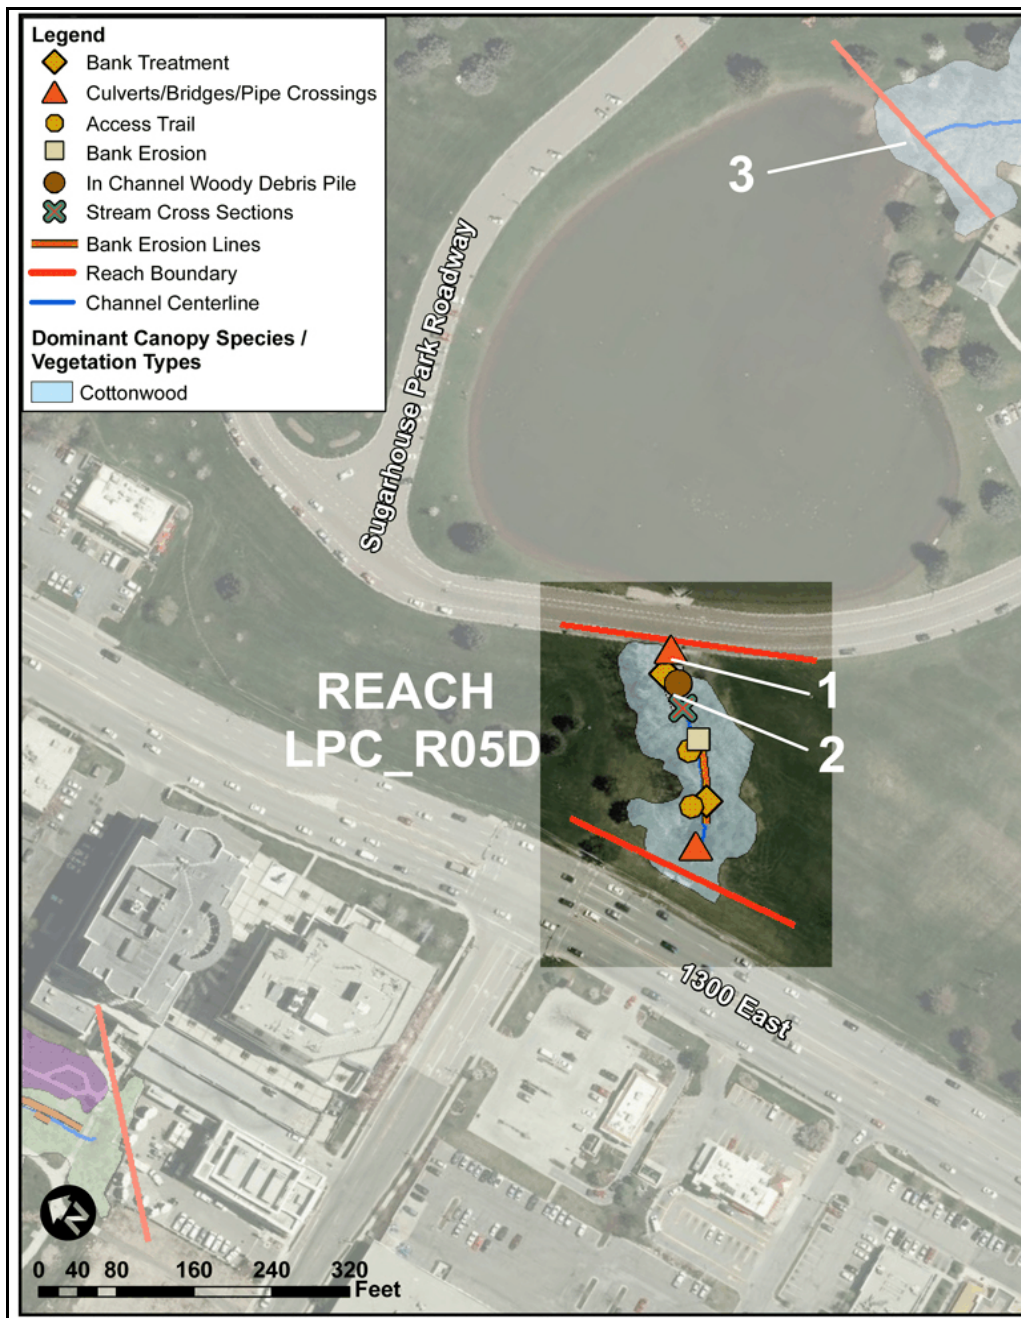
## LPC\_R05D: SUGAR HOUSE PARK - BELOW POND

This is a short, isolated stream reach between the pond and the 1300 East culvert. Existing concrete bank protection near the top of the reach provides limited benefit in terms of aesthetic, filtration, or floodplain storage functions. Siberian elm is common in the canopy and shrub layers. Bed material is coarser than upstream reaches, and slope is relatively high.

RECOMMENDATIONS	
IMPROVEMENT MEASURE	LOCATION
Invasive plant removal/control <sup>a</sup>	within vegetation type(s)
Restoration of native understory plants <sup>a</sup>	within vegetation type(s)
Culvert outlet protection <sup>a</sup>	point 1 on map
Replace concrete with biotechnical bank stabilization <sup>a</sup>	near points 1 and 2 on map
Access control/trail stabilization <sup>a</sup>	reach-scale
Establish "no mow" buffer <sup>a</sup>	reach-scale
Naturalize and revegetate banks of pond near inflow area	point 3 on map
