**SALT LAKE CITY  
HISTORIC LANDMARK COMMISSION**

**REQUEST BY ERIC SAXEY TO DEMOLISH THREE BUILDINGS IN THE  
CENTRAL CITY HISTORIC DISTRICT INCLUDING 256 SOUTH 700 EAST,  
262-264 SOUTH 700 EAST, AND 268 SOUTH 700 EAST STREET.**

**CASE NO. 470-06-33  
WEDNESDAY, SEPTEMBER 6, 2006**

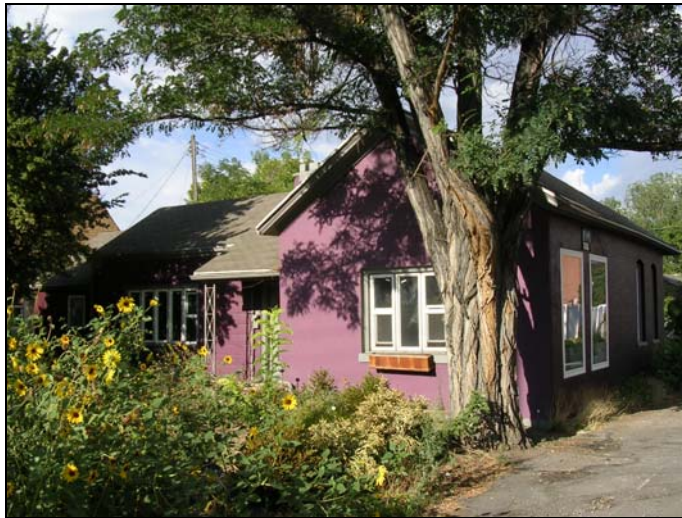
### 256 South 700 East Street

**Discussion:** This building is one of the extant “pioneer homes” constructed when the area was first settled. Other similar cottages are located at: 237 South 600 East; 515 East 300 South; and 558 East 300 South. These small houses are also distinctive because they were typically set back farther from the street than other houses, presumably in compliance with the recommended 25 foot setback established in “The Plat of Zion”.

A one-story cross-wing house, this home may have originally been constructed as a single-cell frame building since the forward projecting gabled wing is constructed of a different material, brick. The Sanborn Maps indicate that the building footprint has not change significantly since 1898. However, the east and a portion of the north façades of the brick projecting wing have been covered with a stucco finish. The early Sanborn Maps show that a porch fronting the main entrance of the side wing was replaced by a shed roof covering over the entry. There are also several extensions to the rear of the building. A brick addition and rear lean-to may be early additions to the house, while the room furthest to the west appears to have been added in the 1940’s. As such, these types of alterations

have acquired historic significance in their own right. Although the windows have been replaced and some original openings changed, these alterations are reversible. The house retains much of its original massing, historic materials and ornamentation.

**Finding:** The physical integrity of this building as established in Section 21A.34.020(C)(2)(b) of the Zoning Ordinance is evident. Although the building has undergone alterations, these alterations do not obscure the character defining elements associated with this simple builder's vernacular style. The property is a significant resource because it represents one of the first structures to exist in the Central City Historic District and is a rare surviving example of its type (builder's vernacular). The project does not substantially comply with this standard.

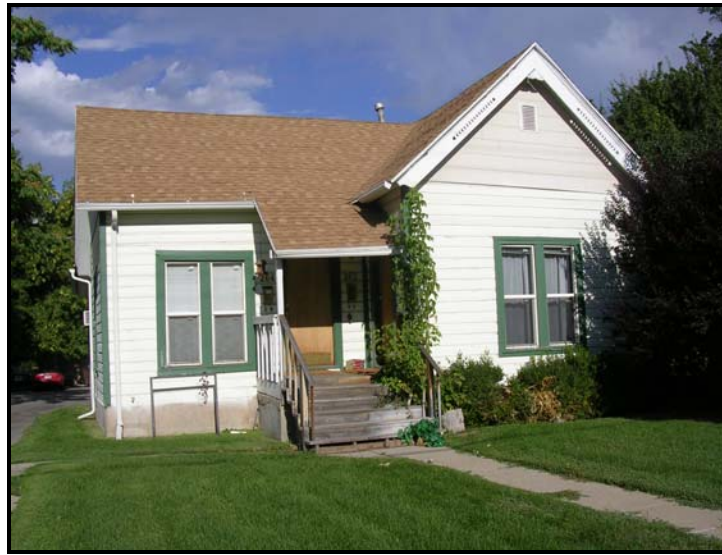
### 262-264 South 700 East Street

**Discussion:** According to the site form, this house was constructed in about 1891. The small one-story cross-wing house is simple in design with decorative bargeboards and an addition to the rear. Sanborn Maps show that the rear addition was constructed by 1911, and within the historic period. When comparing the current appearance of this building with its appearance in the late 1930's tax photograph, it is evident that the front porch is not original, but can be considered to be an element of the house that has also achieved significance within the architectural history of this house. Staff finds that while the house has been altered from its original appearance, many of the character-defining features of this building remain intact. Although the gable ends are covered with asbestos siding and the original window trim replaced, these types of alterations can be reversed.

**Finding:** The property is a physical record of its time, place and use and the physical integrity of this site is evident. The project does not substantially comply with this standard.

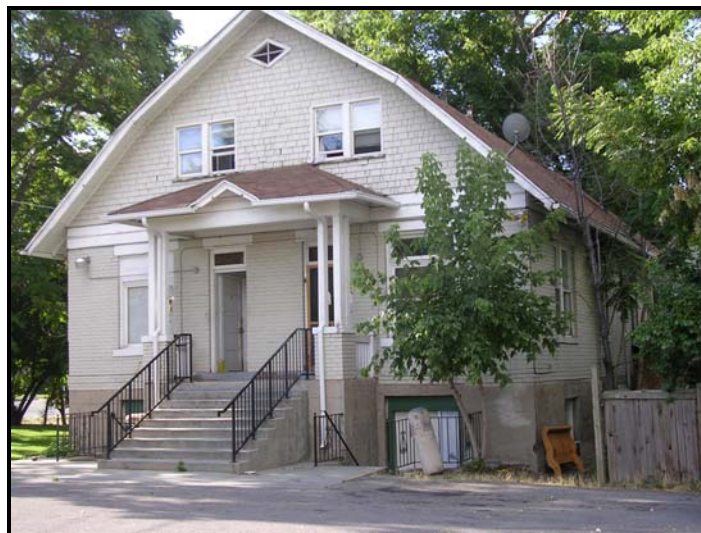
### 268 South 700 East Street

**Discussion:** This gambrel-roofed brick Colonial Revival building was constructed as an apartment house in 1905. The paired square columns supported by a projecting hipped-roofed porch, exposed rafters with rounded ends and large gabled dormer accentuate a Colonial Revival character.

When comparing the current appearance of this building with its appearance in the late 1930's tax photograph, it is evident that many of the character-defining features of this building remain intact. The massing, including the height, roof form and orientation of the building is unaltered. These alterations could easily be reversed.

**Finding:** This property is a physical record of its time, place, and use and its character defining features remain intact. The project does not substantially comply with this standard.
