HISTORIC LANDMARK COMMISSION
STAFF REPORT

Petition 470-08-08 Lawrence House Legalization
Located at 285 North "C" Street in the Avenues Historic
District
April 2, 2008

470-08-08 Lawrence Home Legalization
285 North "C" Street

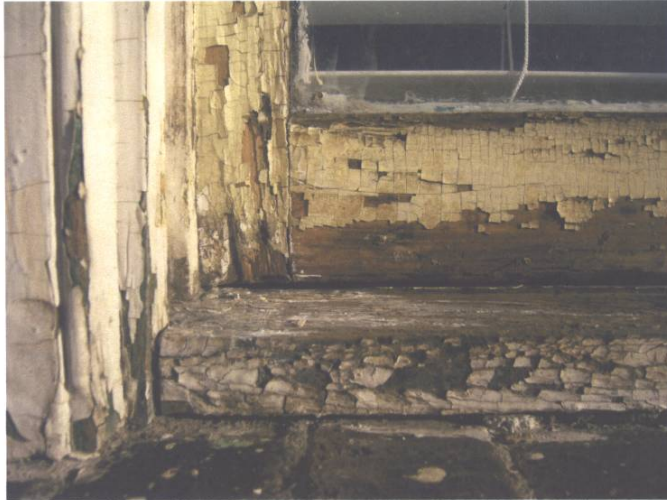
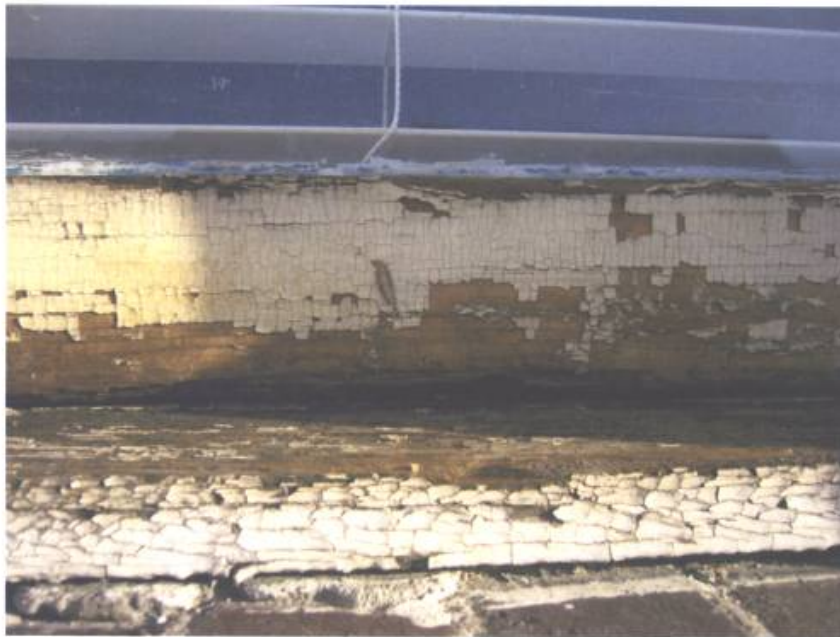
Figure 1 - Original Window

- 2) Existing windows were in bad condition.
 - a. Because the duplex had not been properly maintained for years a lot of the paint had come off the window frames allowing the wood to be exposed, which had begun to deteriorate.

- b. Many layers of paint on the inside of the windows and lack of maintenance over many years had made them non functional. Because the windows weren't usable it was felt that they posed a fire hazard.
- c. The original single pane windows were terribly inefficient with the cost of heating and cooling the home unnecessarily high.

Replacing historic windows with vinyl is considered on a case by case basis. In determining if a replacement vinyl window is appropriate, the manner in which a window is replaced and the amount of original material removed are considered. Important items to consider include preserving the original casing, the amount of glazing to be diminished, the proposed finish, and the profile of the proposed replacement window. In this instance, the applicant replaced only the sash of the window. The original

casing was preserved. The amount of glazing is similar. The finish is a smooth vinyl. The profile of the window is similar to the original (refer to Exhibit C).

The applicant indicates that the original windows did not work and were beyond repair. The replacement windows maintained some of the character defining features of the original. As discussed in Standard 3, the replacement windows match the historic windows in terms of profile, amount of glazing, trim, etc.

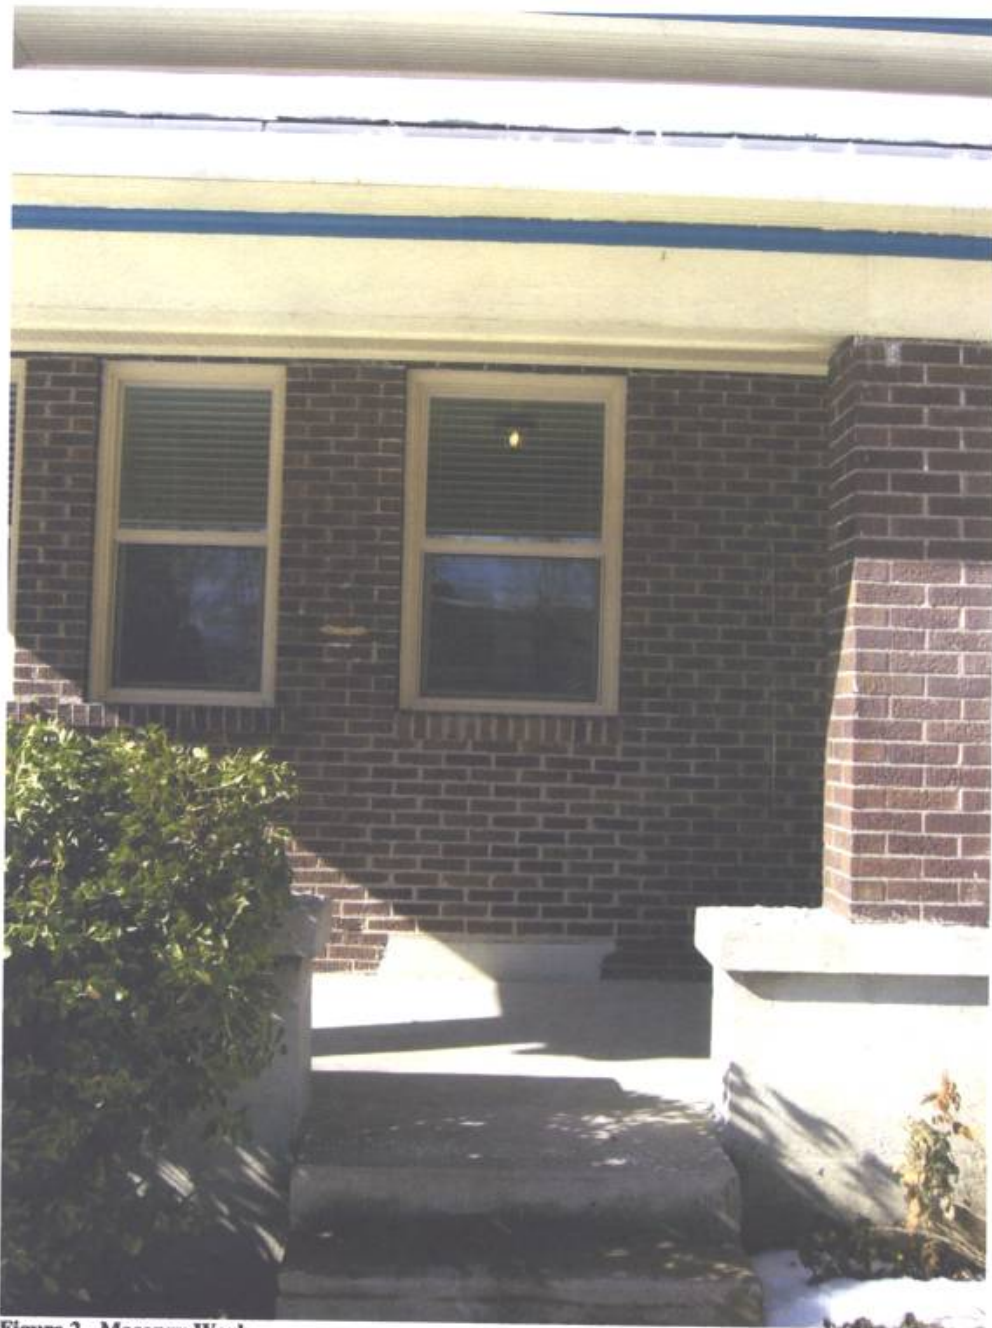
Figure 2 - Masonry Work

Project consisted of masonry work to fill in one of the front doors. A new window was installed in place of that door. The four other windows on the front of the house were replaced. I think it's important to note that the original door had windows on it, because of that **the rhythm of solid to voids has maintained.**

Finding: Replacing the second door on the primary façade of the structure altered the historic character of the structure and is inconsistent with this standard. The replacement windows maintained the pattern of window, the openings, and the general profile of the historic windows. With the exception of the window where the door was, the replacement windows are consistent with this standard.

Finding: The replacement of the second front entry on the primary façade of the structure creates a false sense of history because it is not based on historical documentation and alters the historic character of the property. The new window treatment preserved all but the sashes of the original windows and is of a similar profile to the historic windows. The replacement windows appear to be consistent with the design guidelines for replacing windows on the primary façade. Replacing the door with brick and a window altered the historic character of the property and is not consistent with this standard.

Finding: Replacing the second door on the front of the subject property with a window and brick does not maintain the historic character of the property. This alteration is not compliant with this standard.

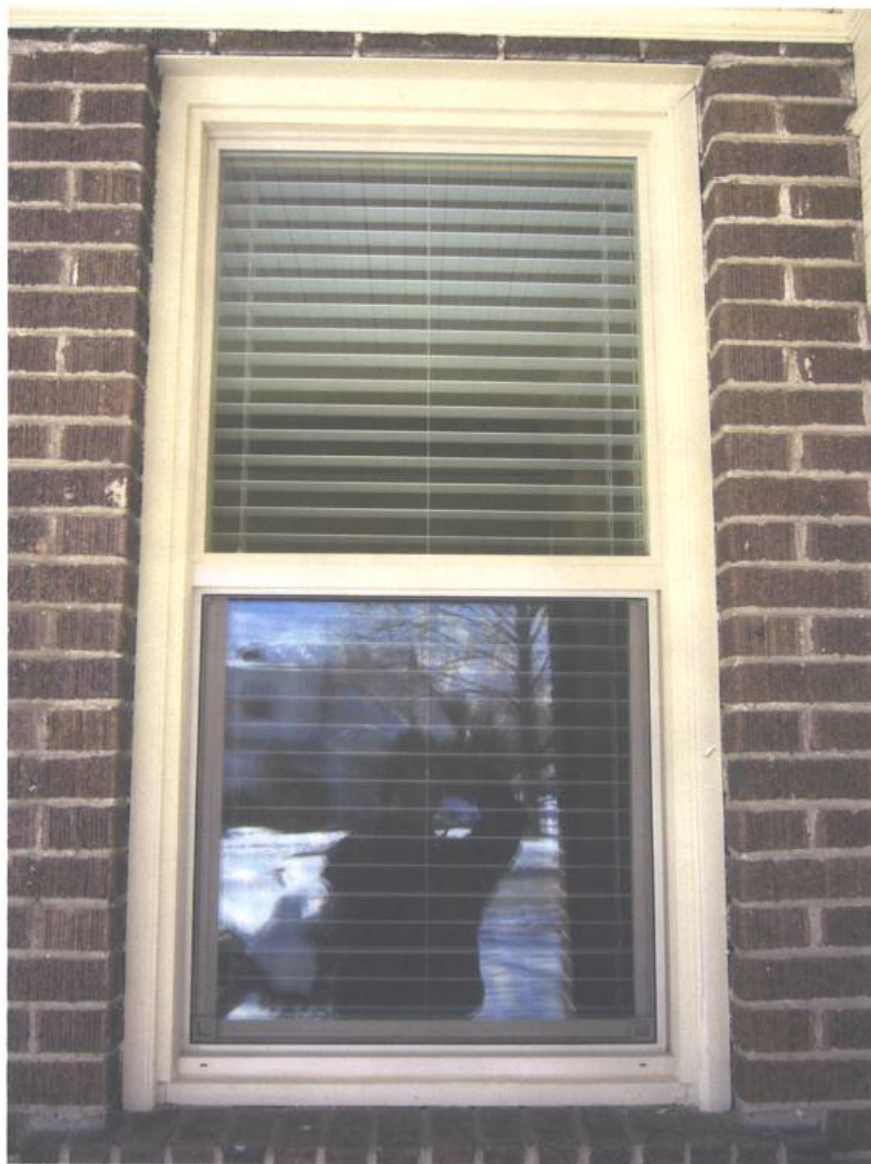
Figure 5 - New Window

Below are pictures of the new and old windows to show how similar they still look.
