# HISTORIC LANDMARK COMMISSION STAFF REPORT

Cannon Office Building  
Minor Alterations  
PLNHLC2008-00591  
633 E. South Temple Street  
December 3, 2008

The applicant requests to appeal an administrative decision that denied the removal of original metal windows to be replaced with metal windows of a different design. The Historic Landmark Commission has final approval authority.

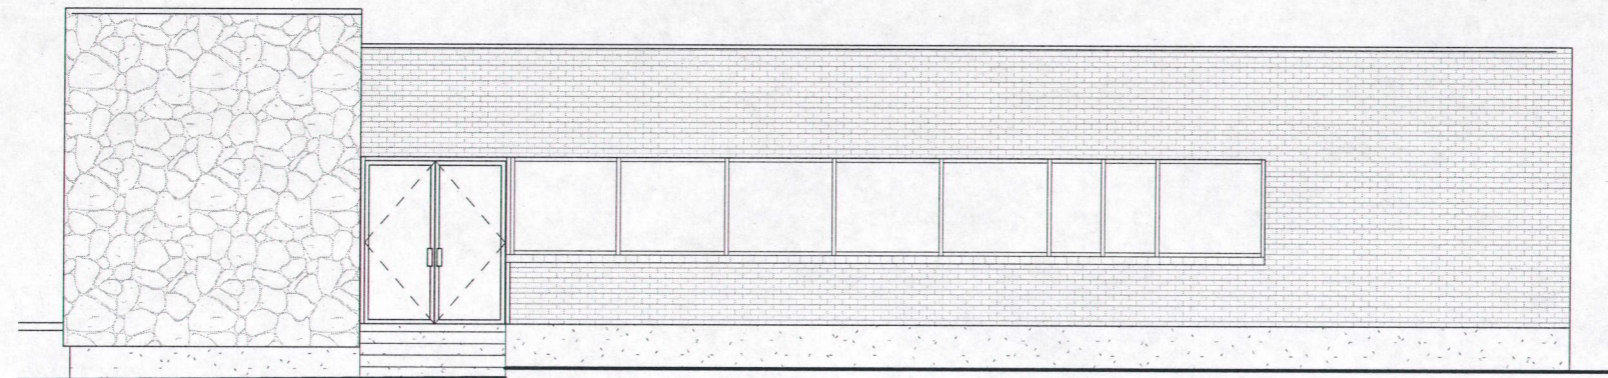
1 EXISTING ELEVATION -SOUTH  
H-1 1/8" = 1'-0"

The subject site is located on a 0.31 acre site on the north side of South Temple Street at the corner of ‘H’ Street. The brick office building was built in 1960 in a mid-century Modern style that incorporates earlier International Style elements such as a flat roof, simple rectangular volume, and smooth wall surfaces. Character-defining features of the building include a distinctive stone panel that wraps around the southwest

corner of the building, and an off-centered front entrance that is flanked by a strip of metal sash windows that vary in width. The window opening runs to the east and has a sill of header bricks. An operable casement window is located toward the east end and interrupts the mostly uniform window configuration.
