HISTORIC LANDMARK COMMISSION  
STAFF REPORT

Kimble Shaw, Major Alteration, 470-08-10,  
30 North S Street in the Avenues Historic District  
June 4, 2008

1. construct a detached garage; and
2. remodeling existing structure at approximately 30 North S Street, an interior property.

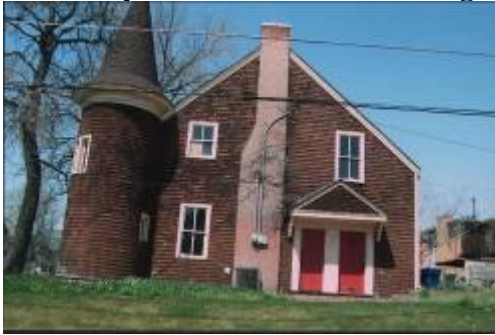
South Elevation

- Replace the smaller upper story window with a new aluminum clad wood window with insulated glass and simulated divided lights to match the size of the larger upper story window and replace the larger window with an aluminum clad window of the same size as the existing.
- Change the existing lower wood window to a wood panel door with three-light transom
- Remove the existing paired-door entry and overhang and replace with a large aluminum clad wood boxed window with insulated glass and simulated divided lights to match the size of the double entry.
- Remove the existing gable above the paired-door entry and replace with an 8" to 10" deep shed roof overhang of copper.

Doors: The paired doors of the south elevation, a secondary elevation, will be removed and enclosed with a boxed window the same size as the combined paired entry. The gable above will be replaced with a copper shed roof. A new single door will be added to the North and a window on the south elevation will be changed to a door. These two new doors will match the design and materials of the existing single door on the east elevation. The door and the majority of the first floor wall of the east elevation (rear) will be removed and replaced with glass. Evidence of ghosting suggests that there was a large stable door on the east side, roughly opposite of the door on the west side.

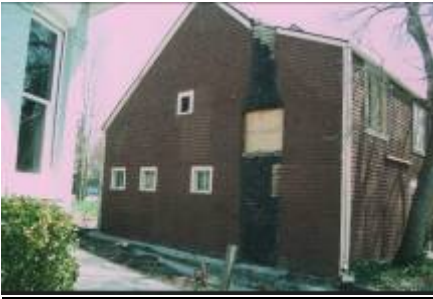
North elevation

- Replace the upper story window and the far right window with new aluminum clad wood windows with insulated glass and simulated divided lights to match the existing size. (The ground floor windows will remain.)
- Add a new wood paneled door with three-light transom
- Chimney was removed before the current owner's purchase of the property

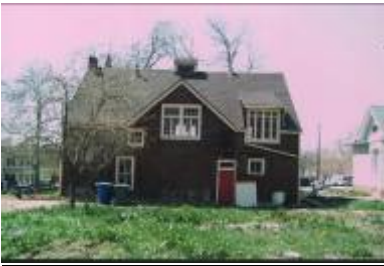
East elevation

- Add a rear patio. The cover will be a hipped roof with dimensional asphalt shingle to match the existing roof shingle. The columns are round Doric columns of painted fiber-glass-reinforced gypsum.
- Add a shed roof dormer of the same dimension, design, and materials as the existing dormer, sided with matching wood shingle, roofed in asphalt shingle to match the existing and with wood trim. It will include an aluminum clad wood window to match the opposite dormer.
- Add a new interior chimney that is covered in wood shingles to match the house.
- Replace all wood windows with aluminum clad wood windows
- Remove the majority of the all lower floor openings and replace with French doors.
- Replace wood shingles with same

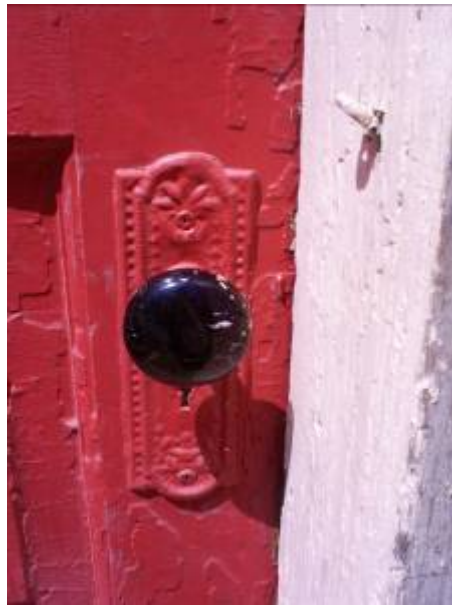
Hardware of rear entrance

Doors: The essence of one existing secondary entrance will be retained by covering the opening with glass rather than enclosing with siding. Other entrances proposed to be relocated are also on secondary elevations. The dramatic changes to the rear door and rear wall proposed will not be seen from the street. **Staff recommends that the rear door and hardware, which appears to be quite early, be**

**repaired and moved to the location of the proposed north or south side entrances, if possible. If not possible, the door should be replaced as proposed.**

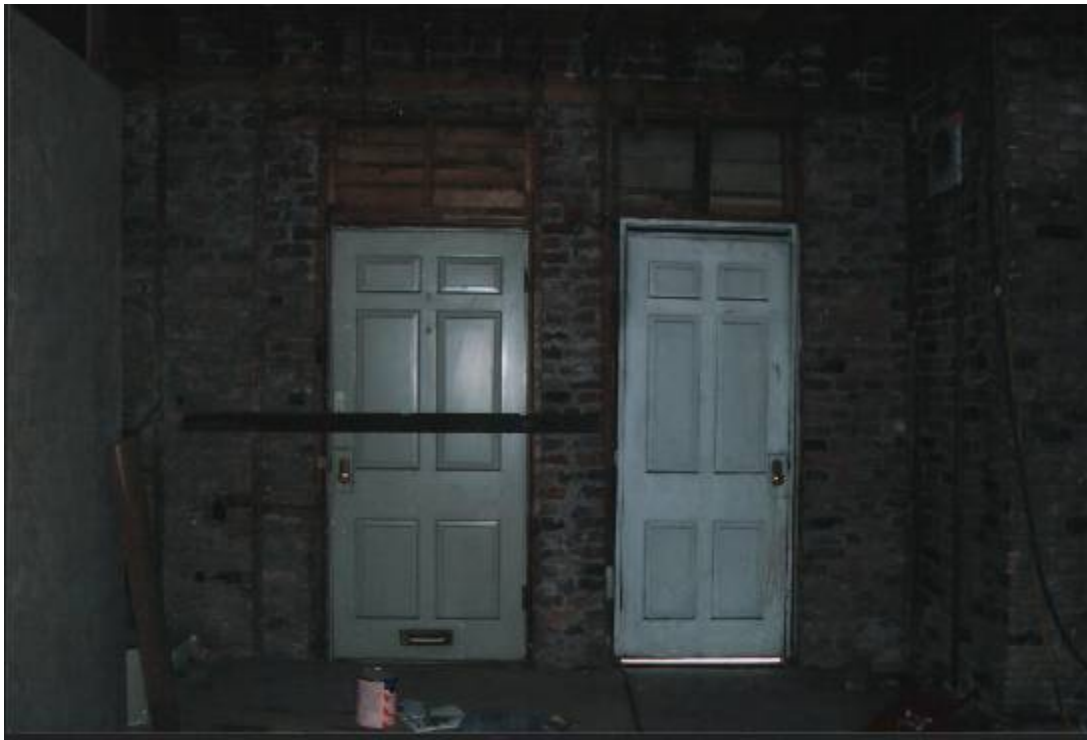
Partial sill to left of the left door shows that the second door was a later addition.

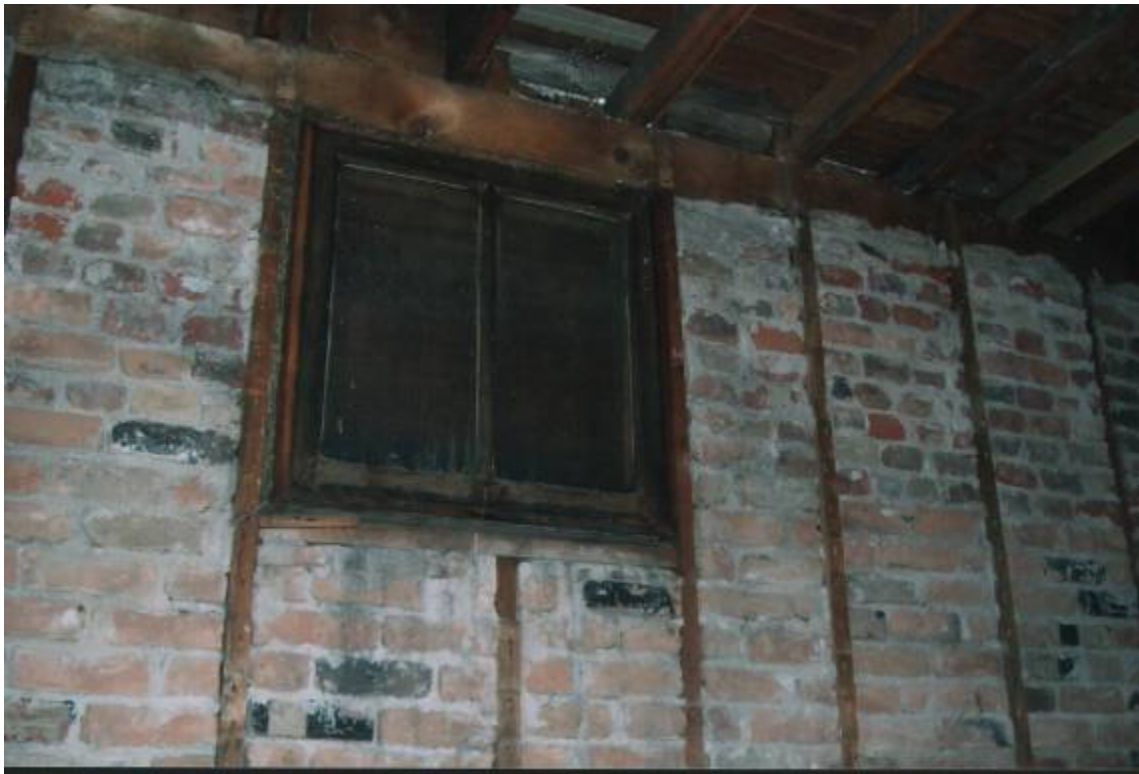
This window is where the chimney used to be--evidence that the missing chimney was not original.

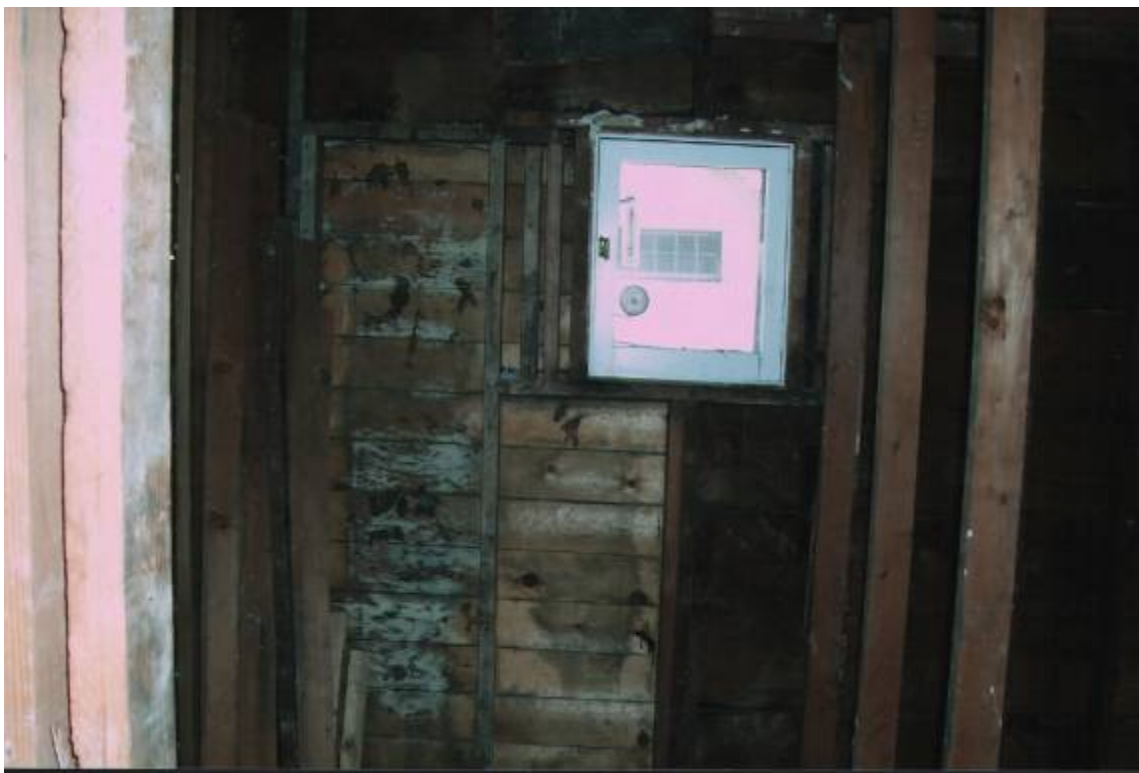
The lighter boards to the left are evidence of a hay loft door on the second floor, north side.

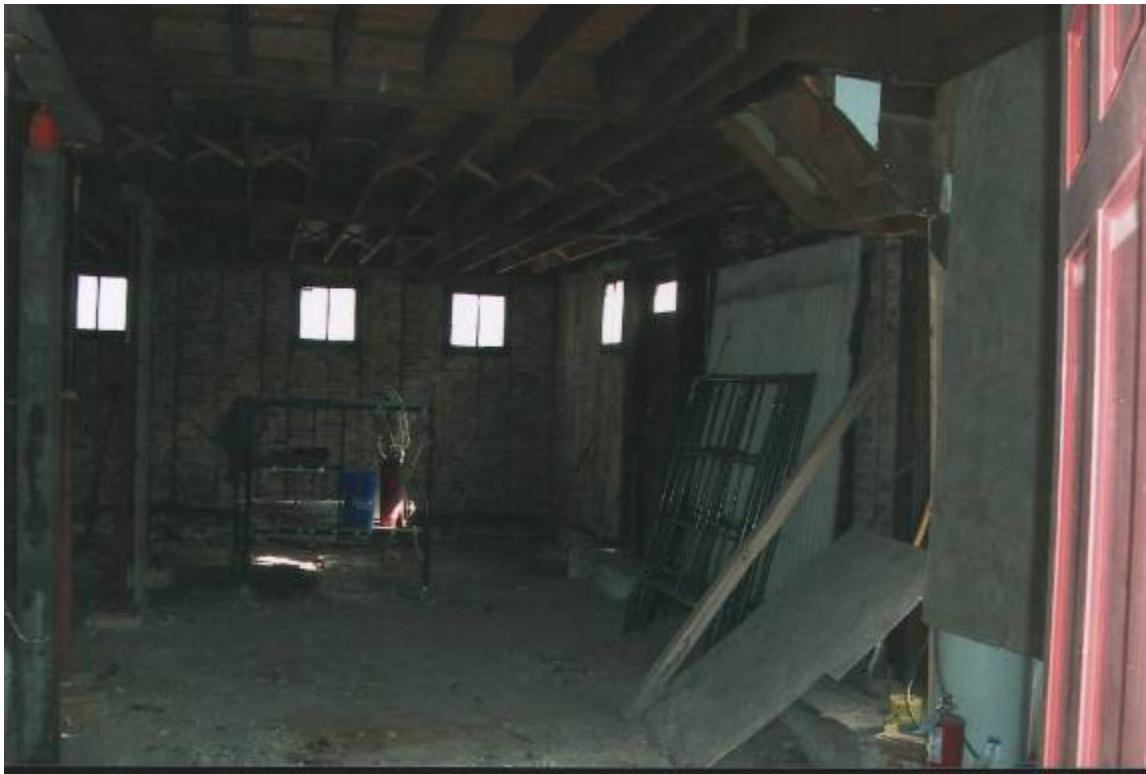
To the right is the sliding barn door which was removed prior to the 1970s documentation.

The current garage door, which is not original, is proposed to be removed for a sliding barn door. The design of the sliding door comes from a sliding door and hardware found stored inside the building; however, staff believes that the stored door might have been a later addition, and not original. Staff could not find a sliding door design, like the one proposed, on early 1900s stables but found them on barns. Attachment G shows two stables designed by Frederick Hale, neither of which used a sliding barn door. In addition, the bottom of the structure has a slight flare making it unlikely that a sliding door was used. **Staff recommends that the design of the stable/garage entrance be changed so that the glazing in the entry is reminiscent of an outward opening, double door, stable entrance and the sliding barn door be removed.**

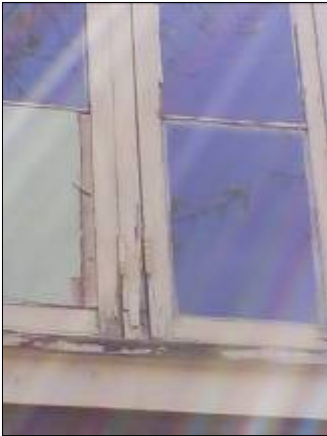
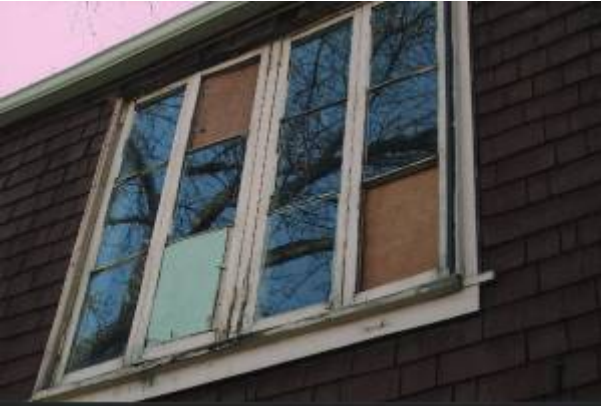
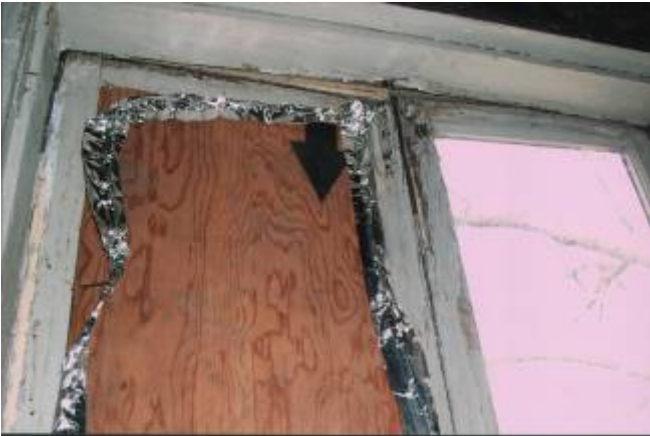
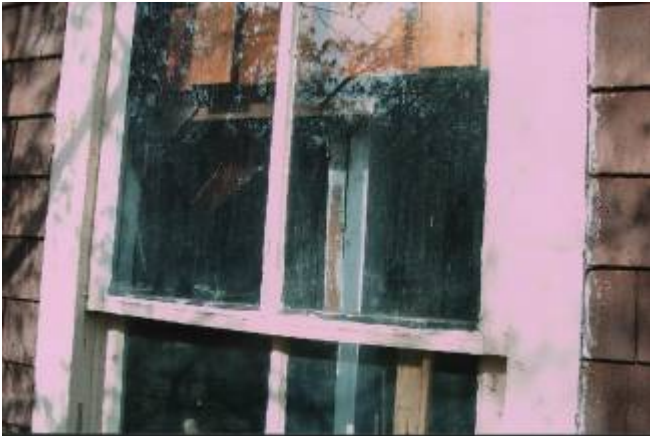
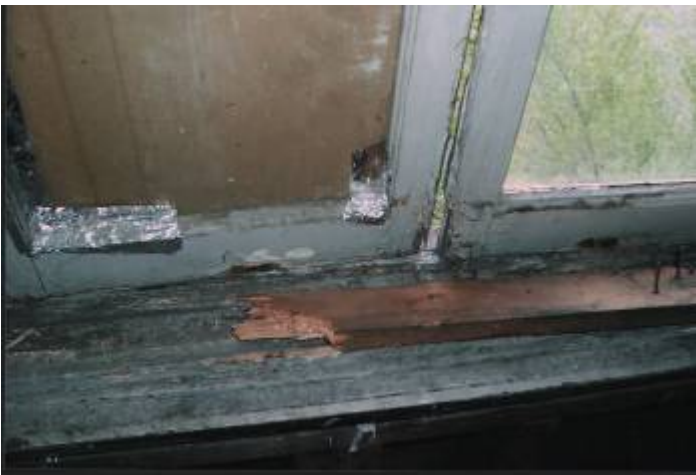
Evidence of window conditions

Windows: Although windows should be repaired rather than replaced, photographic evidence and an inspection revealed the poor condition of the windows. Applicant will keep some of the earliest windows. The replacement windows proposed meets the standard since the design and dimensions match existing windows and the rhythm of solids to void is not compromised.

**Finding for Standard 6:** The majority of the windows are too deteriorated to be repaired and the replacement windows match the existing windows in design and dimensions. The proposed doors match existing doors in terms of design, dimension and materials; therefore the replacement of windows and doors meets the standard. **Staff recommends relocating the existing rear door and transom to the location of the proposed north or south side entrances, if possible.** If not, possible the entrance should be replaced as proposed.

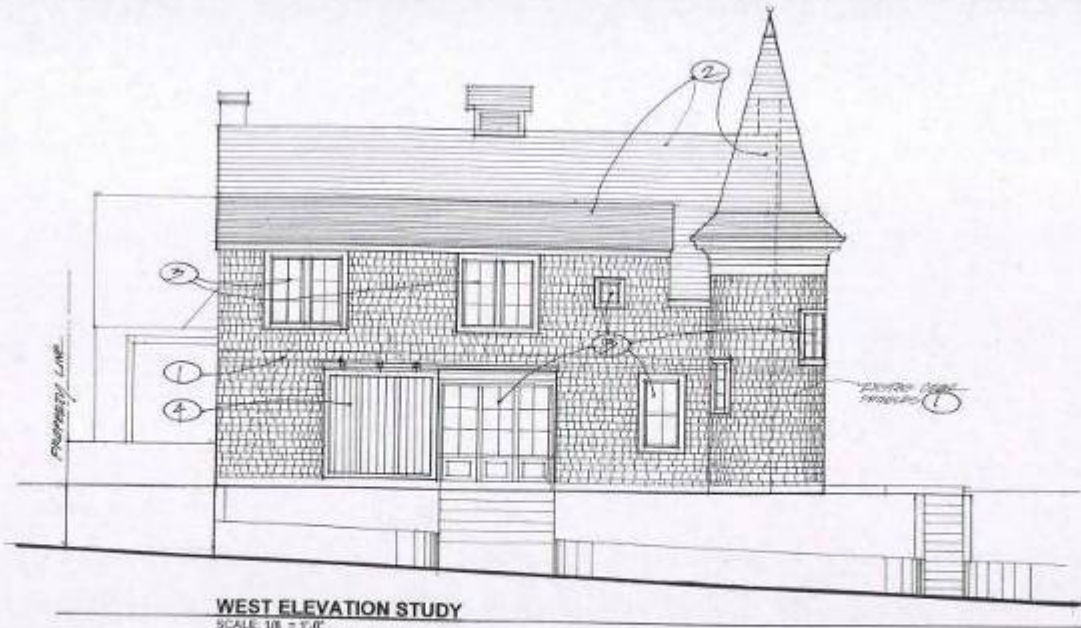
**WEST ELEVATION STUDY**  
SCALE 1/8" = 1'-0"

- Replace all existing wood windows with aluminum clad wood windows
- Remove existing door and replace with windows and add new wood barn door on sliding rack

- 1 EXISTING CEDAR SHINGLES TO REMAIN.
- 2 EXISTING ASPHALT SHINGLE TO REMAIN.
- 3 NEW ALUMINUM-CLAD WOOD WINDOW W/  
INSULATED GLASS & SIMULATED DIVIDED  
LITES TO FIT EXISTING OPENING.
- 4 NEW WOOD BARN DOOR ON SLIDING TRACK.
- 5 NEW ROOF DORMER TO MATCH EXISTING.
- 6 NEW FRENCH DOOR ASSEMBLY BY  
WINDOW MANUFACTURER.
- 7 FIBER-GLASS-REINFORCED GYPSUM  
COLUMN, PAINTED
- 8 NEW CEDAR SHINGLES TO MATCH  
EXISTING HOUSE.
- 9 NEW ALUMINUM-CLAD WOOD WINDOW W/  
INSULATED GLASS & SIMULATED DIVIDED  
LITES IN NEW OPENING.
- 10 EXTERIOR WOOD DOOR
- 11 9'-0" X 8'-0" WOOD GARAGE DOOR W/  
SIMULATED DIVIDED LITES.
- 12 WOOD TRIMS TO MATCH EXISTING HOUSE.
- 13 CEMENT-BOARD SHINGLES BY HARDI-PLANK  
OR EQUAL TO MATCH EXISTING HOUSE,  
PAINTED.
- 14 WOOD CORBEL
- 15 NEW DIMENSIONAL ASPHALT SHINGLE TO  
MATCH EXISTING HOUSE.
- 16 EXISTING BRICK CHIMNEY TO REMAIN.
- 17 NEW WOOD-FRAMED CHIMNEY.
