HISTORIC LANDMARK COMMISSION
STAFF REPORT

Carl Jones
Legalization, 470-08-14
104 F Street in the Avenues Historic District
June 4, 2008

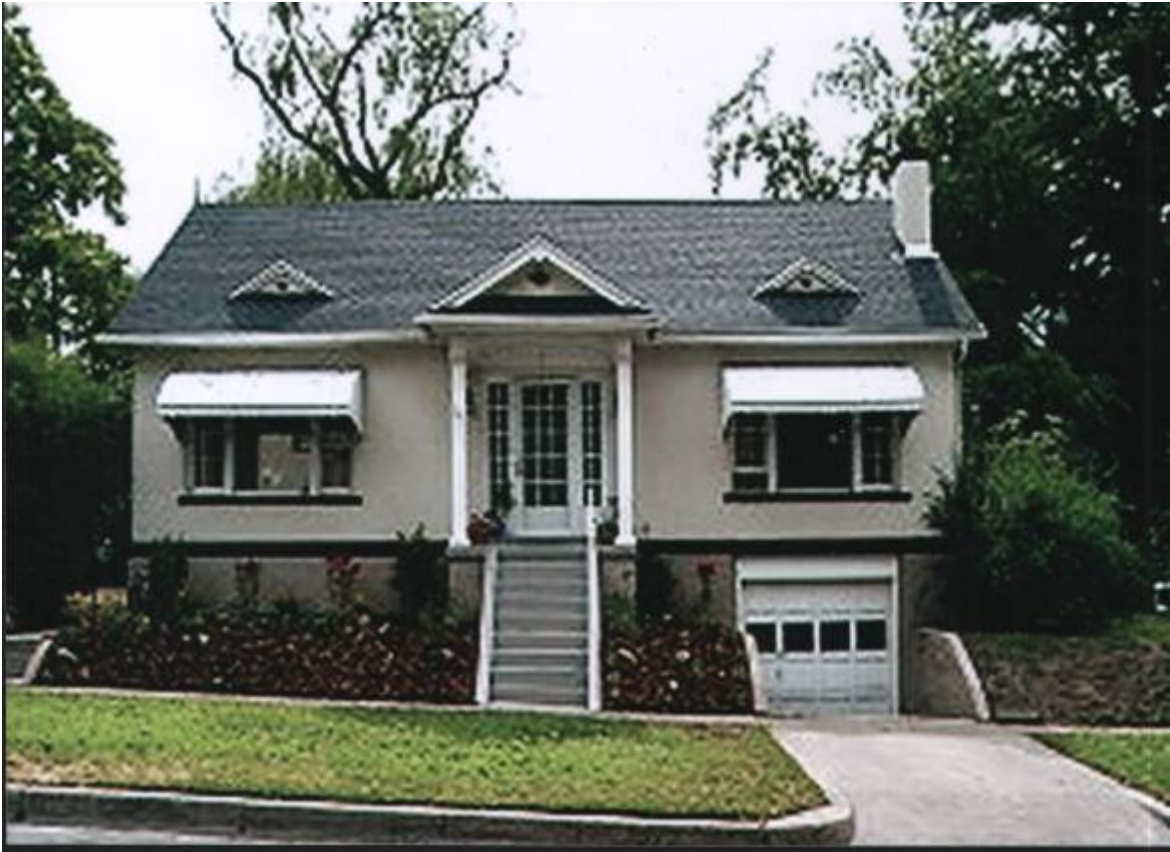
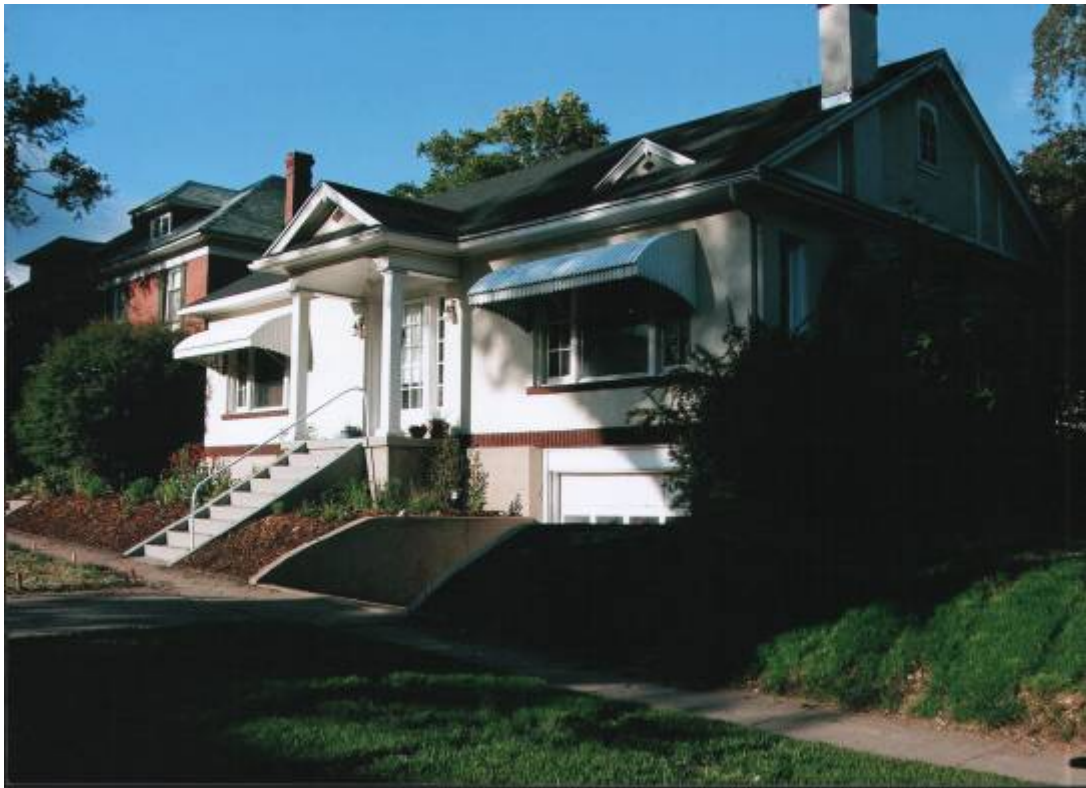
Attachment A
Photos of building prior to alteration

Discussion for Standards 2, 5, and 6: There is no evidence as to the condition of the original windows. The original windows on the main façade were tri-part windows with a one-light fixed center window flanked by multi-light windows. The replacement windows use grids between the glass for all three sections of the tri-part windows, including the center section which originally had no divisions. The overall size of the original and the new windows appears to be the same or similar.

Staff recommends that the Historic Landmark Commission approve the proposed replacement windows on the rear and secondary facades of the dwelling, since they are not readily seen from the street, but require appropriate windows for the main façade which match the originals in dimension and design. This recommendation is based on the Discussion and Findings of Fact in the staff report.

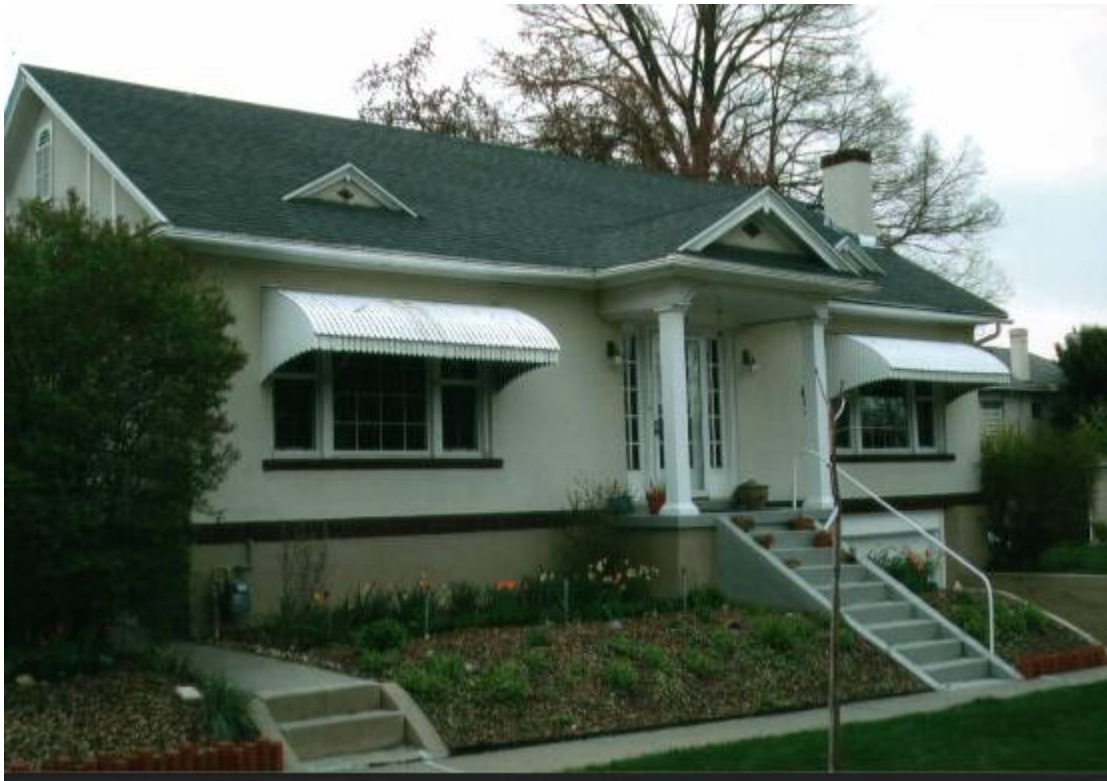
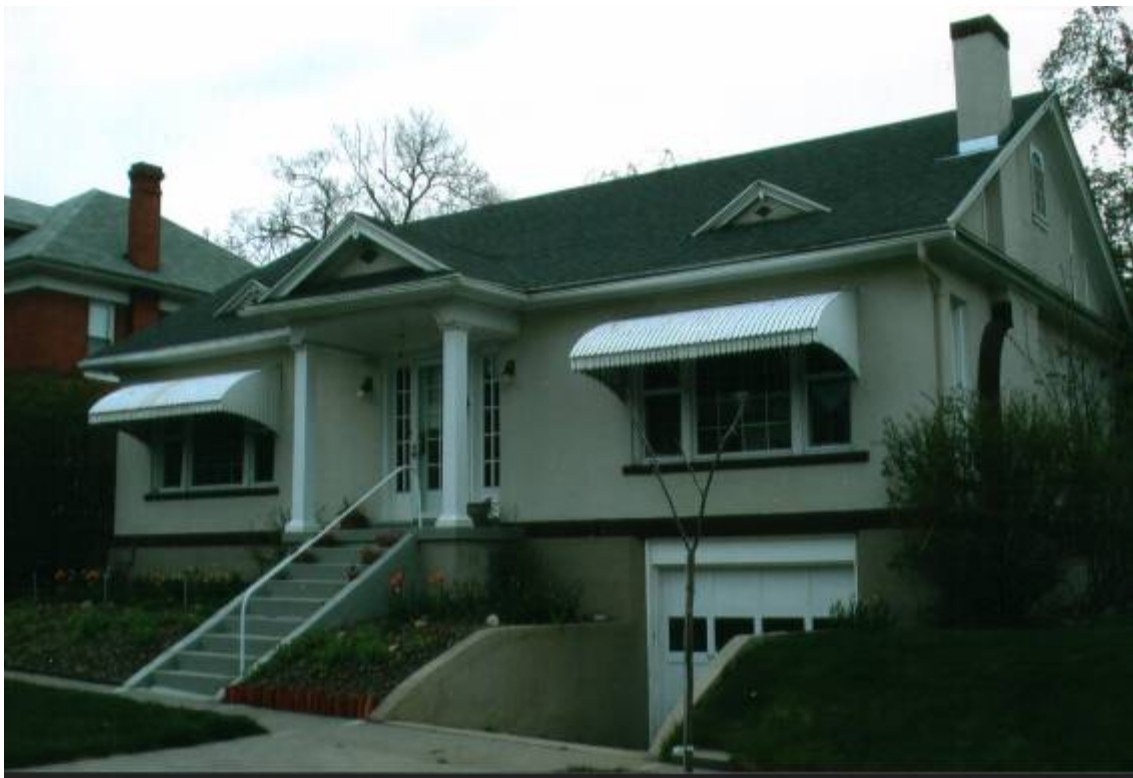
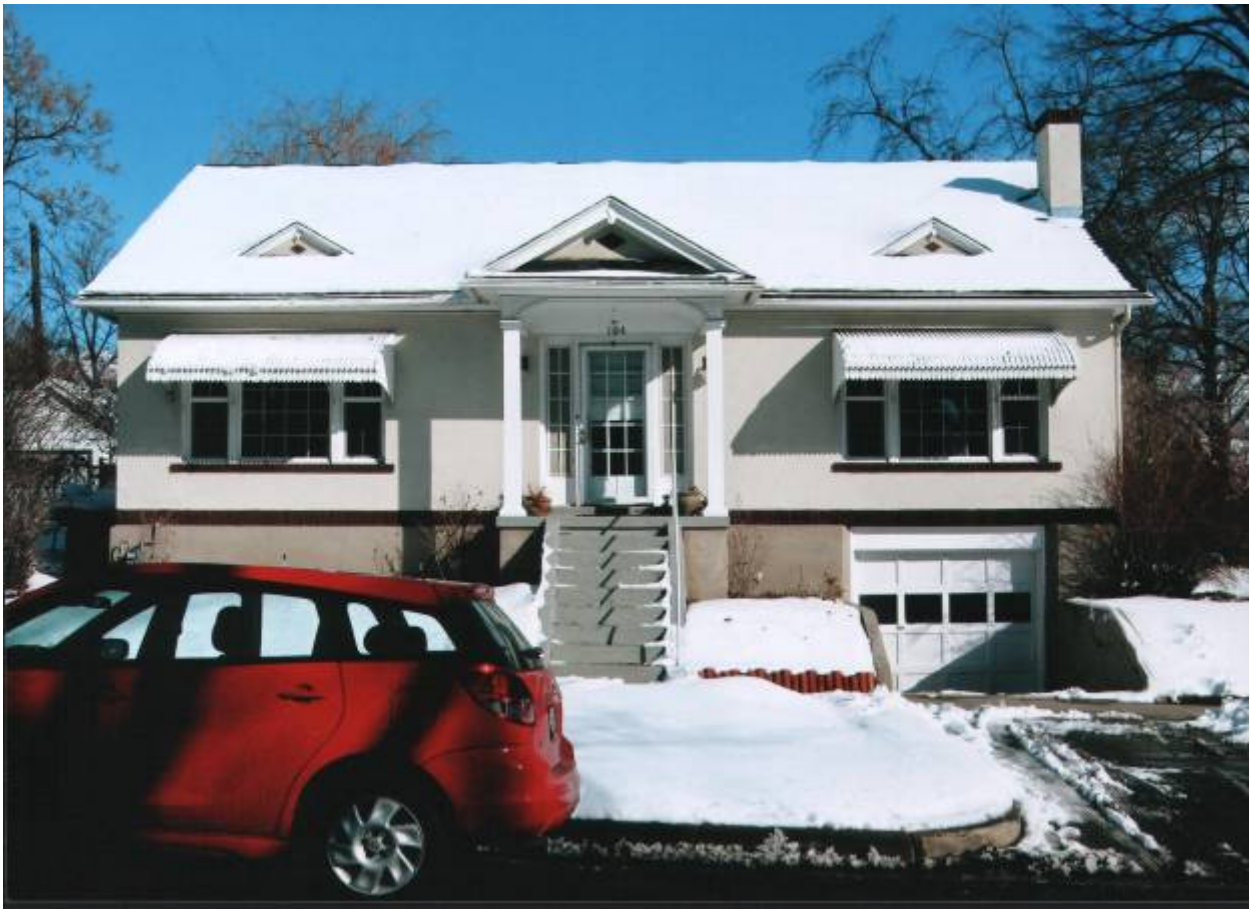
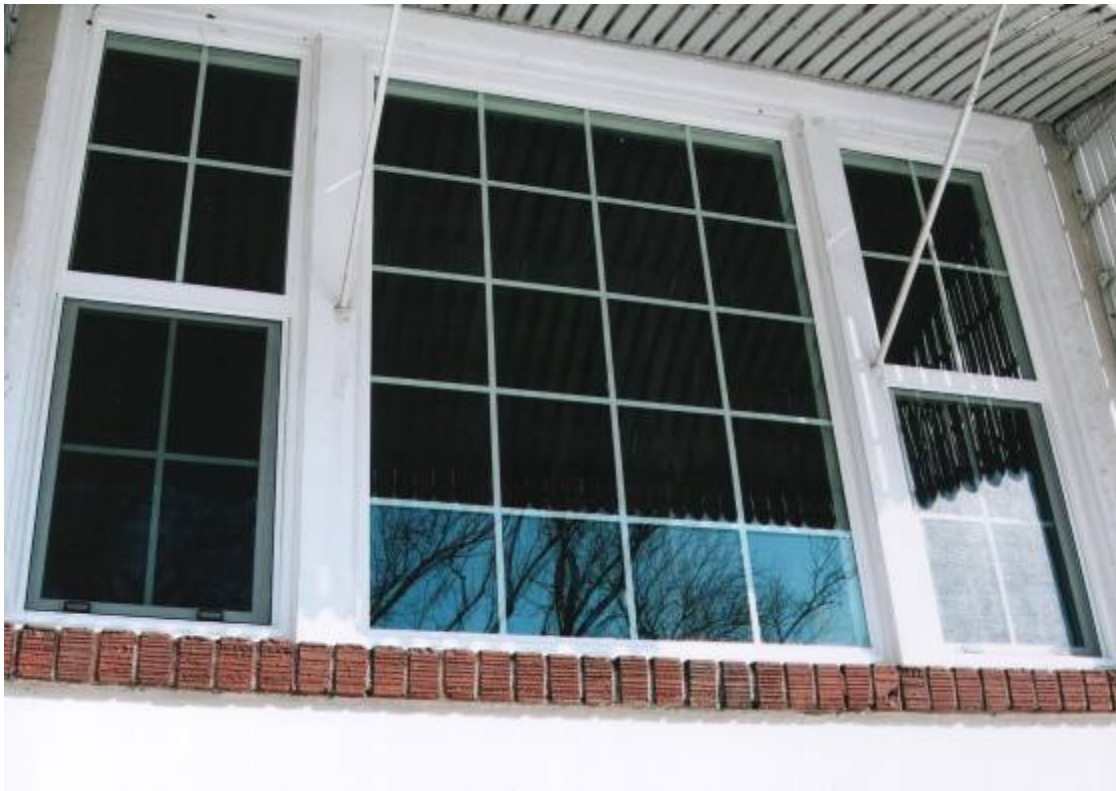
Attachment B
Photos of building after alteration

Finding for Standards 2, 5 and 6: The current replacement windows do not meet standards 2, 5, and 6 nor the design guidelines since character defining windows were removed and there is no evidence of their condition to warrant replacement. Assuming that window replacement was an appropriate action, the replacement windows also do not meet these standards since they do not match the original design or material. Adding divisions in the center section of the tri-part windows which were originally single lights and using between-the-glass muntins as opposed to true divided lights or simulated divided lights, are the main reasons the replacement windows do not meet the standards.

Discussion for Standard 3: The vinyl replacement windows use a between-the-glass muntin that does not have the dimension and reveal of the original windows. In addition, grids have been added to a section of the window that did not historically have grids.

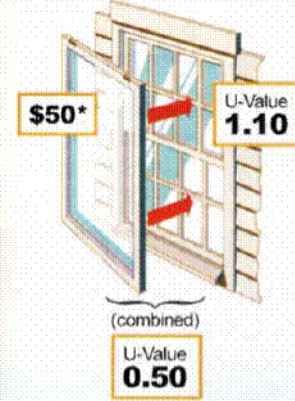
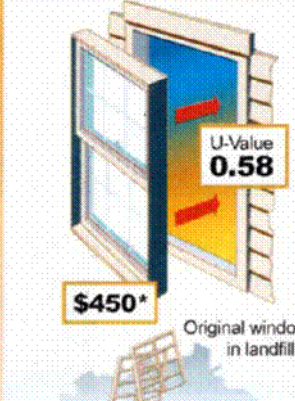
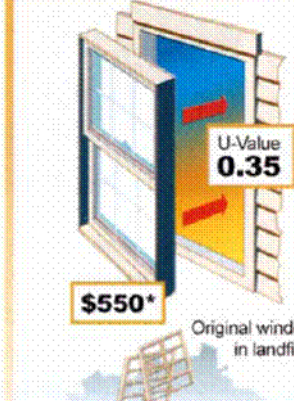
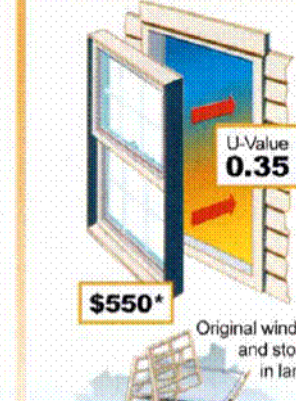
Window Comparison Graphic

Let the Numbers Convince You: Do the Math

TUNE-UP STRATEGIES	Double-pane thermal replacement of single-pane window	Low-e glass double-pane thermal replacement of single-pane window	Low-e glass double-pane thermal replacement of single-pane window with storm window

<p>\$50* (combined) U-Value 1.10 U-Value 0.50</p>

<p>\$450* U-Value 0.58 Original window in landfill</p>

<p>\$550* U-Value 0.35 Original window in landfill</p>

<p>\$550* U-Value 0.35 Original window and storm in landfill</p>
ANNUAL ENERGY SAVINGS	625,922 Btu	902,772 Btu	132,407 Btu
ANNUAL SAVINGS PER WINDOW**	\$11.07	\$16.10	\$2.29
SIMPLE PAYBACK	40.5 Years	34 Years	240 Years
$\$50 / \$13.20 =$ 4.5 Years	$\$450 / \$11.07 =$	$\$550 / \$16.10 =$	$\$550 / \$2.29 =$

*Cost of 3' x 5' window, installed
 **Assuming gas heat at \$1.09/therm

The applicant's reason for appeal was based on the energy efficiency of vinyl windows. However, the majority of energy loss in a home is through the roof and not the windows. Studies show that the payback period to begin to see a return on investment is beyond the life of the window. The graphic in Attachment G illustrates this point. Wood windows can last almost forever if properly repaired, maintained and painted. Storm windows are an additional action that meets the standards of the ordinance and design guidelines.
