HISTORIC LANDMARK COMMISSION
STAFF REPORT

Tom Brooks
Legalization, PLNHLC2008-00317
460 South 1200 East in the University Historic District
October 1, 2008

The applicant requests to legalize a change to the historic roofline of 460 South 1200 East that is different than the work approved and to legalize a fence which was constructed without a Certificate of Appropriateness. The Historic Landmark Commission has final approval authority.

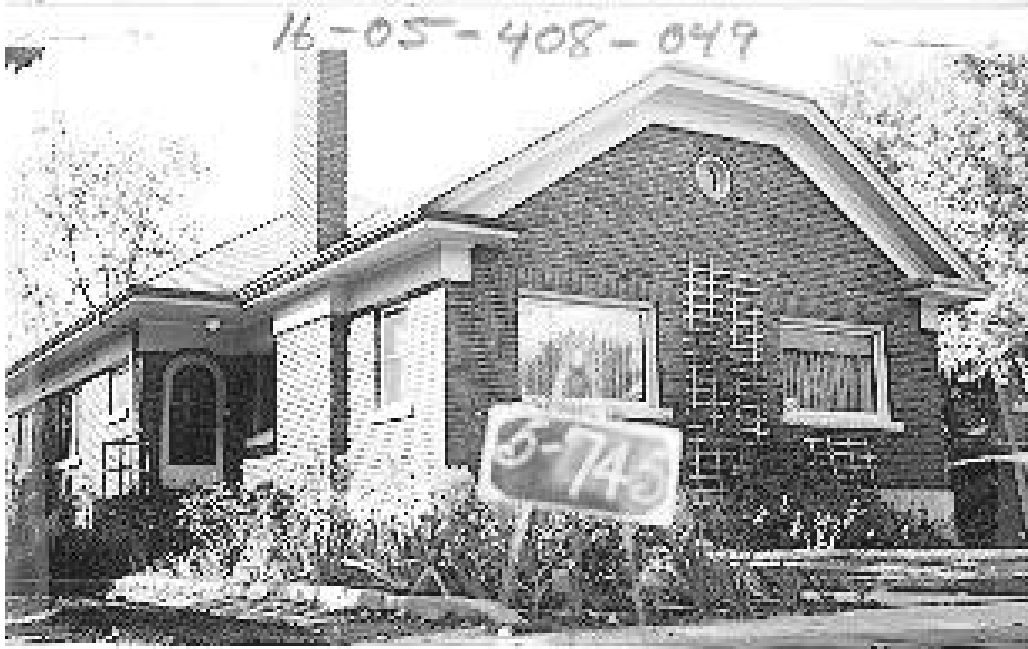
Assessor's Photo

This one-story brick structure has elements of Colonial Revival and Tudor revival styles on a bungalow form. It was constructed in 1922. In the 1980s historic survey of the University District it was listed as a contributory structure.

hip roof with broad clip-gabled front wing; returns on gable; brick exterior; round arched doorway; concrete foundation; tall corbeled chimney;

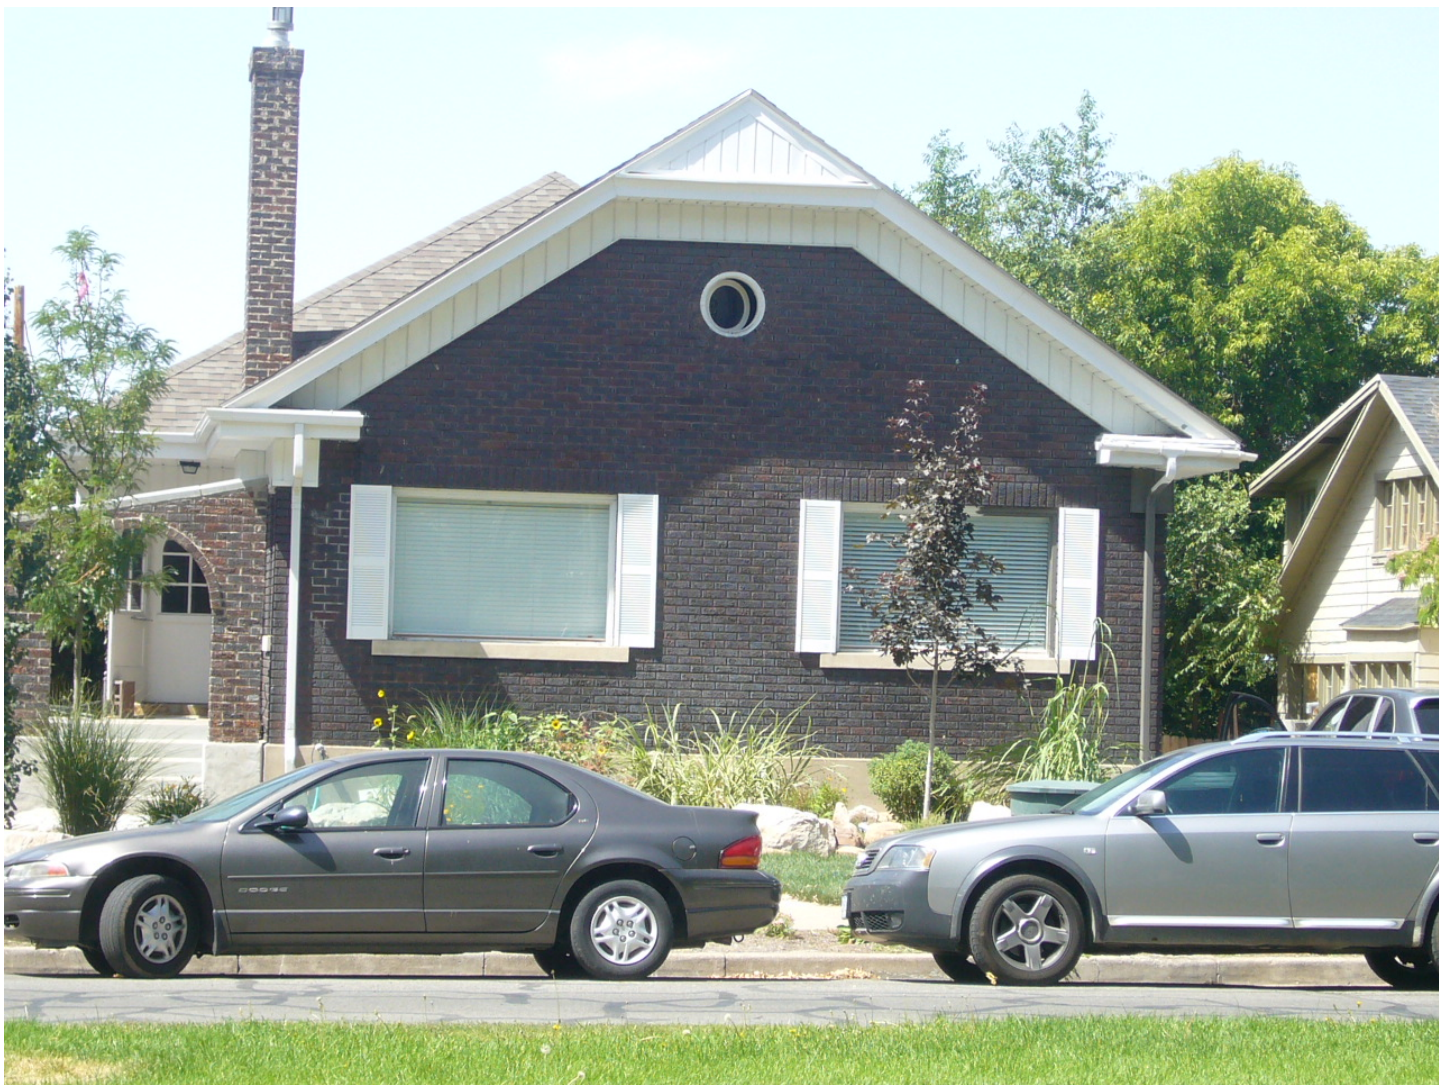
Current Documentation

(1.) It appears that a full gable was added and covered in vinyl, rather than retaining the original clipped gable roof design. (2.) The applicant now proposes to remove the vinyl siding and fill-in with brick. (3.) In addition, a portion of the front brick wall was extended to form an arched entrance in front of the existing main entrance.

Discussion for Standards 2, 5, and 6: (1.) The home originally had a clipped gable roof, also known as a jerkin-gable. After a fire in late 2007, the property owners reconstructed the roof as a full gable, rather than as a clipped gable. The design guidelines state that the roof is a major character defining feature of a house. According to *American Vernacular Design, 1870 to 1940*, a gable roof's "visual impact derives from the broad expanses of roof, from major accent points along the roof's lines, and from the gable end itself. . . Flared roofs and clipped gables are used in designs attempting to convey rustic effects." (37)

(3.) The front wall of the house has been extended to create an arched entrance in front of the main entrance creating an illusion of an extension of the main façade and obscuring the view of the main entrance.

Staff recommends that the Historic Landmark Commission deny the alteration as it does not meet any of the standards of section 21A.34.020 G of the zoning ordinance. This recommendation is based on the Discussion and Findings of Fact in the staff report.

(2.) The applicant now proposes to remove the vinyl in the gable field of the alteration and replace with brick.
