HISTORIC LANDMARK COMMISSION  
STAFF REPORT

TRACY AVIARY WILSON PAVILION  
RENOVATION, SOUTHERN GROUND  
HORNBILL'S NEW CONSTRUCTION,  
INSTALLATION OF TEMPORARY BUILDING,  
ACCEPT MASTER PLAN  
Major Alterations and New Construction &  
PLNHLC2008-00684  
Liberty Park, 589 East 1300 South  
August 5, 2009

# SOUTHERN GROUND HORNBILLS HOLDING BUILDING:

TRACY AVIARY, 589 E. 1300 S. SALT LAKE CITY, UTAH 84105

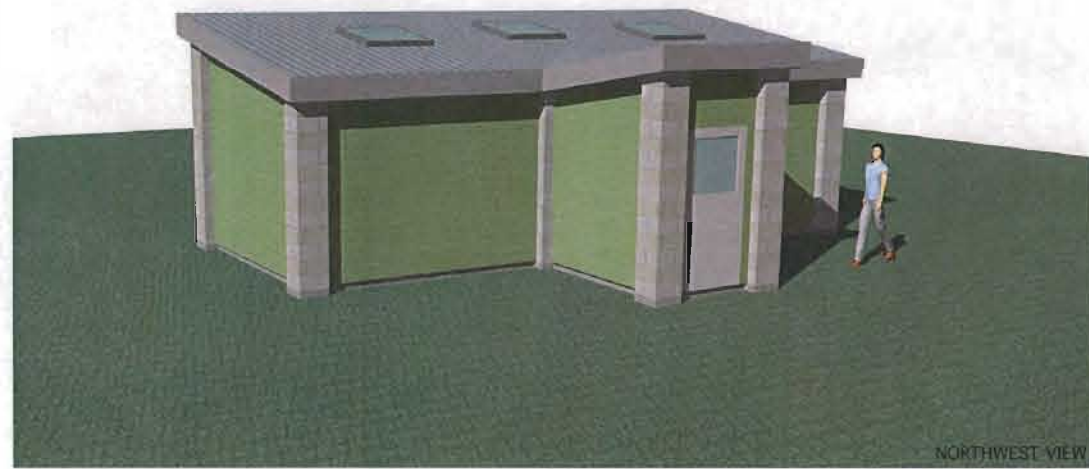
3 BUILDING PERSPECTIVES

NORTHWEST VIEW

NORTHEAST VIEW

This exhibit will be a 394 square foot one-story structure. The siding is composite lap siding and honed CMU, the shed roof is standing seam metal with skylights and the people and bird entrances are steel doors. There are no windows. Construction of this structure will require the removal of one to two trees which has been accepted by the City's Urban Forester, and the installation and alteration of concrete pathways and fencing, which are not historic.

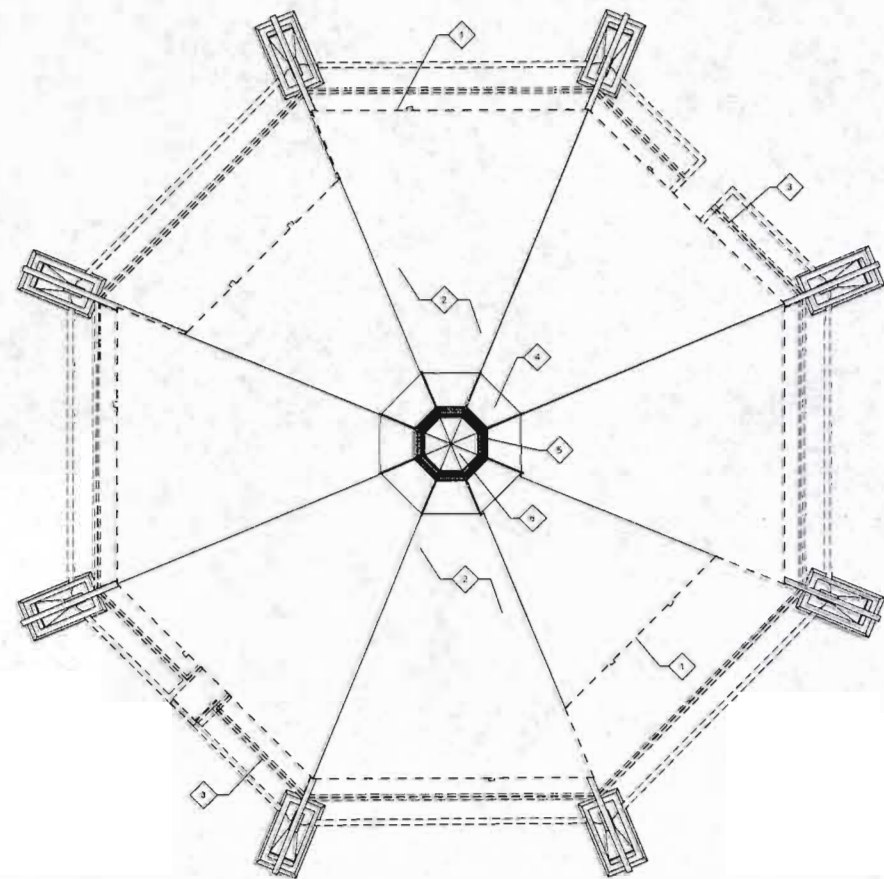
2 DEMOLITION ROOF PLAN

- A RECYCLE ALL MATERIALS REMOVED FROM BUILDING. SEE SPECIFICATION DOCUMENT AND WGBH MATERIALS FOR LEAD CREDITS.
- B DASHED LINES SHOW ELEMENTS TO BE REMOVED
- C ROOF FRAMING AND ROOF DECK TO REMAIN. REMOVE DAMAGED ROOF DECK AND REPLACE WITH NEW ROOF DECK TO MATCH EXISTING.

- **Roof:** Replace roofing membrane. Retain existing louvers, metal cap and skylights. Remove roofing along the flattest portions of the roof and replace with new skylights that will extend eight inches above the roofline.

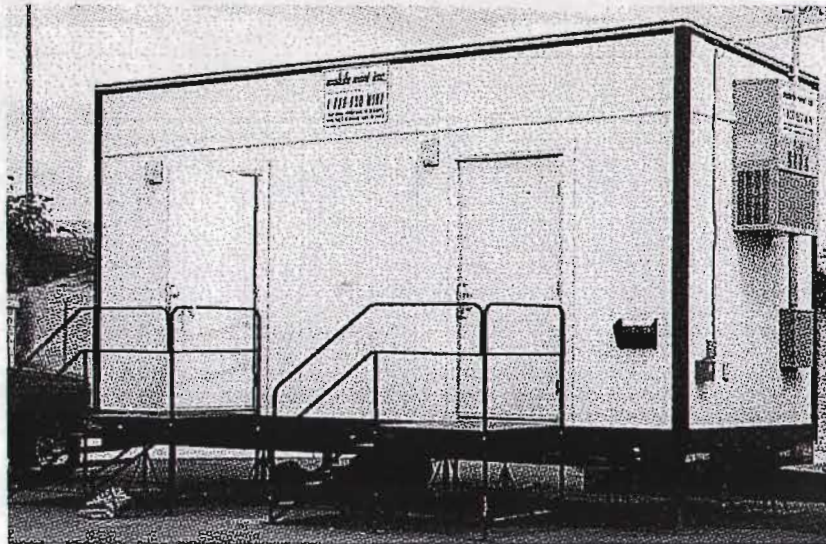
- 24' long (including hitch)
- 20' box size
- 8' wide
- 8' ceiling height

A portable 8' x 20' office trailer for temporary bird holding during Wilson Pavilion remodel will be placed in a grassy area northwest of the Wilson Pavilion. It is estimated that it will need to be in place for about nine months.

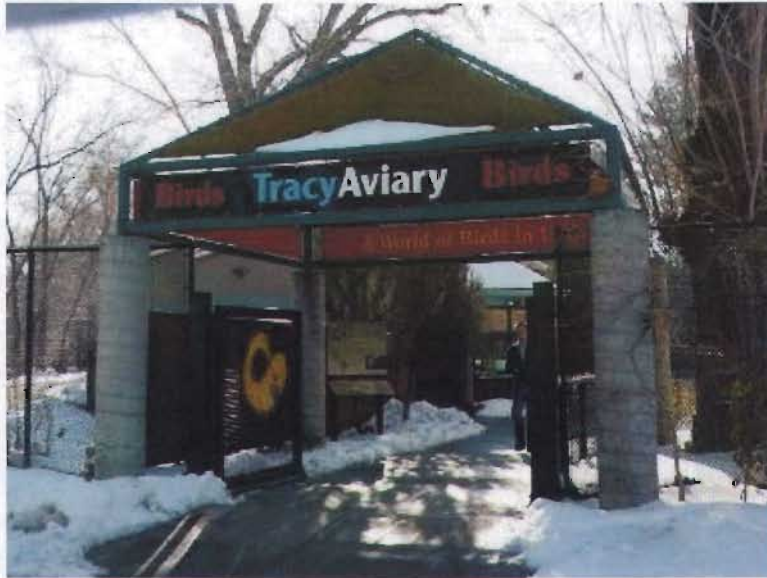
## 1

**Current Use:** Current Entrance  
**Materials:** concrete, pipe and awning  
**Plan:** replace

**Historic Use:** N/A  
**Construction Date:** c. 1994  
Part of Phase II - bond

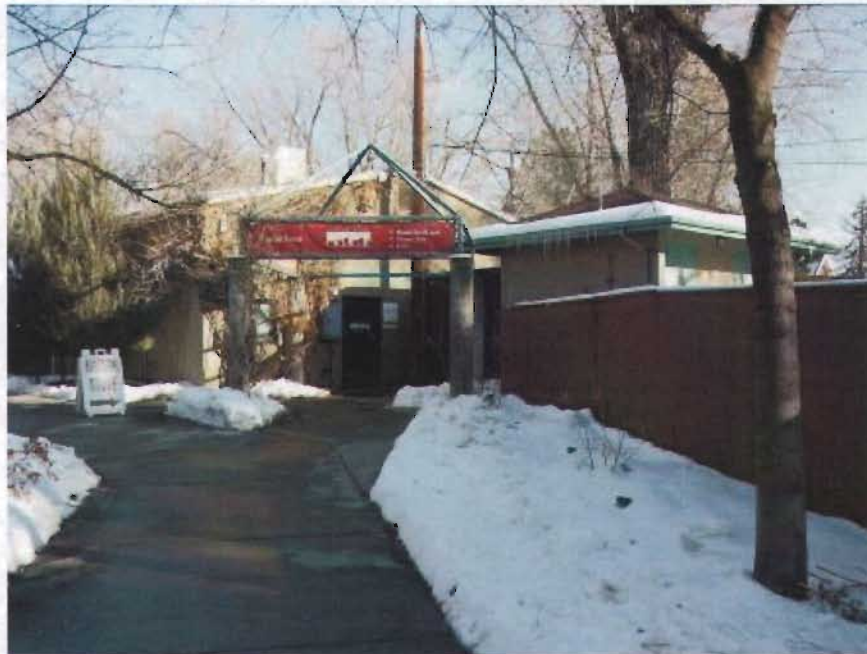
## 2

<b>Current Use:</b> Nature Store, tickets	<b>Historic Use:</b> Vehicle Maintenance
<b>Materials:</b> concrete block	<b>Construction Date:</b> Remodeled 1994
<b>Plan:</b> replace, possibly reuse, Phase II	<b>Significance:</b> Not historically significant

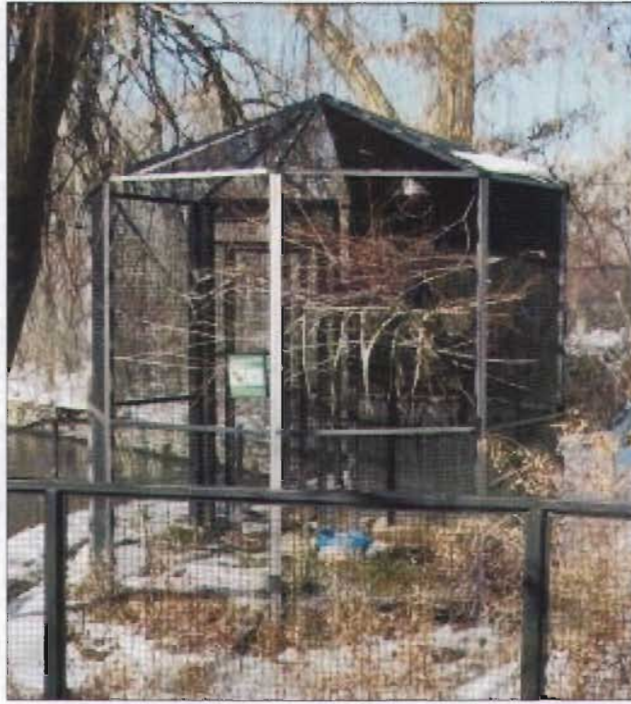
3

<b>Current Use:</b> Exhibit	<b>Historic Use:</b>
<b>Materials:</b> metal pipe and wire mesh	<b>Construction Date:</b> 2006
<b>Plan:</b> Remove	<b>Significance:</b> Not historically significant

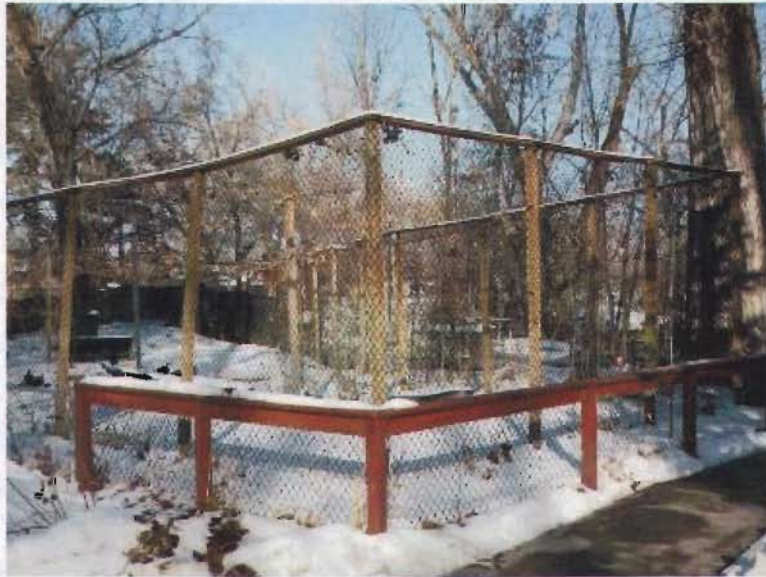
4

<b>Current Use:</b> Red-crowned crane	<b>Historic Use:</b>
<b>Materials:</b> wood and wire mesh	<b>Construction Date:</b>
<b>Plan:</b> Replace with more shorebird exhibit	<b>Significance:</b> Not historically significant

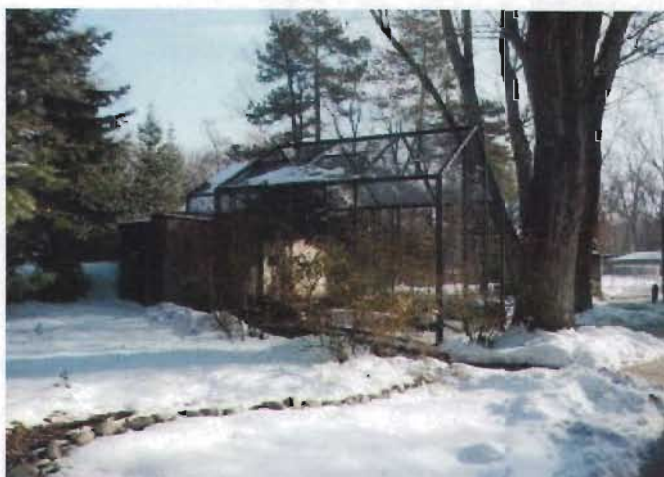
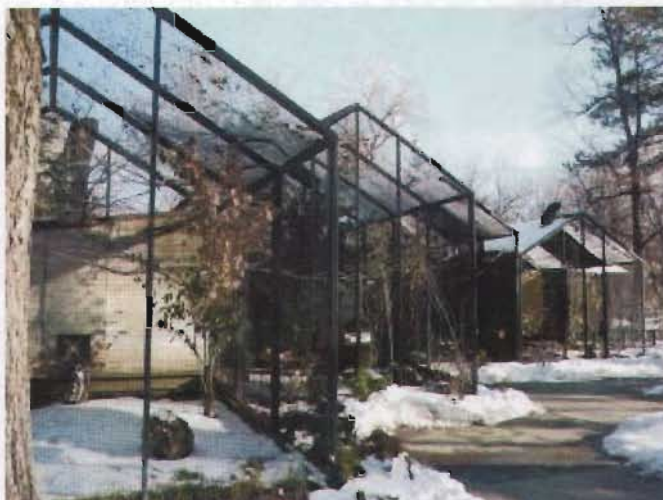
# 5

<b>Current Use:</b> Pheasant Exhibit	<b>Historic Use:</b>
<b>Materials:</b> concrete, wood, pipe and wire mesh	<b>Construction Date:</b> 1986
<b>Plan:</b> remove/replace

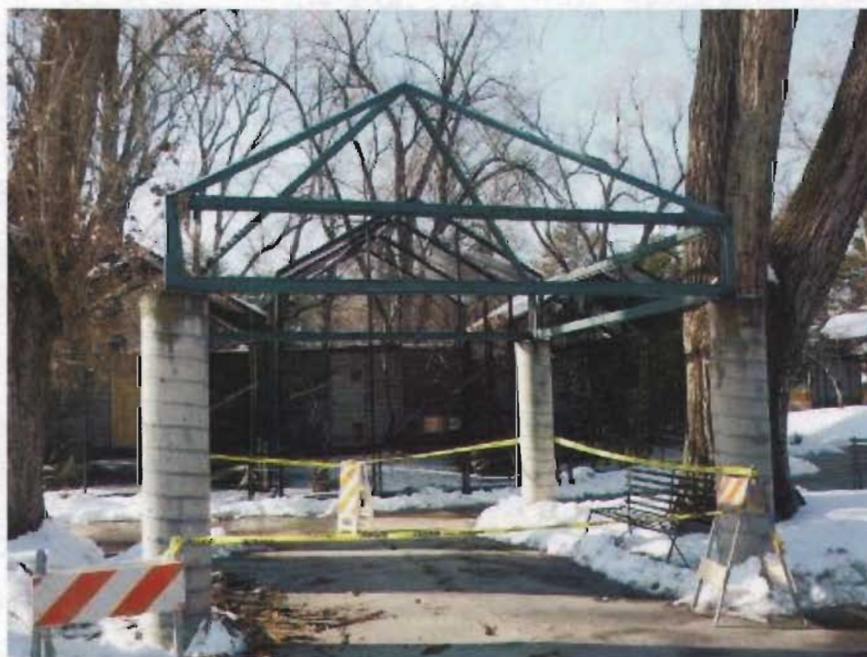
# 6

<b>Current Use:</b>	<b>Historic Use:</b>
<b>Materials:</b>	<b>Construction Date:</b> c.1994
<b>Plan:</b> Remove	<b>Significance:</b> Not historically significant

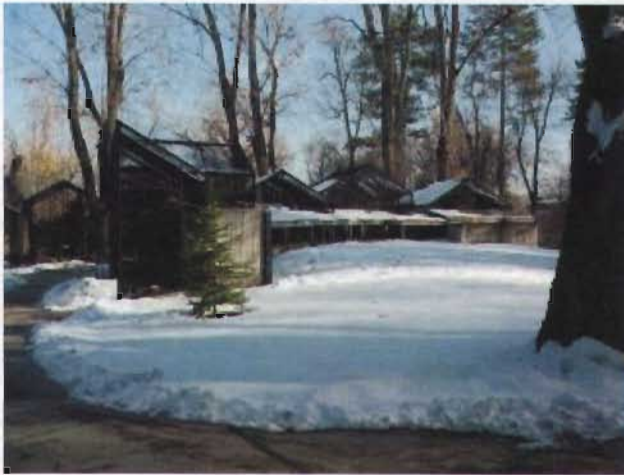
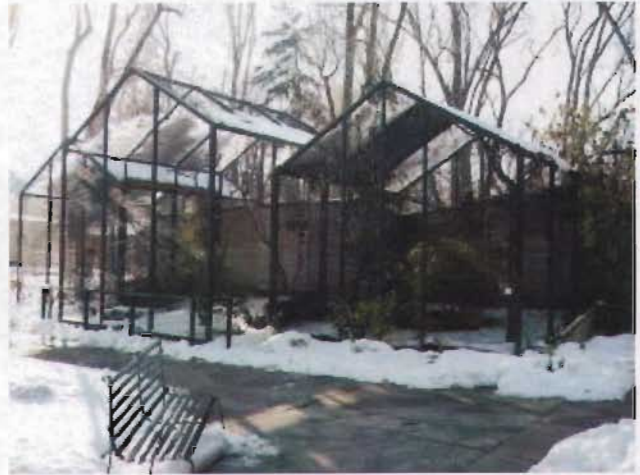
# 7

<b>Current Use:</b> Magpie/ Cuckoo exhibit	<b>Historic Use:</b>
<b>Materials:</b> concrete, wood, pipe and wire mesh	<b>Construction Date:</b> c. 1986
<b>Plan:</b> Replace

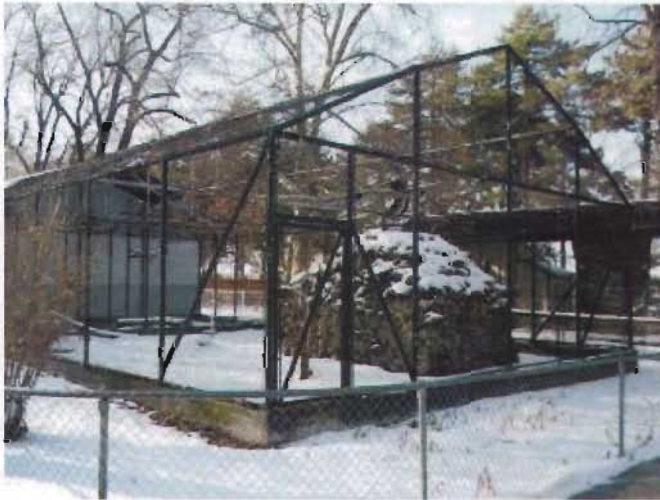
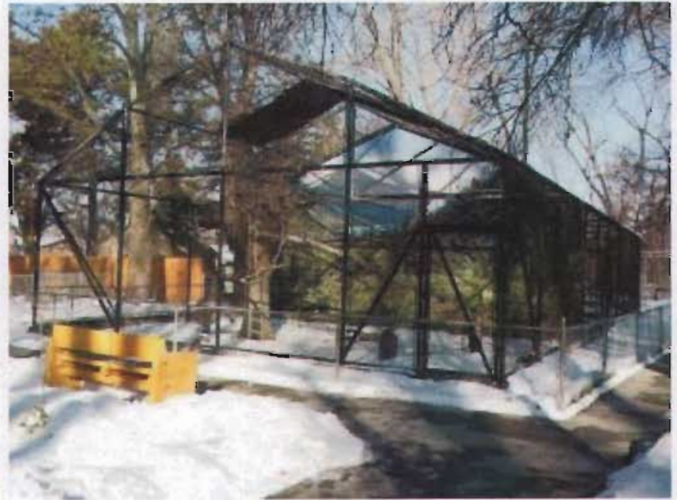
# 8

<b>Current Use:</b> Condor/ Hawk exhibit	<b>Historic Use:</b> bird cage
<b>Materials:</b> concrete, wood and wire mesh	<b>Construction Date:</b> c. 1968
<b>Plan:</b> Remove, Add SSP exhibit or Utah wetland	<b>Significance:</b> Not historically significant

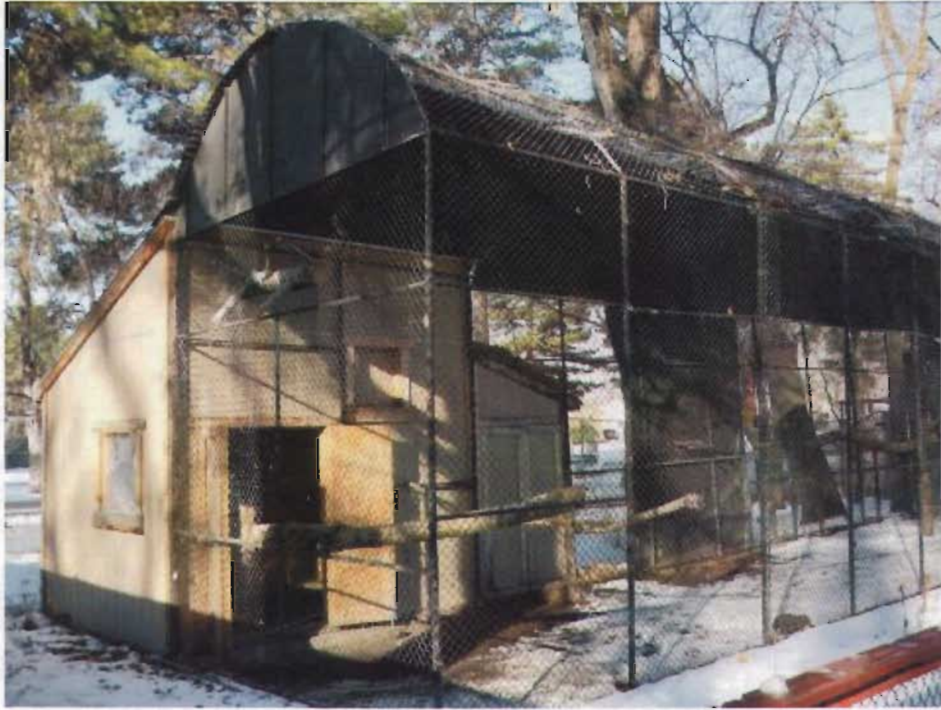
<b>Current Use:</b> King Vulture exhibit	<b>Historic Use:</b>
<b>Materials:</b> pipe and wire mesh with wood frame structure	<b>Construction Date:</b>
<b>Plan:</b> Replace with more permanent structure	<b>Significance:</b> Not historically significant

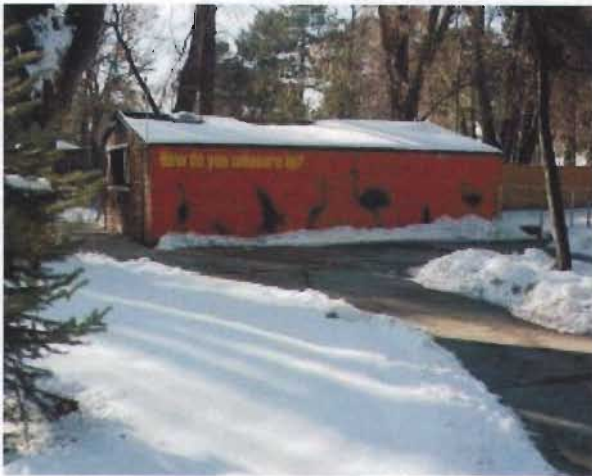
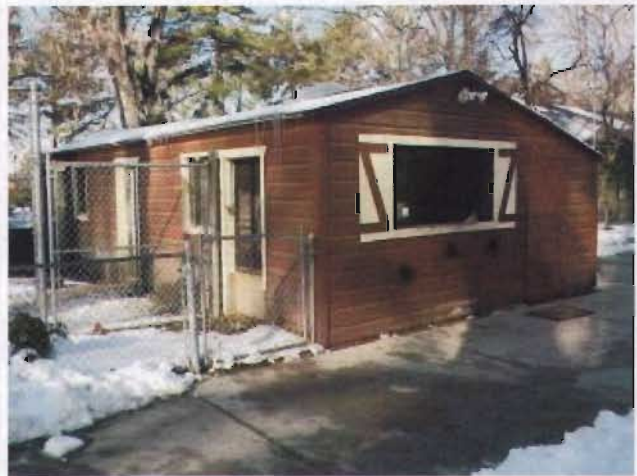
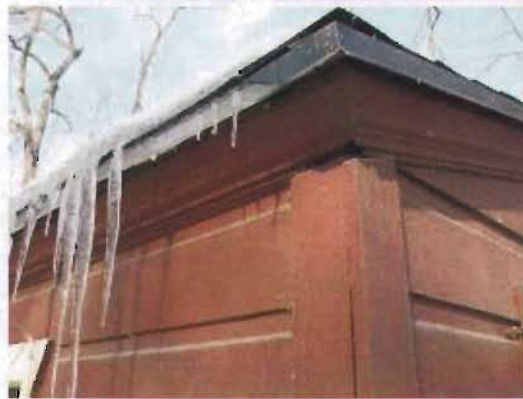
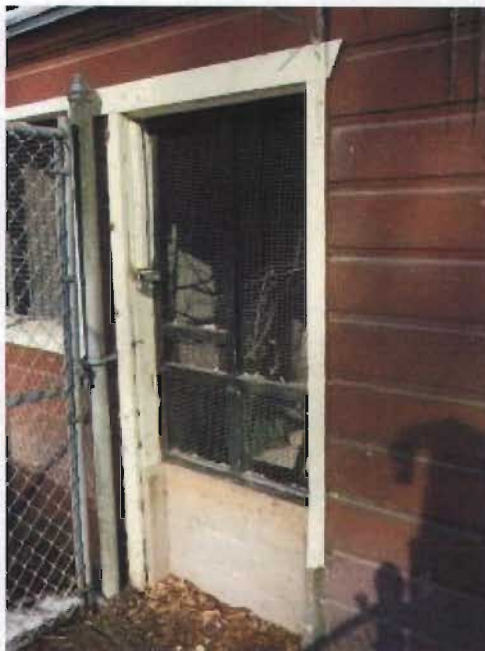
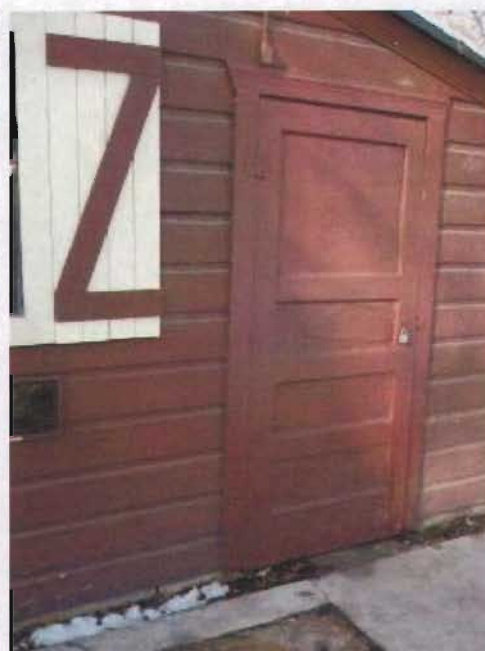
<p><b>Current Use:</b> Burrowing owl exhibit</p>	<p><b>Historic Use:</b> bird cage</p>
<p><b>Materials:</b> wood frame</p>	<p><b>Construction Date:</b> c.1938</p>
<p><b>Plan:</b> Demolish</p>	<p><b>Significance:</b> Significant as an early feature of the Aviary which retains historic integrity.</p>

#	Name	Construction date	Recommendation
10.	Burrowing owl exhibit	c. 1938	Although this is one of the early zoo buildings, this structure appears to have undergone multiple changes including the relocation of windows and doors, which undermines its historic integrity. Staff recommends approval of demolition.
14	Southern Ground hornbill exhibit	c. 1970	This structure does not appear on the 1968 plan for the site. It helps to tell the story of development in the Aviary in the 1960s and 70s and does not appear to have undergone major changes. However, research has not revealed any information on its original use and it is probable that the structure does not meet the “exceptional significance” standard of the ordinance for properties younger than 50 years. If demolition is approved, staff recommends documentation following the State Historic Preservation Office’s requirements of Intensive Level Survey.

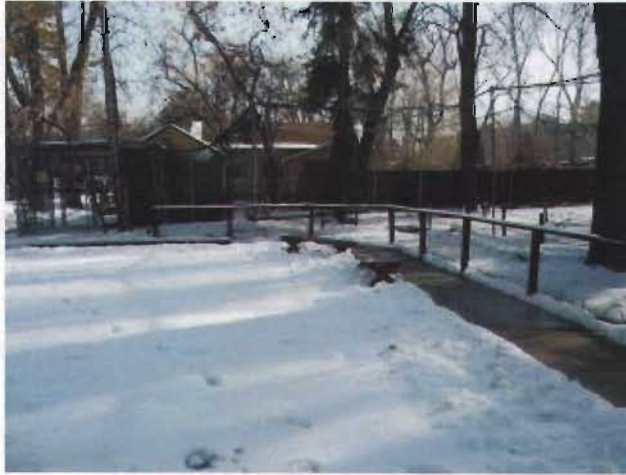
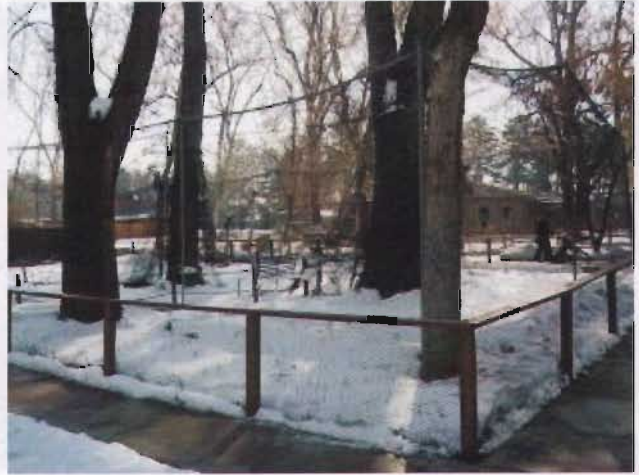
# 11

<b>Current Use:</b> Sun Conure exhibit	<b>Historic Use:</b>
<b>Materials:</b> pipe and wire mesh	<b>Construction Date:</b> late 90s or early 00s
<b>Plan:</b> Remove. Possibly replace with more permanent interactive feeding exhibit	<b>Significance:</b> Not historically significant

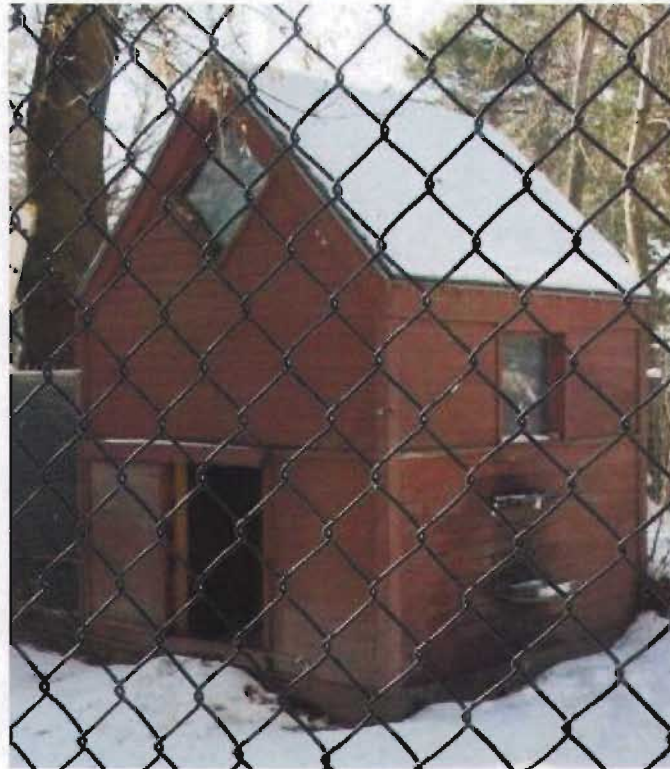
# 12

<b>Current Use:</b> Sandhill Crane exhibit	<b>Historic Use:</b>
<b>Materials:</b> wood frame	<b>Construction Date:</b>
<b>Plan:</b> Reuse elsewhere	<b>Significance:</b> Significant as an early feature of the Aviary which retains historic integrity.

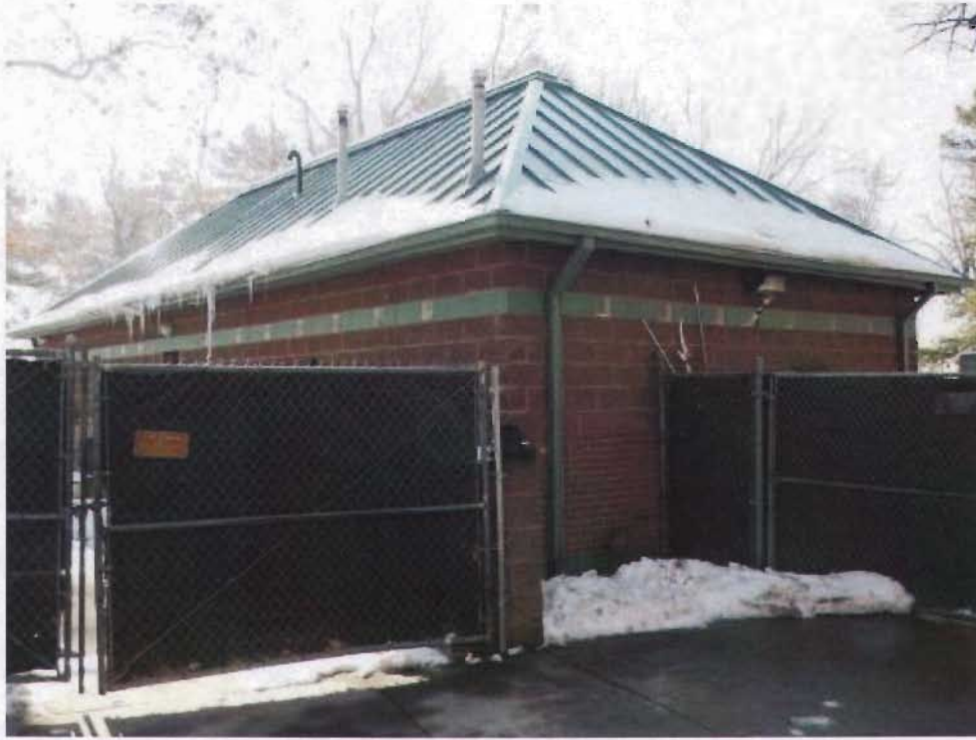
13

<b>Current Use:</b> Maintenance building	<b>Historic Use:</b>
<b>Materials:</b> cinder block, metal roof	<b>Construction Date:</b>
<b>Plan:</b>	<b>Significance:</b> Not historically significant

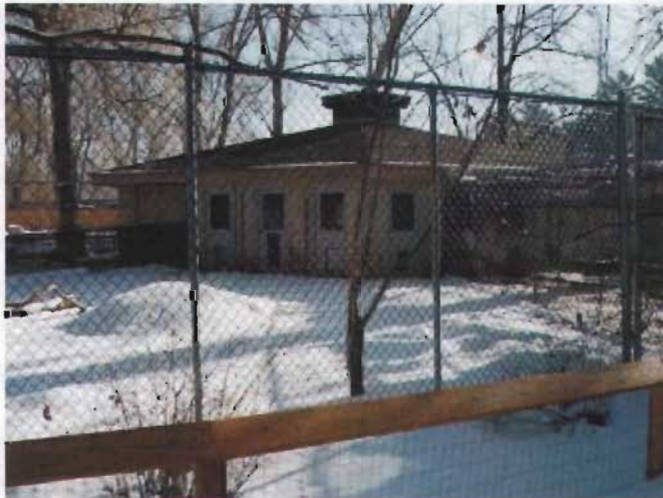
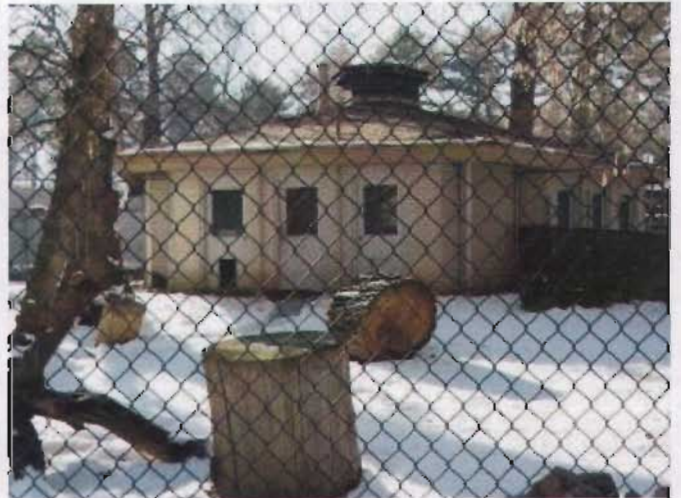
14

<b>Current Use:</b> Southern Groundhornbill exhibit	<b>Historic Use:</b>
<b>Materials:</b> brick, asphalt shingle roof	<b>Construction Date:</b>
<b>Plan:</b> Demolish

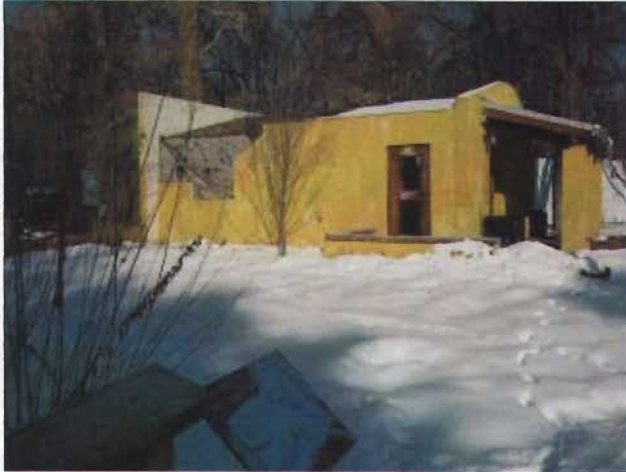
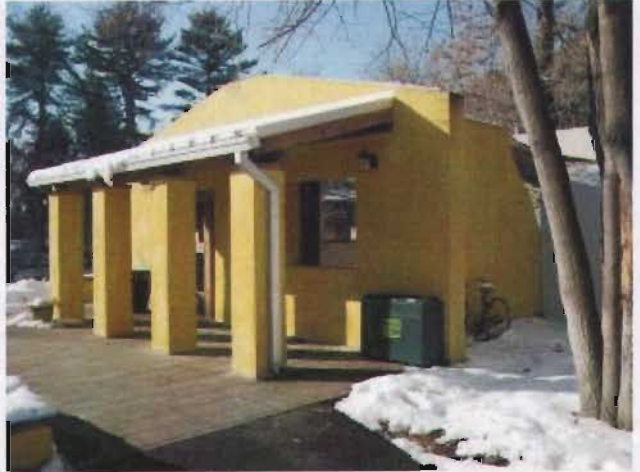
<b>Current Use:</b> Argentina interactive exhibit	<b>Historic Use:</b>
<b>Materials:</b> concrete, wood	<b>Construction Date:</b> c. 2004
<b>Plan:</b>	<b>Significance:</b> Not historically significant

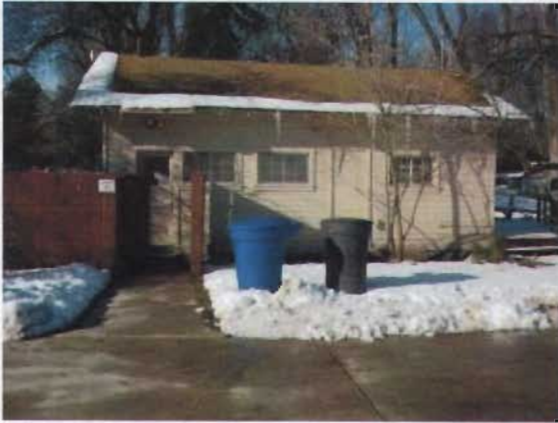
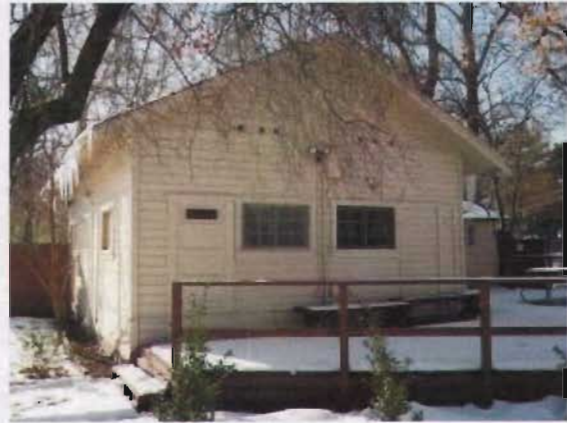
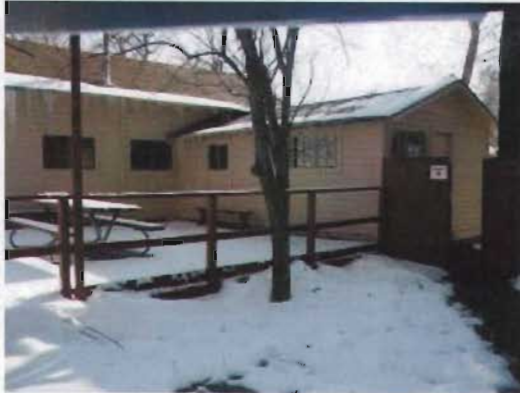
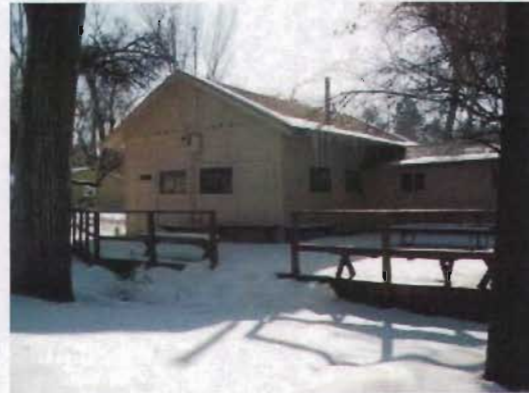
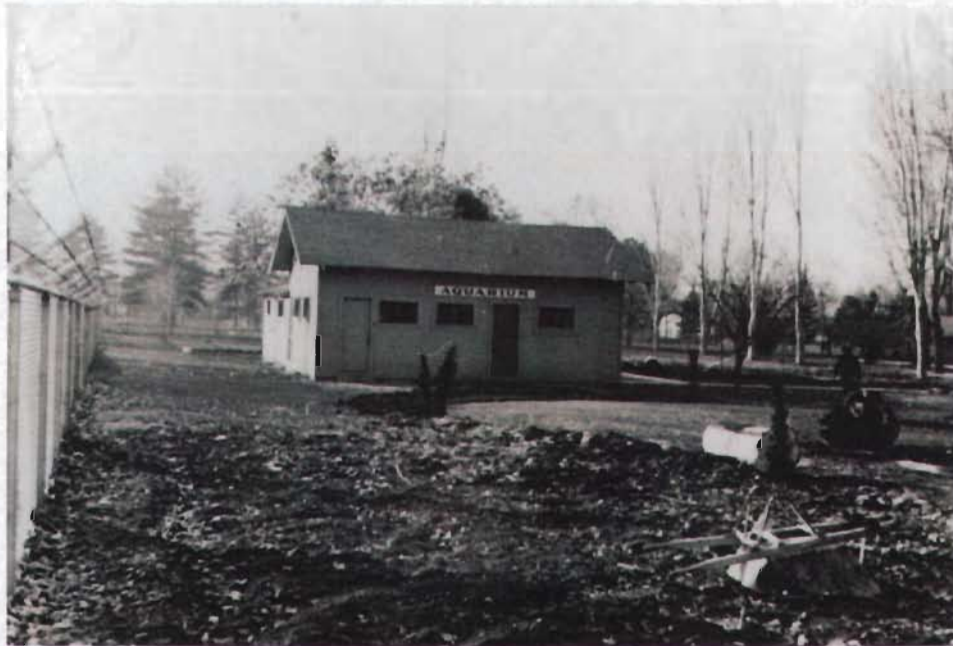
<b>Current Use:</b> Office building	<b>Historic Use:</b> Aquarium (1938) Caretakers cottage (1968)
<b>Materials:</b> wood, asphalt shingle	<b>Construction Date:</b> c. 1938
<b>Plan:</b> Demolish	<b>Significance:</b> Significant as an early feature of the Aviary which retains historic integrity.

<p>zoo. The 1938 and 1968 plans show it as an L-shaped building. It may be appropriate to move this structure to a location in the central portion of the Aviary, if necessary. In 1938, the central portion of the site was the location of the majority of the structures which were centered around an interior drive. Staff recommends interpretive signage for this building and the “feed house” which would provide a short history of the site and its transition from zoo to aviary, as well as these specific buildings. The applicant may wish to work with the Utah State Historic Preservation Office on the design and content of the marker.</p>
17	Shed	c. 1938	<p>This building was a “feed house” in 1938. If the Office/Aquarium is moved, this structure should move with it. Staff recommends retaining this structure within the central portion of the Aviary.</p>
20	Duck pond	c. 1968	<p>This feature has undergone several changes and is in extremely poor condition and so no longer has historic integrity. At the July 2009 meeting, the Commission recommended documentation of this feature before removal. Staff recommends the documentation follow the State Historic Preservation Office’s requirements of Intensive Level Survey.</p>

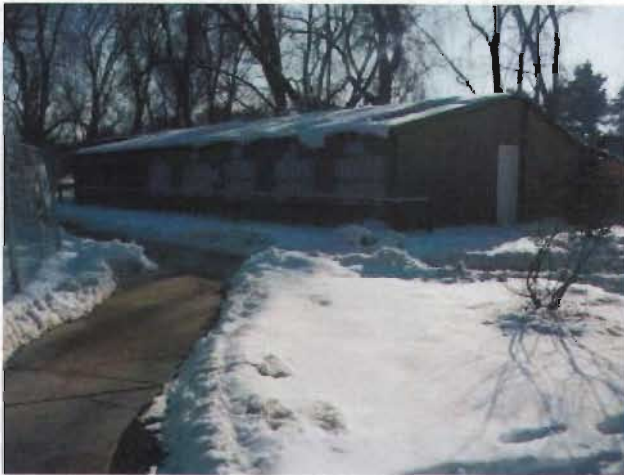
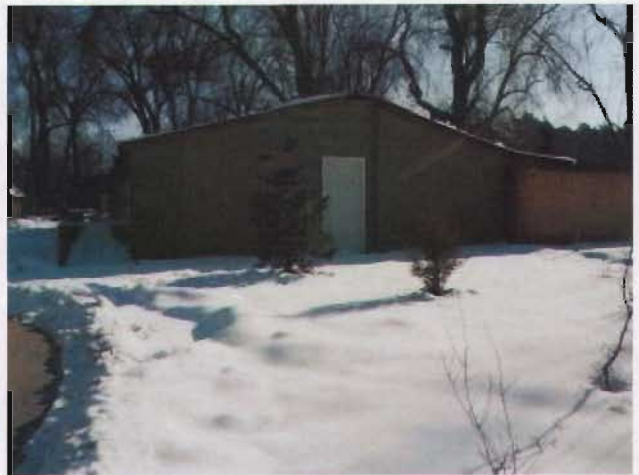
18

<b>Current Use:</b>	<b>Historic Use:</b>
<b>Materials:</b> wood, asphalt shingle	<b>Construction Date:</b> c. 1938
<b>Plan:</b> Demolish	<b>Significance:</b> Significant as an early feature of the Aviary which retains historic integrity.

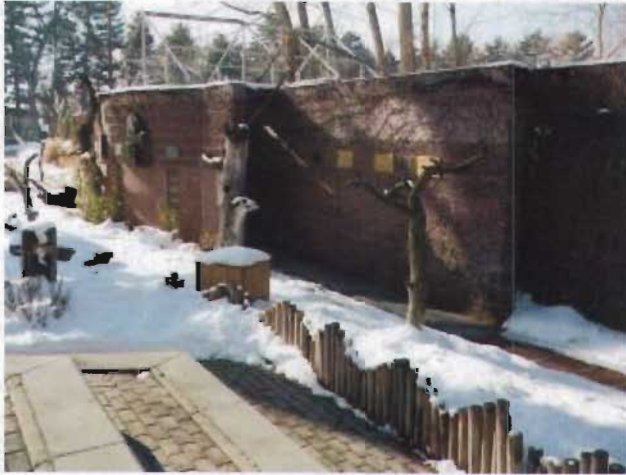
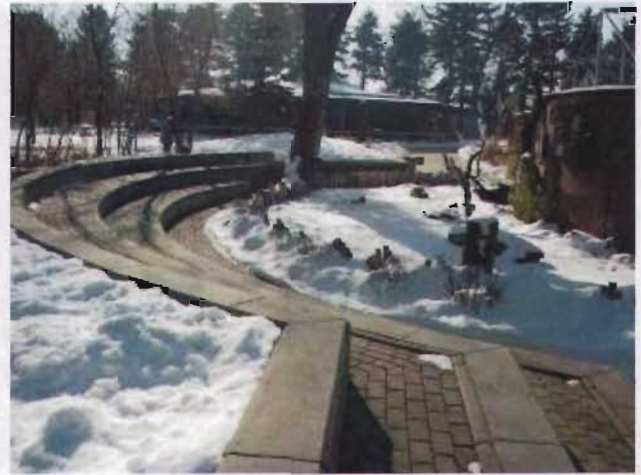
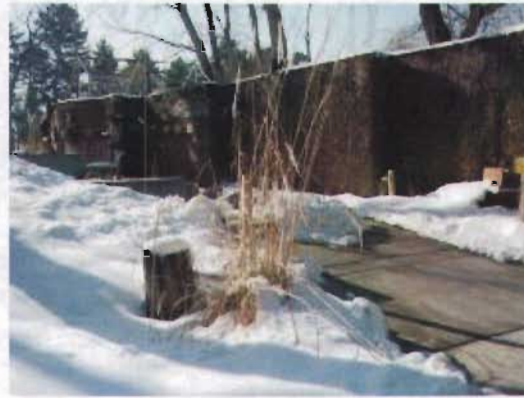
19

<b>Current Use:</b> Bird Show Mews	<b>Historic Use:</b>
<b>Materials:</b> wood	<b>Construction Date:</b> c. 2008
<b>Plan:</b> Demolish	<b>Significance:</b> Not historically significant

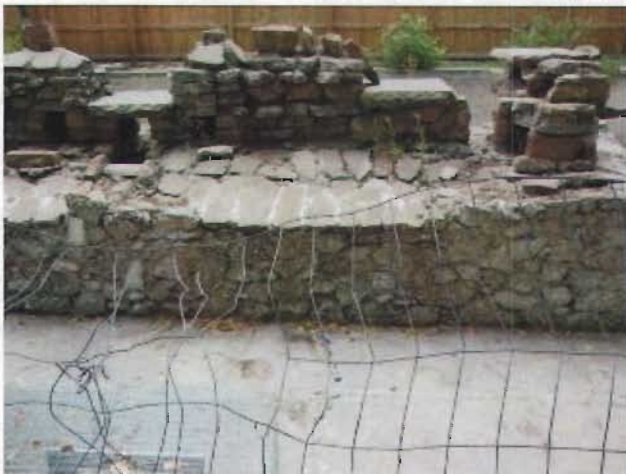
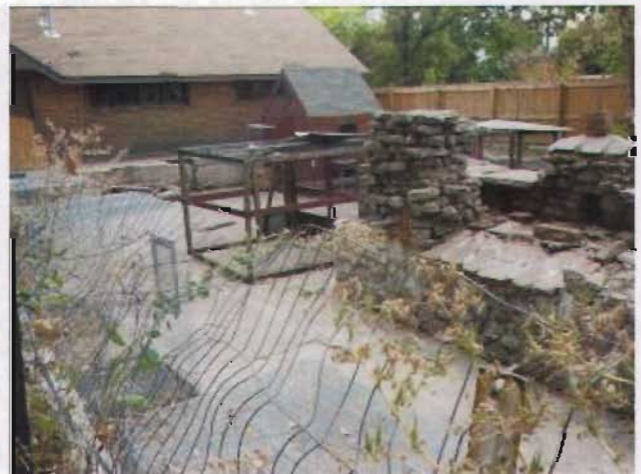
20

<b>Current Use:</b>	<b>Historic Use:</b> Exhibit and amphitheater
<b>Materials:</b> concrete block, brick	<b>Construction Date:</b> c. 1988
<b>Plan:</b> Demolish/reuse as holding for a new exhibit

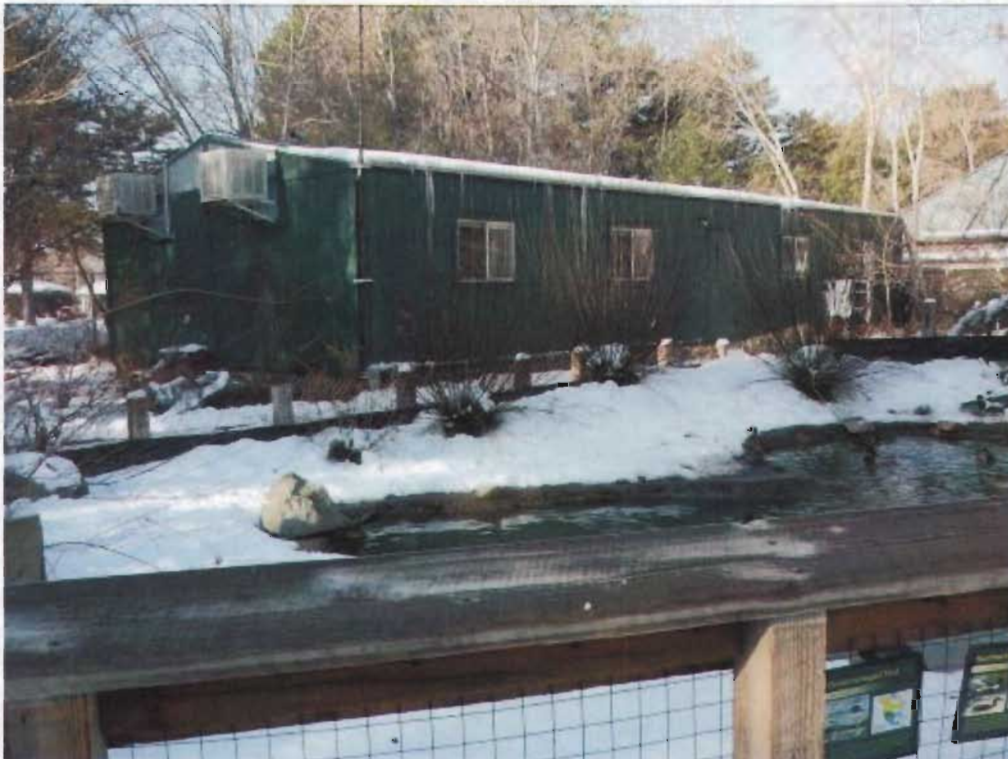
# 22

<b>Current Use:</b> Bathroom	<b>Historic Use:</b> bird house (Lorikeet)
<b>Materials:</b> brick, asphalt shingle	<b>Construction Date:</b> 1960s
<b>Plan:</b>

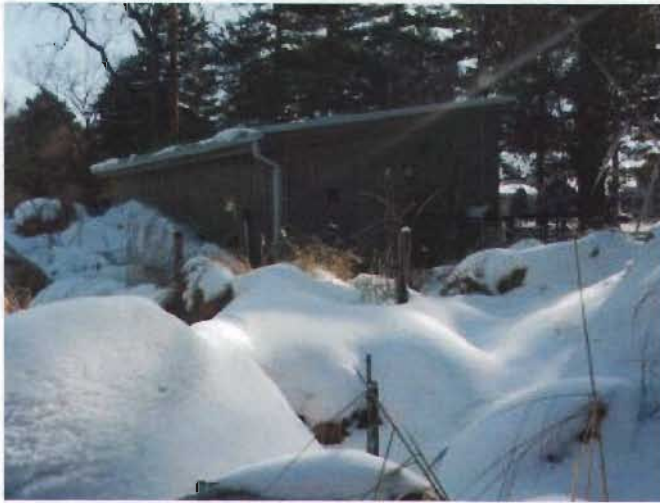
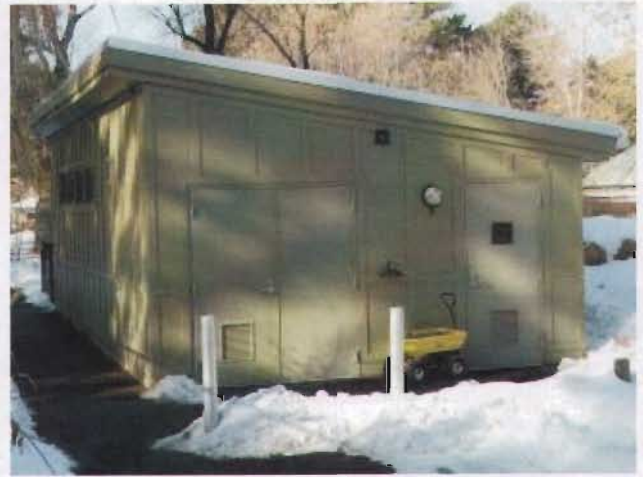
## 23

<b>Current Use:</b>	<b>Historic Use:</b>
<b>Materials:</b> modular	<b>Construction Date:</b> c.1996
<b>Plan:</b> Replace with modern modular	<b>Significance:</b> Not historically significant

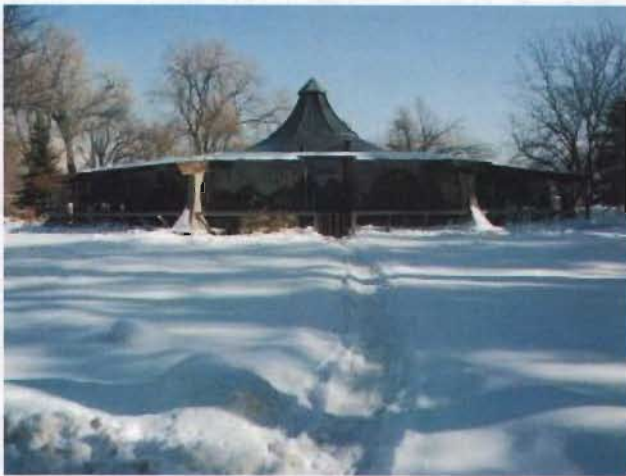
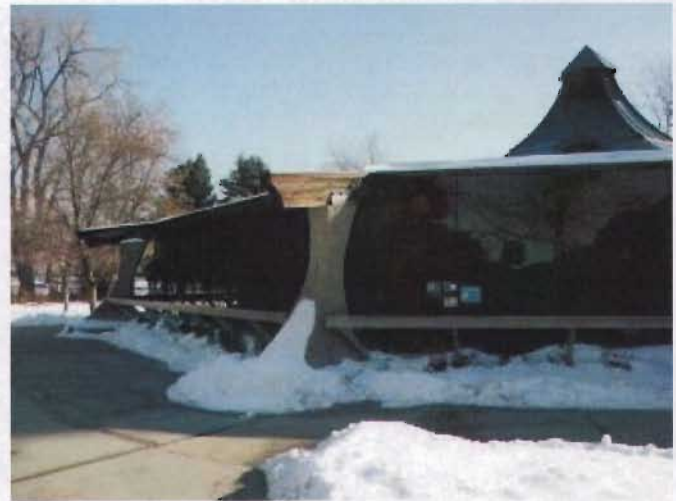
## 24

<b>Current Use:</b> Flamingo holding	<b>Historic Use:</b>
<b>Materials:</b> wood	<b>Construction Date:</b> 2004
<b>Plan:</b>	<b>Significance:</b> Not historically significant

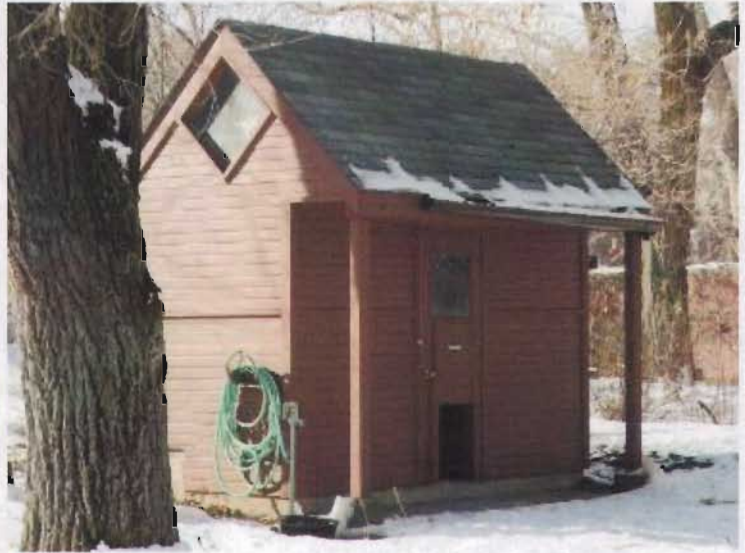
## 25

<b>Current Use:</b>	<b>Historic Use:</b> Wilson Pavilion
<b>Materials:</b>	<b>Construction Date:</b> 1970
<b>Plan:</b> Renovate, Phase II	<b>Significance:</b> Significant as an early feature of the Aviary which retains historic integrity.

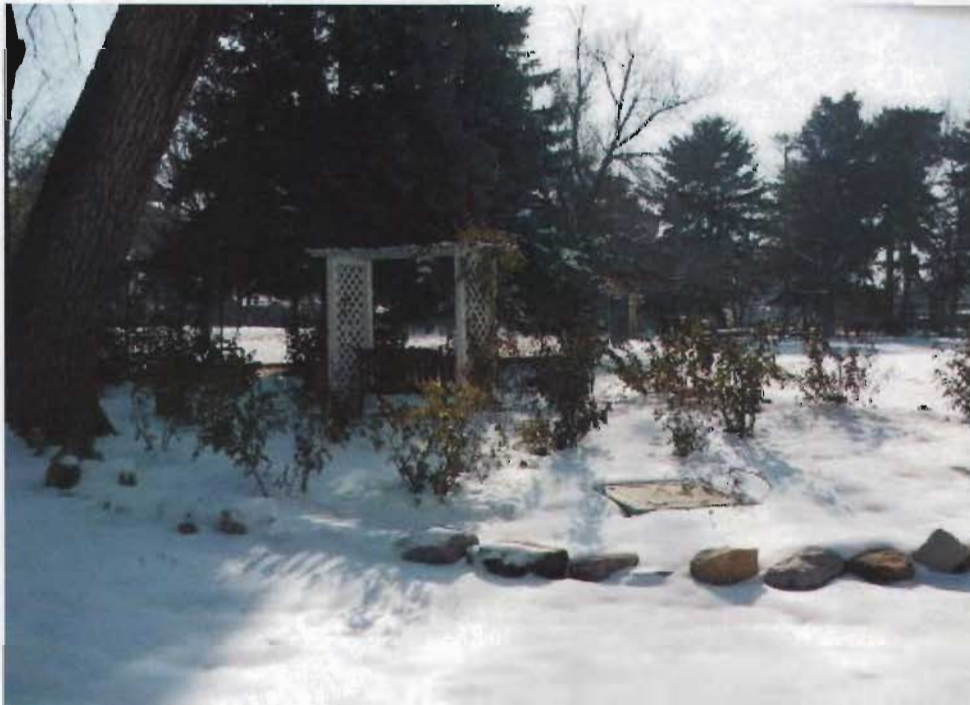
26

<b>Current Use:</b> Turkey Vulture exhibit	<b>Historic Use:</b>
<b>Materials:</b> wood	<b>Construction Date:</b> c. 1968
<b>Plan:</b> Demolish	<b>Significance:</b> Significant as an early feature of the Aviary which retains historic integrity.

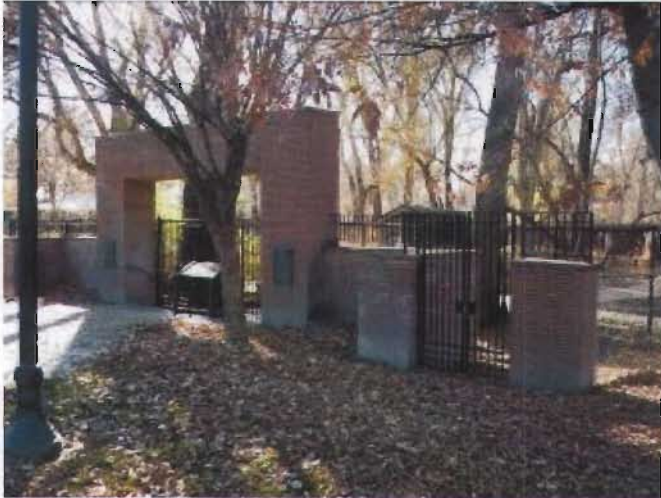
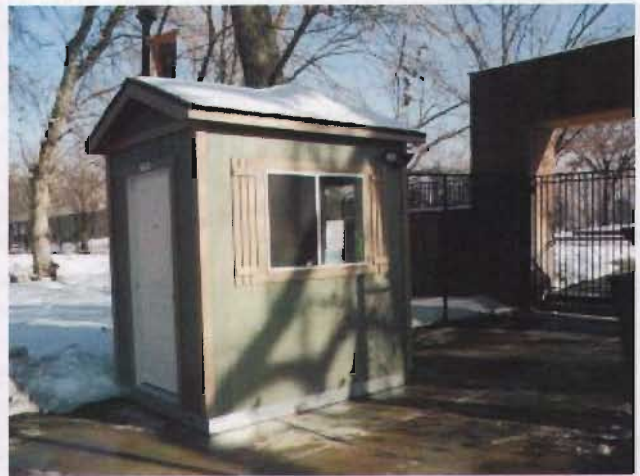
## 28

<b>Current Use:</b> Vacant (Amazon Adventure Exhibit planned)	<b>Historic Use:</b>
<b>Materials:</b> concrete, pipe and wire mesh	<b>Construction Date:</b> 2009 proposed
<b>Plan:</b>	<b>Significance:</b> Not historically significant

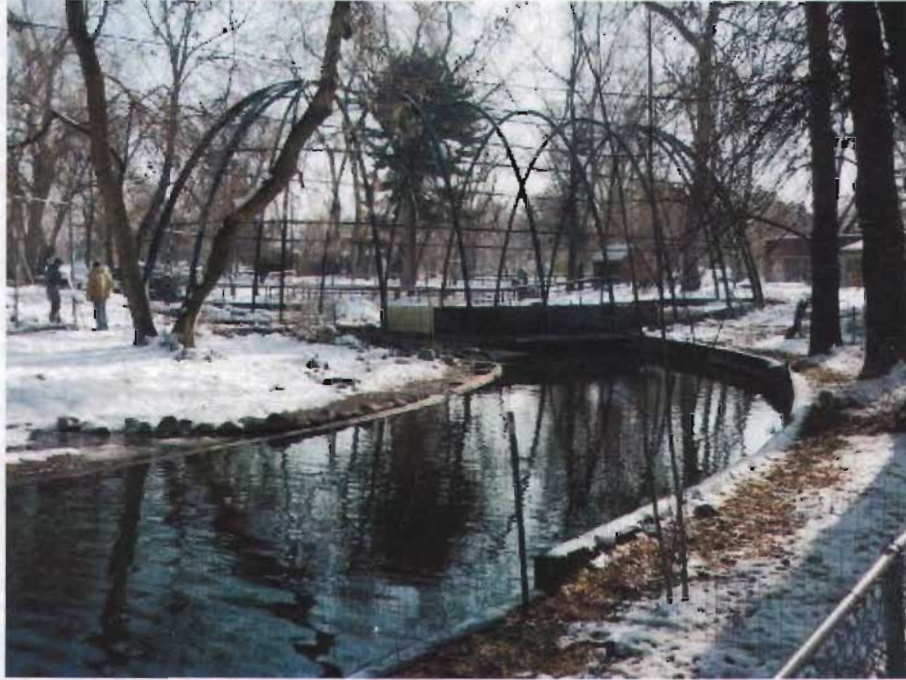
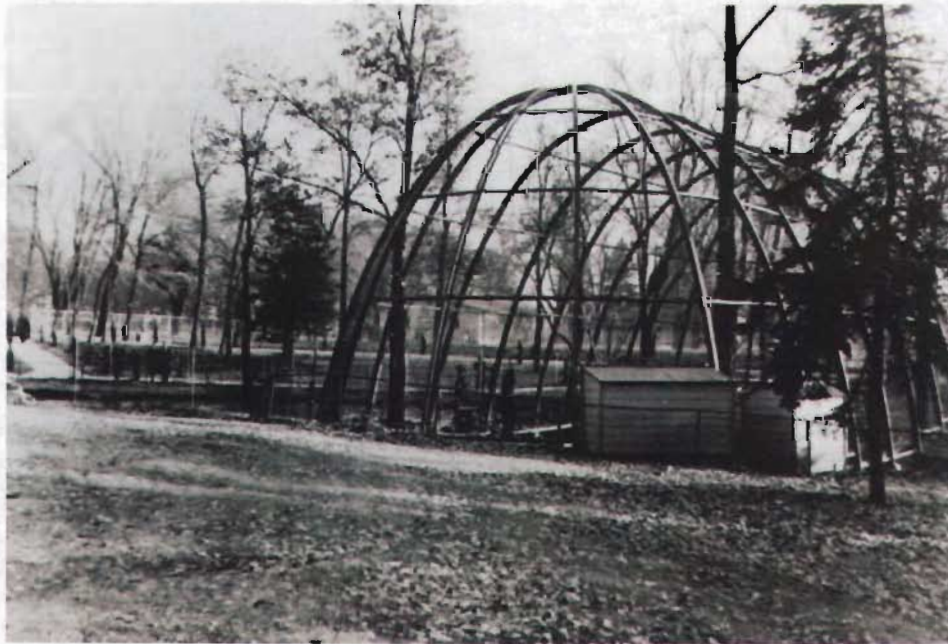
<b>Current Use:</b> holding/storage	<b>Historic Use:</b>
<b>Materials:</b>	<b>Construction Date:</b>
<b>Plan:</b> Demolish
