HISTORIC LANDMARK COMMISSION  
STAFF REPORT

TRACY AVIARY WILSON PAVILION  
RENOVATION, SOUTHERN GROUND  
HORNBILL'S NEW CONSTRUCTION,  
INSTALLATION OF TEMPORARY BUILDING,  
ACCEPT MASTER PLAN  
Major Alterations and New Construction &  
PLNHLC2008-00684  
Liberty Park, 589 East 1300 South  
August 5, 2009

# SOUTHERN GROUND HORNBILLS HOLDING BUILDING:

TRACY AVIARY, 589 E. 1300 S. SALT LAKE CITY, UTAH 84105

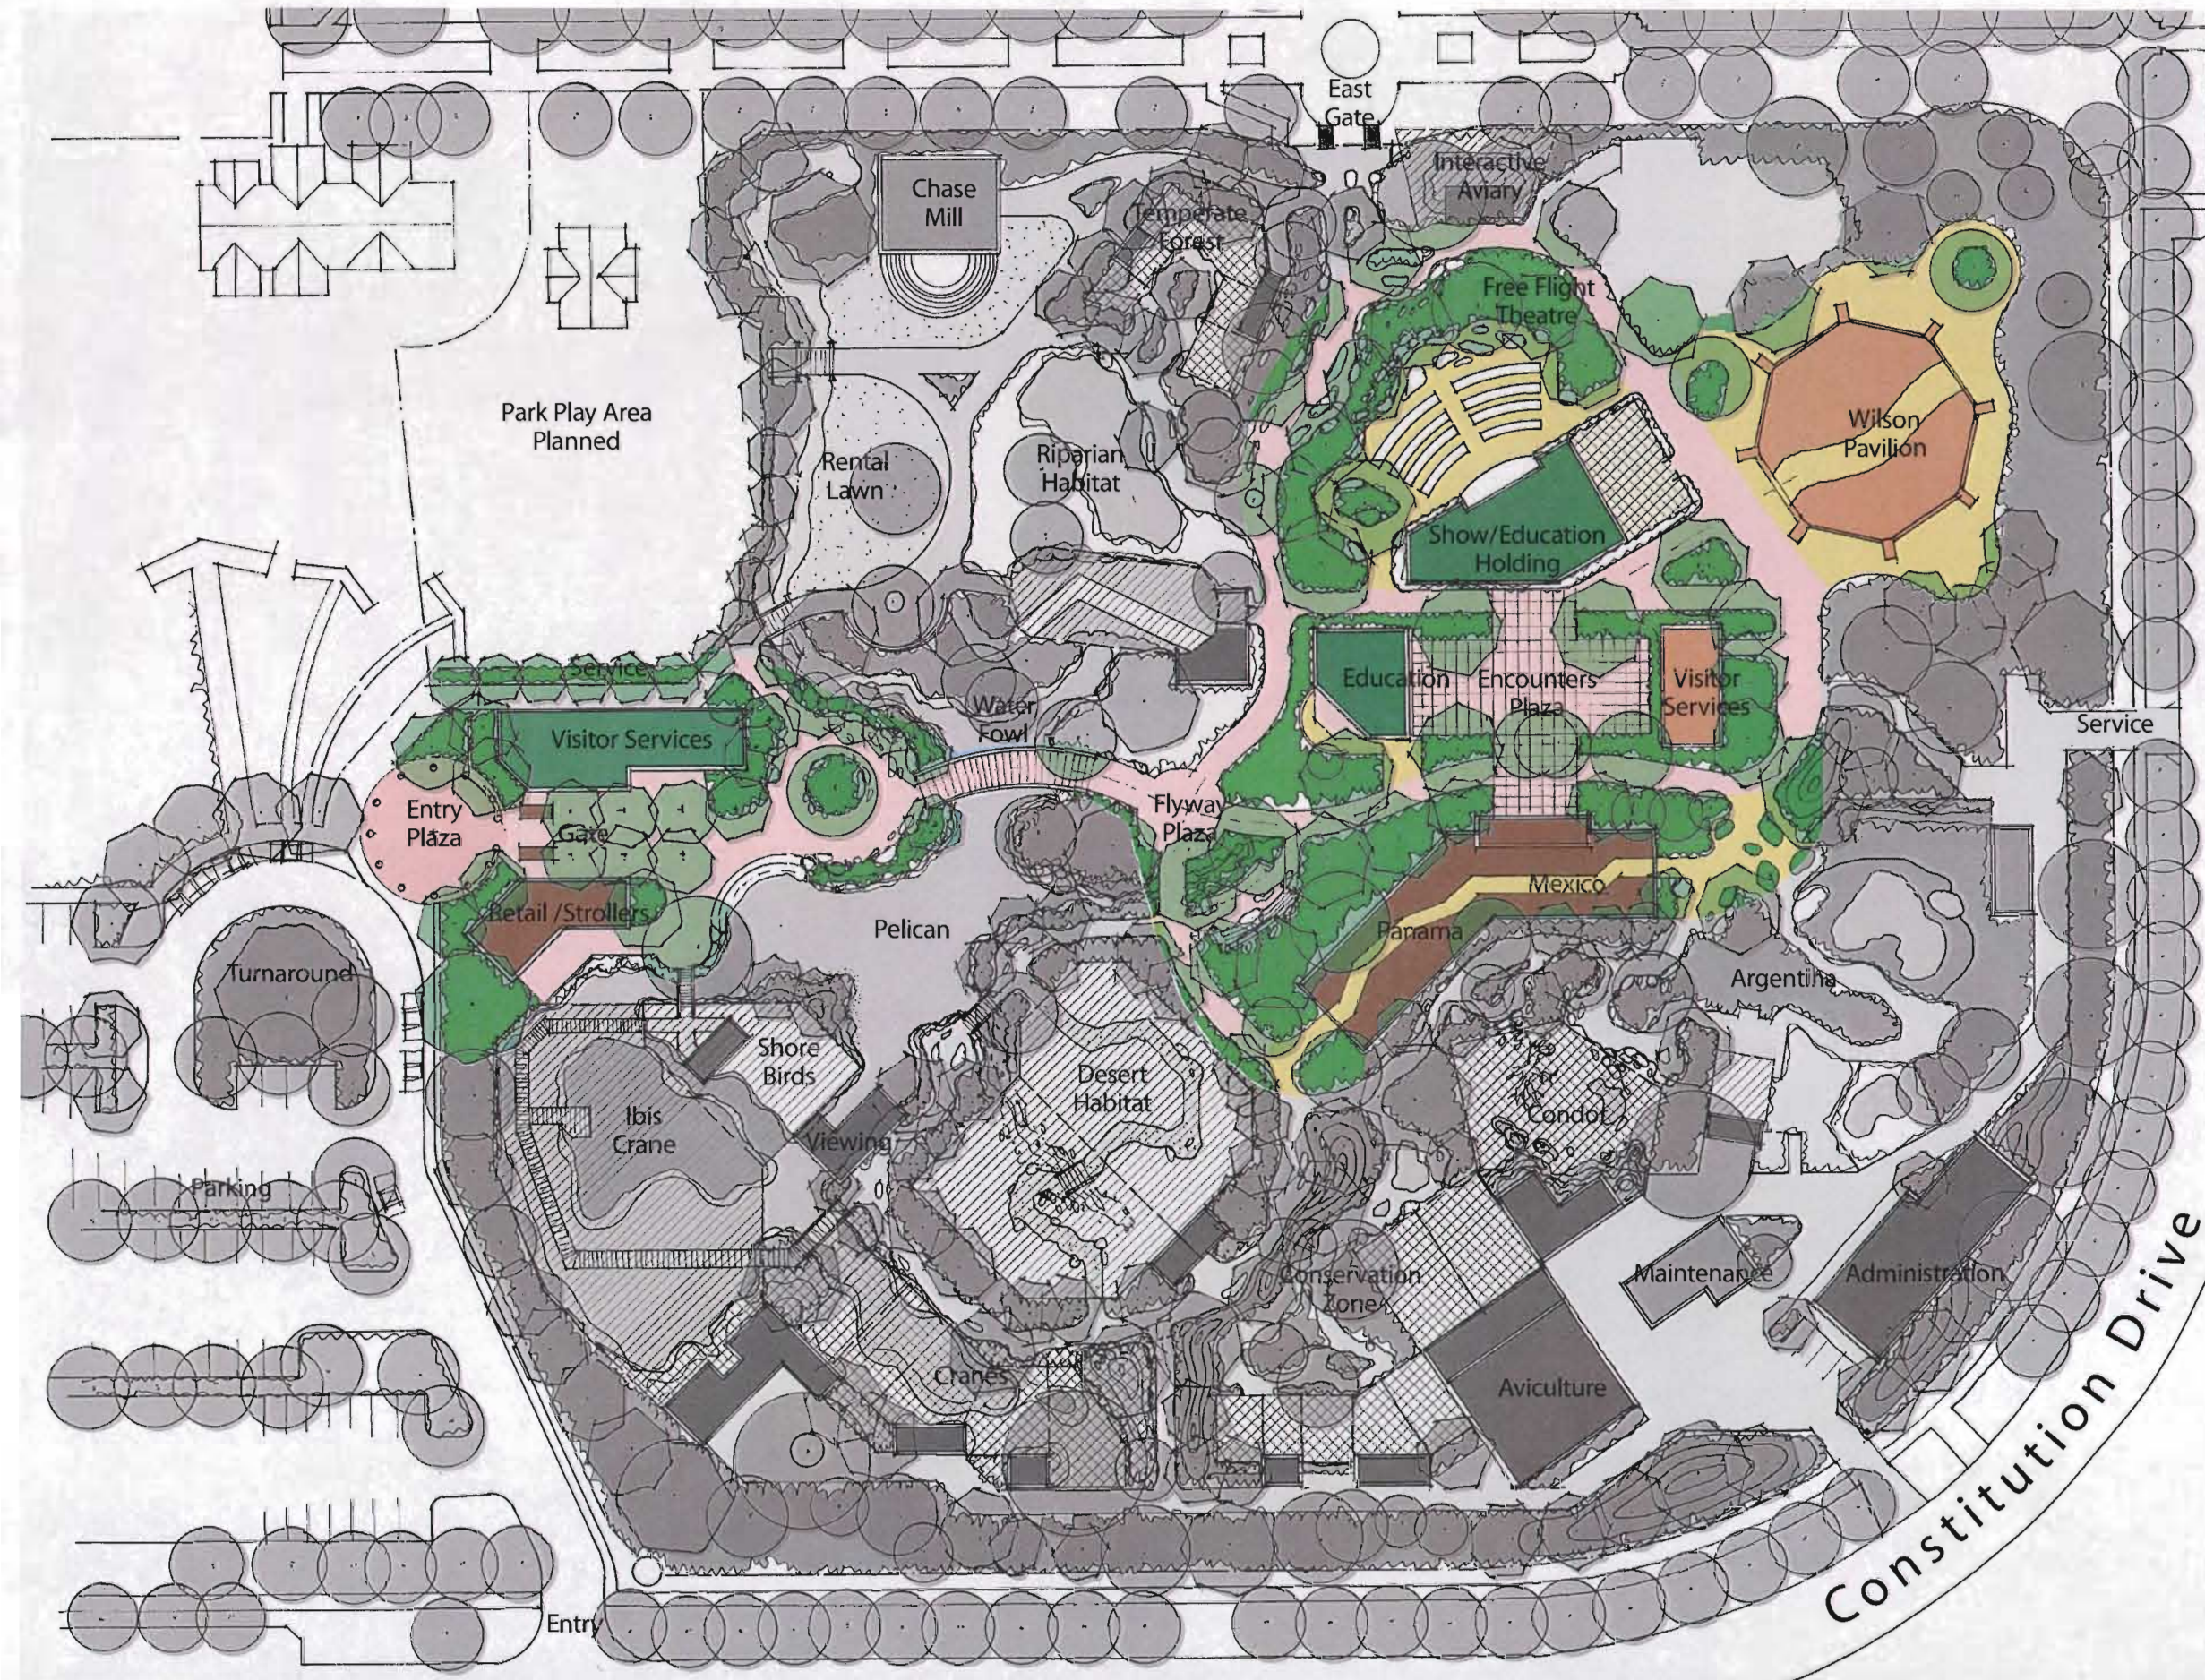
-   Existing Building
-   New Building
-   New Building with "Green Roof"
-   Meshed Exhibit (Visitor Walk-Through)
-   Meshed Exhibit (Views Through Mesh)
-   Exhibit Pathway
-   Visitor Pathway
-   Service Pathway
-   Existing Tree to Remain
-   Proposed New Tree
-   Perimeter Fence
-   Green/Planted areas
-   Lawn
-   Wetland
-   Water
