HISTORIC LANDMARK COMMISSION STAFF REPORT

Clay Home Minor Alterations 589 E. Sixth Avenue PLNHLC2009-00525 July 1, 2009

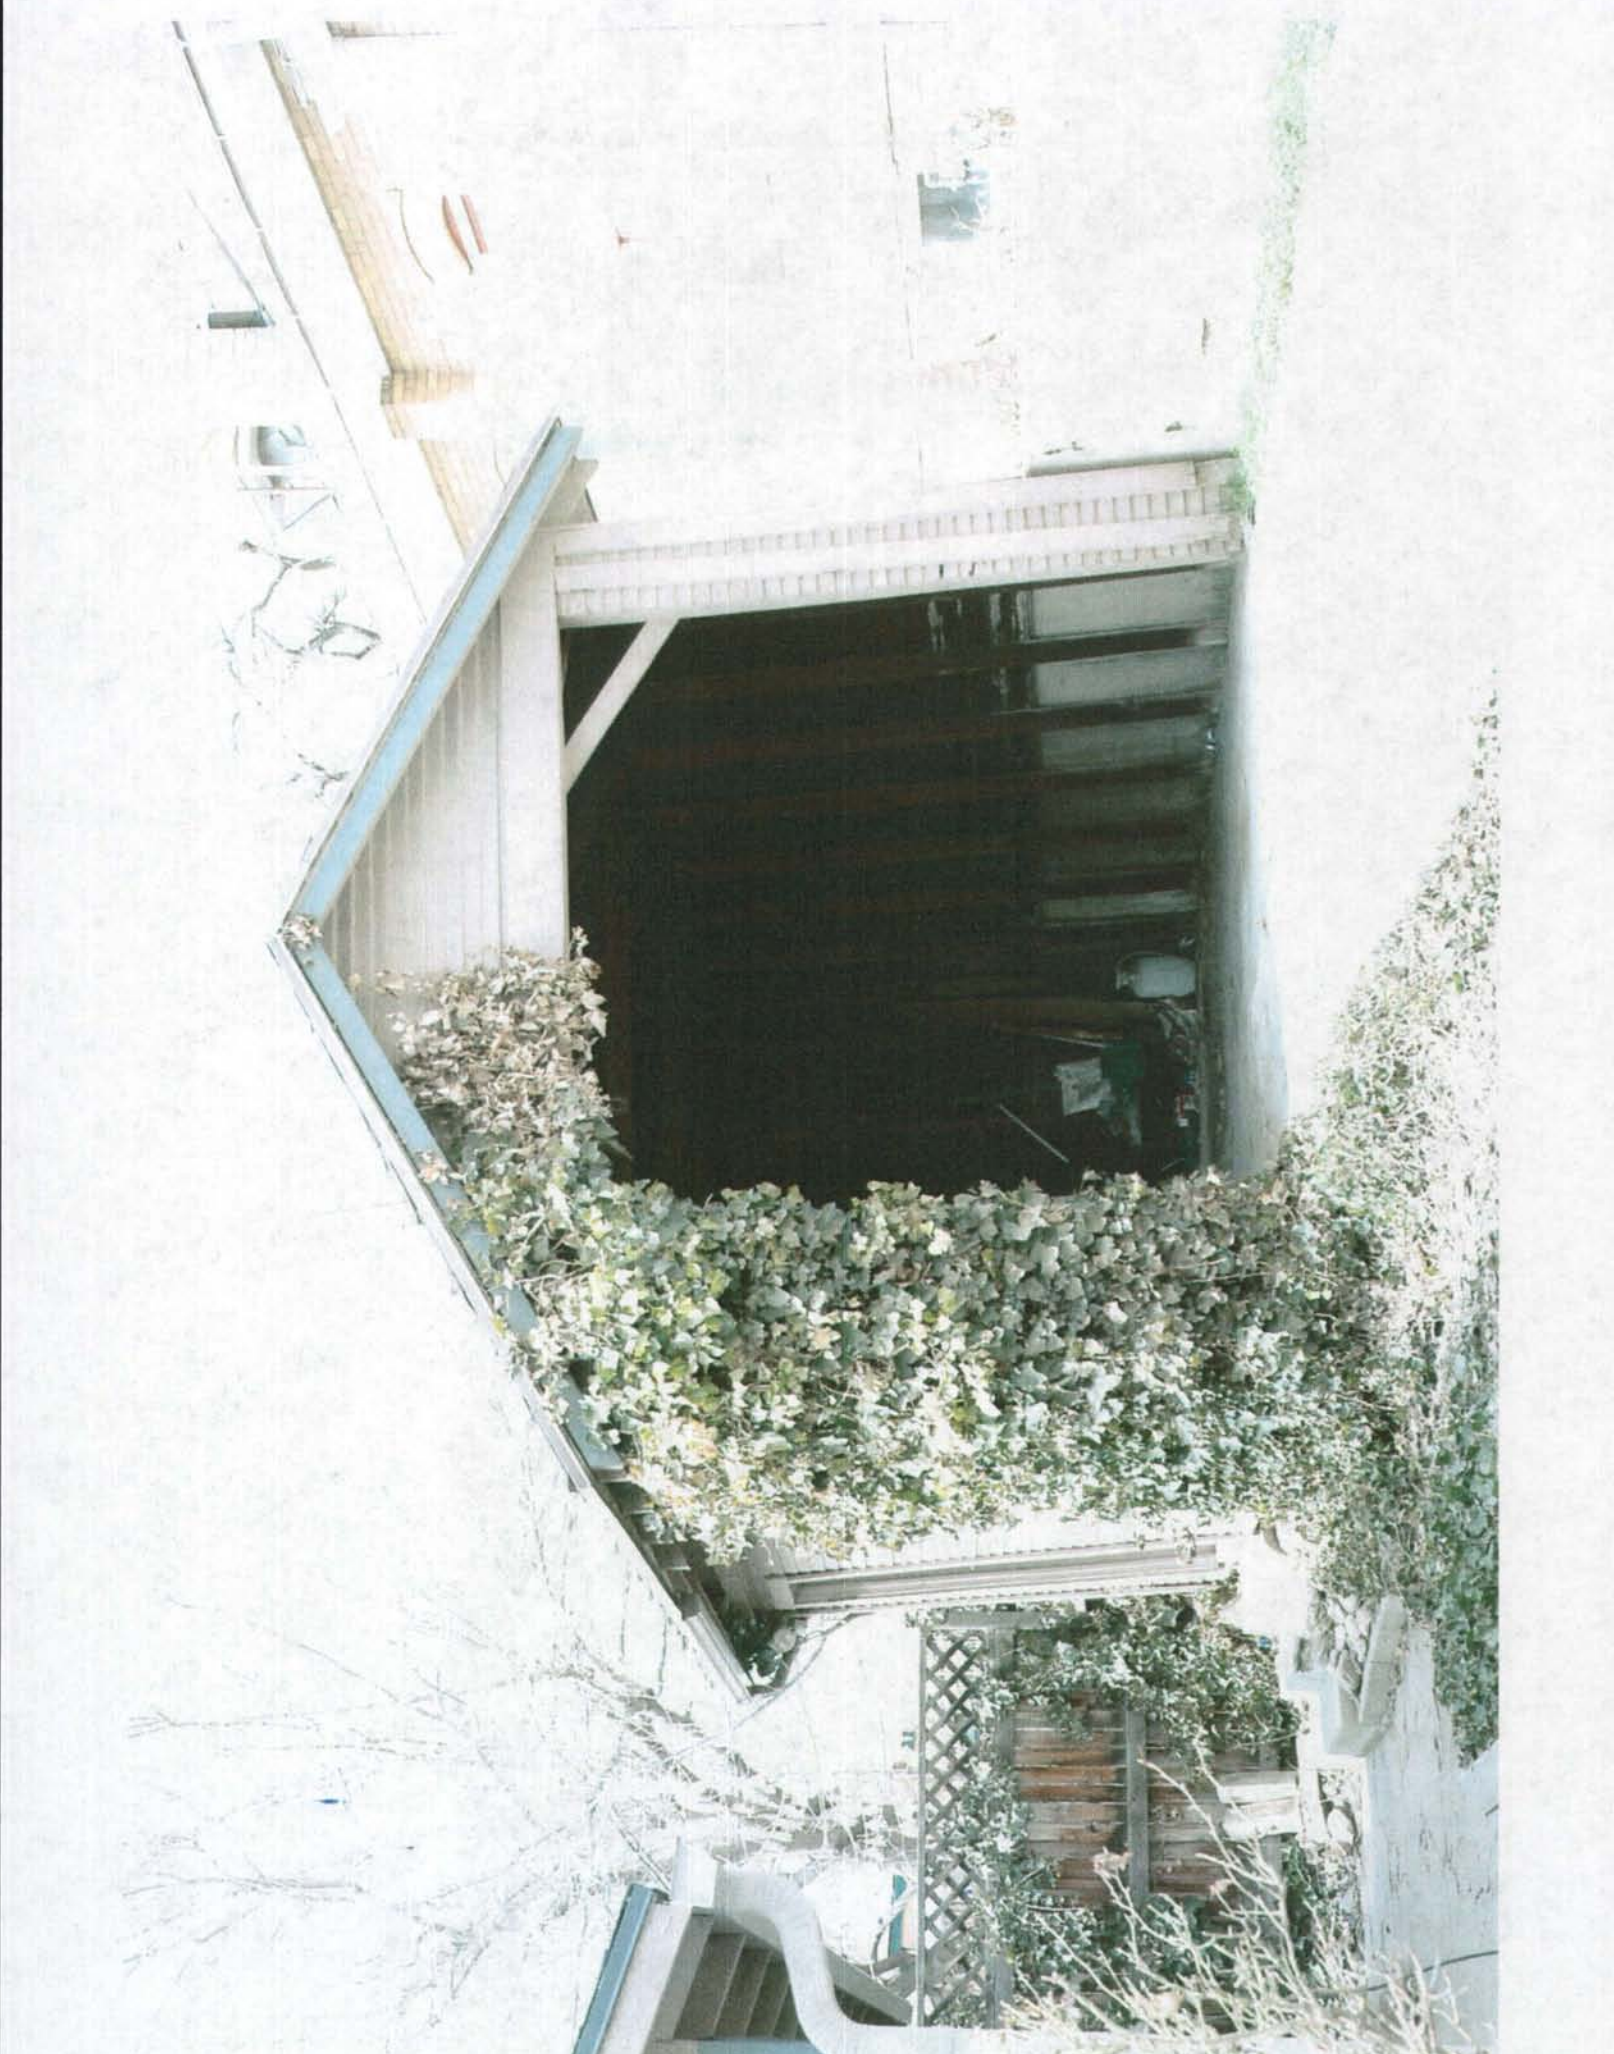
South Elevation

- New Rockwalls as shown
on S. Elevation. Porch / Stairing
Railings to remain.
New irrigation and planters.

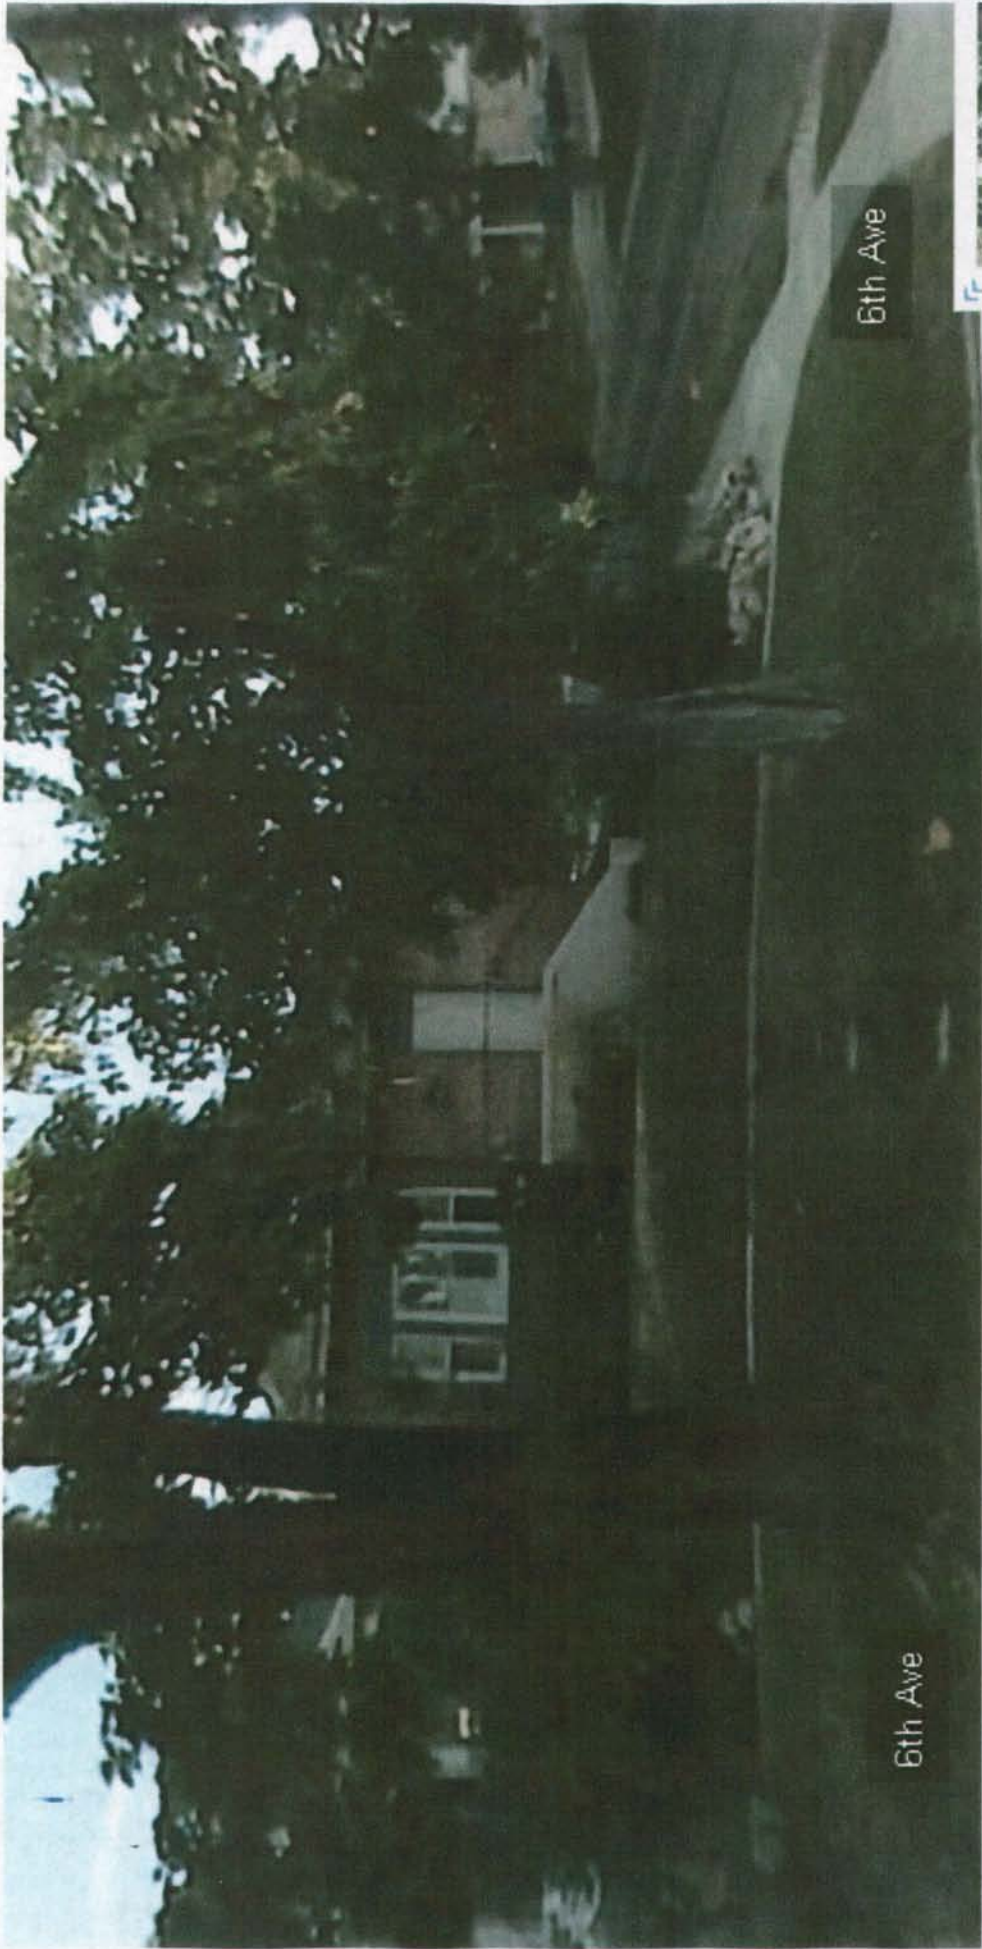
South Elevation

Analysis: The curvilinear design of the retaining walls and size of the rocks, as well as the new stone covering of the front steps and walkway are clearly contemporary additions to the property.

Finding: The application presents large rock retaining walls that drastically change the historic grade of the site. In this case, the use of stone as a replacement material is inconsistent with this standard because the scale, proportion, texture and finish to those used historically.

1. That the Historic Landmark Commission denies the request to cover the steps to the front entrance and walkway, because the proposed design is not compatible with the historic character of the house. The new stone work shall be removed.

2. That the Historic Landmark Commission denies the request to change the historic slope of the site, as this modification negatively affects the historic character of the individual site and its context as seen from the street. The historic topography shall be restored.

3. The Commission denies the request to install new retaining in the front of the property as the design and configuration is inconsistent with the historic character of the building and neighborhood. Should the applicant present a design that is similar in scale, texture, finish, and configuration with those used historically, staff requests that the Commission direct staff to administratively approve the alterations.

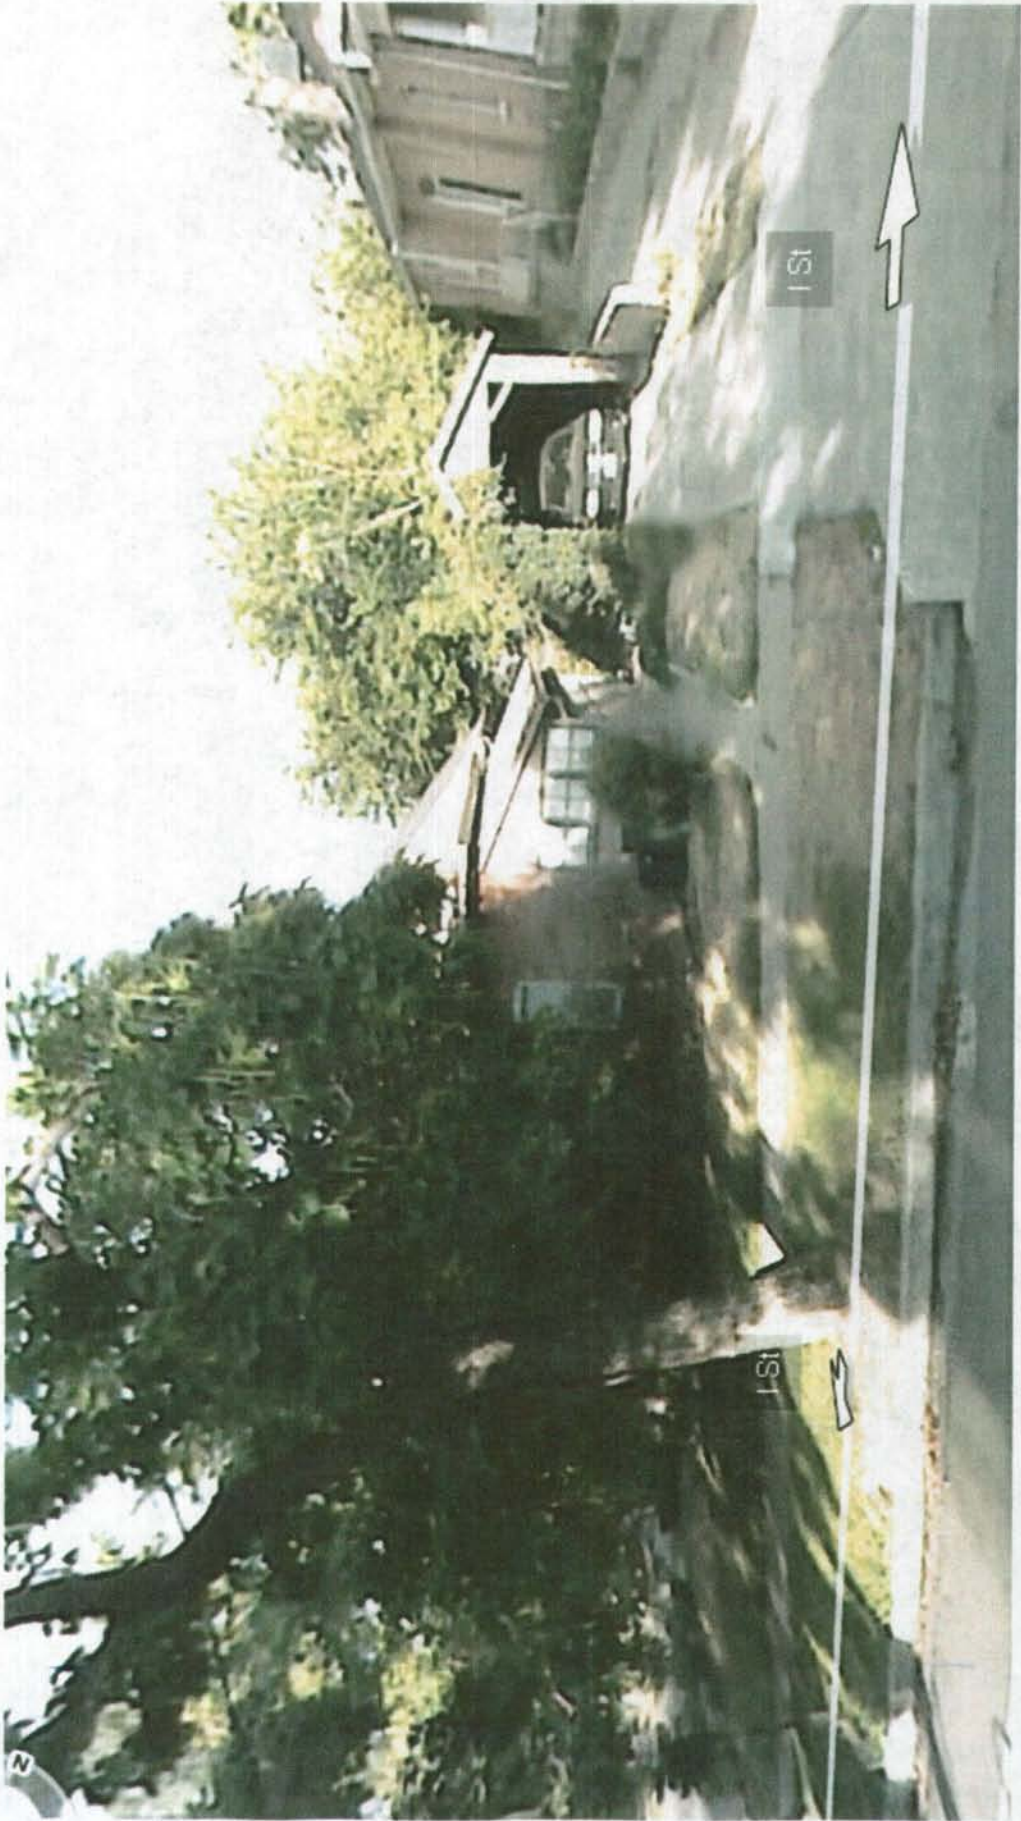
East Side of Property

- Front – Changes to the slope, new retaining, and a stone covering on the stairs and walkway.
- Rear - Removal of the accessory structure, new driveway and foundation wall for an accessory structure, new paving, and fencing for trash receptacles.

Due to the extent of the changes to the front of the property, Planning staff refers this portion of the request to the Historic Landmark Commission for consideration. Staff is of the opinion that the remainder of the work at the rear of the property can be approved administratively, once the applicant submits additional information about the work that was completed to augment the drawings.
