Memorandum

**Planning Division
Community & Economic Development Department**

Re: Commercial Design Guidelines

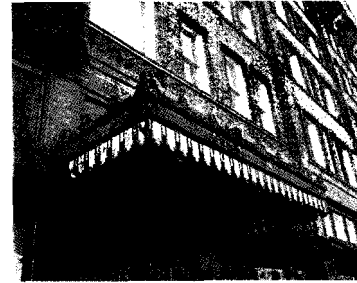
An example of a metal awning at 379 South Main Street.

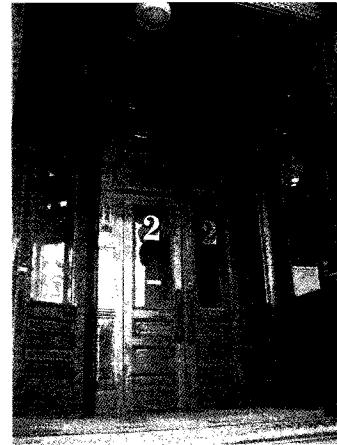
*Original wood doors at 22
100 South.*

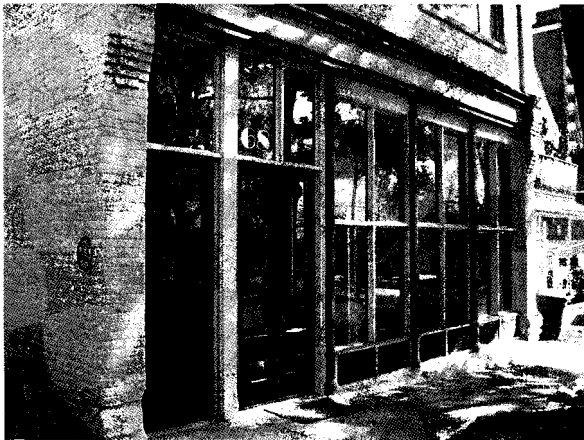
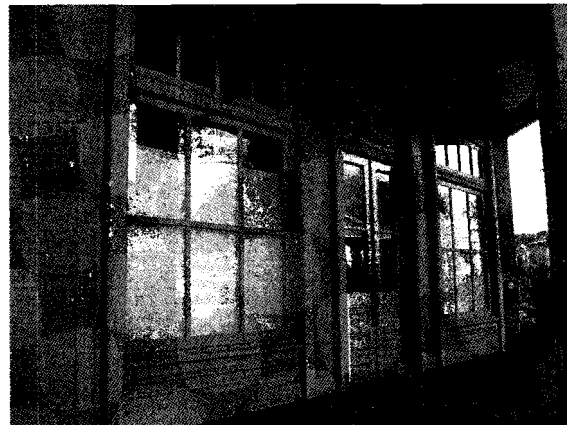
Good examples of rebuilt storefronts are those at 68 East K Street (above) and 740 2nd Avenue (right).

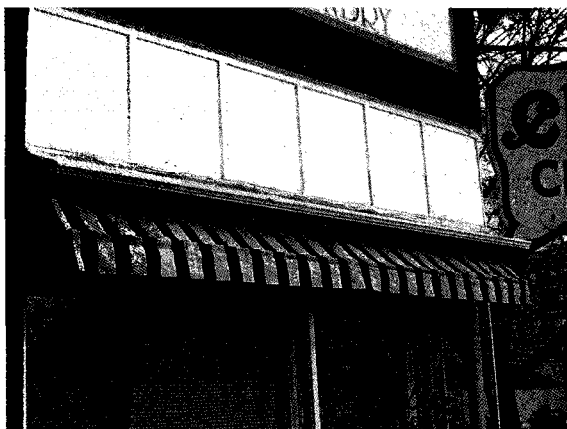
Awnings are appropriate for Salt Lake City commercial buildings: 501 East 300 South (left) and 736 North 300 West (right).

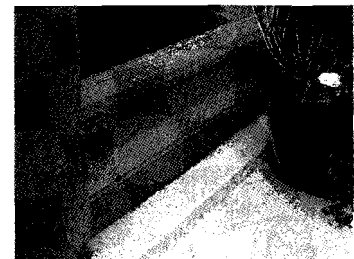
This rebuilt bulkhead at 361 North Center Street is a good example of in kind replacement.

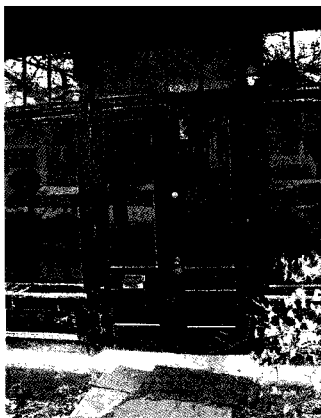
Salt Lake City's commercial buildings have a variety of doors and entrances: Original double doors at 361 N. Main Street (left) and 740 2nd Avenue (center), and an original steel door at 736 N. 300 West Street (right).

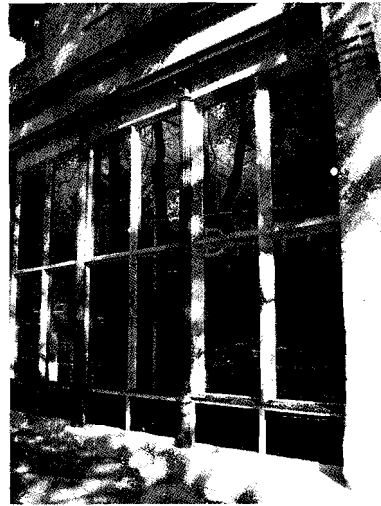
Original cast iron features such as those at 268 South State Street (below) and 68 East K Street (right) should be preserved and maintained.

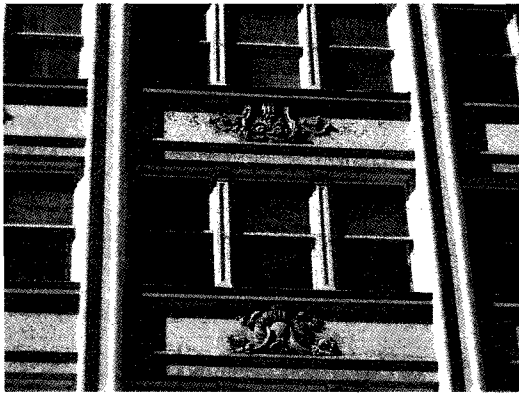
Original sash windows at 68-72 South Main Street (above), and original metal casement windows at 300 300 South (right).

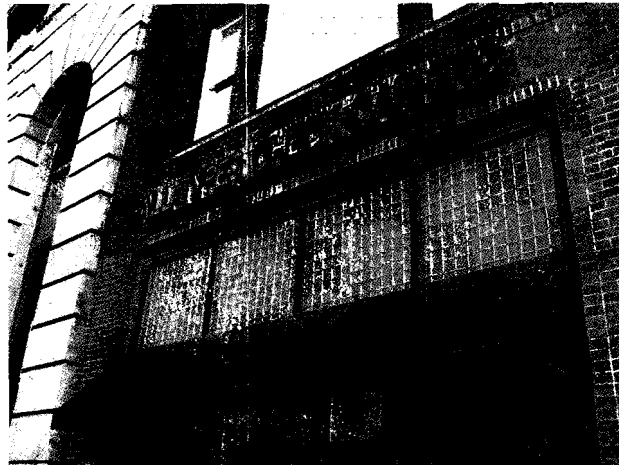
The distinctive Luxfer glass transom at 369 South Main Street should not be removed or concealed.

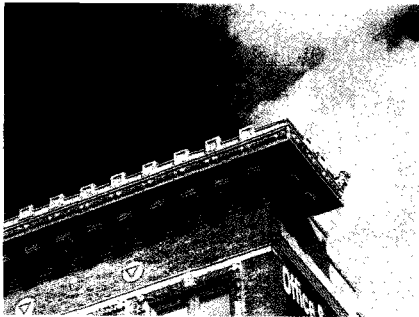
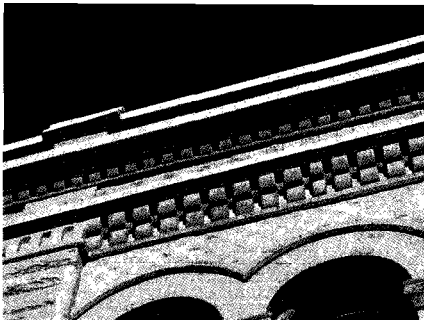
Salt Lake City commercial buildings offer a wide variety of cornice styles and materials, each giving its building distinct character and identity.

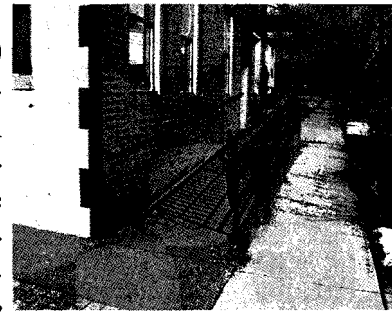
An appropriate access ramp at 569 2nd Avenue North.

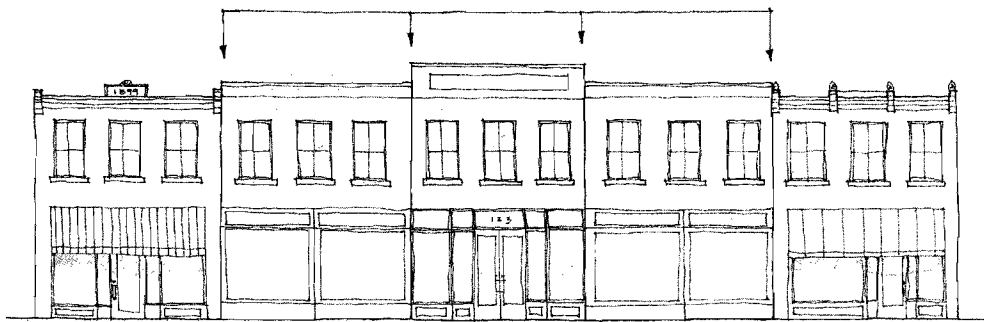
Large new buildings should be designed with vertical divisions to be consistent with traditional historic building widths.

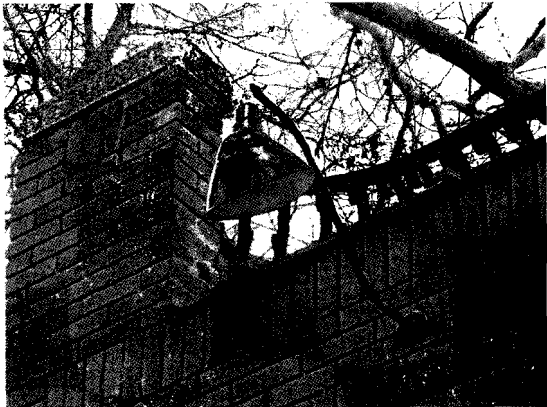
Swan- or goose-neck fixtures in dark metals are appropriate new light fixtures for commercial buildings, as at 82 East Q Street (left) and 422-426 North 300 West (right).

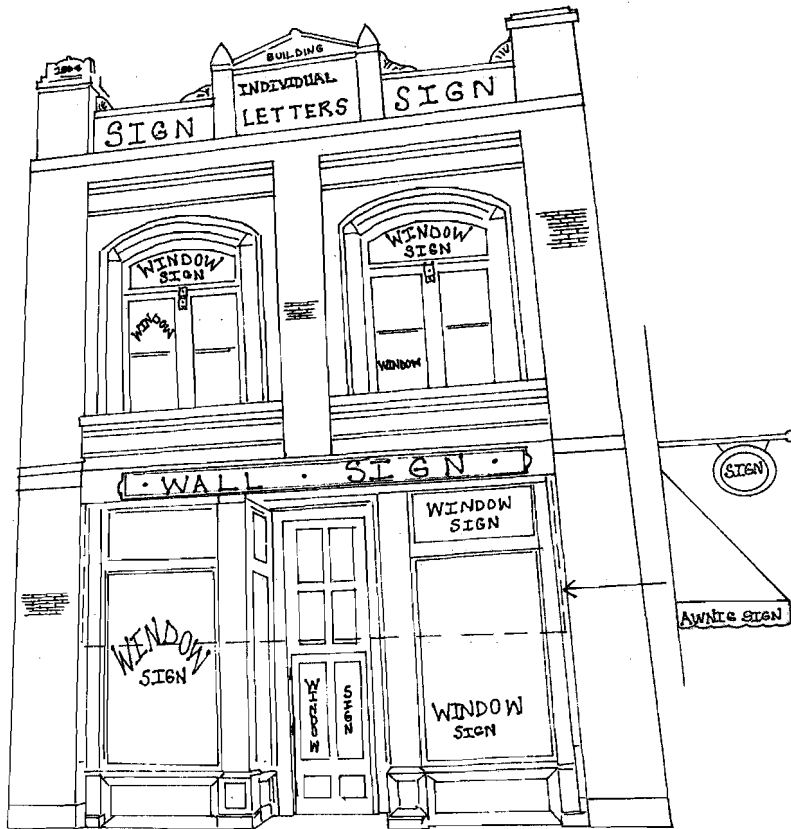
This drawing shows appropriate locations for commercial signage. No more than three signs should be used per building., not counting signs painted on windows.

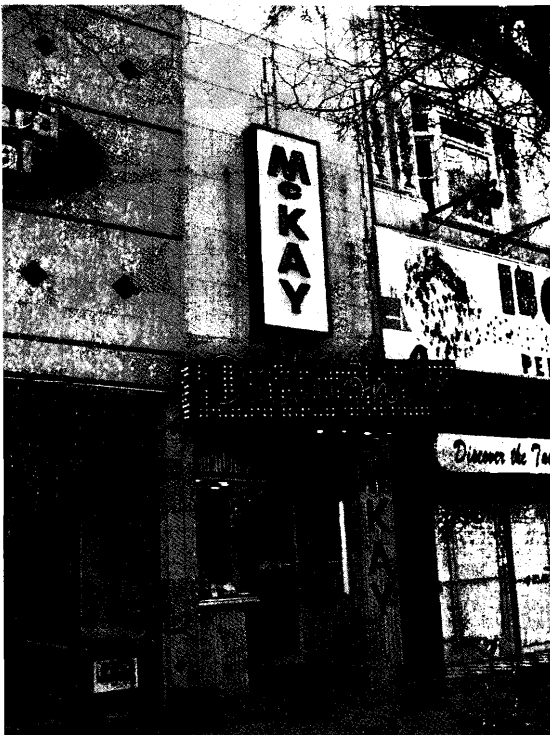
The McKay Jewelry Company at 157 South Main Street occupies a building completed ca. 1950 and features a restrained upper facade and original aluminum and glass storefront.

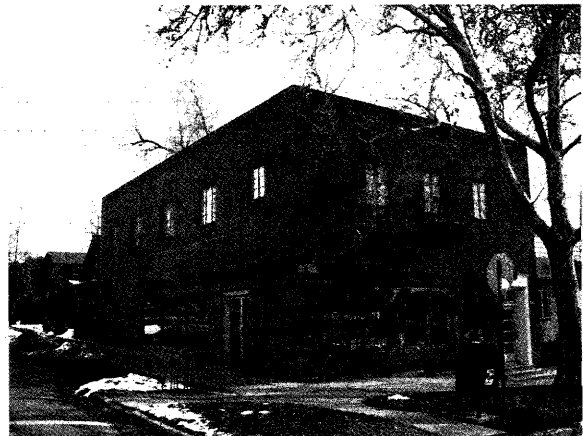
This building was designed with simple detailing ca. 1930 and has rectangular steel casement windows and original display windows (702 E. K Street).
