HISTORIC LANDMARK COMMISSION STAFF REPORT

Petition #PLNHLC2009-00385 Willmore Remodel

Address: 175 North Virginia Street

Type of Request: Major Alteration

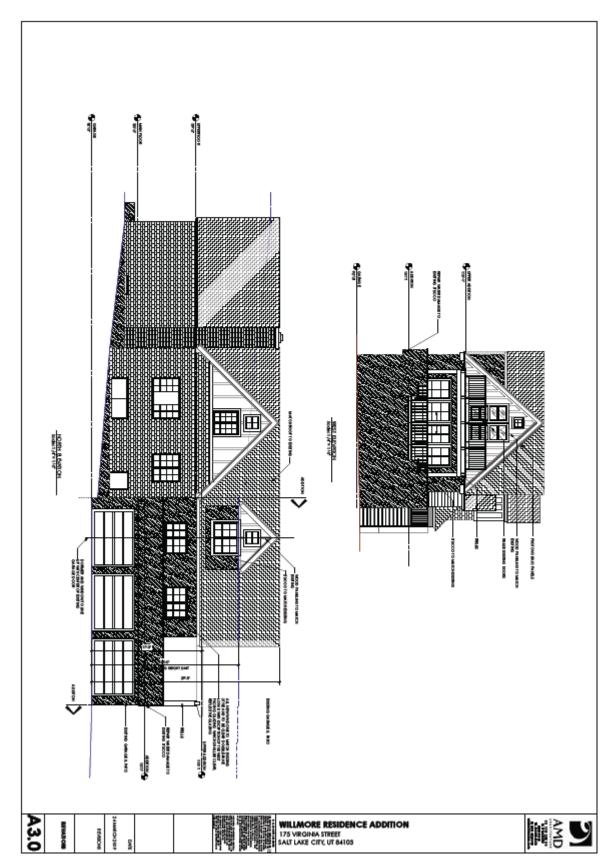
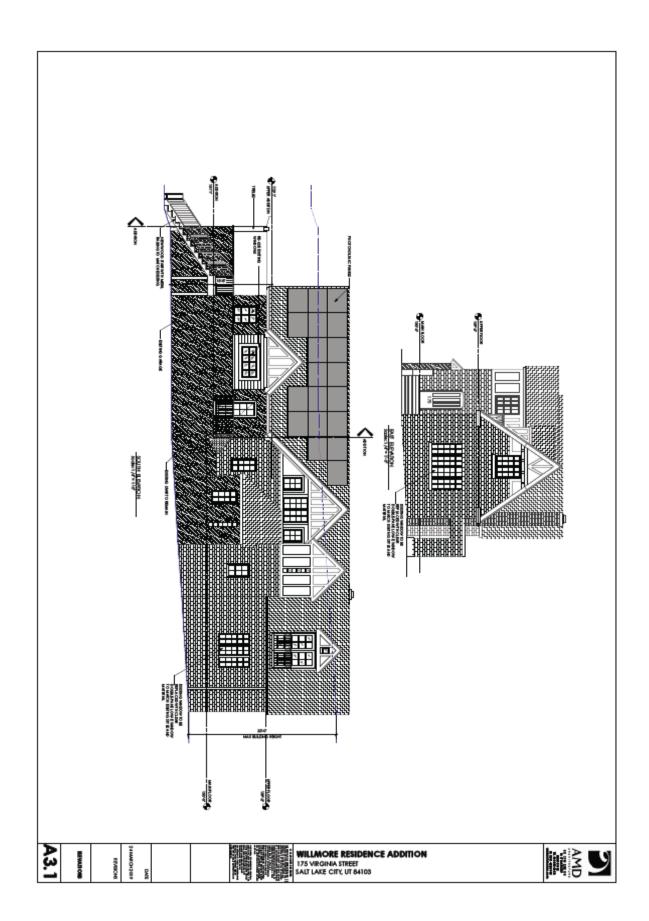
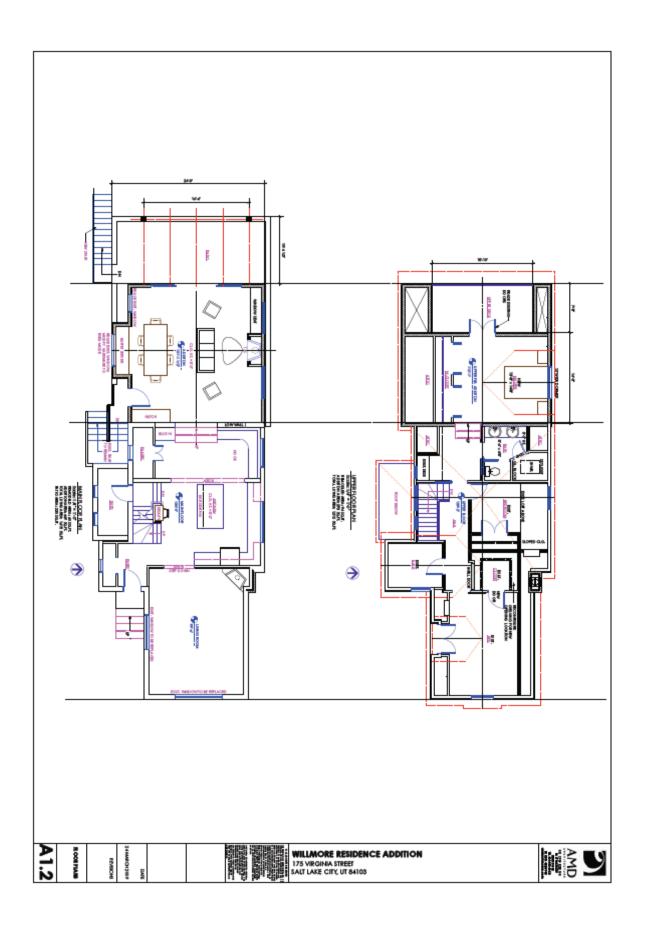
Attachment B Proposed Elevations

The addition would be a two story structure built on the garage with a ridgeline perpendicular to the street and a traditional style gable at the end. The exterior materials are proposed to be primarily stucco (matching the existing garage) and wood paneling in the gable and dormers (matching the existing dormers and gables).

Windows and doors are proposed to match existing materials as well. Because the addition is located on top of the existing garage, no changes to the existing footprint of the building are proposed.

On the roof of the proposed addition, the applicant is requesting approval of a series of photovoltaic panels that would be attached below the ridgeline and follow the plane of the rear roof addition.

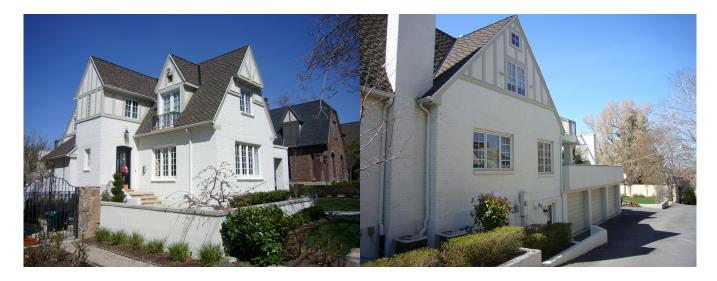
Attachment C Photos of Site

Front and South Sides

North Side

The applicant is requesting that the Commission allow the removal of two original windows that were not replaced as part of the 2004 remodel of the home. Staff finds that although the windows are in need of repair, they have not deteriorated to a point where they are unsalvageable. As a result, staff recommends that the Commission consider denying the request to replace them and encourages the applicant to refurbish these two remaining windows.

Staff further finds that the existing windows on the front and south facades of the home have not deteriorated to a point where they cannot be salvaged. Staff recommends that the applicant refurbish these windows rather than replace them.

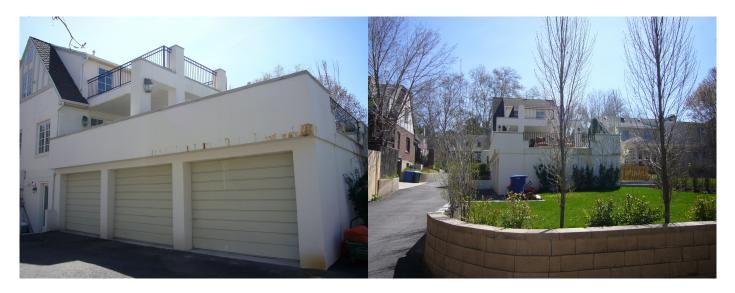
Garage Rear
