HISTORIC LANDMARK COMMISSION STAFF REPORT

Clark Residence Minor Alterations PLNHLC2010-00029 April 12, 2010

The applicant requests Certificate of Appropriateness approval to replace an existing wood window and increase the window opening on the lower level of the west side of the home located at 553 E Fifth Avenue. The applicant states the reason for the proposed alterations is the lack of suitable alternatives to meet egress requirements to the lower level and interior mechanical system needs. Planning Staff determined that the application could not be approved administratively because the proposed window replacement does not meet the criteria for the treatment of historic windows. Therefore, Planning Staff refers this application to the Historic Landmark Commission for consideration.

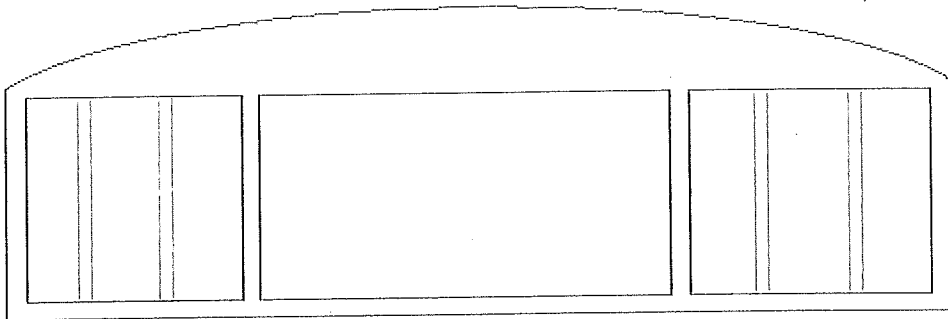
New Window

Window will be elongated maintaining old header and new wood window framing to meet egress requirements for basement habitability.

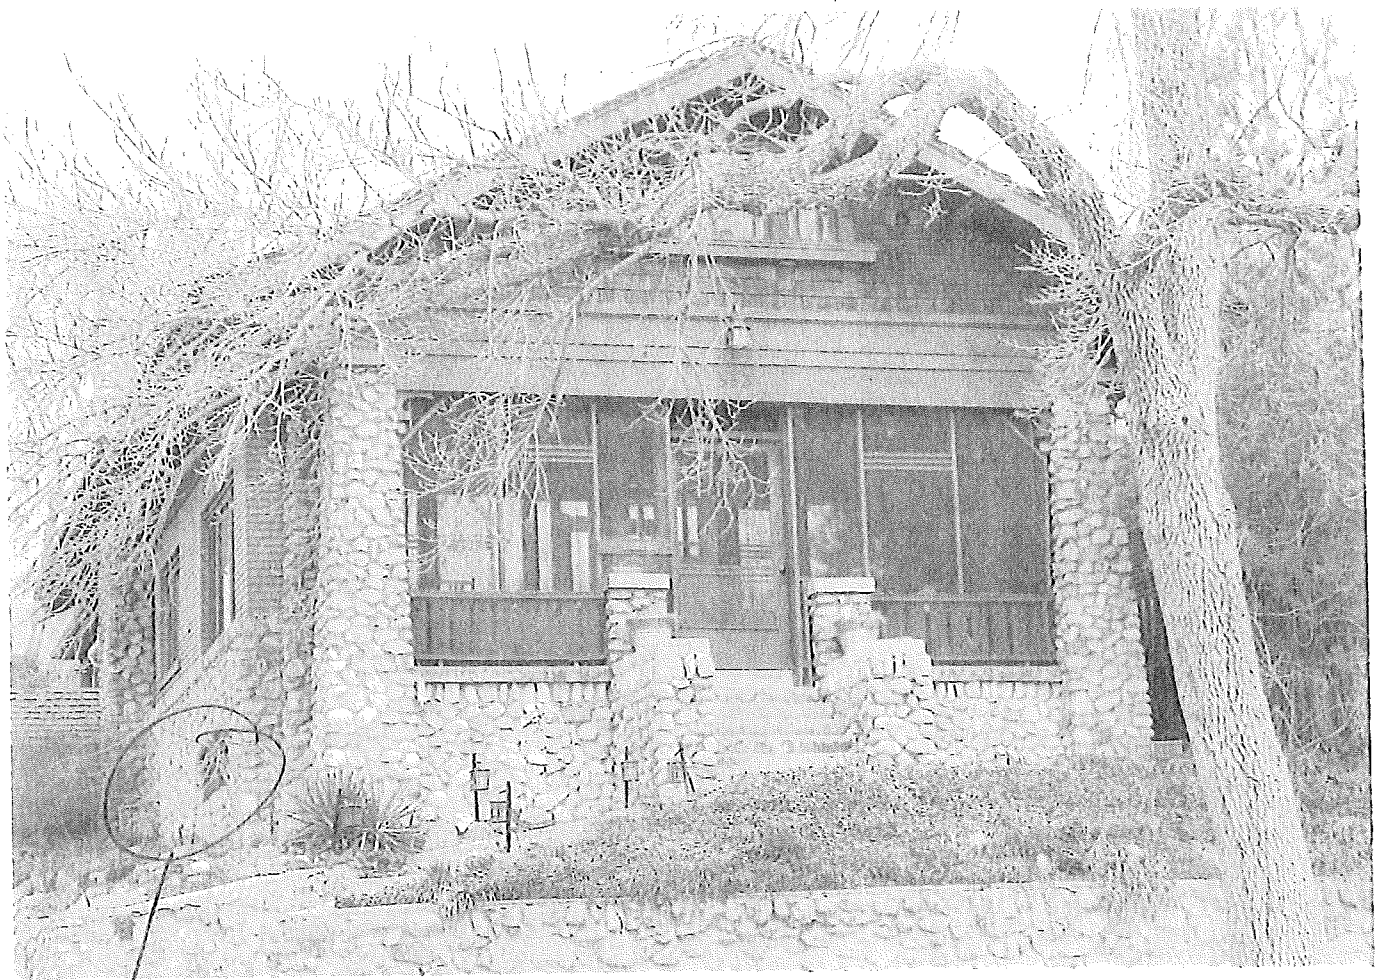
Window to be enlarged
