HISTORIC LANDMARK COMMISSION
STAFF REPORT

TRACY AVIARY GUEST SERVICES BUILDING
and INFRASTRUCTURE UPGRADES

PLNHLC2010-00427

Liberty Park, 589 East 1300 South

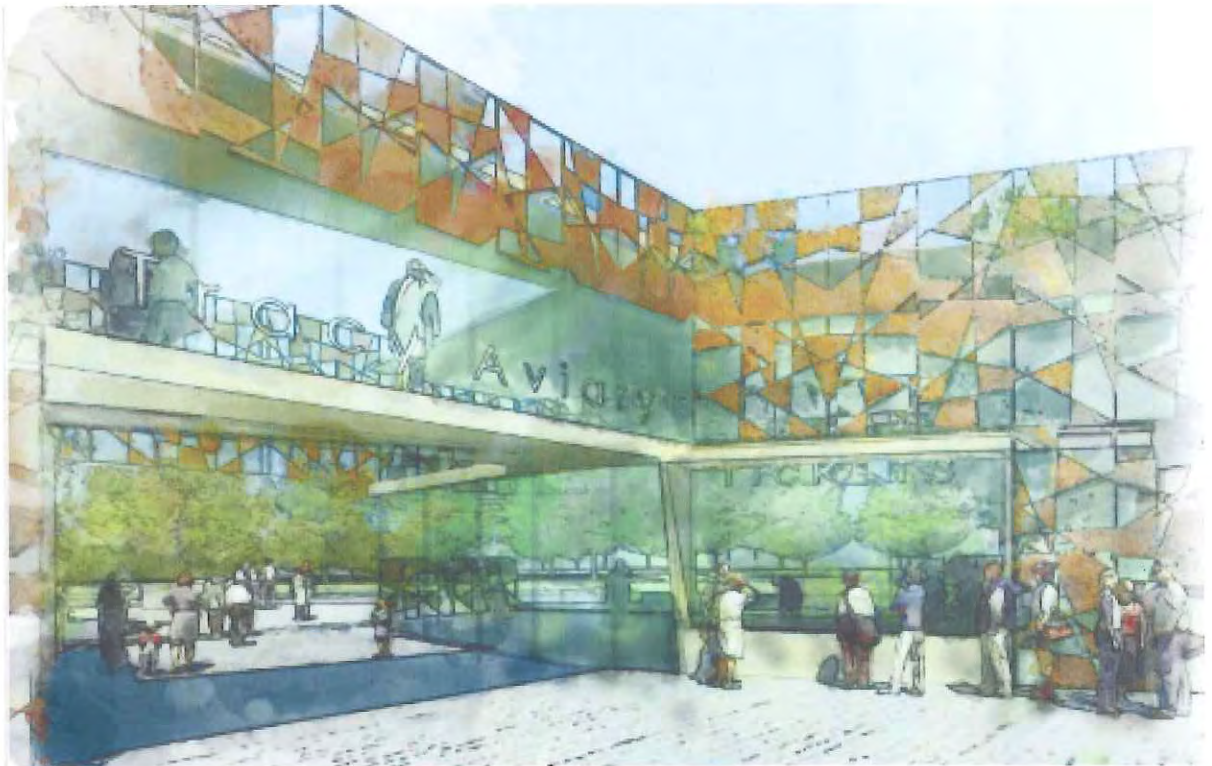
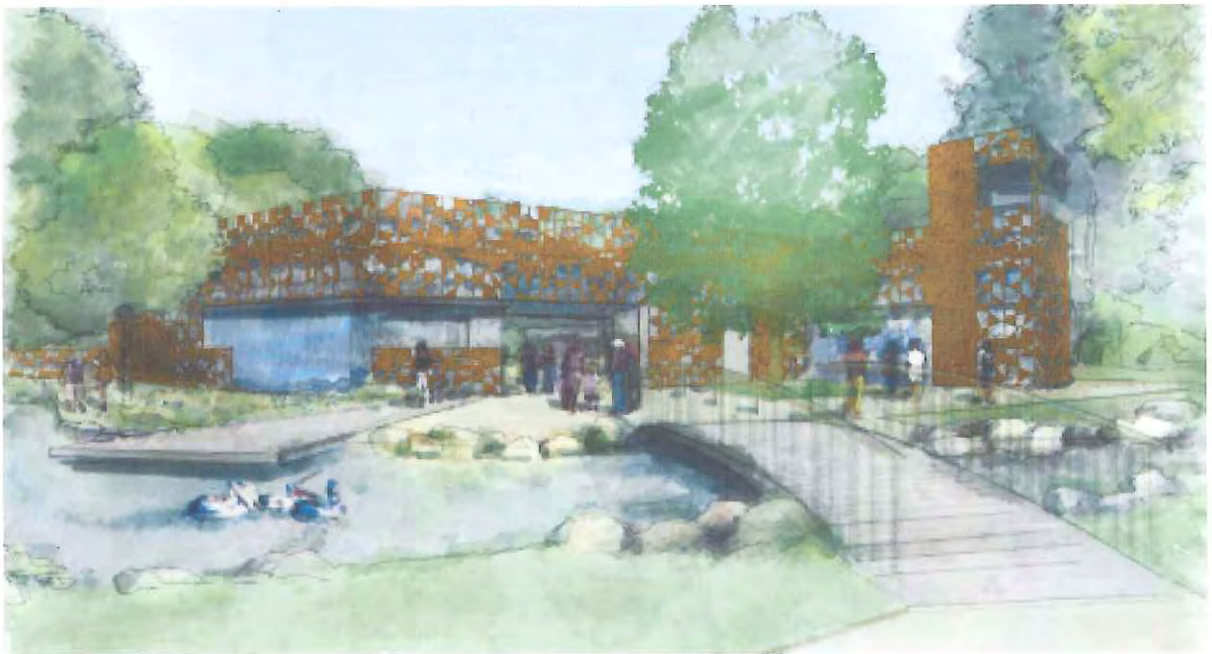
Site Plan and Elevations for Guest Services Building

Building and landscape weave through existing and new trees, and water. The building form embraces plazas and opens opportunities for views and relationships between park, building and aviary.

This building is proposed to replace the existing ticketing and guest services building located at the main entry to the aviary. The two storey building will be approximately 10,000 square feet in size with a Z shaped footprint. The building will be cement block construction with a decorative metal sheathing designed to evoke tree shading or “a flock of birds taking flight” and typical retail window glazing in the ticketing and retail sections of the façade. The roof will be flat with a synthetic membrane cover and a viewing platform located on the northwest corner.

Analysis: The scale and form of historic structures within the park vary greatly depending on their function. The proposed structure will be one of the largest buildings in the park. Nonetheless, the design of the structure is such that it is relatively indiscreet. The size and scale of the building are mitigated by the variegated design of the footprint, the flat roof, and the design of the bridge entry into the aviary. These design elements combine to make the structure appear smaller than it actually is. The Z shaped footprint breaks the mass of the building into smaller components, and thereby reduces the overall visual mass of the building while adding architectural interest. The incorporation of the flat roof into the design reduces the overall height, and mass of the building. The bridge design draws the eye

away from the building, and into the open areas of the aviary. The result is a 10,000 square foot building in which the widest unbroken façade is approximately 79 feet wide.

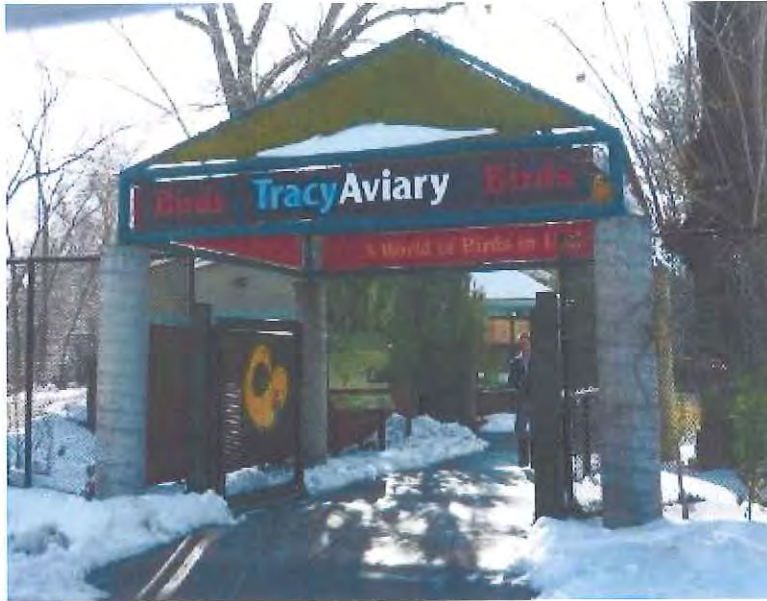
1

Current Use: Current Entrance
Materials: concrete, pipe and awning
Plan: replace

Historic Use: N/A
Construction Date: c. 1994
 Part of Phase II - bond

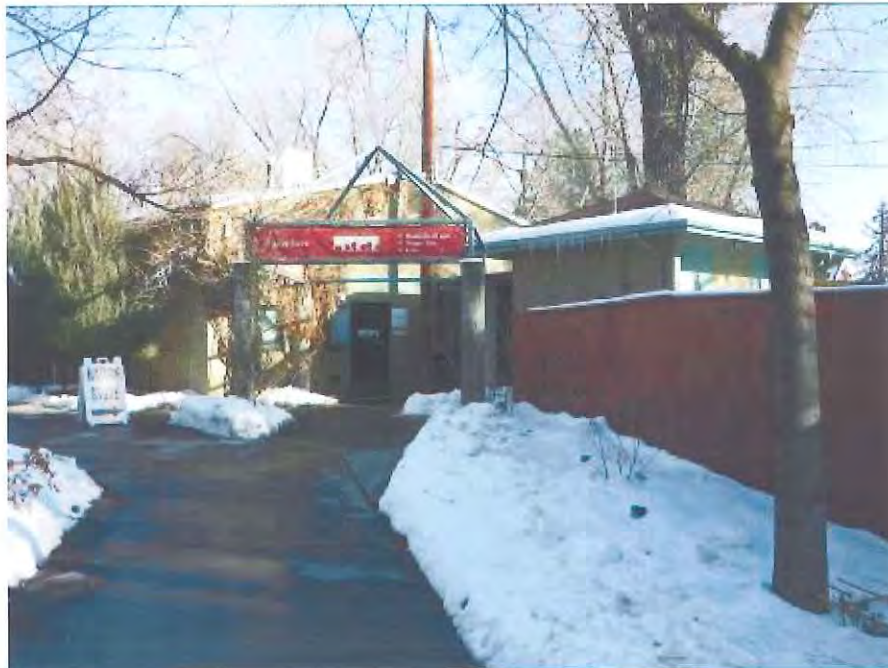
2

Current Use: Nature Store, tickets	Historic Use: Vehicle Maintenance
Materials: concrete block	Construction Date: Remodeled 1994
Plan: replace, possibly reuse, Phase II	Significance: Not historically significant

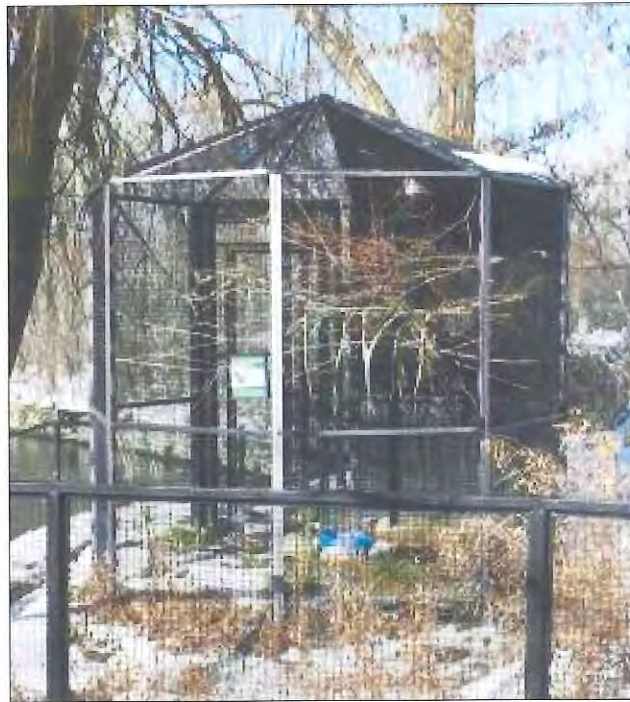
3

Current Use: Exhibit	Historic Use:
Materials: metal pipe and wire mesh	Construction Date: 2006
Plan: Remove	Significance: Not historically significant

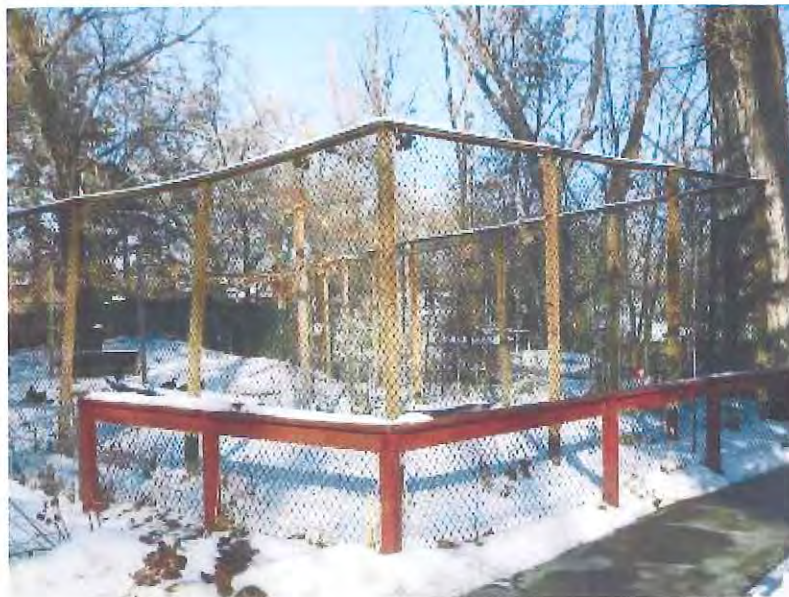
4

Current Use: Red-crowned crane	Historic Use:
Materials: wood and wire mesh	Construction Date:
Plan: Replace with more shorebird exhibit	Significance: Not historically significant

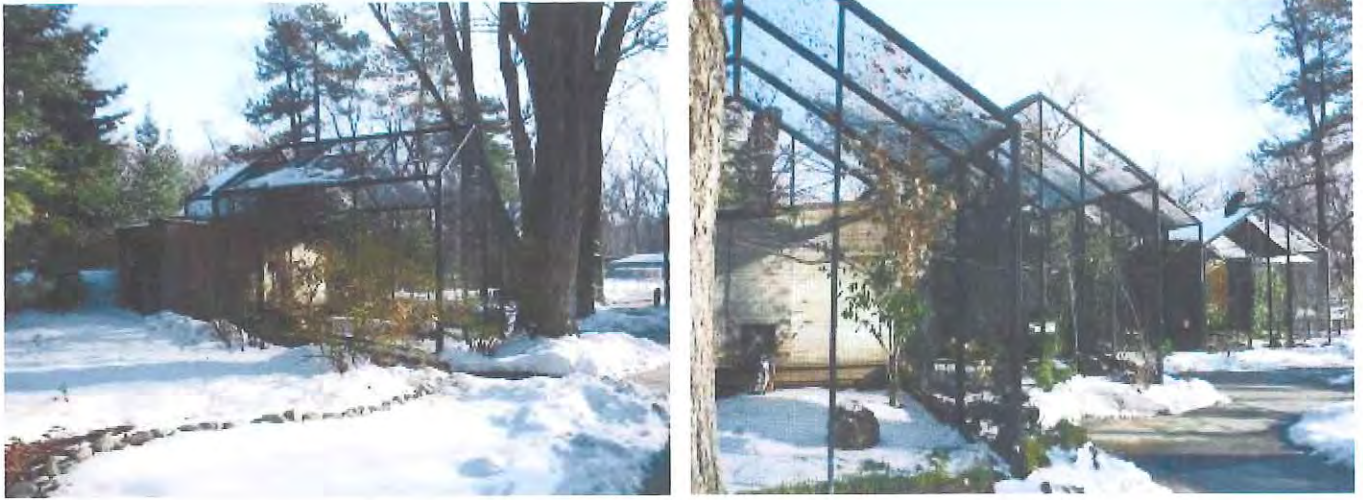
5

Current Use: Pheasant Exhibit	Historic Use:
Materials: concrete, wood, pipe and wire mesh	Construction Date: 1986
Plan: remove/replace

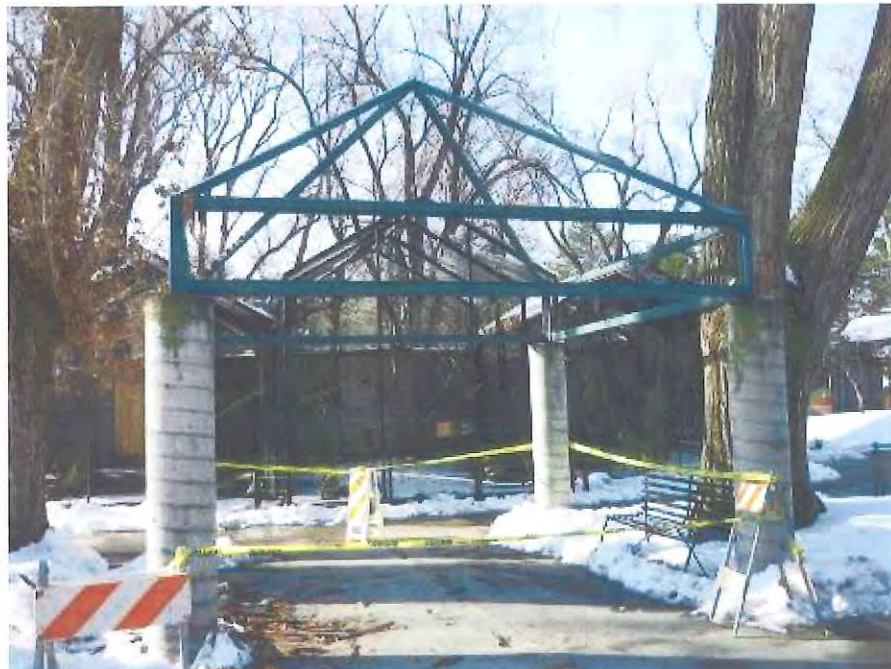
6

Current Use:	Historic Use:
Materials:	Construction Date: c.1994
Plan: Remove	Significance: Not historically significant

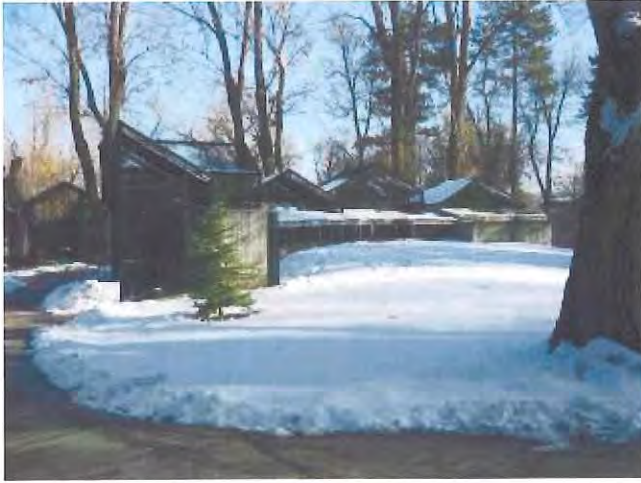
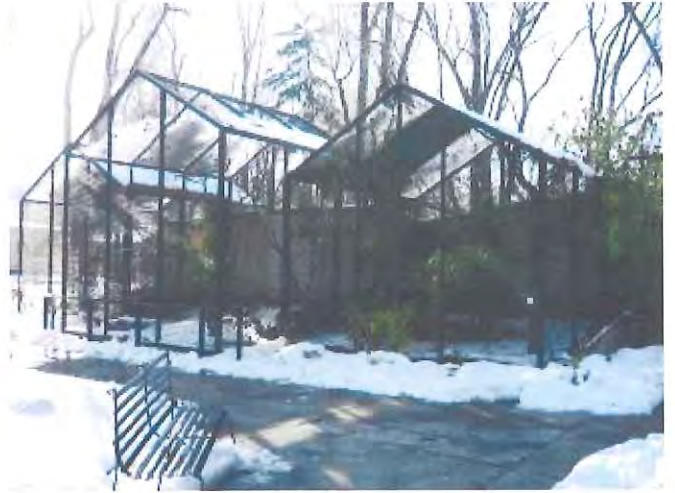
7

Current Use: Magpie/ Cuckoo exhibit	Historic Use:
Materials: concrete, wood, pipe and wire mesh	Construction Date: c. 1986
Plan: Replace

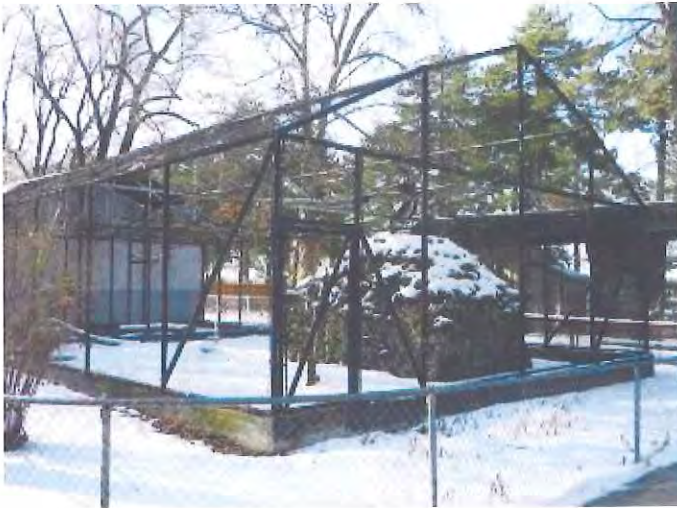
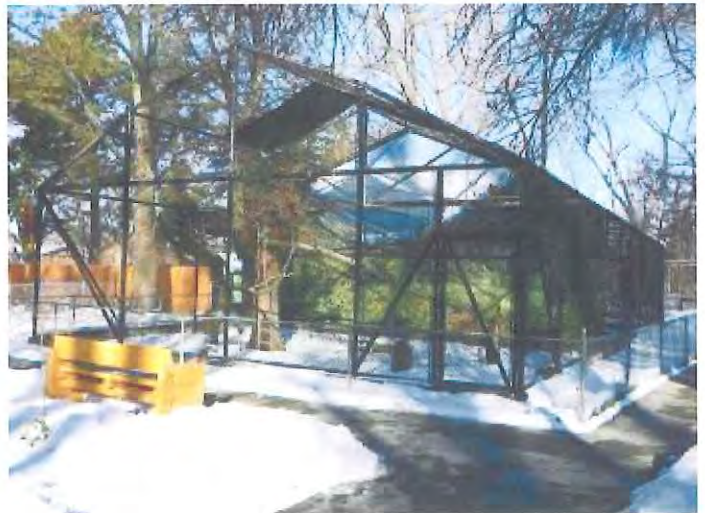
8

Current Use: Condor/ Hawk exhibit	Historic Use: bird cage
Materials: concrete, wood and wire mesh	Construction Date: c. 1968
Plan: Remove, Add SSP exhibit or Utah wetland	Significance: Not historically significant

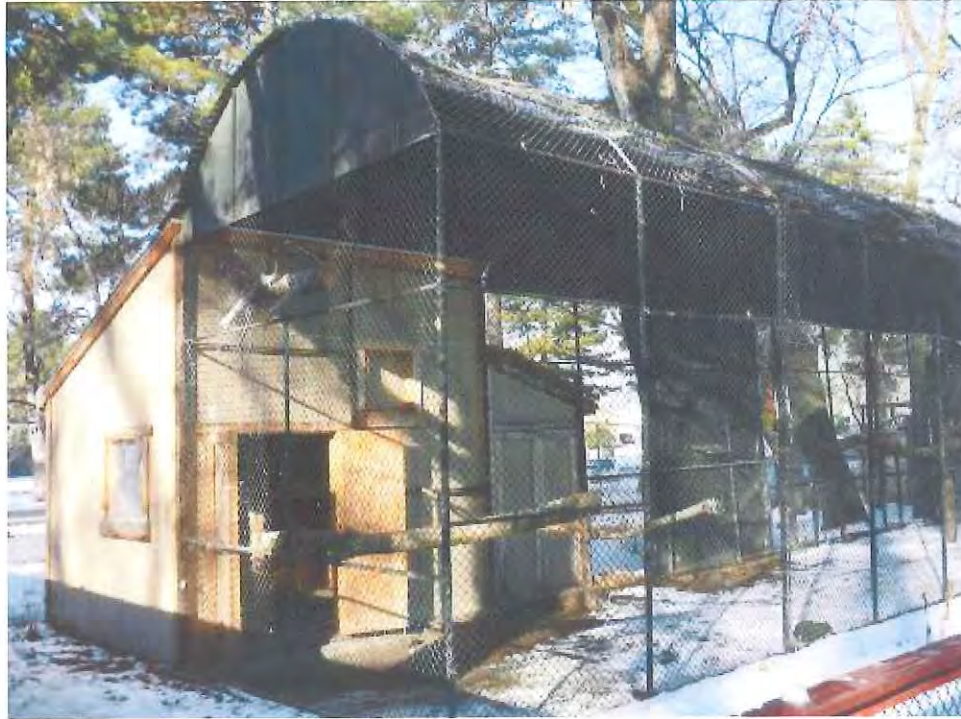
Current Use: King Vulture exhibit	Historic Use:
Materials: pipe and wire mesh with wood frame structure	Construction Date:
Plan: Replace with more permanent structure	Significance: Not historically significant

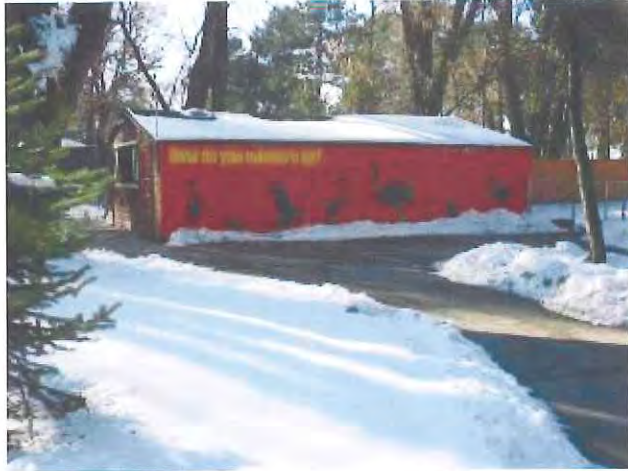
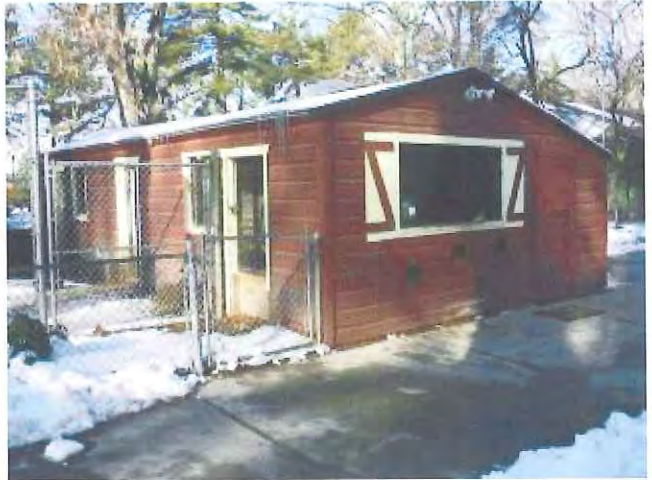
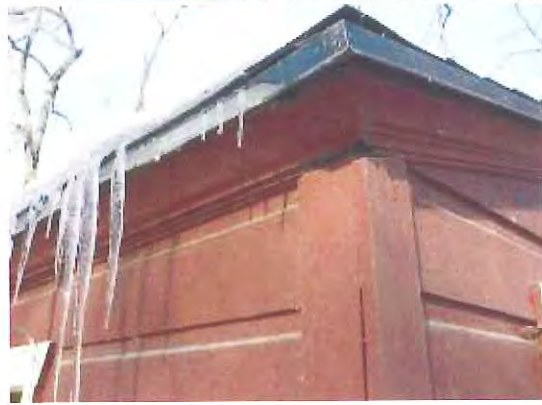
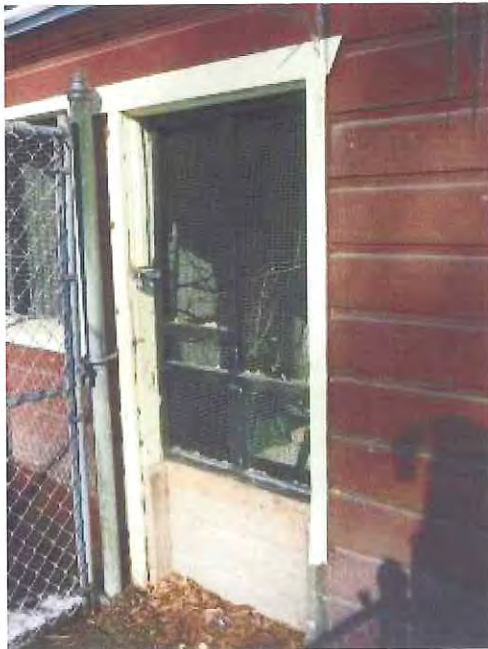
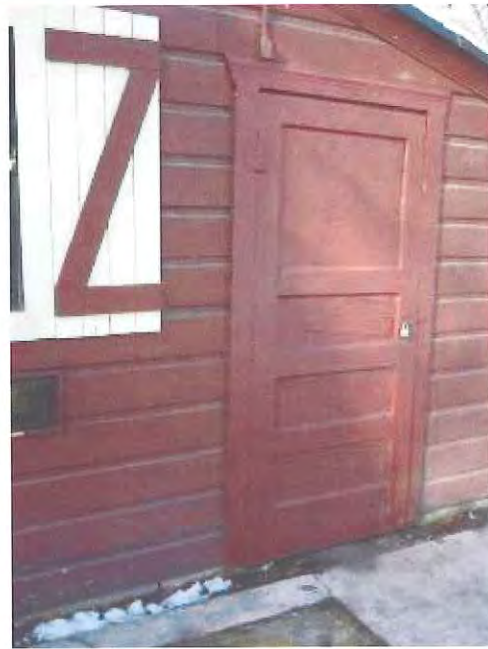
10

Current Use: Burrowing owl exhibit	Historic Use: bird cage
Materials: wood frame	Construction Date: c.1938
Plan: Demolish	Significance: An early feature of the Aviary which has undergone significant alterations.

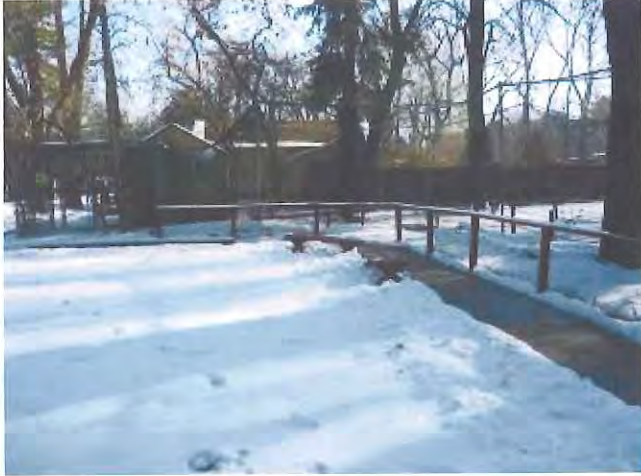
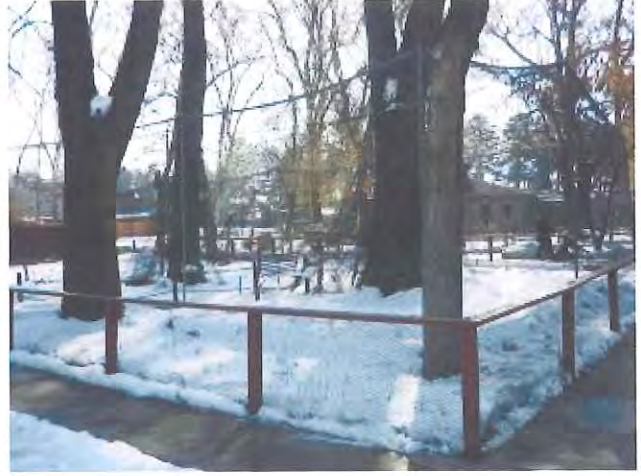
11

Current Use: Sun Conure exhibit	Historic Use:
Materials: pipe and wire mesh	Construction Date: late 90s or early 00s
Plan: Remove. Possibly replace with more permanent interactive feeding exhibit	Significance: Not historically significant

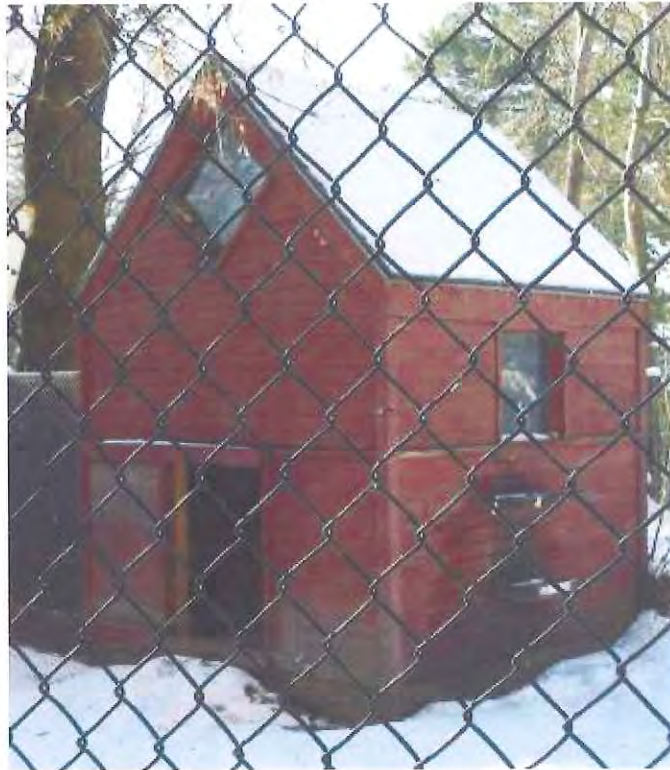
12

Current Use: Sandhill Crane exhibit	Historic Use:
Materials: wood frame	Construction Date:
Plan: Reuse elsewhere	Significance: Significant as an early feature of the Aviary which retains historic integrity.

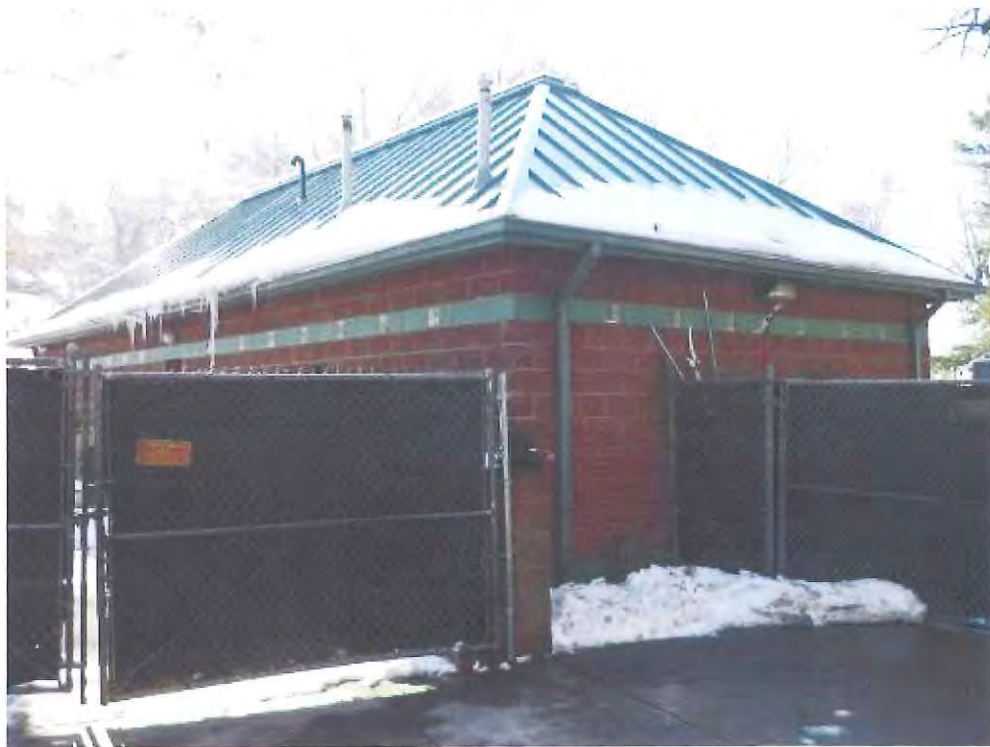
13

Current Use: Maintenance building	Historic Use:
Materials: cinder block, metal roof	Construction Date:
Plan:	Significance: Not historically significant

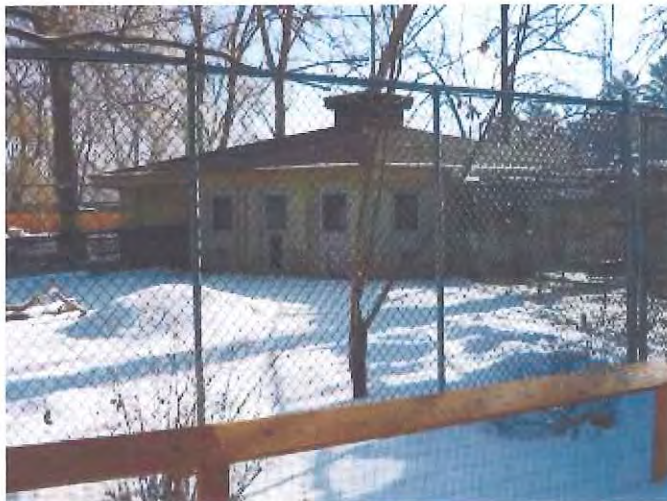
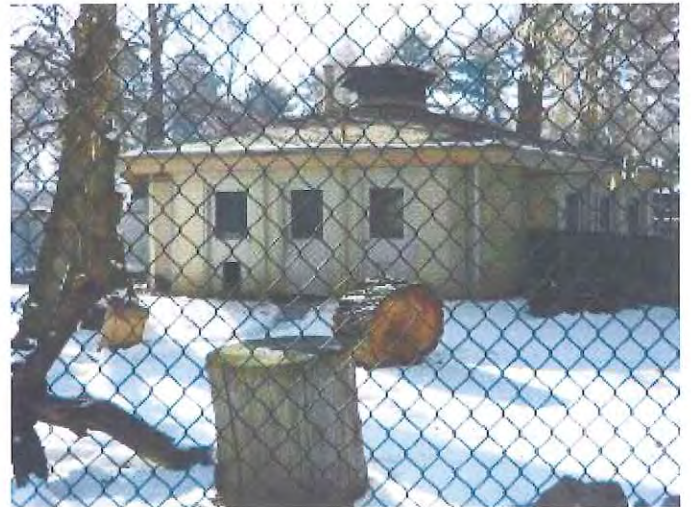
14

Current Use: Southern Groundhornbill exhibit	Historic Use:
Materials: brick, asphalt shingle roof	Construction Date:
Plan: Demolish

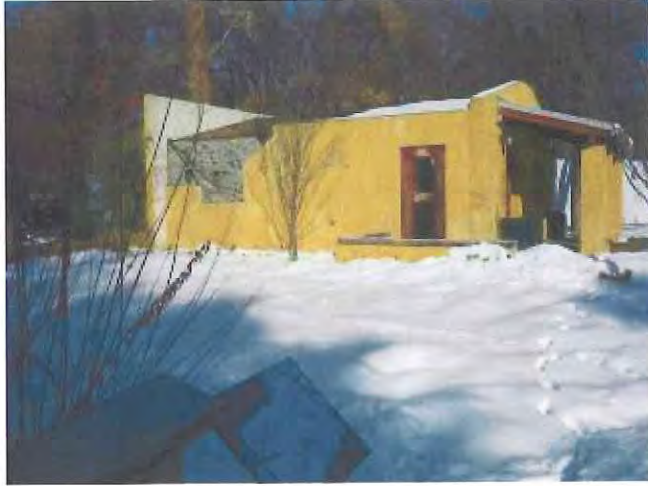
15

Current Use: Argentina interactive exhibit	Historic Use:
Materials: concrete, wood	Construction Date: c. 2004
Plan:	Significance: Not historically significant

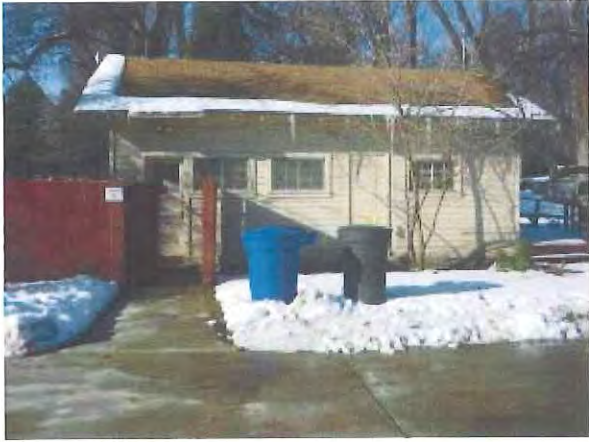
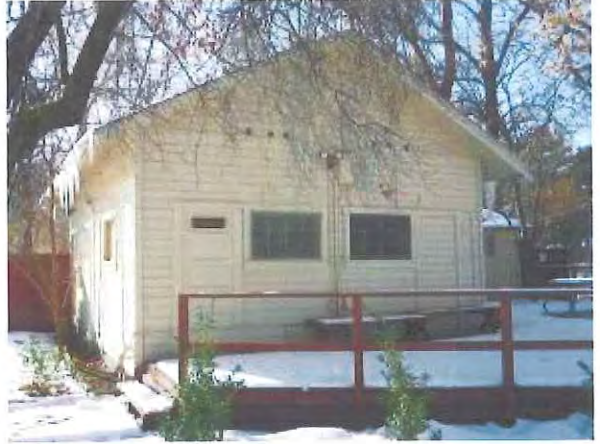
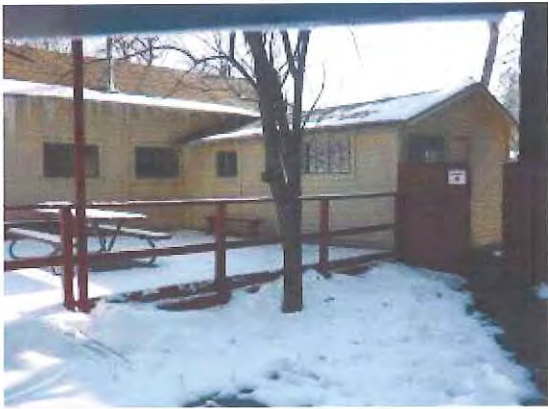
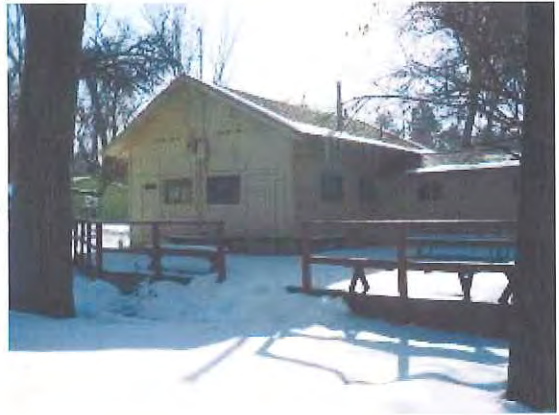
Current Use: Office building	Historic Use: Aquarium (1938) Caretakers cottage (1968)
Materials: wood, asphalt shingle	Construction Date: c. 1938
Plan: Demolish	Significance: Significant as an early feature of the Aviary which retains historic integrity.

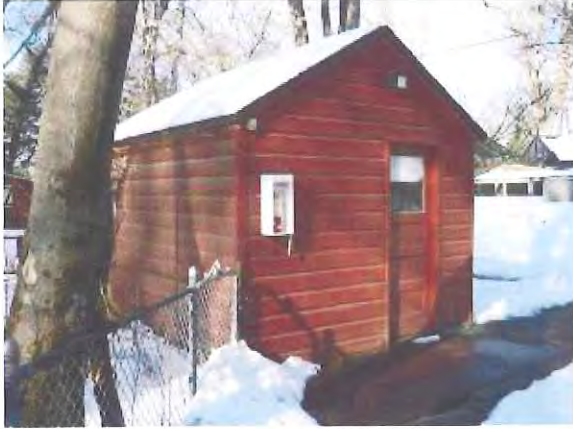
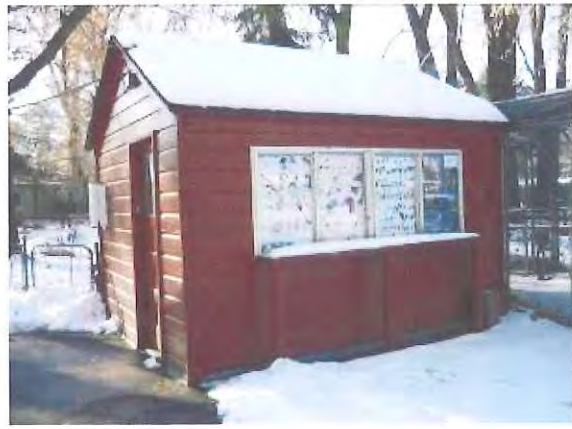
17

Current Use:	Historic Use:
Materials: wood, asphalt shingle	Construction Date: c. 1938
Plan: Demolish	Significance: Significant as an early feature of the Aviary which retains historic integrity.

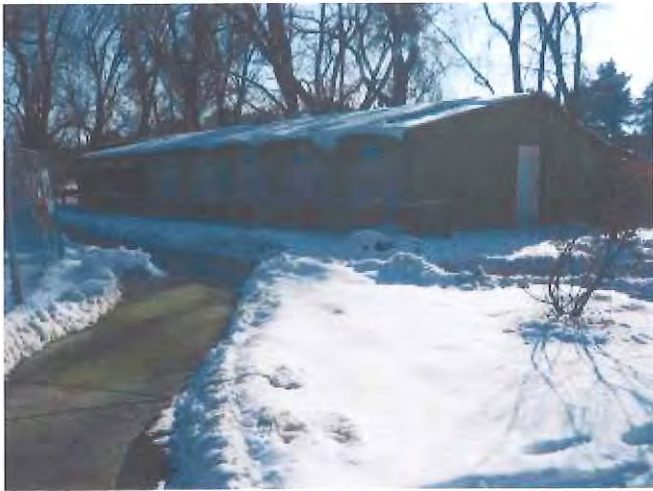
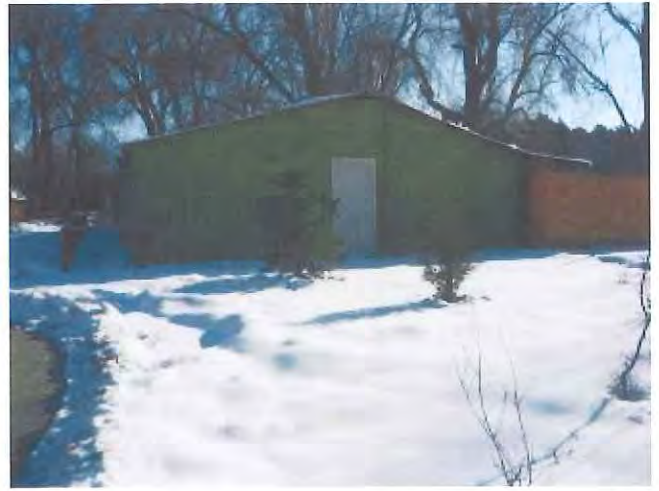
18

Current Use: Bird Show Mews	Historic Use:
Materials: wood	Construction Date: c. 2008
Plan: Demolish	Significance: Not historically significant

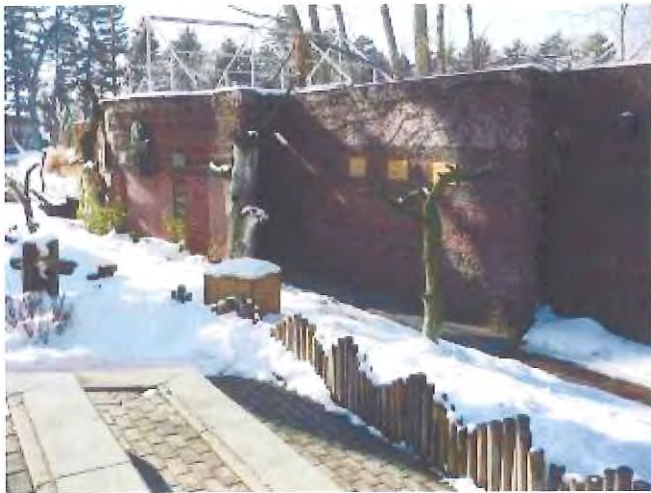
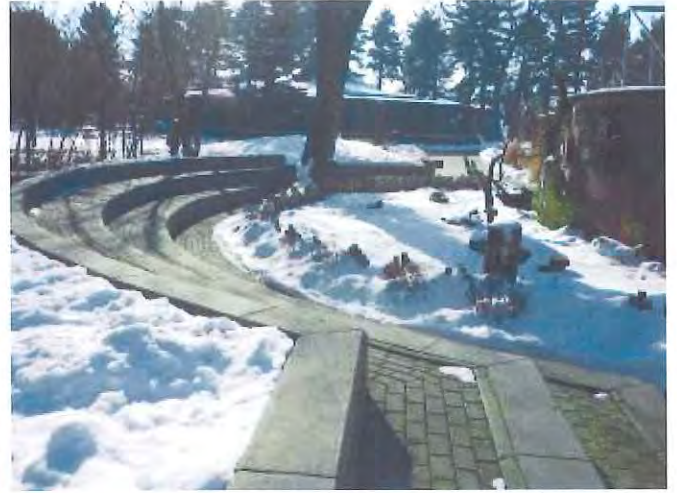
19

Current Use:	Historic Use: Exhibit and amphitheater
Materials: concrete block, brick	Construction Date: c. 1988
Plan: Demolish/reuse as holding for a new exhibit

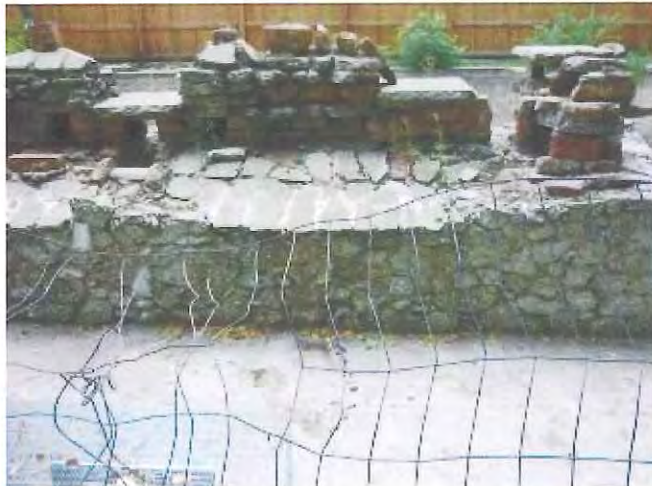
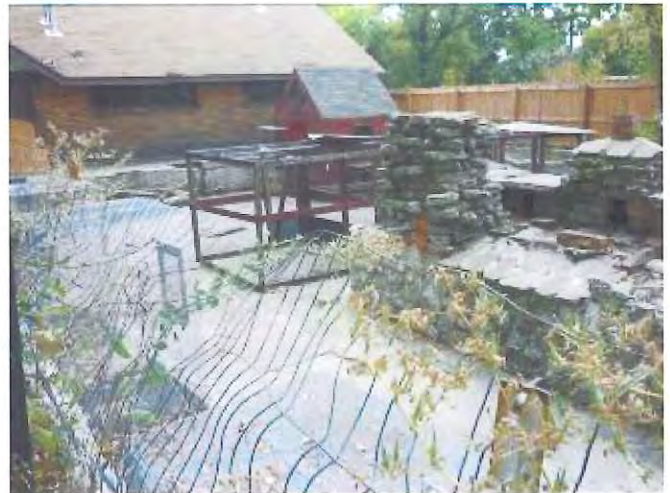
20

Current Use: Unused	Historic Use: duck pond
Materials: concrete	Construction Date: c. 1968
Plan: Demolish	Significance: Significant as an early feature of the Aviary; however because of severe deterioration its integrity is questionable.

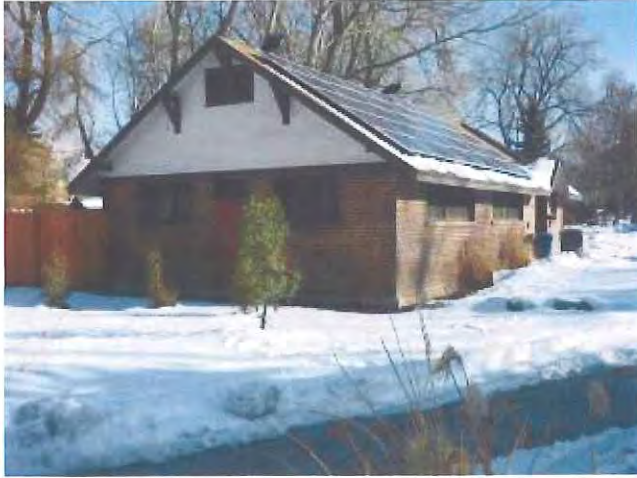
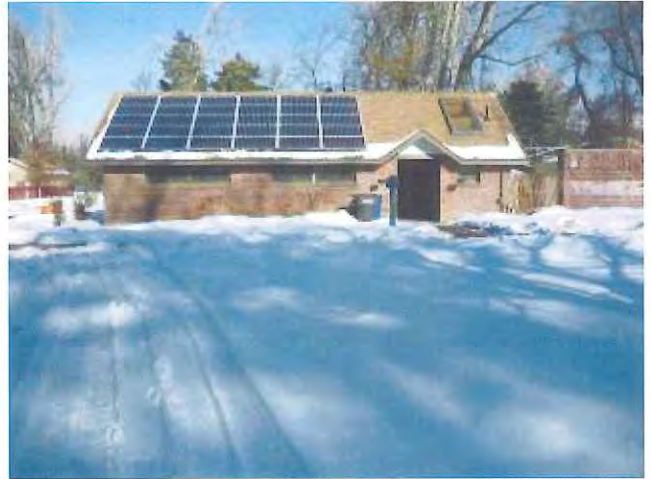
21

Current Use: Bathroom	Historic Use: bird house (Lorikeet)
Materials: brick, asphalt shingle	Construction Date: 1960s
Plan:

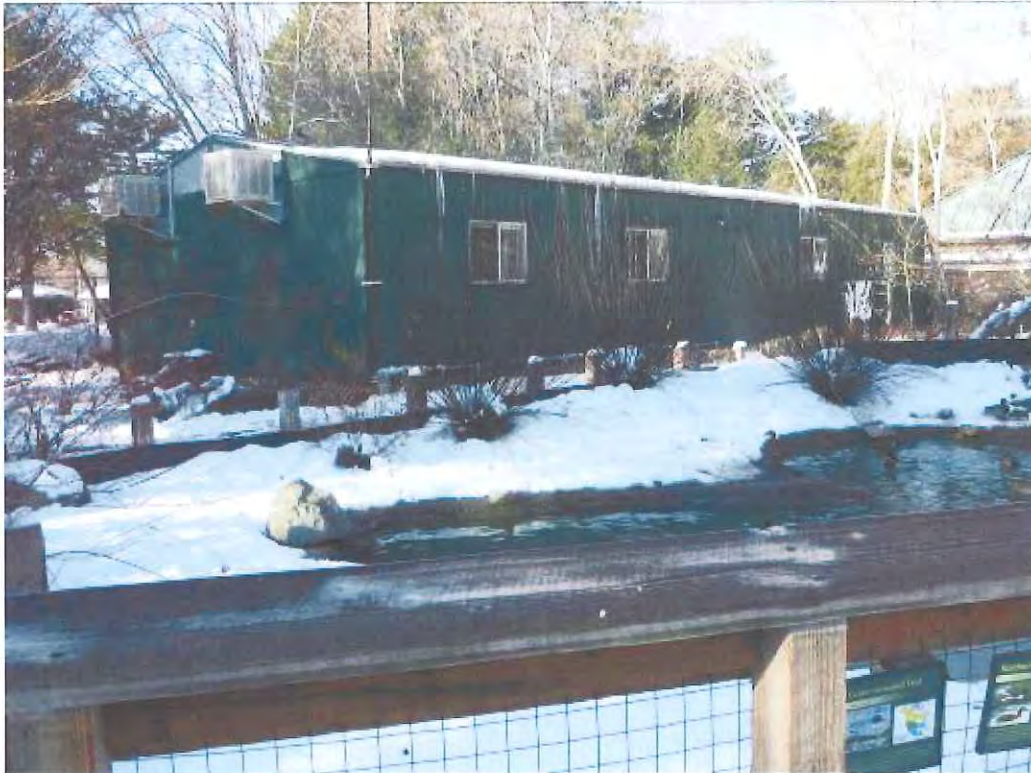
22

Current Use:	Historic Use:
---------------------	----------------------

Materials: modular	Construction Date: c.1996
Plan: Replace with modern modular	Significance: Not historically significant

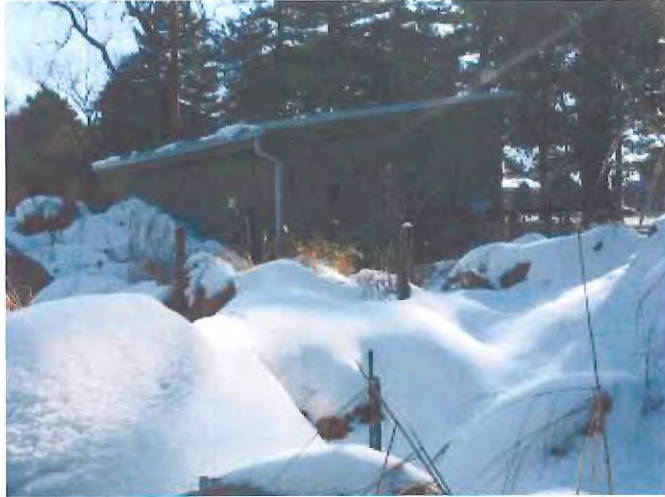
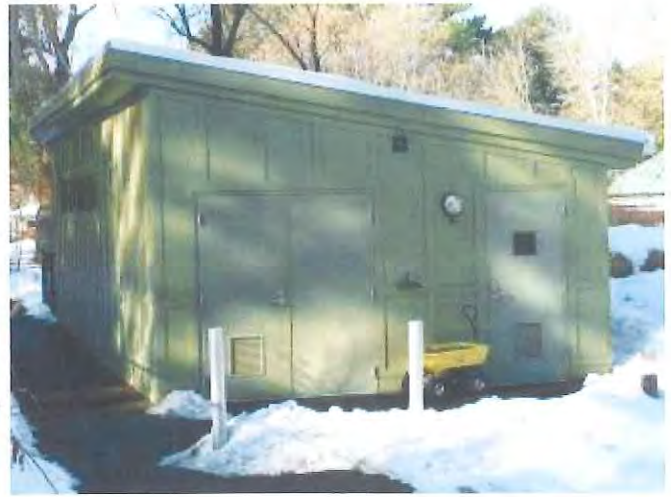
23

Current Use: Flamingo holding	Historic Use:
Materials: wood	Construction Date: 2004
Plan:	Significance: Not historically significant

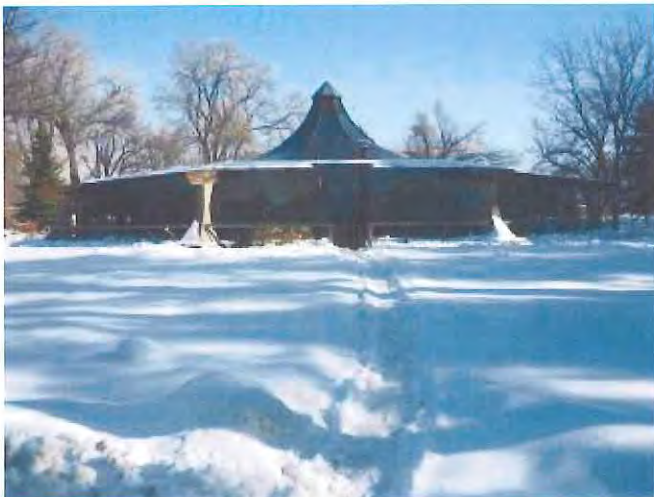
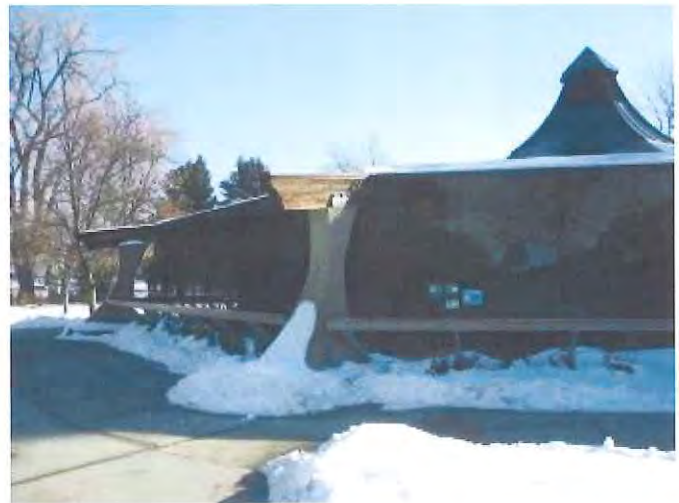
24

Current Use:	Historic Use: Wilson Pavilion
Materials:	Construction Date: 1970
Plan: Renovate, Phase II	Significance: Significant as an early feature of the Aviary which retains historic integrity.

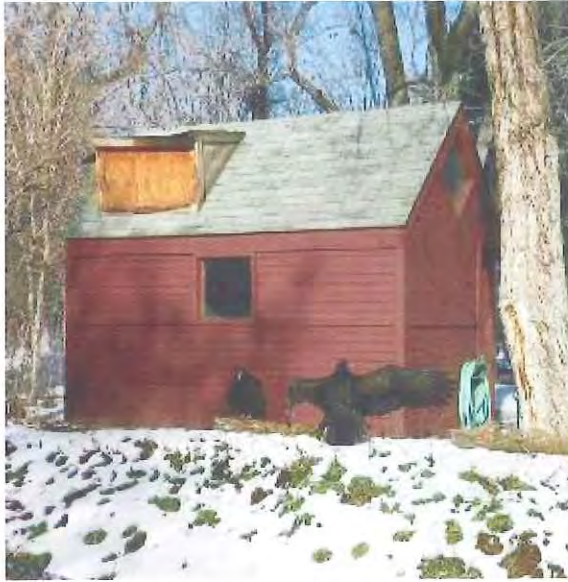
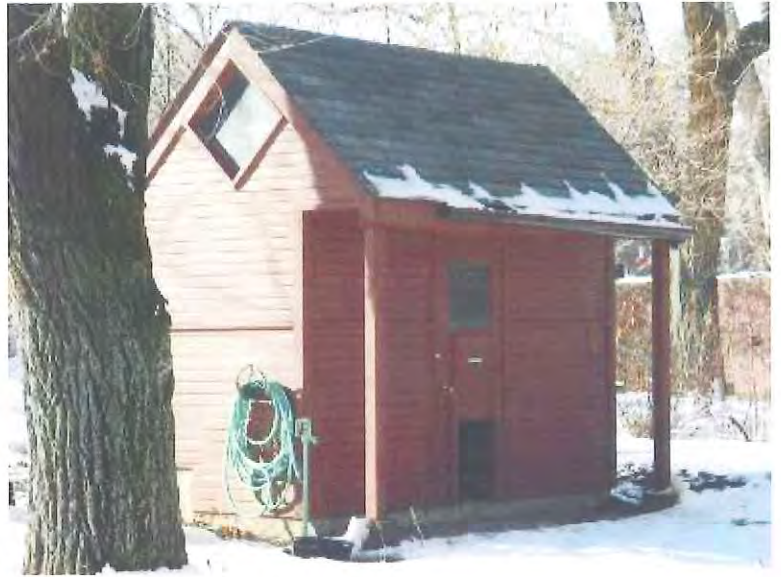
25

Current Use: Turkey Vulture exhibit	Historic Use:
Materials: wood	Construction Date: c. 1968
Plan: Demolish	Significance: Significant as an early feature of the Aviary which retains historic integrity.

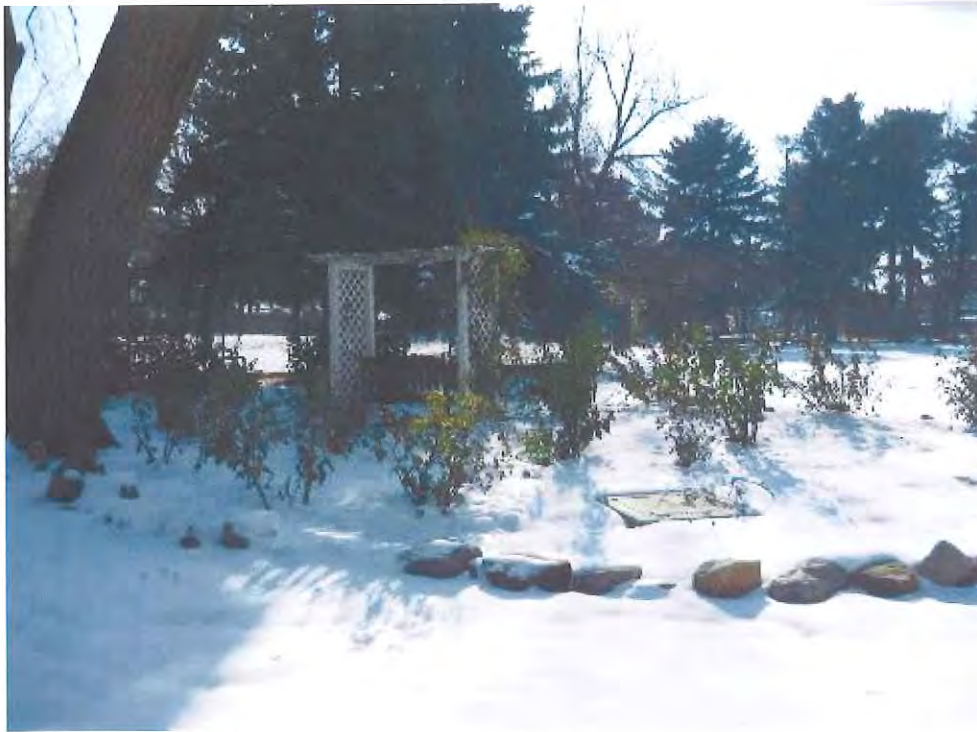
26

Current Use: Rose Garden	Historic Use:
Materials:	Construction Date:
Plan:

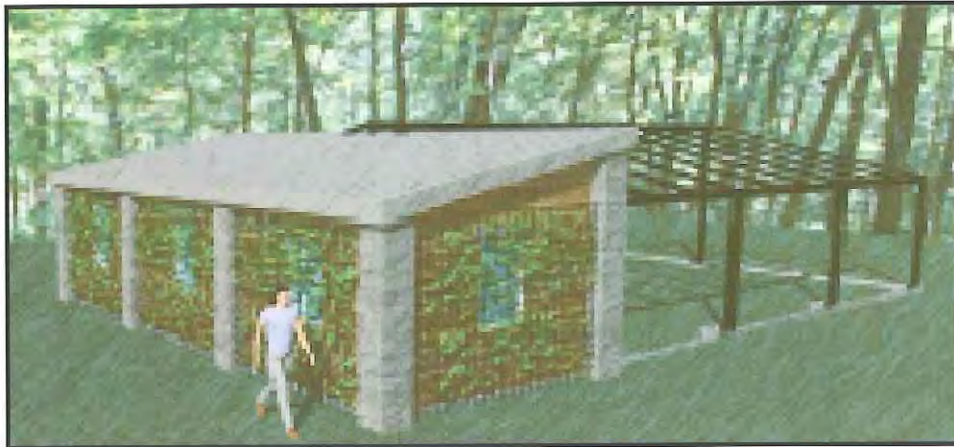
27

CONCEPTUAL RENDERING
Scale: 1/4" = 1'-0"

Current Use: Vacant (Amazon Adventure Exhibit planned)	Historic Use:
Materials: concrete, pipe and wire mesh	Construction Date: 2009 proposed
Plan:	Significance: Not historically significant

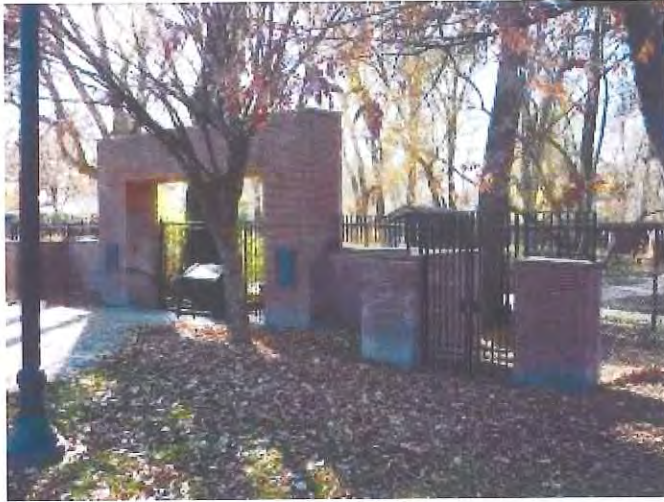
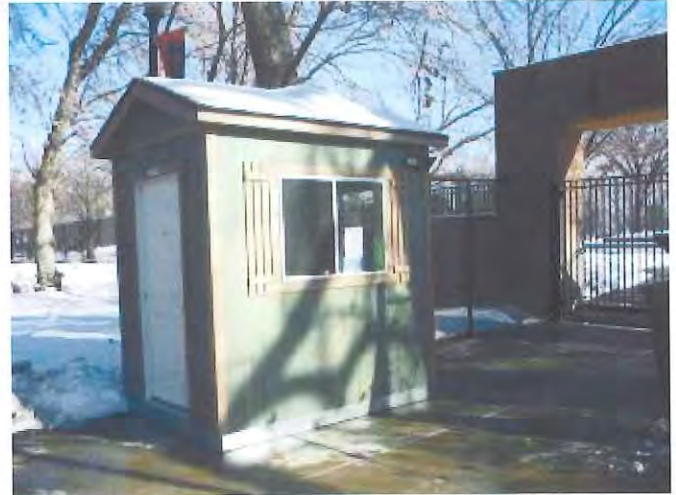
28

Current Use:	Historic Use: Original Entrance
Materials: brick, metal, temporary structure	Construction Date: c. 1939
Plan: Integrate Aviary and park	Significance: Entrance is significant but not the ticket booth

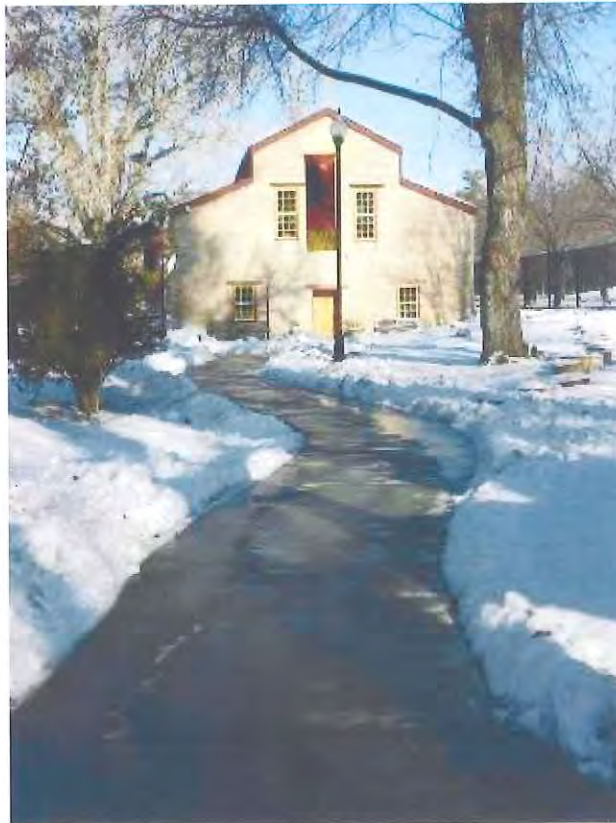
29

Current Use: Events/ education	Historic Use: Chase Mill
Materials: brick, wood	Construction Date: c. 1854
Plan:	Significance: Significant as an early feature of the site

which retains historic integrity.
