HISTORIC LANDMARK COMMISSION
STAFF REPORT

TRACY AVIARY GUEST SERVICES BUILDING
and INFRASTRUCTURE UPGRADES

PLNHLC2010-00427

Liberty Park, 589 East 1300 South

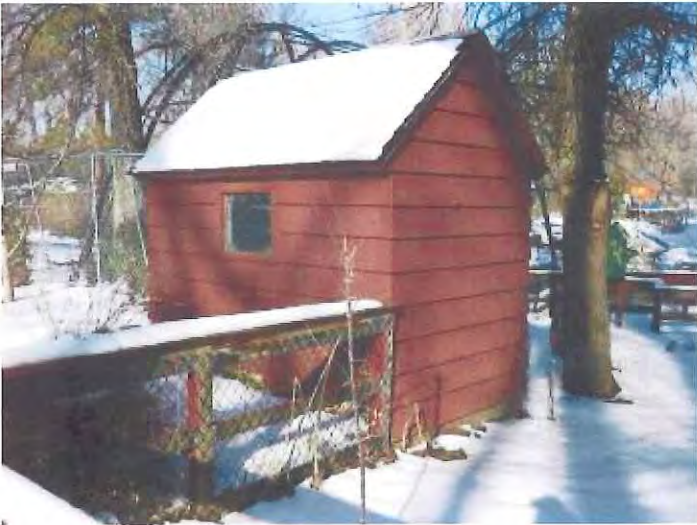
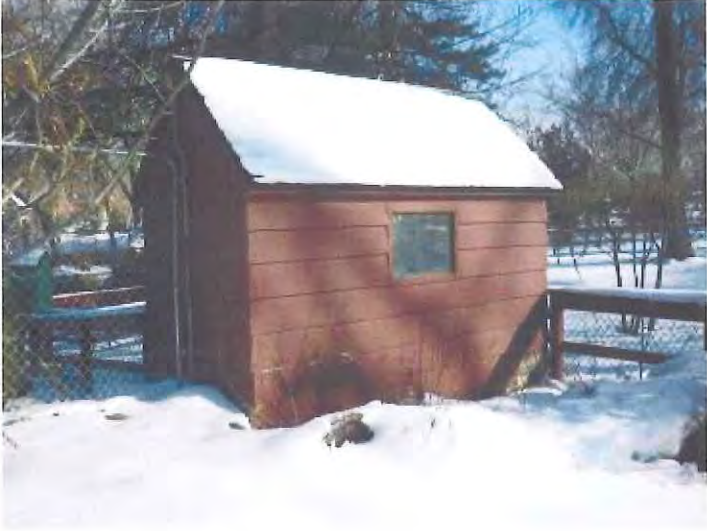
30

Current Use: holding/storage	Historic Use:
Materials:	Construction Date:
Plan: Demolish

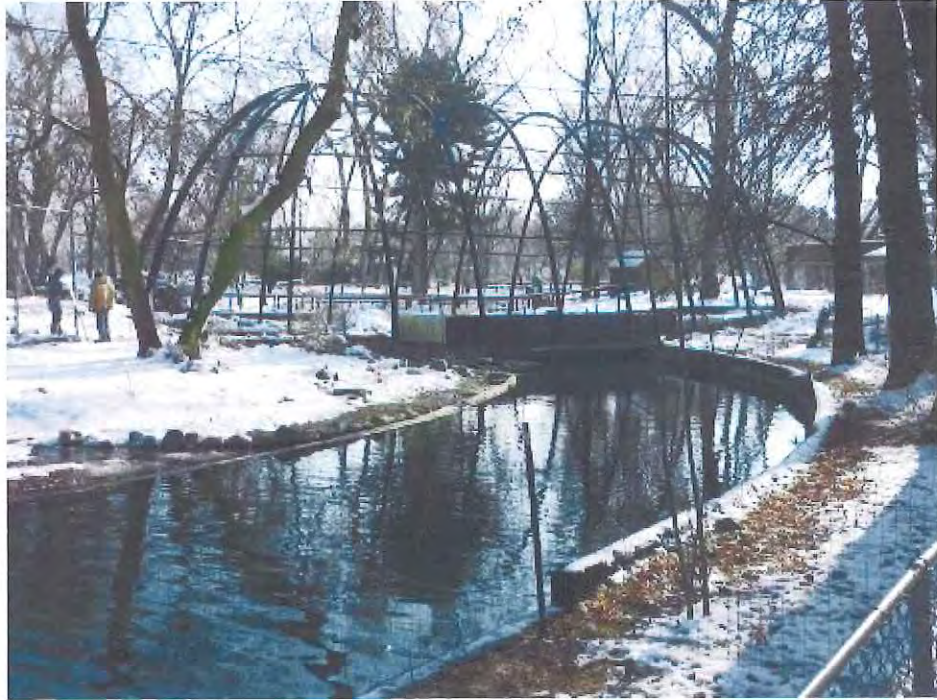
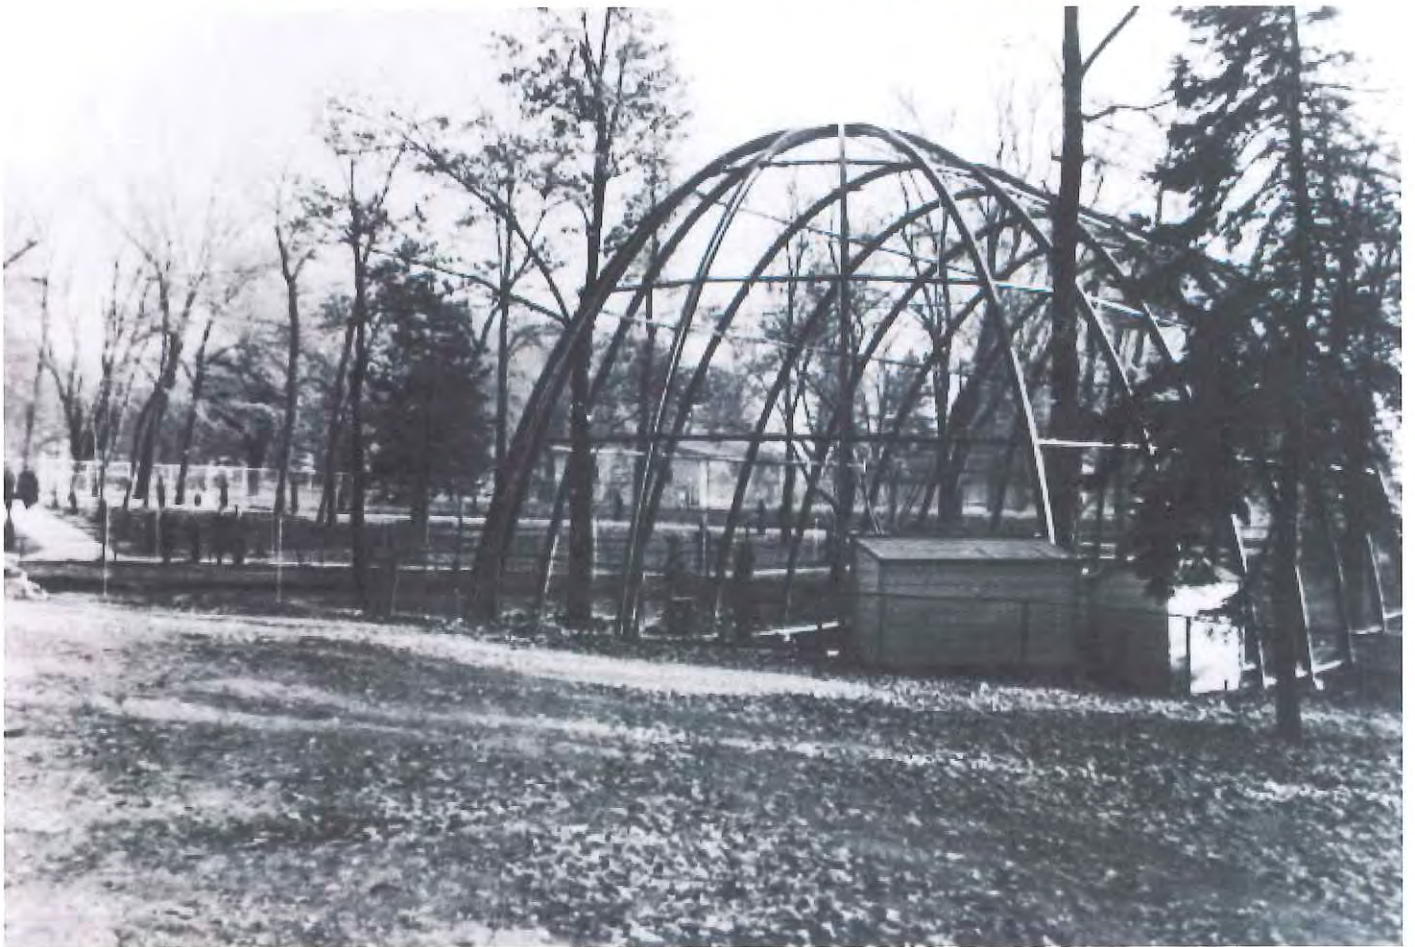
Current Use: Flight Cage	Historic Use:
Materials: steel and wire mesh	Construction Date: 1938
Plan: Renovate as walk through exhibit	Significance: Significant as an early feature of the Aviary which retains historic integrity.

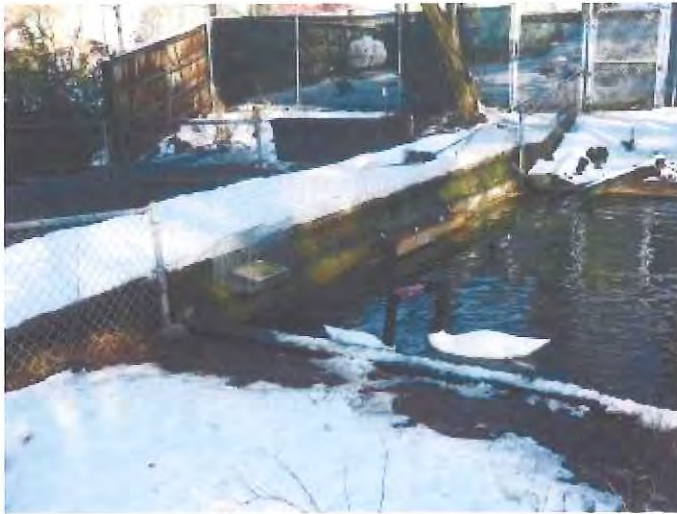
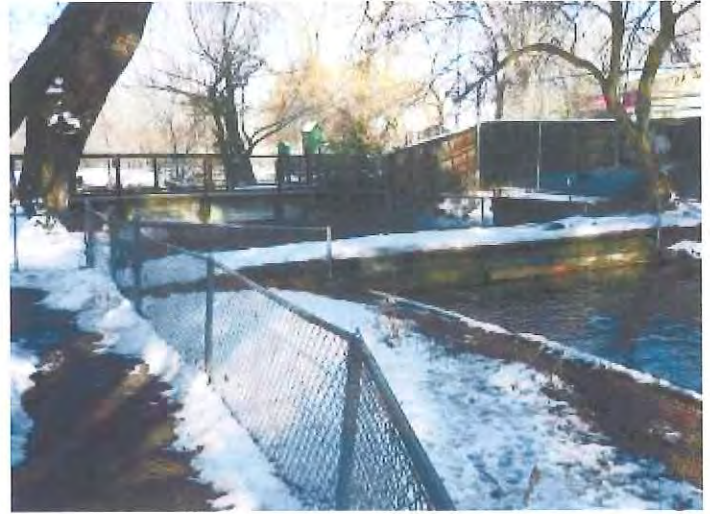
Current Use: Bridges	Historic Use: Bridge
Materials: original: wood, new: concrete and metal	Construction Date: original: c. 1938, new: ?
Plan: Likely to be demolished	Significance: New bridge is not significant but the older bridge is significant
