HISTORIC LANDMARK COMMISSION

**Graylynn Apartments Window Replacement
PLNHLC2010-00311
205 2nd Avenue
August 4, 2010**

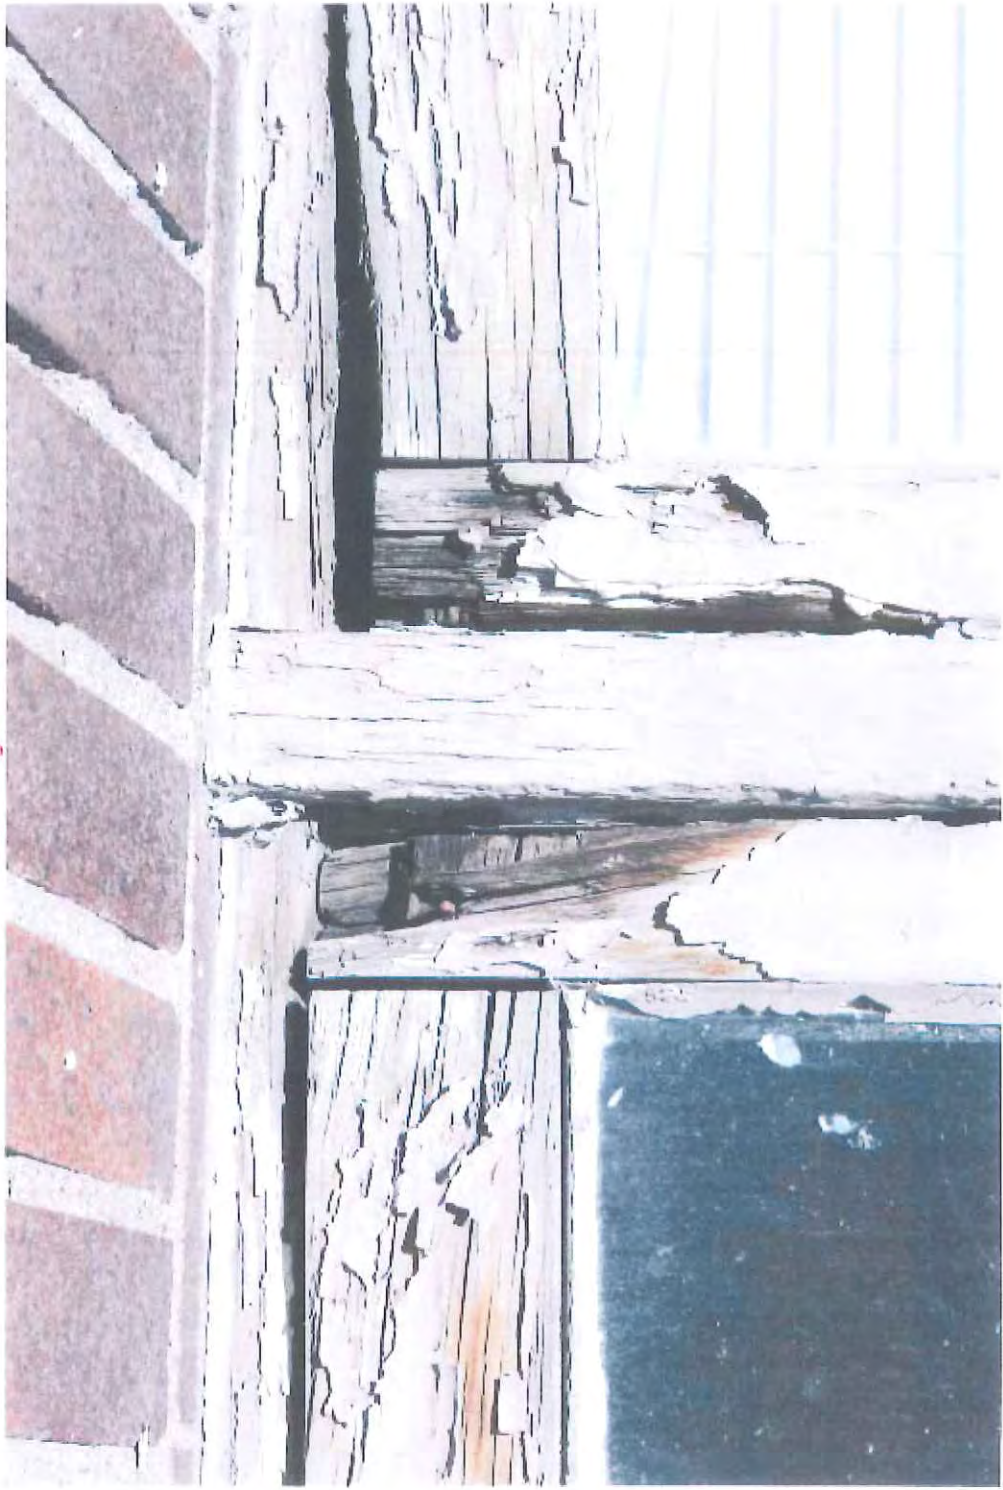
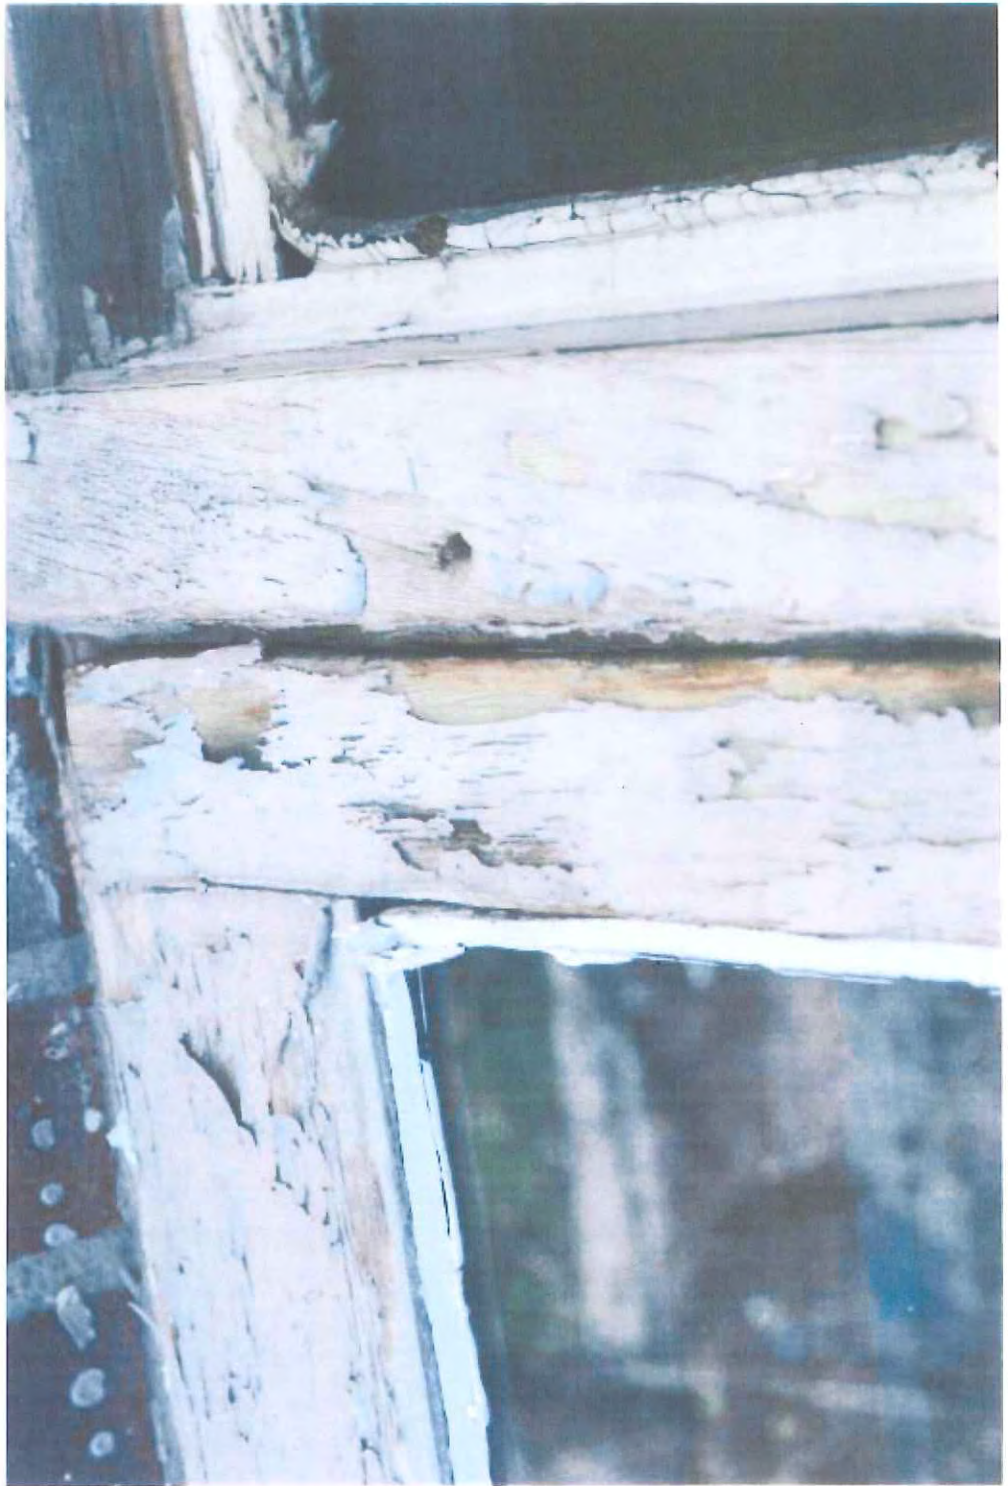
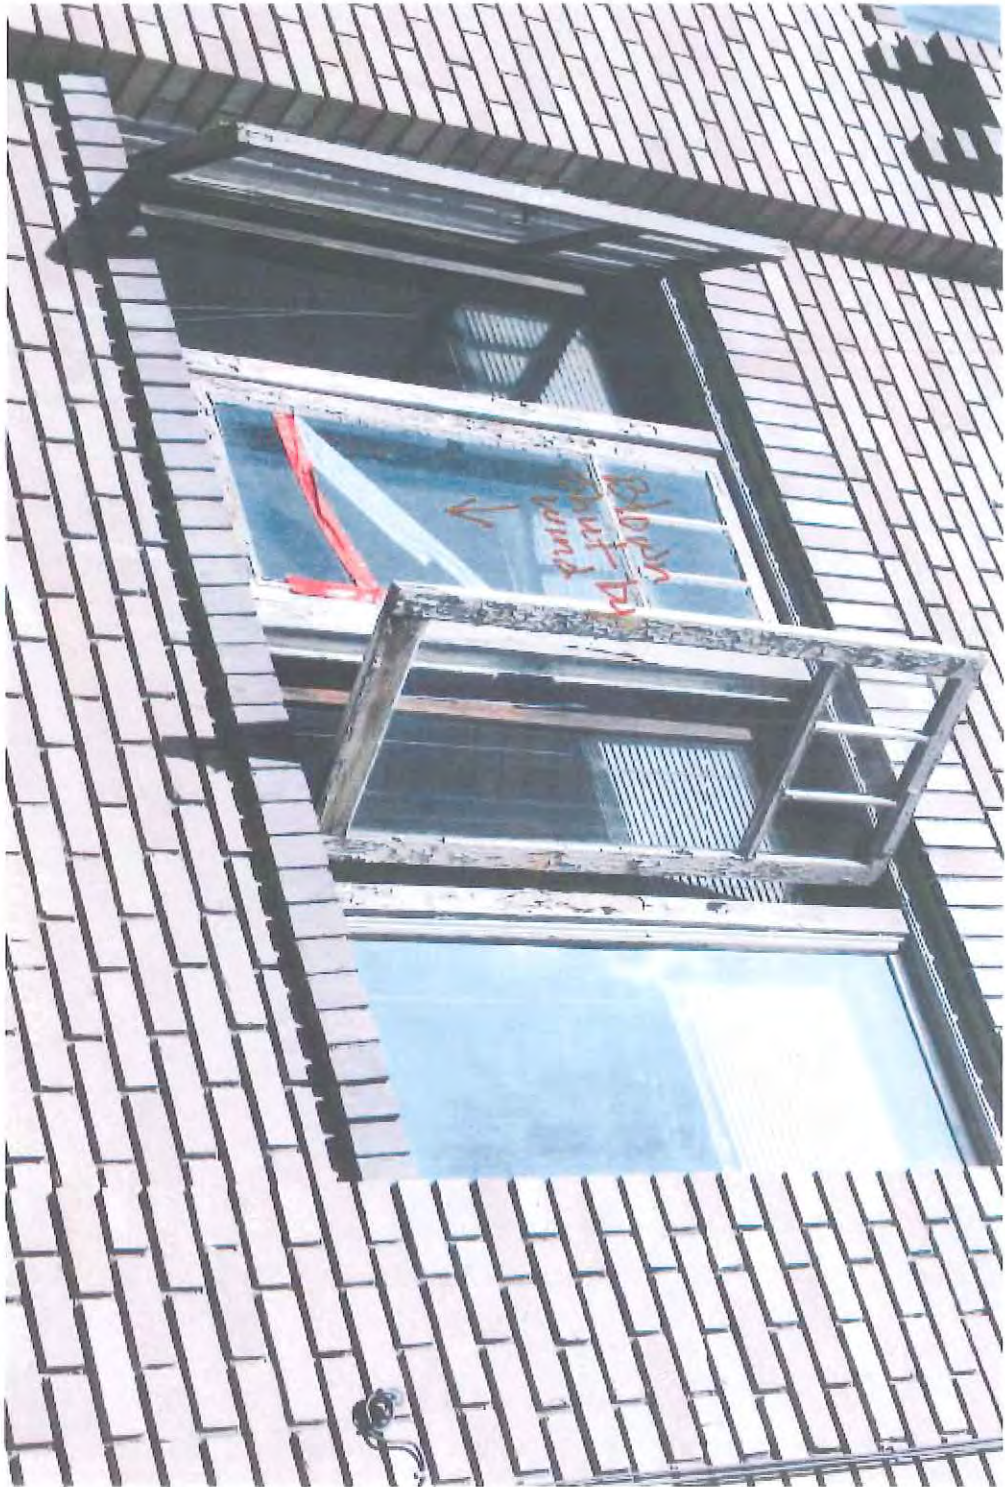
Beyond Repair

Analysis: A majority of the remaining windows are original. They are however, in poor repair. The applicant states that the majority do not properly operate, are broken, or have been modified

significantly and as such, many have been nailed shut so that they do not fall out of place (see photos exhibit B).

1. The new windows (including those installed without a building permit) shall have significant exterior muntins installed with the same design as the muntins on the original windows.
2. Prior to the issue of a building permit, the applicant shall bring examples of the muntins to staff for review and approval.
3. To the greatest extent possible, the casing of each window shall be preserved.

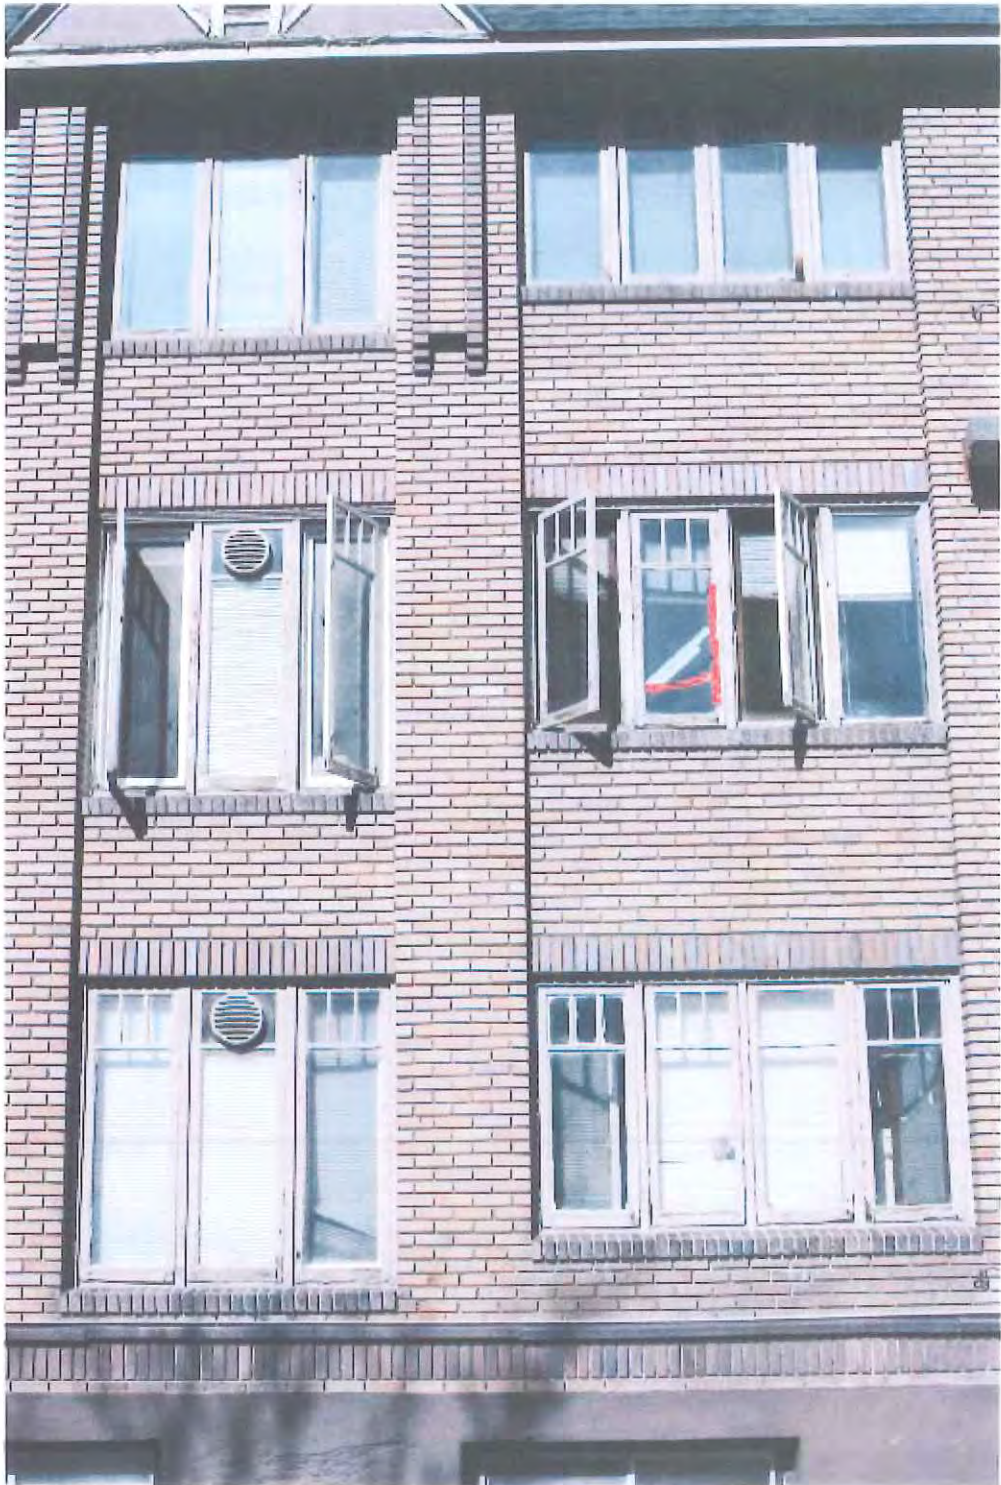
East side

Our apartment units do not have air conditioning. Our residents must leave their windows open to help cool their apartments during the summer. Because these windows swing out ward to open a gust of wind can blow the window completely open and break the window frame and cause glass to tumble down. (this happens often) The new windows because they slide side to side to open will never snap because of a gust of wind.

wind has done its damage

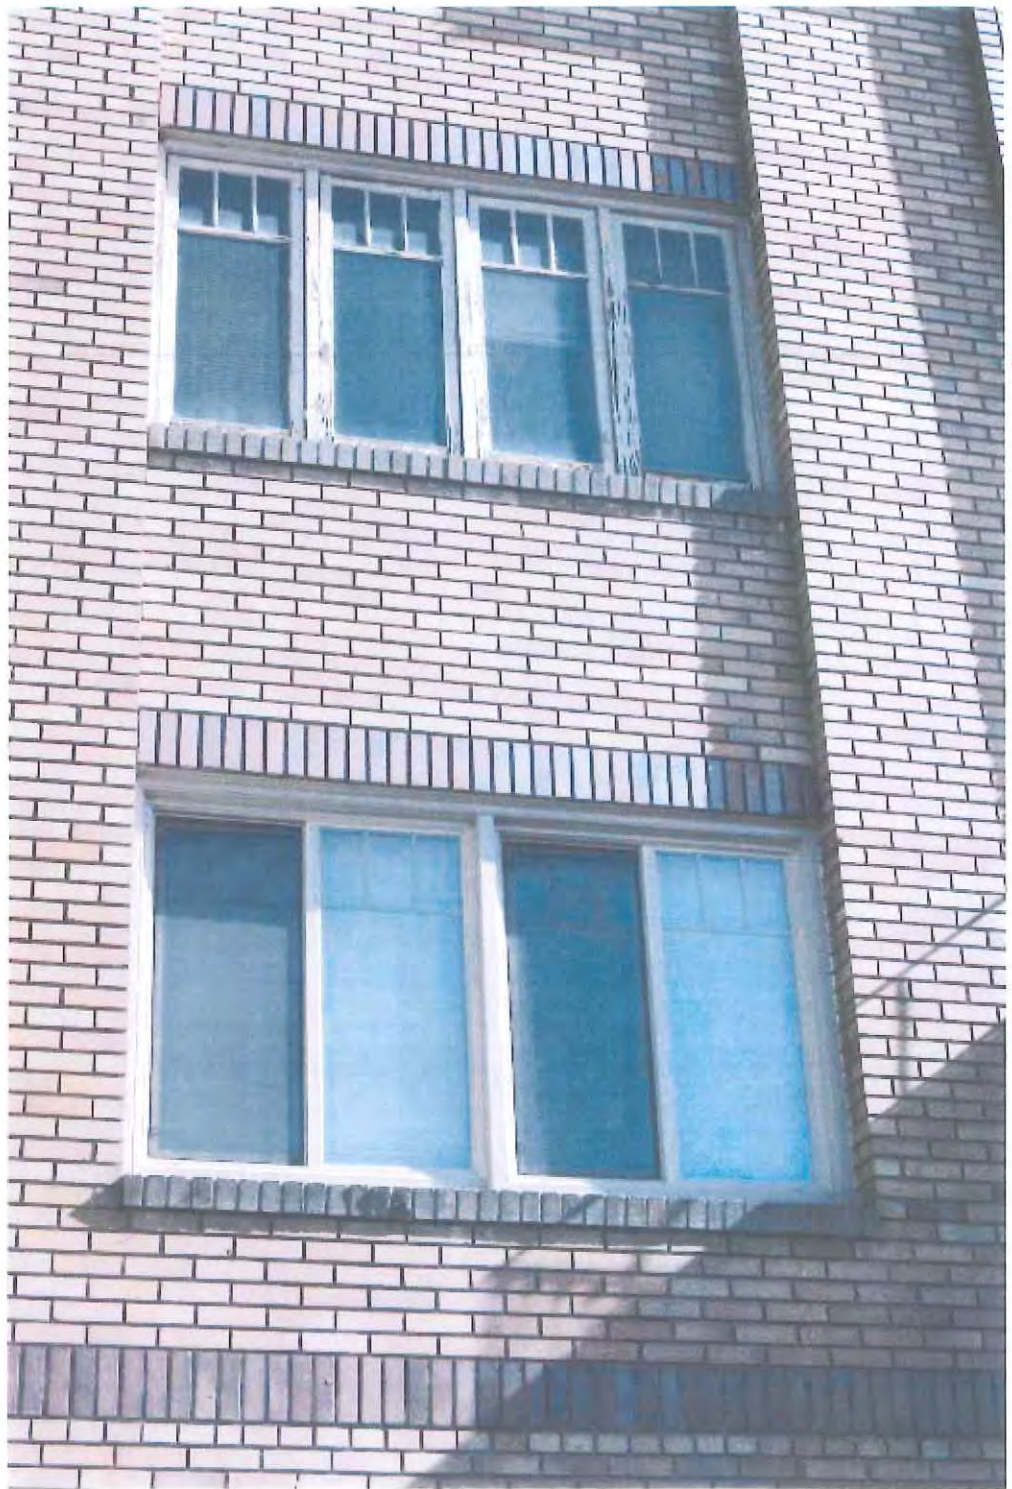
East side

A majority of the existing windows are original from the 1929 construction. They are wood casement style windows with a large frame, and small panes with divider muntins in the top ¼ section.

Existing windows
