HISTORIC LANDMARK COMMISSION STAFF REPORT

Keyes Fence and Retaining Wall Minor Alteration Petition No. PLNHLC2010-00267 233 E 4th Avenue December 1, 2010

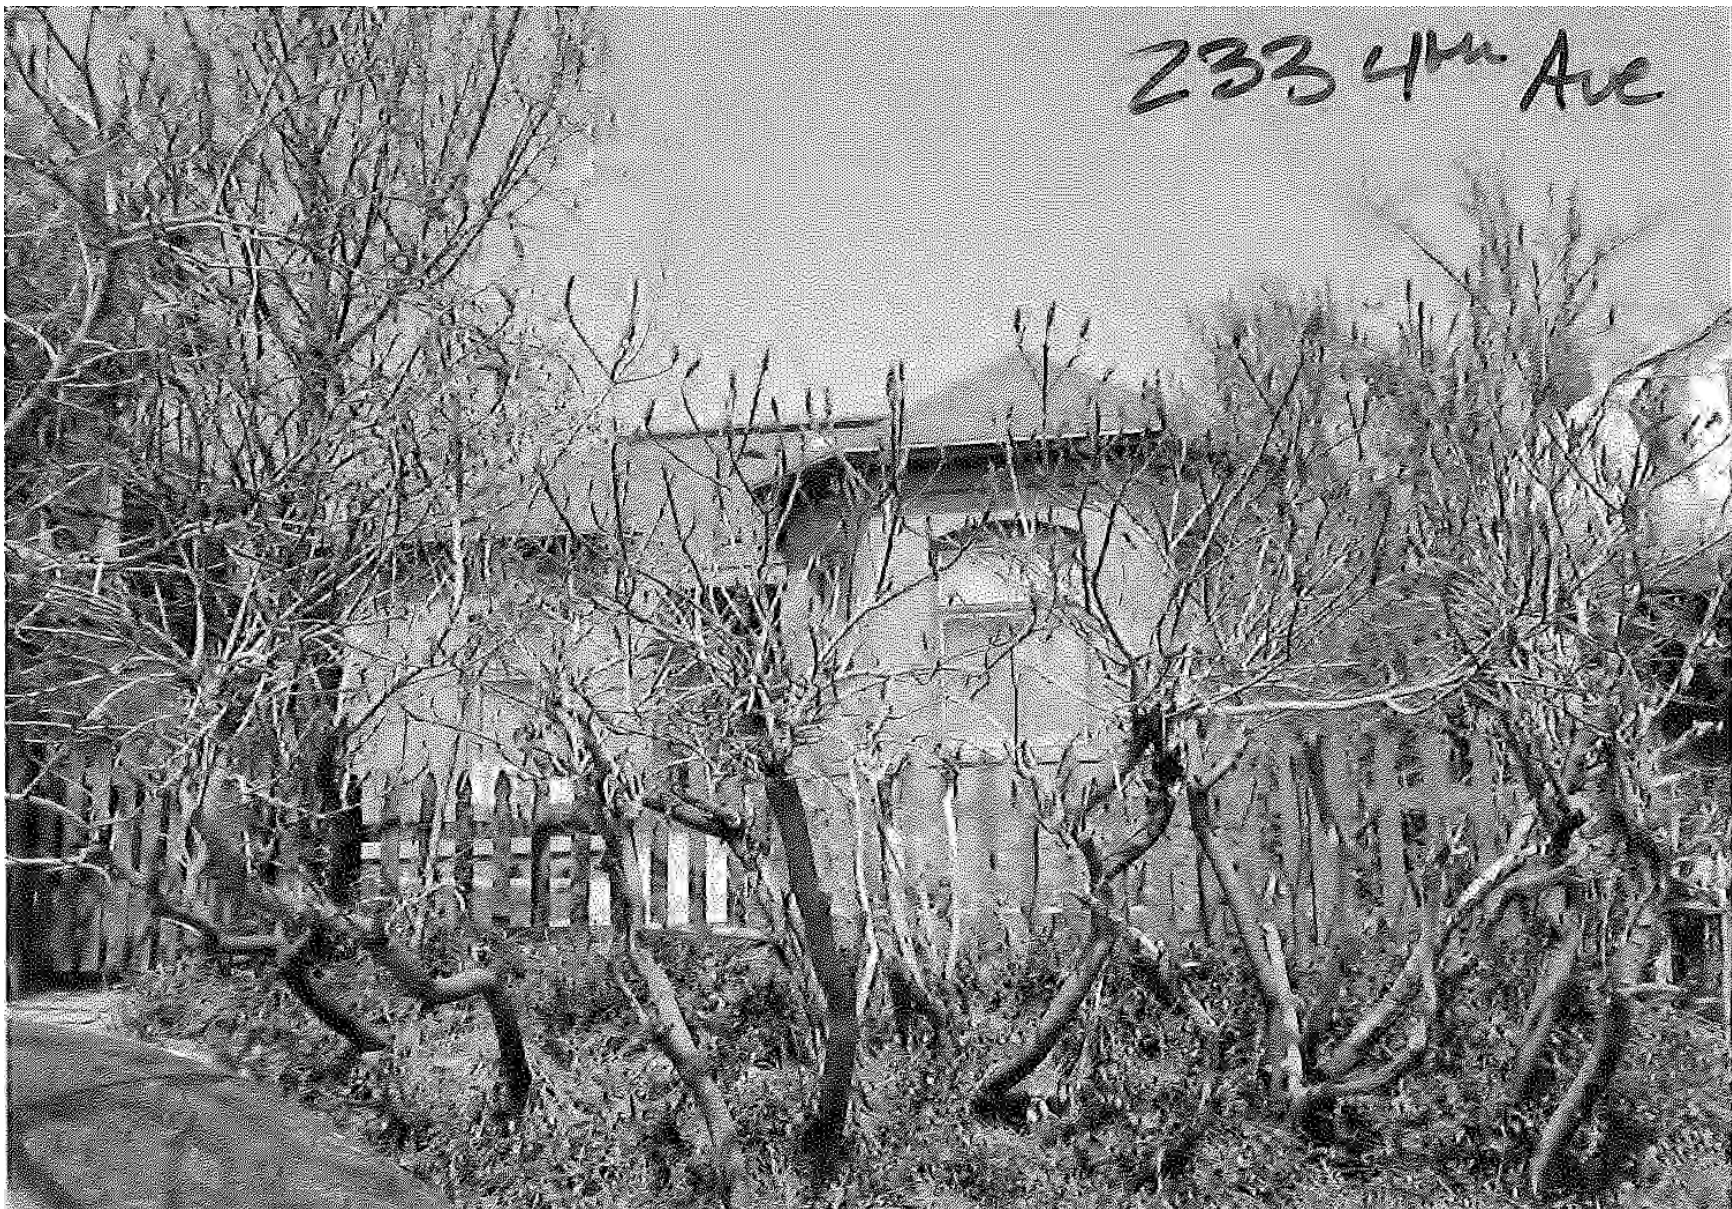
233 4th Ave

This is a one-story Victorian home with a truncated hip roof and a projecting bay that has a segmental hip roof. Windows have arched tops, and the two larger front windows have transoms. The original wooden front porch columns have been replaced with wrought iron ones. A picket fence with a gate runs along the street.

Analysis: The pattern of the original fence is commonly known as “Virginia Picket Spaced”—which is constructed of scalloped wood pickets with a large separation between each picket (see property photograph within Attachment B – Historic Documentation). The pattern of the replacement fence is commonly referred to as “Dogear Overlap Picket” or “Cedar Board on Board”—which is constructed using off-setting or overlapped cedar boards that have clipped corners along the top of the fence (see current photographs within Attachment C – Property Photographs).
