HISTORIC LANDMARK COMMISSION STAFF REPORT

Larson Fence Replacement Minor Alteration PLNHLC2010-00567 391 North Wall Street December 1, 2010

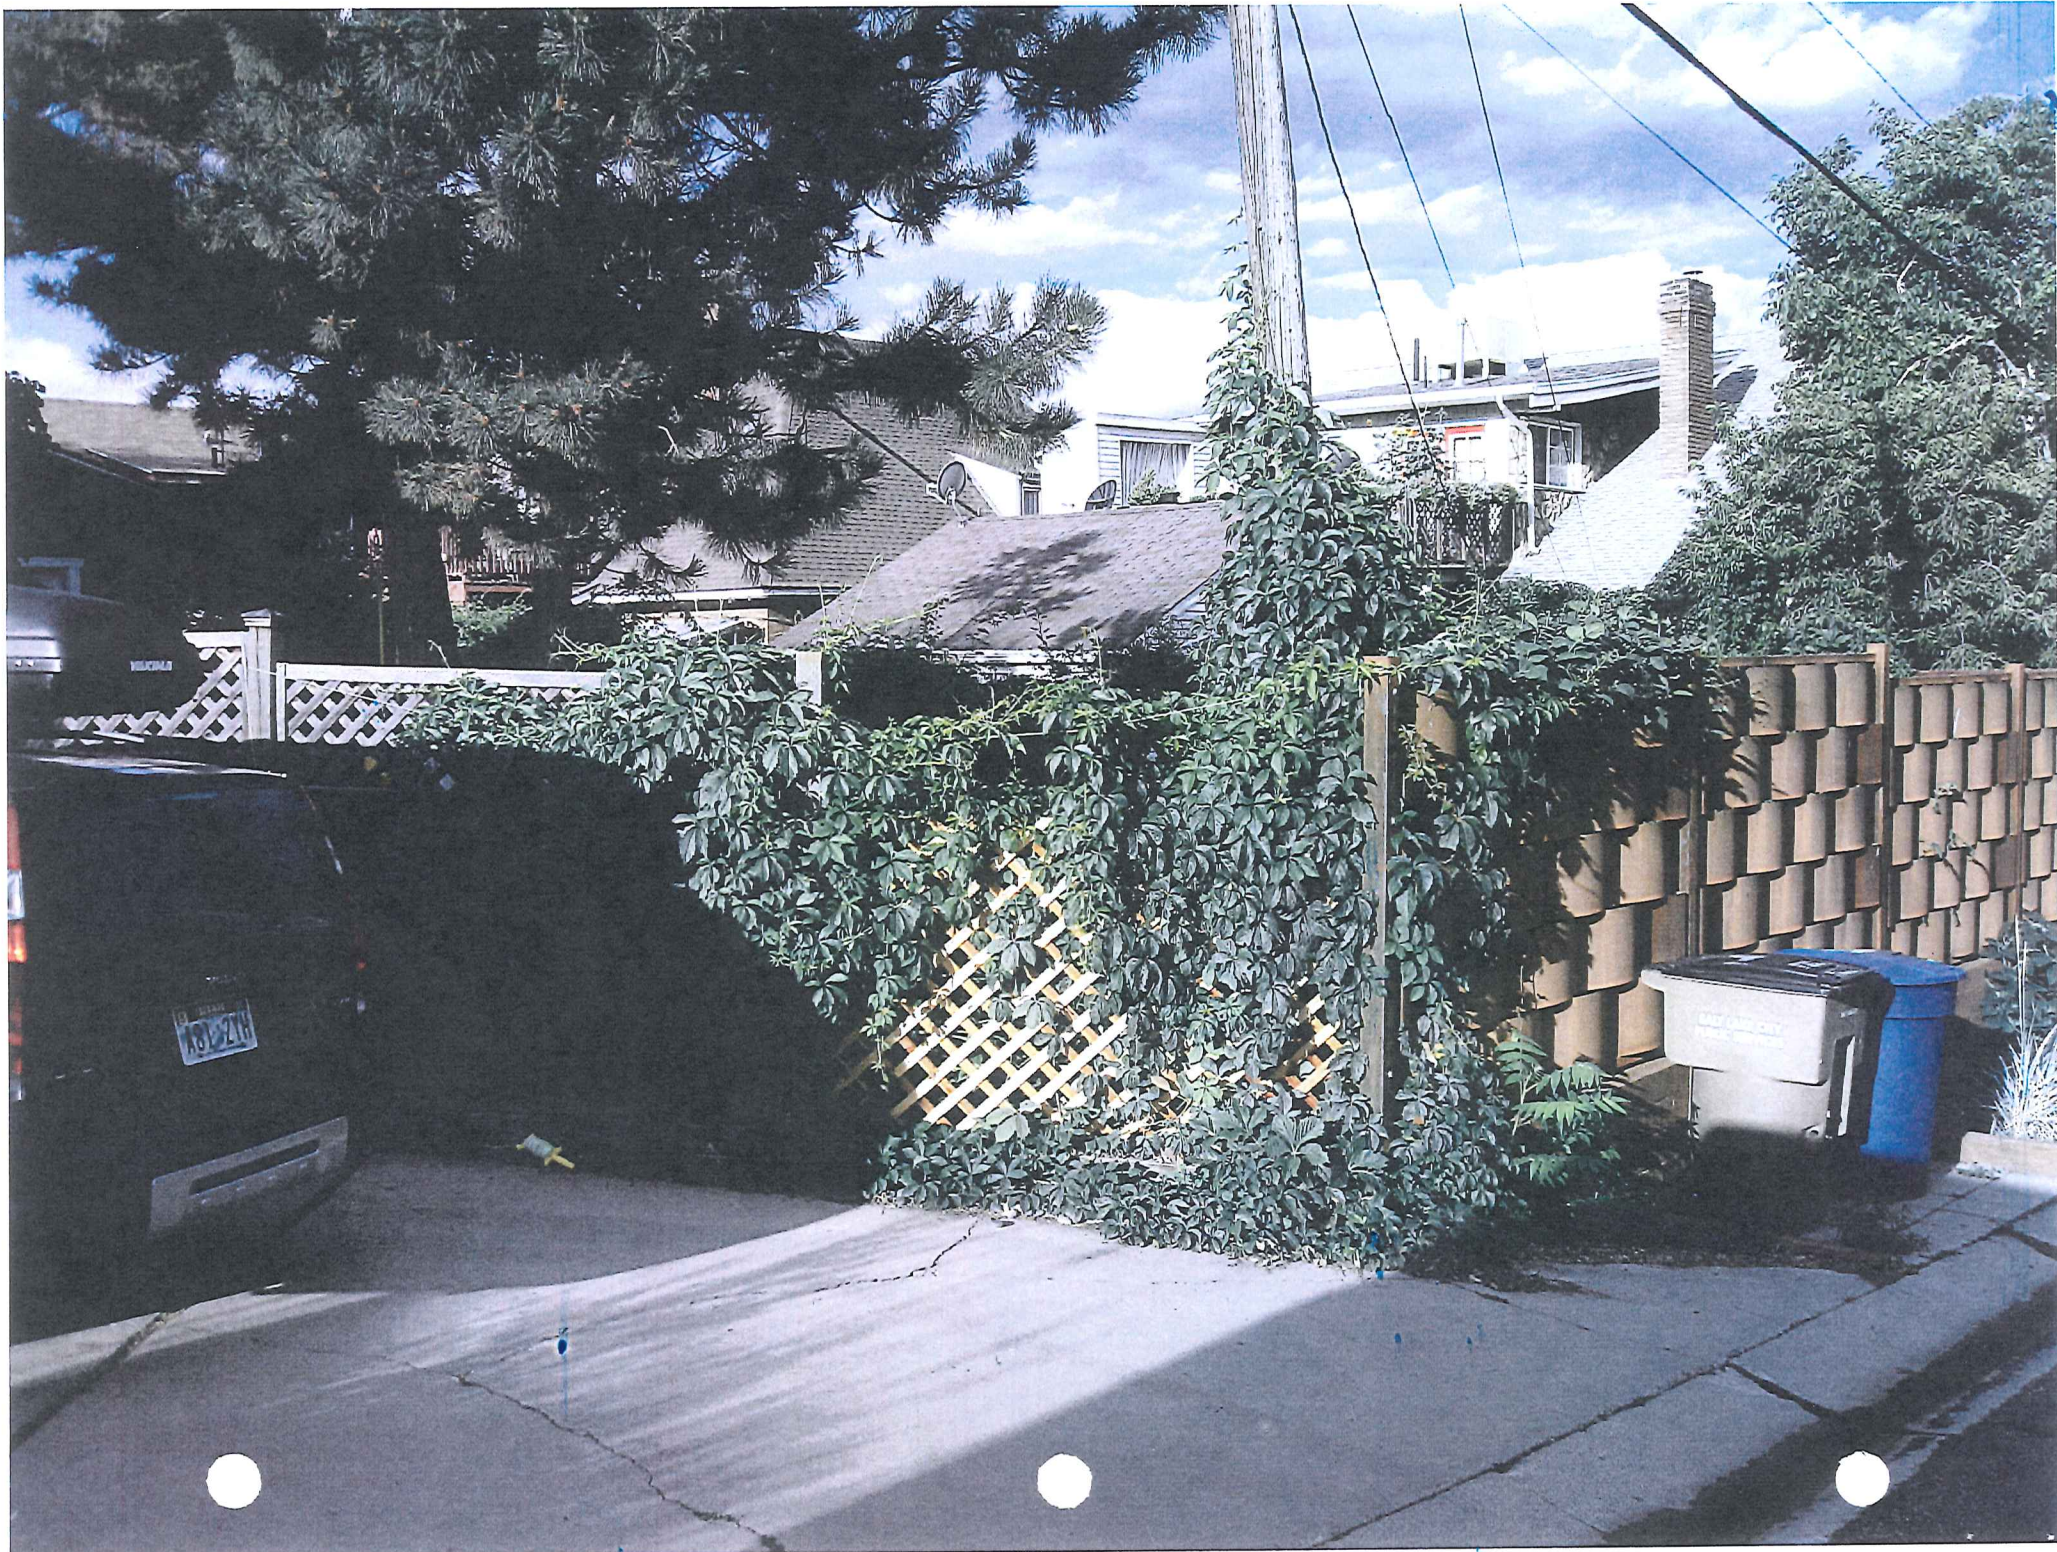
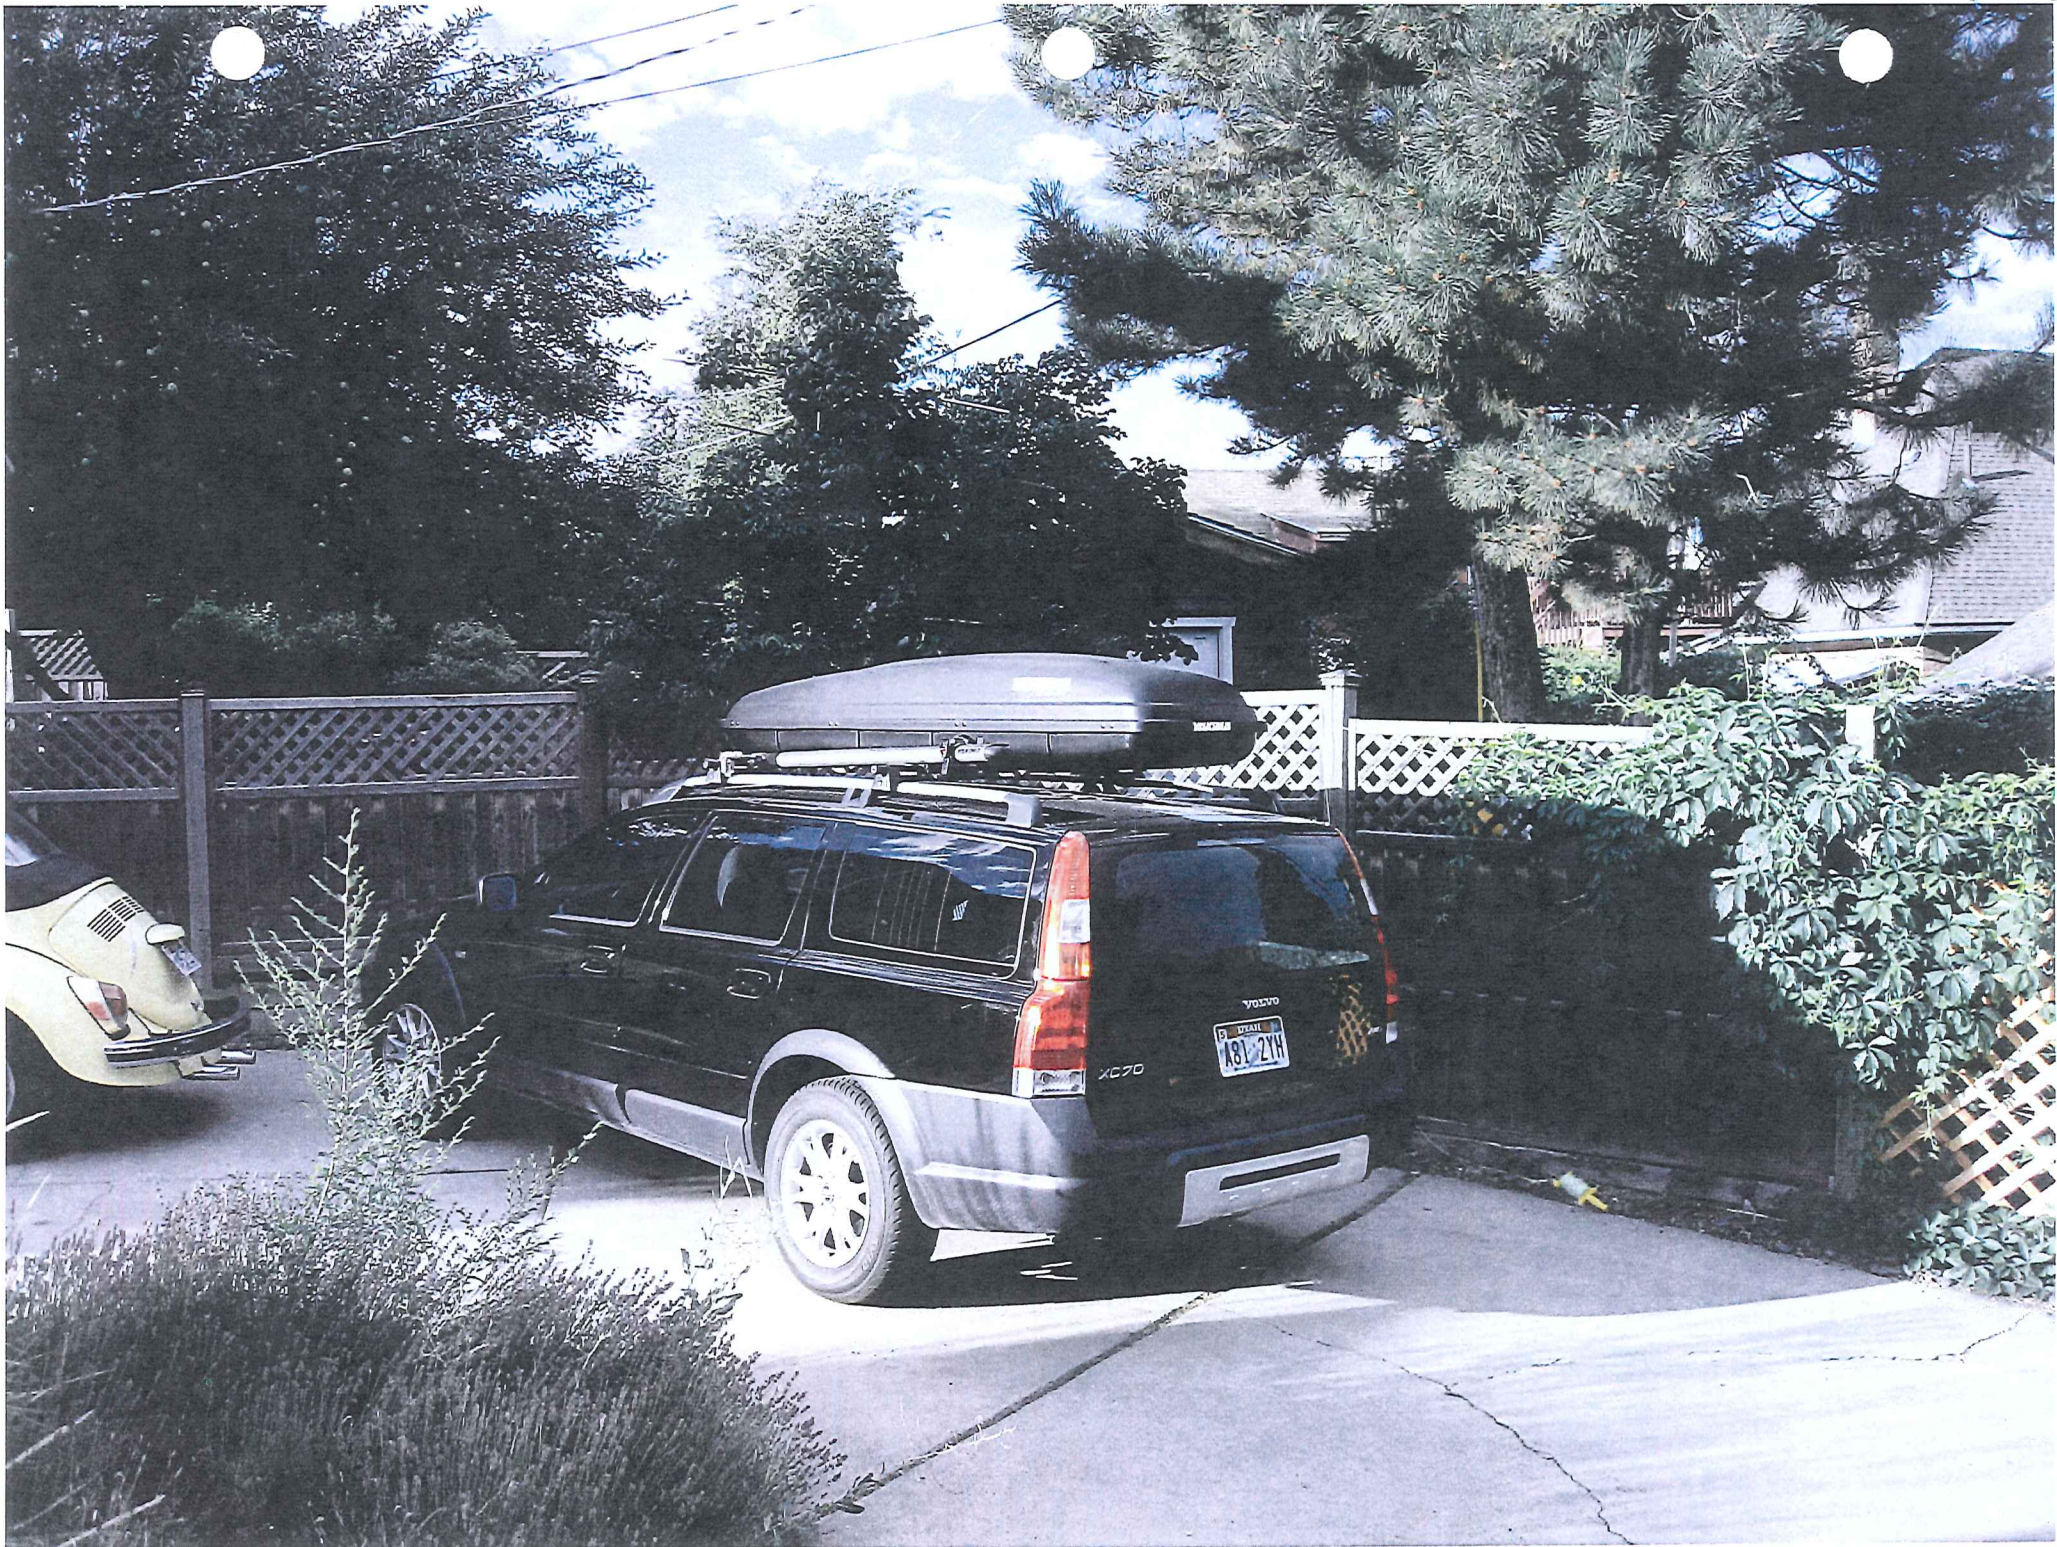
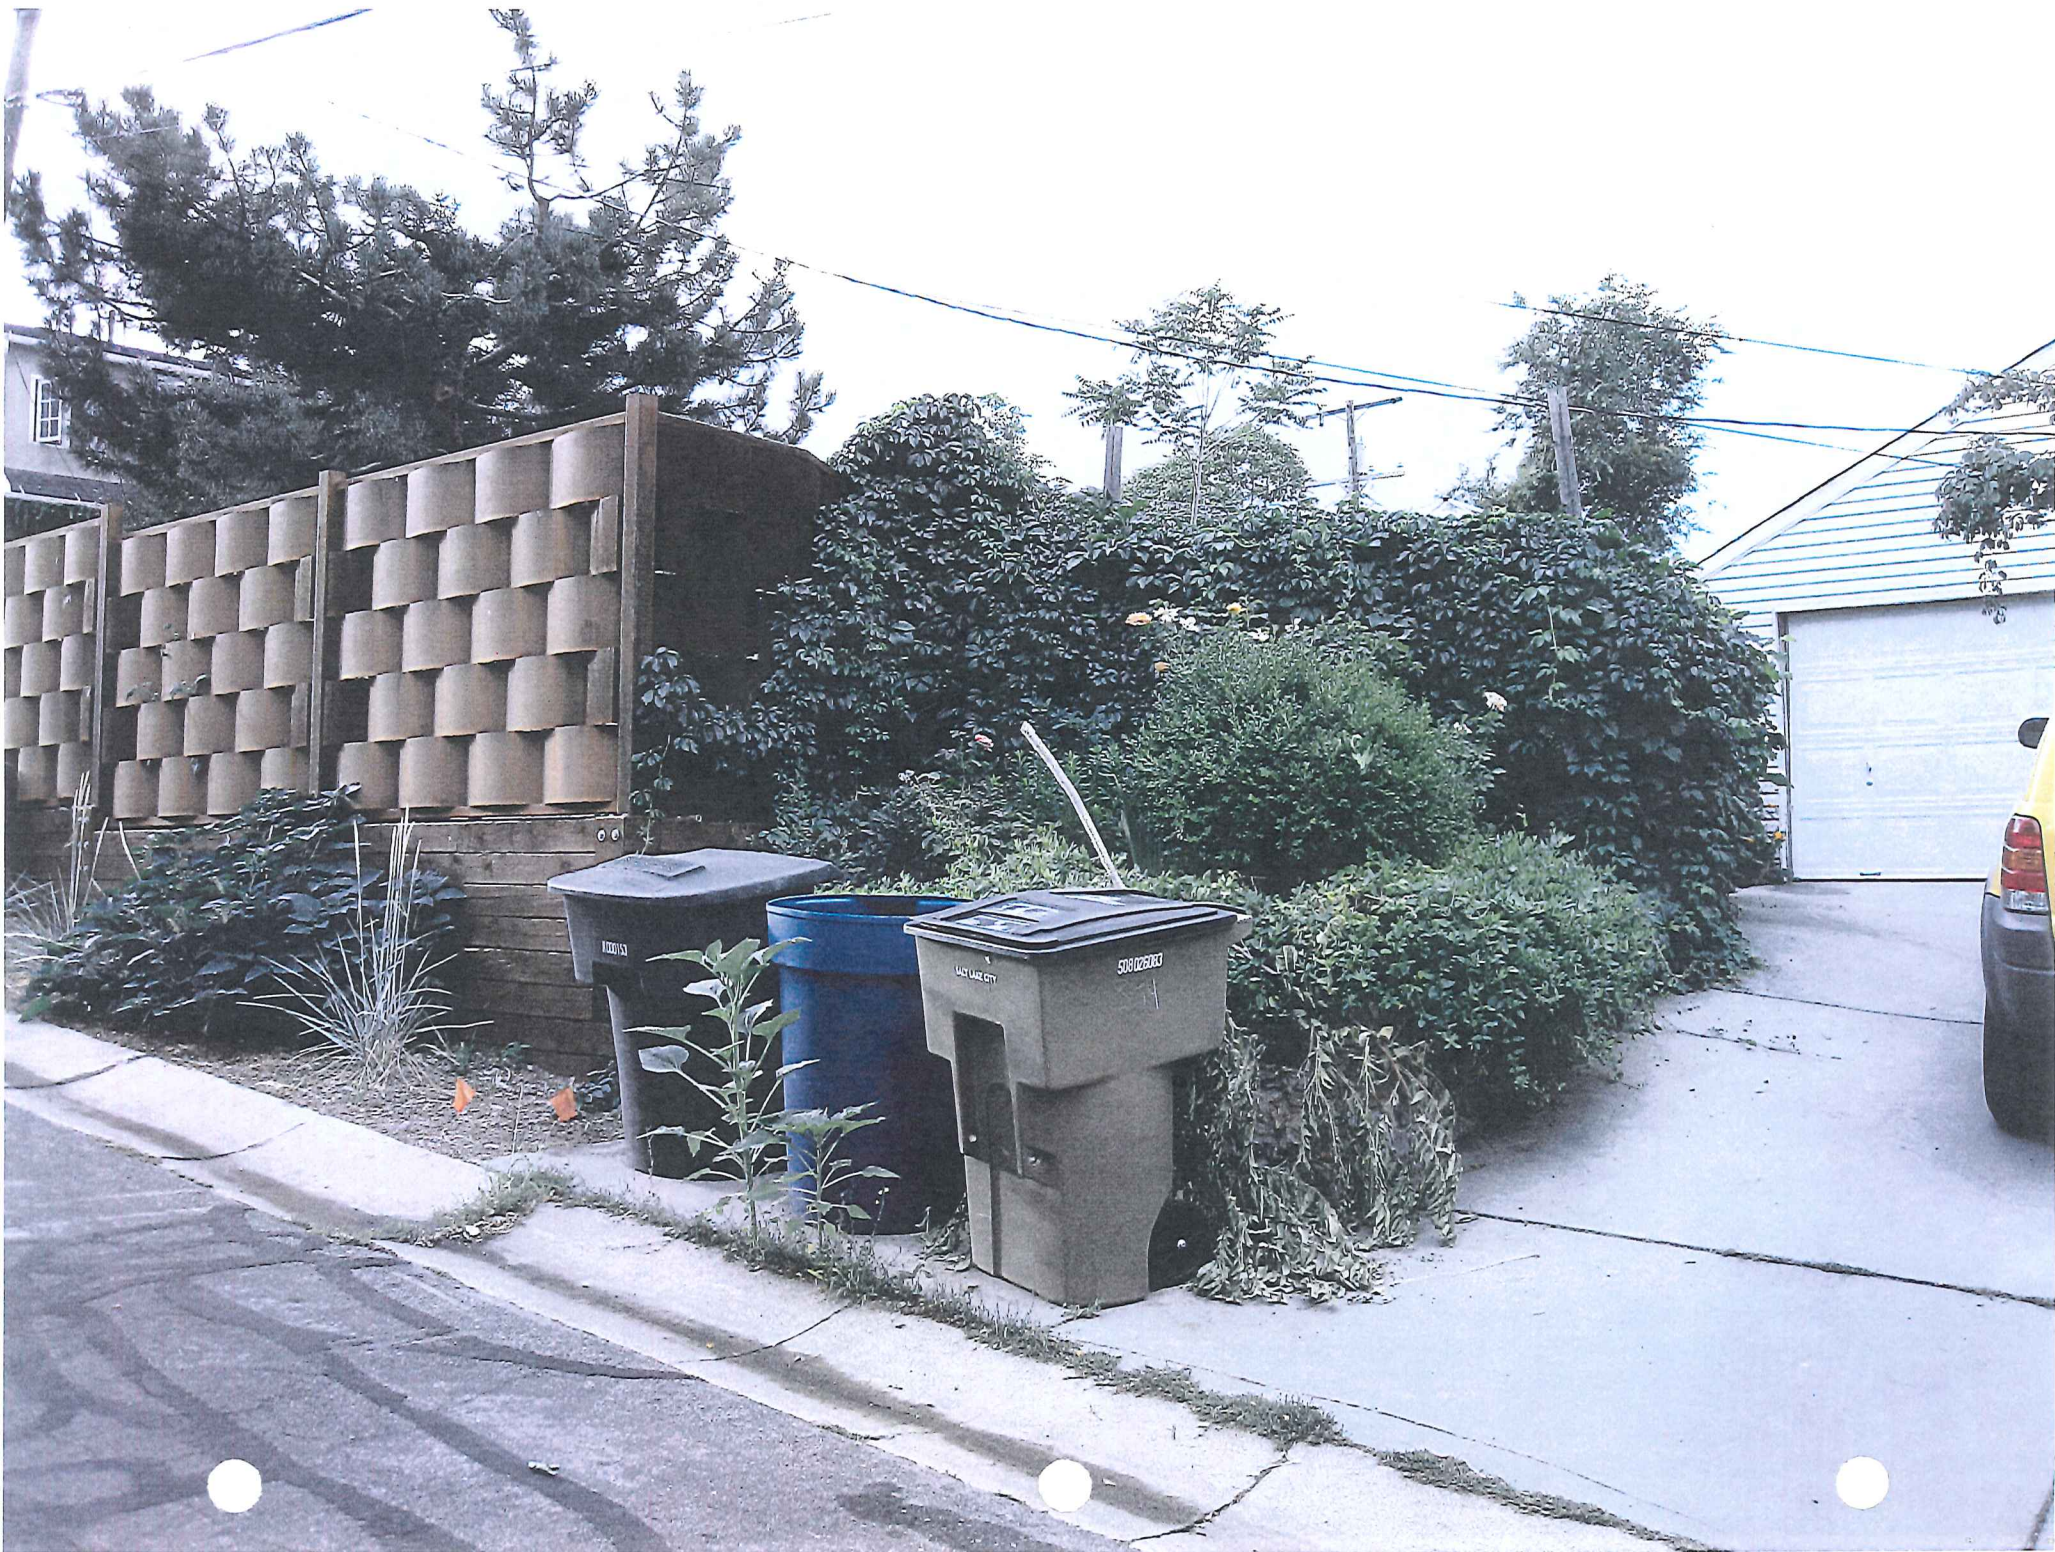
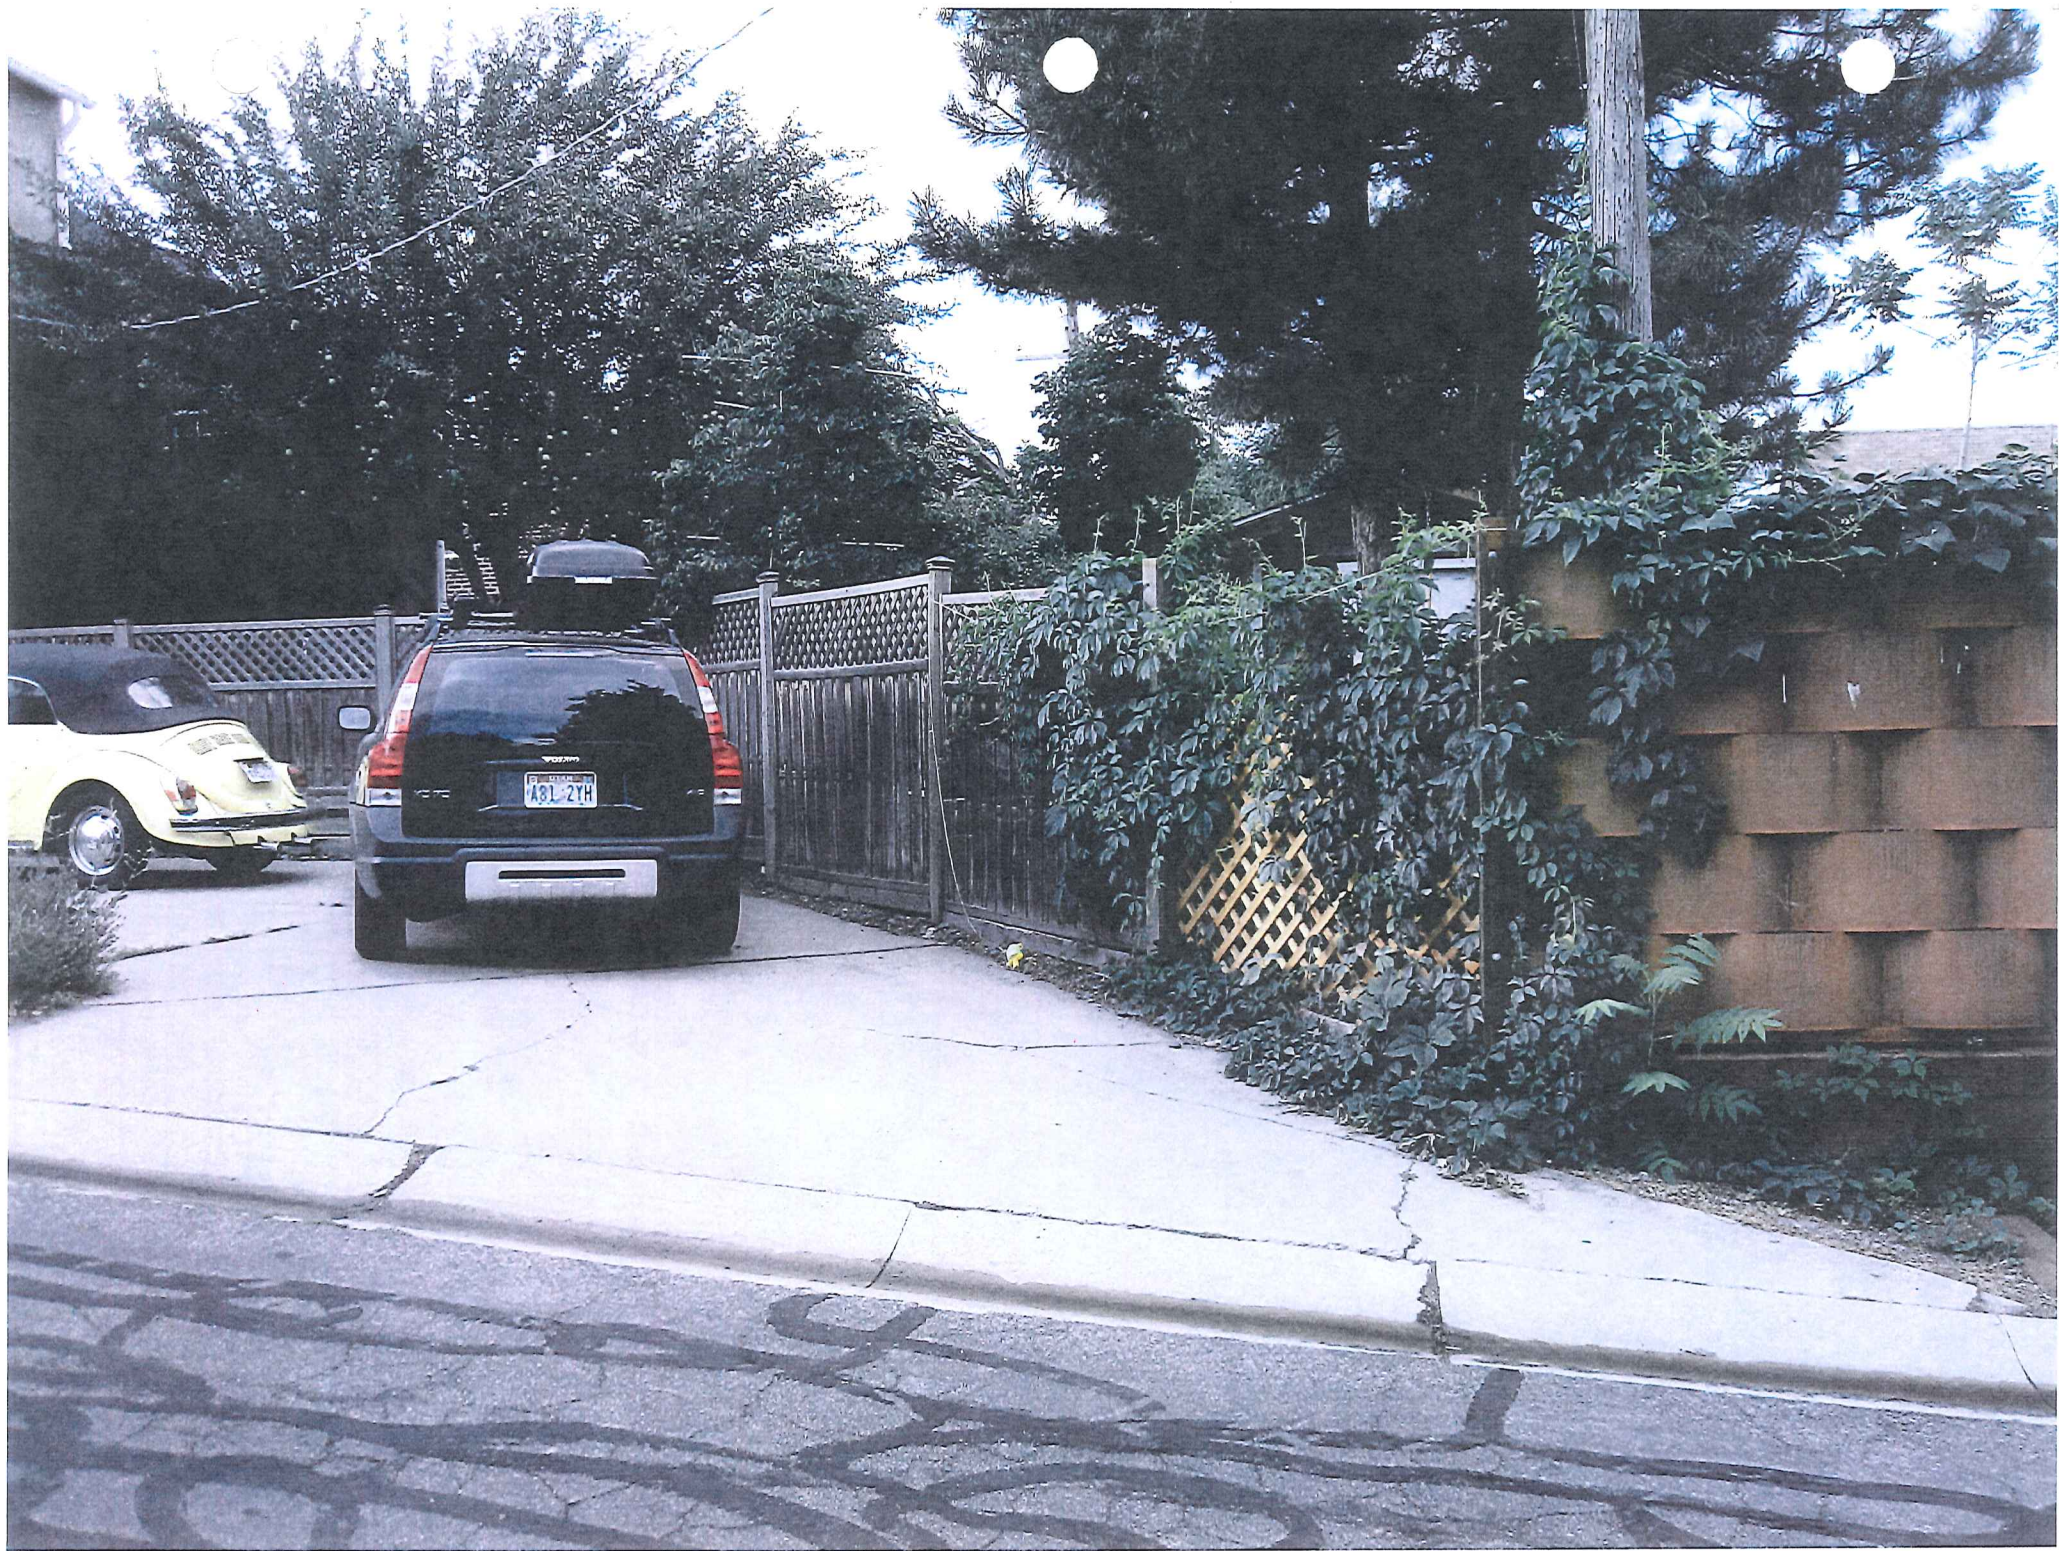
ATTACHMENT B
Photographs

The subject fence is made of unfinished steel and the design is based on the traditional horizontal woven wood pattern. Planning staff acknowledges that steel material may have been approved in the past as a fencing material within the historic districts, but the appearance of the steel would have been more along the lines of looking similar to wrought iron. Staff is not aware of unfinished steel of this size or design being approved in any historic district. This new fence replaced a broken and worn out fence that was

wood. A portion of this wood fence does remain on the property. The applicant also desires to replace the older wood fence with the newer unfinished steel fencing.

The applicant has provided photographs of the new fence and the older wood fence for reference. These are attached as Exhibit B. A narrative from the applicant describing the project is included as Exhibit C. Staff has included the historic documentation of the property from the most recent reconnaissance survey completed for the Capitol Hill District. As noted on this survey, the property is categorized as “B” which indicates it is a contributory structure.

The fence replaces a broken worn out fence (as seen in the provided images) that parallels 400 North and continues up the drive way.

The material is unfinished steel and the design is based on the traditional horizontal woven wood pattern.

Analysis: The subject fence appears to be a high quality, well constructed fence, and may be an appropriate solution in other areas of Salt Lake City that are not designated historic districts. In light of the above referenced design standards that have been adopted by the city, the subject fence does not appear to meet those design standards. First, Guideline 1.2 indicates that only those portions of a fence that are deteriorated beyond repair should be replaced. While it is difficult to determine the condition of the wood fence that was removed to install the new unfinished steel fence, it may have been repairable.

The remainder of the wood fence that exists on the property, while it appears to be older, does not appear to be in a condition that is beyond repair.

Second, Guideline 1.3 notes that replacement fences should be similar to the original material. A new unfinished steel fence is not similar to the wood fence that was replaced or is proposed to be replaced. In addition, this guideline states that all replacement fences should be similar to scale to those seen historically in the neighborhood. Planning staff does not see this unfinished steel woven fence as the type of fence that was typically seen in the historic neighborhood.

Lastly, Guideline 1.4 states that all fences should have a transparent quality allowing views from the street. The subject property is a corner lot and the subject fence is designed to provide some privacy for the rear yard area. Staff would agree that some privacy is needed, but would contend that it could be achieved in other ways than the proposed solution. The previous wood fence could have been repaired or a more transparent fence could have been built with planting materials behind it to help screen the rear yard area.

Findings: The subject fence does not meet Guidelines 1.2, 1.3, 1.4, or 12.9 as noted in the adopted *Design Guidelines for Residential Historic Districts in Salt Lake City*.
