**HISTORIC LANDMARK COMMISSION  
STAFF REPORT**

**Town Club Screening Improvements**  
PLNHLC2010-00299  
1081 East South Temple  
July 7, 2010

TOWN CLUB SCREENING IMPROVEMENTS  
 1081 E. SOUTH TEMPLE-SALT LAKE CITY, UT

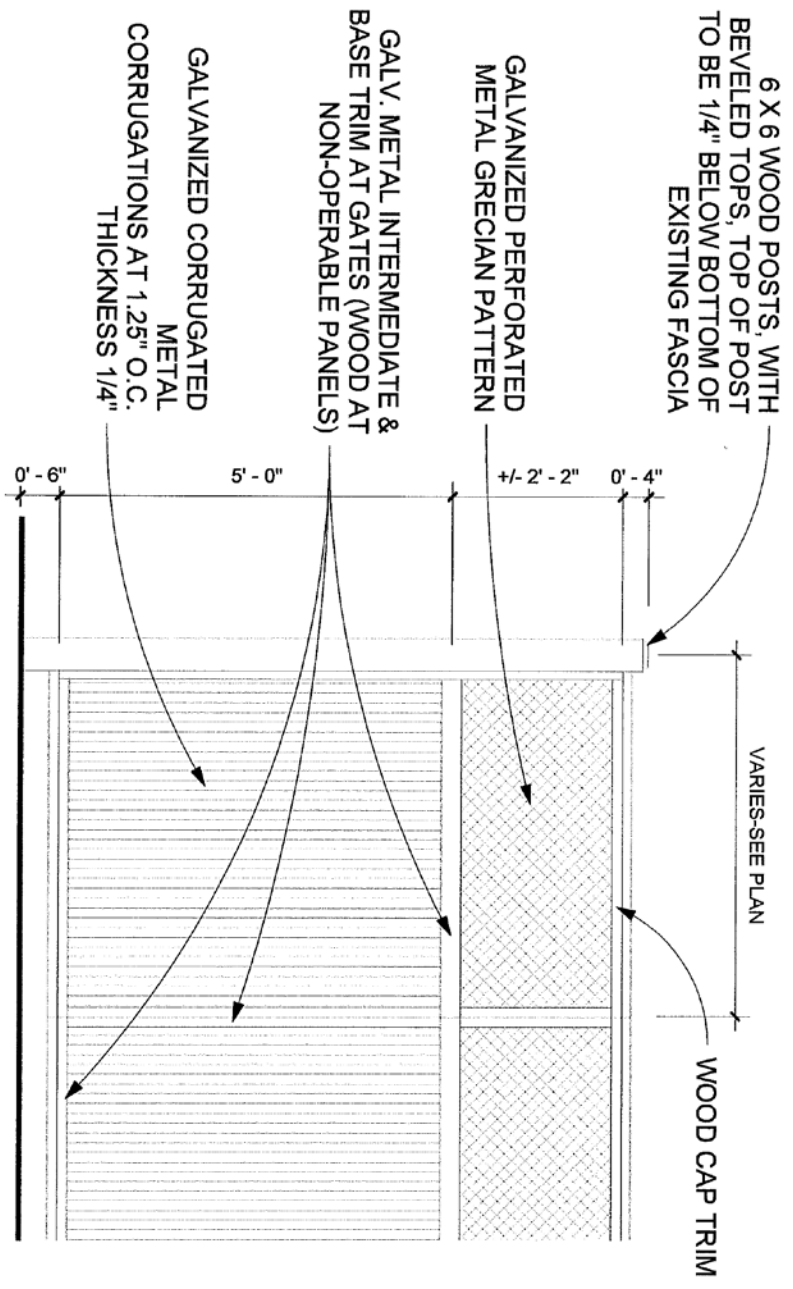
A1  
 SCREEN ELEVATION -

SCREEN SYSTEM TO BE PAINTED WHITE

If approved, the applicant will build an 8 foot tall, two tiered fence like enclosure with 3 entry gates to the various facilities. The bottom (approximately 5 feet) would be constructed from corrugated steel and the top

(approximately 2 feet) built with perforated galvanized steel (see schematic drawing exhibit B). The enclosure would screen a dumpster, mechanical and recycling facilities in the rear of the building.

The proposed material for the solid lower portion of the screen panels is small scale corrugated galvanized metal painted white. The corrugations would run vertically.

The proposed material for the upper portion of the screen panels is perforated galvanized metal painted white.

The posts will be wood, painted white. The top of the posts will be beveled.

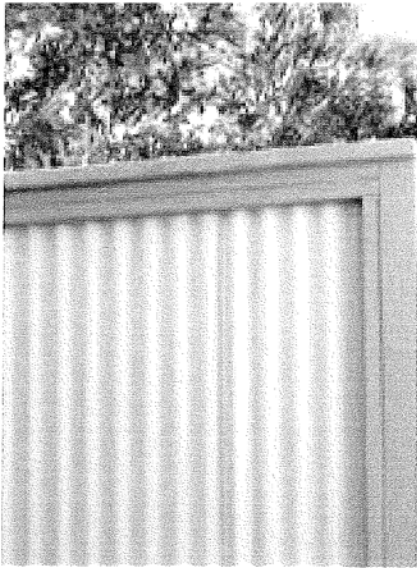
**GALVANIZED CORRUGATED METAL  
(SOLID LOWER PORTIONS OF PANELS)**

**WOOD TRIM AT ALL FIXED  
PANELS**

The frame/trim on fixed panels would be wood.
