Design Guidelines For Commercial Historic Districts in Salt Lake City

April 16, 2010

Prepared for the
Salt Lake City Corporation
By
Thomason and Associates
Nashville, TN

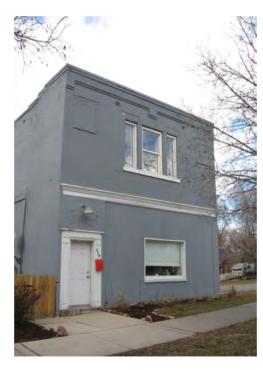
A number of neighborhood commercial buildings were converted into residences in late 20th century. This building at 479 N 200 West lost its original storefront and entrance when it was redesigned for residential use.

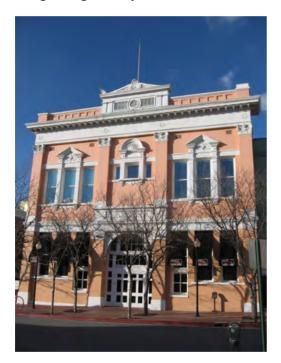
The buildings at 134 W Pierpont Avenue (left) and at 342 W. South (below) are representative of Salt Lake City's Two-Part commercial blocks.

The majority of commercial buildings in Salt Lake City can be characterized in form as Two-Part commercial blocks. These are buildings which have two primary components – storefronts and upper facades. Original storefronts are largely transparent and consist of display windows resting on bulkheads, transoms, and entrances with glass and wood doors. Upper facades have one or more floors of windows and decorative detailing such as brick, concrete or terra cotta panels and cornices at rooflines. These buildings are generally no more than three-stories in height.

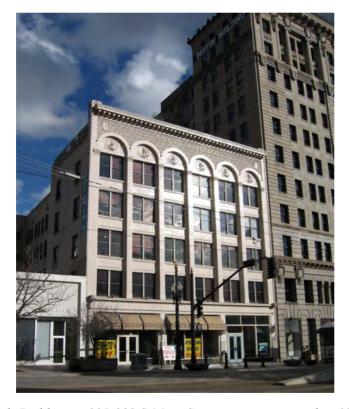
The Felt Building at 335-339 S Main Street was constructed in 1909 and has a separate storefront zone and unified upper façade. The building is distinguished by its glazed terra cotta and arched panels below the cornice.

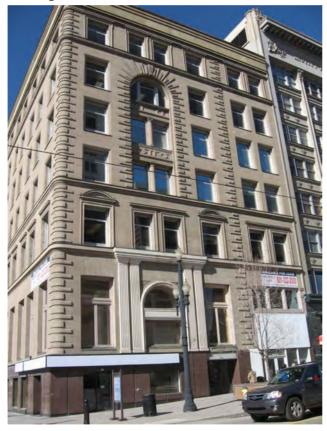
The McCornick Building, built in 1893, is the best available example of a three-part commercial building in Salt Lake City. Although the first floor has been altered, it still retains its distinct treatment of designs which provide a definitive first floor zone. Another zone or division is distinguishable in the upper stories with various window arrangements, and a third zone is seen in the seventh floor attic story with a band of rectangular windows.

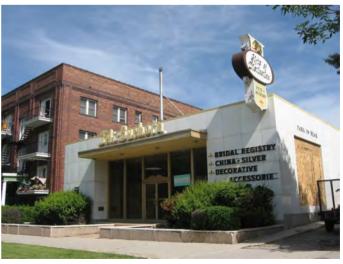
Another example of an enframed window wall plan is the Felt-Buchorn Building at 445 E South Temple Street. Built in 1959, it displays a continuous surround of porcelain steel panels which frames the display windows and entrance.

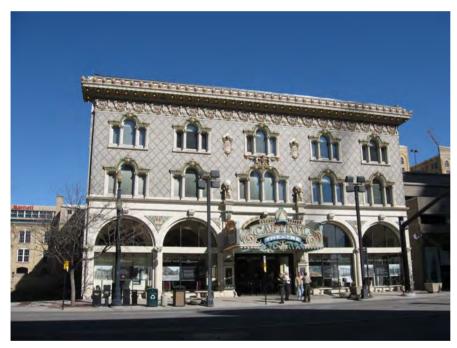
The Orpheum (Capitol) Theatre was built in 1913 and reflects the arcaded block building type and Renaissance Revival architectural style. The building displays polychrome terra cotta on the main façade and has been restored into a multi-use theater building.

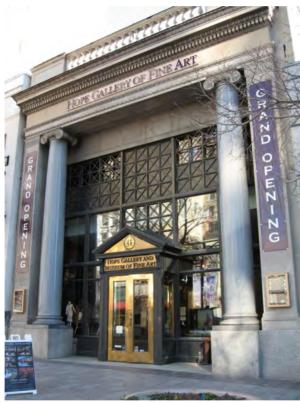
Built in 1916, the Tracy Loan Trust Company was constructed at 151 S Main Street. This vault design features a large central bay with a pedimented entrance flanked by Ionic columns. In addition to the entrance, the central bay is composed of a large window wall.

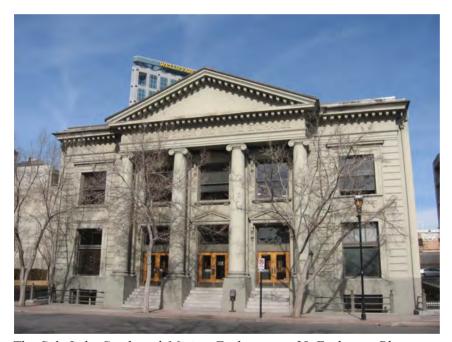
The Salt Lake Stock and Mining Exchange at 39 Exchange Place was built in 1908 and it retains much of its original design. The building's form is central block with wings while its architectural style is Neoclassical. The projecting central bay displays Ionic columns and a large pediment with modillion blocks.

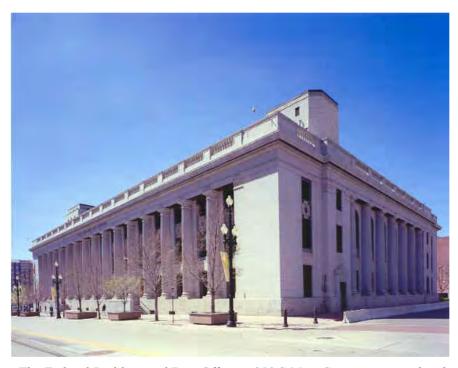
The Federal Building and Post Office at 350 S Main Street was completed in 1906 and is an example of an enframed block designed in the Neoclassical style. The building is distinguished by its long row of engaged Doric columns on each elevation.

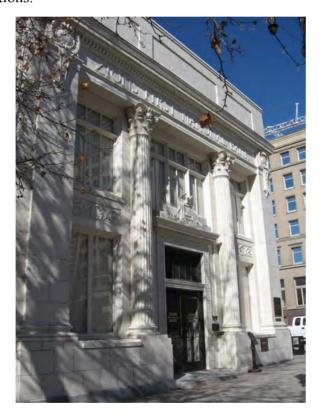
The building at 102 S Main, was originally the Eagle Emporium and was built in the mid-19th century. In 1916, the building was remodeled for its occupant, the Zion's First National Bank. The façade features central Corinthian columns flanking a pedimented entrance.

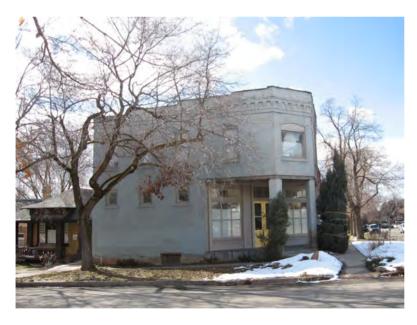
Corner entrances and corner lot locations gave neighborhood commercial buildings such as this one at 740 E 2nd Avenue easy access to customers.

Often neighborhood commercial buildings were located on corners at primary cross streets within neighborhoods. These locations gave a business good visibility to potential customers and offered easy access. Corner commercial buildings were often two-stories in height and featured a recessed corner entrance. In many cases the first floor business owners resided in rooms on the second floor. Neighborhood commercial buildings were also constructed in the middle of blocks but corner locations were preferred.

- location on corner lot or mid-block
- recessed corner entrance
- simple design

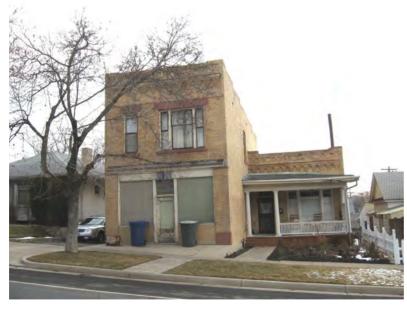
This house store at 228 N 'B' Street demonstrates the compatible, yet distinct commercial and residential units of this building form.

House stores are found throughout America but are relatively rare in most communities. Salt Lake City is distinctive in having numerous examples within the Avenues, University and Capitol Hill Historic Districts. This commercial building form combines commercial and residential structures in one location, but with distinct separate architectural units. The form is characterized by a one—or two-story commercial structure attached to a one-story residential structure on a side elevation. The commercial unit typically is the dominant structure and features a traditional commercial storefront. The residential unit is commonly set back from the façade of the commercial unit and features a more domestic, yet compatible, architectural design. This type of building form allowed business owners to maintain businesses on their own property and closely combine their work and living space, yet maintain distinctly separate spaces for each.

- one— to two-story commercial structure laterally attached to a one-story residential structure.
- traditional storefront on commercial section
- domestic architectural design of residential unit

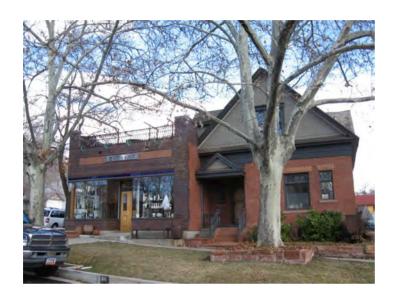
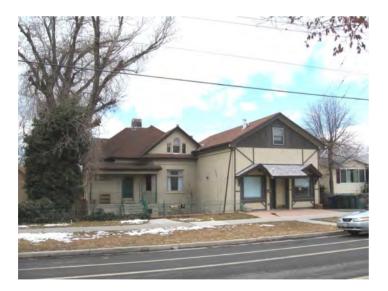
House stores can be found in a variety of styles and forms throughout Salt Lake City.

Top: 82 N 'Q' Street This building features an original storefront in the commercial section.

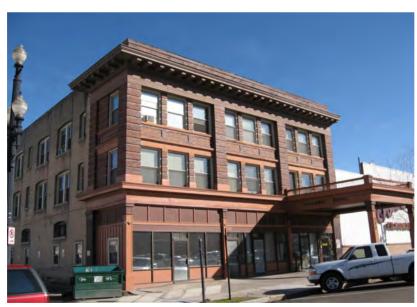
Pilasters divide the upper façade at 222 W 300 South and present a balanced and symmetrical appearance.

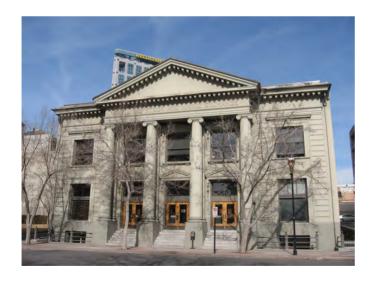
The Salt Lake Stock and Mining Exchange at 39 Exchange Place (left) and 151 S Main Street (right) demonstrate the Neoclassical style with prominent classical columns and accentuated entrances.

- large columns, typically with Ionic or Corinthian capitals
- elaborate entrance, often with a pediment
- rectangular, double-hung sash windows
- dentil molding or modillions at the cornice

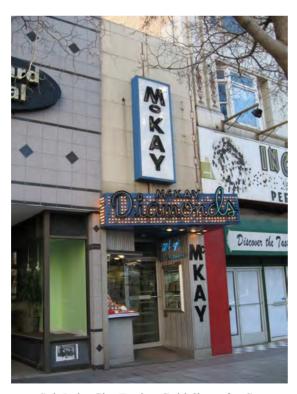
The McKay Jewelry Company at 157 S Main Street occupies a building completed ca. 1950 and features a restrained upper façade and original aluminum and glass storefront.

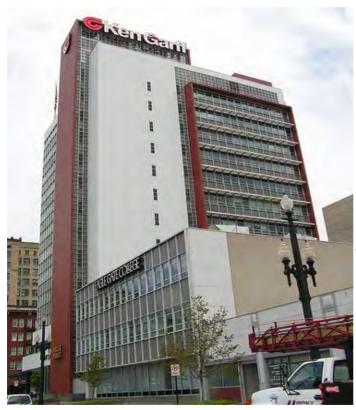
The First Security Bank Building at 405 S Main Street was built in 1955 and features an exterior curtain wall of glass, aluminum, and enameled porcelain panels.

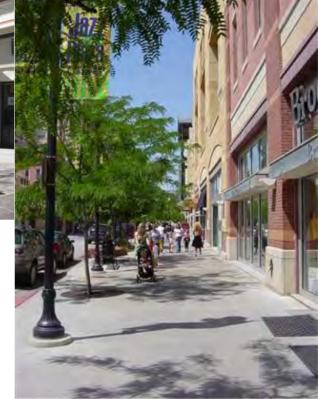
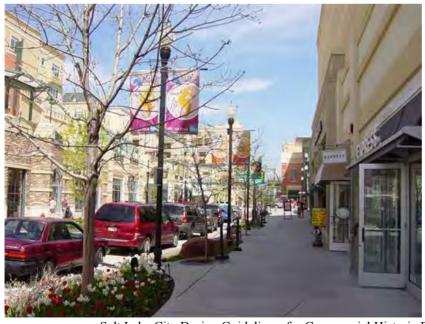
Added planter box and street trees in the 200 block of S Main Street.

Many downtown blocks display added street trees, traditional light standards and varying sidewalk paving materials.

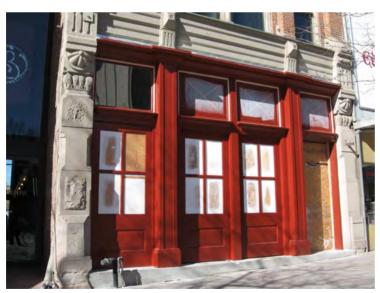
Maintain historic painted appearances (128 S Main Street).

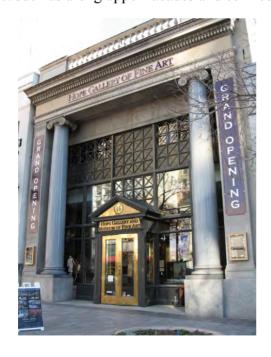
Classical columns and an accentuated entrance are key architectural features of 151 S Main Street.

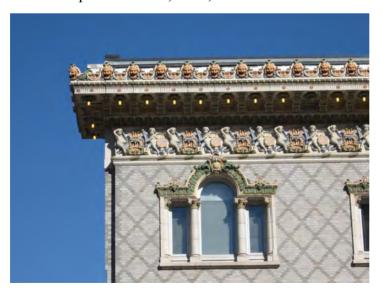
Architectural details of the Capitol Theatre include an ornate cornice and decorative window hoods and surrounds.

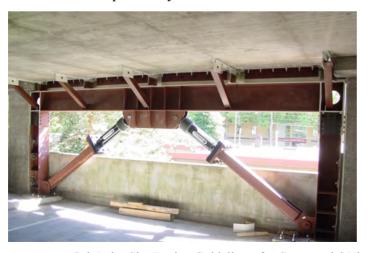
Seismic retrofitting can include adding steel frames and dampers in basement and parking areas of commercial buildings.

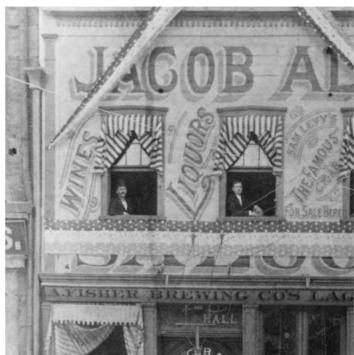
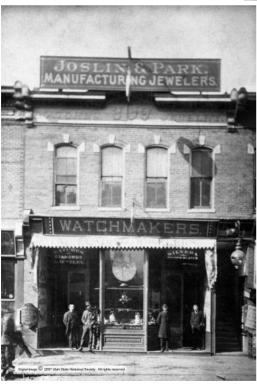
Nineteenth century buildings in downtown Salt Lake City were often covered with signs. The building at 109 S Main Street shown ca. 1876 has painted wall signs, a painted sign board over the storefront and signs on the display windows (Photo courtesy of the Utah Historical Society).

This jewelry company at 170 S Main Street advertised through a large wall sign mounted at the roofline, a projecting sign, sign above the storefront and window signs. This photograph is from ca. 1880. (Photo courtesy of the Utah Historical Society).

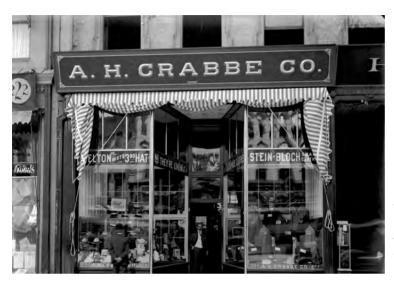
The A.H. Crabbe Company at 220 S Main Street advertised its wares in 1905 through a wall sign above the storefront and signs painted on the display windows. (Photo courtesy of the Utah Historical Society).

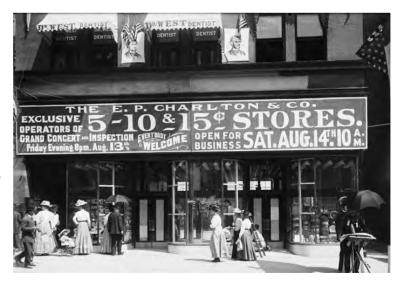
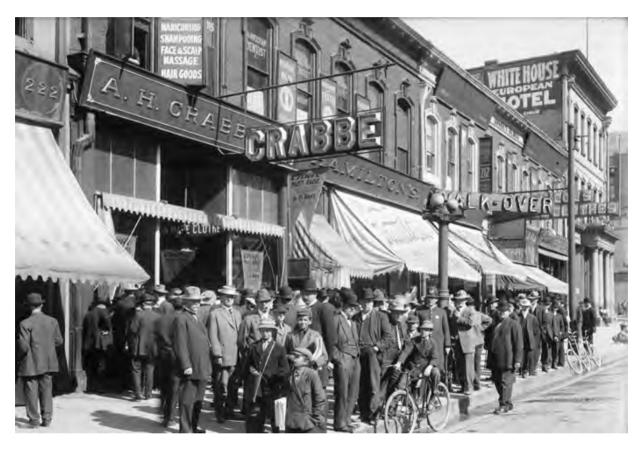
The E. P. Charlton Company installed a large wall sign over the storefront to advertise its business at 249 S Main Street in 1909. An upstairs tenant, Dr. West used signage on the awning valence and painted window signs. (Photo courtesy of the Utah Historical Society).

This streetscape of the 200 block of S Main Street taken in 1912 shows a large variety of signs including sign panels over storefronts, projecting signs, awning signs, window signs and signs painted on the sides of buildings. (Photo courtesy of the Utah Historical Society).

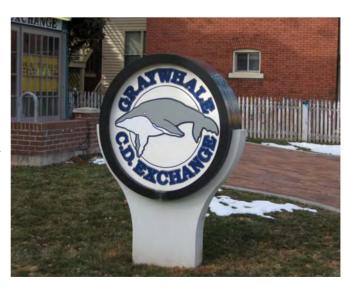
Appropriate freestanding or monument sign at 208 S 1300 East.

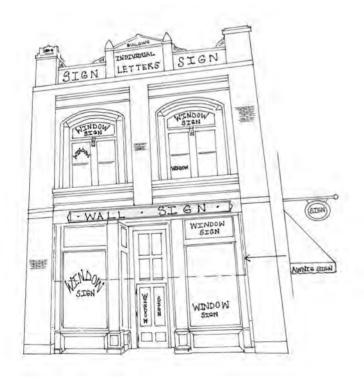
This drawing shows appropriate locations for commercial signage. No more than three signs should be used per building, not counting signs painted on windows.

Signage should not dominate the building visually, so no more than three signs should be used per building, not counting signs painted on windows. Also wall signs should not exceed 20% of the overall wall surface.

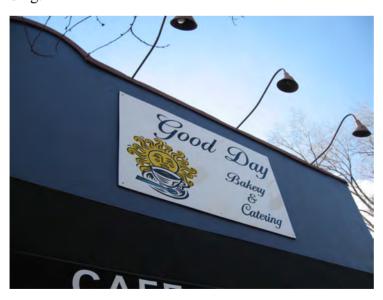
This example of an appropriate wall sign at 564 E 3rd Avenue also demonstrates appropriate spot lighting.

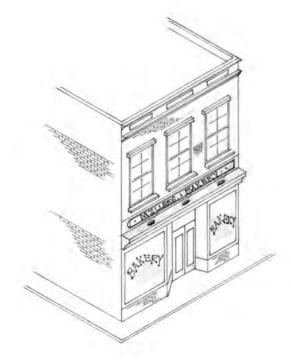
Lighting for signs should be indirect and as unobtrusive as possible. This example shows lights mounted above a storefront cornice.

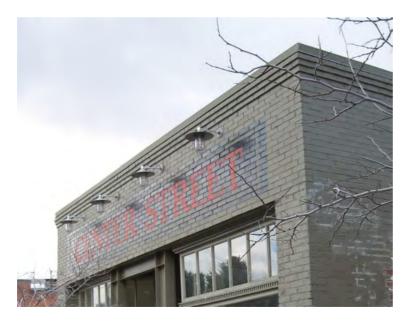
Signs above the storefront are historically correct locations for sign boards or painted wall signs such as at 271 N Center Street.

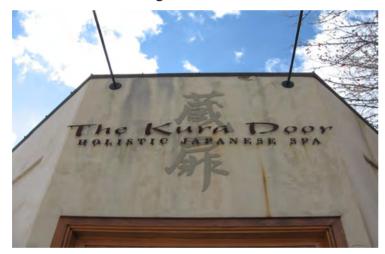
Appropriate use of lettering above the entrance at 1136 E 3rd Avenue.

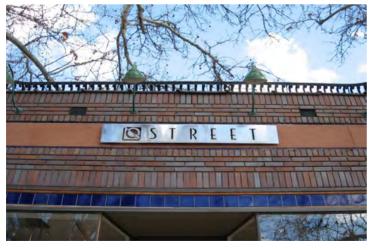
This wall sign at 82 N 'Q'Street is within the historical sign panel location above the entrance.

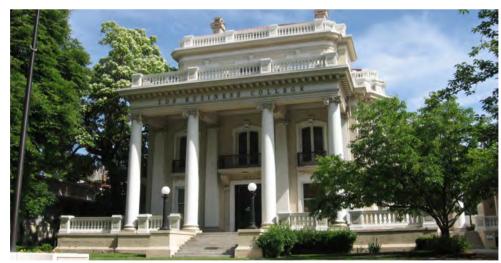
The Enos A. Wall House, built in 1914 at 411 E South Temple Street, is now used as part of the LDS Business College campus. Its signage is appropriately located in the fascia panel below the portico cornice.

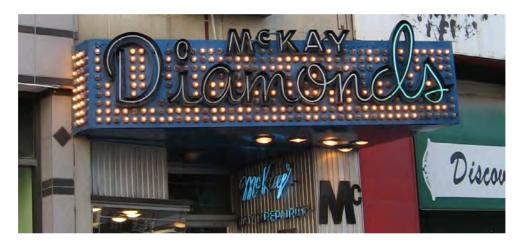
The neon and illuminated marquee for the McKay Jewelry Company at 157 S Main Street dates from 1949 and contributes to the historic character of the building.

Salt Lake City's historic districts contain commercial buildings constructed in the 1940s and 1950s and many of these retain original signs. Property owners are encouraged to preserve or repair these signs and adaptively reuse them whenever possible.

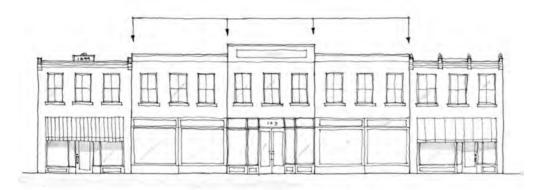
Large new buildings should be designed with vertical divisions to be consistent with traditional historic building widths.

If new construction is filling a large footprint that is wider than traditional buildings along the block, the new construction should be divided into visually separate sections that give the appearance of traditional building widths. This can be accomplished with vertical divisions within the building design.

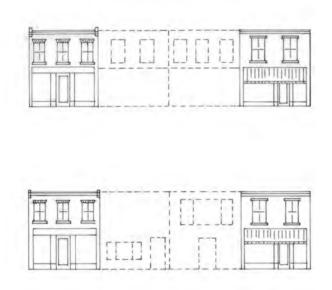
Solid to void ratio: The top sketch at left illustrates new construction that maintains traditional solid to void ratio through appropriate number and size of windows. The bottom sketch illustrates inappropriate window size and placement.

New buildings should have similar amounts of wall space and openings for windows and doors as neighboring historic buildings. Rhythm, size, and spacing of window and door openings should be in patterns similar to surrounding historic buildings.

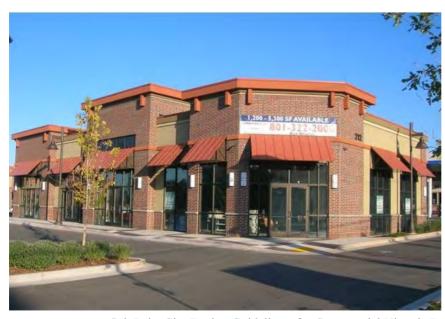
New construction should be designed with appropriate storefronts and awnings as at (242 S 700 East).

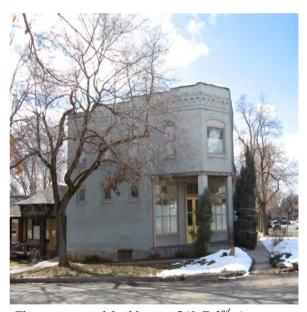
This commercial building at 740 E 2nd Avenue retains much of its original storefront and arched upper floor windows.

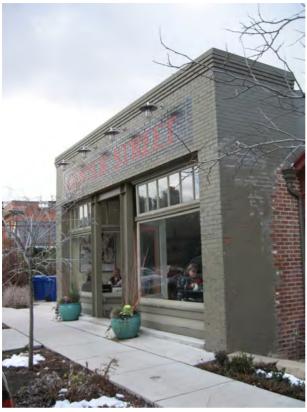
The building at 271 N Center Street has been preserved and rehabilitated as a restaurant.

In addition to the various residential buildings, a number of brick and frame commercial buildings were also constructed in the neighborhood. Most of these were One-Part commercial blocks with large storefronts and detailing on the upper façade such as corbelled brick cornices. Businesses in these buildings provided groceries, restaurants and other services for the neighborhood. These types of commercial buildings are scattered throughout the Capitol Hill Historic District and continue to be used for restaurants and other businesses. A fine example is the building at 271 N Center Street

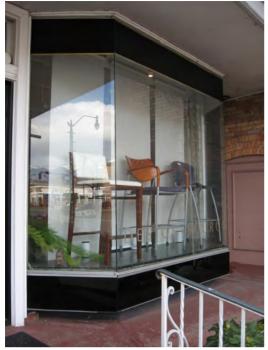
Few historic commercial buildings are located along South Temple but at 432-434 S Temple is a building with an intact ca. 1930s Carrara glass storefront.

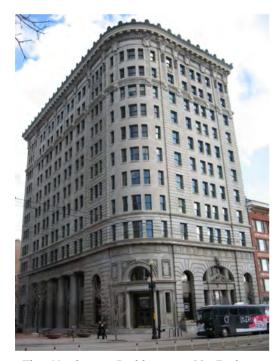
The Newhouse Building at 10 Exchange Place was one of the city's first skyscrapers.

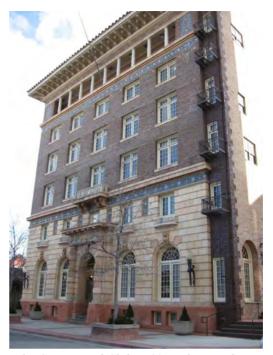
The Commercial Club at 32 Exchange Place is noted for its elaborate façade of brick and terra cotta.

Newhouse donated Exchange Place land for a new Commercial Club Building. Essentially the Chamber of Commerce of its day, the Commercial Club chose to build a luxurious building designed to look like a smaller version of the New York Athletic Club, complete with a swimming pool, banquet room, private dining rooms, and game rooms. The building was designed with the influences of the Renaissance Revival style in its arched windows and entrance on the first floor and elaborate cornice at the roof-line.
