HISTORIC LANDMARK COMMISSION STAFF REPORT

Planning Division
Department of Community and
Economic Development

318 6th Avenue
Avenues Historic District
Rear Dormer Window
PLNHLC2010-00118
May 19, 2010

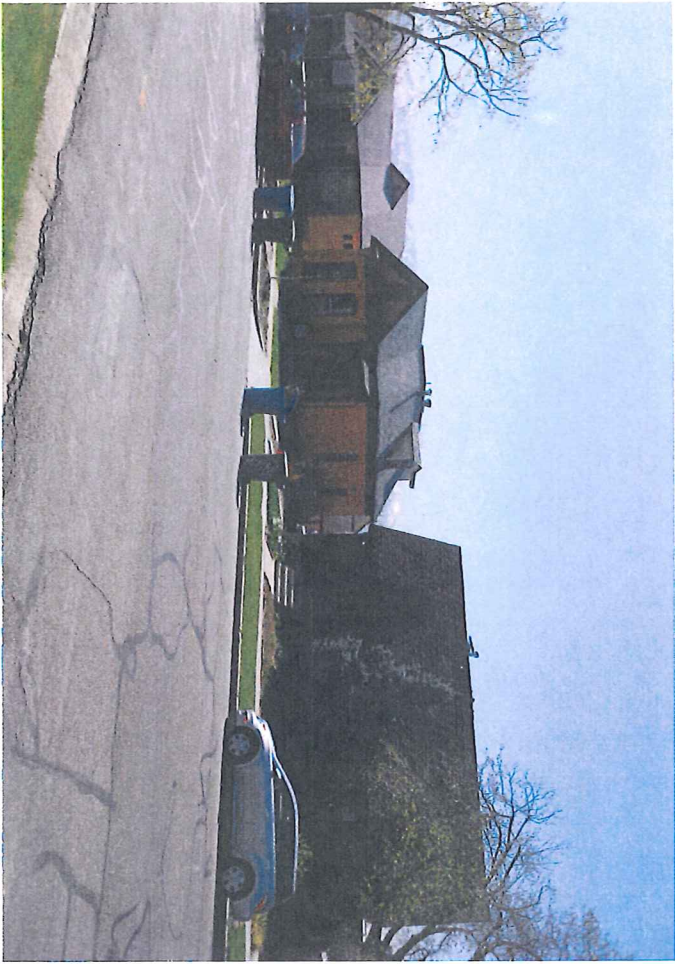
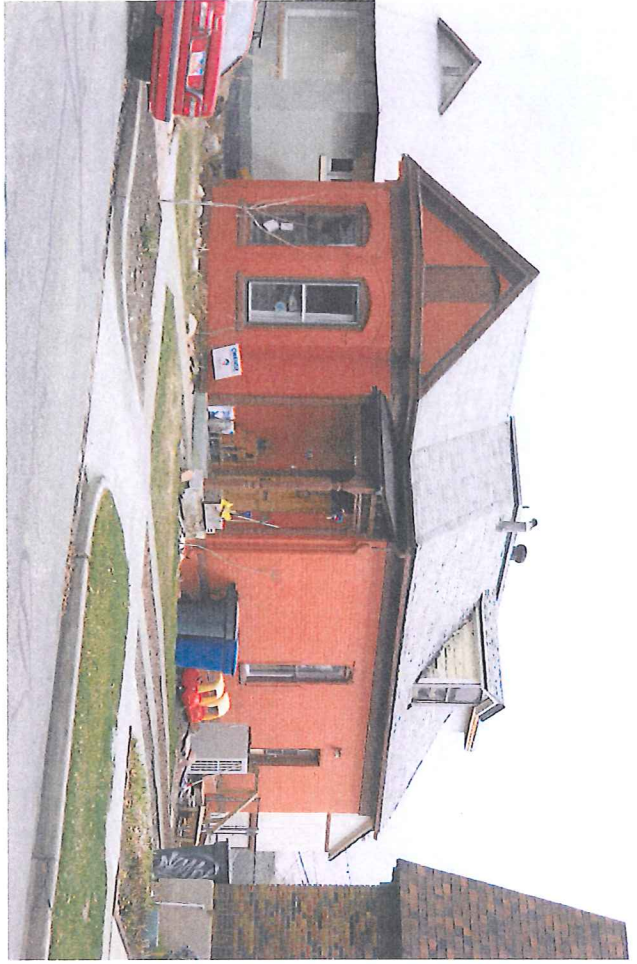
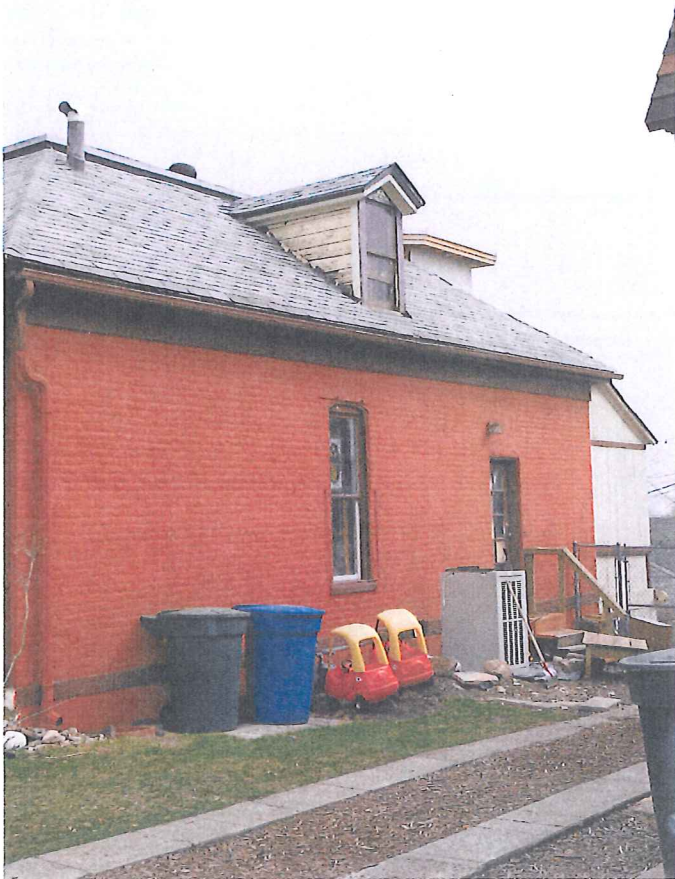
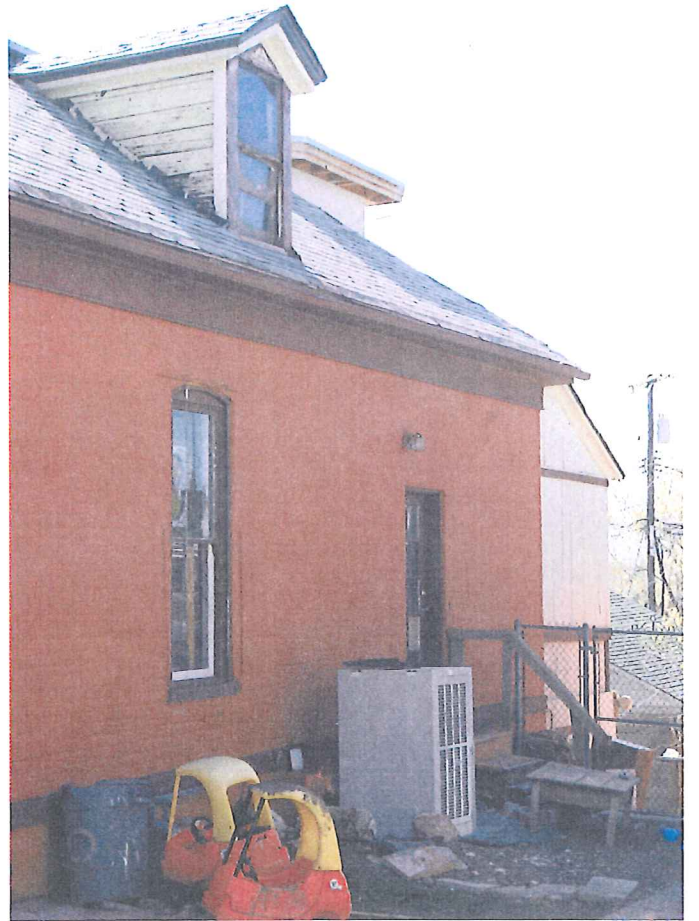
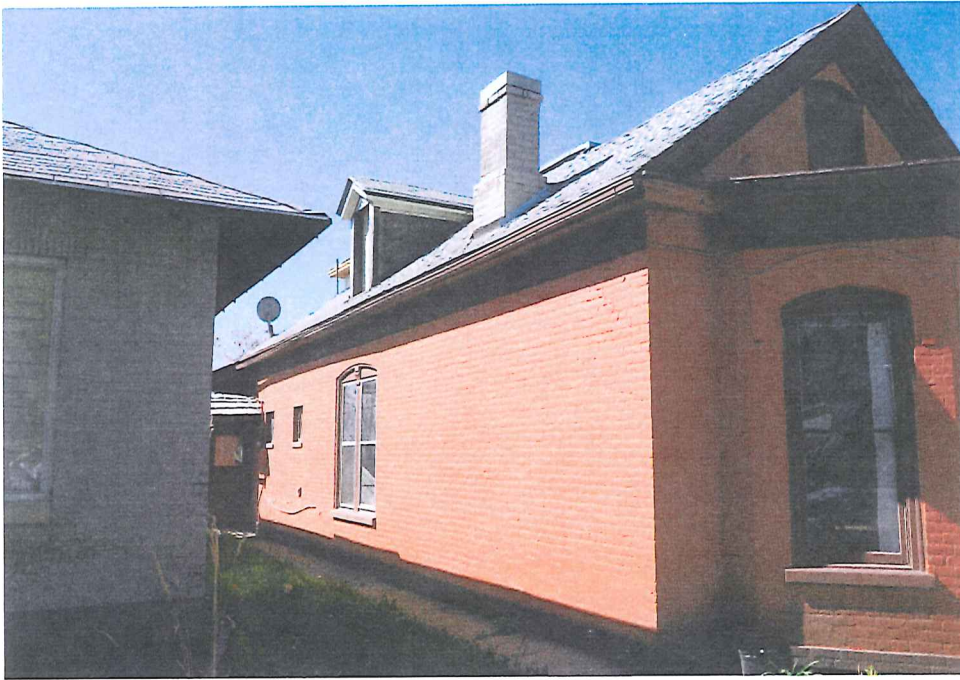
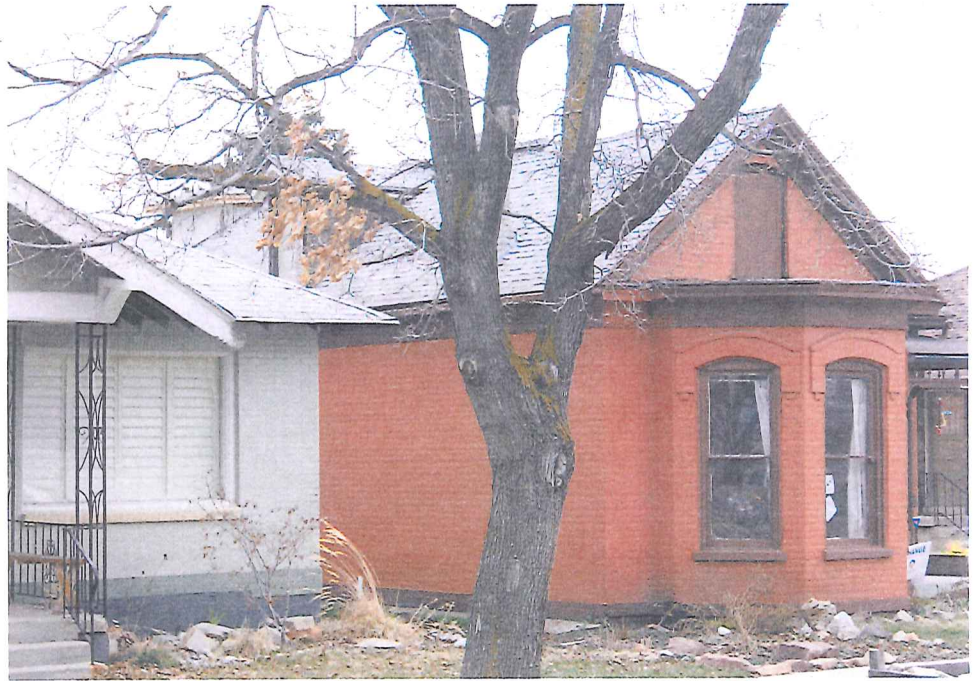
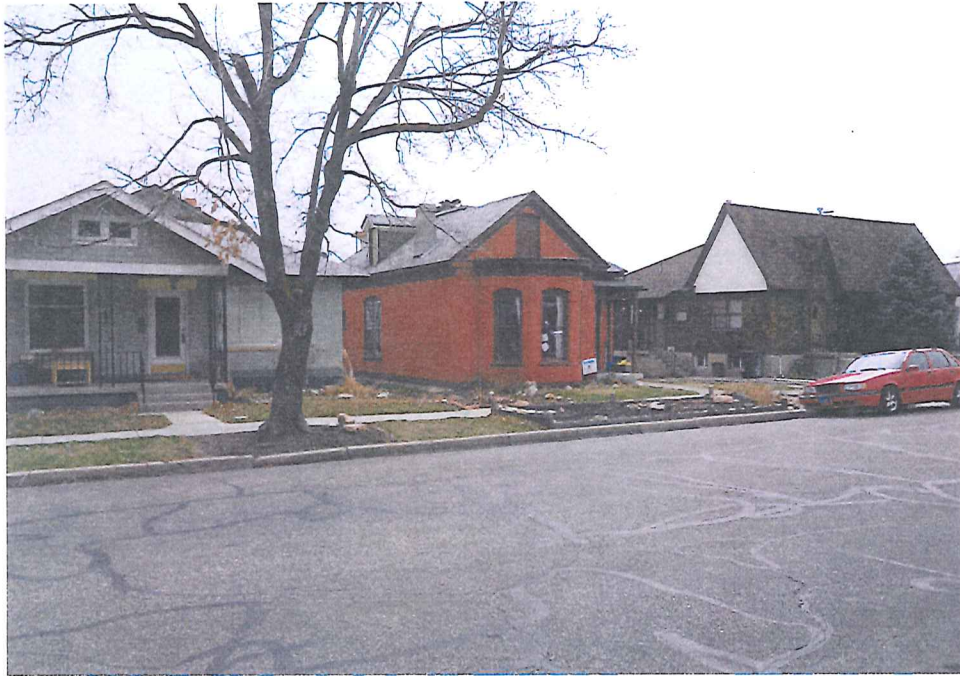
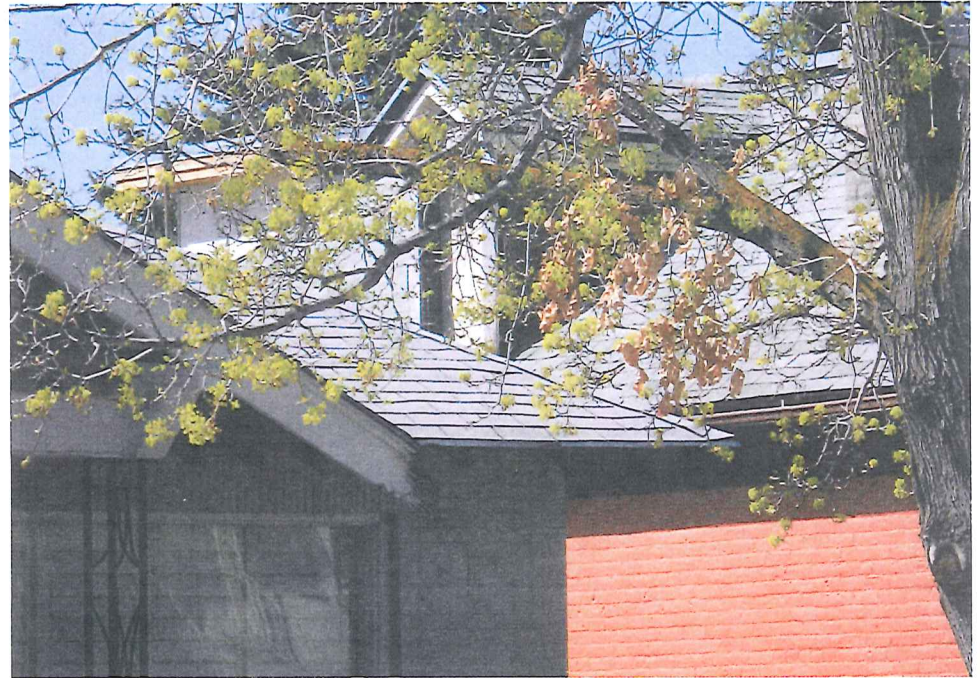
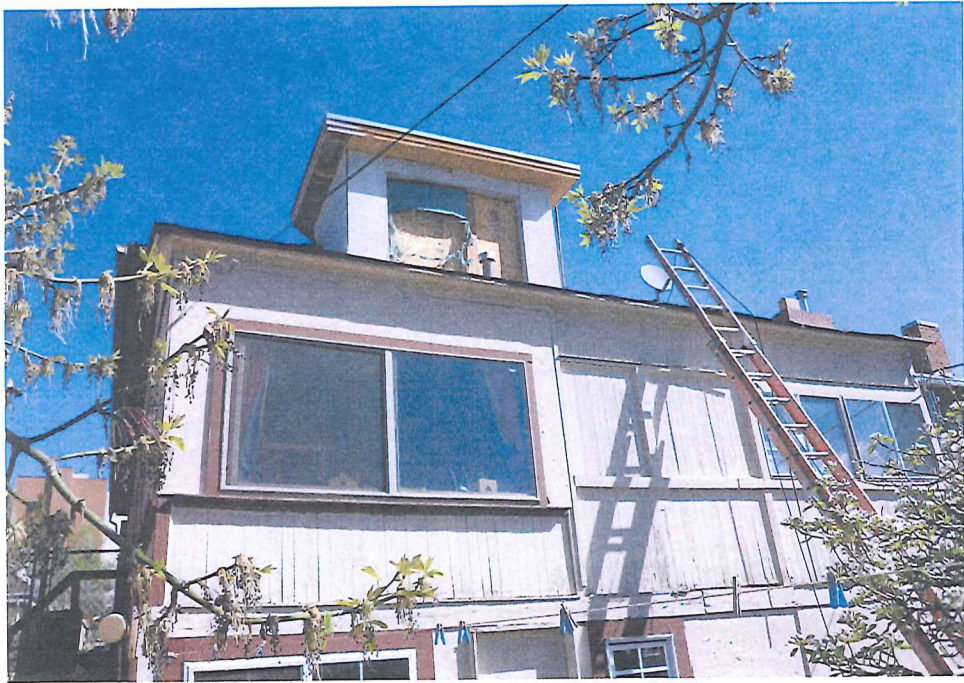
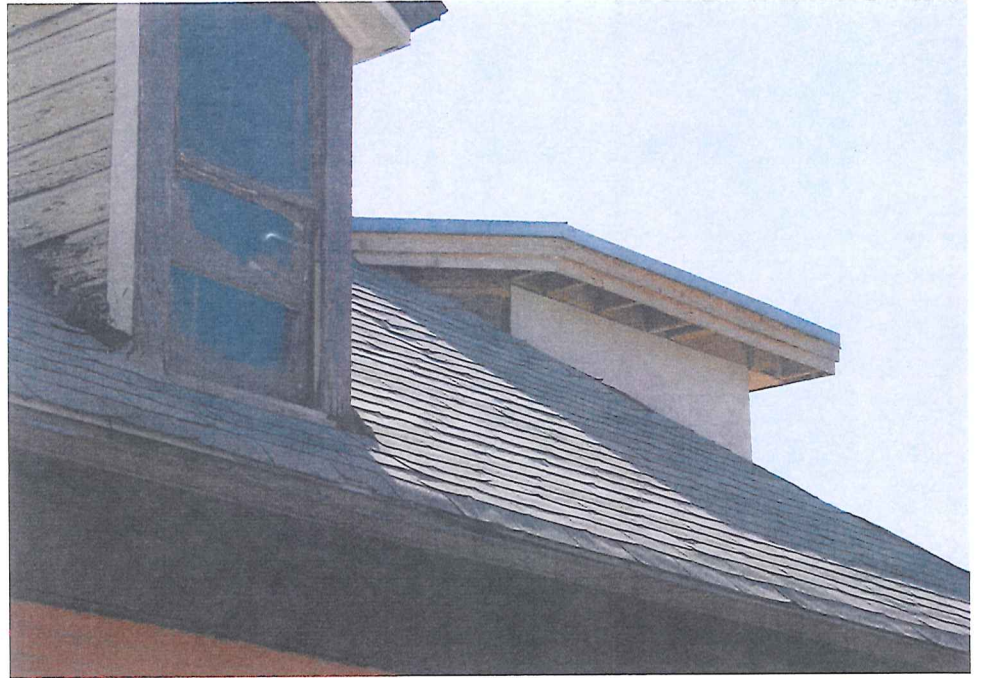
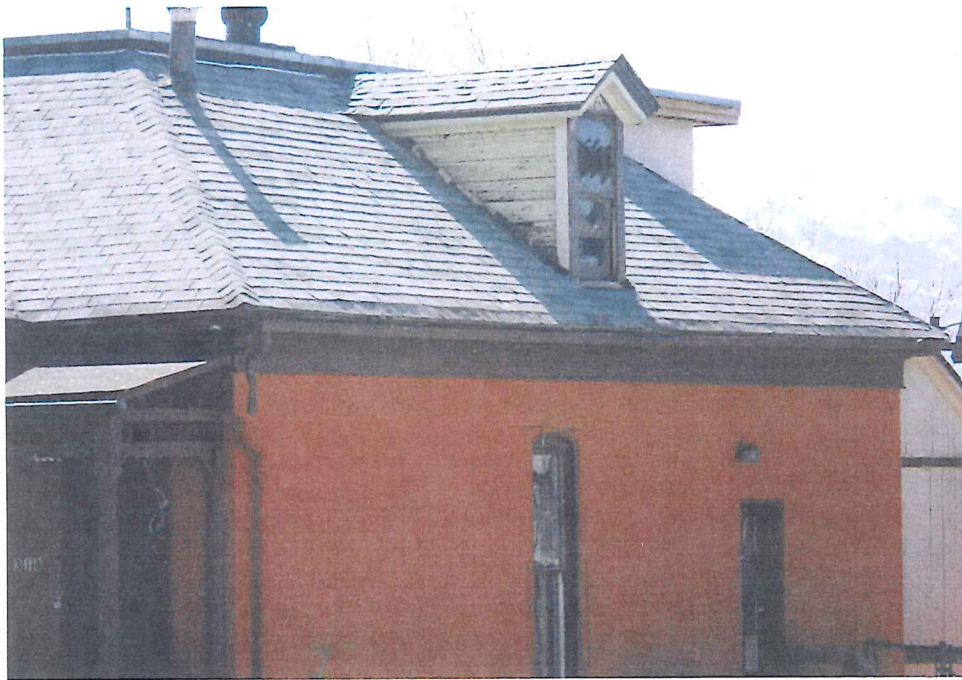
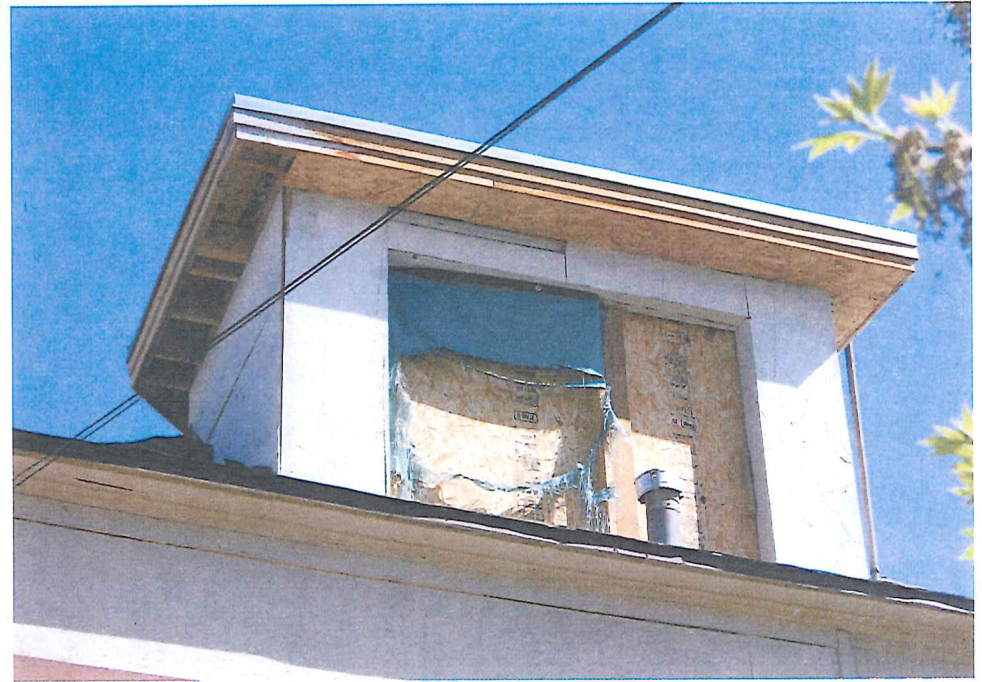
Photographs

The dormer is constructed as a continuation of the flat roofed section of the house and is approximately 9 ft wide by 6 ft deep (not measured), with pronounced eaves to the front and both returns. Although placed at the rear of the property the dormer can be seen from the street on both sides, as well as neighboring properties.

Analysis: The property has an original dormer window on both the east and west facing roof slopes. These dormers are gabled, relatively narrow and vertical in proportion. They are in a relatively poor state of repair. The additional dormer to the rear has been constructed with a flat roof and eaves, is larger in dimension and scale, and more square to horizontal in proportion.
