HISTORIC LANDMARK COMMISSION

**Carter Apartments Window Replacement
PLNHLC2010-00541
235 West 700 North
October 6, 2010**

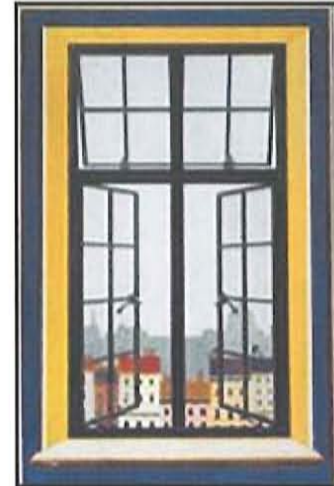
A NOTE TO OUR USERS: The web versions of the **Preservation Briefs** differ somewhat from the printed versions. Many illustrations are new, captions are simplified, illustrations are typically in color rather than black and white, and some complex charts have been omitted.

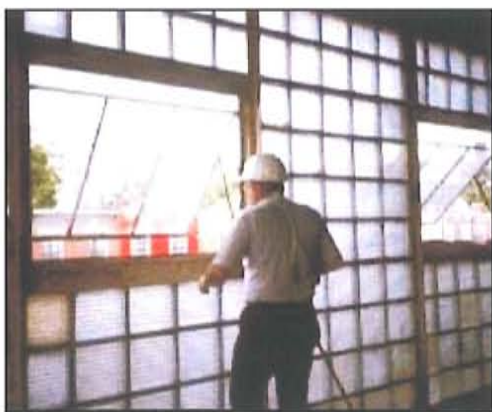
Maintaining historic steel windows for continued use is always recommended.
Photo: NPS files.

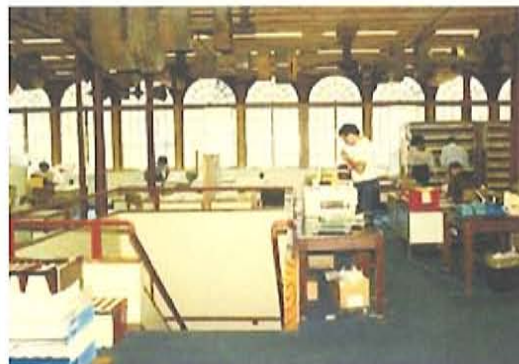
Historic metal windows provide abundant natural light in this rehabilitated industrial space. Photo: NPS files.

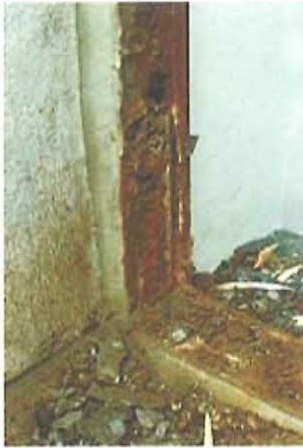
A severely deteriorated frame, such as this, can be replaced in kind.
Photo: Henry Chambers, AIA.

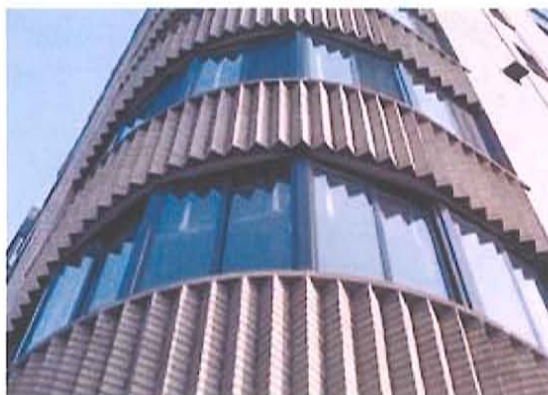
The historic steel sash (see photo above) was removed and replaced with modern aluminum sash, resulting in a negative visual impact on the building's historic character. Photo: NPS files.

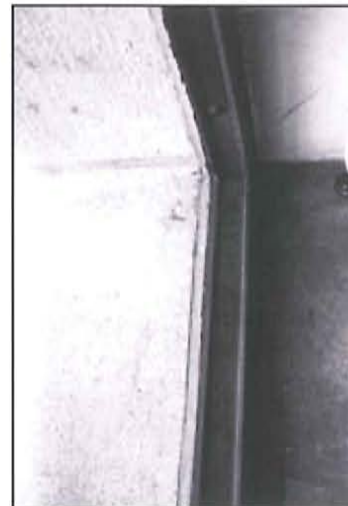
This is a successful replacement in kind of the deteriorated frame shown above. Photo: Henry Chambers, AIA.
