HISTORIC LANDMARK COMMISSION STAFF REPORT

Meck Residence Major Alterations 505 E Third Avenue PLNHLC2012-00384 July 19, 2012

MECK RESIDENCE
ADDITION-REMODEL & DETACHED GARAGE

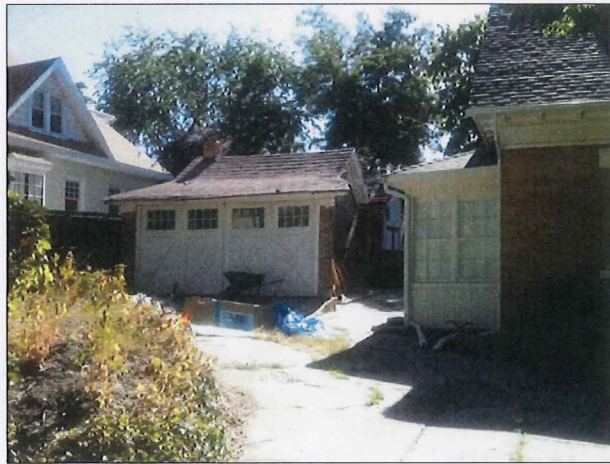
505 E. Third Avenue - garage

Analysis: This accessory building may have originally been constructed as a single-cell outbuilding using materials similar to those on the house. The Sanborn Maps show that the structure's footprint has changed since 1911. However, based on an examination of the building materials, the shed addition with repeating bays may have been an early addition to accommodate an automobile. As such, this type of alteration has acquired historic significance in its own right. The building retains much of its historic massing, materials and simple architectural elements that define its historic function and character.

Finding: The physical integrity of this building as established in Section 21A.34.020(C)(2)(b) of the Zoning Ordinance is evident. Although the building has undergone alterations, these alterations contribute to the simple design of this utilitarian building and have acquired historic significance in their own right. The building is a historic resource because it is a surviving example of its building type (garage) and represents the widespread acceptance of the automobile. The project does not substantially comply with this standard.

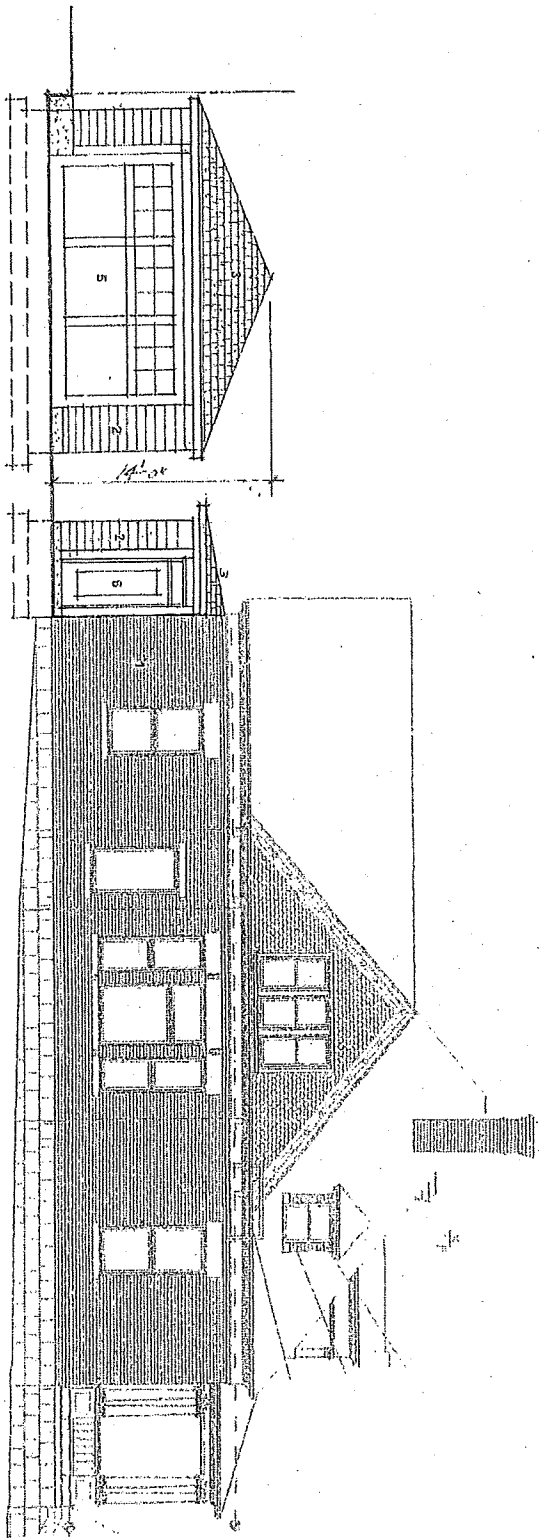
WEST ELEVATION STUDY
SCALE: 1/8" = 1'-0"

- LEGEND**
- 1 EXISTING BRICK TO REMAIN
 - 2 CEMENT BOARD LAP SIDING, PAINTED
 - 3 ASPHALT SHINGLES TO MATCH EXISTING
 - 4 STANDING SEAM METAL ROOF, BAKED-ON EMAMEL FINISH
 - 5 CARRIAGE HOUSE GARAGE DOOR
 - 6 FRENCH DOOR, W/ TEMPERED GLASS
 - 7 CEDAR SHINGLES PAINTED
 - 8 REMOVE EXISTING DORMER
 - 9 NEW SHED DORMER
 - 10 WOOD DOUBLE HUNG WINDOW
- THIS AREA FOR
SOLID WOOD DOOR
