HISTORIC LANDMARK COMMISSION STAFF REPORT

Front Yard Terracing

PLNHLC2014-00362 259 South 1200 East Meeting Date: August 7, 2014

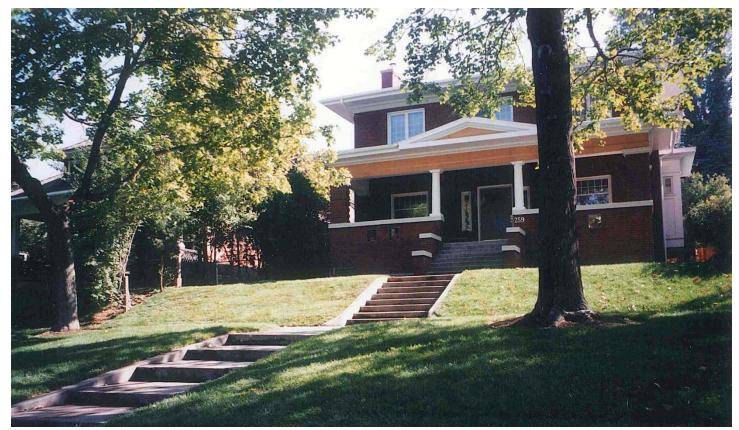
Photo of the subject property. Photo submitted with the application prior to unauthorized grading of the front yard.

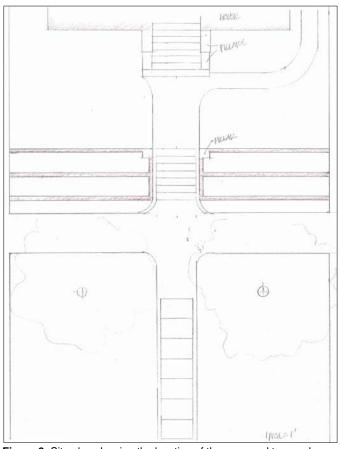
Figure 2: Site plan showing the location of the proposed terraced retaining wall.

The proposal includes grading of a portion of the front yard to create two level garden areas, construction of a new terraced retaining wall to contain the raised garden areas. The proposed terraced garden would be at a height in line with both sides of the existing stairway, and would run the length of the property line. The design of the retaining wall encompasses two interconnected levels that measure 3 feet (3') deep, and three terraced retaining walls—each retaining wall would have a height of 18 inches (18"). Next to the highest terraced wall on both sides of the stairway, a 24 inch (24") pillar with a cement cap is proposed. The retaining wall would be constructed of red concrete block material, matching the red brick of the historic house as closely as possible.

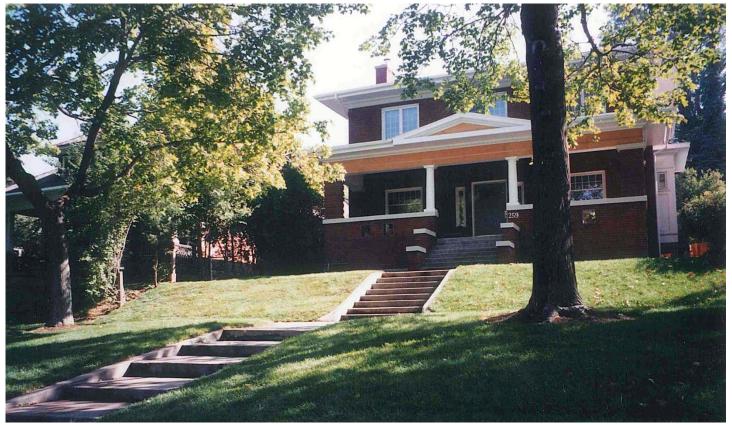
East View of the subject property from 1200 East. Photo submitted with the application prior to unauthorized grading of the front yard. Proposed terraced retaining wall would be located in the front yard area at the base of the stairs and step up to a point in line with the top of the staircase. Two pillars with cement caps are proposed to match the design of the front porch as closely as possible.

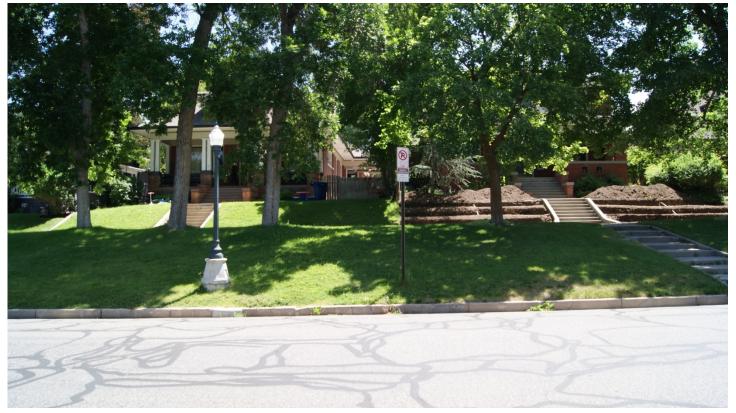
Unauthorized construction related to this proposal has begun. In the area where the terraced retaining wall is proposed, the lawn has been removed and the front yard has been graded to create a series of level tiers for the proposed landscaping (see photos in Attachment B). The applicant was not aware that a Certificate of Appropriateness was required before beginning the work. An enforcement case has not been opened on the matter; however, if the petition is denied by the Historic Landmark Commission, the matter will be forwarded to Zoning Enforcement.

East View of the subject property from 1200 East. Recent photo of the subject property shows unauthorized grading of the front garden area.

Staff intends to forward the application to Zoning Enforcement for unauthorized grade changes to the property.

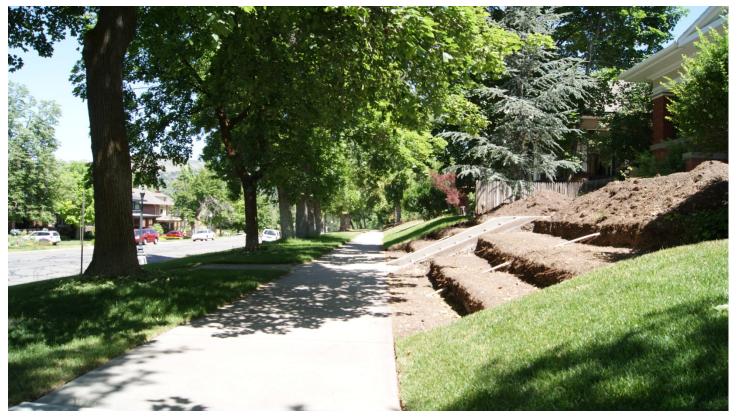
Pedestrian View of the Subject Property Looking North. Photo depicts a close up view of the historic walkway pattern on 1200 East.

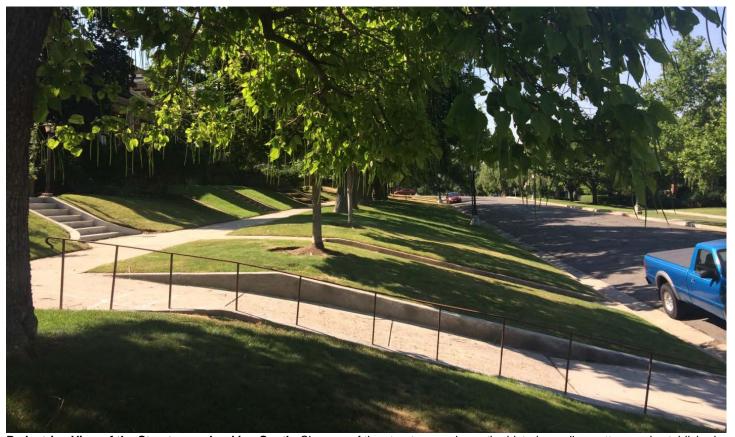
Pedestrian View of the Streetscape Looking South. Close up of the streetscape shows the historic grading pattern and established progression of site features.

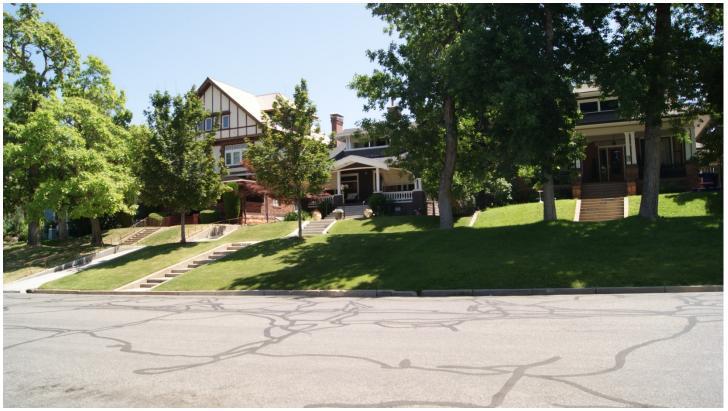
East View of the Streetscape on 1200 East. Wide park strips and tree lined walkways combine with front yards to mediate between the varying levels of the house and street in much of the District.

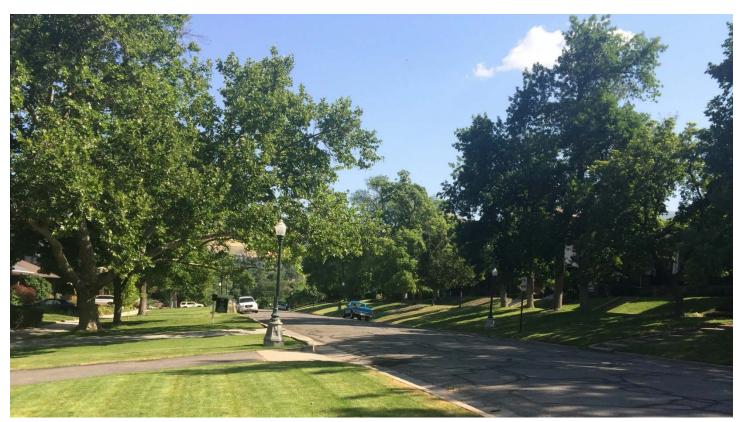
Established Progression of Entry Elements. The east side of 1200 East has an established progression of entry elements, including wide park strips that contain a series of steps that provides a public entry point from the street to the sidewalk, and a stairway that connects the front entry with the public sidewalk. These connecting visual elements help maintain the character of the streetscape.

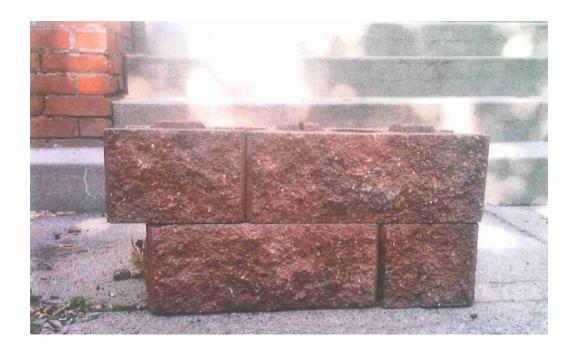
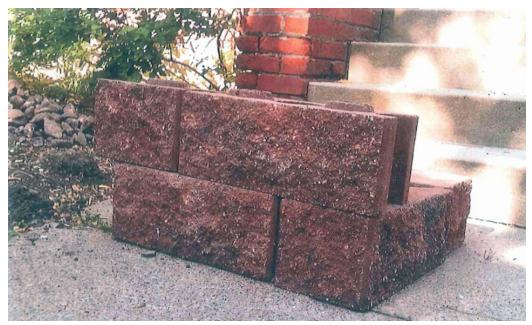
Example of Red Concrete Block Material: Applicant provided the above examples of proposed red concrete blocking material. The red brick of the historic house can be seen in the background.
