**HISTORIC LANDMARK COMMISSION
STAFF REPORT**

Structures in Park Strip
PLNHLC2014-00789
974 E 300 S
Meeting Date: March 5, 2015

This is a request by David Schutt, the property owner, to allow for structures consisting of natural stone planter benches various structures in the park strip at approximately 974 E 300 S.

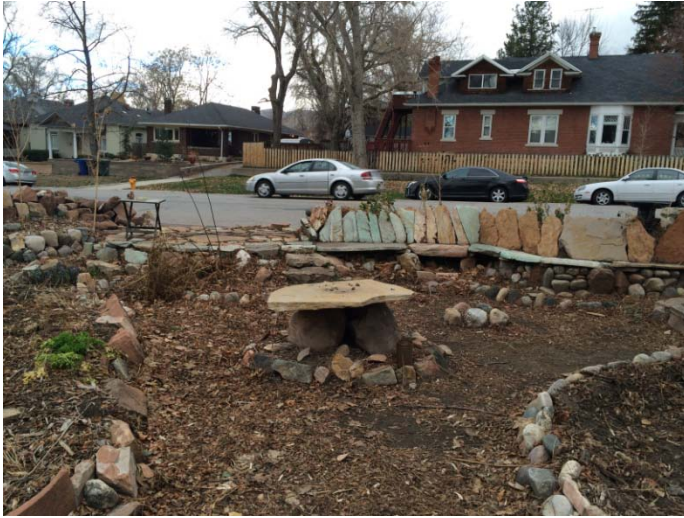
Planter bench structure on north park strip

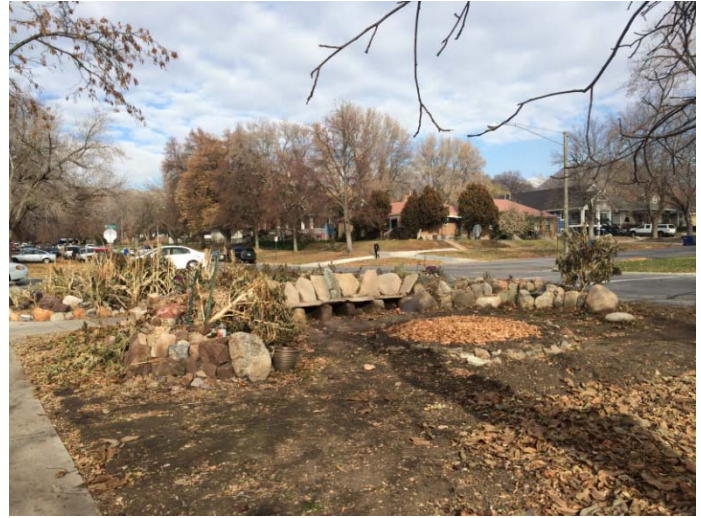
Planter bench structure on east park strip looking north

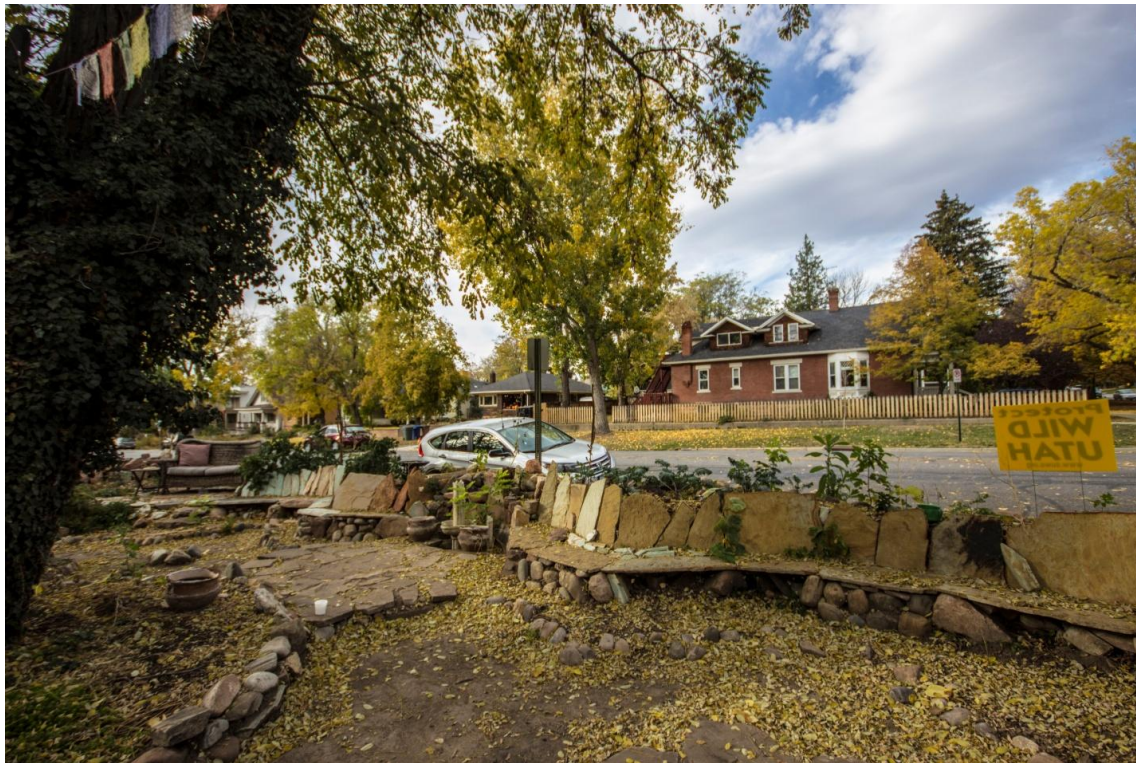
The north facing park strip prominently featured a 50' planter/bench, but has been reduced to a pair of 16' planter benches to ensure accessibility and safety as per requested by Public Utilities. These benches are no higher than 36" and are setback a minimum of 18" from the curb as per 21.A.48. Forethought has been taken to ensure accessibility between the street and sidewalk, as well as ease of getting in and out of parked vehicles. Also since the current ordinance prohibits plants over 18" above grade, alterations have been made accordingly.

There is also a picnic bench located on the east end of the northern park strip.

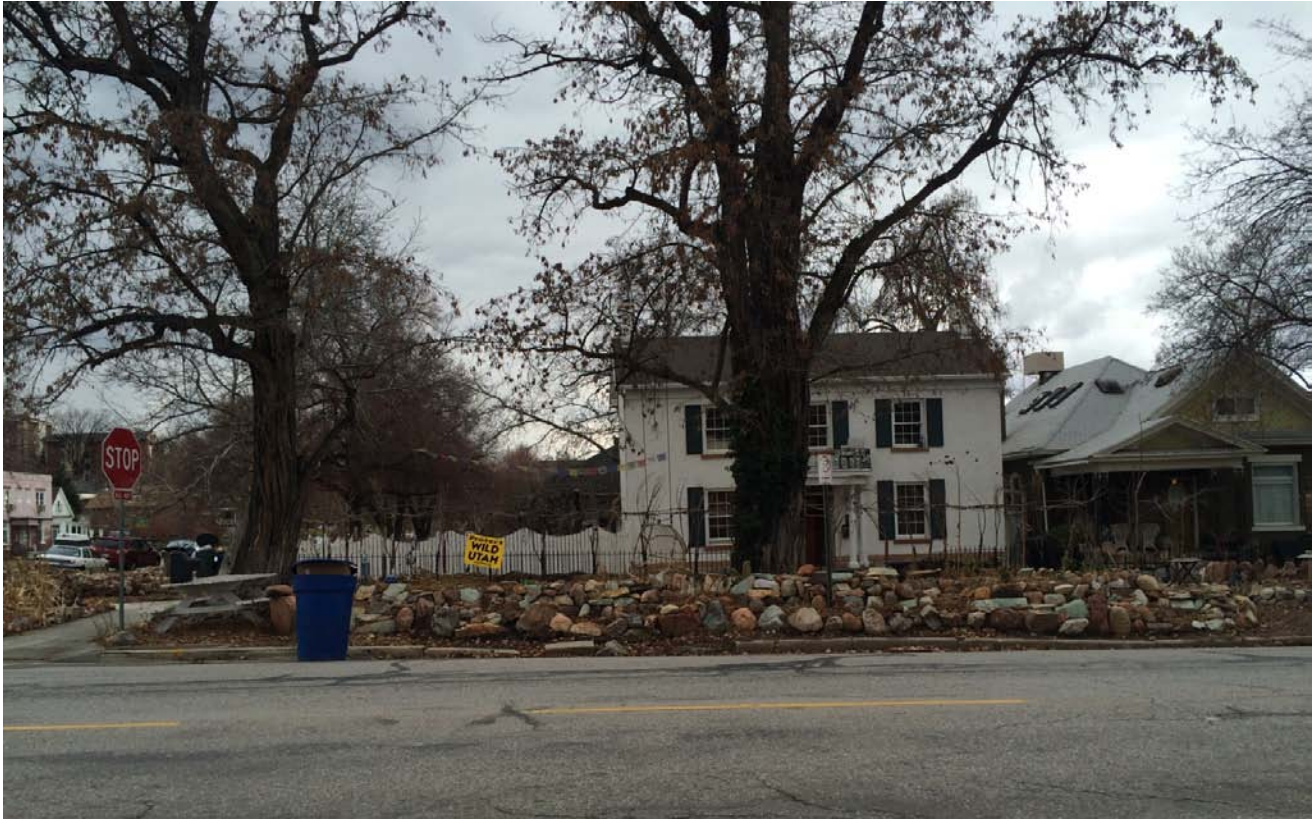
North Park Strip – looking northeast, bench will be reduced to allow utility access

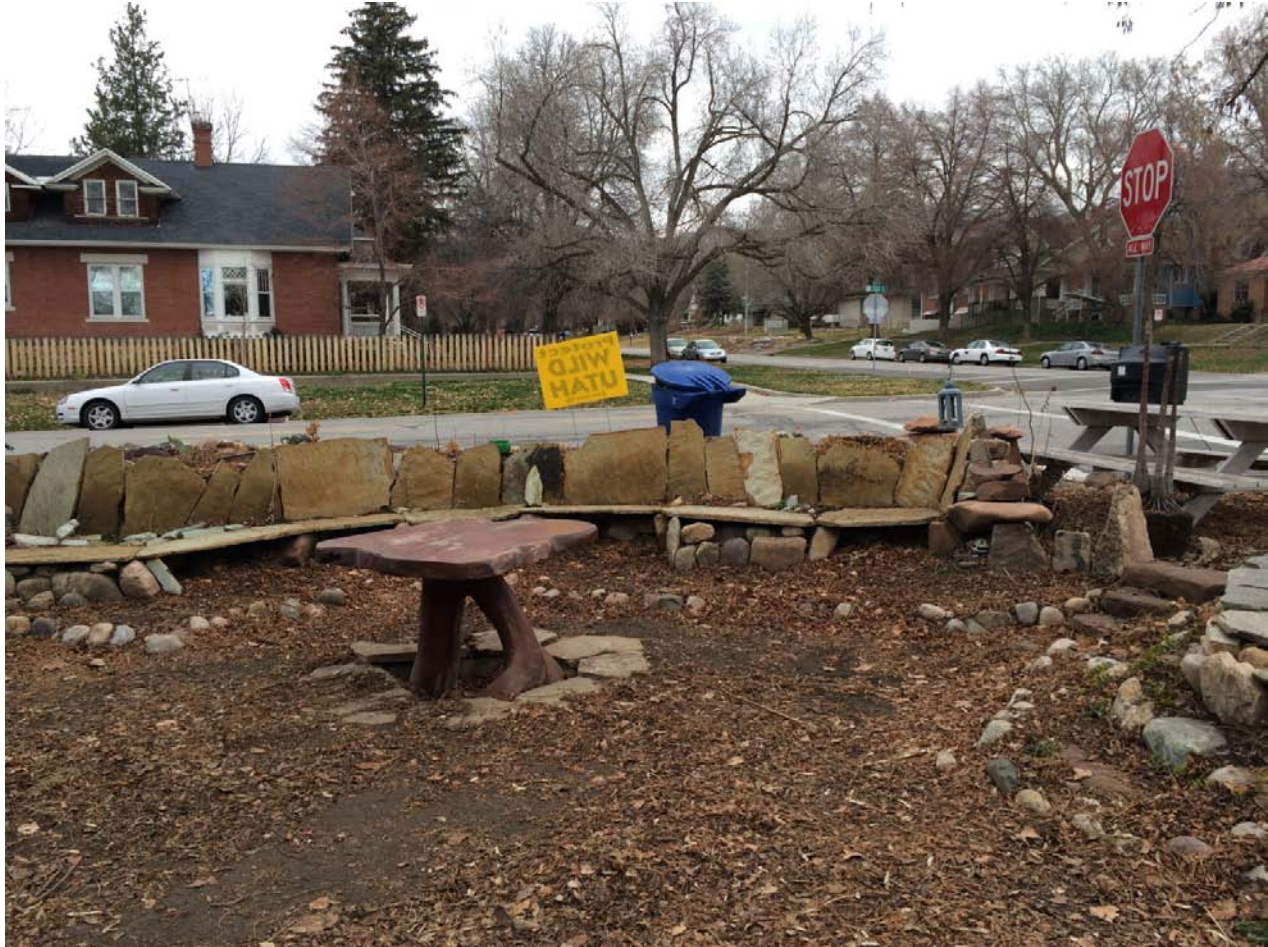
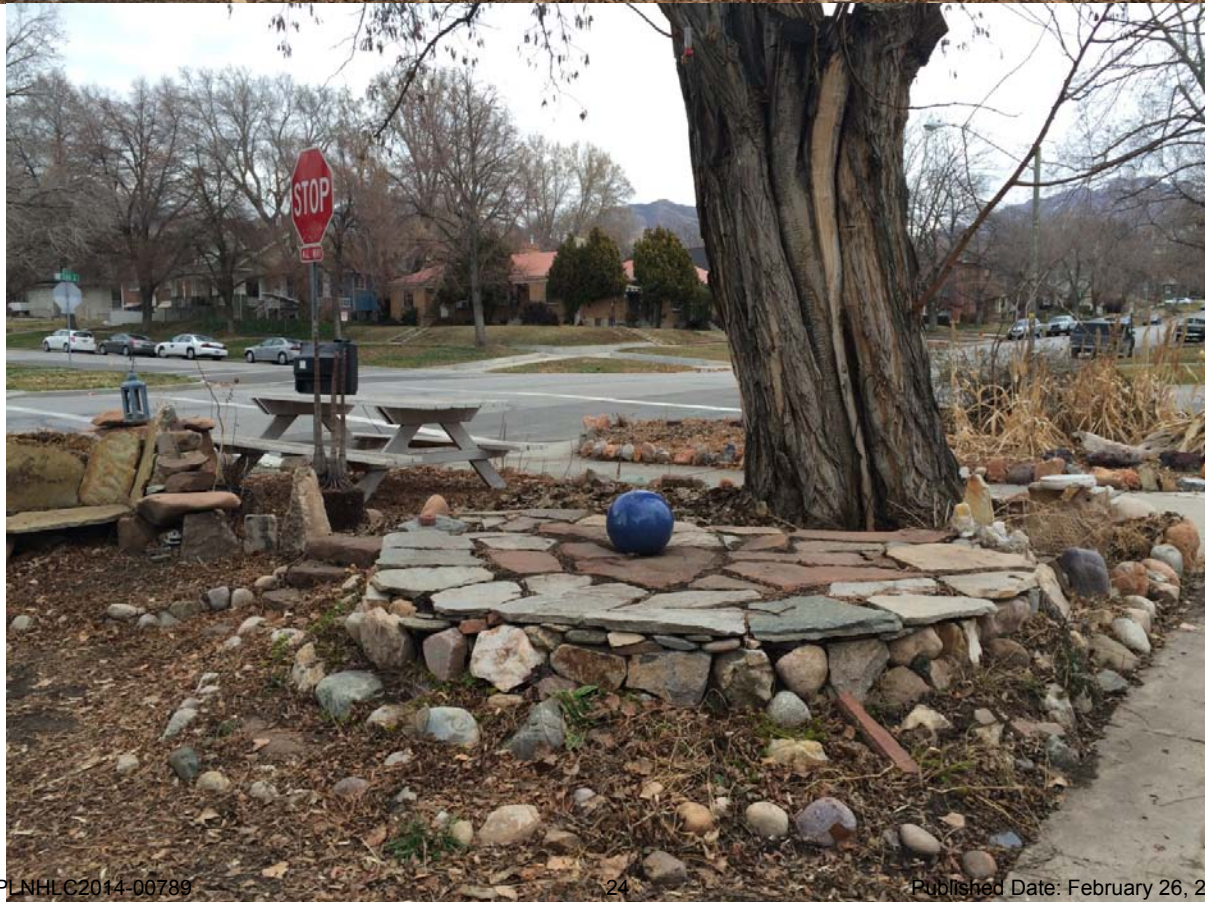
North Park Strip – looking north

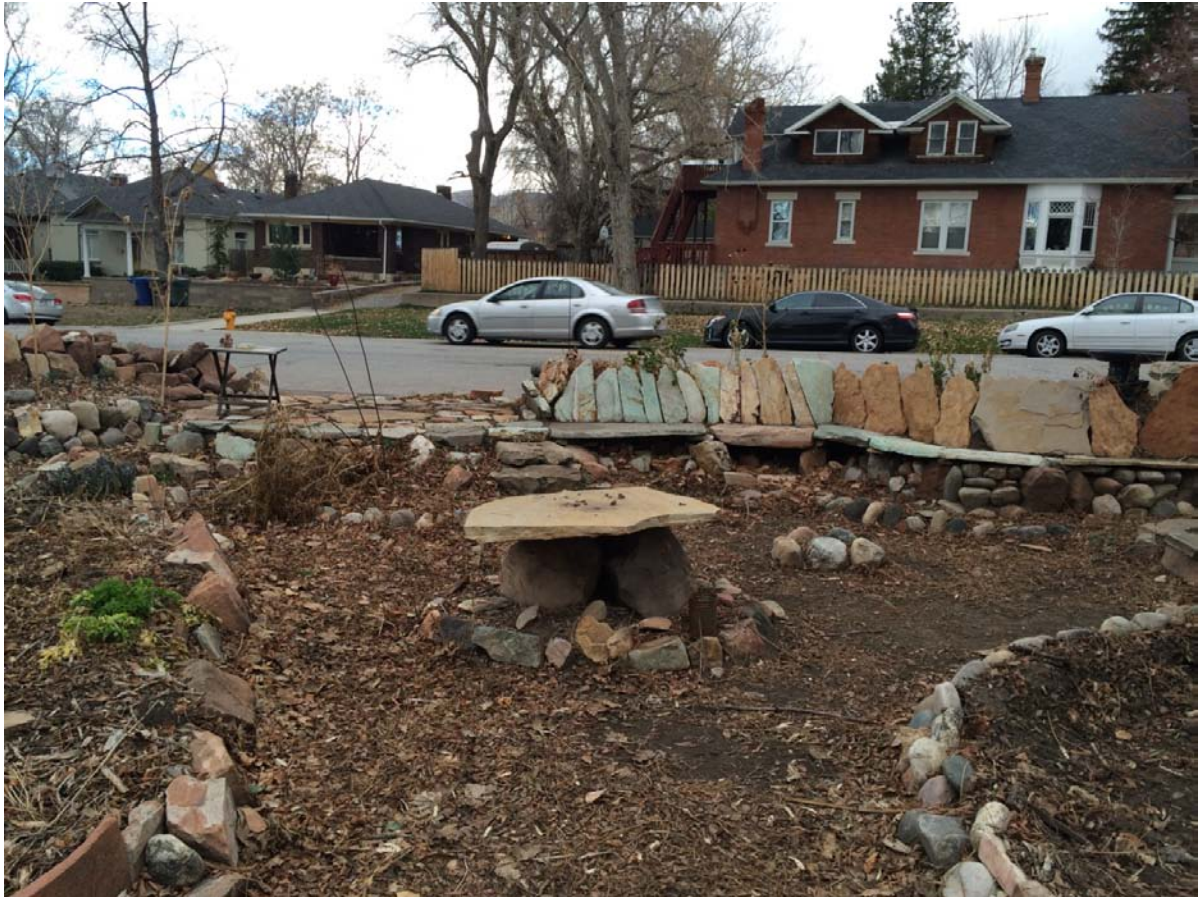
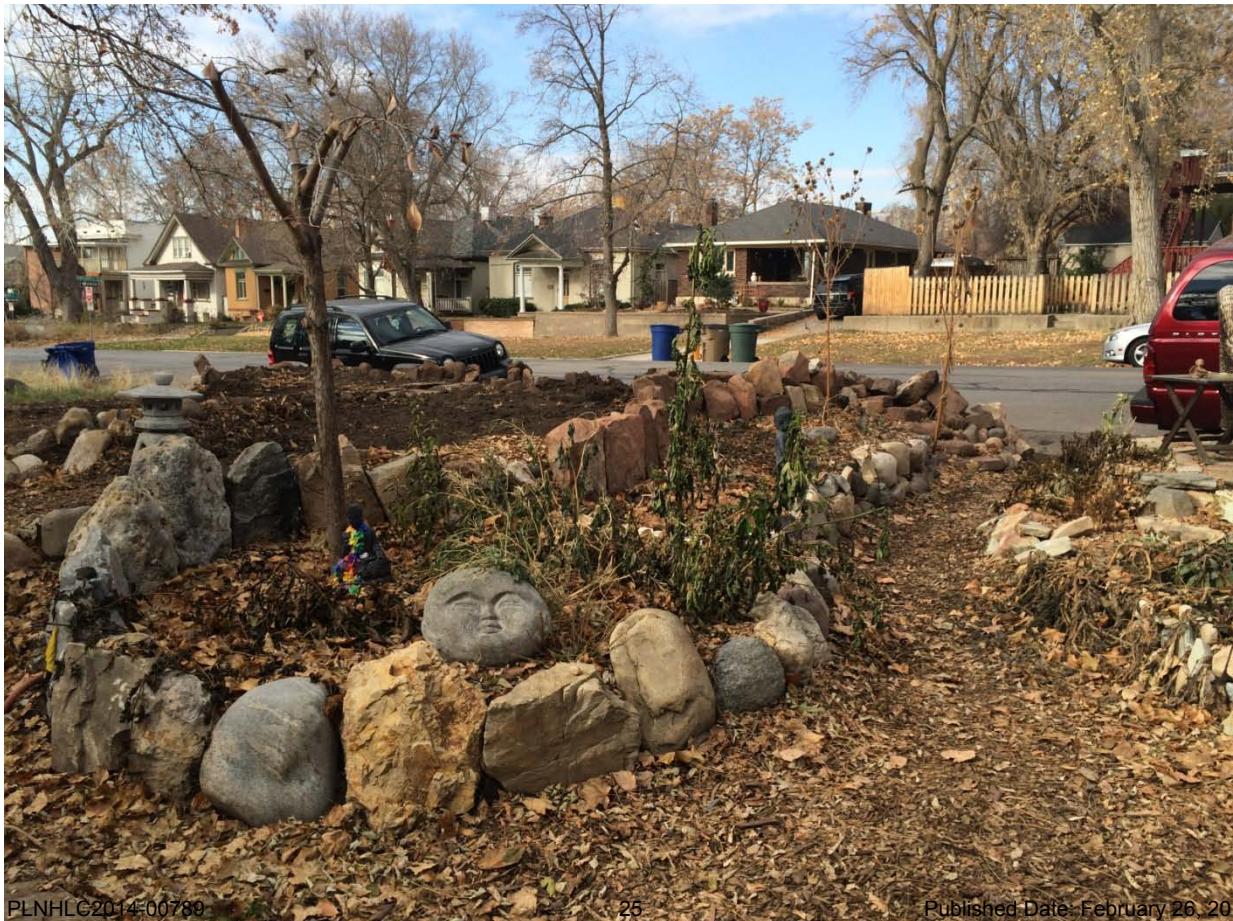
North Park Strip, looking northwest

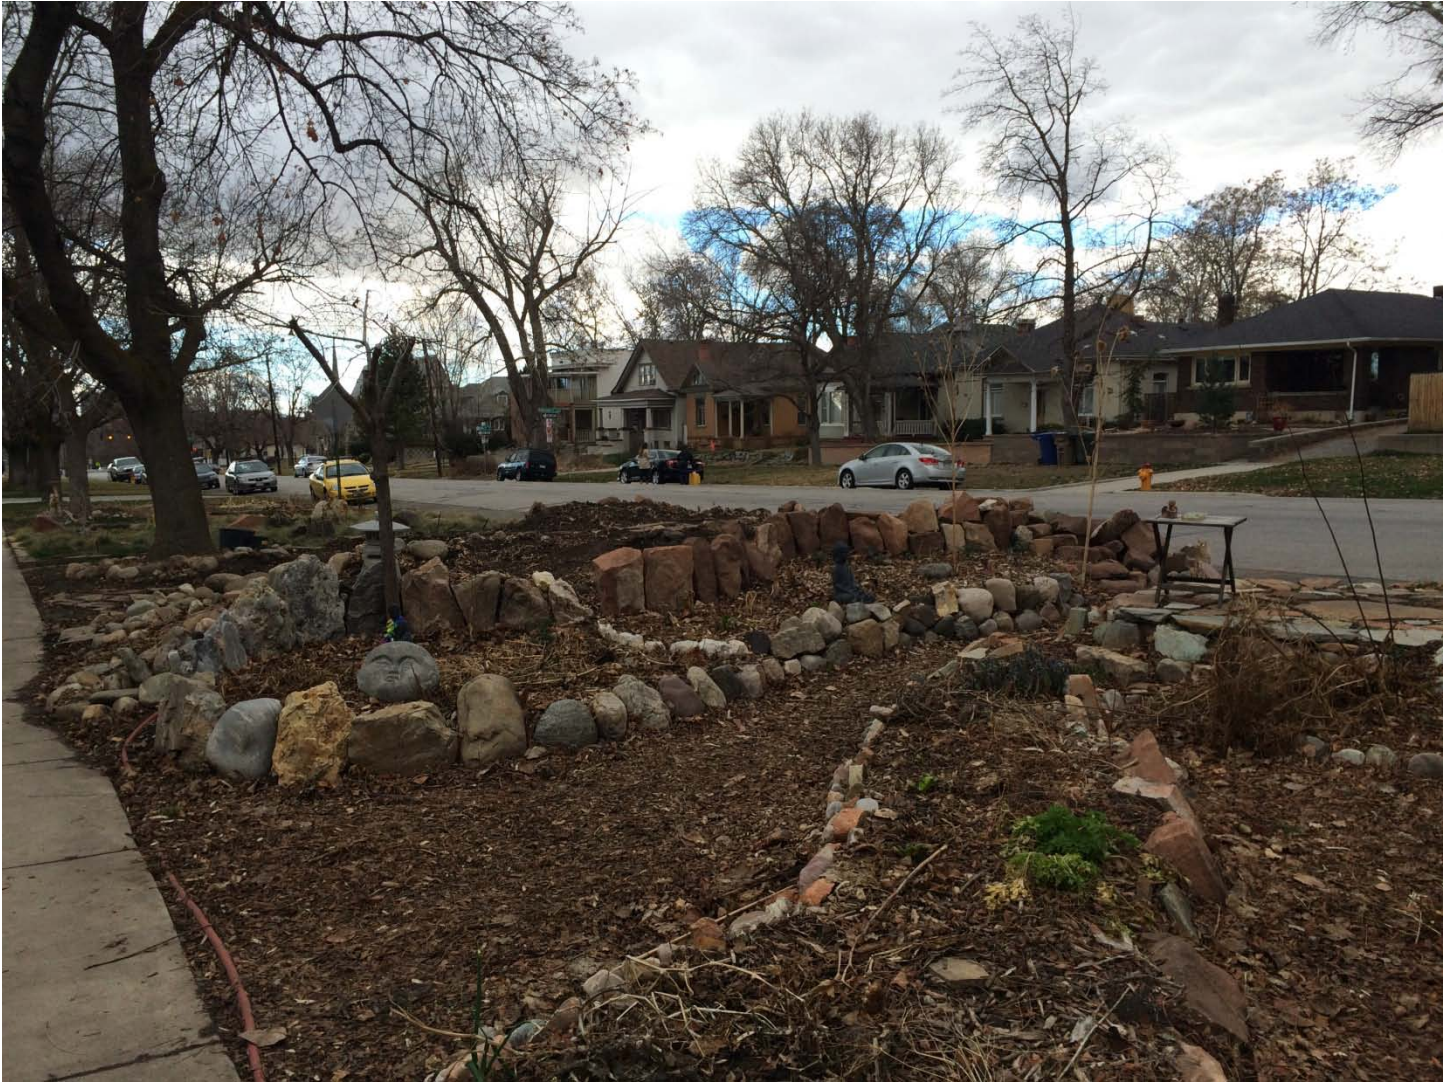
East Park Strip – looking northeast

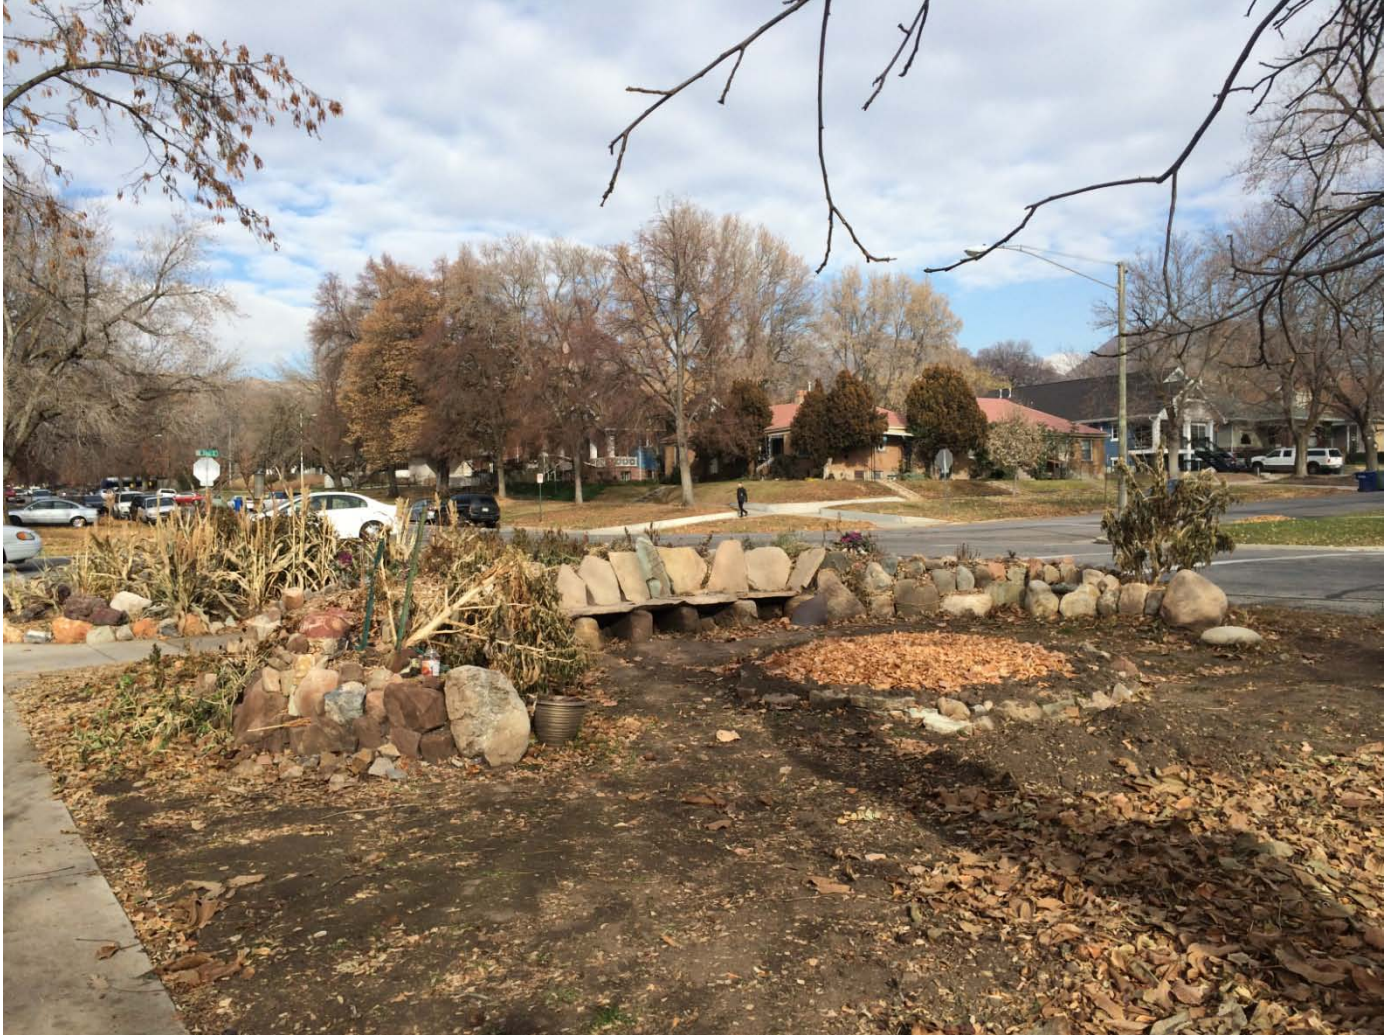
East Park Strip – looking north

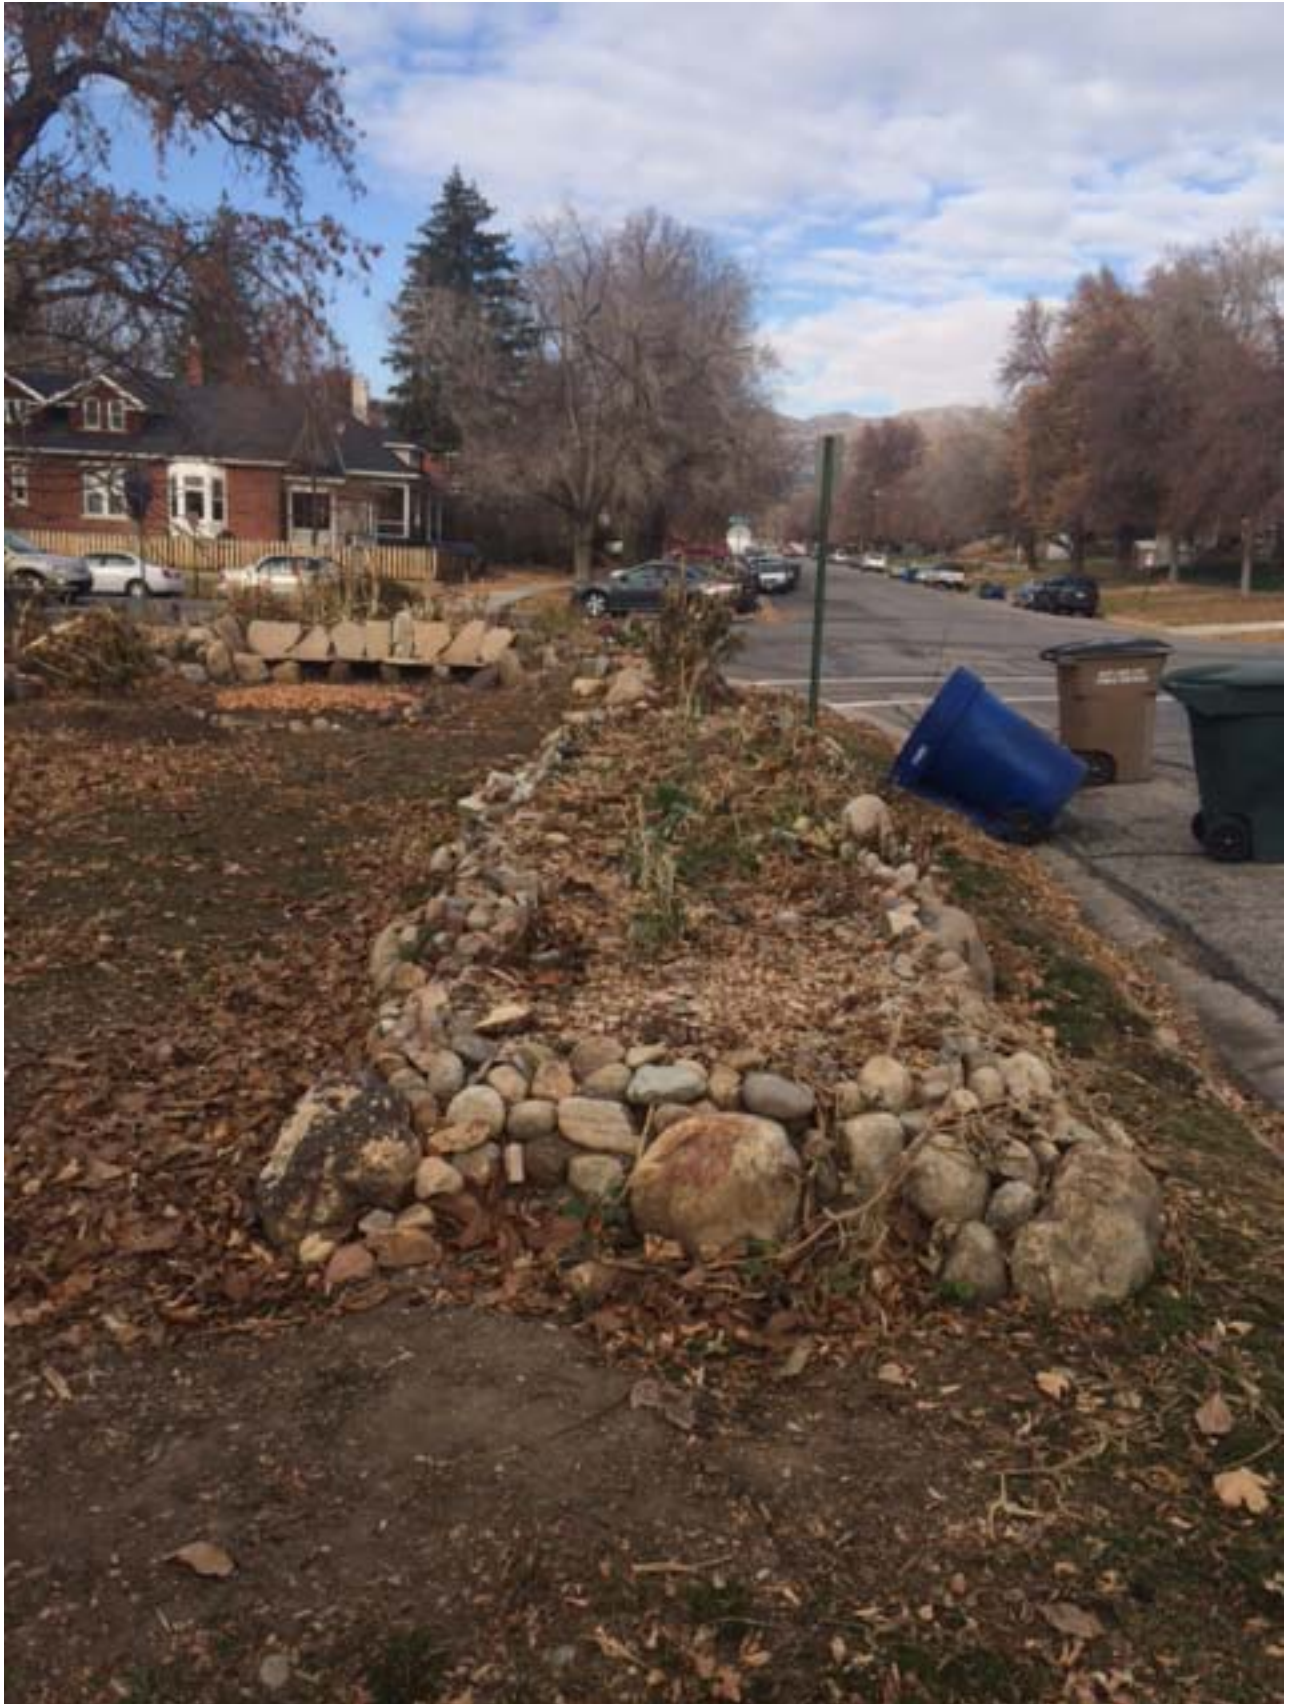
East Park Strip – looking south
