Staff Report

To: Salt Lake City Historic Landmark Commission

Re: ISSUES ONLY - KENSINGTON APARTMENTS SITE
PLNHLC2015-00247 – Relocation of City Landmark Building - 36 East 200 North
PLNHLC2015-00248 – Relocation of Contributing Building – 48 East 200 North
PLNHLC2015-00249 – Demolition of Contributing Accessory Garage – 180 N. Main Street
PLNHLC2015-00250 – Construction of New Parking Garage & Apartment Building – 180 N Main Street, 36 East 200 North, 48 East 200 North
PLNHLC2015-00251 – Special Exception Approvals – 180 N Main Street, 36 East 200 North, 48 East 200 North

RELOCATION OF CONTRIBUTING & LANDMARK BUILDINGS, DEMOLITION OF CONTRIBUTING ACCESSORY STRUCTURE, NEW CONSTRUCTION, SPECIAL EXCEPTIONS

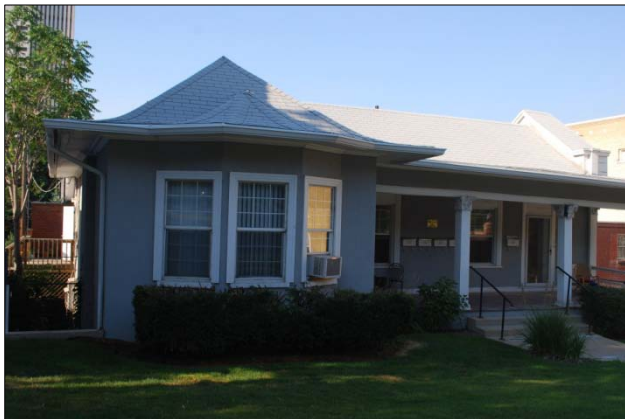
J. Golden Kimball House, 36 East 200 North

Facing 200 North, at 36 East, is the **Kimball House (J. Golden)**, which is a Landmark Building on the Salt Lake City Register of Cultural Resources, and is identified as a category 'A' Architecturally Significant building in the 2006 Capitol Hill Survey. The house, the home of J. Golden Kimball until 1938, is one story in height to the front and two stories to the rear. The house appears to have been initially constructed between 1875 and 1880, with the original structure built of adobe brick on a cobblestone foundation. The house was subsequently extended in c. 1946 with an east wing of frame construction, with this wing extended again towards the parking garage. It is currently subdivided into apartments.

Current proposals involve separating the main floor of the house from its foundation and lower level, supporting it and moving it south during construction of the garage, and relocating it back close to its original position above the new garage. It would be slightly forward and slightly higher in elevation than its current position. The lower level and the foundation of the house would be demolished. It is proposed that the rock foundation from the building would be salvaged and replaced to face the newly constructed parking garage

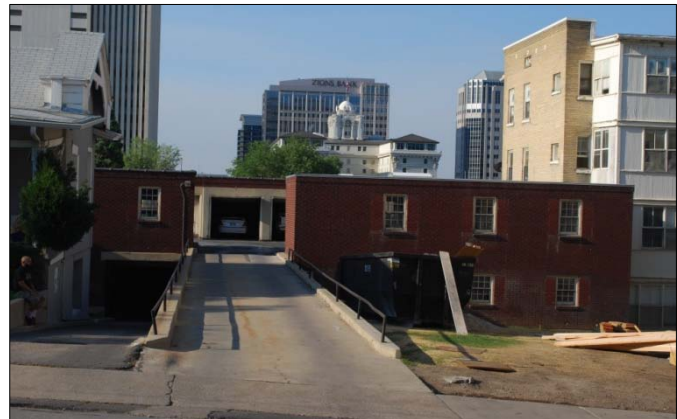
Kensington Parking Garage, 200 North

The present two level **parking garage** is set back from and also set well below the street, effectively rising one story above the level of 200 North, with two stories to the rear. The building dates to c.1930, is designed in period revival style, and is identified as a category 'B' contributing building in the Capitol Hill Historic District and 2006 survey. It abuts the east side of the Kensington Apartment buildings and is an accessory structure of the apartments. The building is accessed from 200 North by separate vehicular ramps to each parking floor, with direct and stair access from the apartments.

The current two story structure was designed as a parking garage for the Kensington Apartments in approximately 1930 and is constructed primarily from red brick and concrete. The structure, designed in period revival residential style, is identified as a contributing building in the Capitol Hill Historic District. It accommodates 38 parking spaces for the adjacent Kensington Apartments. Currently the structure is in need of extensive repair, with a Certificate of Appropriateness approved for repairs in May 2014.

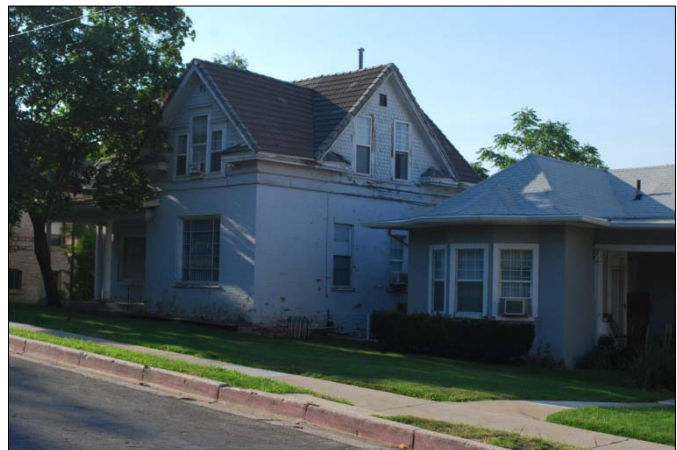
Moroni H Kimball House, 48 East 200 North

Adjacent to the east, is 48 East 200 North, the **Moroni H. Kimball House**. This building of one and a half stories was constructed in c. 1888, and is identified as a category 'B' contributing building in the Capitol Hill Historic District and 2006 survey. It is constructed of brick with a stone foundation, with a later rear addition of concrete block construction. The house is currently subdivided into apartments

The current proposal for this building is to brace the structure, lift it off its current foundation, move it south during construction of the new parking garage, then relocate it in its current position on the site on top of new foundations placed on top of the new garage. The later addition of concrete block construction would be

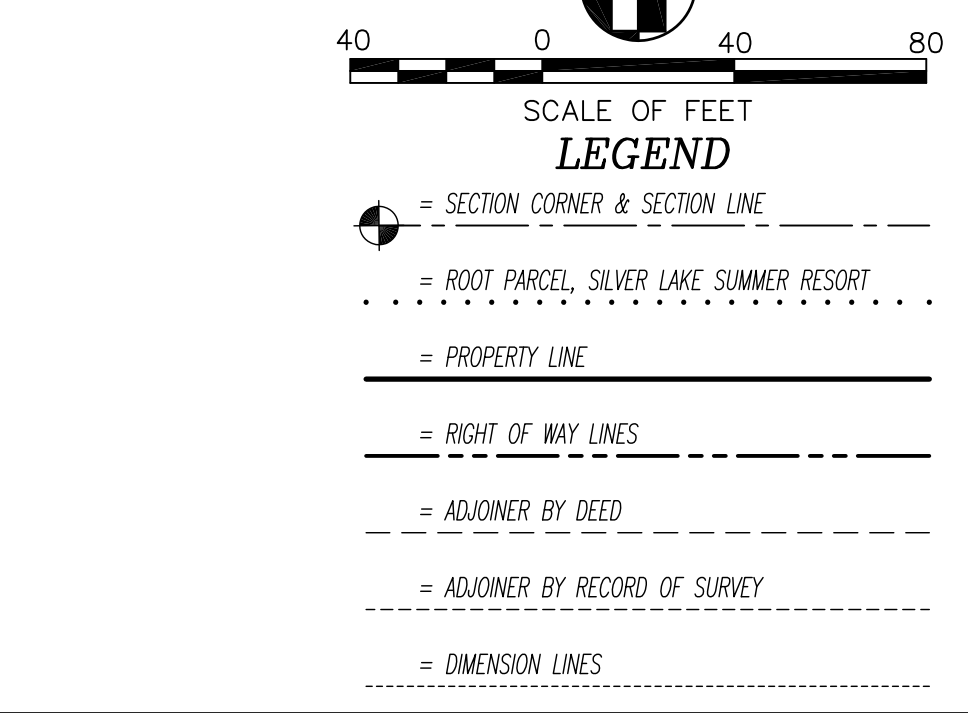
DATE: 09-03-13
SCALE: 1"=40'
PROJECT NUMBER: 1313001

ALTA ACSM SURVEY KENSINGTON APARTMENTS
A PART OF LOTS 5 & 6 BLOCK 93 PLAT "A" SLC SURVEY
LYING AND SITUATE IN THE SOUTHWEST QUARTER OF SECTION 31,
TOWNSHIP 1 NORTH, RANGE 1 EAST, SALT LAKE BASE AND MERIDIAN

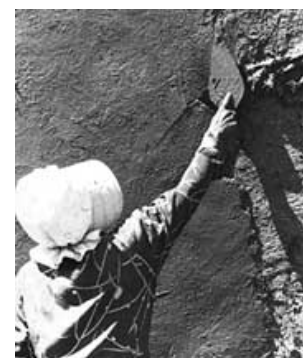
Traditional adobe repair. Photo: Russell Lee, Farm Security Administration Collection, Library of Congress.

Whether built in the 17th century or in the 20th century, adobe buildings share common problems of maintenance and deterioration. This brief discusses the traditional materials and construction of adobe buildings and the causes of adobe deterioration. It also makes recommendations for preserving historic adobe buildings. By its composition, adobe construction is inclined to deteriorate; however, the buildings can be made durable and renewable when properly maintained.

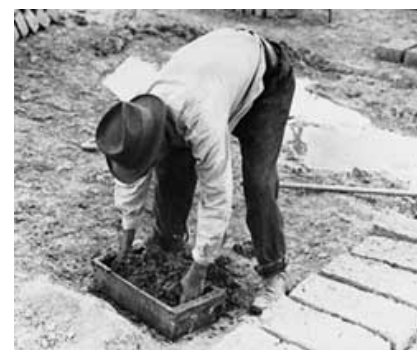
A mixture of mud and straw is pressed into a mold to form an adobe brick. After the adobe brick is removed from the mold, it must dry in the open air for a month or more before it can be used. Photo: Russell Lee, Farm Security Administration Collection, Library of Congress.

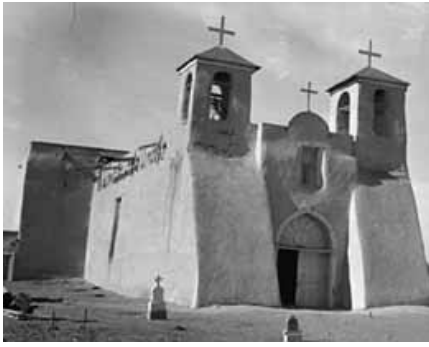
San Francisco de Assisi Mission Church in Rancho de Taos, NM, was constructed of adobe between 1772 and 1819 and, because of its distinctive sculptural quality, is one of the most famous and frequently photographed of the mission churches. Photo: HABS Collection, NPS.

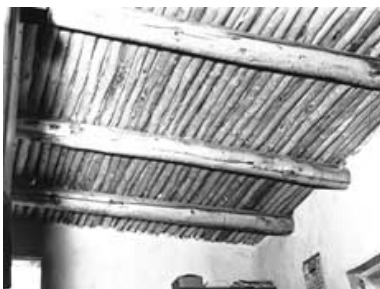
Viga logs and savinos are seen in the interior of the adobe building. Often the wooden materials that comprise the traditional flat adobe roof create interesting and pleasing patterns on the ceilings of interior rooms. Photo: Russell Lee, Farm Security Administration Collection, Library of Congress

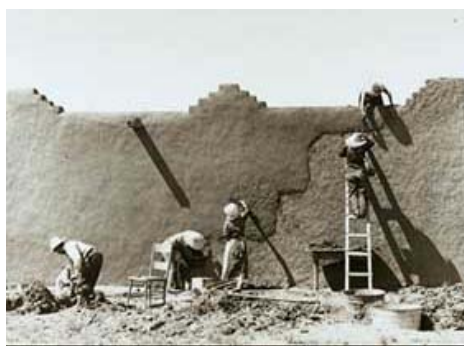
Traditionally, adobe surface coatings that protected the fragile adobe building fabric were renewed every few years. Women are seen here recoating an adobe wall with mud plaster mixed with straw at Chamisal, New Mexico. Photo: Russell Lee, Farm Security Administration Collection, Library of Congress.

Adobe surfaces are notoriously fragile and need frequent maintenance. To protect the exterior and interior surfaces of new adobe walls, surface coatings such as mud plaster, lime plaster, whitewash, and stucco have been used. Such coatings applied to the exterior of adobe construction have retarded surface deterioration by offering a renewable surface to the adobe wall. In the past, these methods have been inexpensive and readily available to the adobe owner as a solution to periodic maintenance and visual improvement. However, recent increases in labor costs and changes in cultural and socioeconomic values have caused many adobe building owners to seek more lasting materials as alternatives to these traditional and once inexpensive surface coatings.

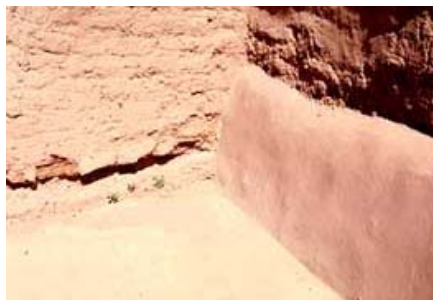
Coving at the base of this adobe wall may have been caused by salts deposited by rising groundwater and/or rainwater splash. Photo: NPS files.

The erosive action of rainwater and the subsequent drying out of adobe roofs, parapet walls, and wall surfaces can cause furrows, cracks, deep fissures, and pitted surfaces to form. Rain saturated adobe loses its cohesive strength and sloughs off forming rounded corners and parapets. If left unattended, rainwater damage can eventually destroy adobe walls and roofs, causing their continued deterioration and ultimate collapse. Standing rainwater that accumulates at foundation level and rain splash may cause "coving" (the hollowing-out of the wall just above grade level).

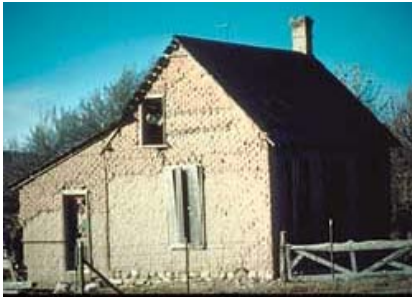
A traditional mixture of mud and straw plaster should be applied to stabilize the exterior of this house. Photo: NPS files.

In patching and replacing adobe brick, every reasonable effort should be made to find clay with a texture and color similar to the original fabric. When an individual adobe brick has partially disintegrated, it may be patched in place. The deteriorated material

may be scraped out and replaced with appropriate adobe mud. Often fragments of the original adobe brick have been ground up, mixed with water, and reused to patch the eroded area. However, some professionals advise against the reuse of material which has spalled off because it frequently contains a high concentration of salts.
