Staff Report

To: Salt Lake City Historic Landmark Commission
From: Amy Thompson, Associate Planner
amy.thompson@slcgov.com
Date: July 16, 2015
Re: **PLNHLC2015-00305** – 1030 E 2nd Avenue: Contributing Status & Facade Renovations

MAJOR ALTERATIONS

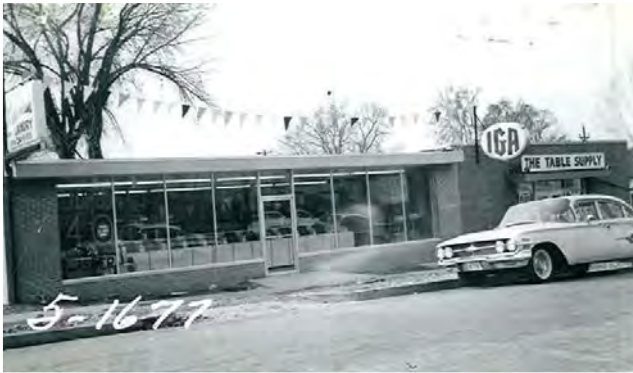
Circa 1956. Photo obtained from Salt Lake County Archives

The subject property was constructed in 1955 and is a classic example of mid-century modern style. The building is rectilinear in form, with a flat roof, large glass storefront aluminum framed windows and brick exterior. The design of the structure is simple with limited or no ornamentation and horizontal emphasis to present a streamlined industrial quality that was typical of this style of post World War II architecture. Many buildings from this era are newly contributing resources to Local Historic Districts and it’s important to understand the opportunities for

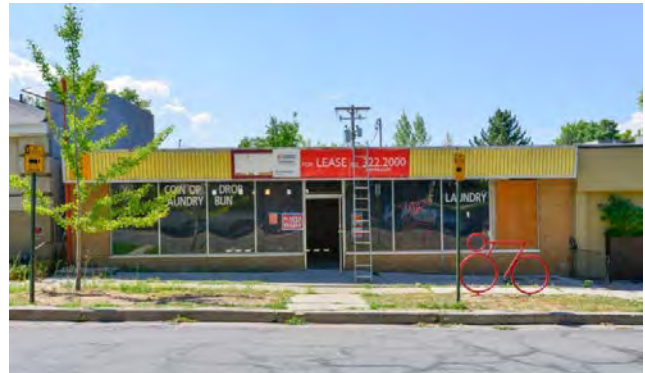
Existing Conditions

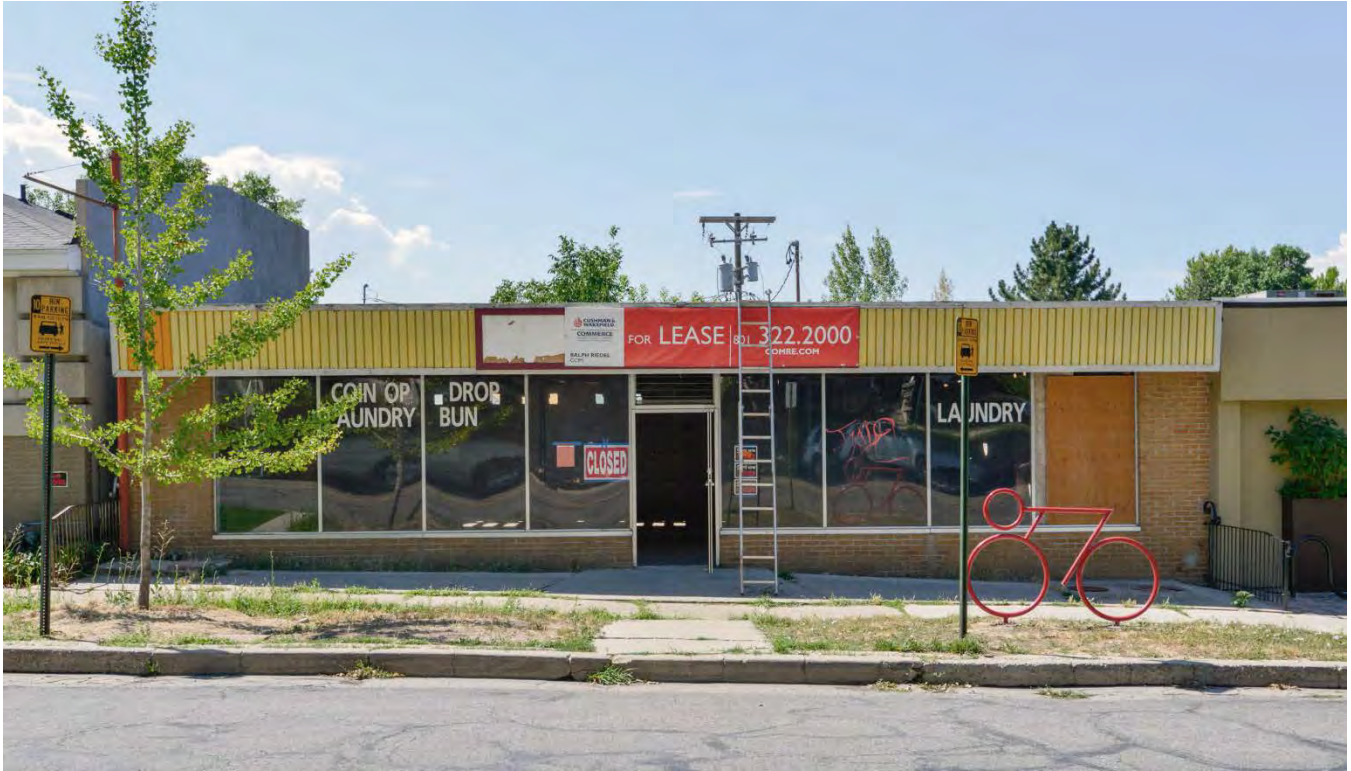
Existing facade of the subject property

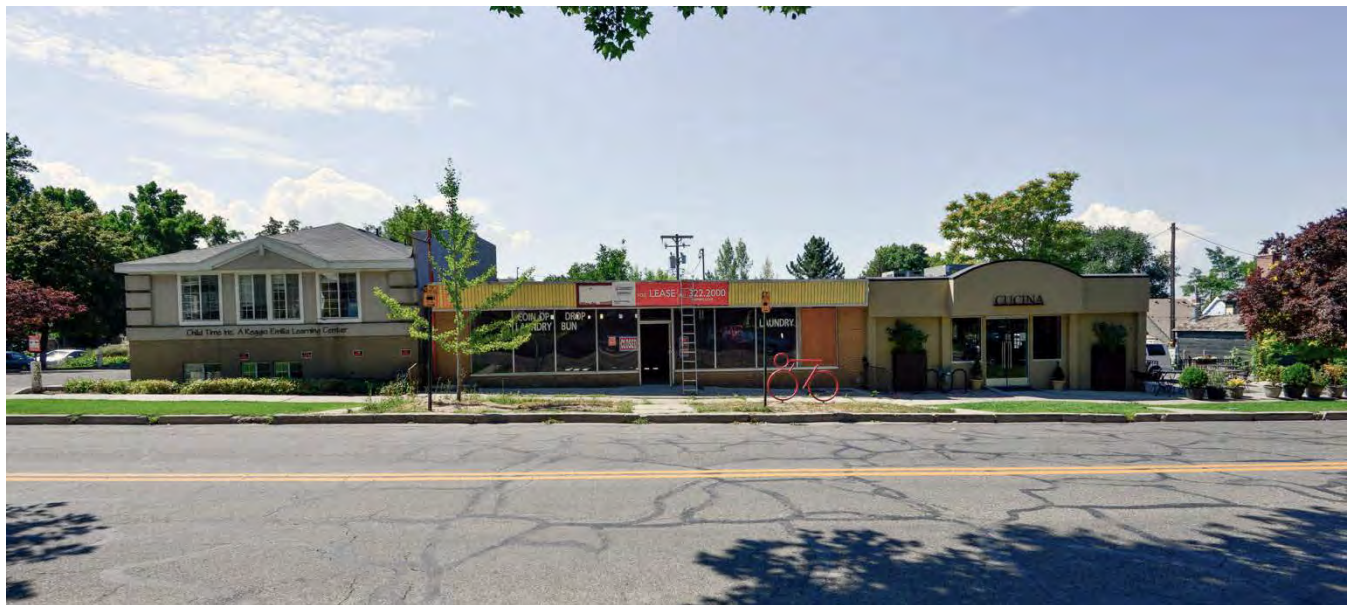
View of subject building (1030 E) and adjacent buildings

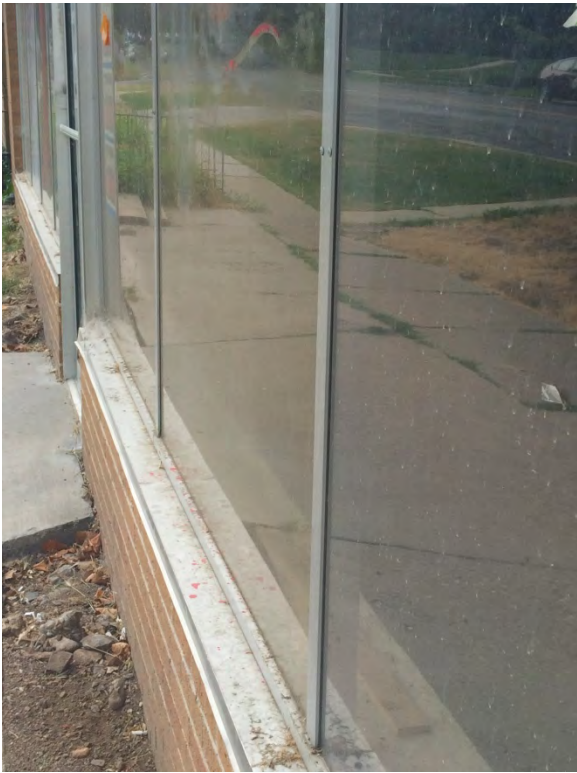
Close-up view of existing aluminum framed storefront windows

Windows be repaired or appropriately replaced: Staff recommends that repair and insulation of the existing storefront windows is considered as an option over replacement. If it's determined the windows are beyond repair, Staff recommends that replacement of the storefront windows be approved with the conditions as noted in the recommended motion.

<p>Standard 6: Deteriorated architectural features shall be repaired rather than replaced wherever feasible. In the event replacement is necessary, the new material should match the material being replaced in composition, design, texture and other visual qualities. Repair or replacement of missing architectural features should be based on accurate duplications of features, substantiated by historic, physical or pictorial evidence rather than on conjectural designs or the availability of different architectural elements from other structures or objects.</p>	<p>With conditions applied, the project complies: Storefront Windows</p> <p>Does not comply: Exterior cladding, new entry columns, new entry doors</p>	<p>Experimental technologies and production line construction made Mid-Century modern buildings innovative, drastically and permanently changing the construction field. It is the same innovation however which threatens the long term preservation of these buildings as the materials used have proven to have shorter lives than their traditional counterparts. The request to replace the dilapidated storefront windows with new insulated glazing; however the fenestration of the new windows alters the existing open visual qualities of the building. Part of the request is to replace the existing single glass aluminum framed door and transom window with new frameless glass double entry doors. There is no historical evidence that suggests this request is a historically accurate duplication of this feature. As a condition of approval, Staff is recommending the existing window system is repaired, and if it's determined that the window is beyond repair, the replacement window shall match in terms of compositions, design, fenestration and size. With conditions applied as recommended by Staff, replacement of the storefront window meets this standard.</p>

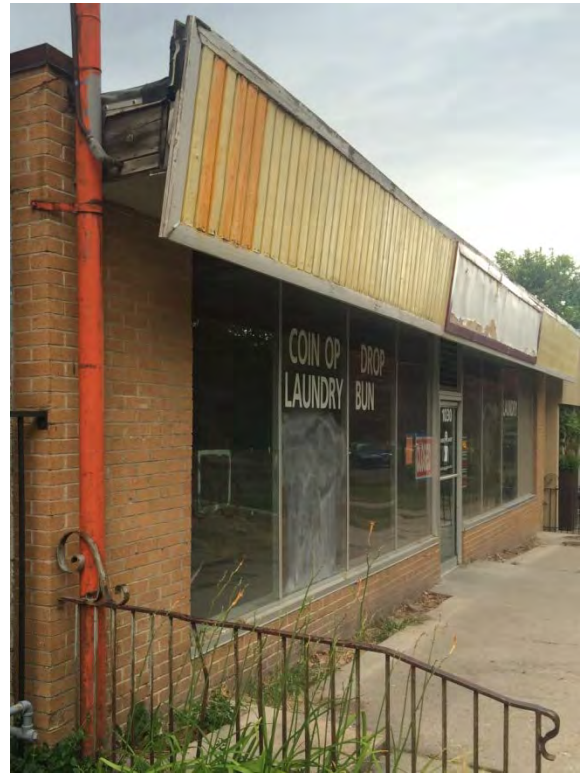
View of existing wood fascia

<p>Standard 4: Alterations or additions that have acquired historic significance in their own right shall be retained and preserved.</p>	<p>With conditions applied, the project complies</p>	<p>As part of the request, the existing wood fascia would be replaced with new aluminum panels on plywood sheathing over existing fascia framing. The existing wood fascia was a later addition to the building and the proposed height of the new aluminum fascia will be reduced by approximately 1 foot, which brings the height closer to the height of the fascia that was original to the building. Where the new entryway columns are proposed, the proposed fascia will project approximately 18 inches beyond the rest of the fascia profile. The architecture of this building is characterized by simple lines and altering the fascia profile is not consistent with the character of the building. As a condition of approval, staff is recommending that the fascia does not project and maintains the profile of the existing fascia band. With conditions applied, this standard is met.</p>

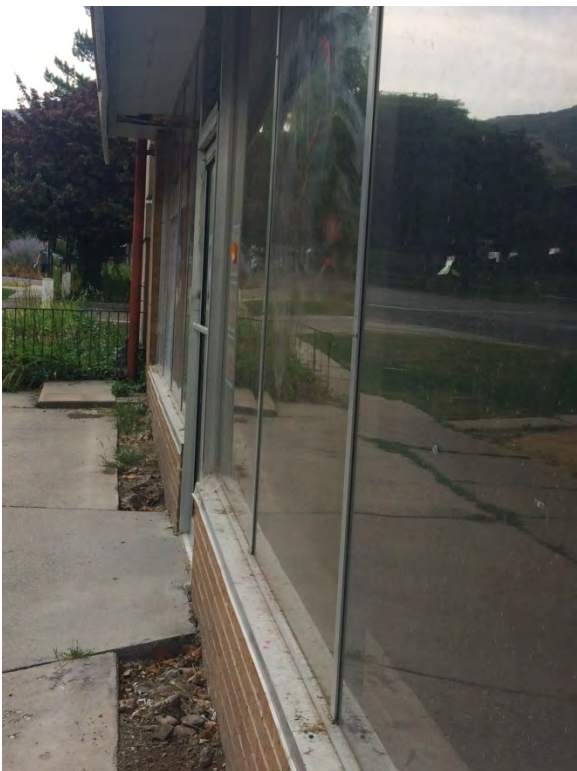
Existing building profile looking east

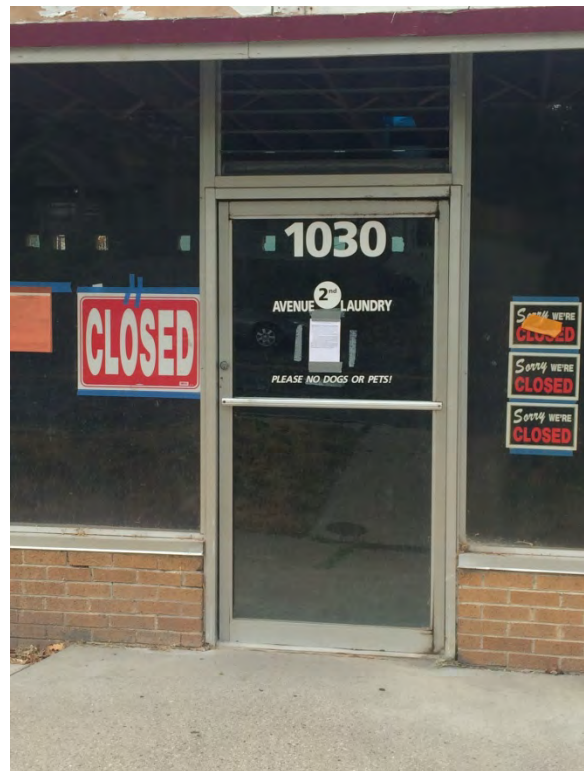
Existing single aluminum framed glass door

Doors: Replacement of the existing single glass aluminum framed door with new frameless glass double entry doors.

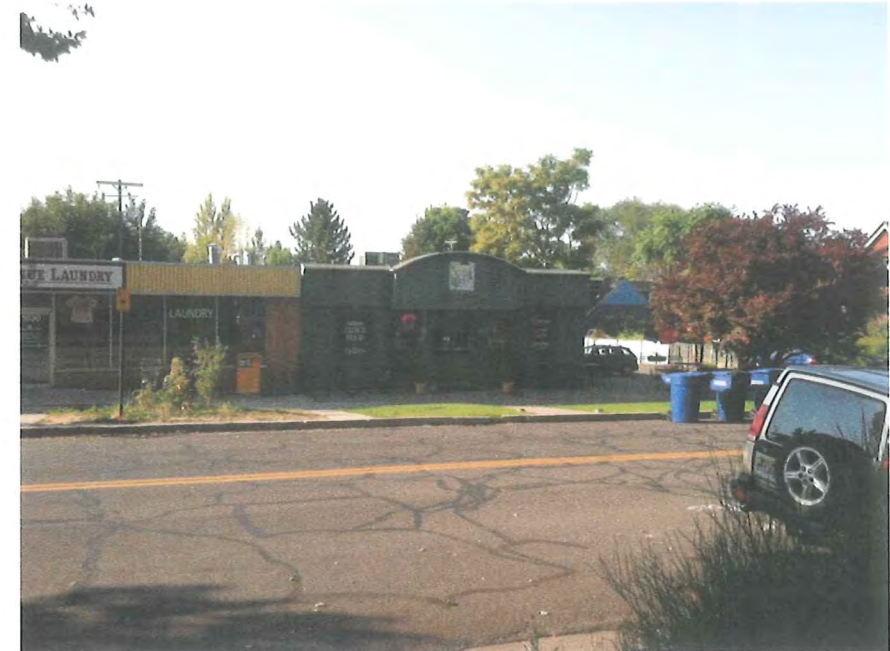
EXISTING CONTEXT
DELI WITH LAUNDROMAT NEXT DOOR.

EXAMPLES OF FACADE FALLING APART

THE GENERAL SCOPE OF WORK IS TO REPLACE THIS EXISTING POORLY CONSTRUCTED FACADE WITH SOMETHING SIMILAR BUT WITH MORE DURABLE MATERIALS SUCH AS A CONCRETE STUCCO WITH A SMOOTH FINISH.

THE SCALE AND ARTICULATION WILL REMAIN THE SAME. THE APPLIED DECORATION WILL GO AWAY FOR A CLEANER LOOK AND MORE IN KEEPING WITH THE SIMPLICITY OF THE ORIGINAL 1940'S BUILDING.

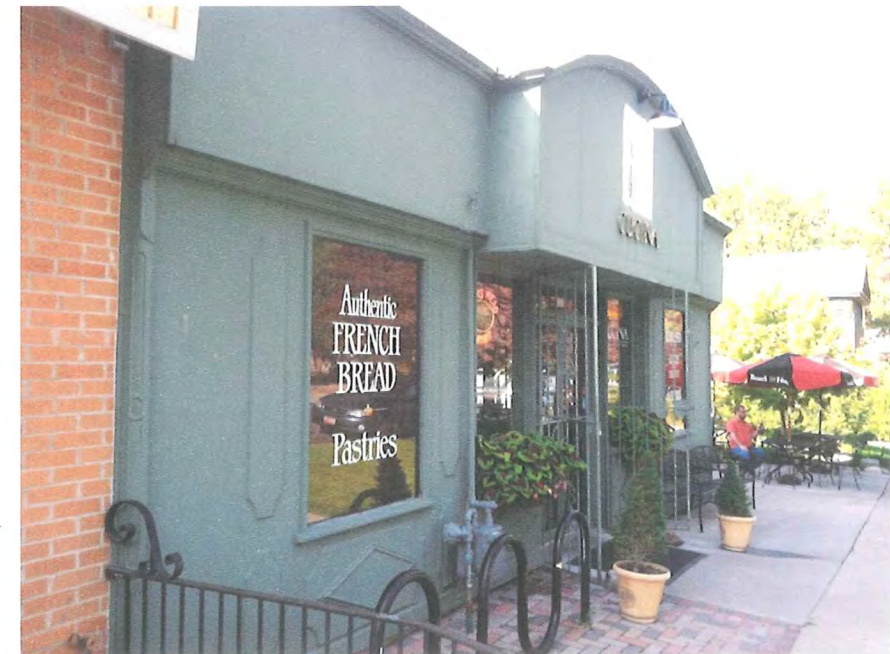
EXISTING DELI FACADE
